**INDIAN CREEK FLUVIAL GEOMORPHOLOGY STUDY,  
OLATHE, KANSAS**

**Final report to Olsson Associates for  
the City of Olathe, Kansas**

**November 26, 2013**

**OEWRI EDR-13-004**

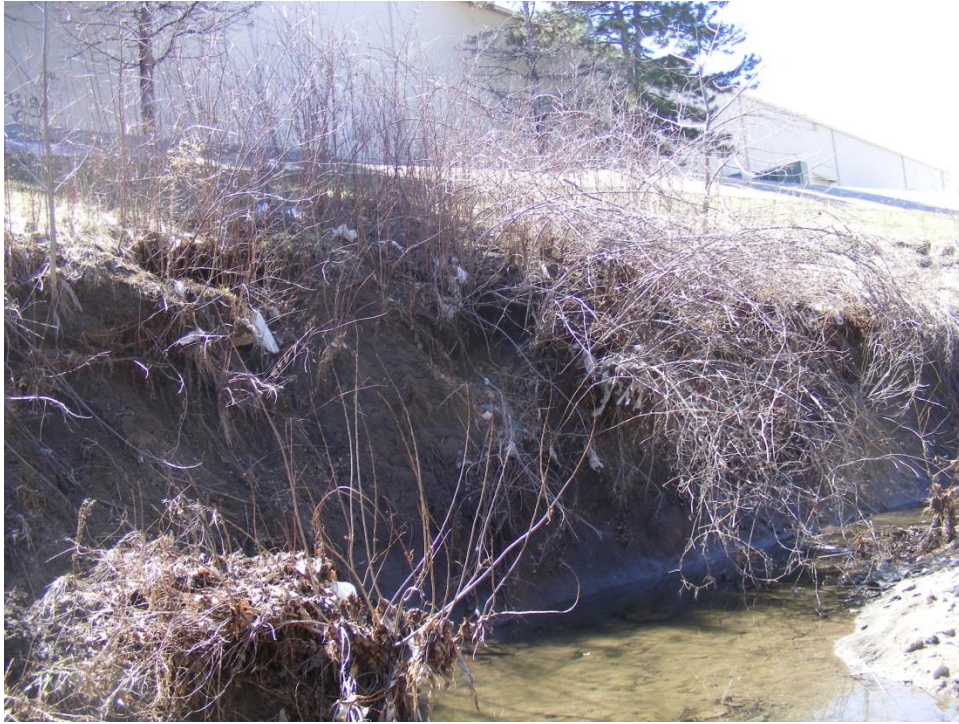
1. Bank erosion and failure risk-commercial property – Channel migration or channel widening poses a threat to commercial property that may include a building or parking lots (Photo 1). Level of concern is based on proximity to the property and the bank showing indicators of erosion such as bank angle, erosion scars, and newly uncovered tree roots.

Photo 1. Example of problem type 1. Bank erosion and failure risk-commercial property

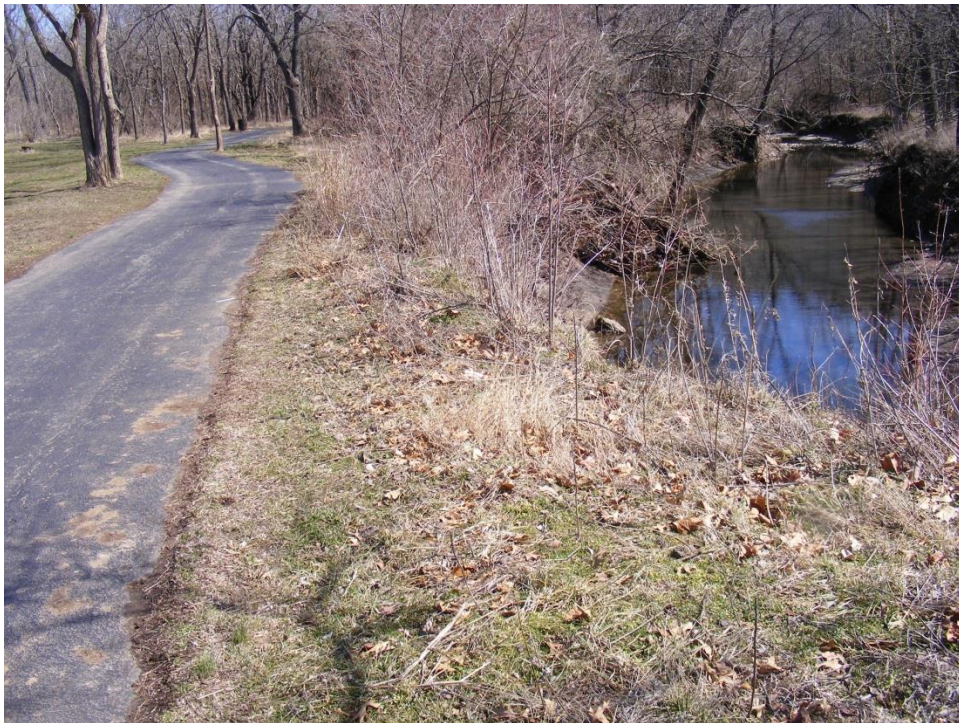
2. Bank erosion and failure risk-greenway trail - Channel migration or channel widening poses a threat to a greenway trail (Photo 2). Much of the main channel has a greenway trail constructed adjacent to the stream. Level of concern is based on proximity to the trail and the bank showing indicators of erosion such as steepness of the bank angle, presence of recent erosion scars, and newly uncovered tree roots.

Photo 2. Example of problem type 2. Bank erosion and failure risk-greenway trail

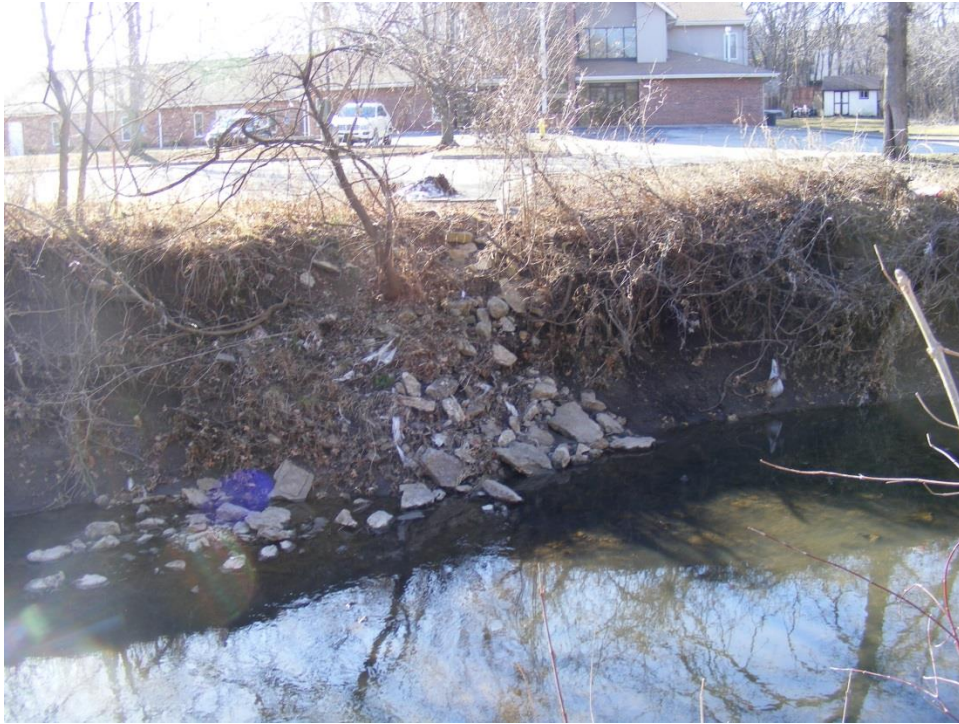
3. Bank erosion and failure risk-public building - Channel migration or channel widening poses a threat to a public owned building that may also include the parking lot (Photo 3). Level of concern is based on proximity to the property and the bank showing indicators of erosion such as steep bank angle, erosion scars, and newly uncovered tree roots.

Photo 3. Example of problem type 3. Bank erosion and failure risk-public building

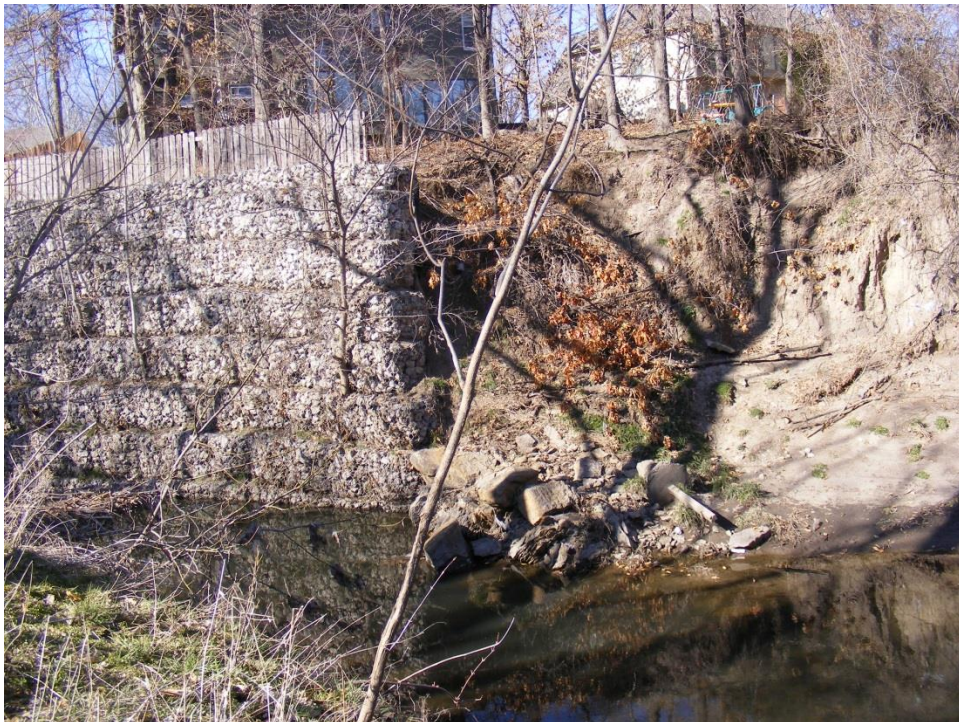
4. Bank erosion and failure risk-residential private - Channel migration or channel widening poses a threat to residential private property (Photo 4). This may include channel encroachment on the property line that may threaten fences or outbuildings. Level of

concern is based on proximity to the property and bank erosion indicators such as bank angle, fresh erosion scars, and newly uncovered tree roots.

Photo 4. Example of problem type 4. Bank erosion and failure risk-residential private

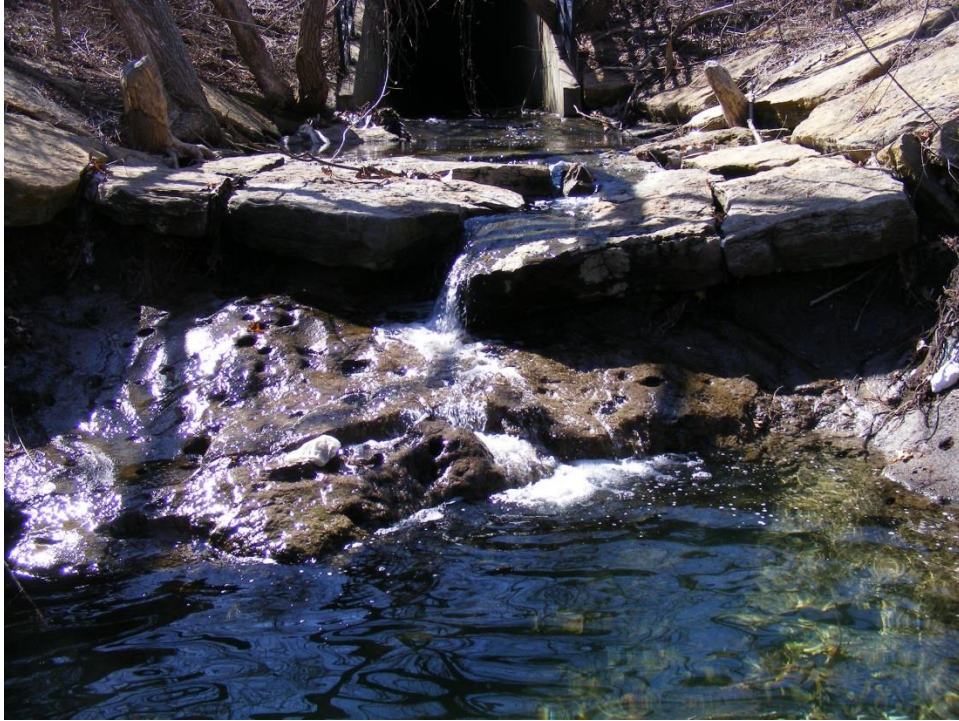
5. Bed erosion/undermining at bridge - Channel incision, or down-cutting has compromised the integrity of a bridge (Photo 5). Typically this will occur on the downstream footing when a headcut moves upstream lowering the stream bed or when a deep scour pool is formed downstream that undermines the bridge footing or wingwalls. Level of concern is based on the depth of the stream bed below the footing and any signs of failure to the bridge structure.

Photo 5. Example of problem type 5. Bed erosion/undermining at bridge

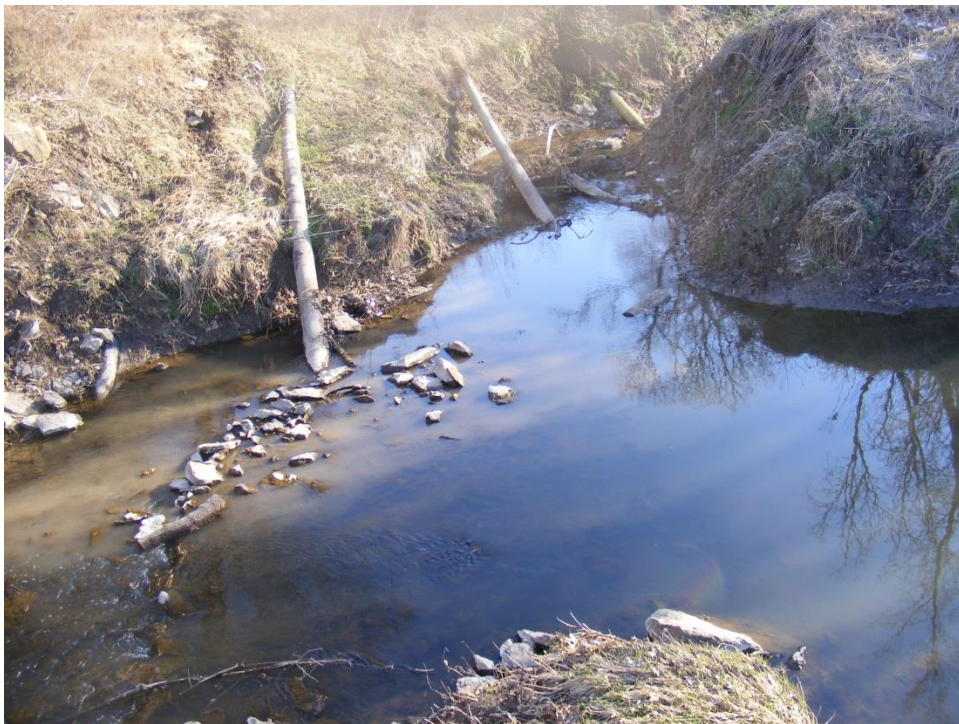
6. Exposed pipes or cables due to erosion - Occurs when channel migration or channel widening expose utility lines in the channel bank, or when channel incision exposes utilities in the bed of the stream (Photo 6). Level of concern is based on the type and degree of exposure, as well as presence of bank erosion indicators such as bank angle, fresh erosion scars, and newly uncovered tree roots

Photo 6. Example of problem type 6. Exposed pipes or cables due to erosion

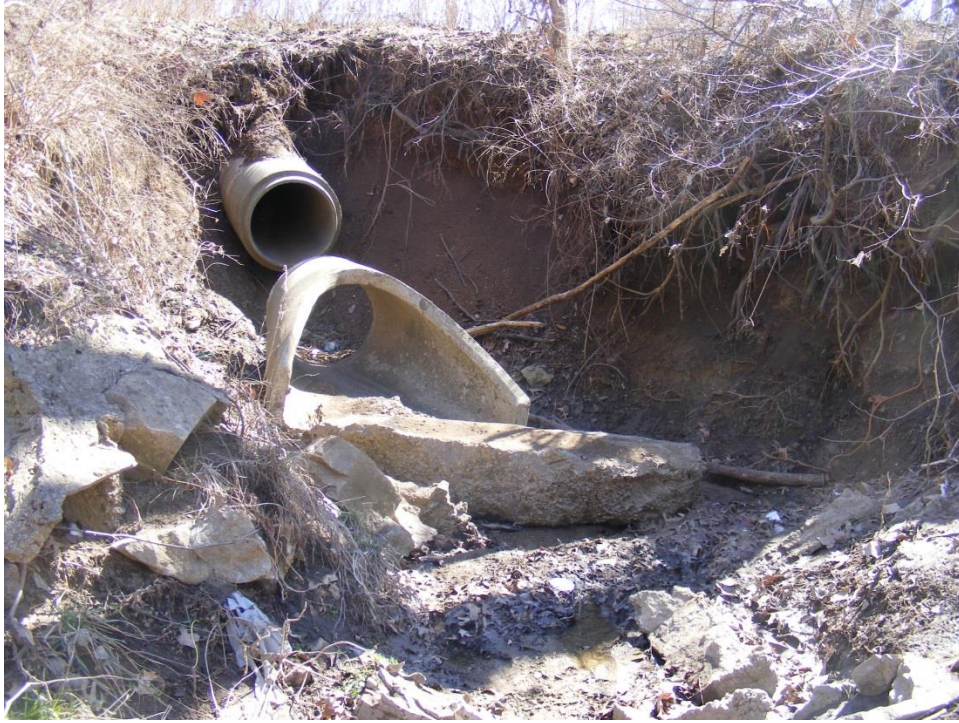
7. Failed culvert/inlet due to undermining - This occurs when flow carried through a pipe to the stream outlet undermines, or scours, below the apron causing bank erosion to occur (Photo 7). In some cases an attempt to stop the bank scour has occurred with rip-rap or large flat bedrock slabs. Level of concern is based on the severity of erosion around the pipe and any structural failure of the pipe or apron.

Photo 7. Example of problem type 7. Failed culvert/inlet due to undermining

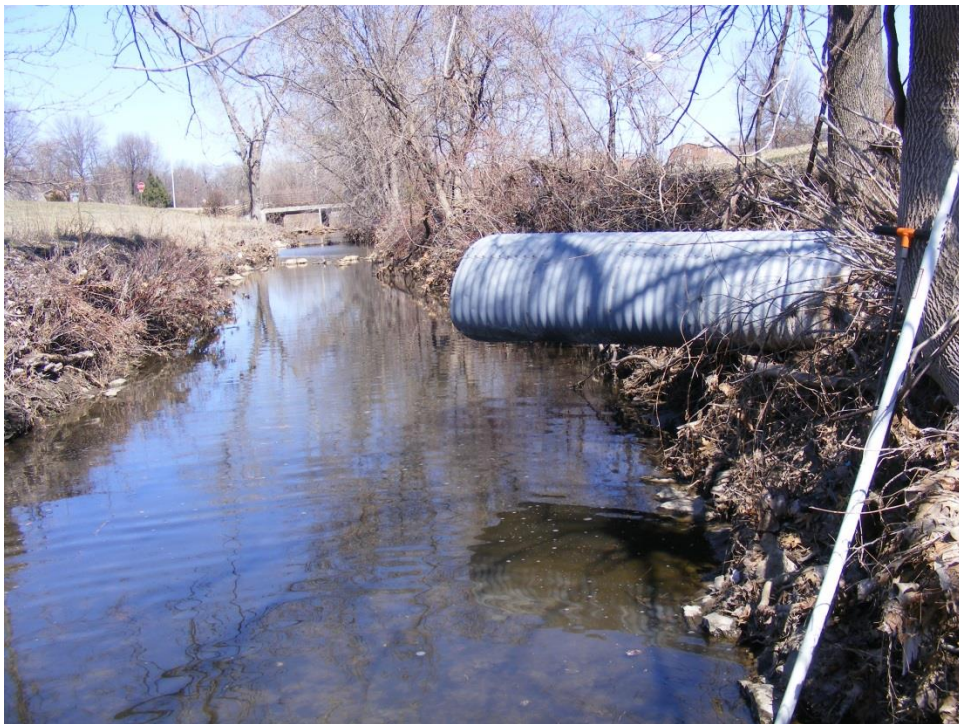
8. Hanging culvert or inlet due to incision - Bed incision has left a culvert outlet above, or “hanging” out over the bed of the stream (Photo 8). In many cases the apron and last section of pipe may have fallen into the stream creating a flow obstacle inducing local bank erosion and bed scour. Level of concern is based on the severity of erosion, the distance from the pipe to the bed, and presence of structural failure of the pipe or apron.

Photo 8. Example of problem type 8. Hanging culvert or inlet due to incision.

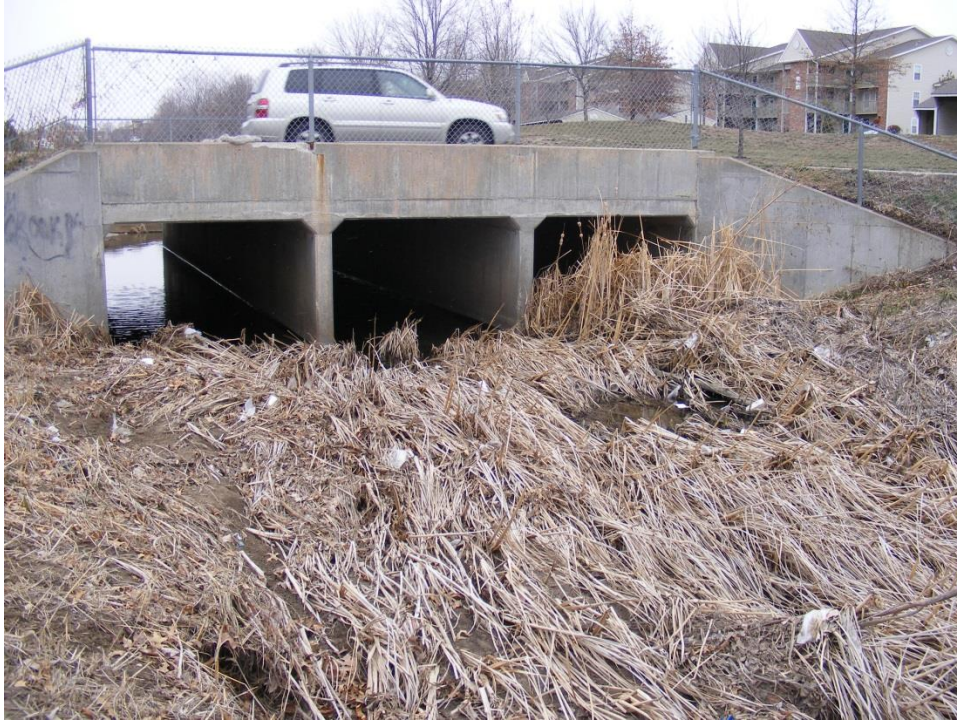
9. Sedimentation inside culvert decreasing flow capacity – Over-widened culvert cells or bridges can accumulate sediment that will decrease the ability of the structure to pass flood flows. Clogged culverts can cause upstream flooding and sedimentation problems. Level of concern is based on the degree of which the cell is blocked.

Photo 9. Example of problem type 9. Sedimentation inside culvert decreasing flow capacity.

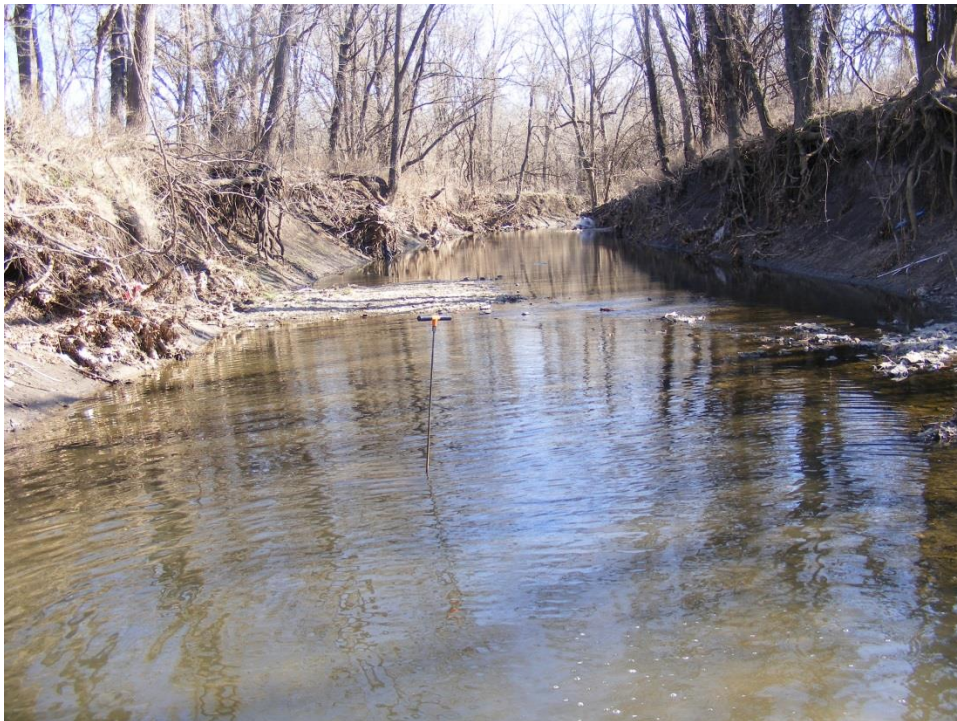
Results of the main channel assessment suggest bank erosion is the major process creating infrastructure problems along the main channel of Indian Creek as it appears bedrock is limiting incision along much of the channel. Increased impervious surface in the watershed due to urban development has caused the main channel to enlarge from increased storm water loads. Channel width increases rapidly downstream going from about five feet in the upper main channel to about 40 ft about five miles downstream at station 10,000 ft (Table 3, Figure 4). At the same time channel depth increases at a much lower rate from about 5-10 ft at station 15,000 ft. This suggests bedrock that was observed along the bed has limited the ability of the channel to incise, as a result the channel is increasing its capacity through bank erosion (Photo 10). However, below station 8,000 ft, where there is a large bedrock knick point in the stream, evidence suggests the channel bed has lowered through incision as the banks are getting higher as the channel width is getting lower (Photo 11). This pattern on incision and bedrock control is likely to continue downstream beyond the limits of this study. Also, in the lower 8,000 feet of stream the channel appears to be migrating into high loess bluffs with houses built near the edge. The stability of the slope and the level of stability due to bedrock needs to be determined.

Photo 10. Example of main channel widening - high vertical banks, exposed tree roots, and slumping are indicators of erosion.

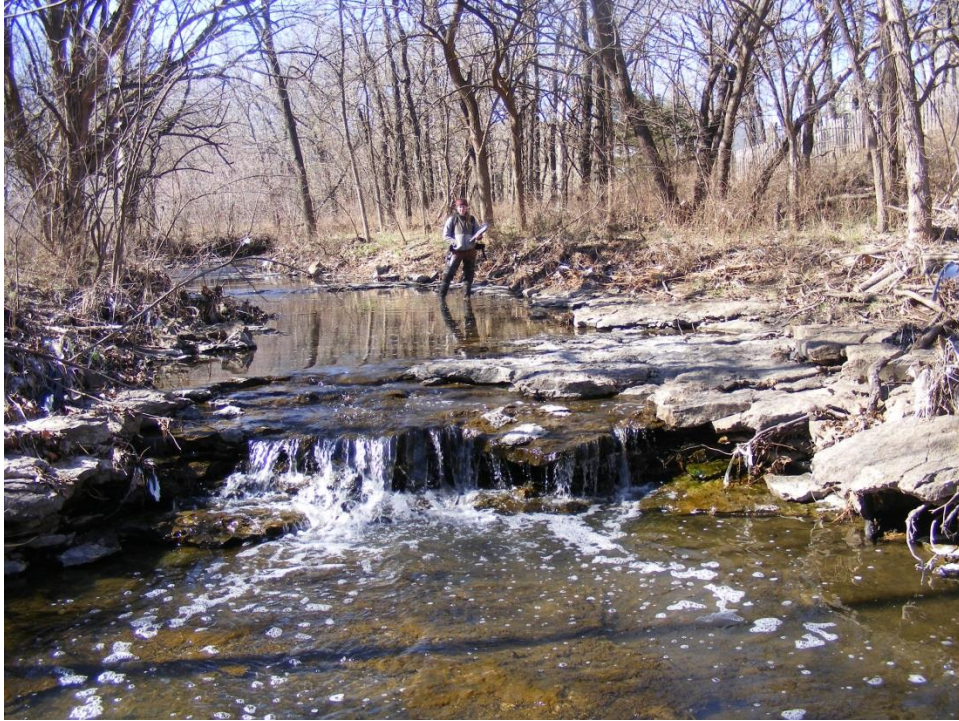
Photo 11. Bedrock knickpoints serve as natural grade controls in the main channel and in the lower reaches of many tributaries.

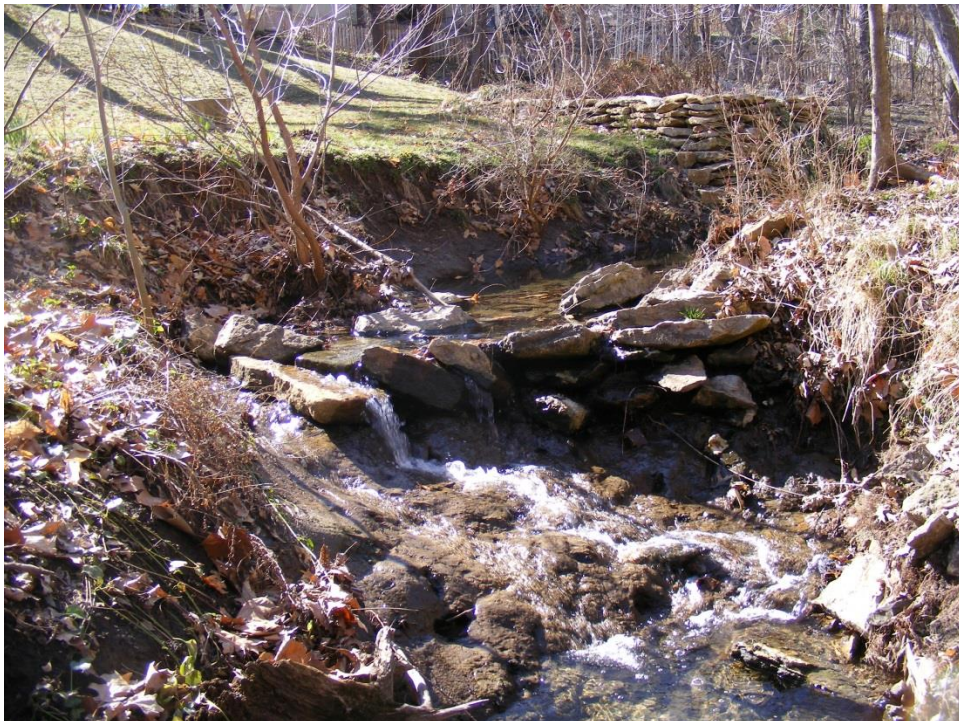
Photo 12. Headcuts are progressing upstream in most of the tributaries.

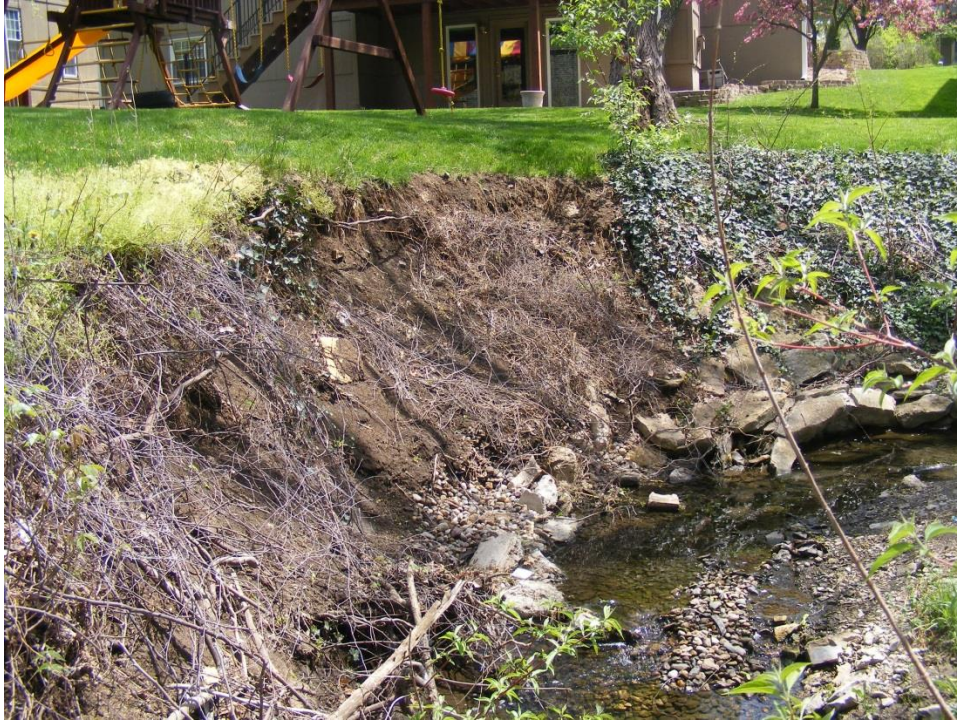
Photo 13. Lateral channel migration encroaches on to private property in areas downstream of headcuts.

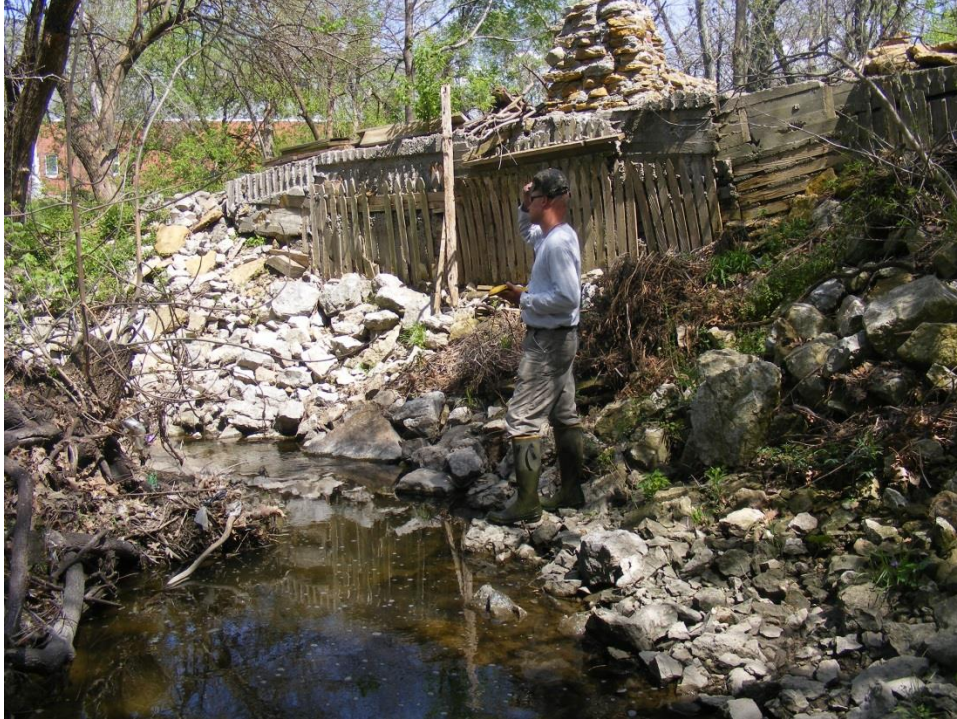
Channel incision is the major process impacting public infrastructure and private property along the tributaries within the Indian Creek watershed. Primary, secondary, and in some cases tertiary head cuts were observed in all tributaries investigated for this project (Photo 12). The lowering of the bed exposes utility crossings and undermines culverts as the head cuts progress upstream. Subsequent bank erosion has created a situation where liberated sediment is deposited downstream in areas of lower slope causing the lateral channel migration. Lateral migration creates problem areas in the tributaries when the channel meanders into private property and utilities (typically phone and cable lines) that are often placed adjacent to the back property lines (Photo 13). Furthermore, obstacles and other debris (homemade rip-rap, trees, trash etc.) along the tributaries add to local stream instability (Photo 14).

Photo 14. Local residents are trying to protect their land in areas where bank erosion threatens their property.
