**INDIAN CREEK FLUVIAL GEOMORPHOLOGY STUDY,
OLATHE, KANSAS**

**Final report to Olsson Associates for
the City of Olathe, Kansas**

November 26, 2013

OEWRI EDR-13-004

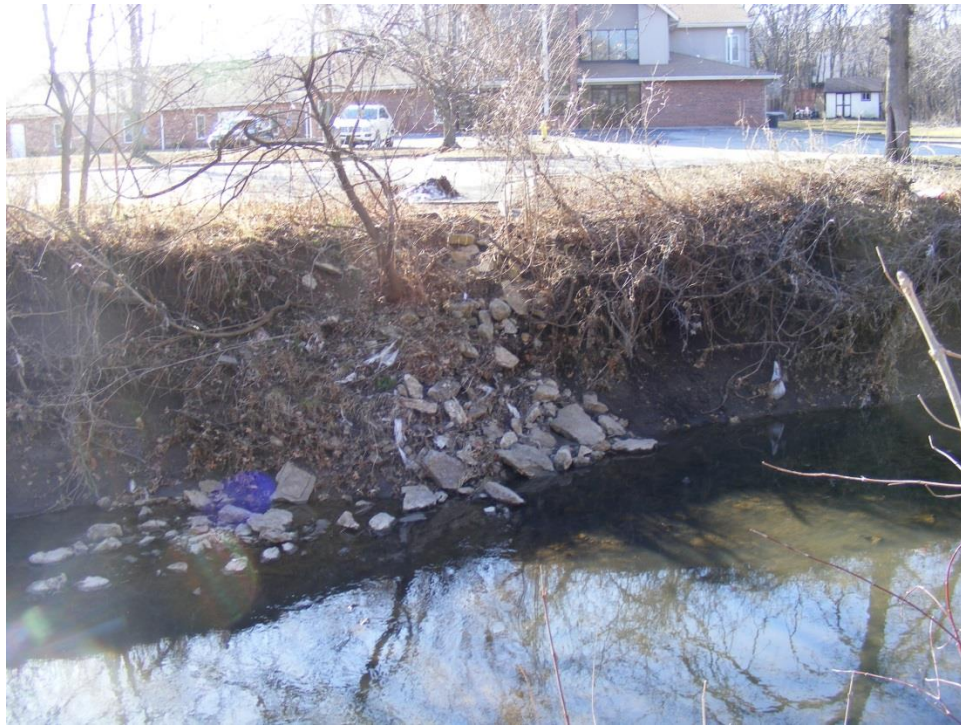
3. Bank erosion and failure risk-public building - Channel migration or channel widening poses a threat to a public owned building that may also include the parking lot (Photo 3). Level of concern is based on proximity to the property and the bank showing indicators of erosion such as steep bank angle, erosion scars, and newly uncovered tree roots.

Photo 3. Example of problem type 3. Bank erosion and failure risk-public building

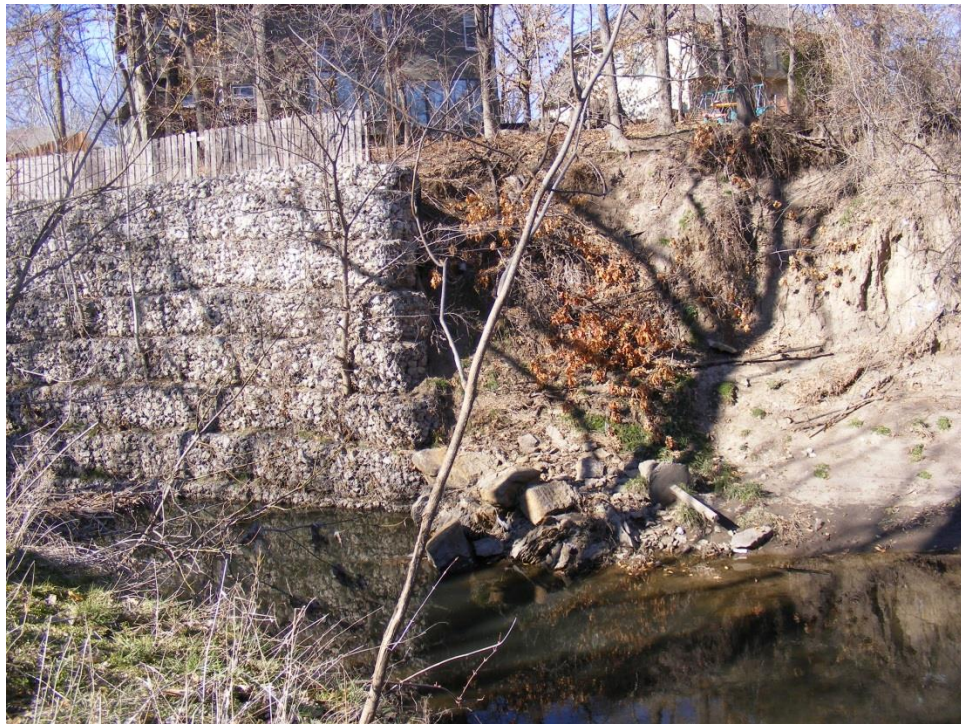
4. Bank erosion and failure risk-residential private - Channel migration or channel widening poses a threat to residential private property (Photo 4). This may include channel encroachment on the property line that may threaten fences or outbuildings. Level of

Photo 4. Example of problem type 4. Bank erosion and failure risk-residential private

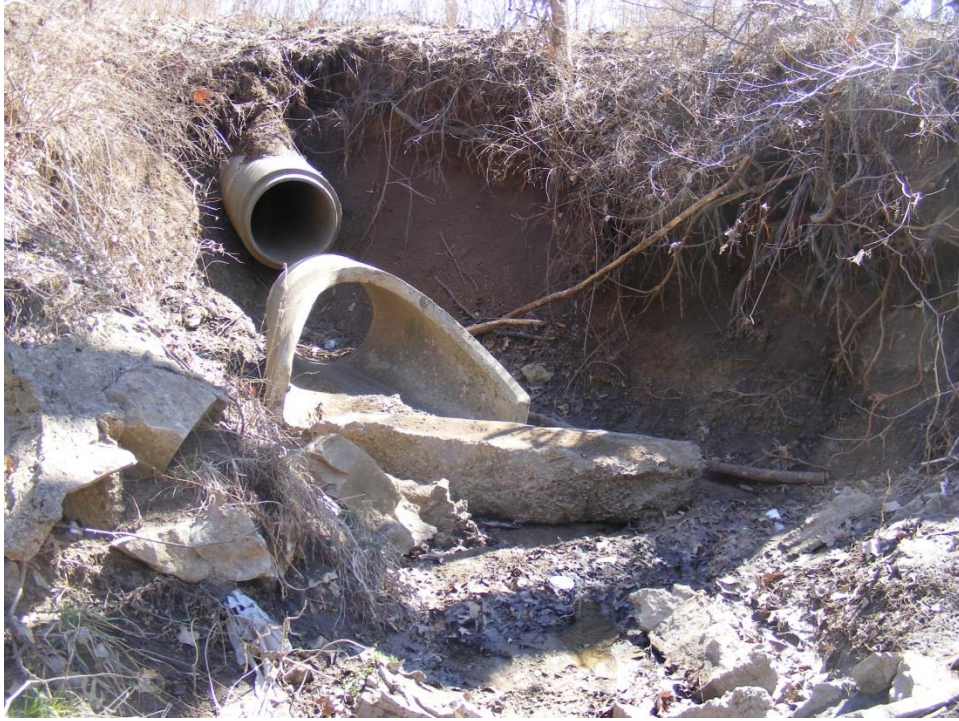
7. Failed culvert/inlet due to undermining - This occurs when flow carried through a pipe to the stream outlet undermines, or scours, below the apron causing bank erosion to occur (Photo 7). In some cases an attempt to stop the bank scour has occurred with rip-rap or large flat bedrock slabs. Level of concern is based on the severity of erosion around the pipe and any structural failure of the pipe or apron.

Photo 7. Example of problem type 7. Failed culvert/inlet due to undermining

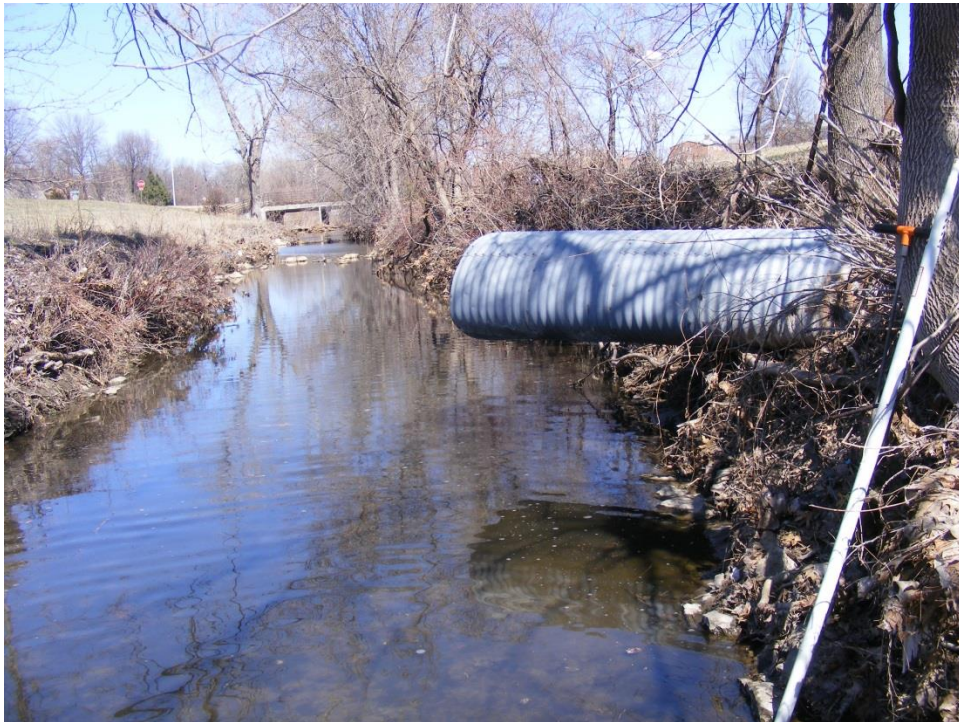
8. Hanging culvert or inlet due to incision - Bed incision has left a culvert outlet above, or “hanging” out over the bed of the stream (Photo 8). In many cases the apron and last section of pipe may have fallen into the stream creating a flow obstacle inducing local bank erosion and bed scour. Level of concern is based on the severity of erosion, the distance from the pipe to the bed, and presence of structural failure of the pipe or apron.

Photo 8. Example of problem type 8. Hanging culvert or inlet due to incision.

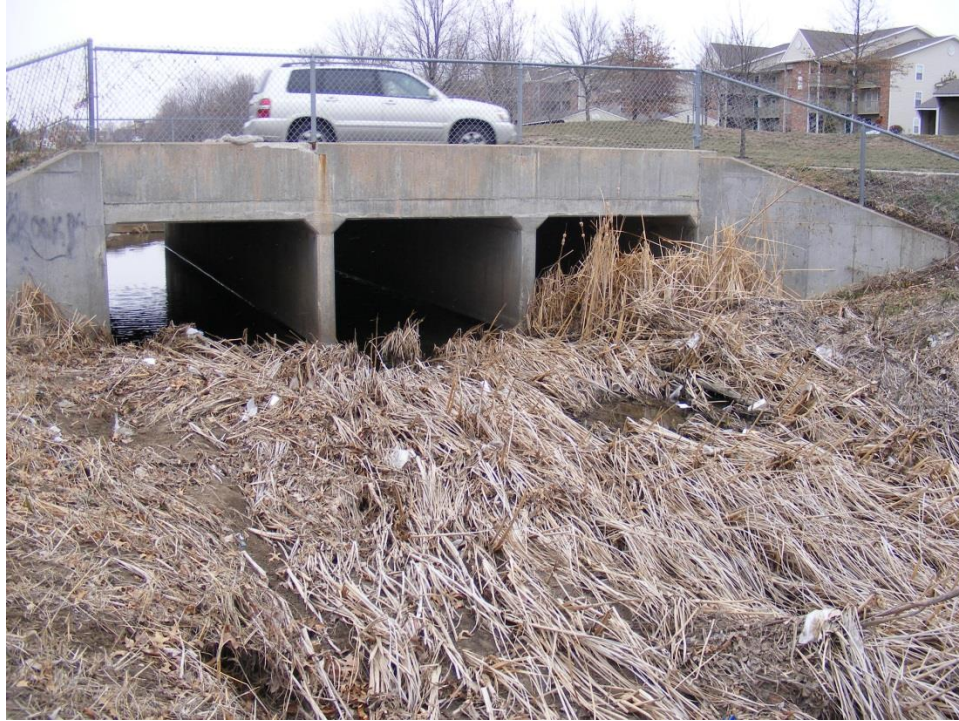
9. Sedimentation inside culvert decreasing flow capacity – Over-widened culvert cells or bridges can accumulate sediment that will decrease the ability of the structure to pass flood flows. Clogged culverts can cause upstream flooding and sedimentation problems. Level of concern is based on the degree of which the cell is blocked.

Photo 9. Example of problem type 9. Sedimentation inside culvert decreasing flow capacity.

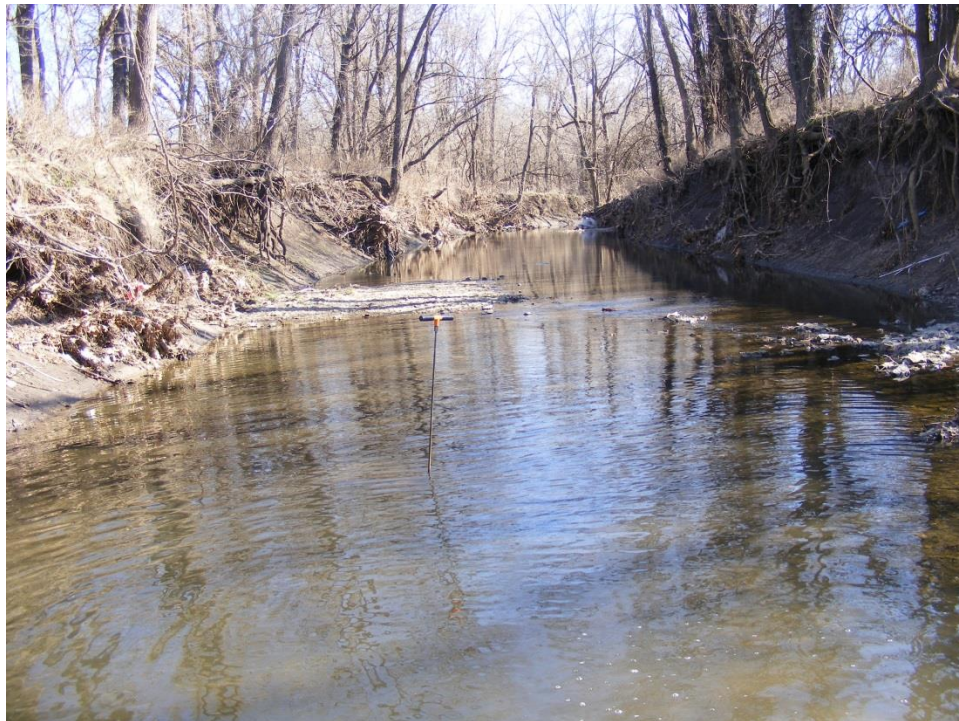
Results of the main channel assessment suggest bank erosion is the major process creating infrastructure problems along the main channel of Indian Creek as it appears bedrock is limiting incision along much of the channel. Increased impervious surface in the watershed due to urban development has caused the main channel to enlarge from increased storm water loads. Channel width increases rapidly downstream going from about five feet in the upper main channel to about 40 ft about five miles downstream at station 10,000 ft (Table 3, Figure 4). At the same time channel depth increases at a much lower rate from about 5-10 ft at station 15,000 ft. This suggests bedrock that was observed along the bed has limited the ability of the channel to incise, as a result the channel is increasing its capacity through bank erosion (Photo 10). However, below station 8,000 ft, where there is a large bedrock knick point in the stream, evidence suggests the channel bed has lowered through incision as the banks are getting higher as the channel width is getting lower (Photo 11). This pattern on incision and bedrock control is likely to continue downstream beyond the limits of this study. Also, in the lower 8,000 feet of stream the channel appears to be migrating into high loess bluffs with houses built near the edge. The stability of the slope and the level of stability due to bedrock needs to be determined.

Photo 10. Example of main channel widening - high vertical banks, exposed tree roots, and slumping are indicators of erosion.

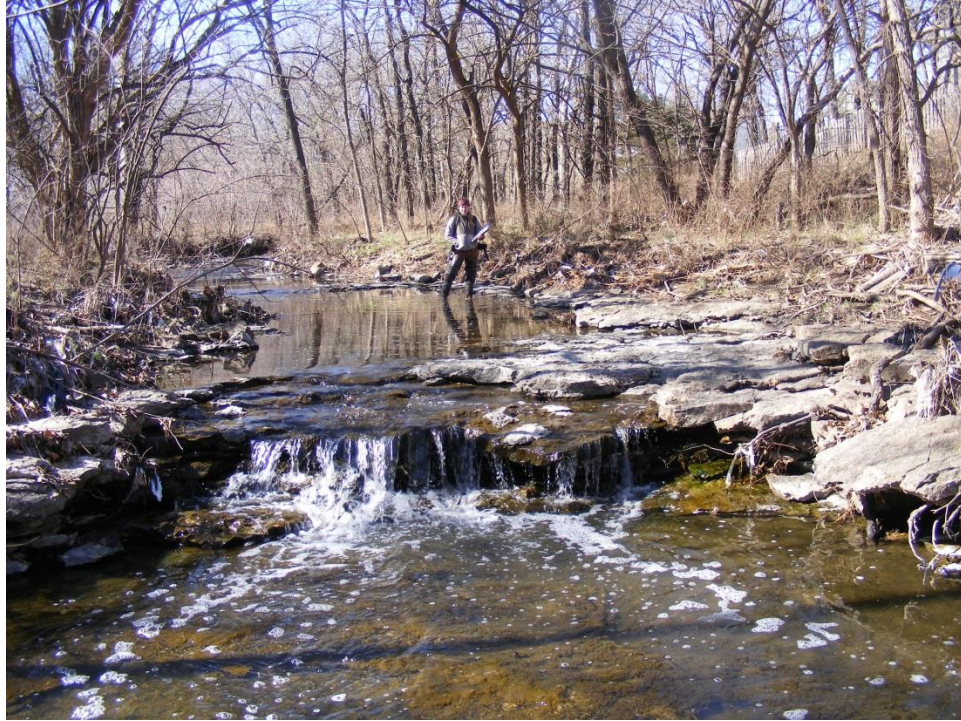
Photo 11. Bedrock knickpoints serve as natural grade controls in the main channel and in the lower reaches of many tributaries.

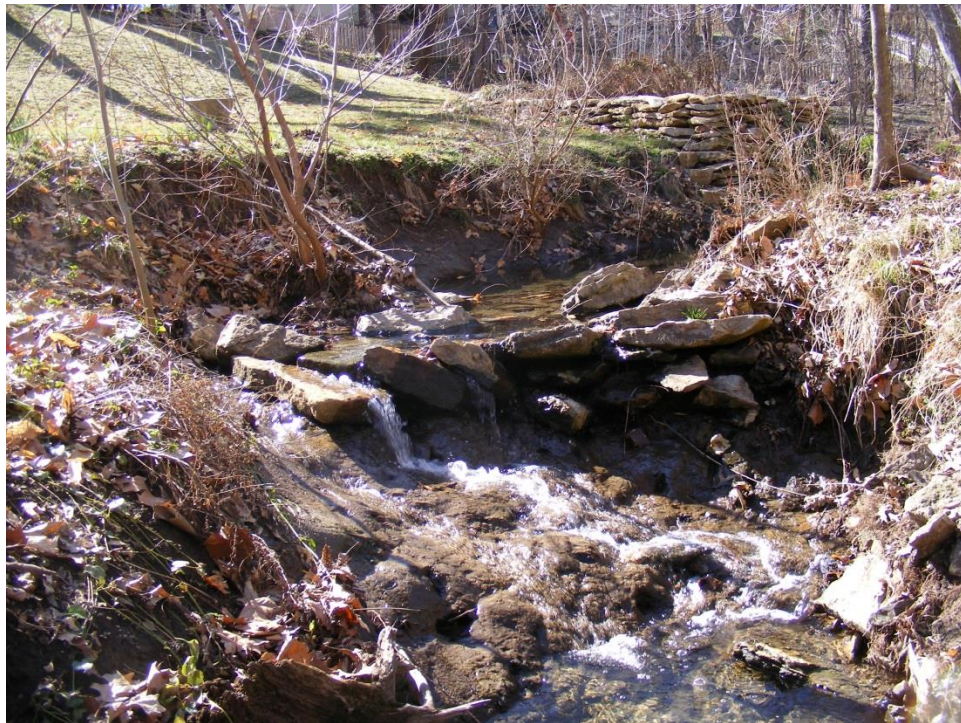
Photo 12. Headcuts are progressing upstream in most of the tributaries.

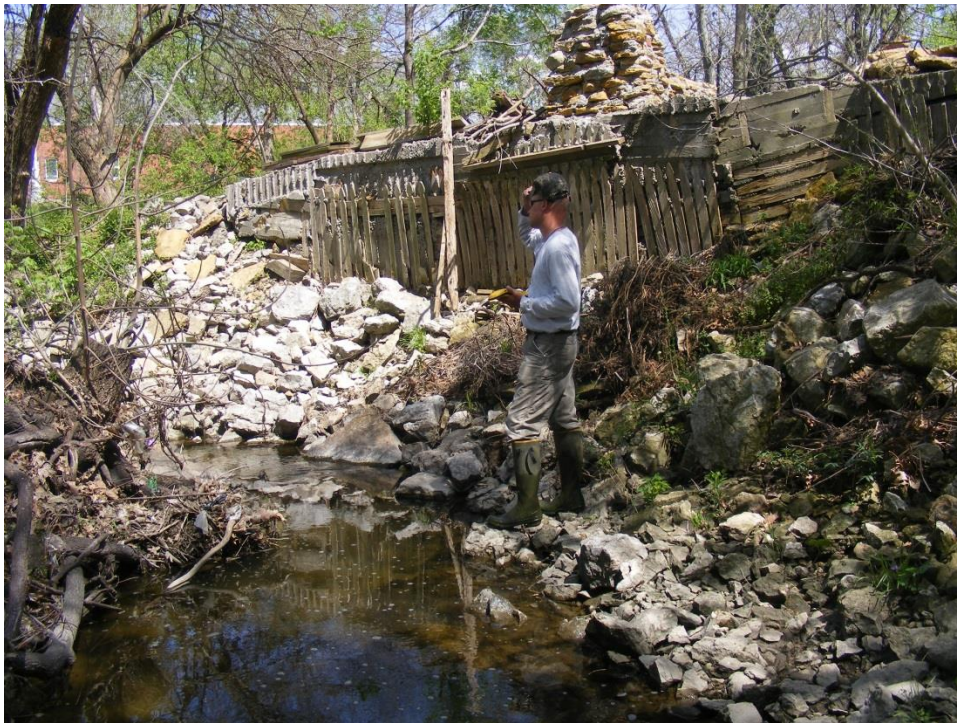
Channel incision is the major process impacting public infrastructure and private property along the tributaries within the Indian Creek watershed. Primary, secondary, and in some cases tertiary head cuts were observed in all tributaries investigated for this project (Photo 12). The lowering of the bed exposes utility crossings and undermines culverts as the head cuts progress upstream. Subsequent bank erosion has created a situation where liberated sediment is deposited downstream in areas of lower slope causing the lateral channel migration. Lateral migration creates problem areas in the tributaries when the channel meanders into private property and utilities (typically phone and cable lines) that are often placed adjacent to the back property lines (Photo 13). Furthermore, obstacles and other debris (homemade rip-rap, trees, trash etc.) along the tributaries add to local stream instability (Photo 14).

Photo 14. Local residents are trying to protect their land in areas where bank erosion threatens their property.
