**The Ozarks Environmental and Water Resources Institute (OEWRI)
Missouri State University (MSU)**

FINAL REPORT

**Nonpoint Source Bank Erosion and Water Quality
Impairment Assessment, James River at Rivercut Golf
Course, Greene County, Missouri**

OEWRI EDR-13-003

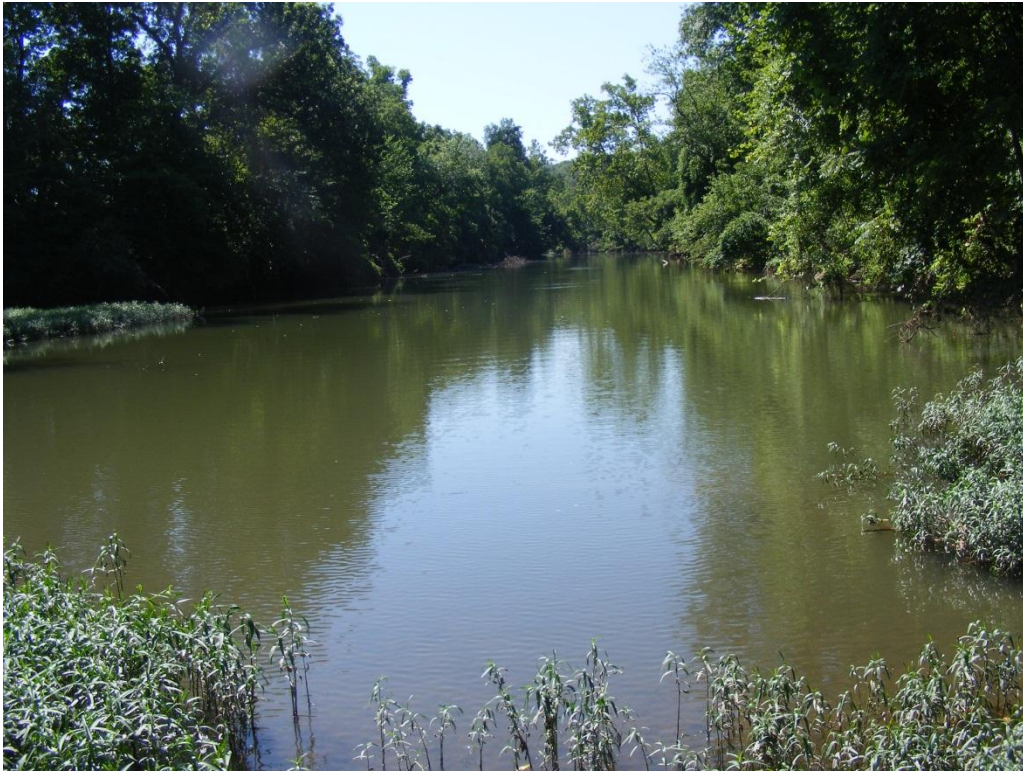
This is a relatively straight reach with a bluff present along the left bank. The right bank appears stable with a thin riparian buffer.

Photo 1. Straight reach looking downstream station 1.6 km

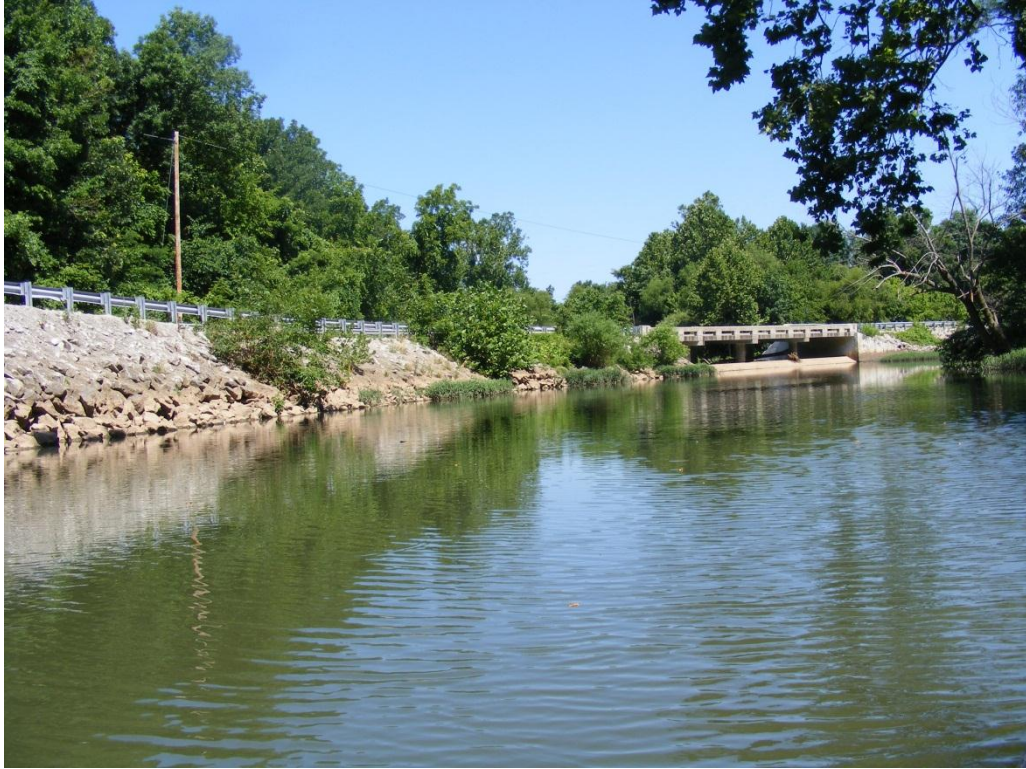
Cox Road runs along the side of the channel through this reach and rip rap has been placed along the left bank for much of the reach. A bridge has been placed over a cutoff channel near station 2.35 km. During high flow water moves through the cutoff channel and reenters the river at station 4.8 km. A thin riparian buffer exists along the floodplain on the right bank. A small tributary that appears to be connected to a wet weather spring enters the river at station 2.65 km.

Photo 3. Rip rap along Cox Road at station 2.3 km.

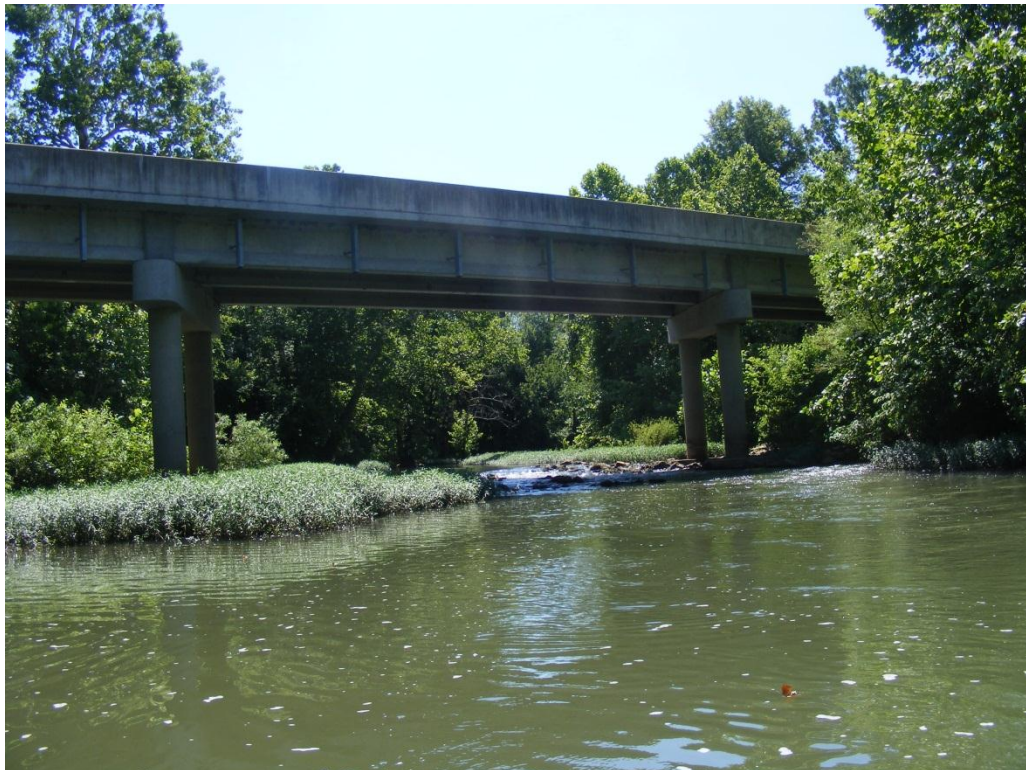
Photo 4. Cox Road Bridge at station 2.7 km

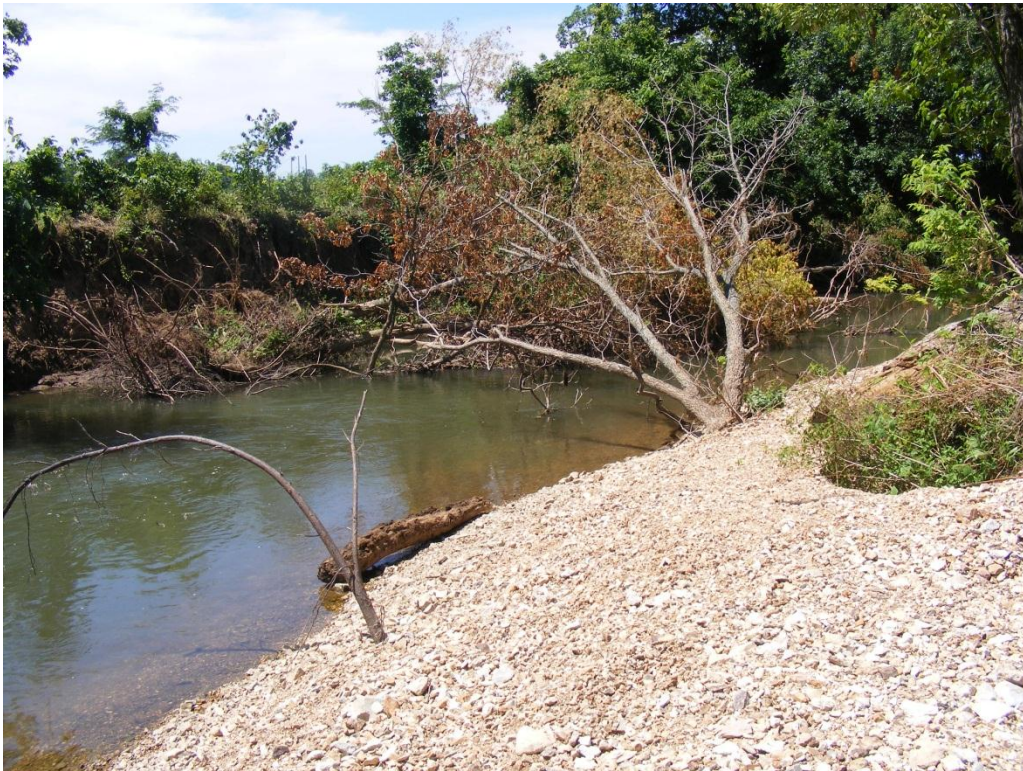
Photo 6. Bank erosion across the channel from delta bar at station 3.4 km

Disturbance Reach #2 is located from 3.2-3.8 km at the confluence with Ward Branch. There appears to be a high bedload entering the river from Ward Branch forming a delta bar at the mouth. Excess bedload is likely originating from bed and bank scour in the highly urbanized areas of Ward Branch upstream. The bar that has formed at the mouth is causing localized bank erosion, but it does not appear to be impacting the road or other infrastructure. This area should be monitored after large floods to watch out for any expansion of the disturbance.

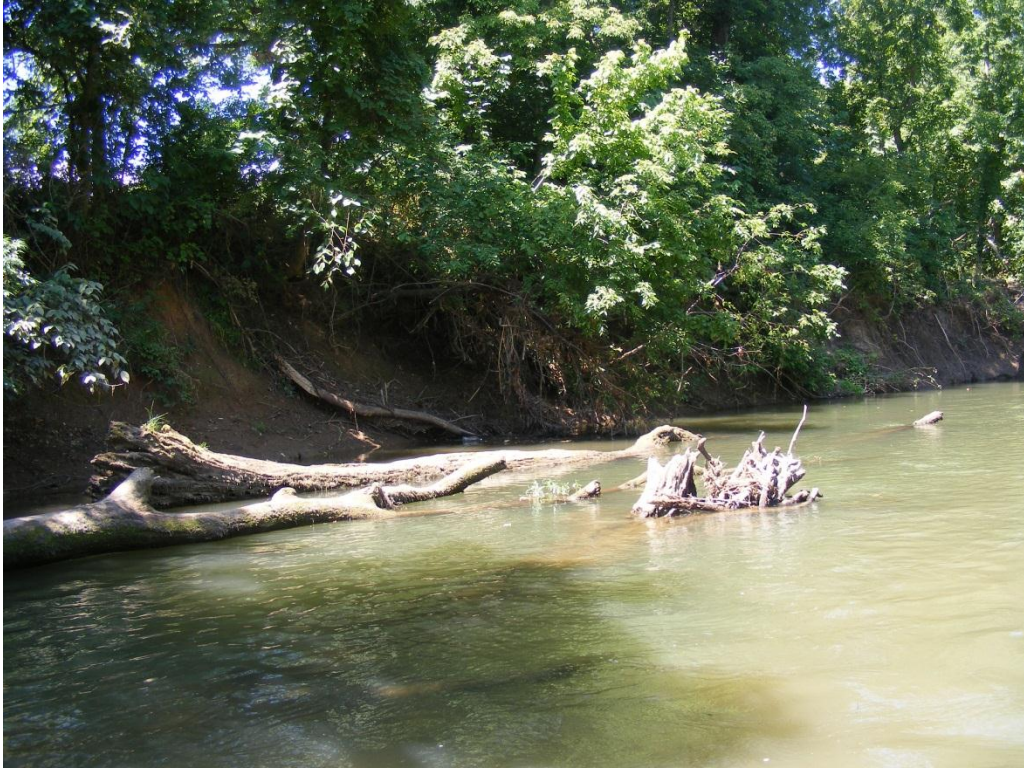
Photo 7. Typical bank erosion between stations 3.4-3.8 km

3. Consider Bank Protection - Bank stabilization could be considered on about 2 km of bank in this reach. More specifically along the right bank from station 2.4-2.8 km, the left bank from station 2.8-3.9, and along the left bank from station 4.4-4.8 km.

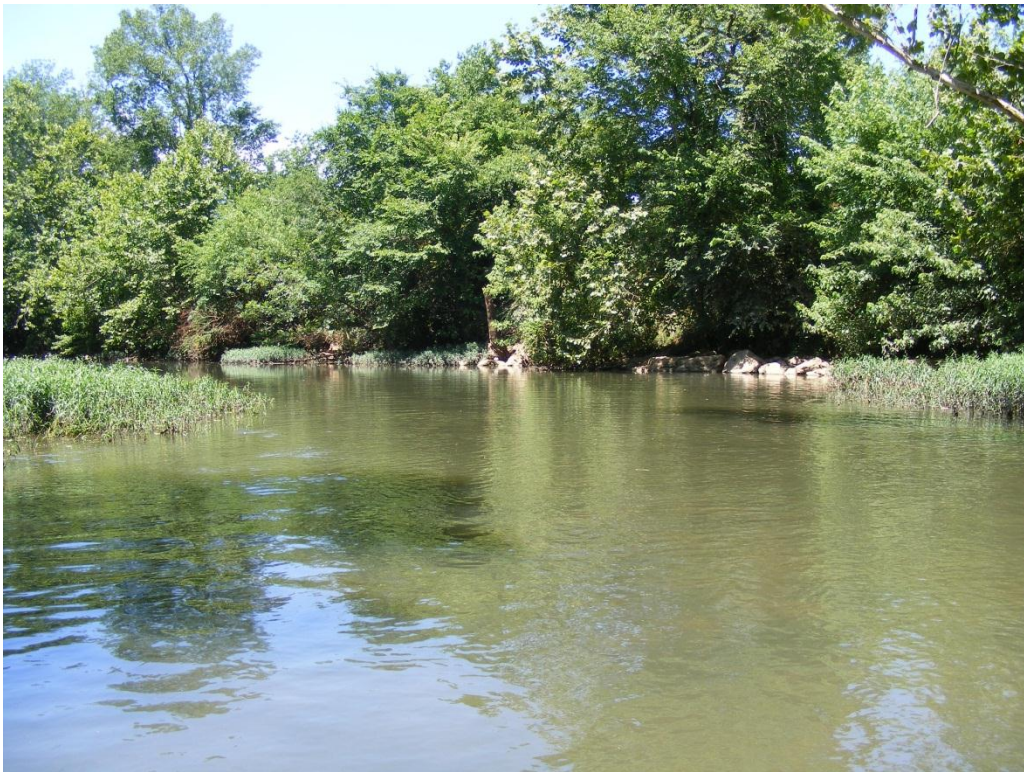
an old strath river terrace resulting from downcutting through the bedrock. There is a narrow riparian buffer along the left bank and it appears to have moderate erosion.

Photo 8. Vegetated bars are forming below the strath terrace on the right with moderate bank erosion on the left at station 4.2 km

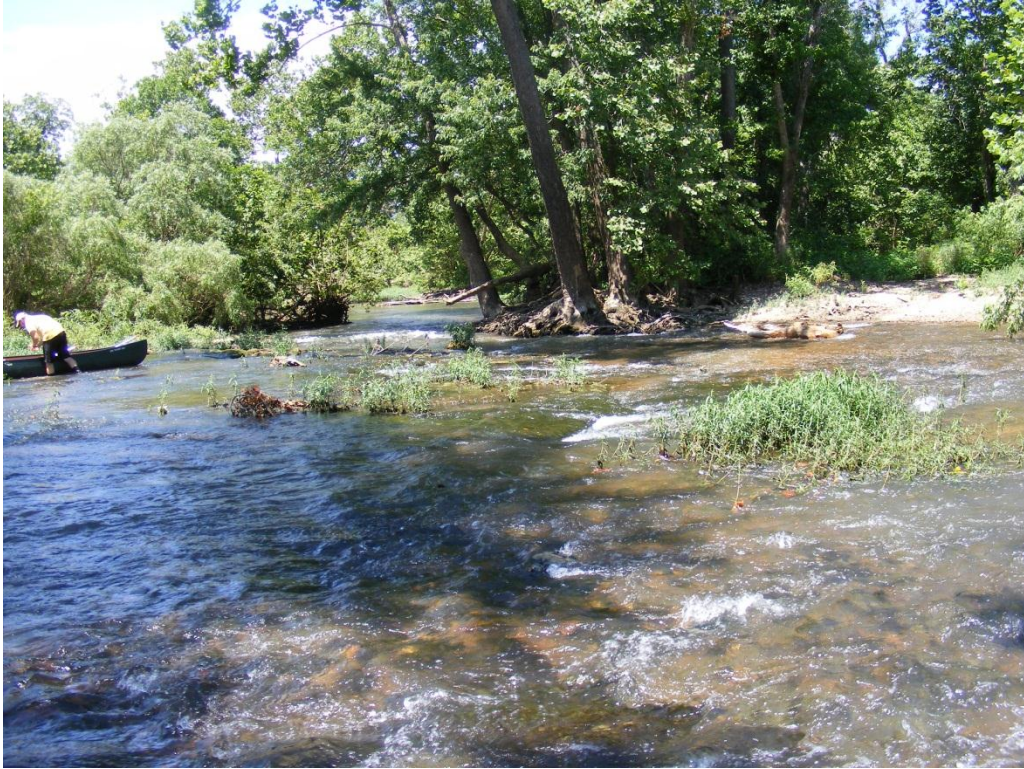
As the channel bends away from the bedrock bluff along the left bank a steep bedrock knickpoint creates a mega bar and a multi-thread channel through this reach. Bedrock is visible at the toe of the left bank that has a thin riparian buffer. The easement ends along the left bank at station 5.6 km.

Photo 12. Bedrock knickpoint at disturbance reach at station 5.6 km

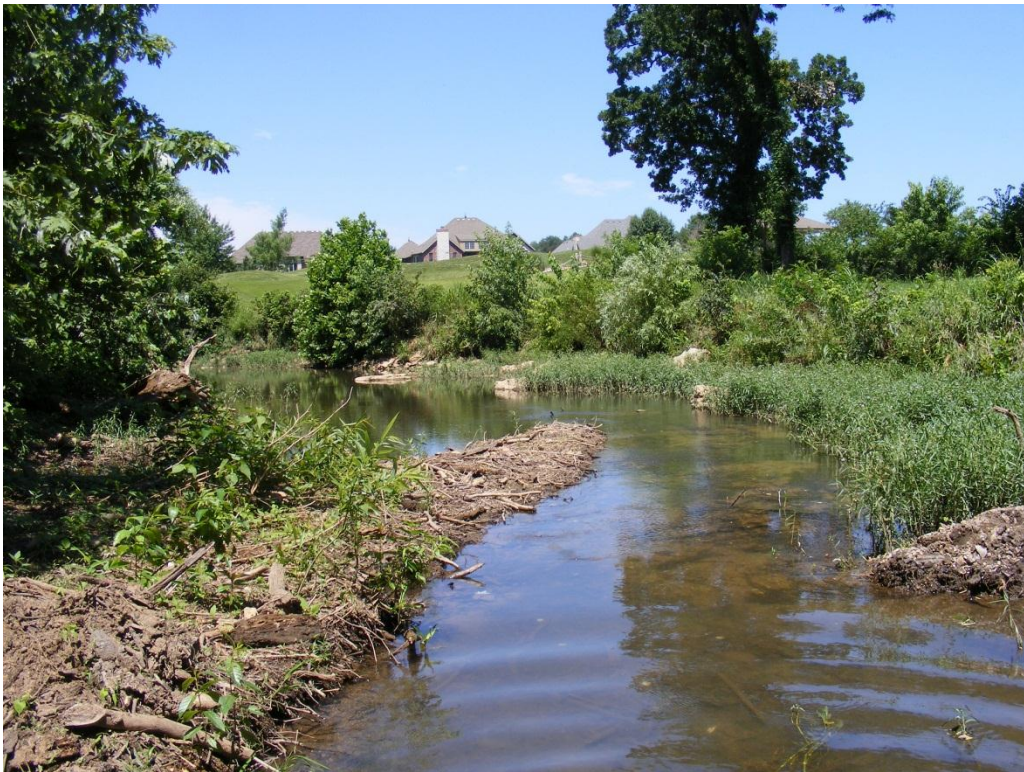
Photo 13. Secondary channel at disturbance reach at station 5.6 km

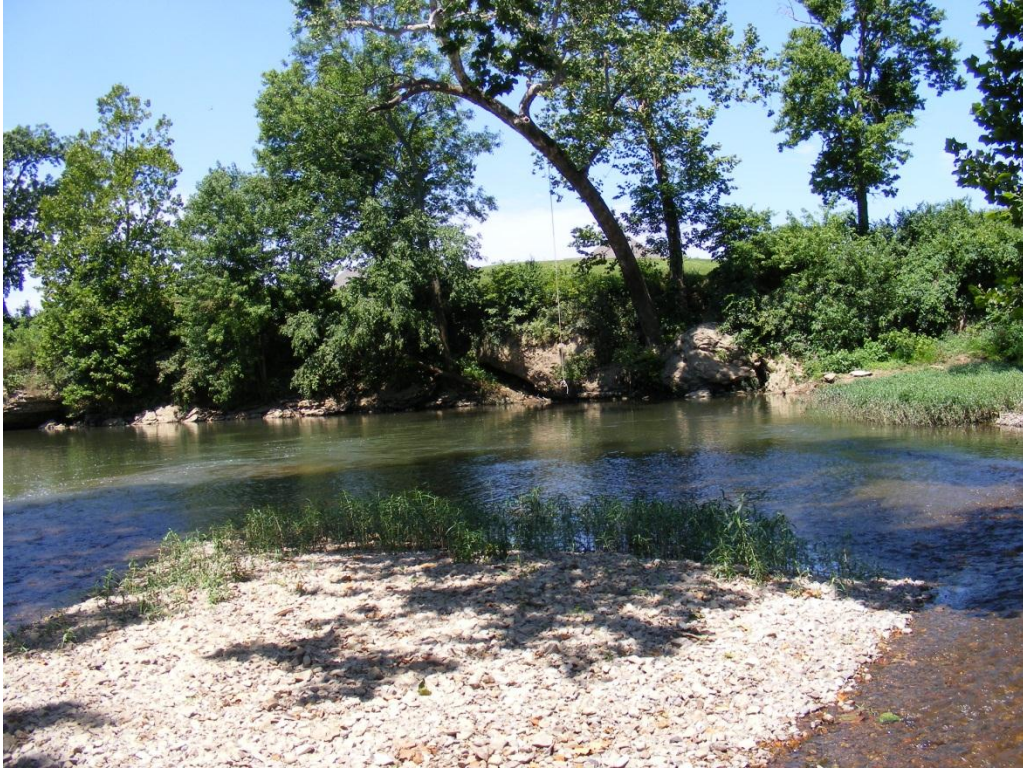
A short stretch of strath terrace is exposed along the right bank of the river through this reach. Similar to the reach upstream, bedrock is visible at the toe of the left bank that has a thin riparian buffer.

Photo 14. Strath terrace reach below disturbance reach at station 5.6 km
