**The Ozarks Environmental and Water Resources Institute (OEWRI)
Missouri State University (MSU)**

FINAL REPORT

**Nonpoint Source Bank Erosion and Water Quality
Impairment Assessment, James River at Rivercut Golf
Course, Greene County, Missouri**

September 17, 2013

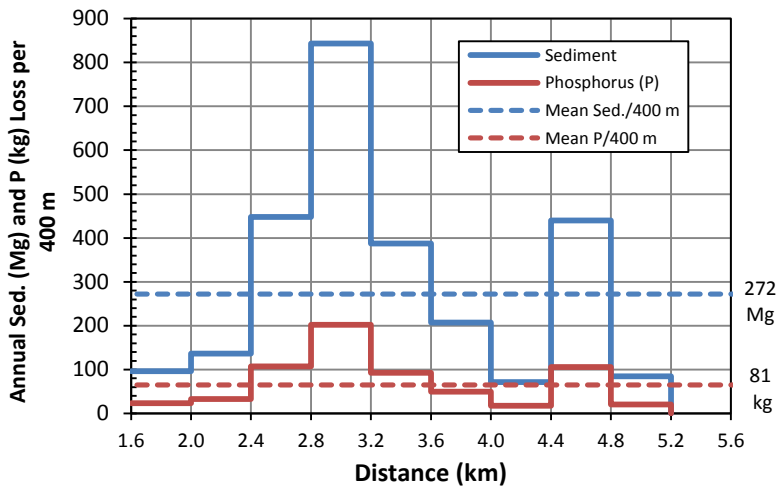
Figure 5. Annual sediment and P loss from bank erosion in study reach.

Soil particles can bind P and other nutrients at relatively high concentrations, so bank erosion has the potential to release large quantities of P to the aquatic environment. Therefore, the spatial trends of P release will be the same as sediment release from bank erosion analysis stated above. For this study an average soil P concentration of 300 ppm was used (Fredrick, 2001). An estimated 9,775 kg of P have been released from bank erosion through this reach since 1996. Annual P release by bank erosion varies by 400 m cell from 0-252.9 kg/yr with an average of 81 kg/yr per cell (Table 2). Annual P loss from bank erosion per unit length of stream varies from 0-0.63 kg/m/year by 400 m cell. The annual average over this period has been 0.2 Mg/km/yr.

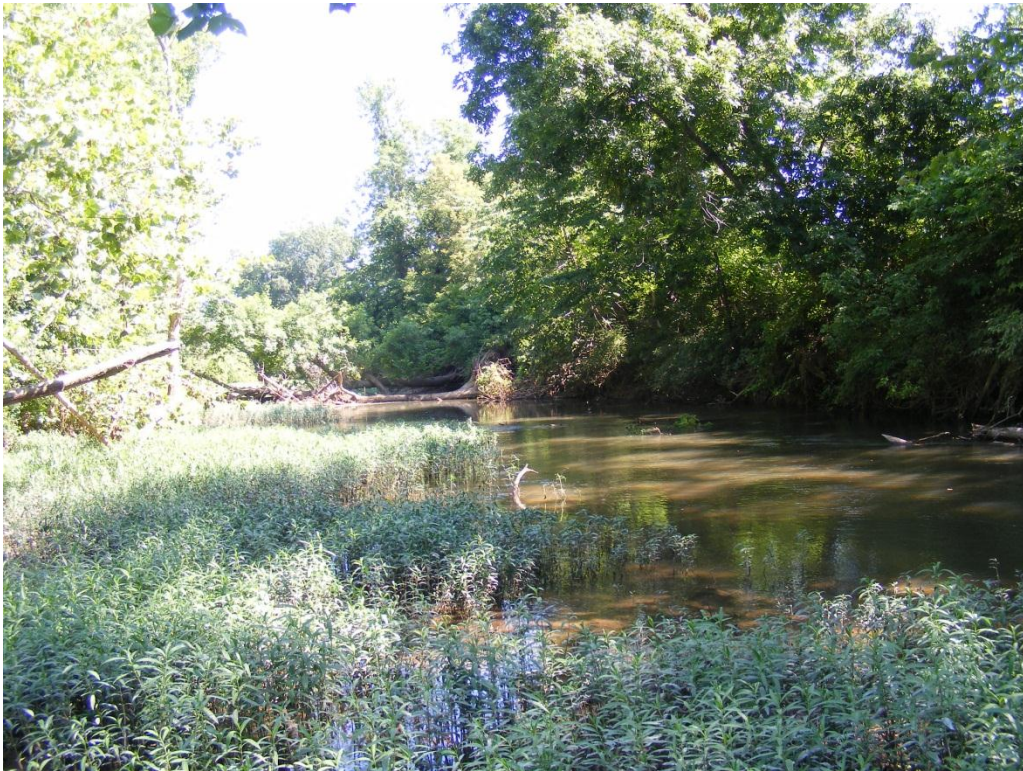
The channel splits around a vegetated island and the channel that splits right appears to be an old channel location that appears to be slowly filling in over time. The right bank on the outside of the disturbance reach is actively eroding. The channel is adjacent to a bluff on the left bank.

Photo 2. Secondary channel in disturbance reach station 1.8 km.

Disturbance Reach #1 from 1.8-2.2 km is within the future Kansas Expressway expansion would likely need to be stabilized. While the right-of-way (ROW) for the road expansion is not within the easement, the entire disturbance reach spans the ROW into easement areas upstream and downstream. Any remediation would have to take into account ROW and easement property for proper stabilization.

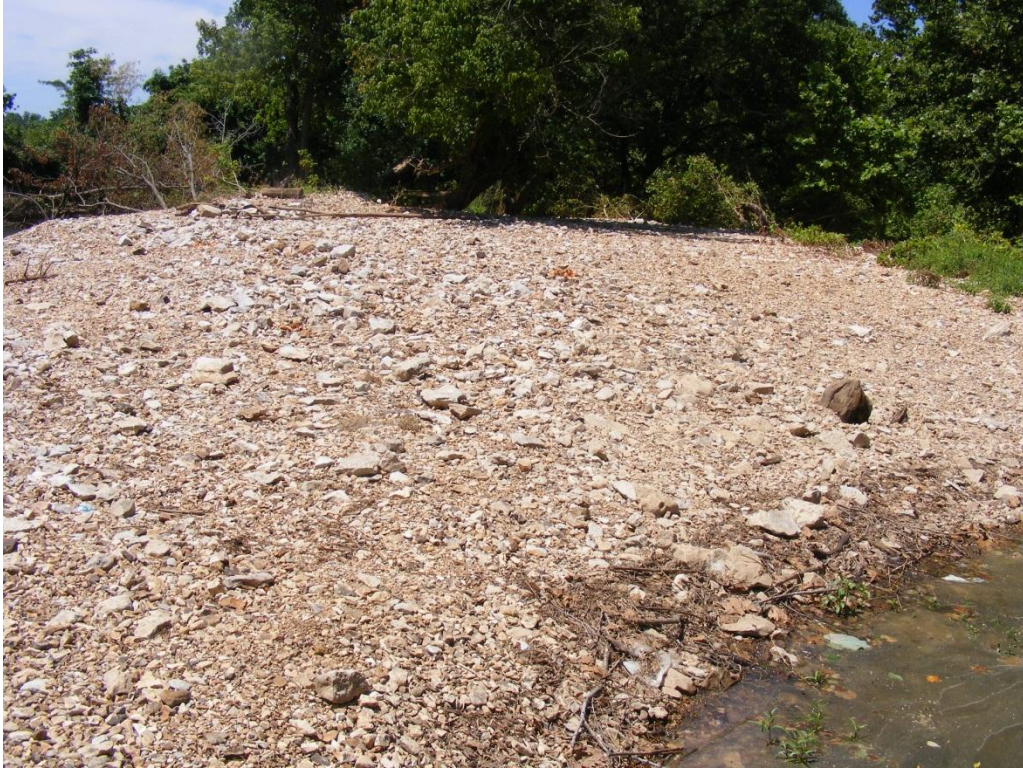
A large delta bar has formed below the confluence of Ward Branch from station 3.3-3.4 causing erosion along the left bank of the river. This reach is also over-widened and has a lower floodplain developing below the upper floodplain surface.

Photo 5. Large delta bar forming at the mouth of Ward Branch station 3.35 km

Disturbance Reach #2 is located from 3.2-3.8 km at the confluence with Ward Branch. There appears to be a high bedload entering the river from Ward Branch forming a delta bar at the mouth. Excess bedload is likely originating from bed and bank scour in the highly urbanized areas of Ward Branch upstream. The bar that has formed at the mouth is causing localized bank erosion, but it does not appear to be impacting the road or other infrastructure. This area should be monitored after large floods to watch out for any expansion of the disturbance.

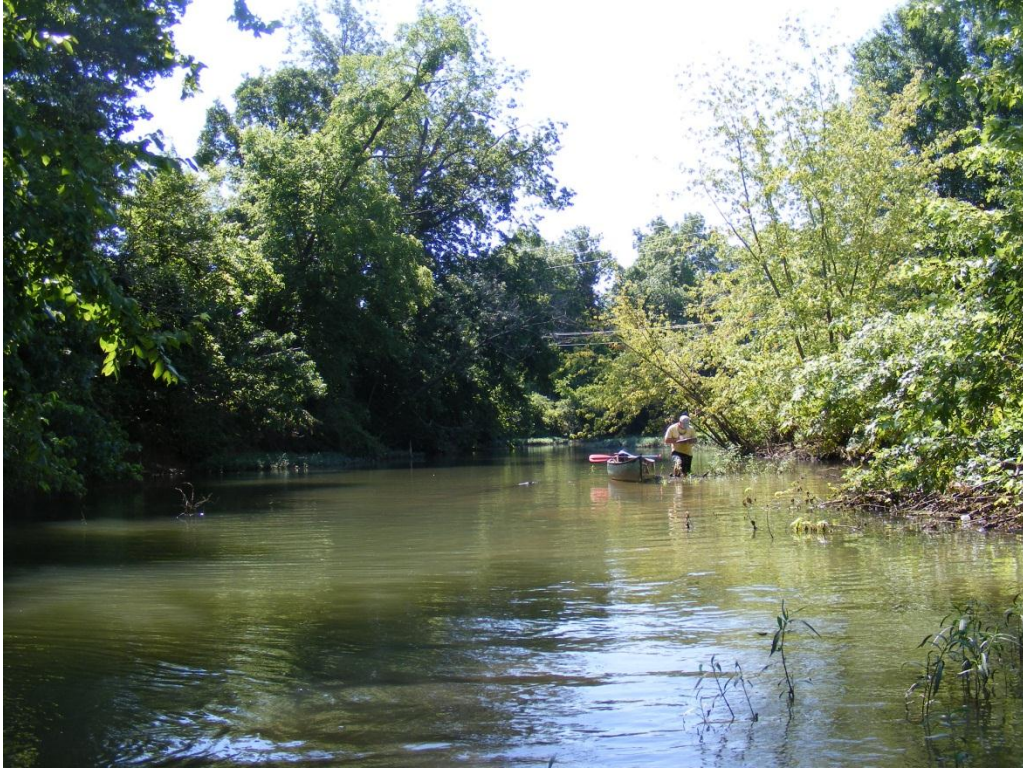
The river at this location is entering another 360 degree bend, but a lower floodplain is building along the right bank. The left bank has a narrow riparian buffer along the left bank and it appears to have moderate erosion.

Photo 8. Vegetated bars are forming below the strath terrace on the right with moderate bank erosion on the left at station 4.2 km

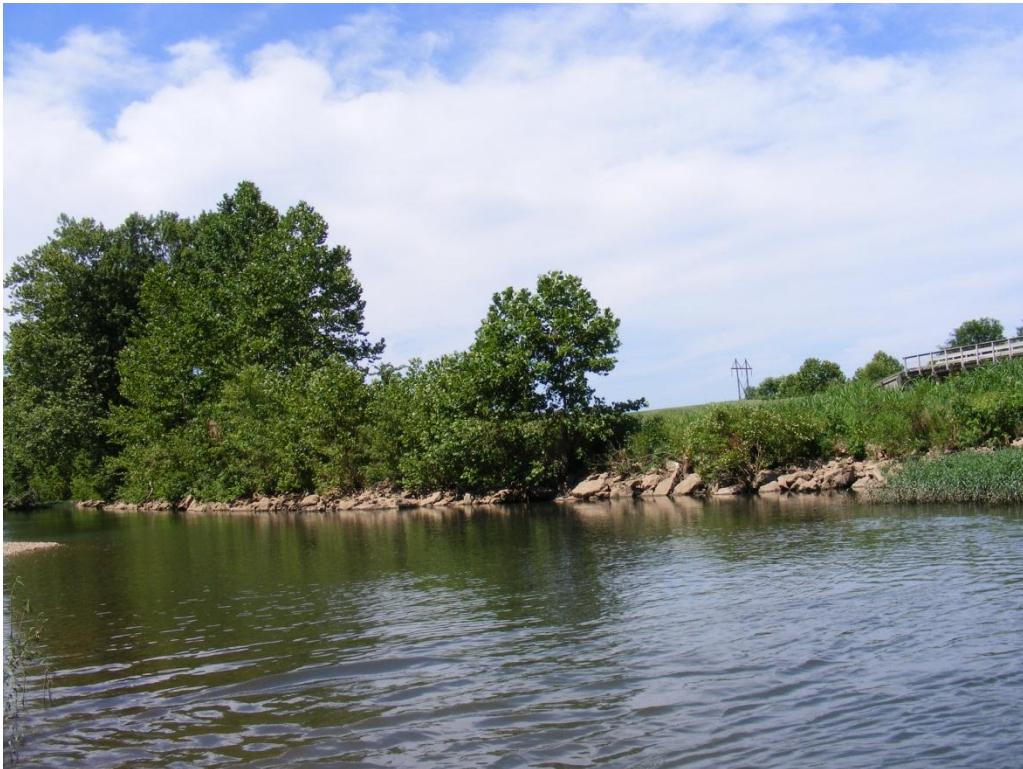
There is a bedrock knickpoint at the beginning of this reach with a large mega bar complex downstream on the left side of the channel. The mega bar complex is forming at the point where the cutoff channel empties back into the river from station 2.35 km. The right bank of the river is adjacent to the golf course, has a poor riparian buffer, and rip rap has been placed along the toe.

Photo 9. Rip rap lined bank adjacent to the golf course near disturbance reach at station 4.6 km

Disturbance Reach #3 from 4.5-4.9 km is located at the confluence with the cutoff channel. This area has likely been a disturbance area for a long time. This area should be monitored for expansion, but it appears the golf course has placed rip rap at the toe of the bank opposite of the reach to arrest further bank erosion at this point.

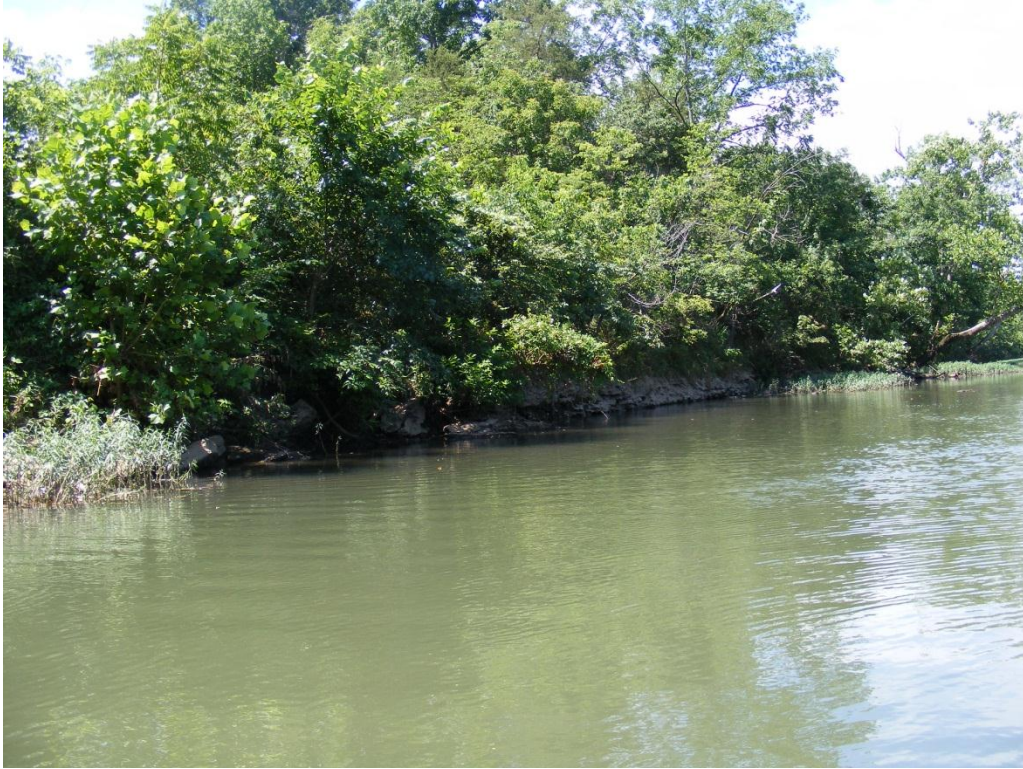
Photo 10. Bedrock at the base of the bank limits lateral erosion near station 5 km

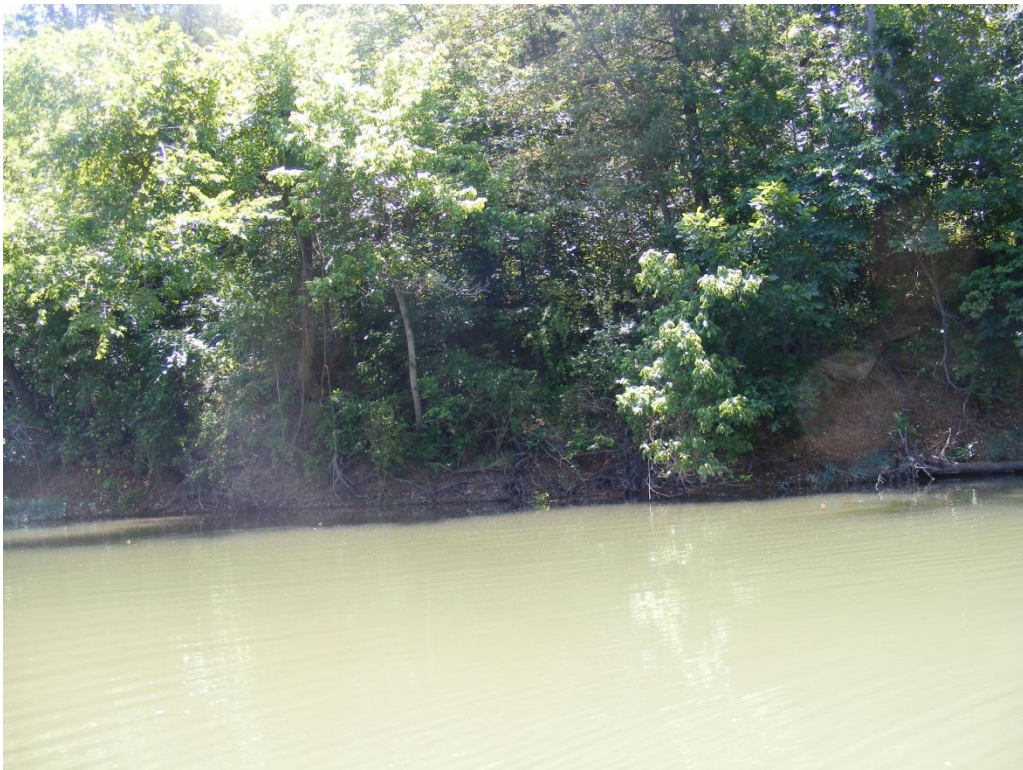
The channel through this section is relatively straight. The bluff extends along the left bank through the reach with a narrow colluvium/alluvium bench formed at the base that is subject to erosion. Much like the reaches above, the right bank has a thin riparian buffer and has moderate erosion.

Photo 11. Colluvium/alluvial bank erosion at the base of bluff near station 5.4 km

4. Golf Course BMPs - While the golf course is not within the easement area, we suggest that JRBP should work with the golf course in implementing best management practices (BMPs) to reduce nonpoint source pollution of nutrients in runoff that leave the property. Also, bank erosion protection and riparian corridor enhancement may be suitable for the banks adjacent to the golf course from 4.9-5.5 km.
