**The Ozarks Environmental and Water Resources Institute (OEWRI)
Missouri State University (MSU)**

FINAL REPORT

**Nonpoint Source Bank Erosion and Water Quality
Assessment, James River at River Bluff Farm, Stone
County, Missouri**

OEWRI EDR-13-002

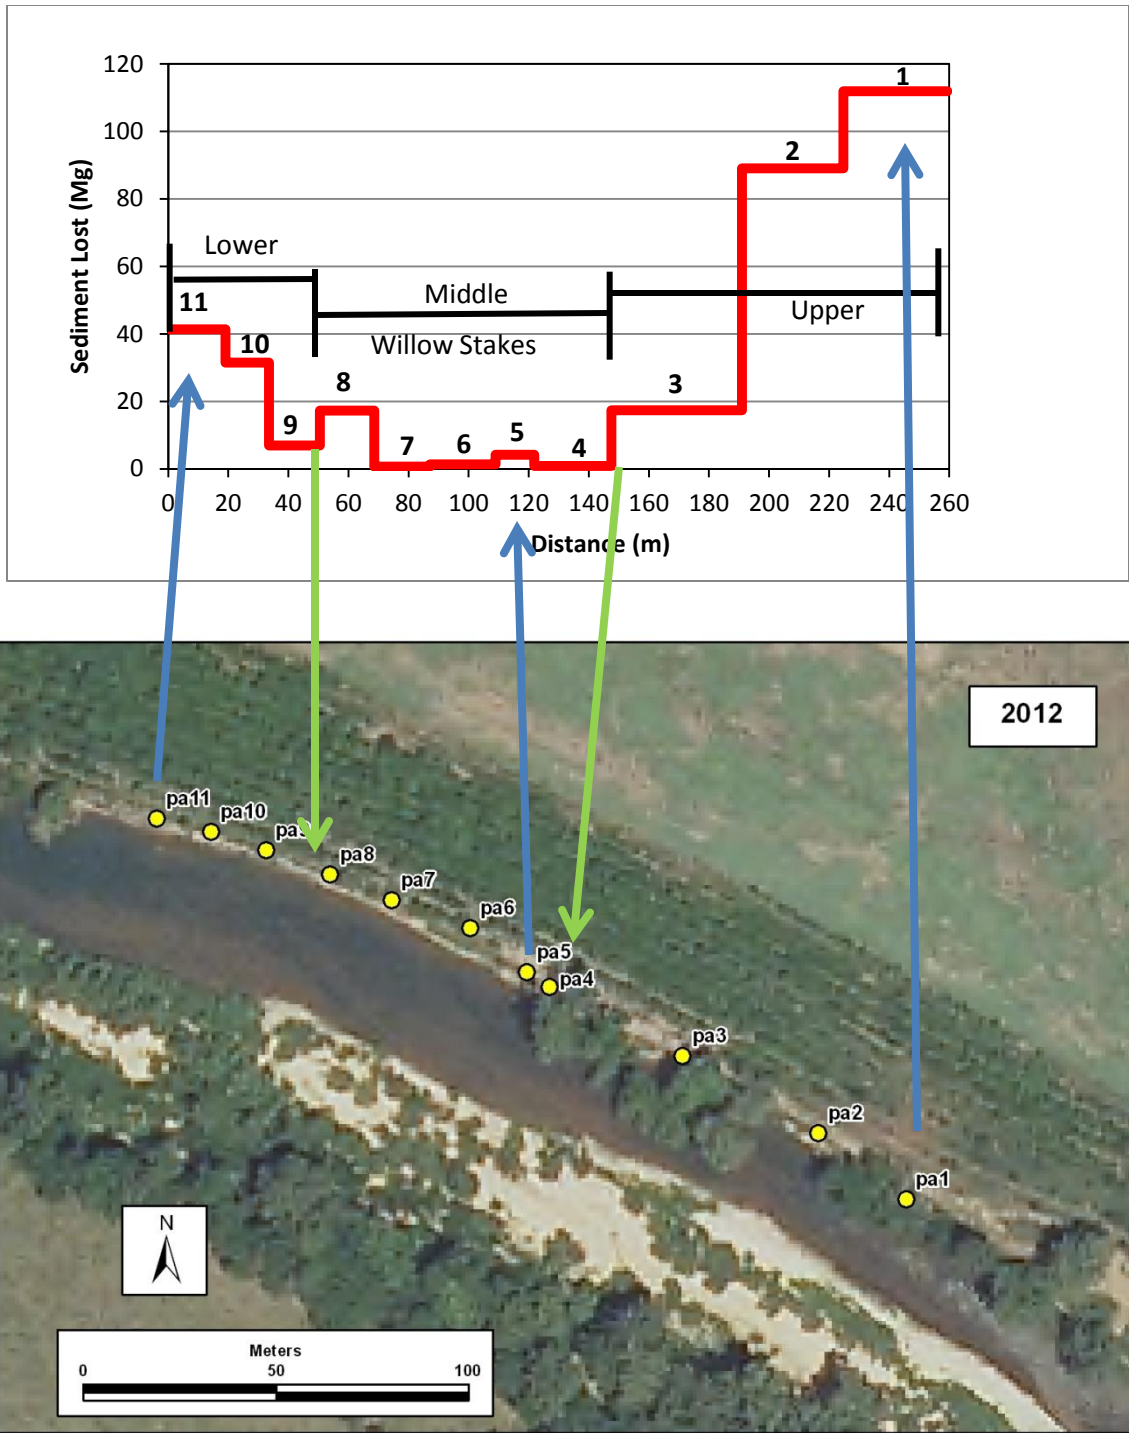
Monitoring results show the majority of the bank erosion occurred in the upper 100 meters of the reach the area upstream of the willow stake section (Figure 10). The second highest amount of erosion occurred in the lower section of the reach and the lowest erosion in the middle section of the reach where the willow stakes were located. The upper section makes up 43% of the reach and consists of erosion pin transects 1-3 (Table 4). The upper section lost 218 Mg of sediment and 87 kg of P over the monitoring period, which is about 68% of the total lost for the reach. The middle section is 97 m long ($\approx 37\%$ of total) and includes pin transects 4-8. The middle section lost 24.3 Mg of sediment and 9.7 kg of P over the monitoring period, which is $<8\%$ of the total lost for the reach. The lower section includes pin transects 9-11 and is only 51 m long, which is about 20% of the reach. Here a total of 79.8 Mg of sediment and 31.9 kg of P was eroded, which is around 25% of the total lost for the reach. Rates of sediment loss per unit of bank ranged from 0.25 Mg/m in the middle section to 2 Mg/m in the upper section, with a total of 1.2 Mg/m for the reach. The P loss per unit of bank ranged from 0.1 kg/m in the middle section to 0.8 kg/m in the upper section, with a total of 0.5 kg/m for the entire reach.

Figure 10. Total sediment loss from short-term bank erosion pin monitoring.

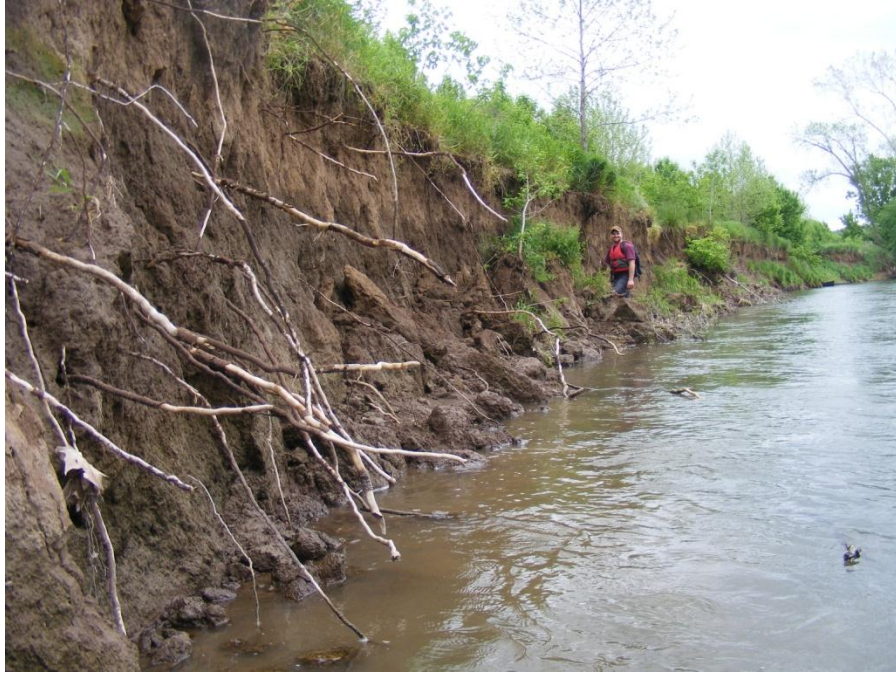
Photo 9. Roots exposed immediately following bank erosion from recent floods, May 2013.

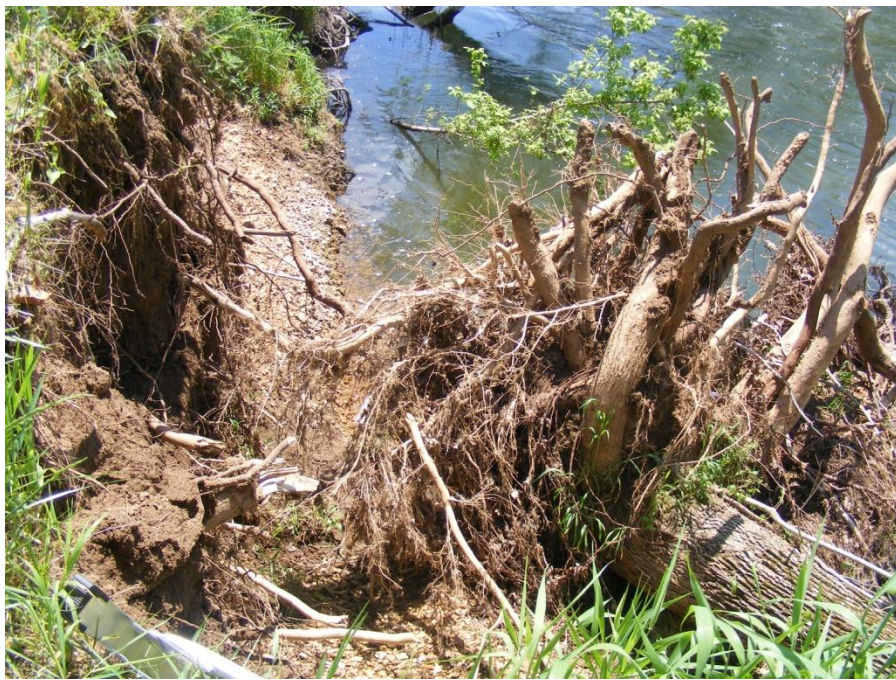
Photo 10. Recently downed tree after bank failure, May 2013.
