FINAL REPORT

**Nonpoint Source Bank Erosion and Water Quality
Assessment, James River at River Bluff Farm, Stone
County, Missouri**

Field work completed May 2012- May 2013

OEWRI EDR-13-002

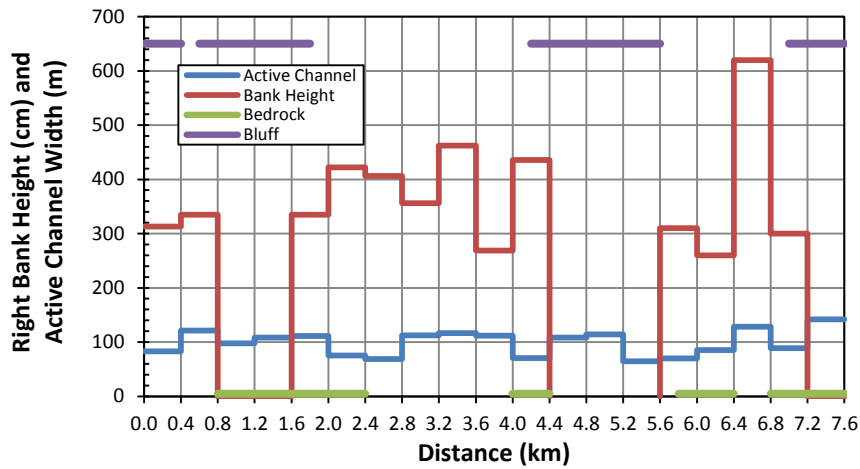
Bedrock has a major influence on the channel along the 7.6 km long study reach. Bluffs form the right bank of the river along the easement for nearly half the reach length and bedrock can be found along the bed of the river frequently (Figure 4). Bedrock in the bed and along bluffs limits the ability of the river to meander and scour the bed and is typical of streams in the Ozarks (Pavlowsky, 2004). Field measurements taken in May 2012 the active channel width varies from about 60 m to 120 m (197-394 ft) in some places. The active channel refers to both the wetted part of the channel at low flow, but also the gravel bars located adjacent to the water, but set below the bank. The high active channel widths indicate areas where large bars are present in the channel. Bank heights vary from around 2.5-6.2 m (8.2-20 ft) through the study reach. Bank heights vary due to the age of the deposit from terraces that could be >10,000 years old to recently formed benches only formed over the last 100 years (Brakenridge 1981; Hajic et al. 2007; Owen et al. 2011). There was no bank present in areas with bluffs along the right bank, but in a few cases, such as between 0-0.8 km, banks did exist right at the base of the bluff. Bank heights measured in the field were used to calculate total sediment volume lost to erosion from the historical aerial photography analysis.

Figure 4. Bank and channel conditions in study reach.

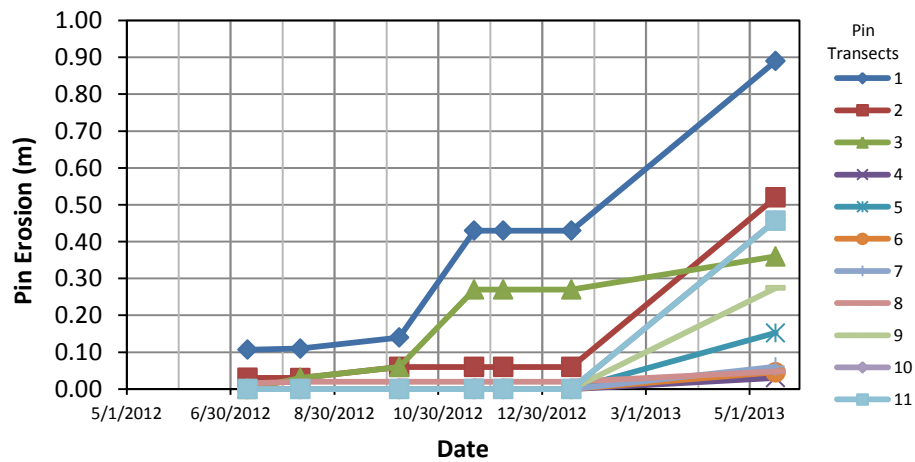
The rainfall-runoff pattern in the river is reflected in the timing and magnitude of bank erosion in the study reach. Very little erosion occurred up to when the pins were checked on the 21st of November (Figure 9). Since the bank at this location was nearly vertical, the erosion that did

occur was likely due to bank failure likely not tied to water levels in the river. The erosion that was measured of the 21st of November was likely the result of the >1-yr flood that occurred in mid-October. This suggests that floods lower than bankfull have the ability to cause significant bank erosion. No erosion was recorded from November 21st to January 17th. Significant rainfall that began in late January through late April kept water in the river at levels where pin measurements could not be taken. Finally, after several months of high water in the river, extensive erosion had occurred over that period when pins were measured on May 17, 2013. Pins at transects 1, 2, 10, and 11 were all missing. The value of 0.46 m was recorded and should be understood to be a conservative estimate. Actual erosion was likely 2-3 times higher at these transects. All pin measurements and bank information is recorded in the Appendix.

Figure 9. Cumulative erosion at pin transects.

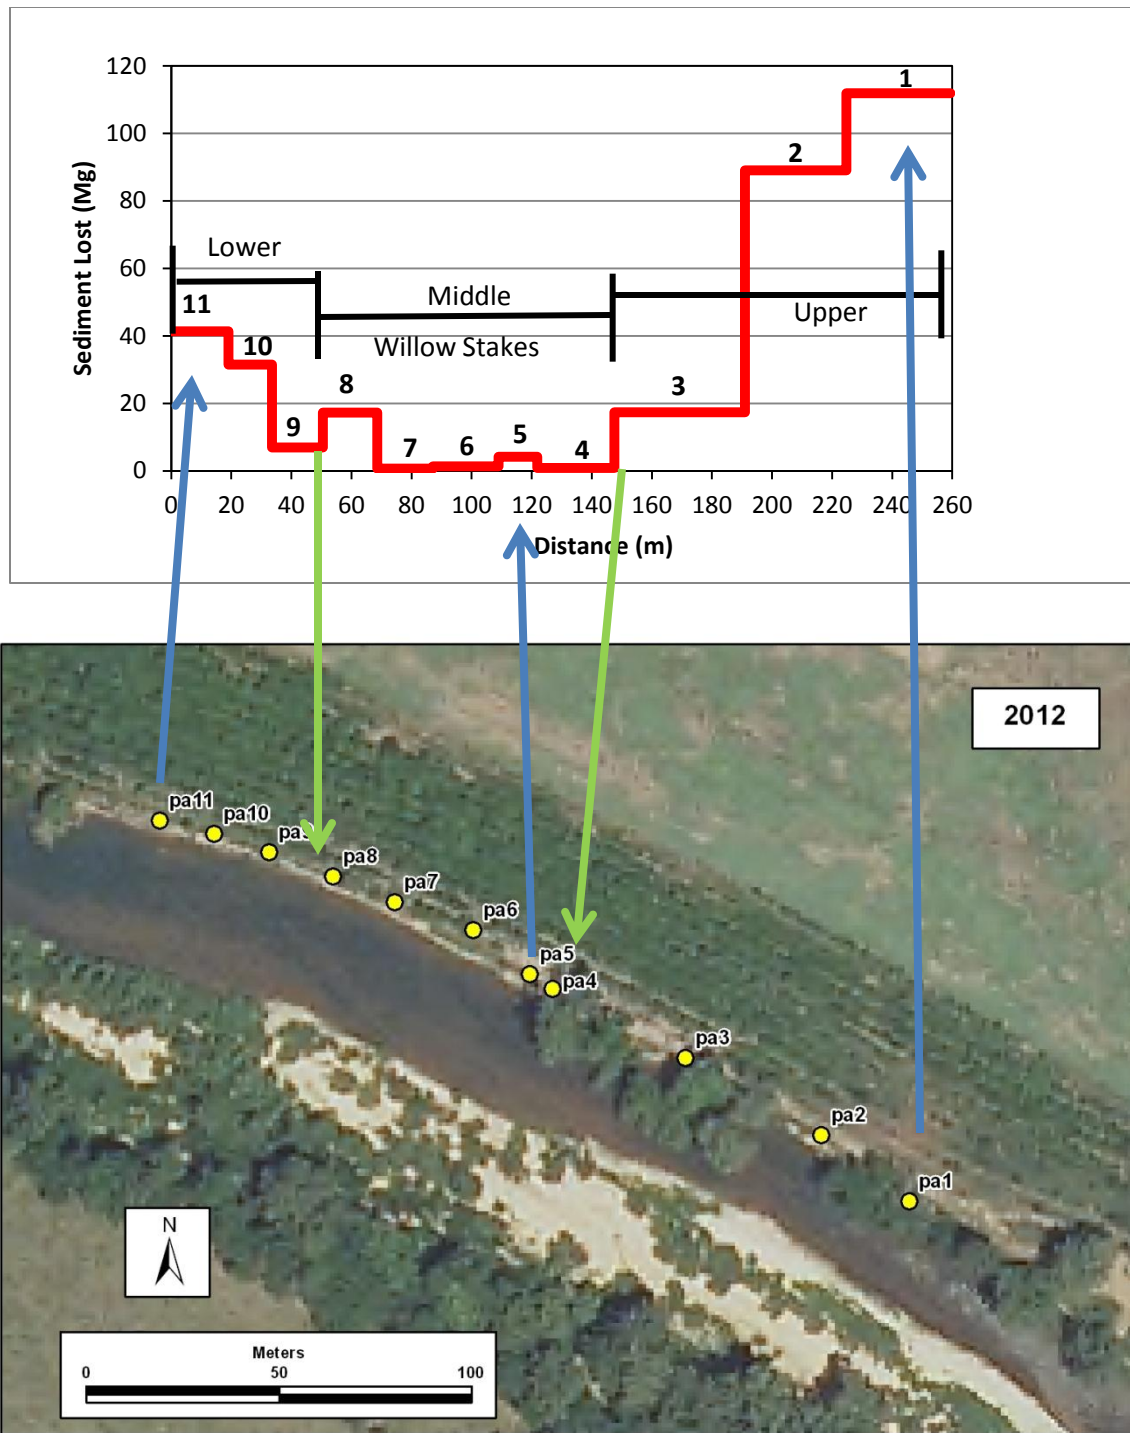
Monitoring results show the majority of the bank erosion occurred in the upper 100 meters of the reach the area upstream of the willow stake section (Figure 10). The second highest amount of erosion occurred in the lower section of the reach and the lowest erosion in the middle section of the reach where the willow stakes were located. The upper section makes up 43% of the reach and consists of erosion pin transects 1-3 (Table 4). The upper section lost 218 Mg of sediment and 87 kg of P over the monitoring period, which is about 68% of the total lost for the reach. The middle section is 97 m long ($\approx 37\%$ of total) and includes pin transects 4-8. The middle section lost 24.3 Mg of sediment and 9.7 kg of P over the monitoring period, which is $<8\%$ of the total lost for the reach. The lower section includes pin transects 9-11 and is only 51 m long, which is about 20% of the reach. Here a total of 79.8 Mg of sediment and 31.9 kg of P was eroded, which is around 25% of the total lost for the reach. Rates of sediment loss per unit of bank ranged from 0.25 Mg/m in the middle section to 2 Mg/m in the upper section, with a total of 1.2 Mg/m for the reach. The P loss per unit of bank ranged from 0.1 kg/m in the middle section to 0.8 kg/m in the upper section, with a total of 0.5 kg/m for the entire reach.

Figure 10. Total sediment loss from short-term bank erosion pin monitoring.

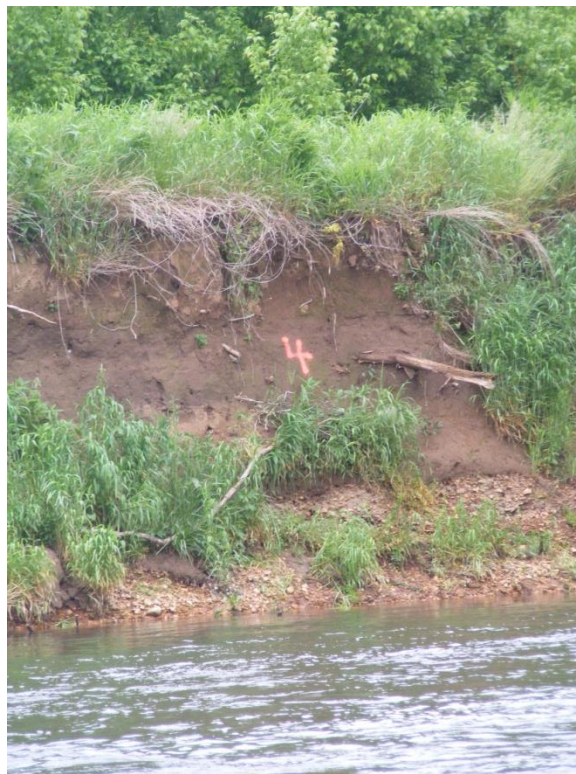
Photo 8. Erosion pin transect 4 at high flow, willows under water, May 2013.

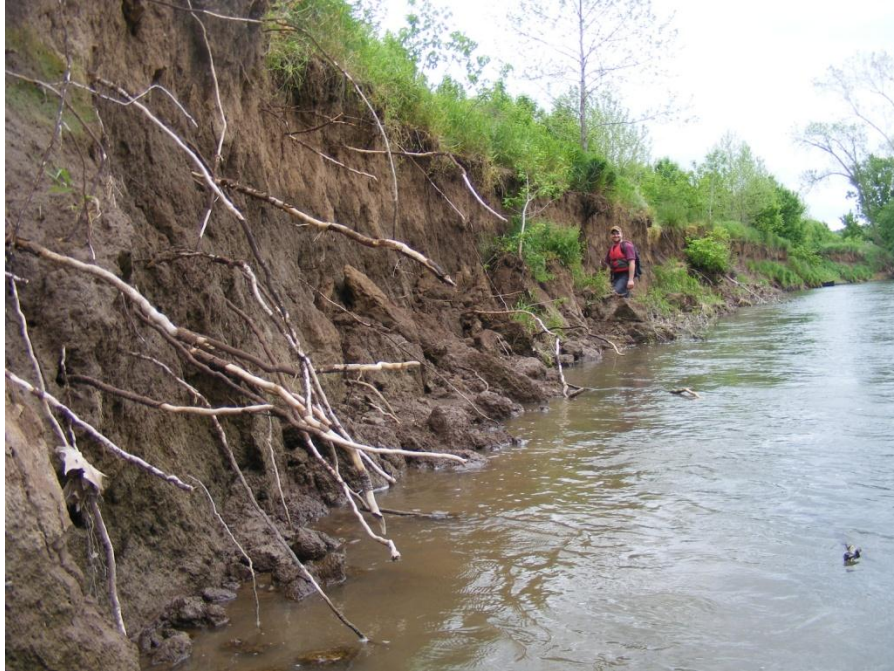
Photo 9. Roots exposed immediately following bank erosion from recent floods, May 2013.

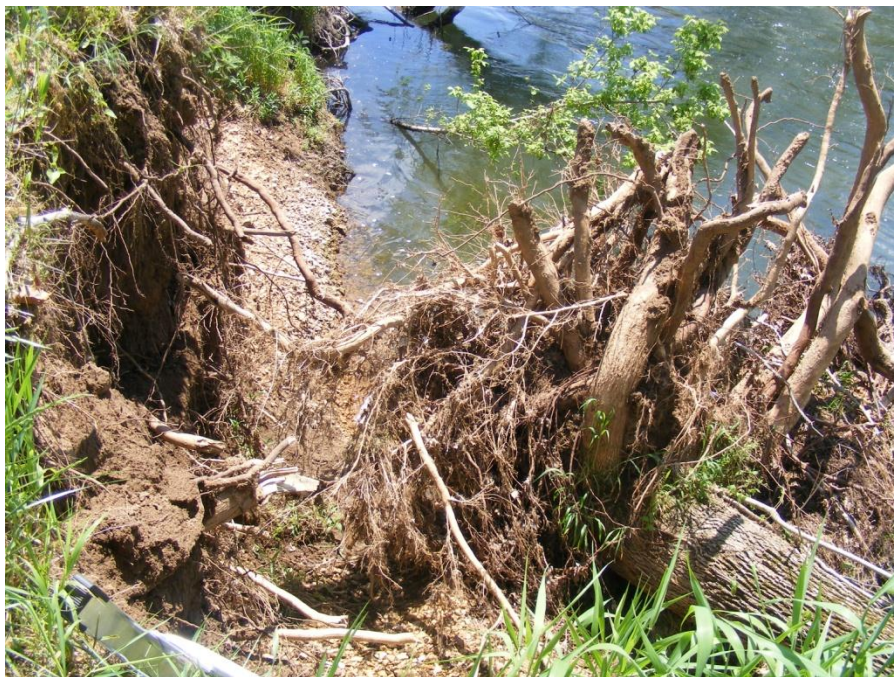
Photo 10. Recently downed tree after bank failure, May 2013.
