Geomorphic Analysis of Lackman Tributary, Lenexa, KS.

Final report to Olsson Associates for the City of Lenexa, Kansas

December 17, 2009

OEWRI TR-09-004

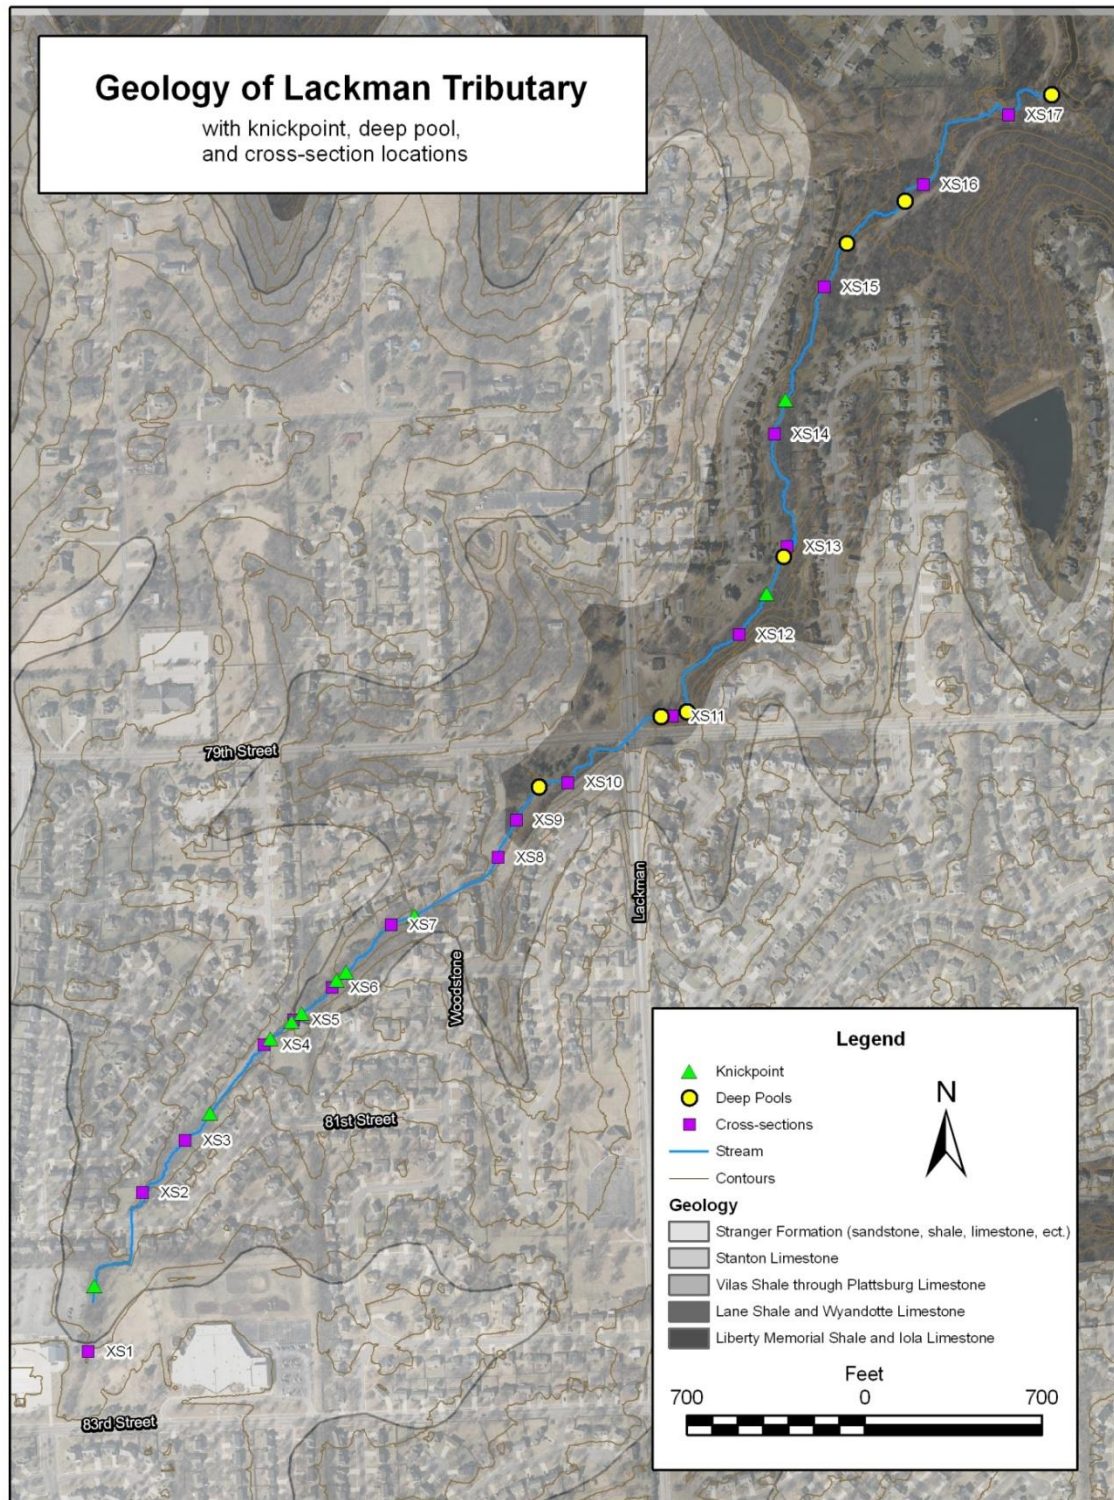
There is a strong influence from bedrock and bedrock residuum on channel form and substrate in Lackman Tributary (Table 2; Figure 3). The locations of relatively stable knick-points and head-cuts are probably controlled by horizontal layers of more resistant limestone beds. Knick-points in more resistant limestone develops as steps, small cascades, or falls across the bed of the stream. In longitudinal profile, bedrock knickpoints indicate locations where channel erosion is slowly lowering bed elevation by retreat of the step through block plucking, scour of weathered material, and joint failure. Since bedrock erosion rates are orders of magnitude less than for soil materials and alluvial deposits, knick-point response can lag behind other geomorphic adjustments and so they can function as natural slope controls for the stream. On the other hand, unstable head-cuts tend to have a similar form in longitudinal profile, but usually occur in less resistant materials such as weaker shale units or soil materials. Since unstable head-cuts are in more erodible materials, they generally migrate or cut headward at a faster rate compared to bedrock knick-point counterparts. It is possible that head-cuts form first, initially erode rapidly in weaker shale or weathered limestone, and then stall out as shale units pinch out. Field observation suggest that larger knick-points and head-cuts (up to 7 ft of local drop) are associated with thicker underlying shale units such as found in the Vilas and Lane Shale units (Table 2).

Figure 3. Geology of the Lackman Tributary with knickpoints and deep pool locations

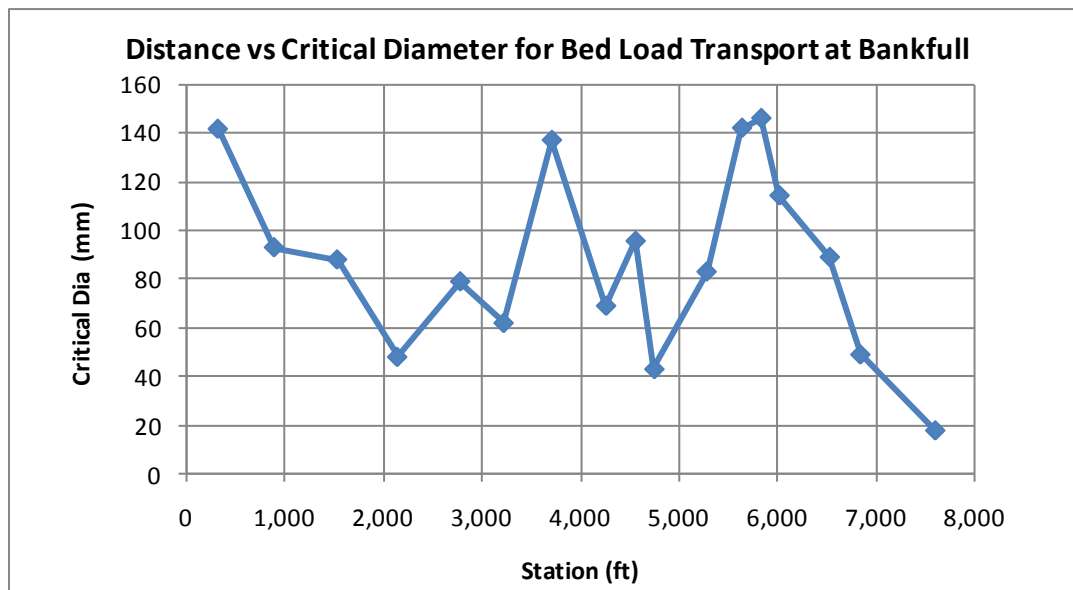
The critical diameter calculated for Lackman Tributary ranges from 40 mm to 140 mm (Figure 11). The downstream patterns are controlled by shear stress values calculated for each site (Table 6). Relative bed stability values indicate that all but four of the sites are within normal ranges of a balanced condition between imposed hydraulic force and sediment size on the bed (Figure 12). Typically, LRBS* values between -0.5 and 0.5 are in the stable range and values < -2 are considered unstable and values > 2 are considered extremely stable. Three relatively unstable sites have LRBS* values below -0.5:

Figure 11. Downstream changes in critical diameter for bed load transport

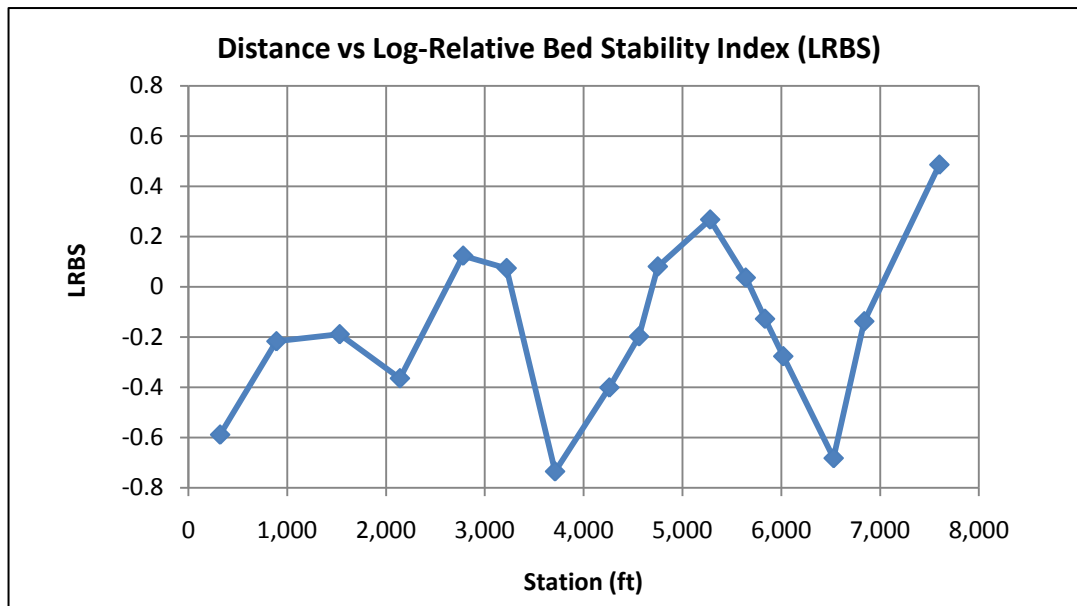
Figure 12. Downstream changes in the Log-Relative Bed Stability Index (LRBS)

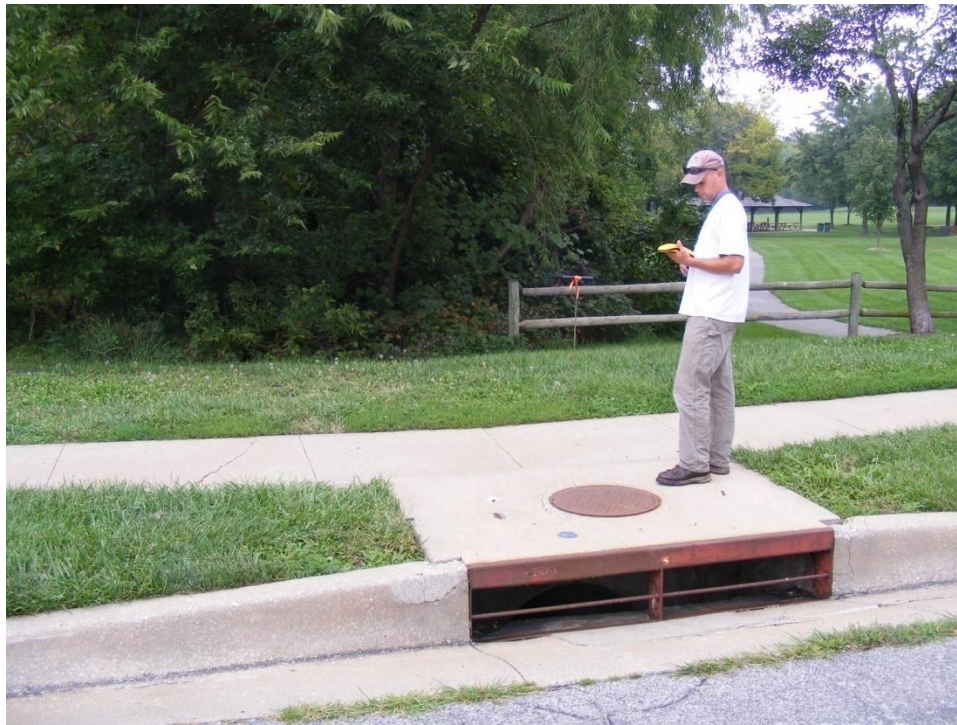
SR-1-A: Typical colluvial channel (Station 7,870-7,350 ft)- The stream bed and banks consist of silty material with occasional construction debris, such as asphalt and crushed limestone, being deposited on the bed. Forced riffles caused by roots, utility crossings, and walking path culverts cause small scour-hole formation locally, but there is no evidence of systemic instability. Cross-section site 1 is in this sub-reach (Photos 1-2)

Photo 1. R1-A Start of Project St. 7,870 ft looking downstream (Sept. 2009)

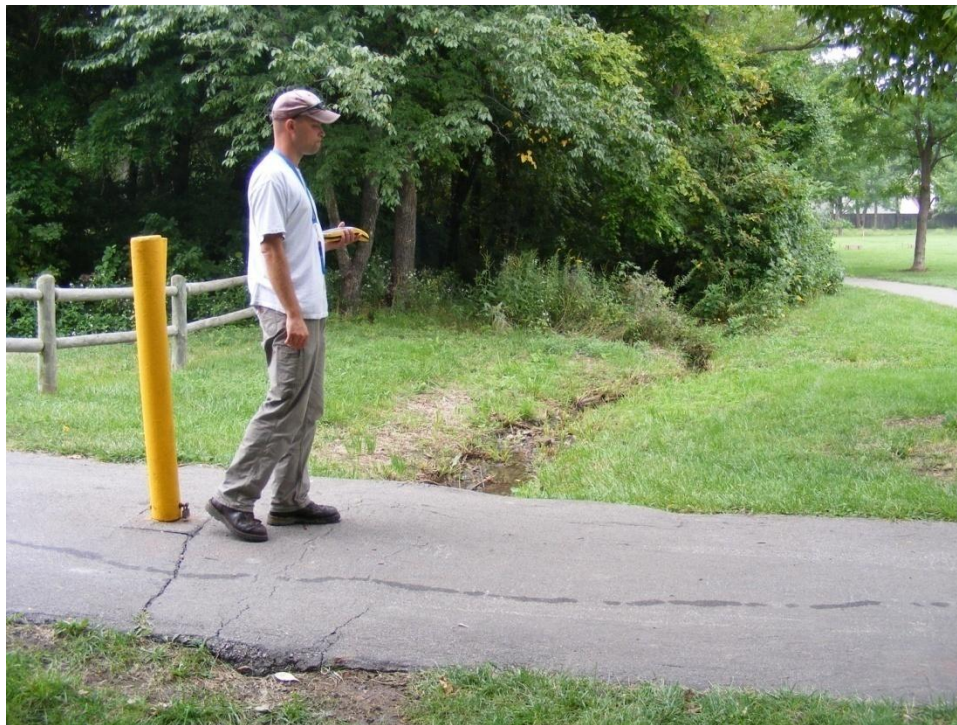
Photo 2. R1-A Path at St. 7,550 looking downstream (Sept. 2009)

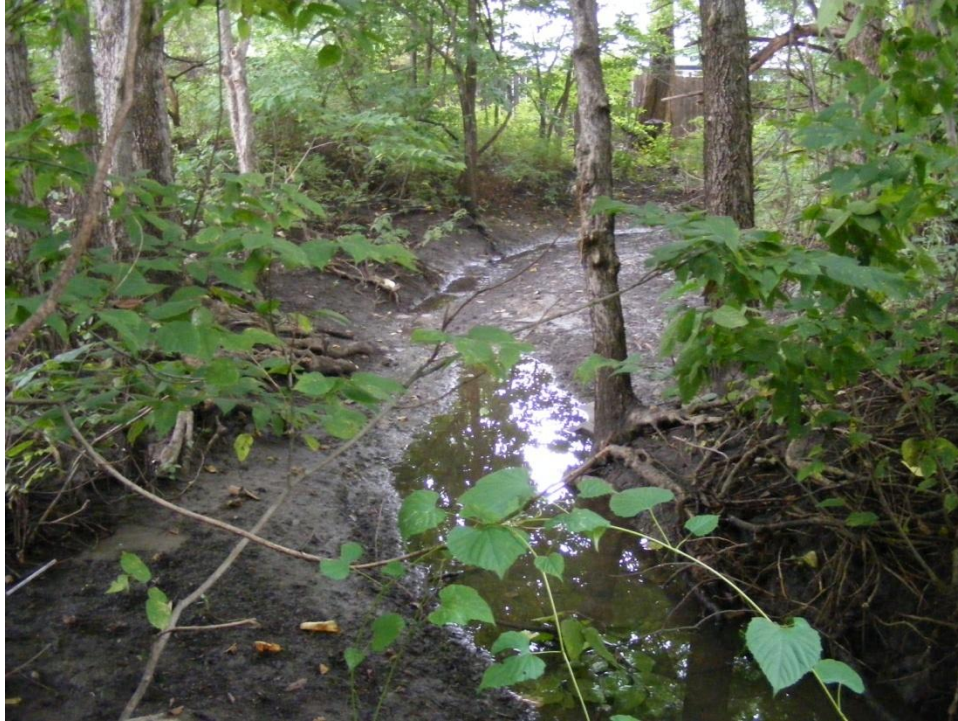
Photo 3. R1-B Channel St. 7,300 looking downstream (Sept. 2009)

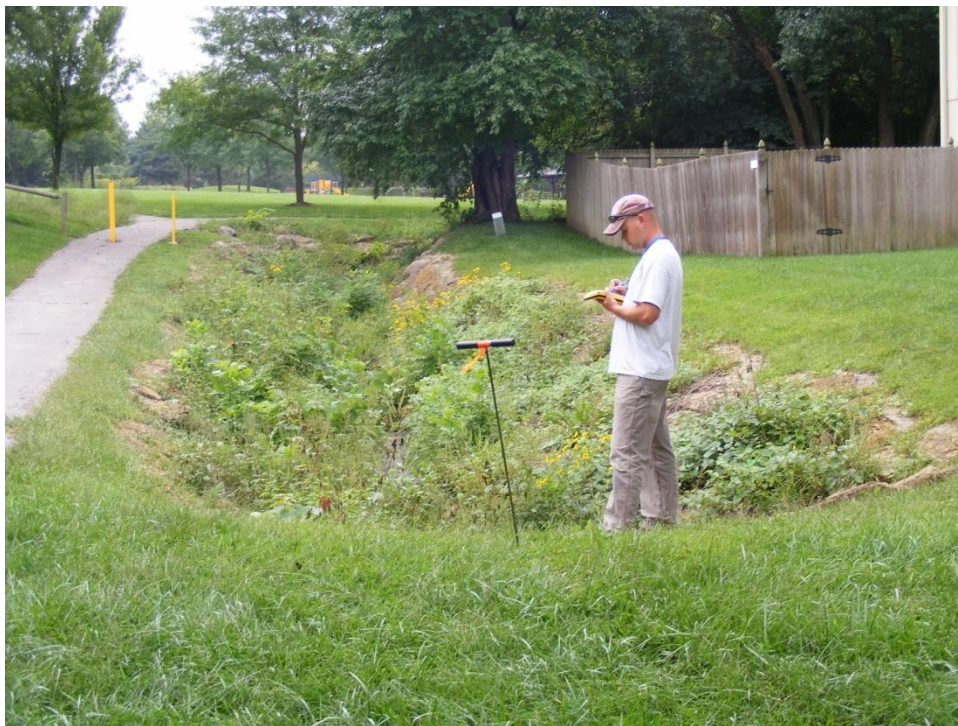
Photo 4. R3 - Rip-rap and culvert inlet St. 7,030 looking upstream (Sept. 2009)

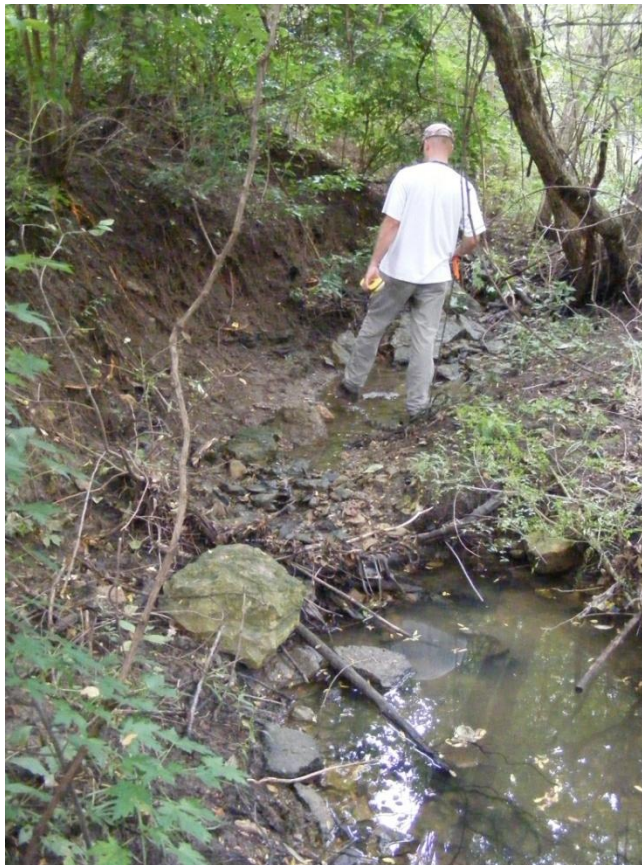
The stream flows across the Vilas Shale and Plattsburg Limestone in this section. Five well expressed knick-points are formed in this unit with bed elevation drops from 3 to 5 ft. The Vilas shale beds are relatively thick and erodible. Thus, knick-points tend to form when overlying limestone beds fail after underlying shale support is removed by erosion. Only the upstream knick-point at station 5,890 ft seems to be head-cutting upstream at timescales of potential concern, albeit slowly. A smaller extension of this head-cut is moving up a small tributary. The limestone unit here is relatively thin over a thick shale unit. The others are formed in relatively thickly-bedded limestone where shale layers are thinner maybe have pinched out. (Photos 8-10)

Photo 8. R6-A knick St. 6,375 ft looking upstream (Sept. 2009)

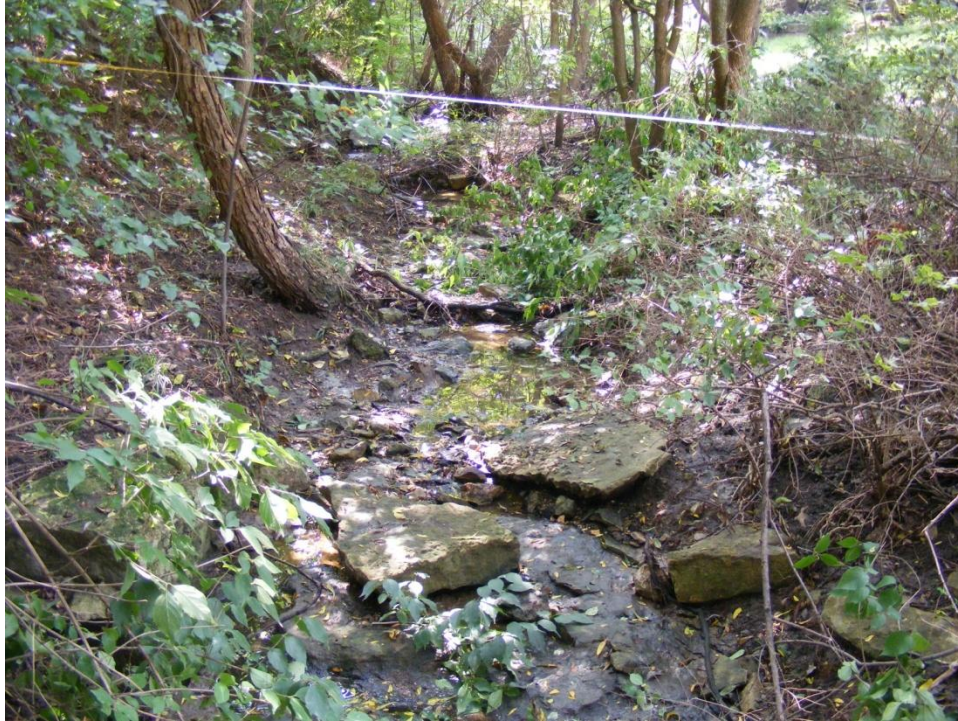
Photo 9. R6-B xs 4 St. 6,020 ft looking upstream (Sept. 2009)

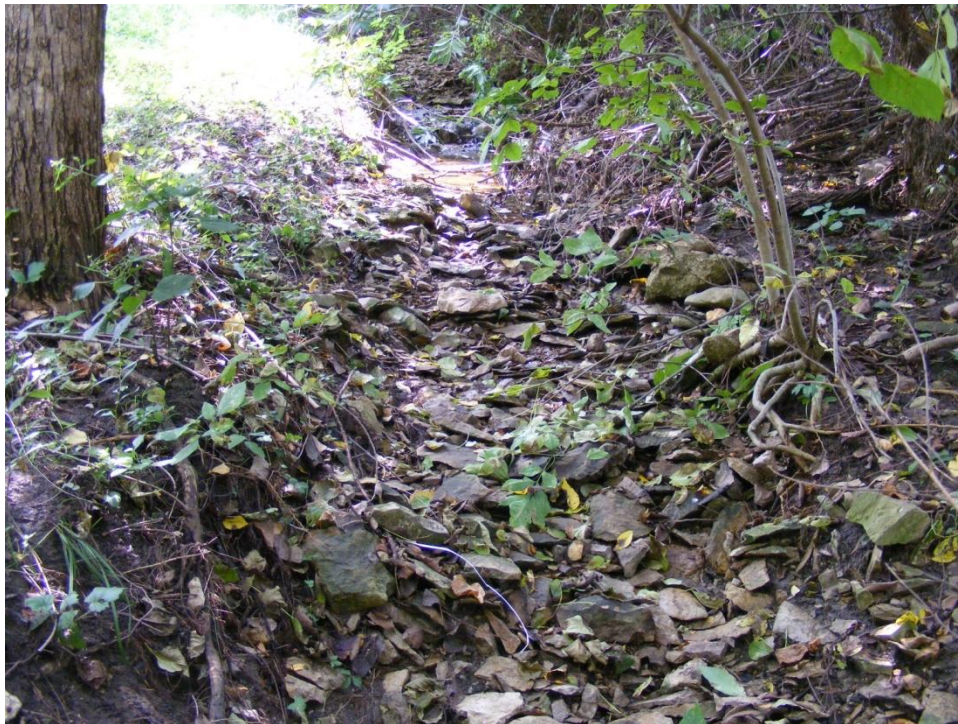
Photo 10, R6-C xs 5 St. 5,835 looking upstream (Sept. 2009)

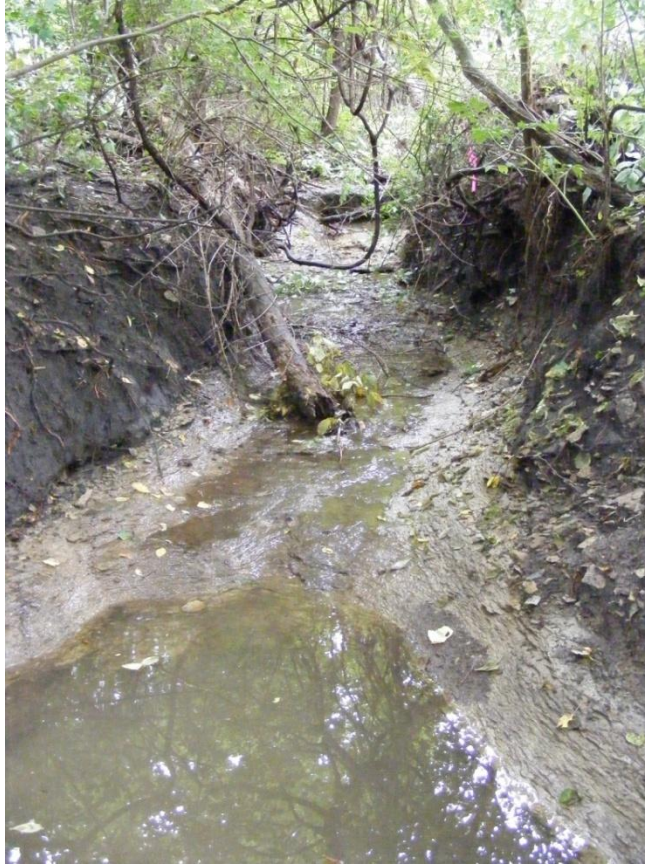
(2) **Bedrock Knick-points:** Bedrock is intermittently exposed on the channel bed and along lower banks below station 6,500 ft to the mouth on Mill Creek. Seven well formed bedrock knick points, some with drops to 7 feet, are found between stations 2,000 to 6,400 ft between elevations of 900-1000 feet. Less resistant shale erodes out from under limestone beds until the slab fails and forms a step. The ages of these knick-points are not known, but most do not appear to be actively migrating upstream at timescales of interest here. However, there are several head-cuts that may be actively migrating upstream at rates of concern between stations 5,800 to 5,900 ft.

Photo 11. R6-C Knick St. 5,800 looking upstream (Sept. 2009)

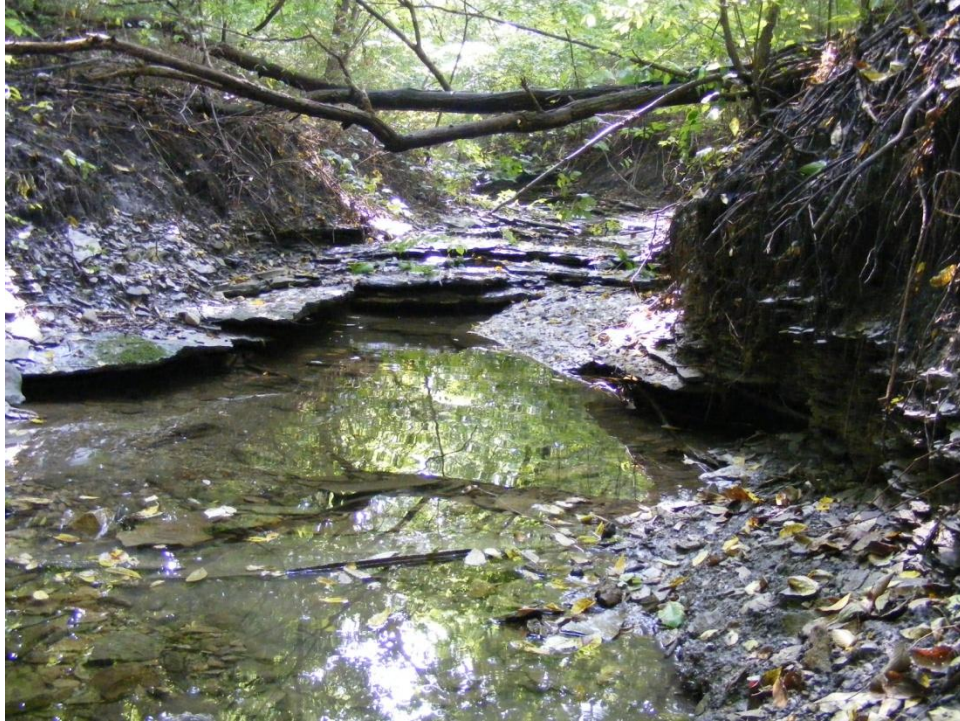
Photo 17. R6-C knick St. 5,175 ft looking upstream (Sept. 2009)

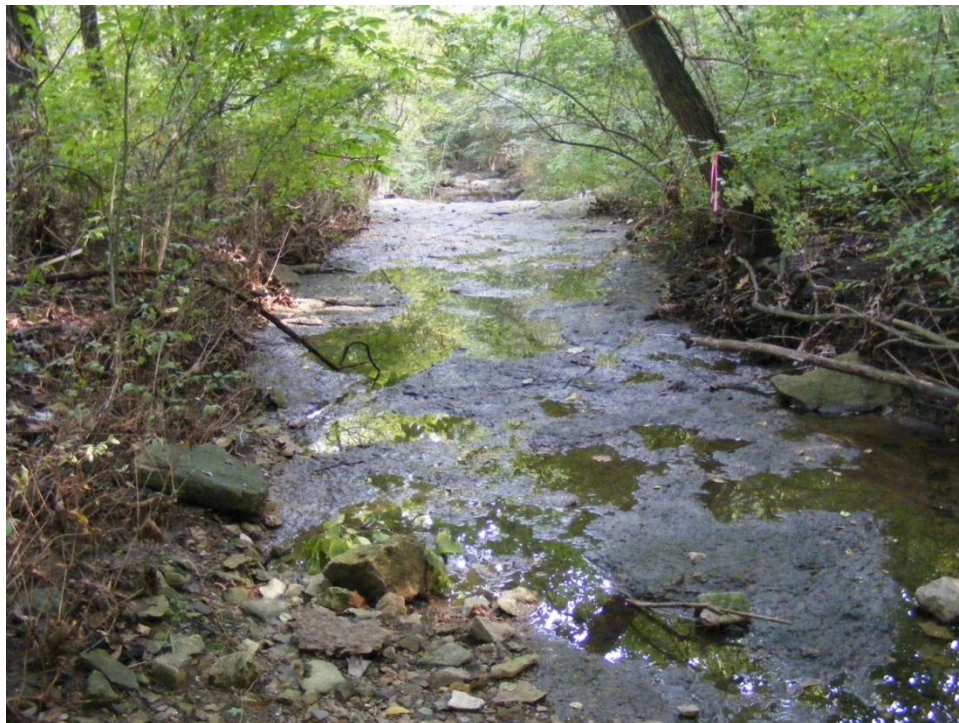
Photo 32. R12 - above knick St. 3,000 ft looking downstream (Sept. 2009)

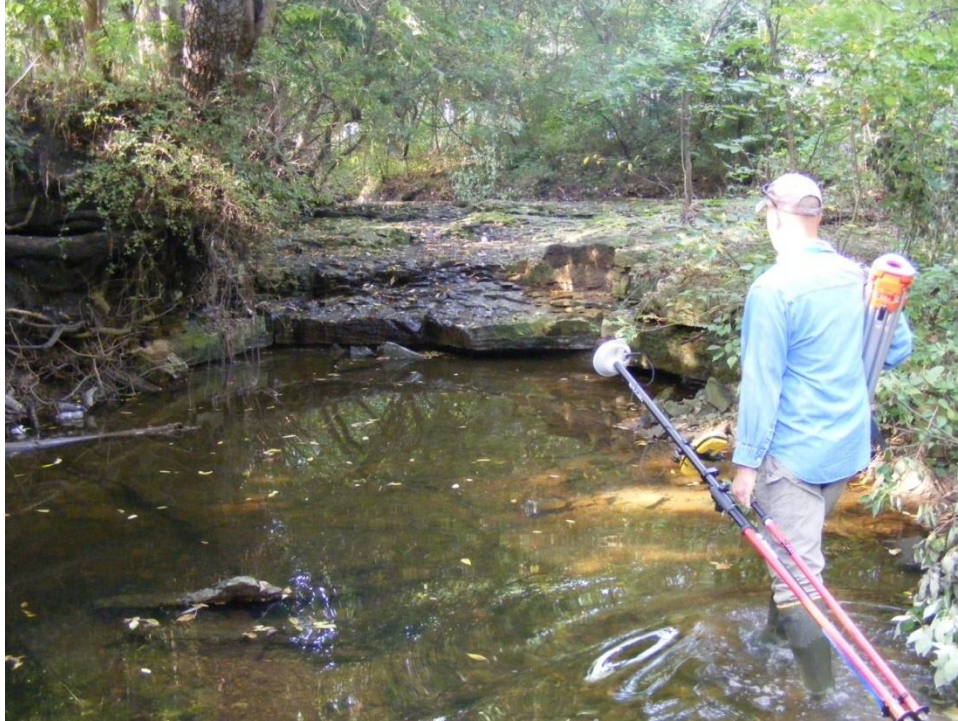
Photo 41. R14 - knick St. 2,050 ft looking upstream (Sept. 2009)
