Ozarks Environmental and Water Resources Institute (OEWRi)

Geomorphic Analysis of Lackman Tributary, Lenexa, KS.

Final report to Olsson Associates for the City of Lenexa, Kansas

December 17, 2009

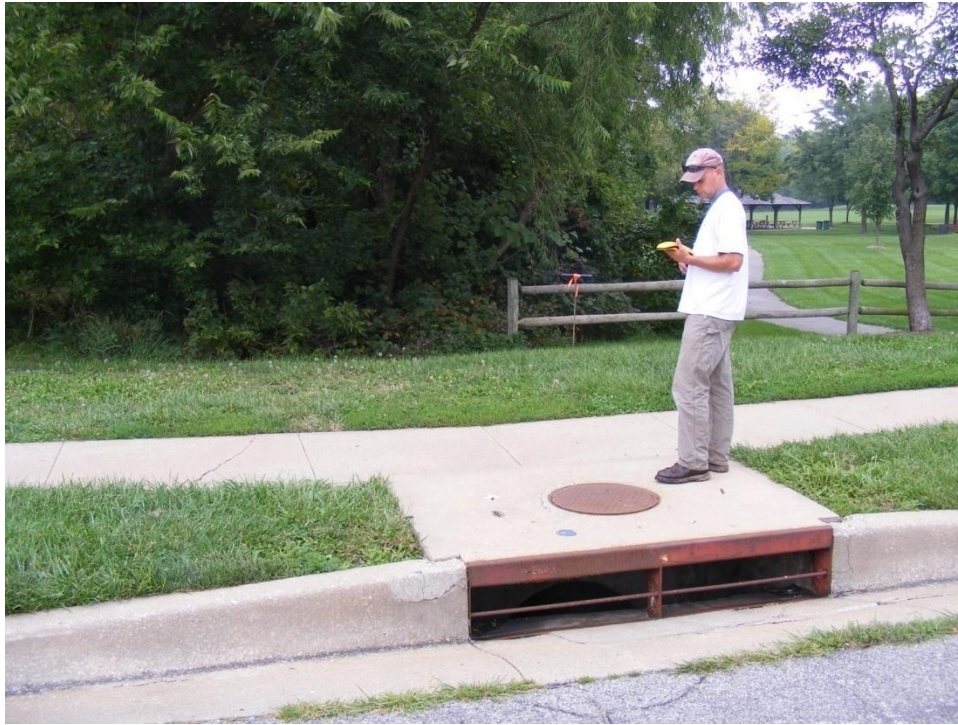
SR-1-A: Typical colluvial channel (Station 7,870-7,350 ft)- The stream bed and banks consist of silty material with occasional construction debris, such as asphalt and crushed limestone, being deposited on the bed. Forced riffles caused by roots, utility crossings, and walking path culverts cause small scour-hole formation locally, but there is no evidence of systemic instability. Cross-section site 1 is in this sub-reach (Photos 1-2)

Photo 1. R1-A Start of Project St. 7,870 ft looking downstream (Sept. 2009)

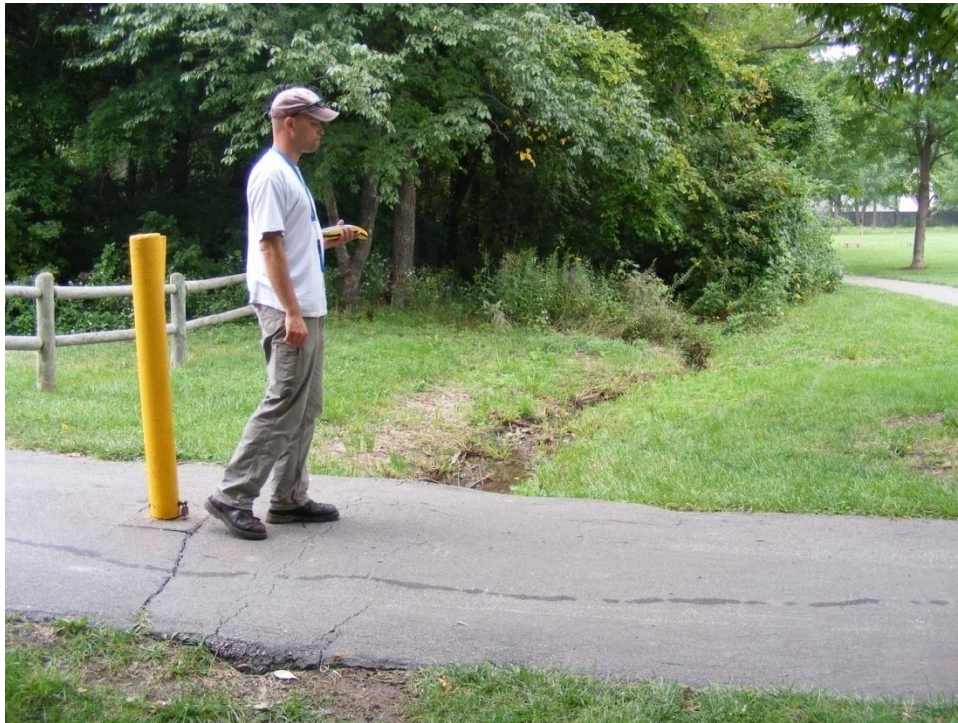
Photo 2. R1-A Path at St. 7,550 looking downstream (Sept. 2009)

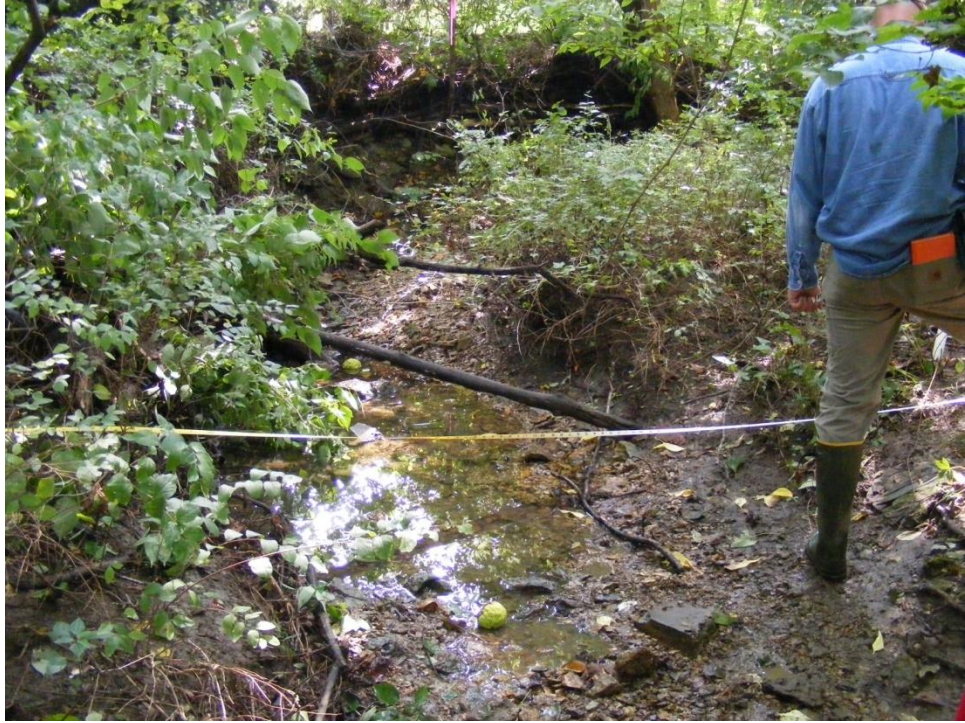
Photo 5. R4 – xs 2, St. 6,840, looking upstream (Sept. 2009)

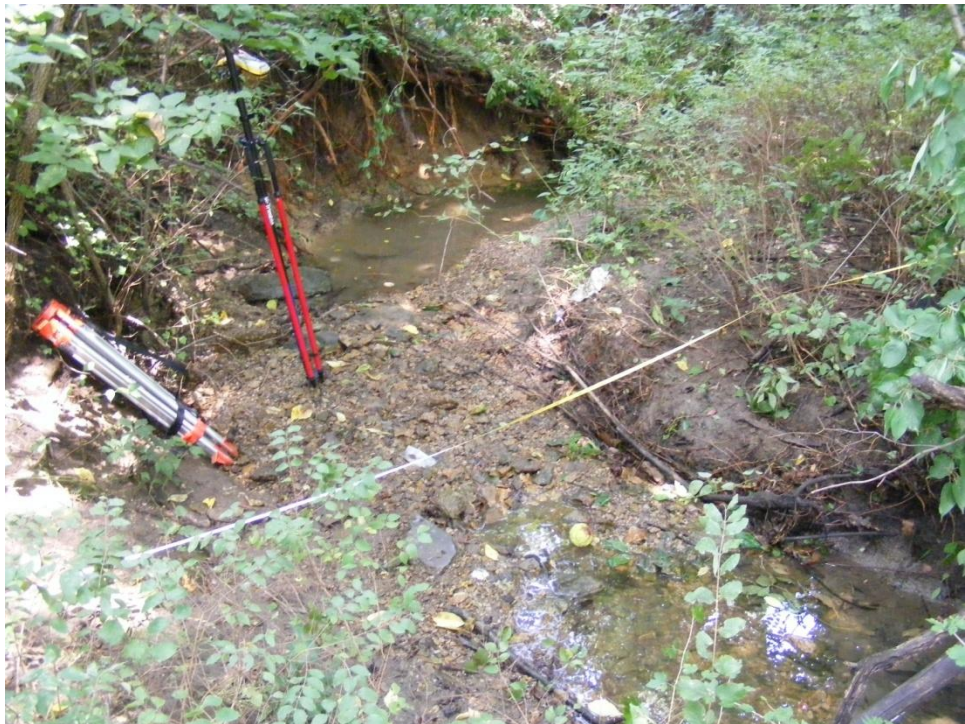
Photo 6. R4 – xs 2, St. 6,840, looking downstream (Sept. 2009)

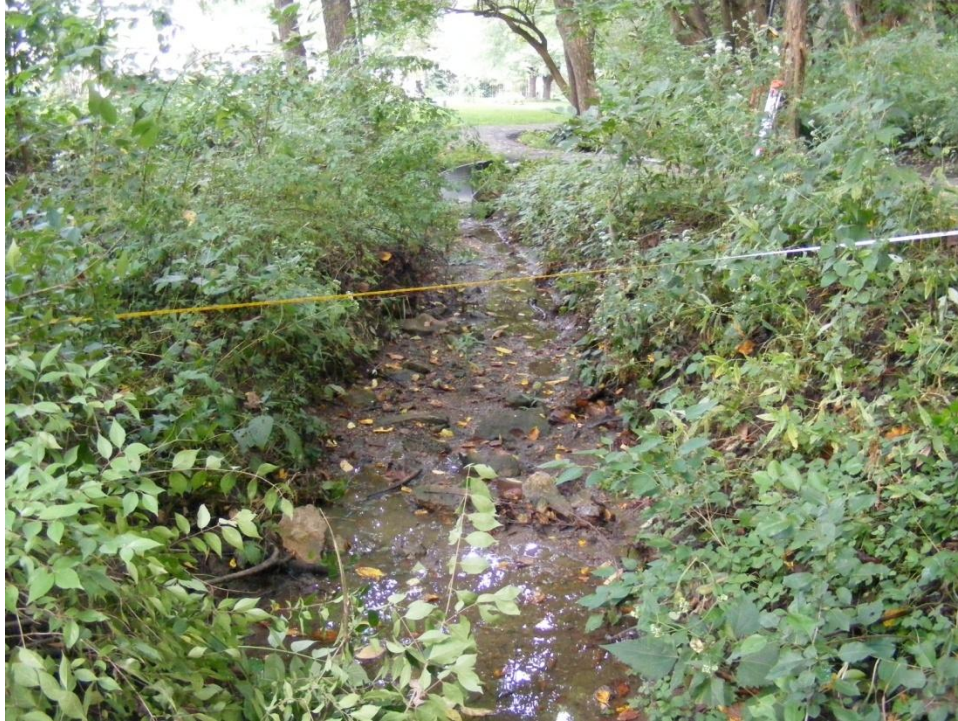
Photo 7. R5 – xs 3 St. 6,530 ft looking downstream (Sept. 2009)

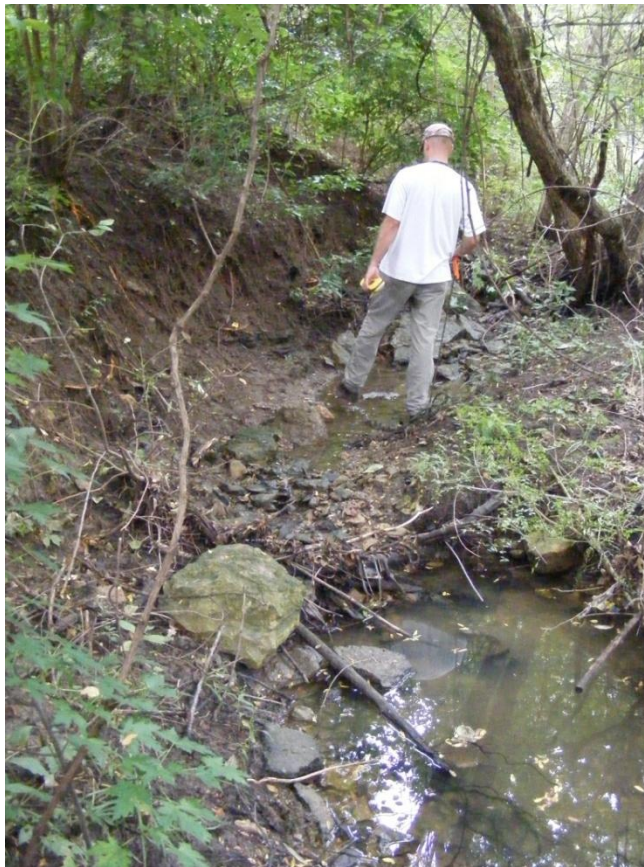
The stream flows across the Vilas Shale and Plattsburg Limestone in this section. Five well expressed knick-points are formed in this unit with bed elevation drops from 3 to 5 ft. The Vilas shale beds are relatively thick and erodible. Thus, knick-points tend to form when overlying limestone beds fail after underlying shale support is removed by erosion. Only the upstream knick-point at station 5,890 ft seems to be head-cutting upstream at timescales of potential concern, albeit slowly. A smaller extension of this head-cut is moving up a small tributary. The limestone unit here is relatively thin over a thick shale unit. The others are formed in relatively thickly-bedded limestone where shale layers are thinner maybe have pinched out. (Photos 8-10)

Photo 8. R6-A knick St. 6,375 ft looking upstream (Sept. 2009)

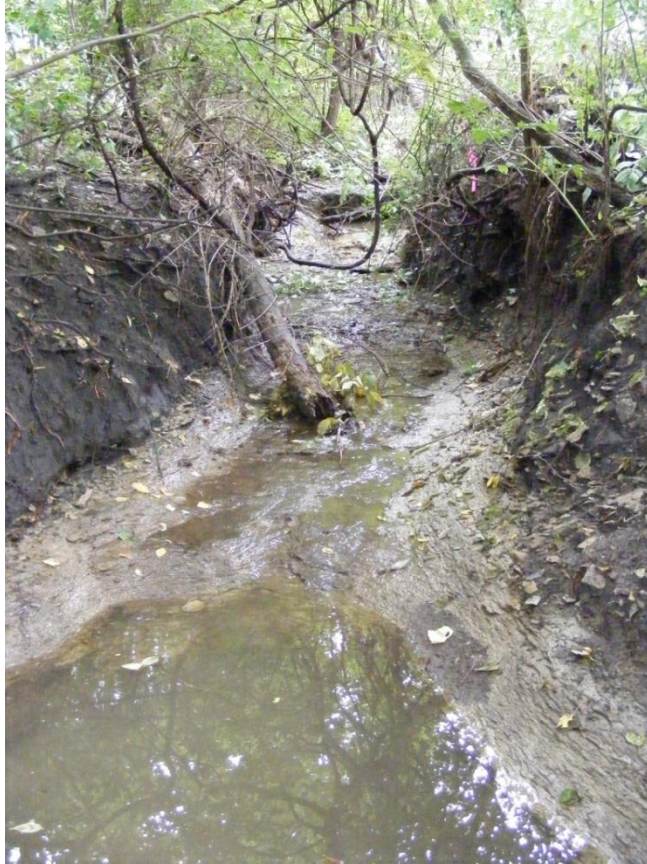
(2) **Bedrock Knick-points:** Bedrock is intermittently exposed on the channel bed and along lower banks below station 6,500 ft to the mouth on Mill Creek. Seven well formed bedrock knick points, some with drops to 7 feet, are found between stations 2,000 to 6,400 ft between elevations of 900-1000 feet. Less resistant shale erodes out from under limestone beds until the slab fails and forms a step. The ages of these knick-points are not known, but most do not appear to be actively migrating upstream at timescales of interest here. However, there are several head-cuts that may be actively migrating upstream at rates of concern between stations 5,800 to 5,900 ft.

Photo 11. R6-C Knick St. 5,800 looking upstream (Sept. 2009)

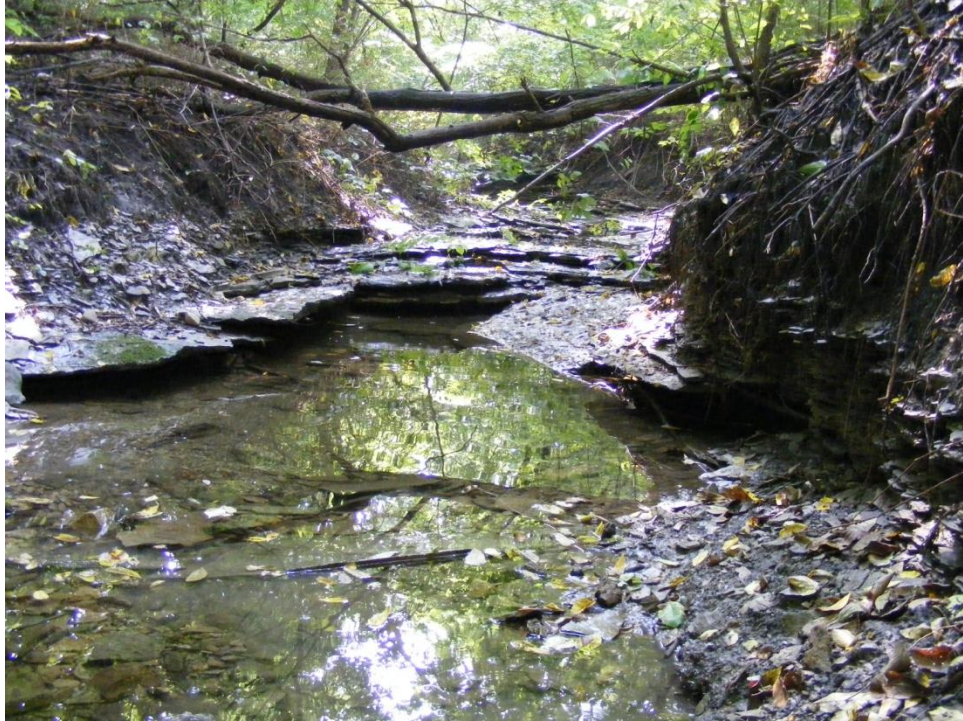
Photo 17. R6-C knick St. 5,175 ft looking upstream (Sept. 2009)
