Geomorphic Analysis of the Main Channel of the Golf Club of Kansas Site in Lenexa, Kansas

By: Dr. Robert T. Pavlowsky
May 22, 2007

This report describes the geomorphic condition and stability of the main stream channel draining the Golf Club of Kansas Site in Lenexa, Kansas. It is prepared for Olsson Associates by Dr. Robert T. Pavlowsky of the Ozarks Environmental and Water Resources Institute at Missouri State University. The information provided in this report was provided by on-line sources, Olsson Associates, and fieldwork at the site by Pavlowsky and three staff on April 11-12, 2007. This report provides data and professional opinion to support the restoration planning and channel design for the site.

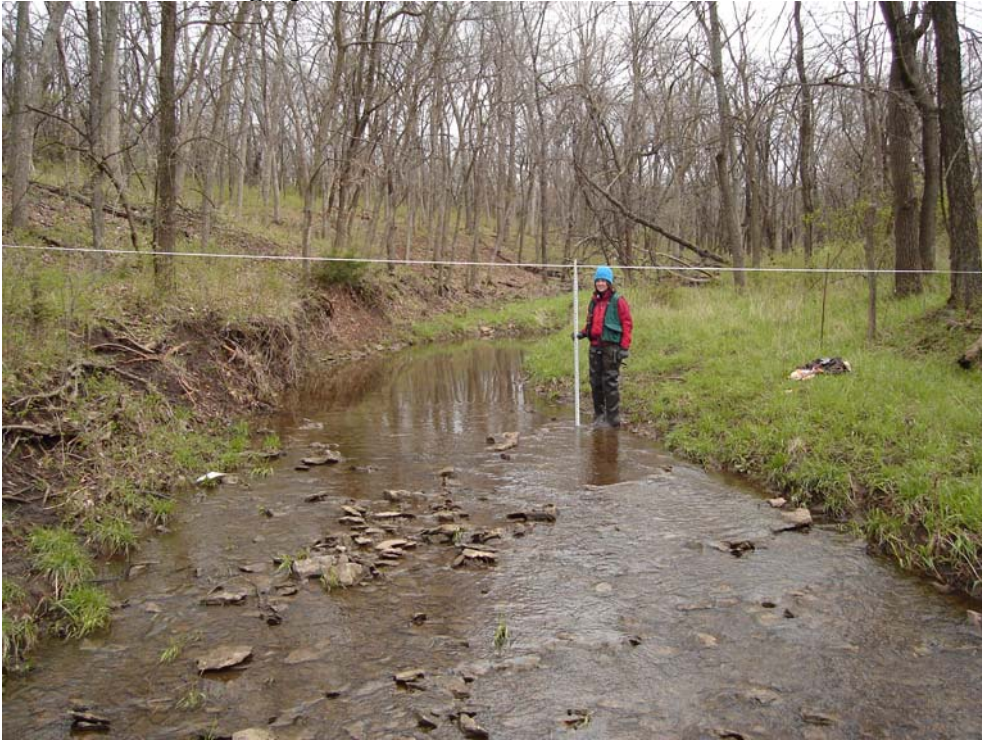
Picture 1. Looking upstream at distance 3146 ft.

>30+00 ft: Adjacent property that is relatively undisturbed (Pictures 1 to 4)

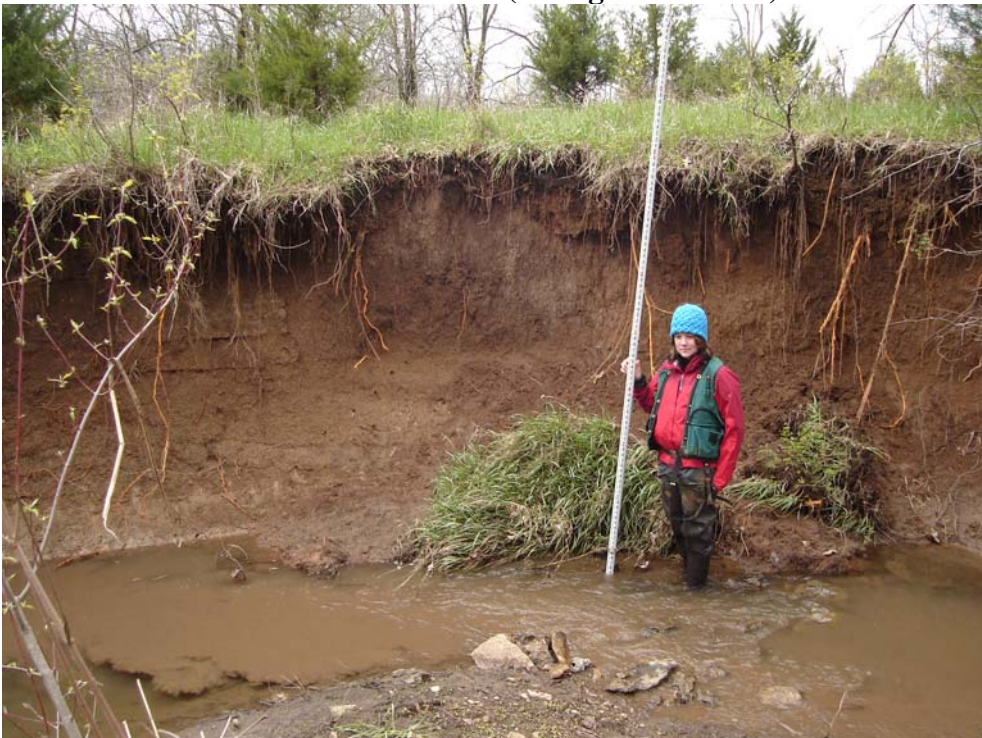
Picture 2. Cutbank at distance 3120 (Ladoga Soil Series)

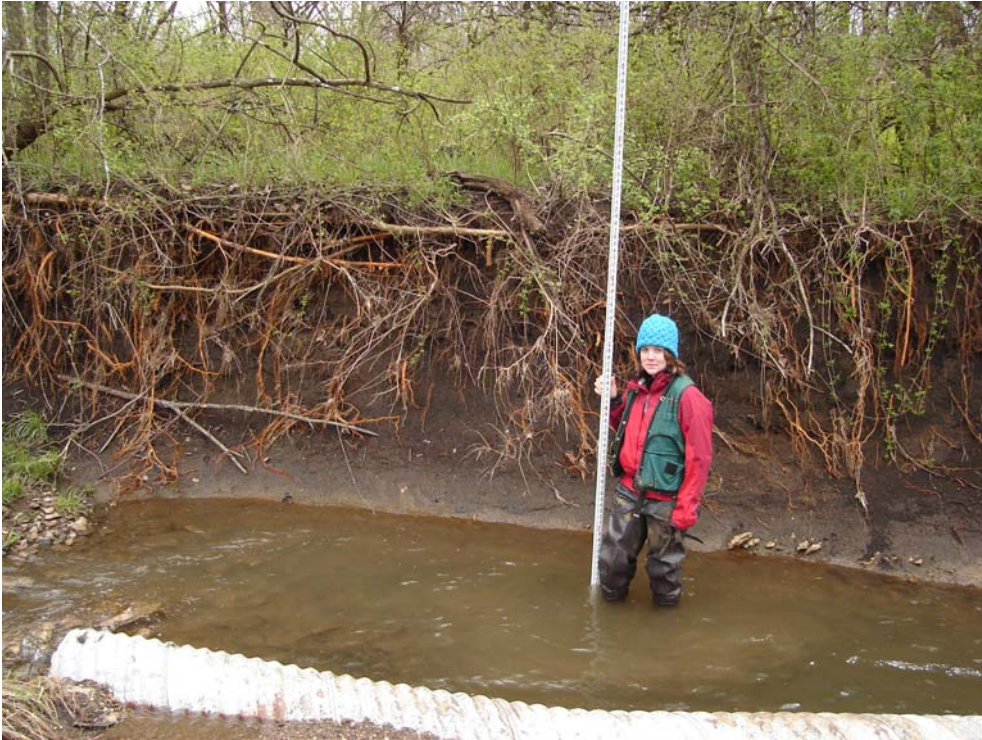
Picture 3. Cutbank at distance 3106 (Kennebec Soil Series)

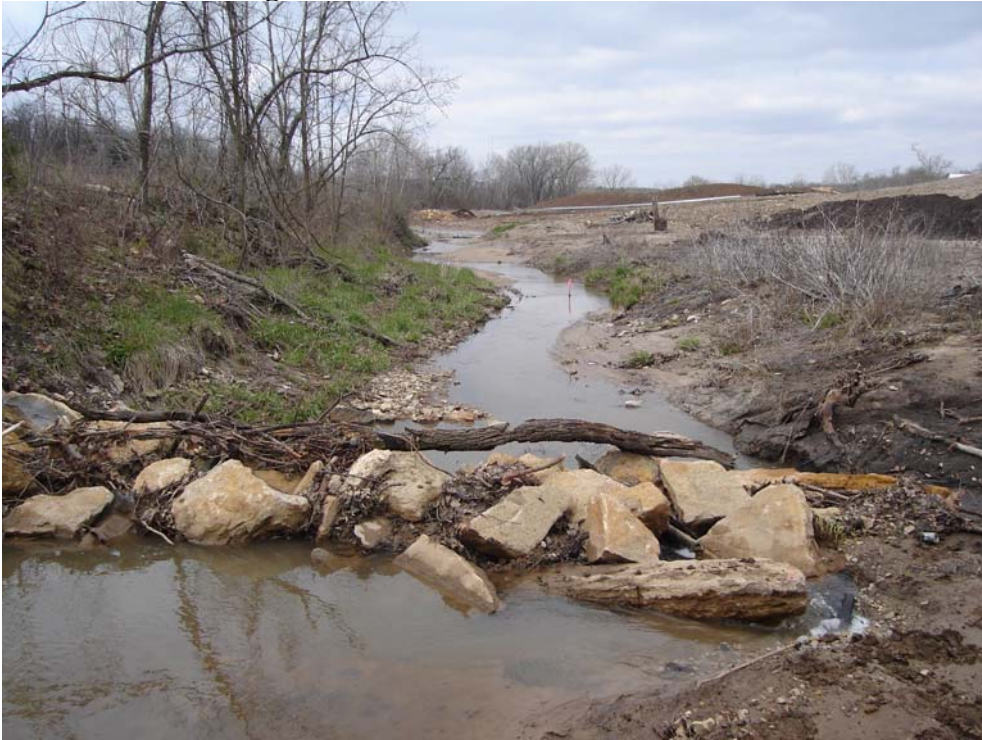
18+75 ft: Sediment control or drop structure #1 with 3-4 feet of fill behind it (Picture 15)

Picture 15. Looking downstream at distance 1950

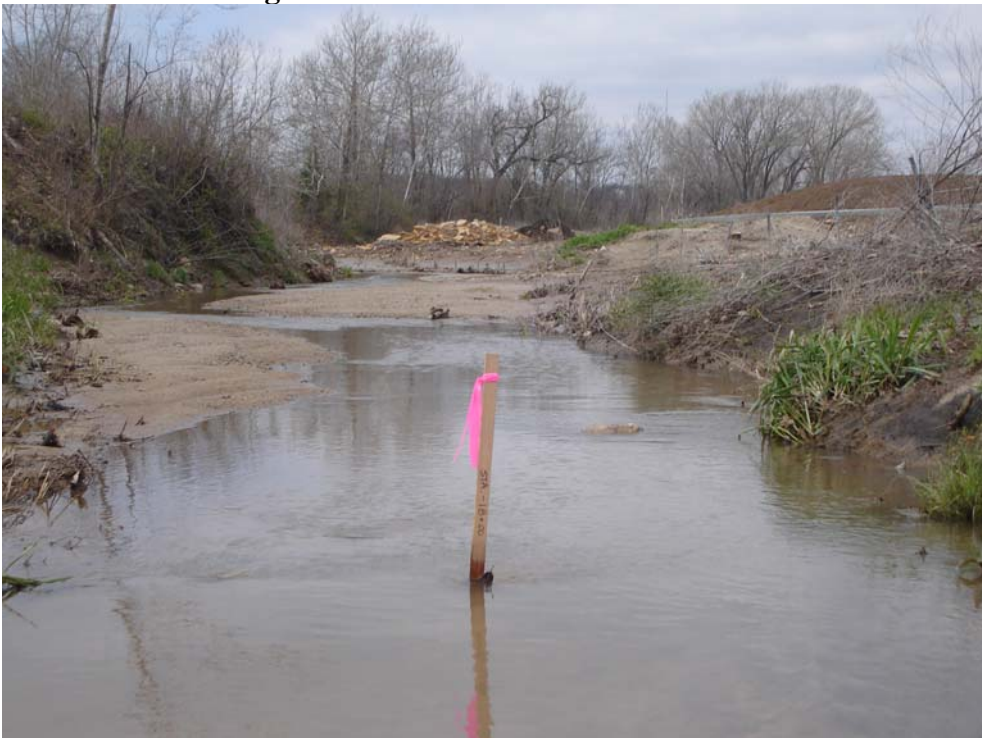
18+75 to 14+80 ft: Braided channel due to introduction of sandy limestone screenings from dump sites (Pictures 16 to 17).

Picture 16. Looking downstream at distance 1800

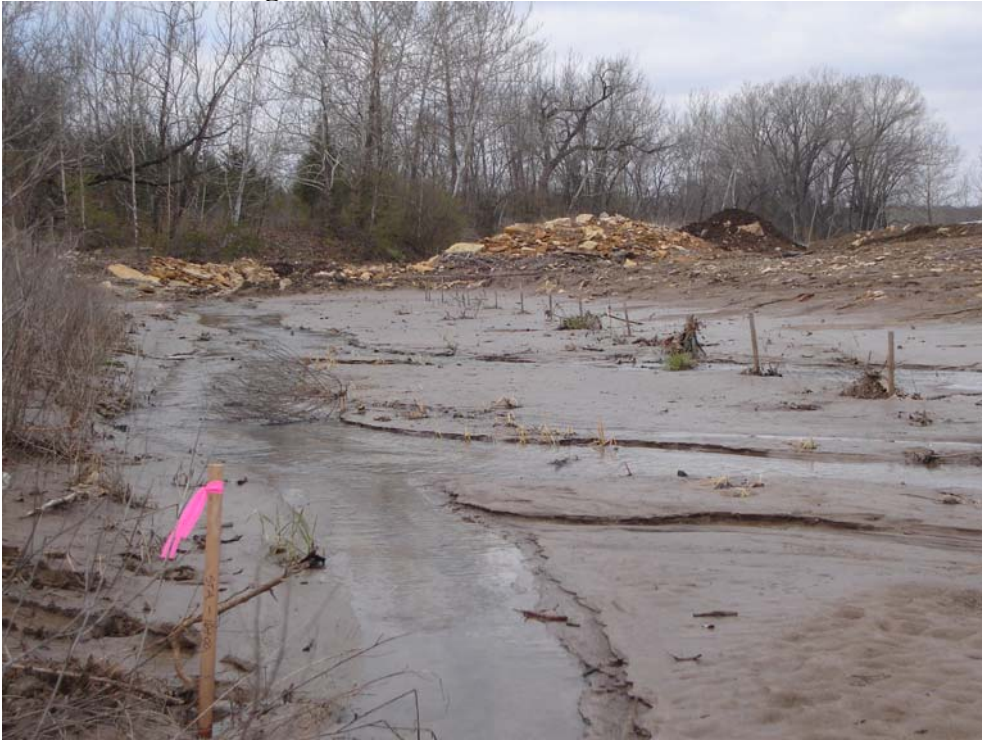
Picture 17. Looking downstream at distance 1600

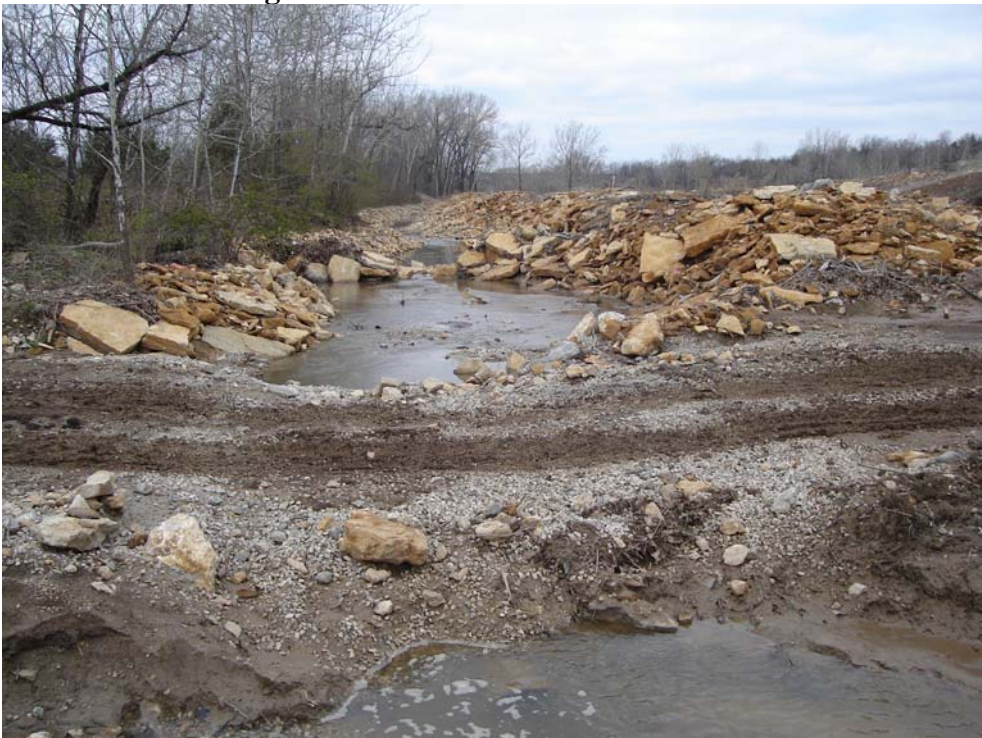
14+80 ft: Low water bridge (Picture 18)

Picture 18. Looking downstream at distance 1400+

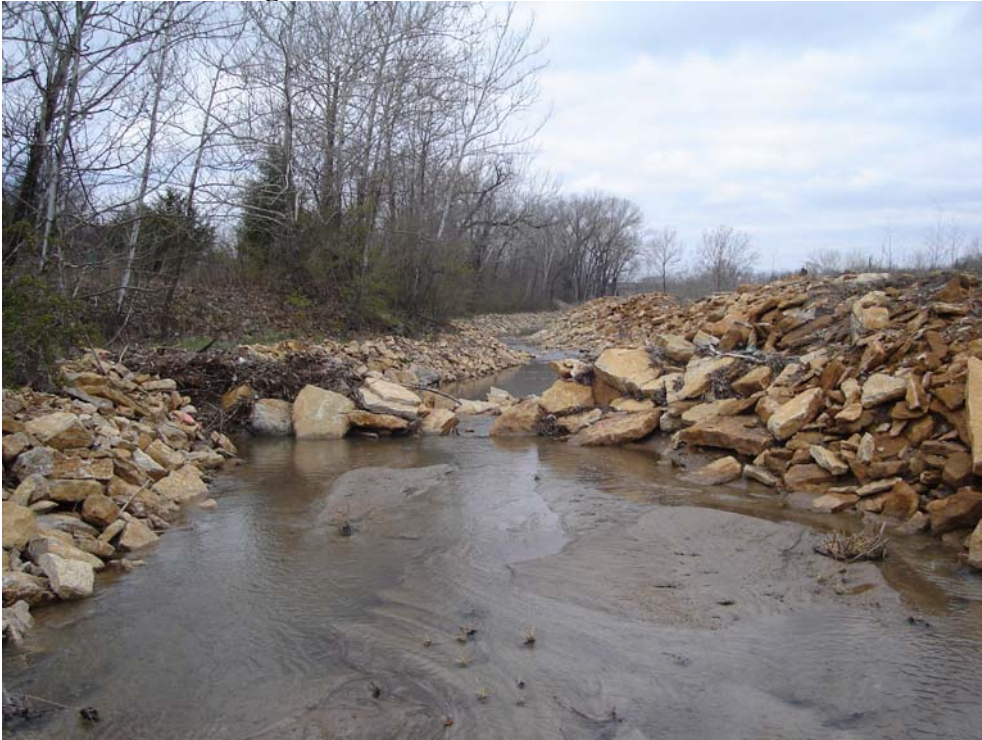
14+50 to 13+50 ft: Sediment control or drop structure #2 with 3 to 5 ft of fill behind it (Picture 19)

Picture 19. Looking downstream at distance 1400

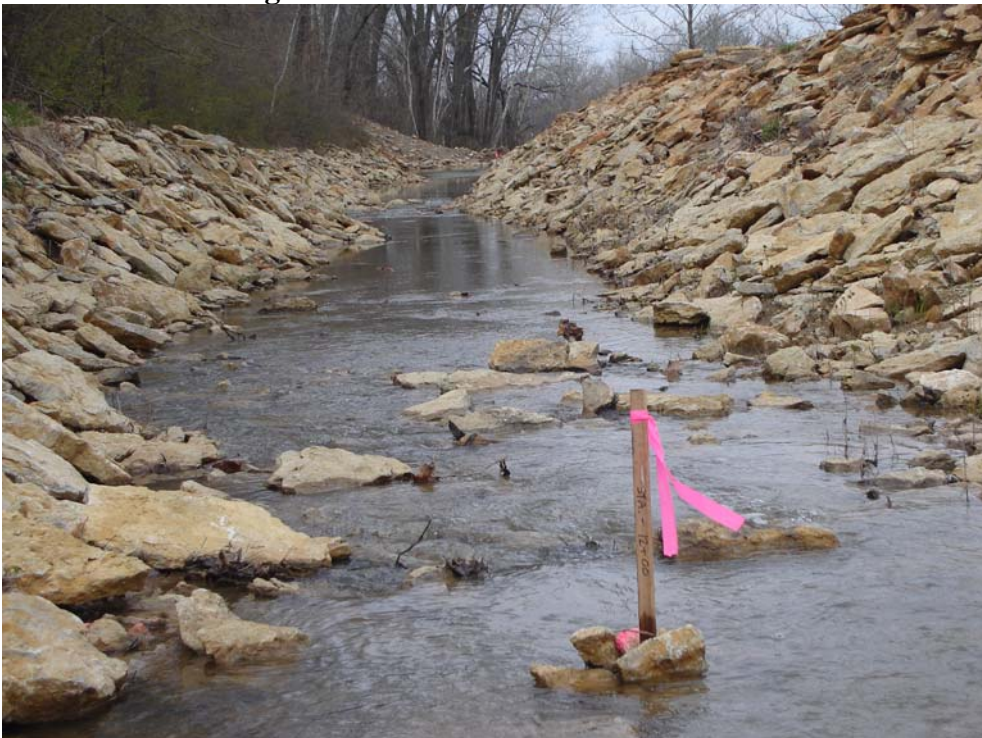
13+50 to 7+85 ft: Trapezoidal rip-rap channel with 1-3 ft diameter rock. Water begins to pool behind next drop structure at 10+00 (Pictures 20 to 21)

Picture 20. Looking downstream at distance 1200

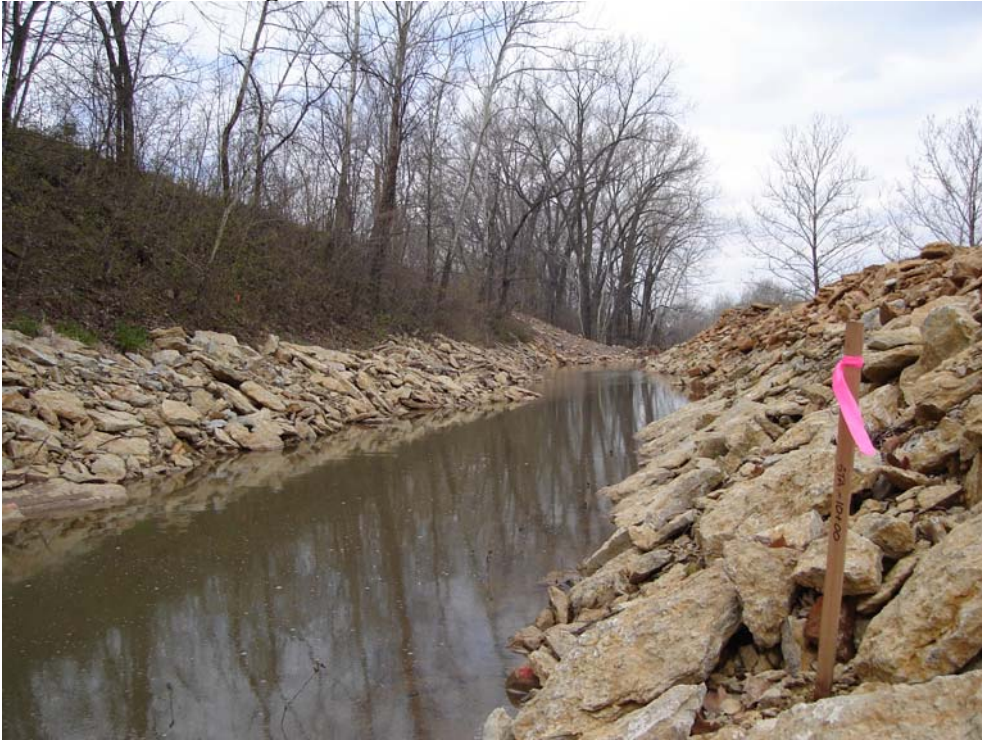
Picture 21. Looking downstream at distance 1000

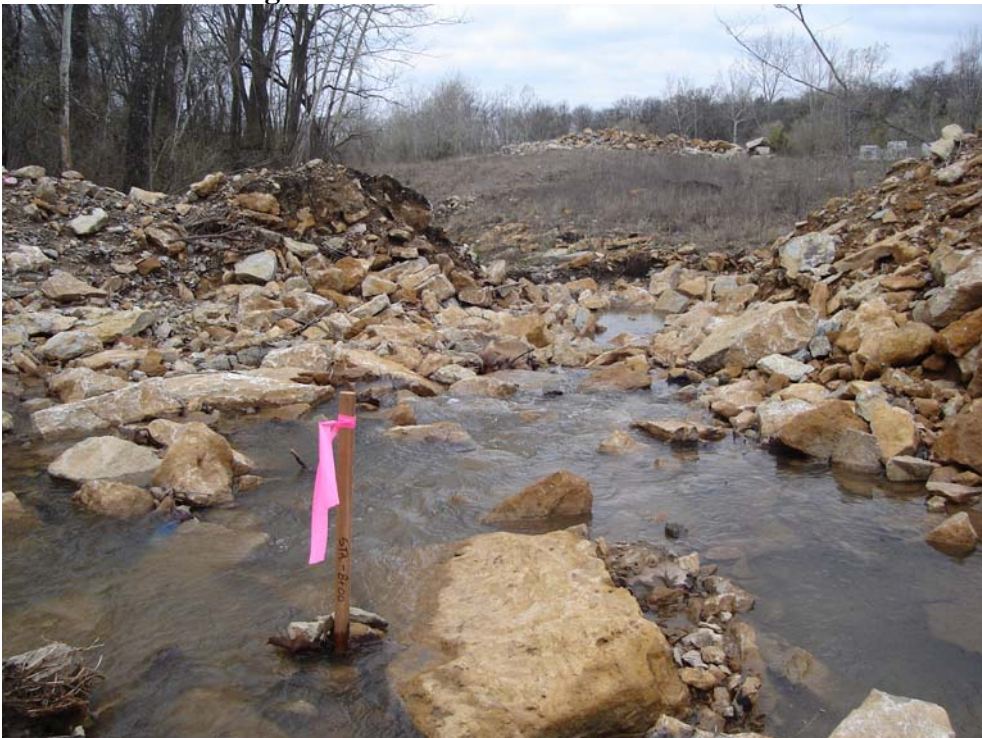
7+85 ft: Sediment control or drop structure # 3 with $\ll 1$ ft of fill behind it (Picture 22)

Picture 22. Looking downstream at distance 800

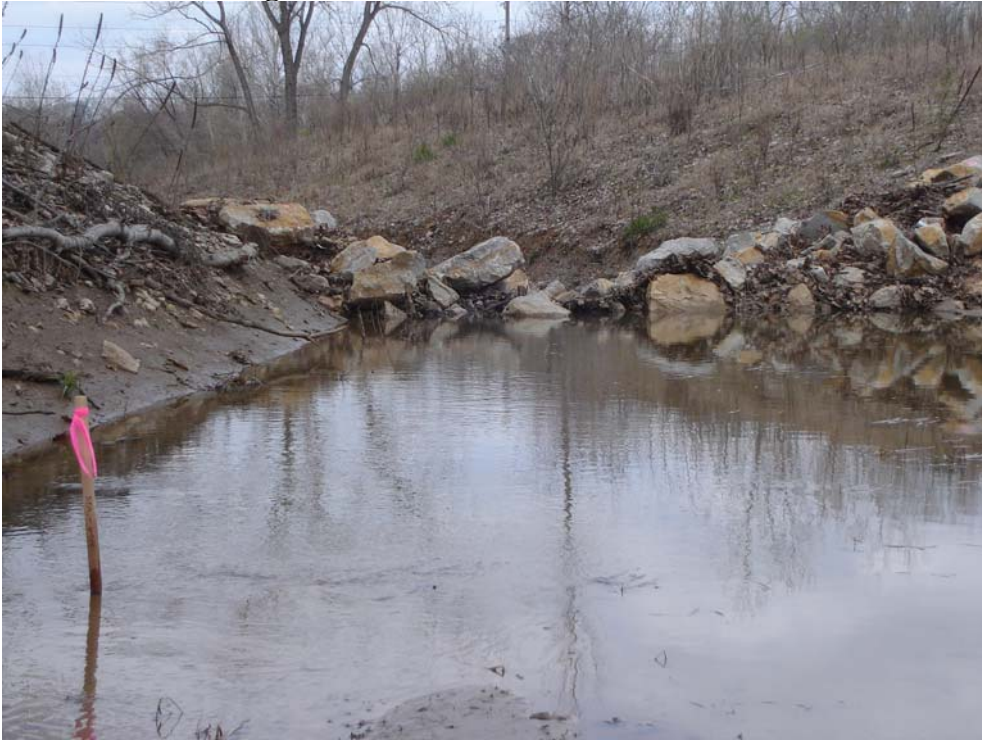
5+50 ft: Sediment control or drop structure # 4 with 1-3 ft of fill behind it (Picture 23)

Picture 23. Looking downstream at distance 600

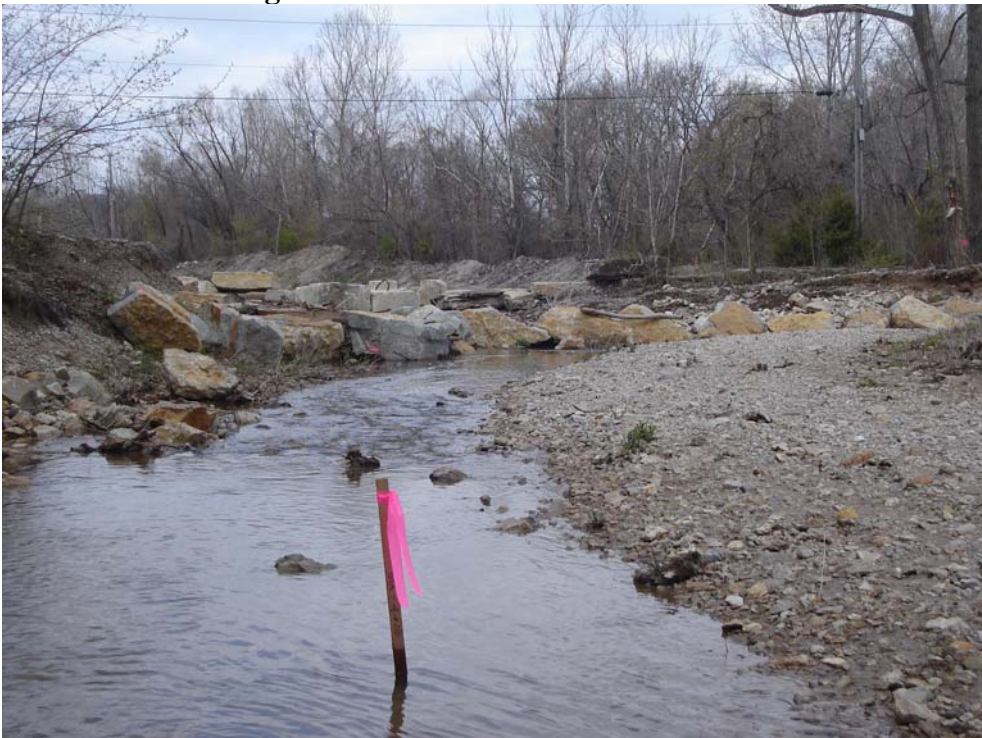
5+00 to 1+50 ft: gravel and sand channel from drop structure #4 to main road culvert (Pictures 24 to 25)

Picture 24. Looking downstream at distance 400

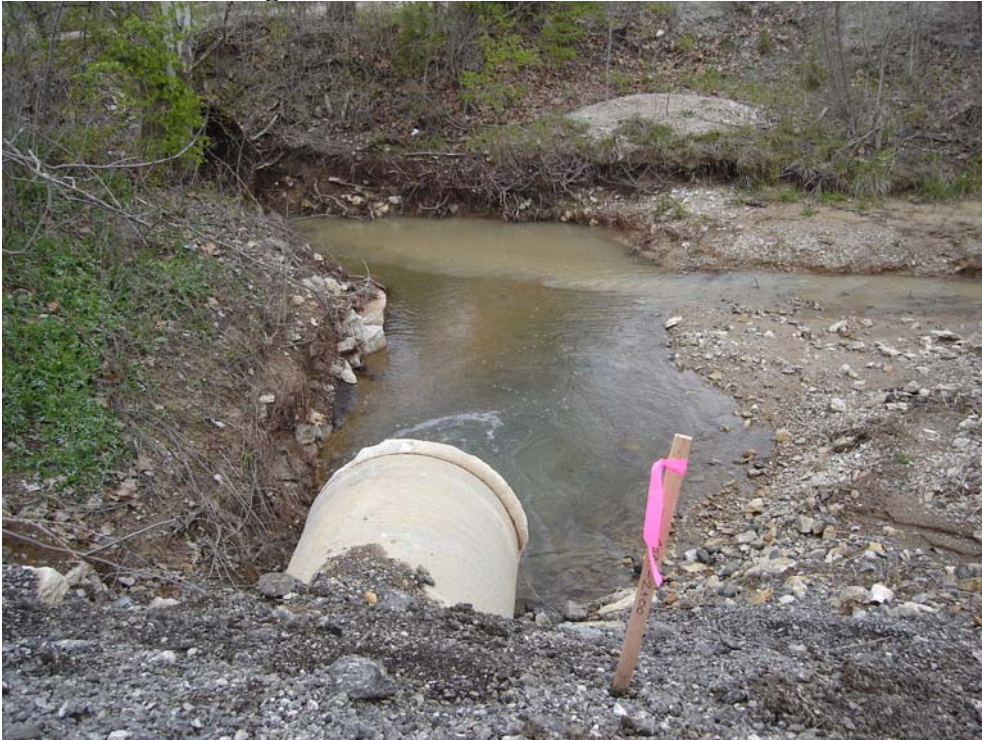
Picture 25. Looking downstream at distance 200
