Geomorphic Analysis of the Main Channel of the Golf Club of Kansas Site in Lenexa, Kansas

By: Dr. Robert T. Pavlowsky
May 22, 2007

Downstream Channel Conditions and Photo Log

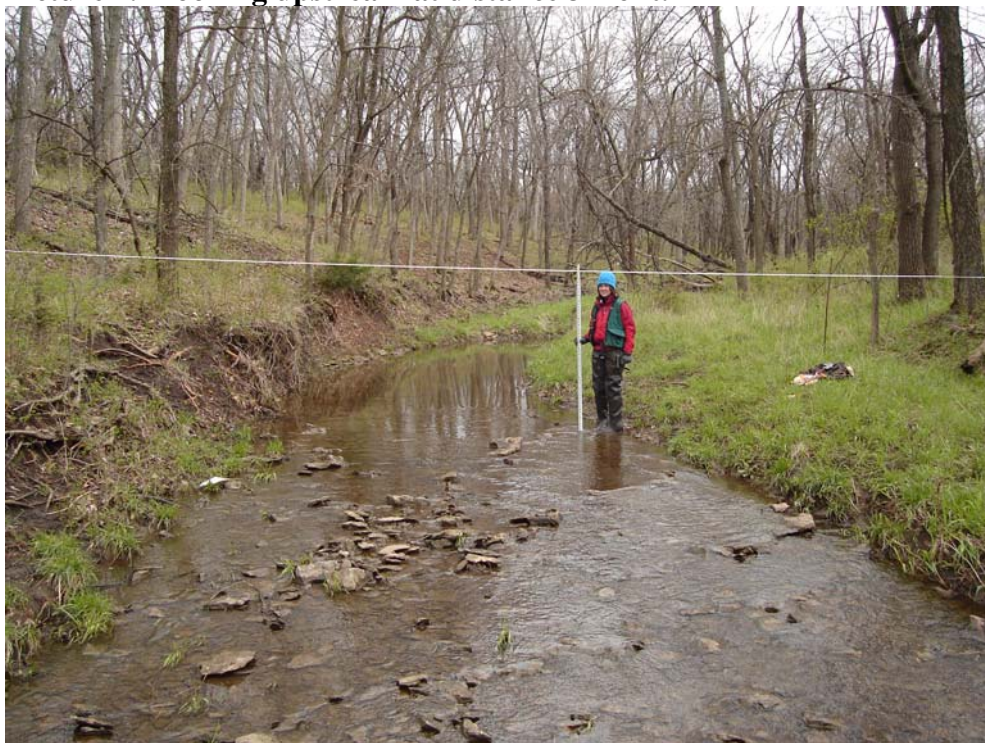
>30+00 ft: Adjacent property that is relatively undisturbed (Pictures 1 to 4)

Picture 1. Looking upstream at distance 3146 ft.

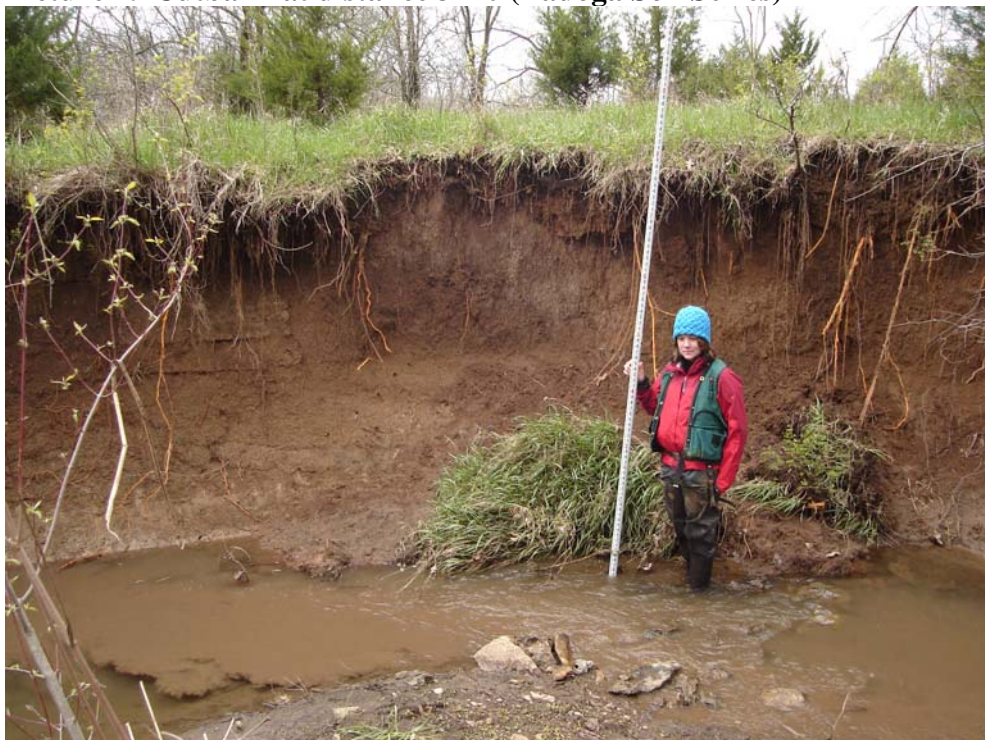
Picture 2. Cutbank at distance 3120 (Ladoga Soil Series)

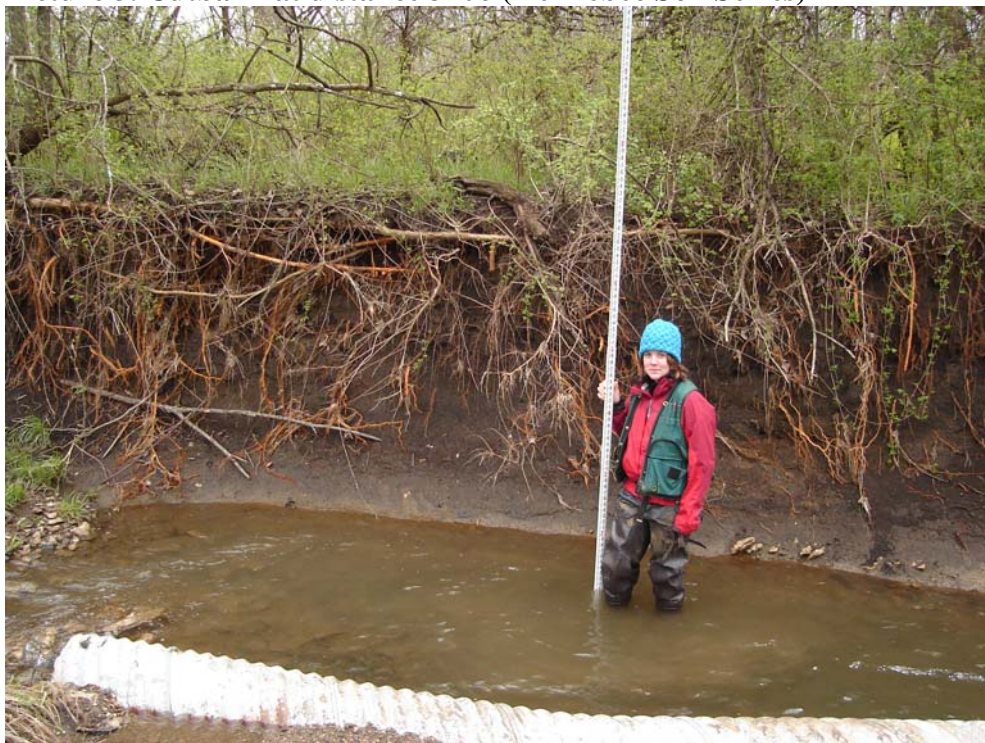
Picture 3. Cutbank at distance 3106 (Kennebec Soil Series)

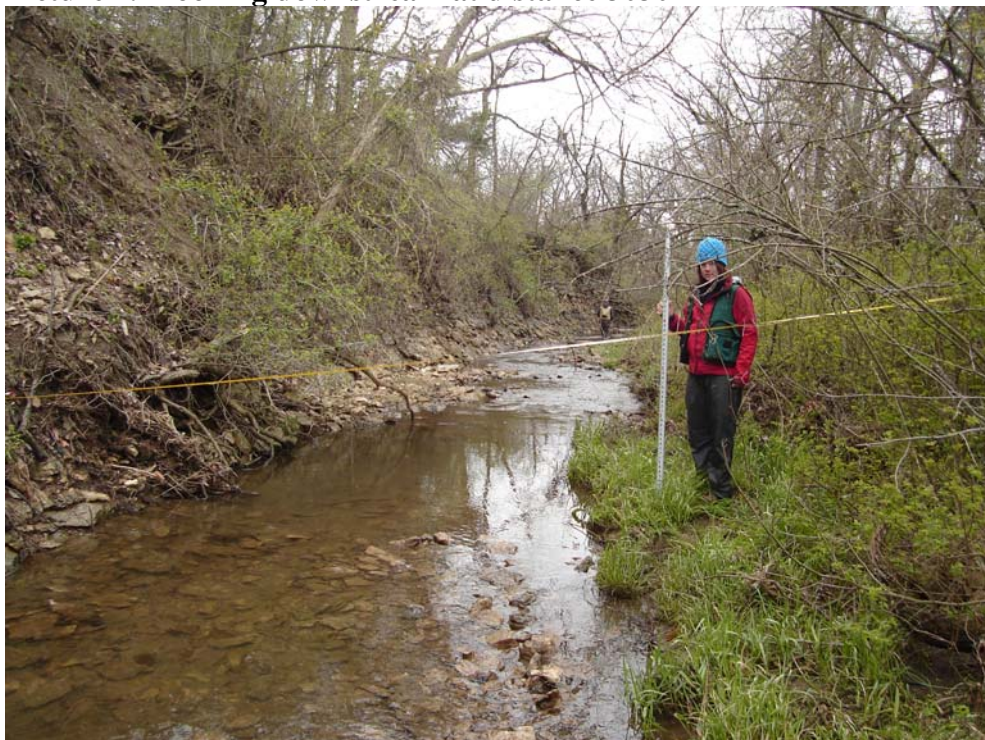
Picture 4. Looking downstream at distance 3030

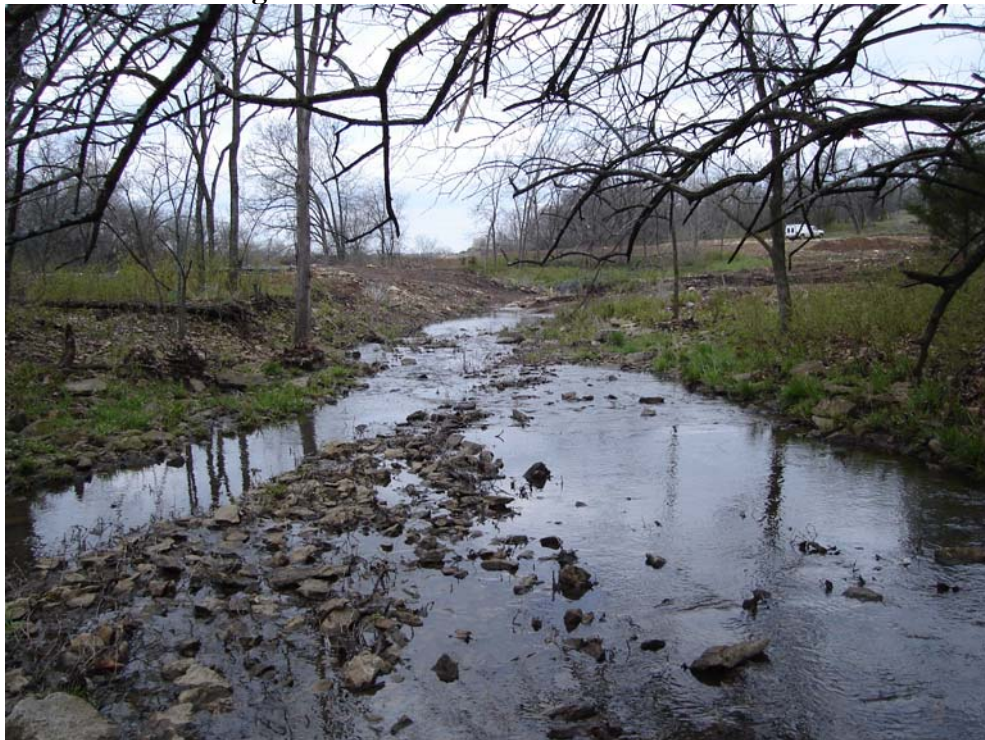
30+00 to 26+00 ft: Somewhat disturbed area around the 13th green (Pictures 5 to 7)

Picture 5. Looking downstream at distance 2944

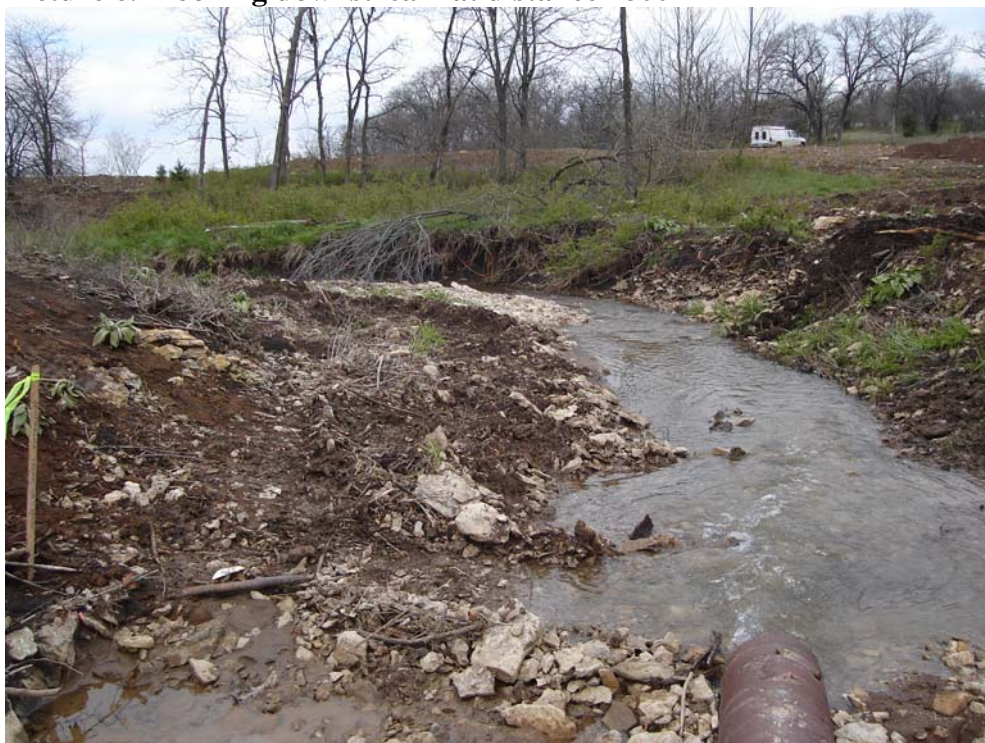
Picture 6. Looking downstream at distance 2800

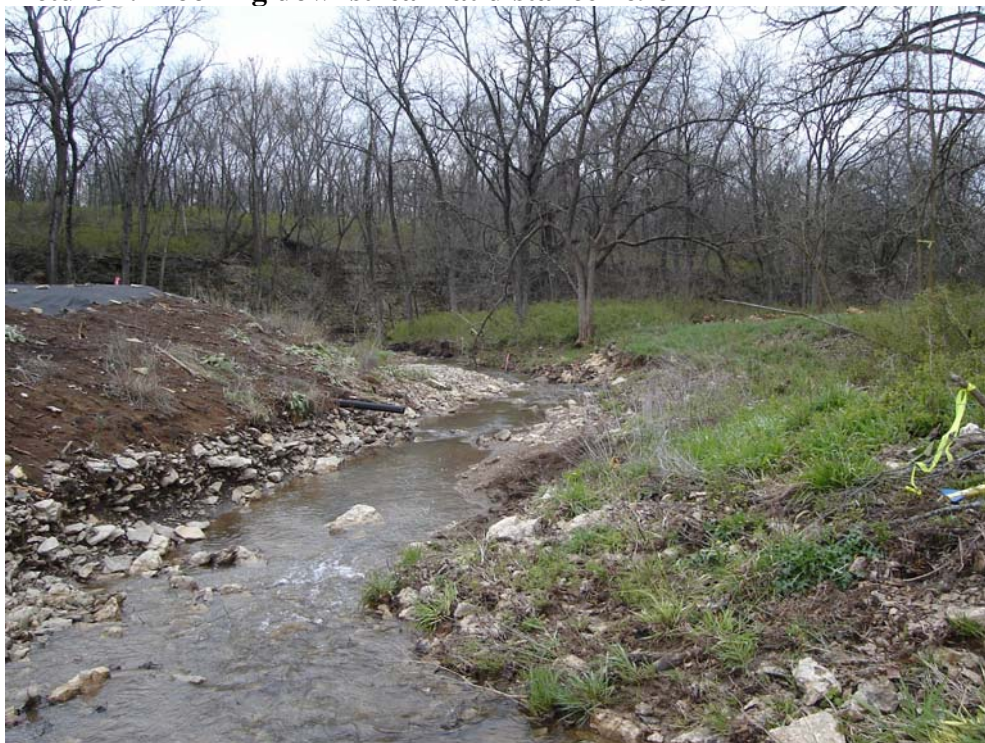
Picture 7. Looking downstream at distance 2696

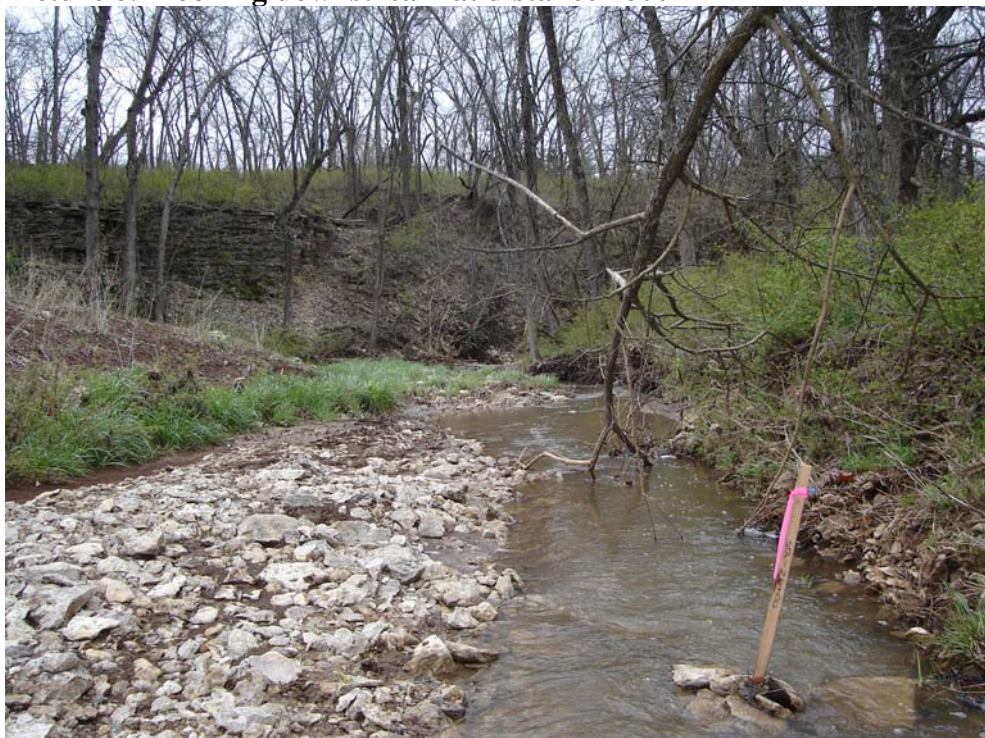
26+00 to 20+50 ft: Reference reach with relatively intact riparian corridor (Pictures 8 to 14)

Picture 8. Looking downstream at distance 2600

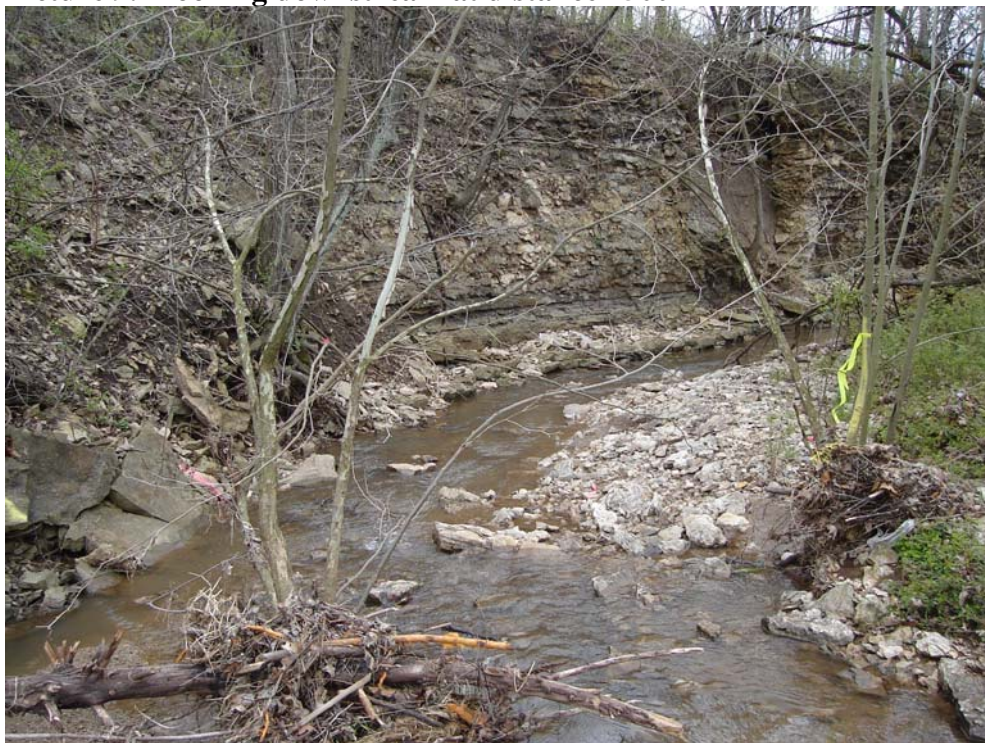
Picture 9. Looking downstream at distance 2500

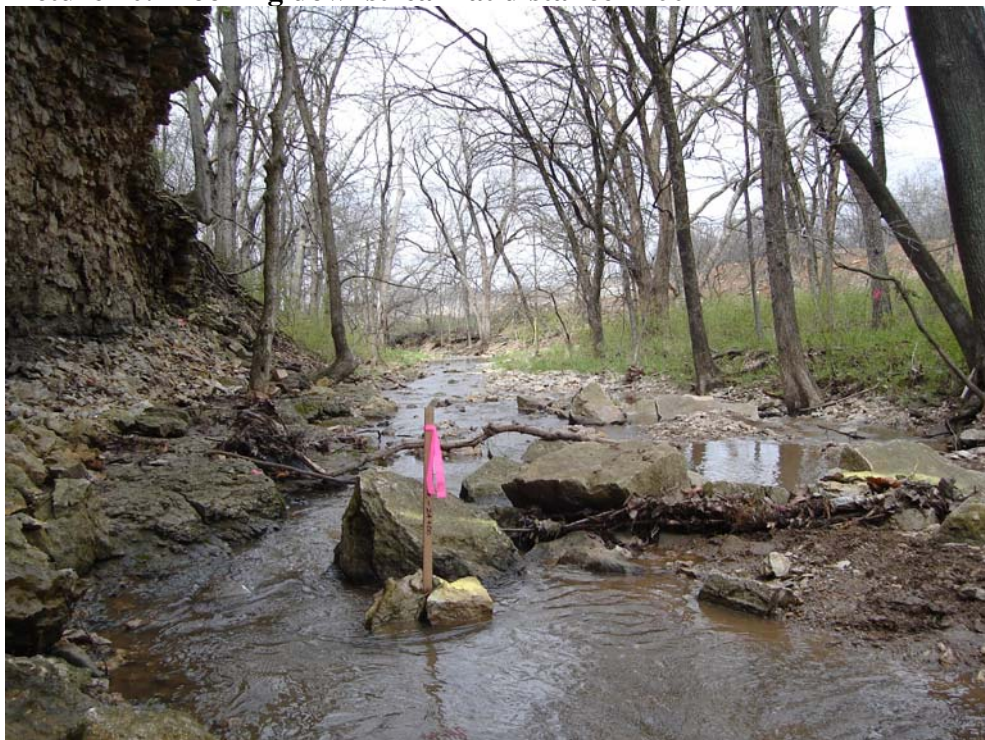
Picture 10. Looking downstream at distance 2400

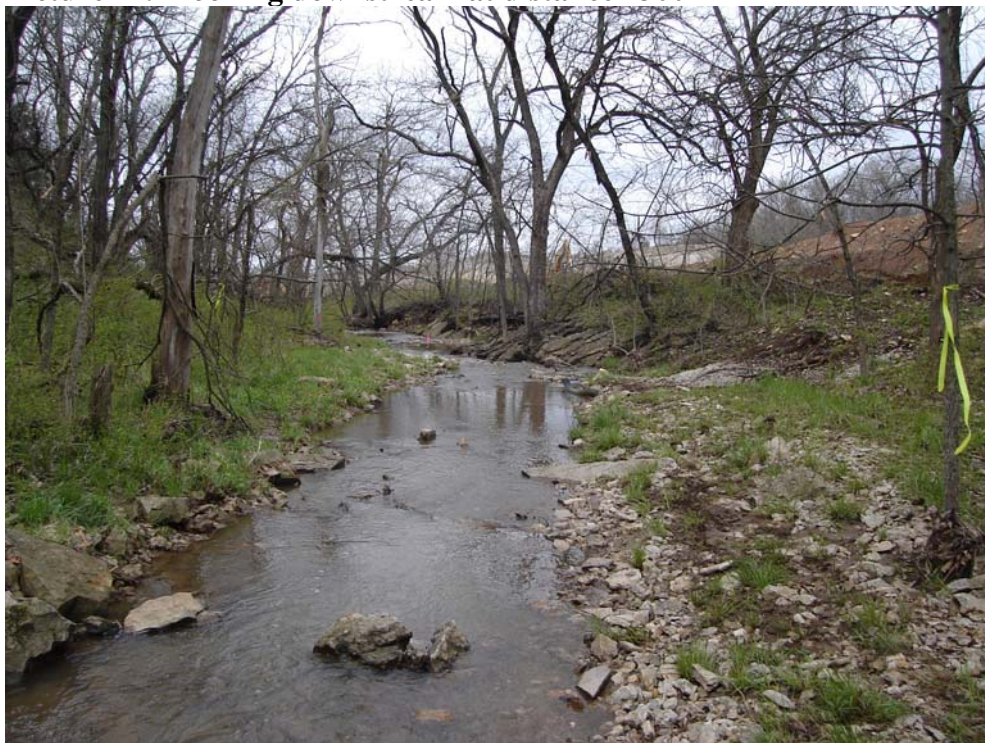
Picture 11. Looking downstream at distance 2300

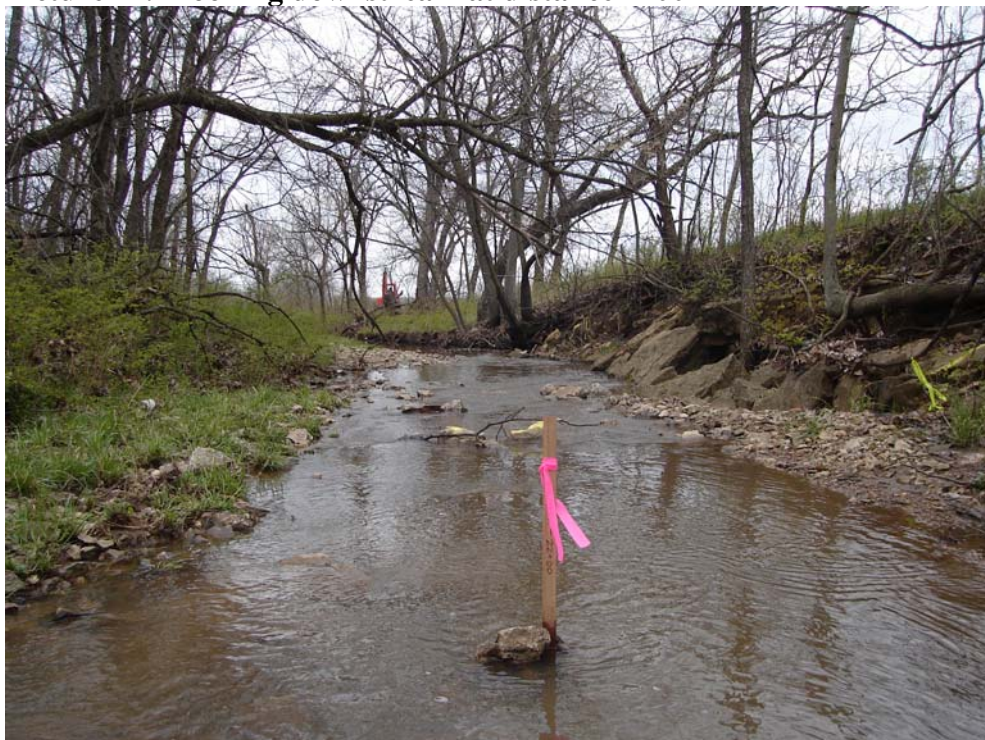
Picture 12. Looking downstream at distance 2200

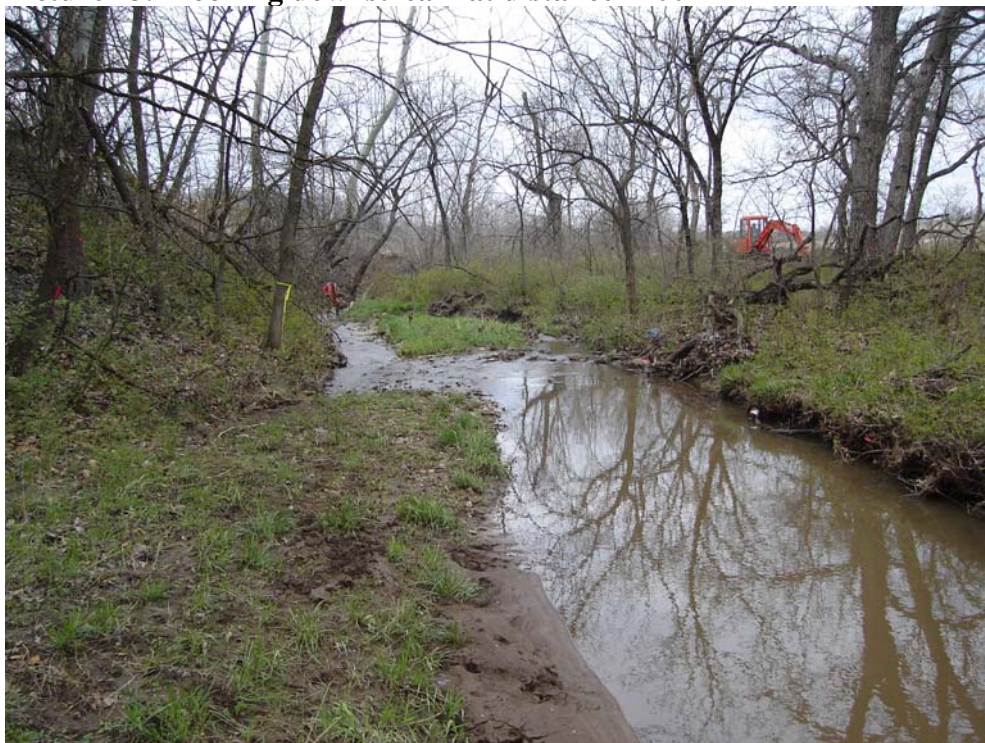
Picture 13. Looking downstream at distance 2100

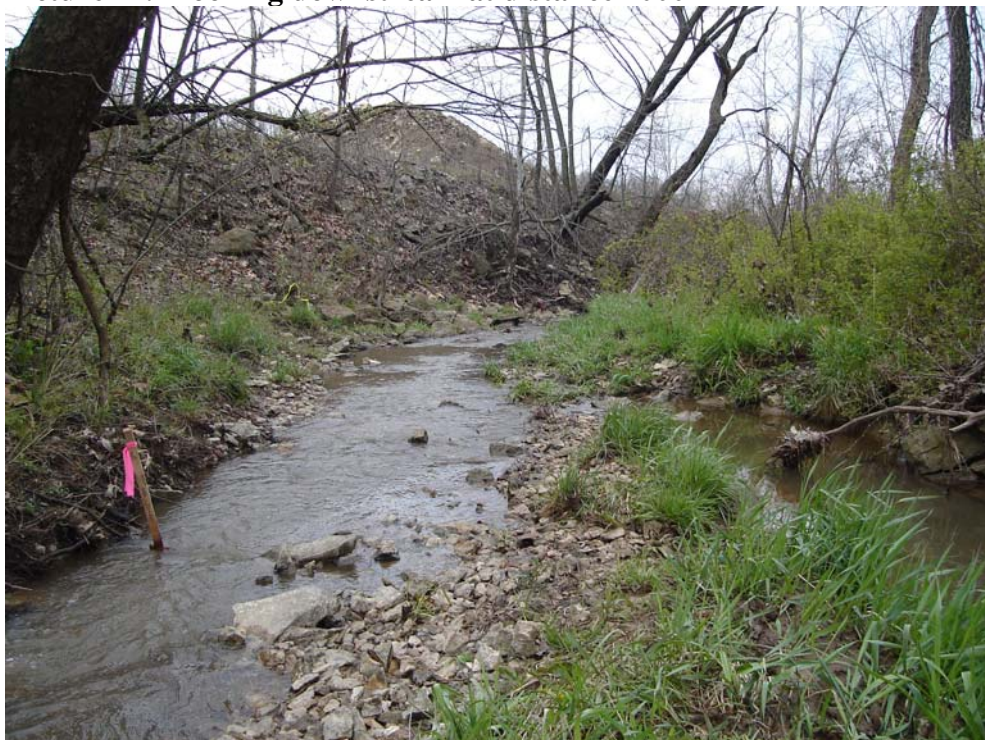
Picture 14. Looking downstream at distance 2000

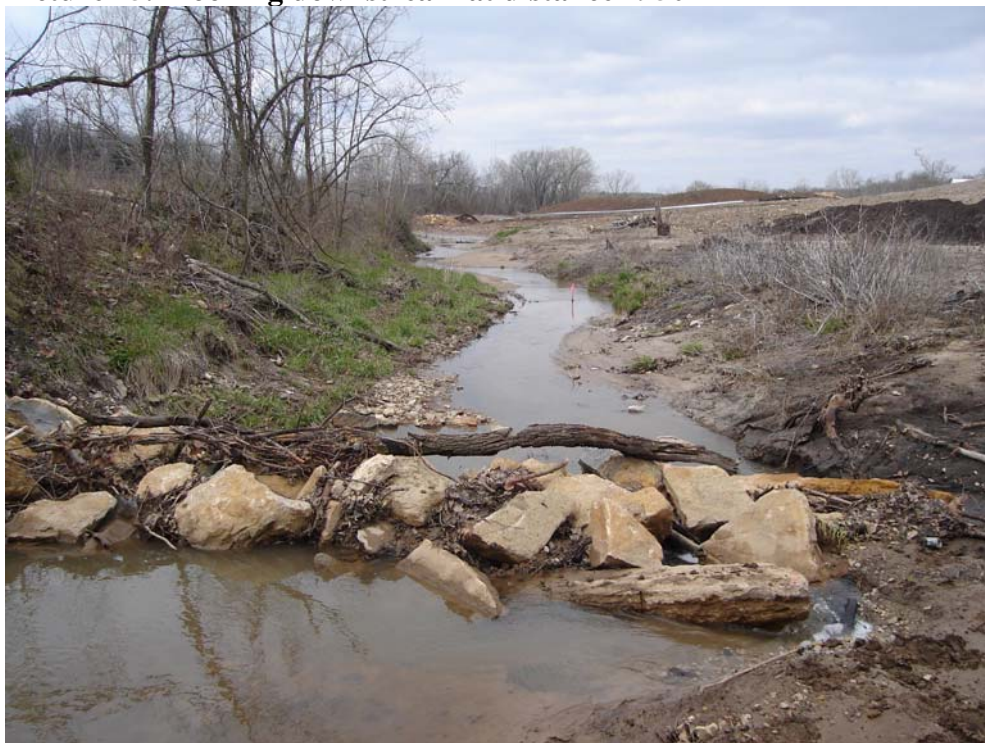
18+75 ft: Sediment control or drop structure #1 with 3-4 feet of fill behind it (Picture 15)

Picture 15. Looking downstream at distance 1950

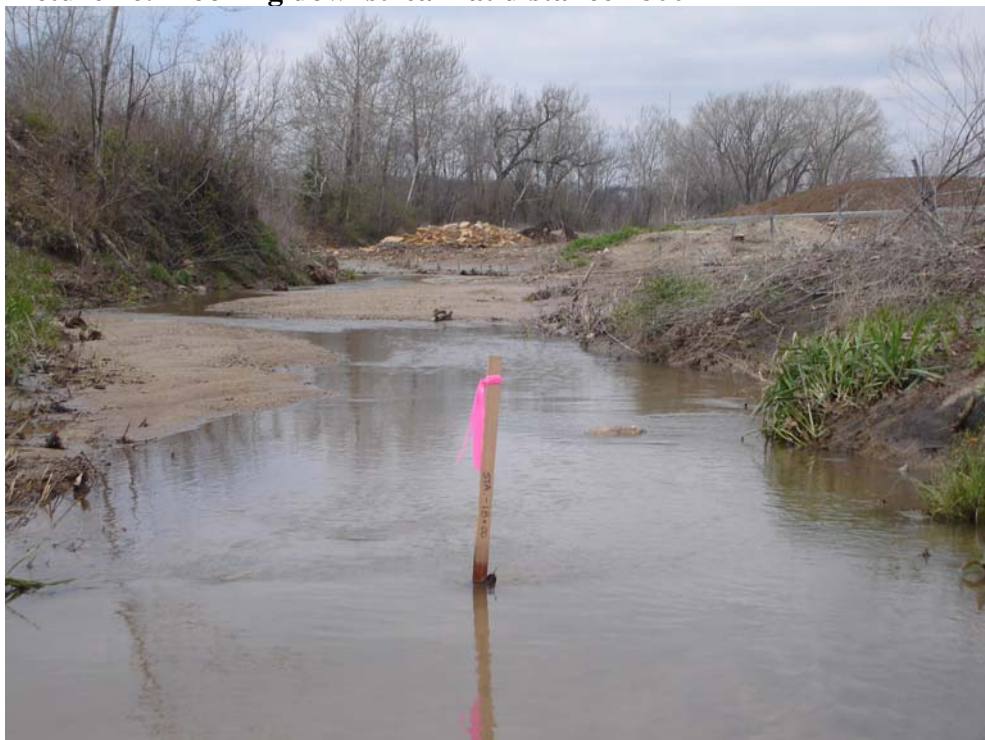
18-75 to 14+80 ft: Braided channel due to introduction of sandy limestone screenings from dump sites (Pictures 16 to 17).

Picture 16. Looking downstream at distance 1800

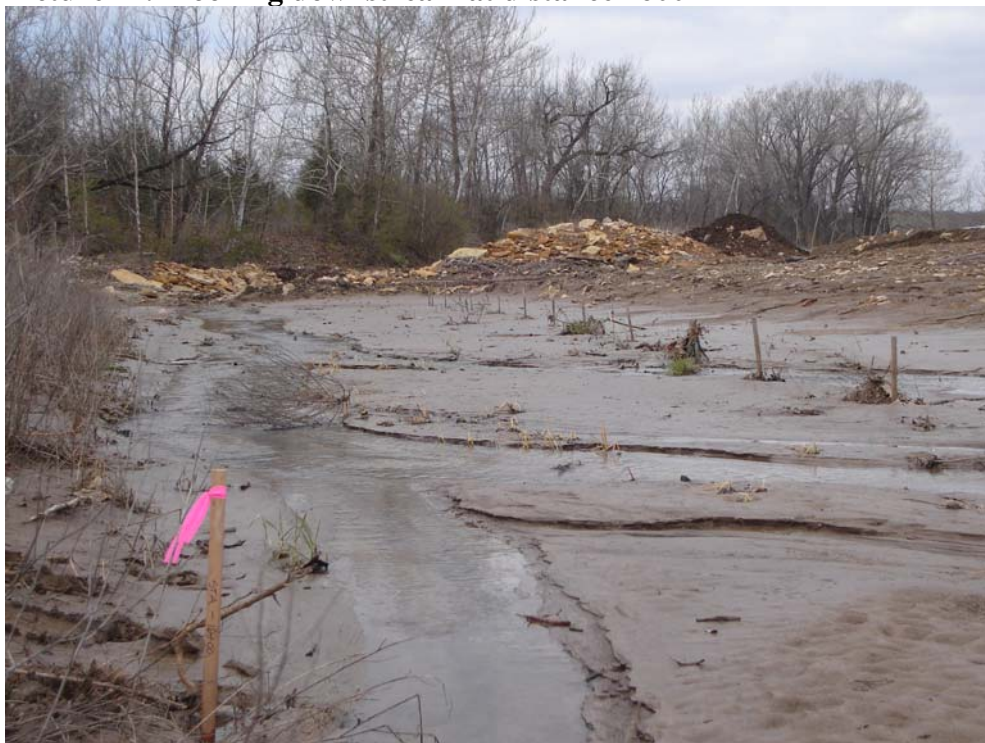
Picture 17. Looking downstream at distance 1600

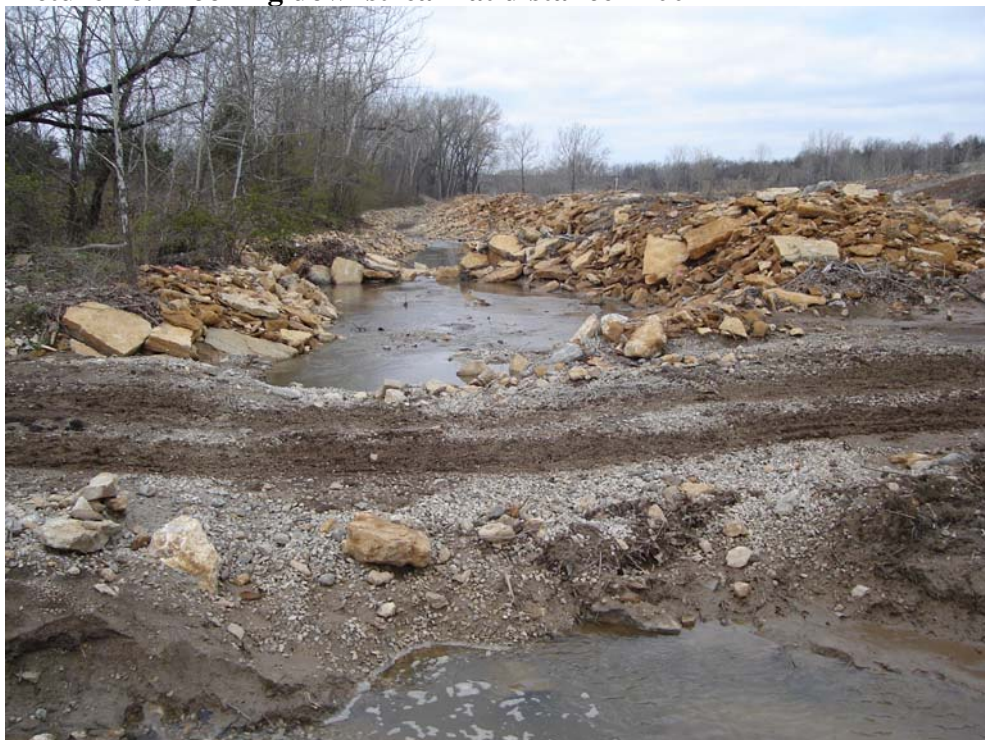
14+80 ft: Low water bridge (Picture 18)

Picture 18. Looking downstream at distance 1400+

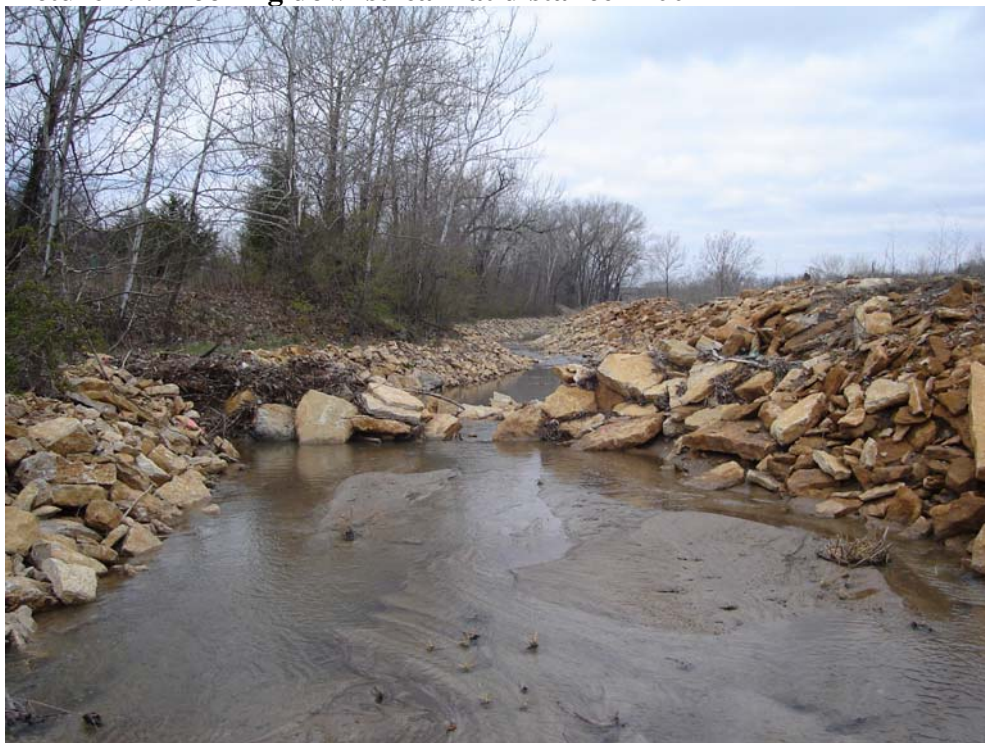
14+50 to 13+50 ft: Sediment control or drop structure #2 with 3 to 5 ft of fill behind it (Picture 19)

Picture 19. Looking downstream at distance 1400

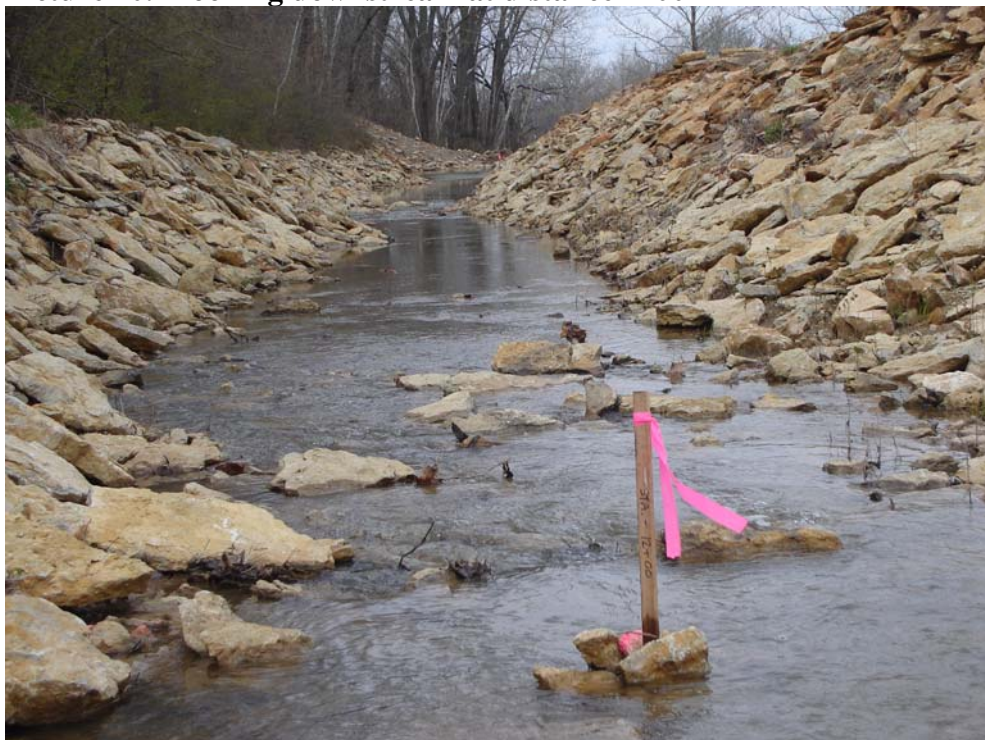
13+50 to 7+85 ft: Trapezoidal rip-rap channel with 1-3 ft diameter rock. Water begins to pool behind next drop structure at 10+00 (Pictures 20 to 21)

Picture 20. Looking downstream at distance 1200

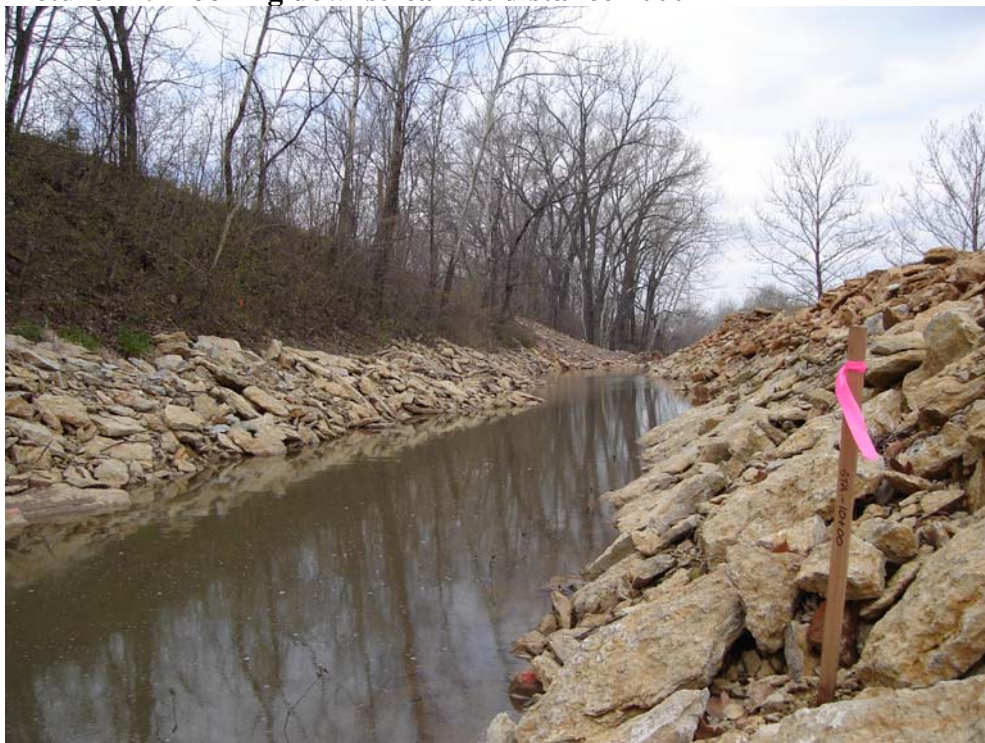
Picture 21. Looking downstream at distance 1000

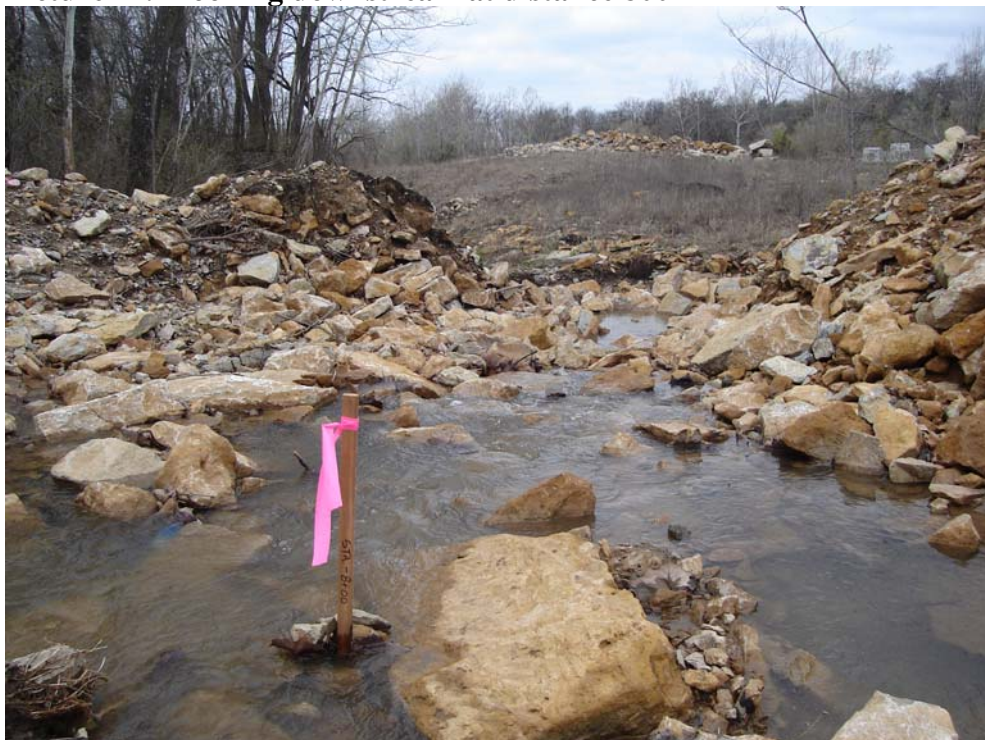
7+85 ft: Sediment control or drop structure # 3 with $\ll 1$ ft of fill behind it (Picture 22)

Picture 22. Looking downstream at distance 800

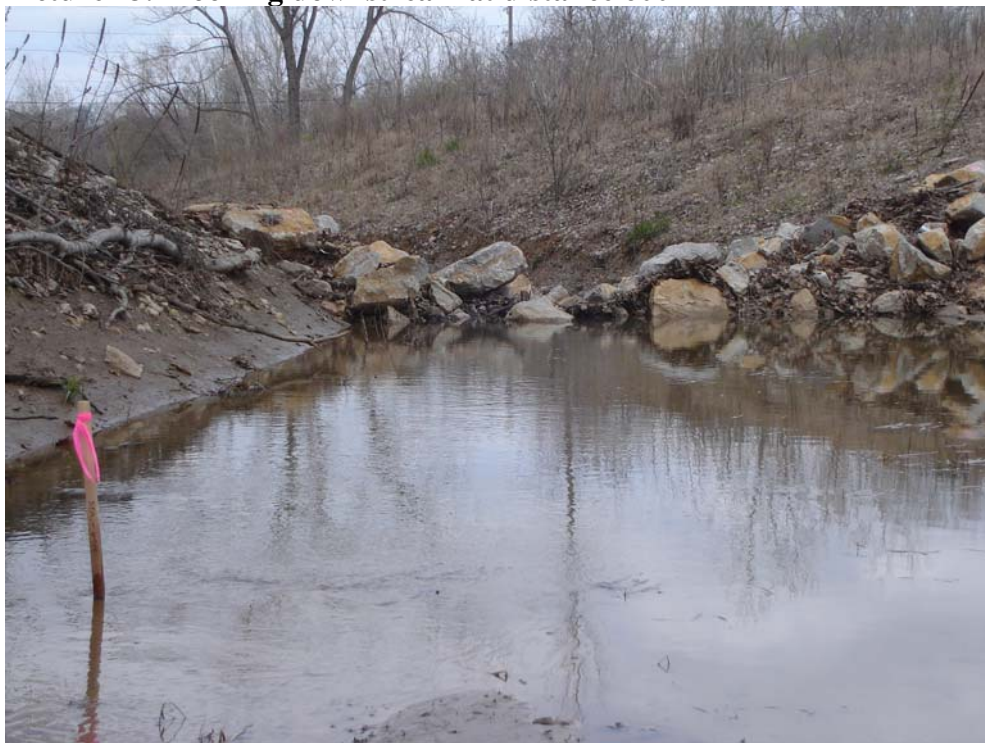
5+50 ft: Sediment control or drop structure # 4 with 1-3 ft of fill behind it (Picture 23)

Picture 23. Looking downstream at distance 600

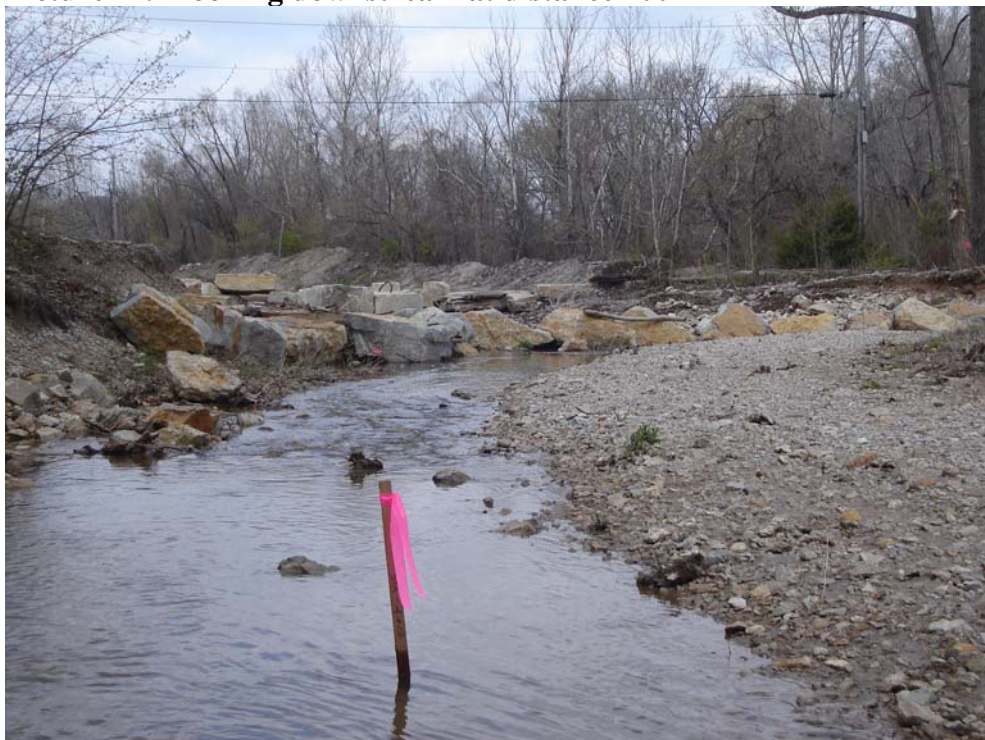
5+00 to 1+50 ft: gravel and sand channel from drop structure #4 to main road culvert (Pictures 24 to 25)

Picture 24. Looking downstream at distance 400

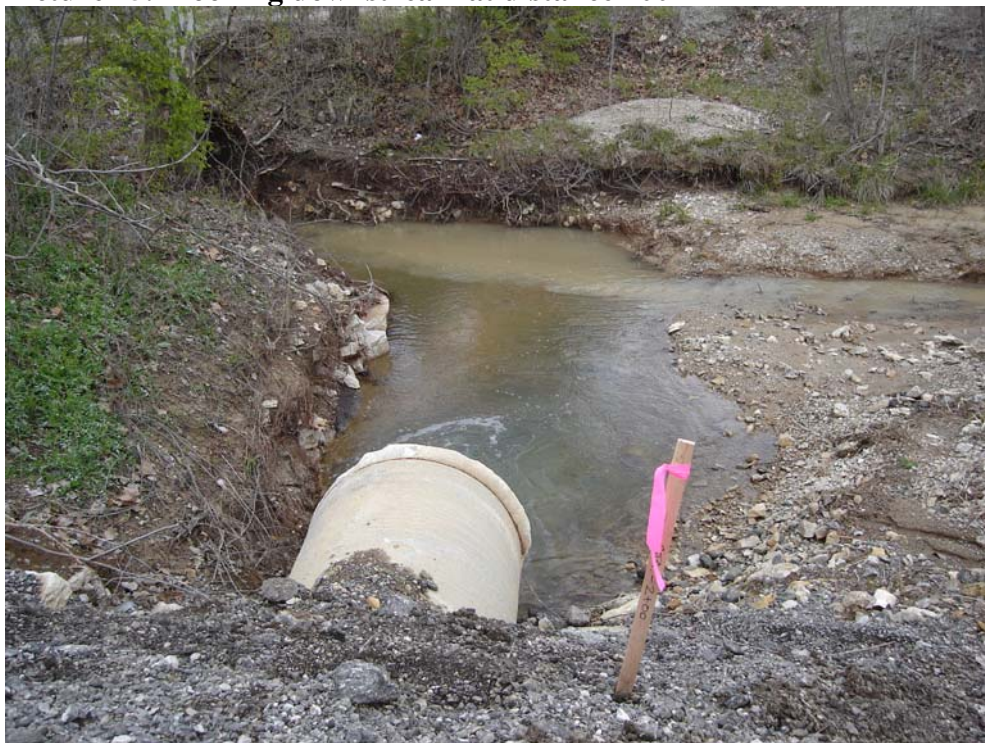
Picture 25. Looking downstream at distance 200

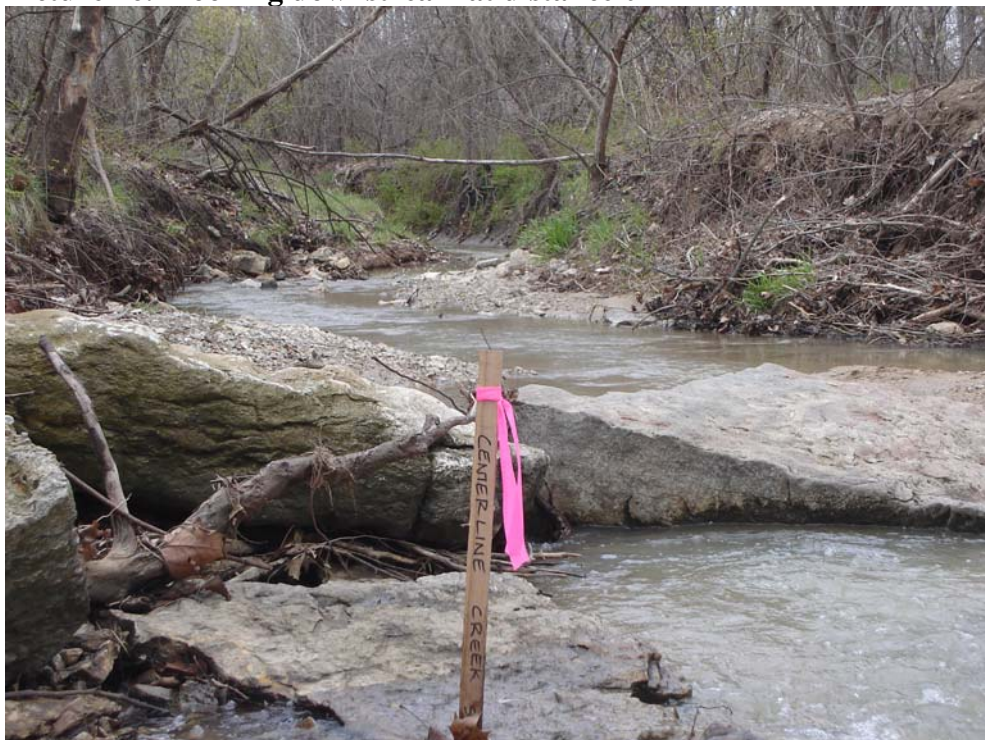
0+00 ft: End of stationing downstream of main road (Picture 26)

Picture 26. Looking downstream at distance 0
