**Geomorphic Assessment of City Center Athletic Club
Development Impacts on Existing Stream Channel
Stability, Lenexa, KS.**

**Final report to Olsson Associates for
the City of Lenexa, Kansas**

**Prepared By:
Robert T. Pavlowsky, PhD
Fluvial Geomorphologist and Professor
Missouri State University
bobpavlowsky@missouristate.edu**

OEWRI TR-09-001

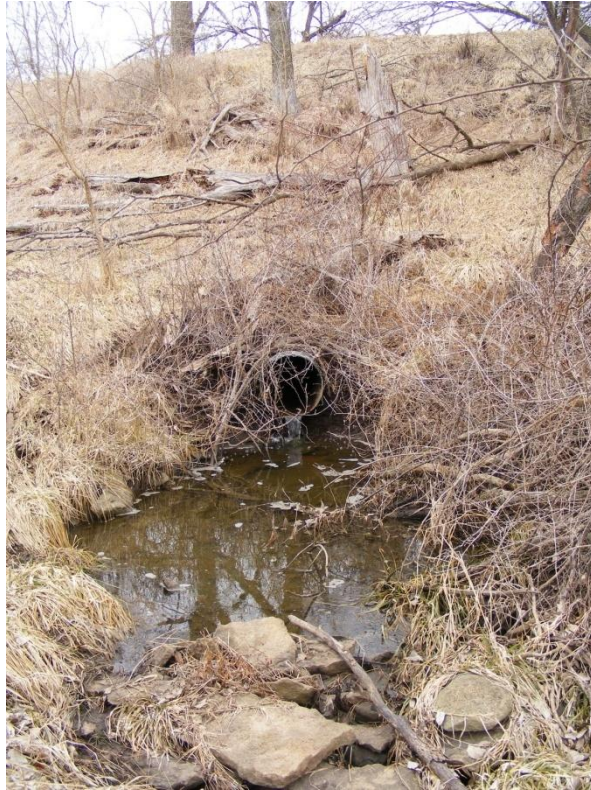
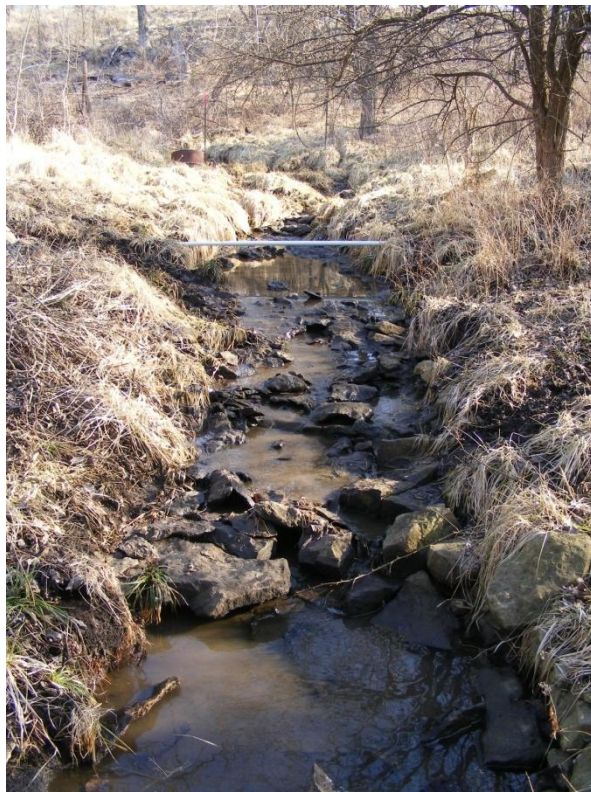
The farm pond above this sub-reach has limited flood storage capacity with outlet controlled through a 24" pipe. A small scour pool has formed at the outlet to dissipate energy. The channel below the outlet is straight with exposed bedrock or boulders common. In some areas a step-pool bedform is obvious. The bankfull channel averages about 5.3 ft wide, ranging from 3.7 ft to 7.8 ft. A young treed buffer is present. The steep stream and low sediment supply due to deposition in the upstream pond results in incision to bedrock. Without the pond, this reach would probably look more like a grassed-waterway or colluvial channel like described for sub-reach 2 below (Photos 1 and 2).

Photo 1. Pond dam outlet begins SR-1 (Feb. 2008)

Photo 2. SR-1 looking downstream (Feb. 2008)

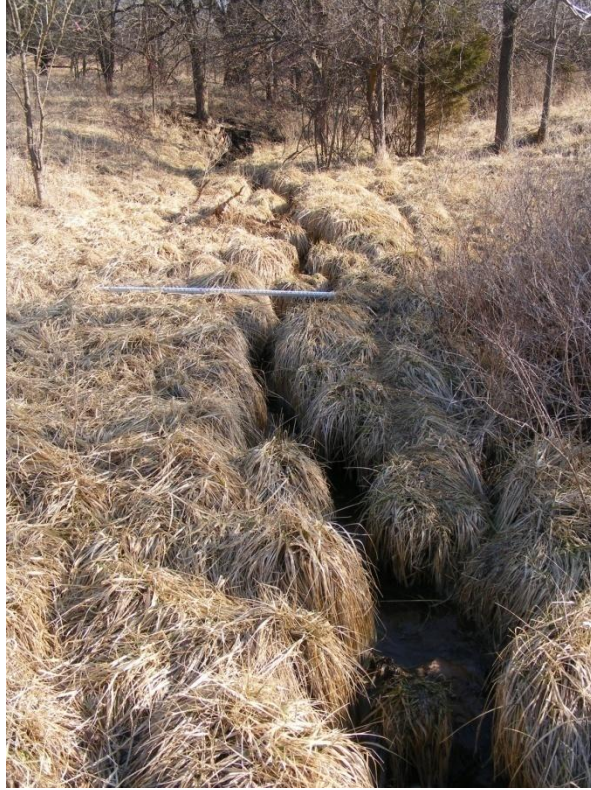
The channel is straight and narrow with heavy influence of soil creep in controlling the colluvial nature of the channel. The stream crosses an open area and grass is the common buffer vegetation. The channel is 2.3 ft wide and 0.8 ft deep. Flat coarse gravel and cobble are the dominant substrate. This sub-reach represents the lowest extent of the colluvial (soil creep-dominated) channel conditions along the study reach. Presently, this area is in transition with a narrow threadlike channel incising into the soil surface of the grassed, waterway channel (Photo 3).

Photo 3. SR-2 looking downstream (Feb. 2008)

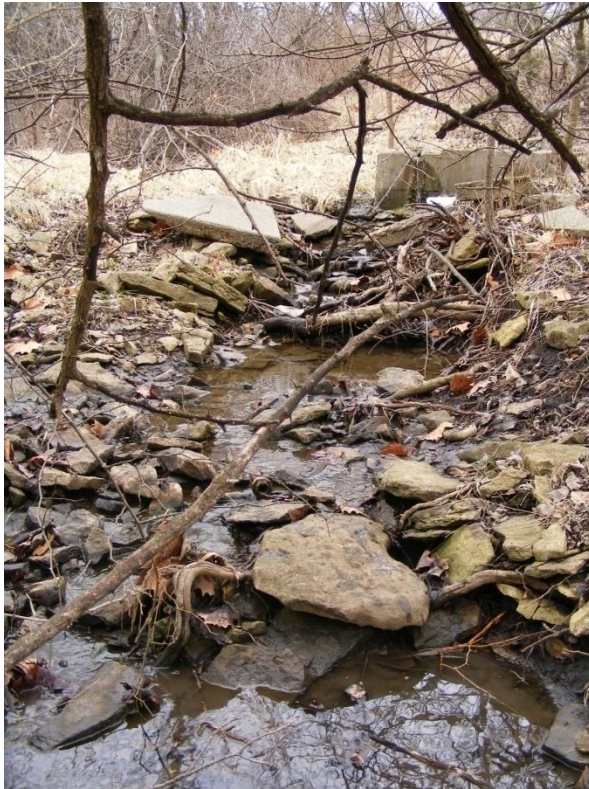
The channel is straight and with a riffle-pool form that is about 6.8 ft wide and 0.75 ft deep. The bed is composed of large flat cobbles and coarse gravel and sometimes takes on a step-pool form where boulders or bedrock influence the channel bed. Sub-reaches 4a, 4b, and 4c contain historical alluvial deposits with higher bank development than upstream areas. In effect this is the transition between steeper, upland areas and gentler, valley areas where alluvial floodplain deposition begins to occur (in contrast to occurrence of colluvial valley floors above this point). A small ephemeral spring marked by an old cattle watering tub is located at the top of this sub-reach. A minor head cut appears to be stalled at the upstream end of sub-reach 4a where bedrock comes to the surface and increases channel resistance to erosion (Photo 6).

Photo 6. SR-4a looking downstream at headcut near concrete stock tank (Feb. 2008)

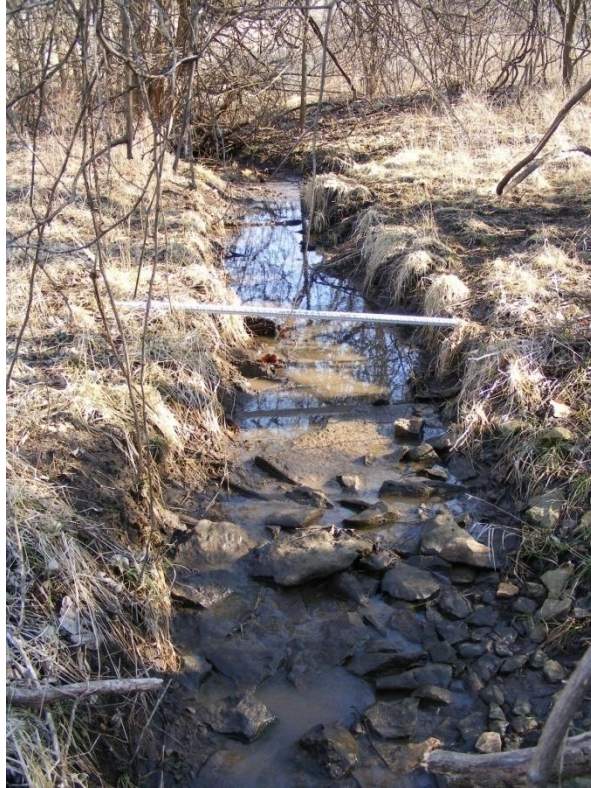
The channel is straight and slightly steeper with a riffle-pool form that is about 8.3 ft wide and 0.75 ft deep. The bed is composed of large flat cobble and sometimes takes on a step-pool form where boulders or bedrock influence the channel bed. PA-2 is located in this sub-reach where 3 sets of evenly spaced vertical pin arrays are located on a cutbank. The upstream set consists of three pins and the two downstream sets have two pins each (Photo 7).

The channel is meandering (sinuosity of about 1.3) with a riffle-pool form that is about 4 ft wide and 0.75 ft deep. Bed slope is decreasing due to the downstream control of flow by the damming of the channel by rubble dam and a 30" diameter concrete pipe. Bed material becomes finer with silt and mud covering the bed in most places. PA-3 is located in this sub-reach with three sets of vertical pin arrays with two pins in each array (Photo 7).

Photo 7. SR-4b looking downstream to SR-4c (Feb. 2008)

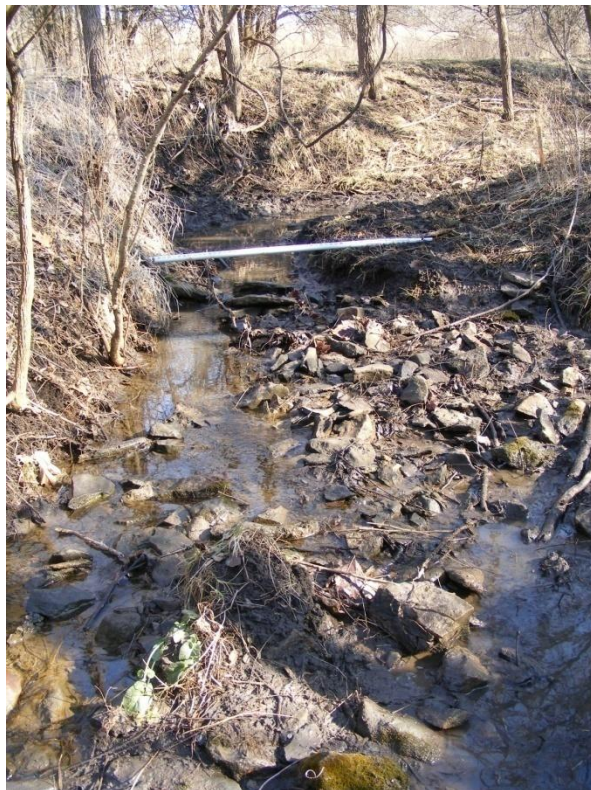
The channel is meandering (sinuosity of about 1.2) with a riffle-pool form that is about 4.5 ft wide and 0.75 ft deep. Locally, bed slope increases a bit and the bed substrate becomes more gravelly with some cobbles. This is probably due to locally shallow bedrock conditions as observed in the bed and along the valley margin. PA-4 is located in this sub-reach with one set of four pins. Three pins are vertically spaced on the cutbank and 1 in the eroding active floodplain on the inside of the meander (Photo 8).

Photo 8. SR-5 looking downstream (Feb. 2008)

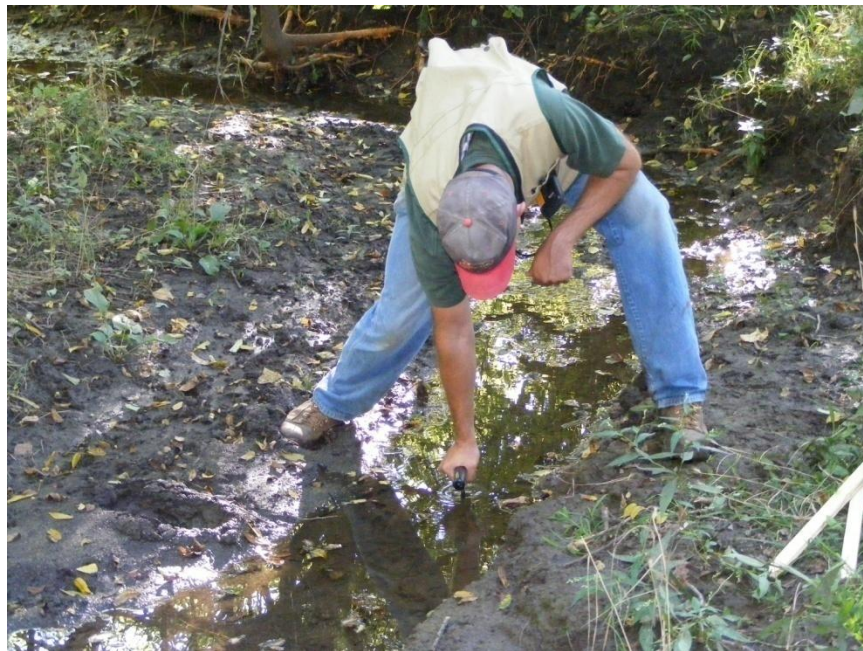
It is expected that sedimentation will continue to occur in Sub-reach 6 and the wedge of influence will slowly shift upstream over time. Development upstream should focus on reducing sediment load to the stream to prevent excessive sedimentation and destabilization of the channel. Bank conditions are relatively stable except where recent alluviation (vertical bank deposition) and aggradation (vertical or upward bed elevation change) has occurred in the impounded areas affected by the rubble dam. Relatively stable beds have formed along most of the study stream, both on and off the property, due to bedrock control and coarse substrate. In the aggraded reach, similar bed substrates are found buried under much finer material to a depth of 3 ft or more.

Photo 12. SR-6 >3ft of fine grain material in channel (Sept. 2007)

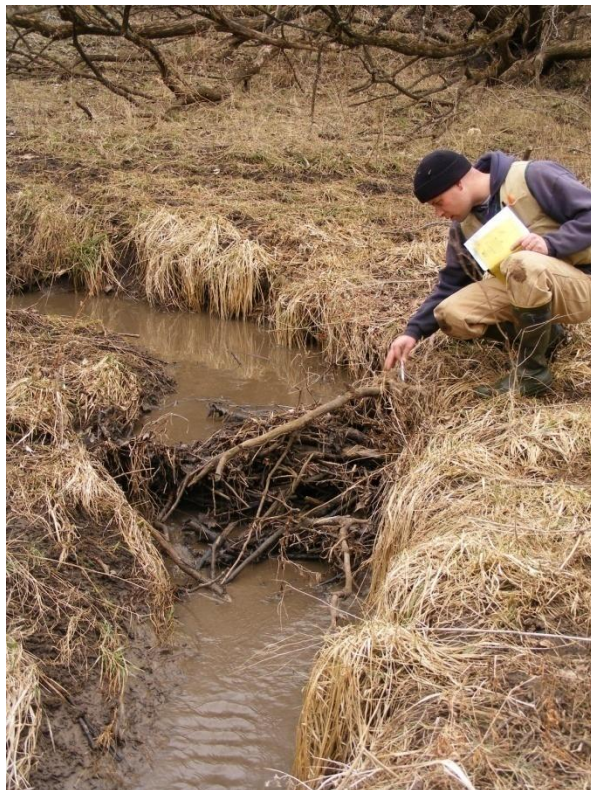
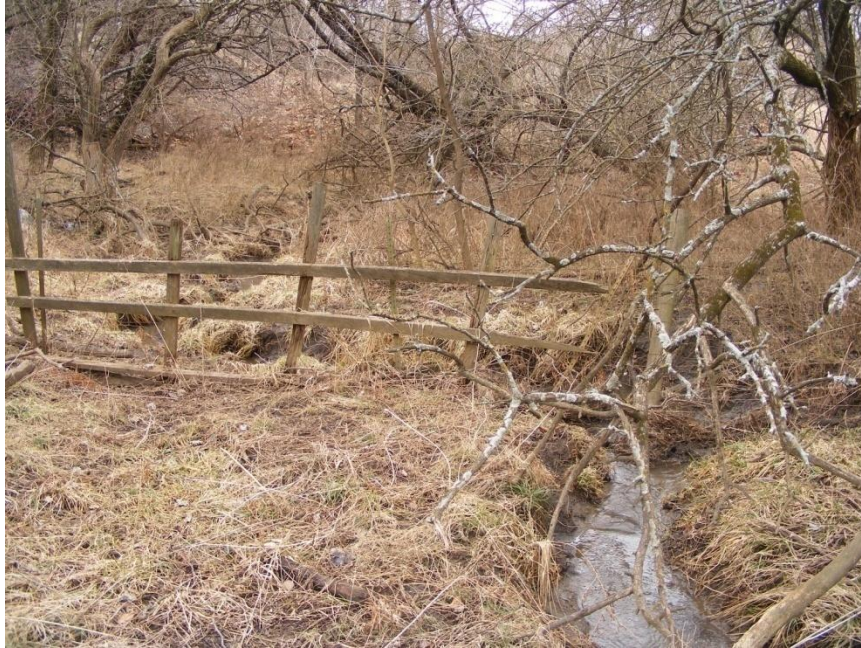
lower due to channel aggradation at this location. In addition, 2 pins were driven horizontally into the top of the active floodplain to measure overbank sedimentation. PA-6 consists of 1 set of 3 vertically spaced pins on a cutbank location 30 feet upstream of the property line (Photos 13, 14 and 15).

Photo 13. SR-6 looking downstream (Feb. 2008)

Photo 14. SR-6 forced riffle (Feb. 2008)

Photo 15. End of SR-6 at property line looking downstream (Feb. 2008)

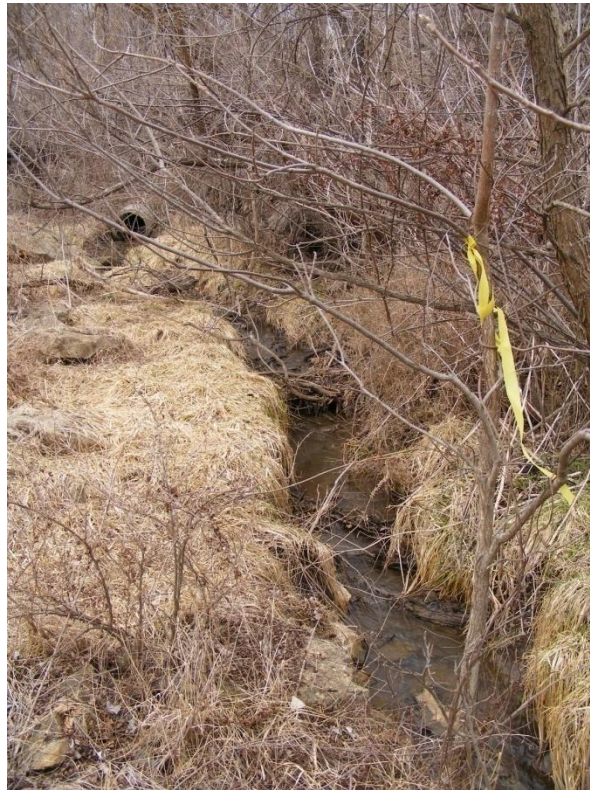
The channel is straight with a bed rock and riffle-pool form that is about 3.7 ft wide and 1 ft deep. The bed is silty with local areas of gravel and cobble. Rubble debris forms the left bank in many places and large blocks and debris provide obstacles to the flow in some places (Photo 16).

Photo 16. SR-8 begins below rubble dam outlet (Feb. 2008)

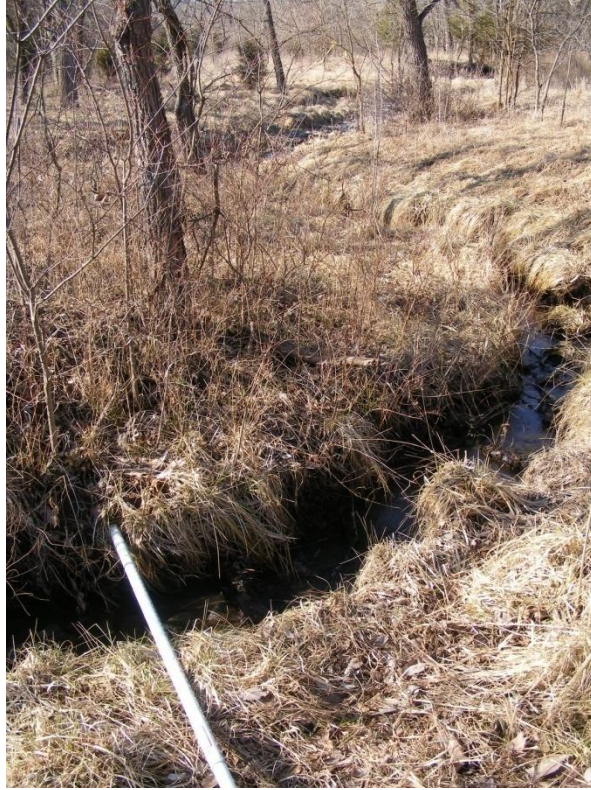
The channel meanders as it is affected by the floodplain control of the larger stream valley. The channel is 2.4 ft wide and 1.1 ft deep with coarse gravel and large cobble on the bed. PA-8 is located in this sub-reach consisting of 2 sets of pins; two vertically spaced pins in the upstream set and three in the downstream set. One pin was positioned in the eroding active floodplain on the inside of the meander at both locations (Photos 21 and 22).

Photo 21. SR-12 looking downstream to confluence (Feb. 2008)

Photo 22. End of SR-12 at confluence with main tributary (Feb. 2008)

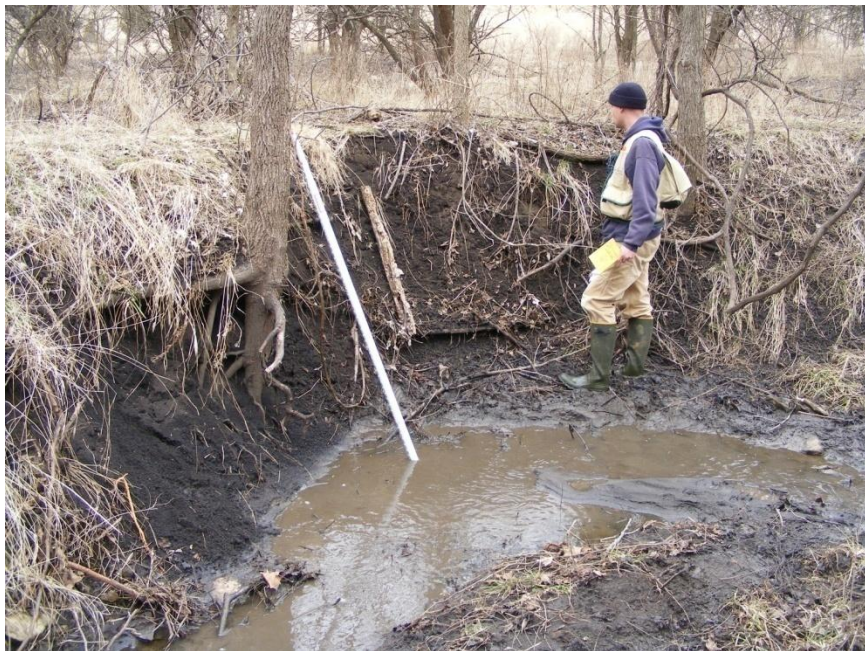
PA-3 is located in SR-4c where the alluvial transition zone begins to meander. Pins remain unchanged with some upper bank slumping lowering the bank angle (Photos 27 and 28).

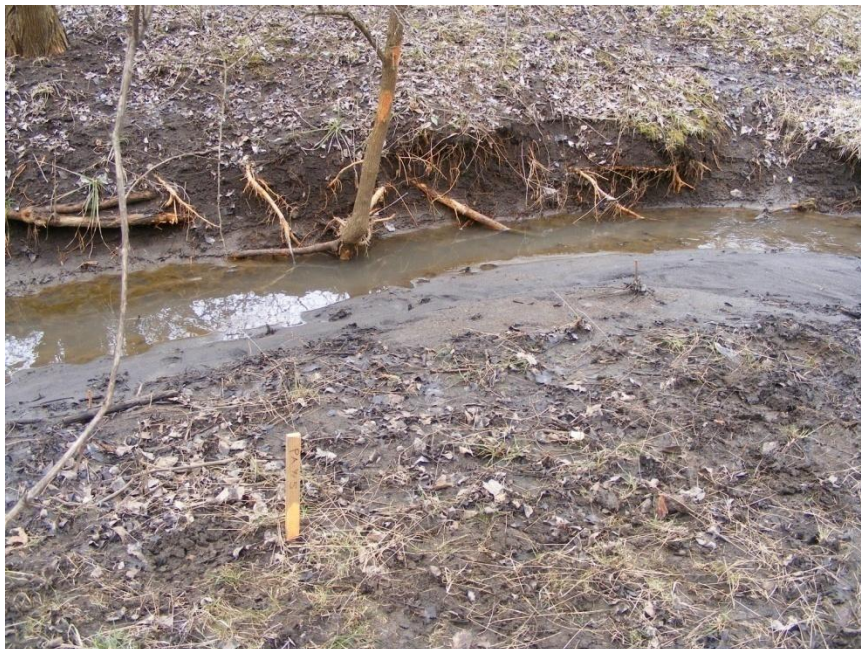
PA-5 is located in SR-6 where valley fill has caused channel/valley aggradation. The upstream pin had 0.25 ft exposed, the next pin going downstream had < 0.1 ft exposed with the remaining pins having no change (Photos 31 and 32).

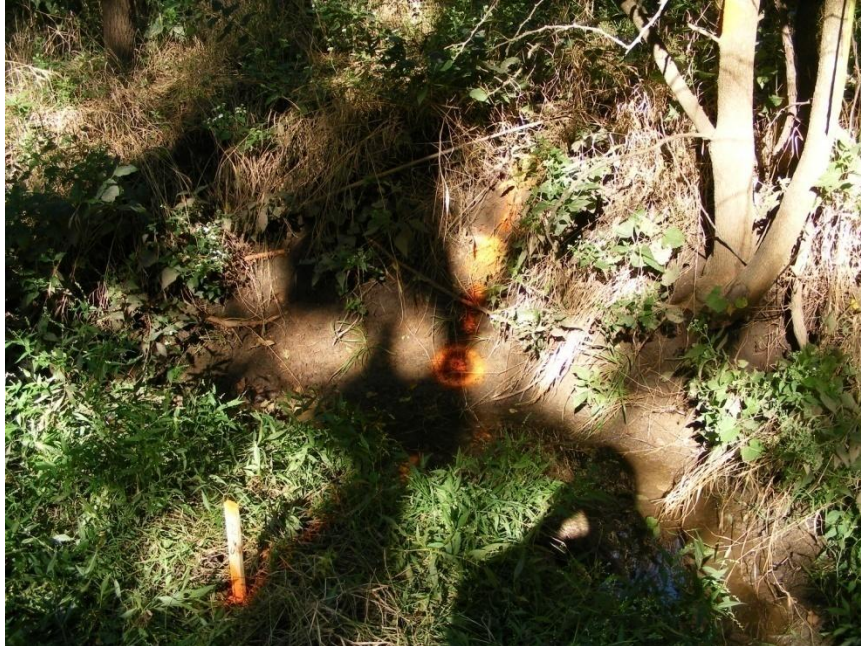
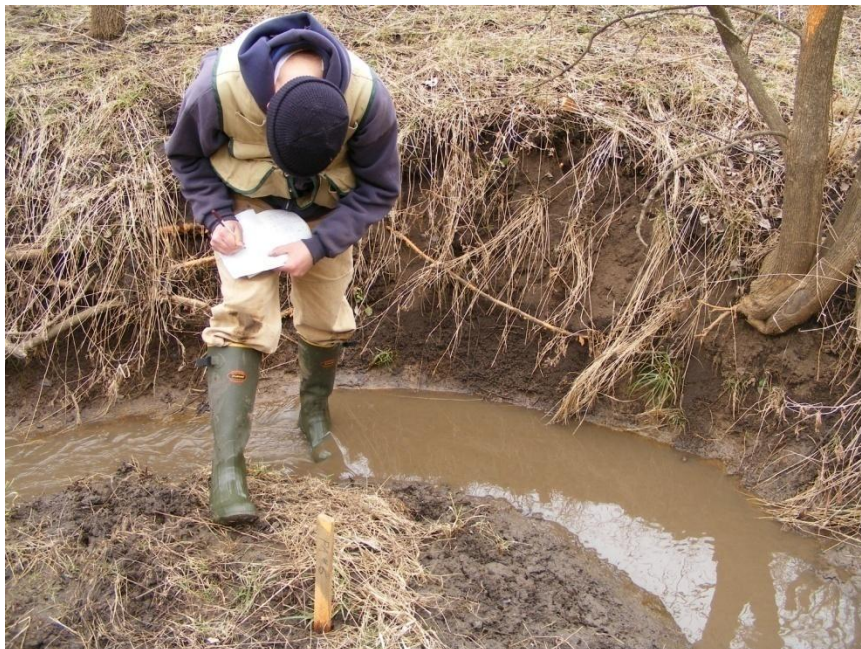
PA-6 is also located in SR-6. Pins at this location showed upper bank slump covering the lower pin decreasing the bank angle at this location (Photos 33 and 34).

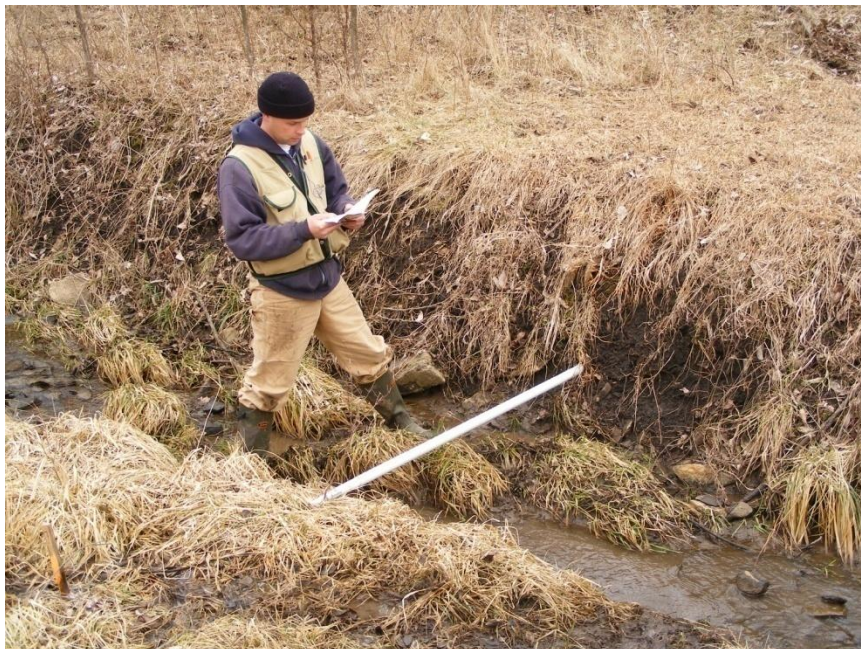
PA-7 is located in SR-10 which is a sinuous stable reach below the valley fill. Pins here had <1 ft of upper bank slump deposition at the toe of the bank (Photos 35 and 36).

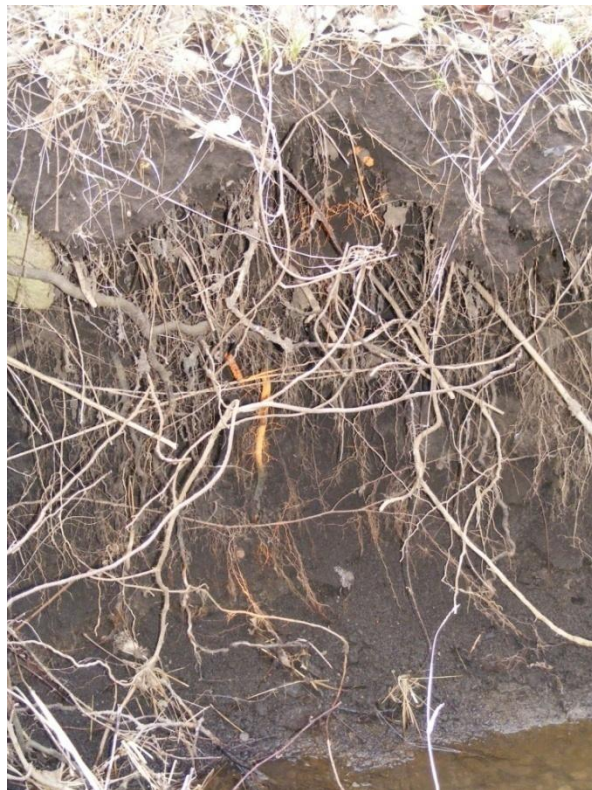
PA-8 is located in SR-12 above the confluence of the main tributary where slope decreases as the channel meets a larger alluvial floodplain. Here, pins showed between 0.1 and 0.25 ft of erosion during the monitoring period (Photos 37 and 38).
