**Geomorphic Assessment of City Center Athletic Club  
Development Impacts on Existing Stream Channel  
Stability, Lenexa, KS.**

**Final report to Olsson Associates for  
the City of Lenexa, Kansas**

**OEWRI TR-09-001**

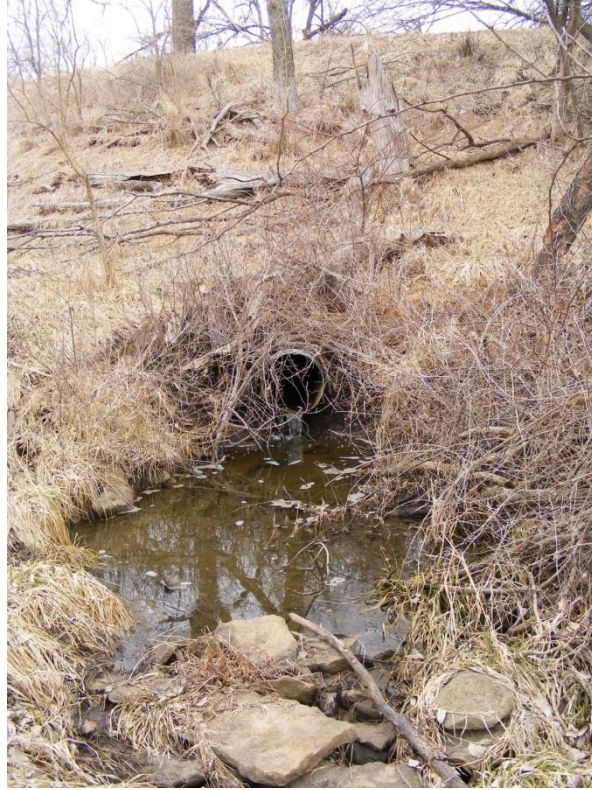
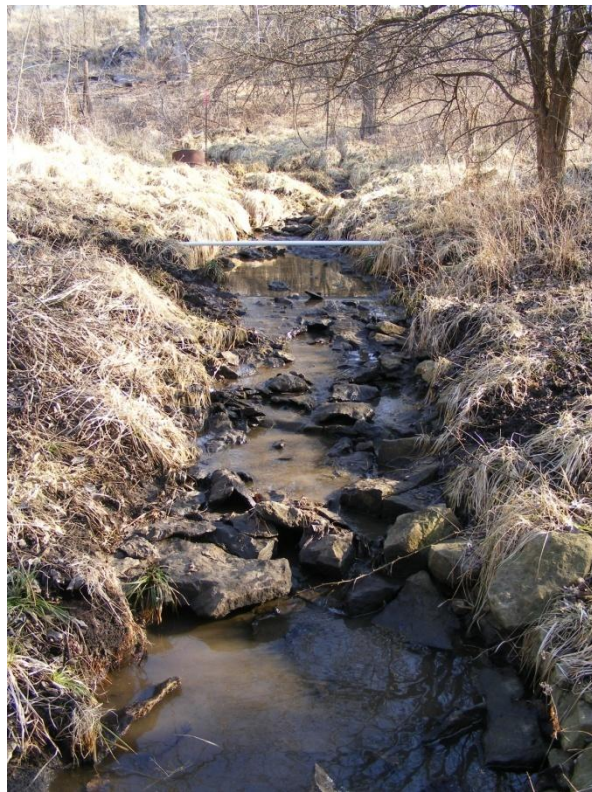
The farm pond above this sub-reach has limited flood storage capacity with outlet controlled through a 24" pipe. A small scour pool has formed at the outlet to dissipate energy. The channel below the outlet is straight with exposed bedrock or boulders common. In some areas a step-pool bedform is obvious. The bankfull channel averages about 5.3 ft wide, ranging from 3.7 ft to 7.8 ft. A young treed buffer is present. The steep stream and low sediment supply due to deposition in the upstream pond results in incision to bedrock. Without the pond, this reach would probably look more like a grassed-waterway or colluvial channel like described for sub-reach 2 below (Photos 1 and 2).

**Photo 1. Pond dam outlet begins SR-1 (Feb. 2008)**

**Photo 2. SR-1 looking downstream (Feb. 2008)**

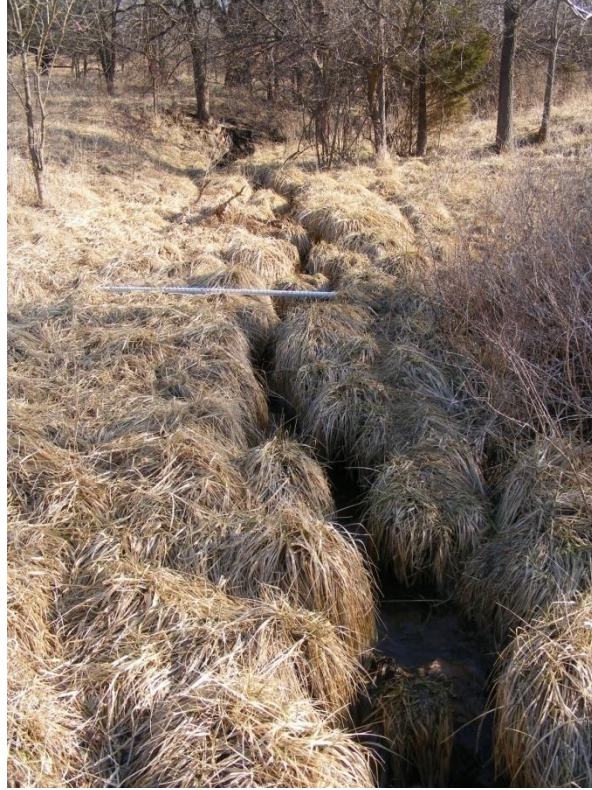
The channel is straight and narrow with heavy influence of soil creep in controlling the colluvial nature of the channel. The stream crosses an open area and grass is the common buffer vegetation. The channel is 2.3 ft wide and 0.8 ft deep. Flat coarse gravel and cobble are the dominant substrate. This sub-reach represents the lowest extent of the colluvial (soil creep-dominated) channel conditions along the study reach. Presently, this area is in transition with a narrow threadlike channel incising into the soil surface of the grassed, waterway channel (Photo 3).

**Photo 3. SR-2 looking downstream (Feb. 2008)**

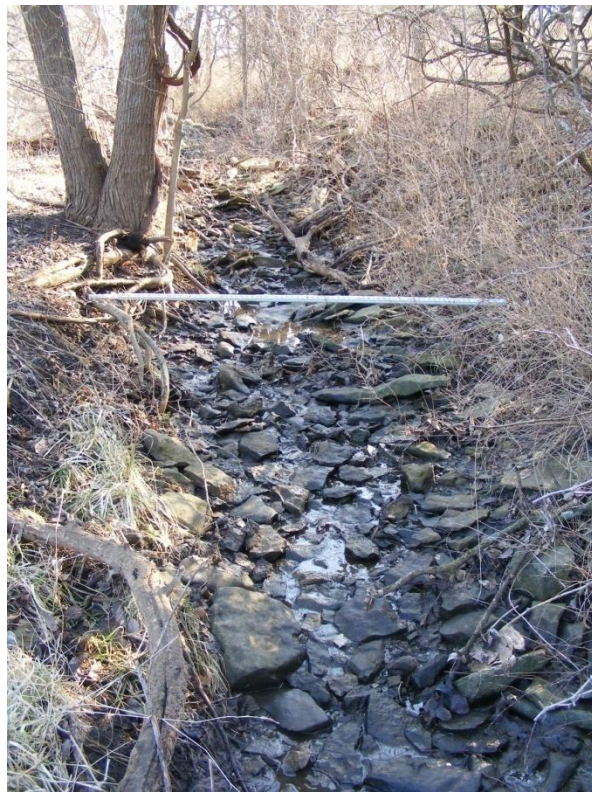
Downstream from this point, upland colluvial influence ends the stream channel is controlled by shallow bedrock, with relatively large cobble common on the bed with small boulder-sized material occurring in some places. There is evidence of a minor head cut at the top of this sub-reach, but no cut banks are present. The head cut probably stalled in the past on shallow bedrock. The upstream channel survey was collected in this sub-reach (Photo 4). The channel is relatively stable in this area due to high bedrock resistance and confinement by bedrock bluffs outcropping along the left valley margin and relatively resistance colluvial deposits along the right side of the channel.

**Photo 4. SR-3a looking downstream (Feb. 2008)**

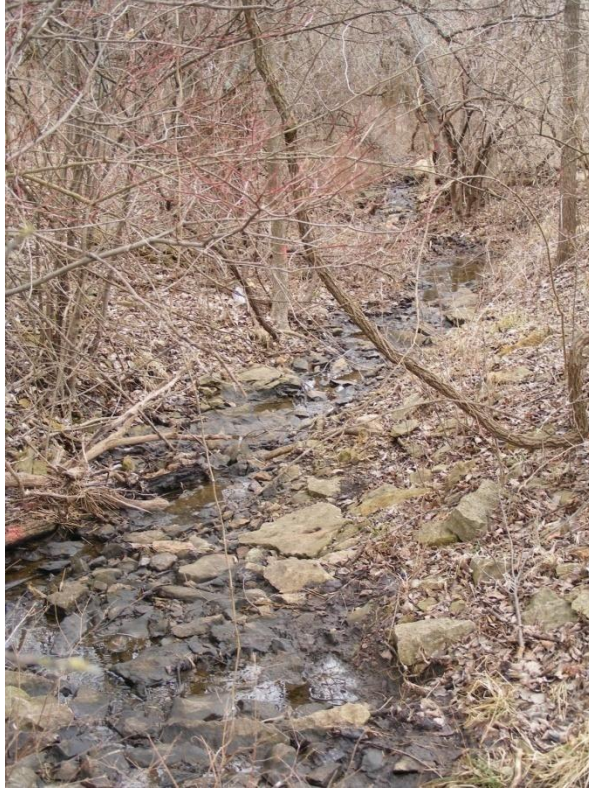
This sub-reach is similar to 3a but with some meandering. Pin array 1 (PA-1) is located in this sub-reach consisting of 4 pins, 3 on the outside of the meander, and 1 pin on the inside. The three outside pins are positioned evenly in a vertical orientation (Photo 5). While no slope measurements were collected in this reach, there appears to be a slight break in slope between SR-3a and SR-3b.

**Photo 5. SR-3b looking downstream (Feb. 2008)**

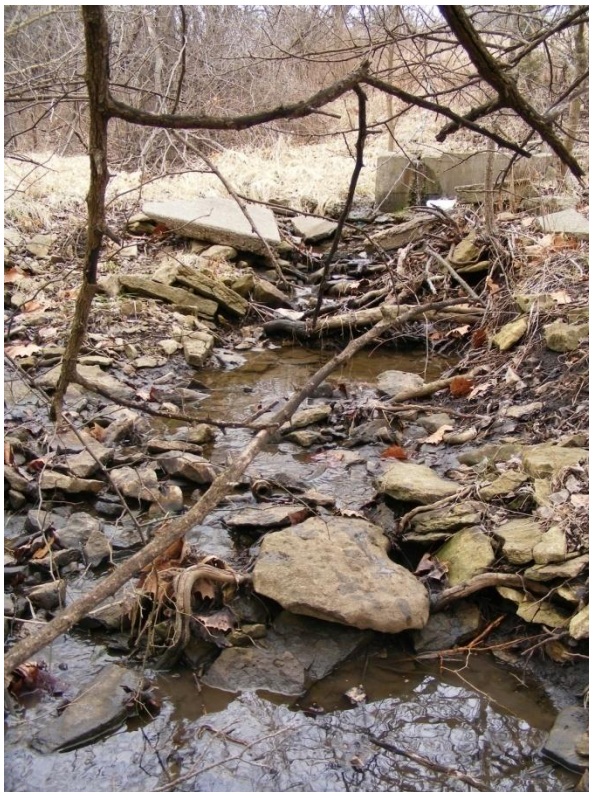
The channel is straight and with a riffle-pool form that is about 6.8 ft wide and 0.75 ft deep. The bed is composed of large flat cobbles and coarse gravel and sometimes takes on a step-pool form where boulders or bedrock influence the channel bed. Sub-reaches 4a, 4b, and 4c contain historical alluvial deposits with higher bank development than upstream areas. In effect this is the transition between steeper, upland areas and gentler, valley areas where alluvial floodplain deposition begins to occur (in contrast to occurrence of colluvial valley floors above this point). A small ephemeral spring marked by an old cattle watering tub is located at the top of this sub-reach. A minor head cut appears to be stalled at the upstream end of sub-reach 4a where bedrock comes to the surface and increases channel resistance to erosion (Photo 6).

**Photo 6. SR-4a looking downstream at headcut near concrete stock tank (Feb. 2008)**

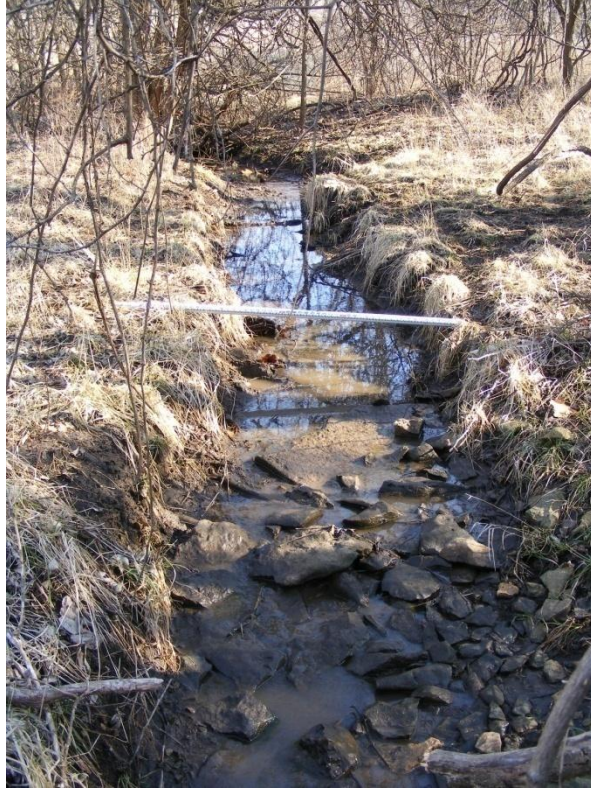
The channel is straight and slightly steeper with a riffle-pool form that is about 8.3 ft wide and 0.75 ft deep. The bed is composed of large flat cobble and sometimes takes on a step-pool form where boulders or bedrock influence the channel bed. PA-2 is located in this sub-reach where 3 sets of evenly spaced vertical pin arrays are located on a cutbank. The upstream set consists of three pins and the two downstream sets have two pins each (Photo 7).

The channel is meandering (sinuosity of about 1.3) with a riffle-pool form that is about 4 ft wide and 0.75 ft deep. Bed slope is decreasing due to the downstream control of flow by the damming of the channel by rubble dam and a 30" diameter concrete pipe. Bed material becomes finer with silt and mud covering the bed in most places. PA-3 is located in this sub-reach with three sets of vertical pin arrays with two pins in each array (Photo 7).

**Photo 7. SR-4b looking downstream to SR-4c (Feb. 2008)**

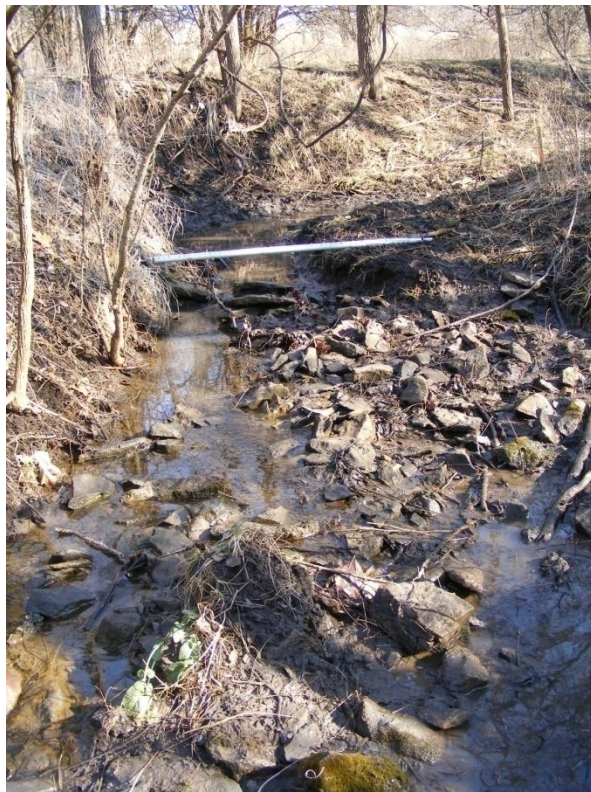
The channel is meandering (sinuosity of about 1.2) with a riffle-pool form that is about 4.5 ft wide and 0.75 ft deep. Locally, bed slope increases a bit and the bed substrate becomes more gravelly with some cobbles. This is probably due to locally shallow bedrock conditions as observed in the bed and along the valley margin. PA-4 is located in this sub-reach with one set of four pins. Three pins are vertically spaced on the cutbank and 1 in the eroding active floodplain on the inside of the meander (Photo 8).

**Photo 8. SR-5 looking downstream (Feb. 2008)**

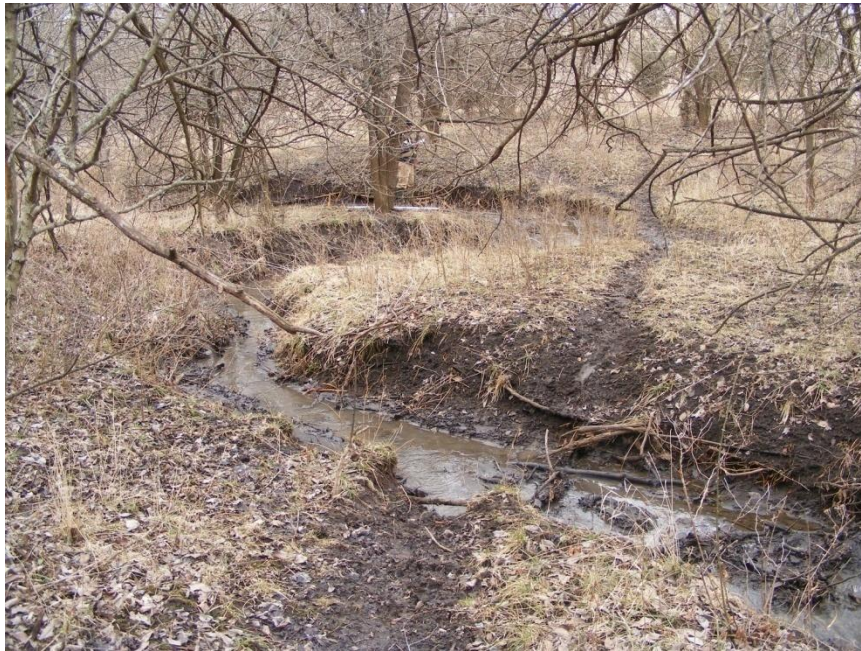
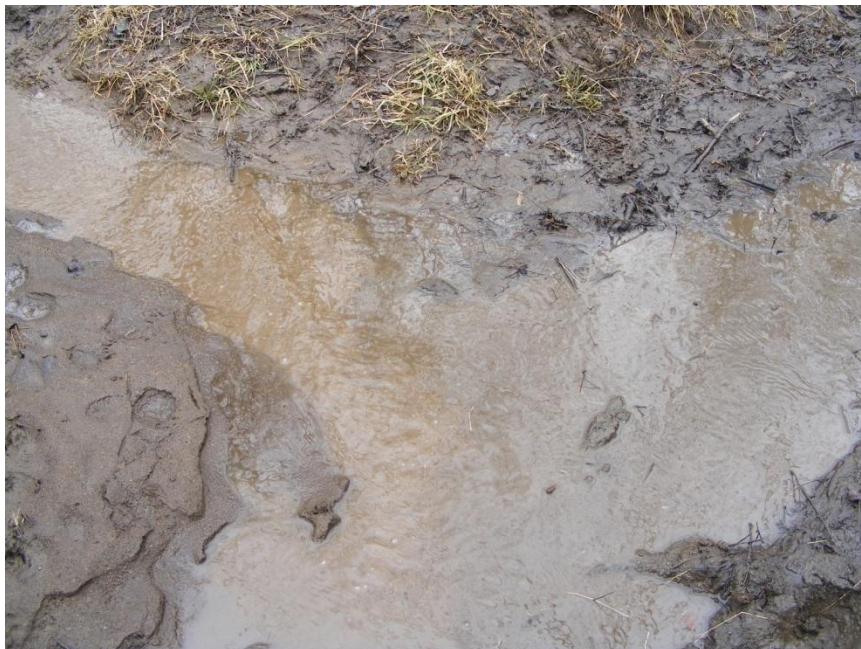
The channel becomes more meandering as fine-grained sedimentation is enhanced due to rubble dam and influence of the golf course tributary (Photos 9 and 10). The channel bed is silty and has aggraded more than 3 feet over its pre-dam bed level (Photos 11 and 12). The width of the channel here is 3.3 ft with a depth of 0.8 ft. Both PA-5 and PA-6 are located in this sub-reach. PA-5 is an array of 4 locations of 1 pin each in the middle of the cutbank, which is relatively

**Photo 9. SR-6 looking downstream (Feb. 2008)**

**Photo 10. SR-6 confluence with the golf course tributary (Feb. 2008)**

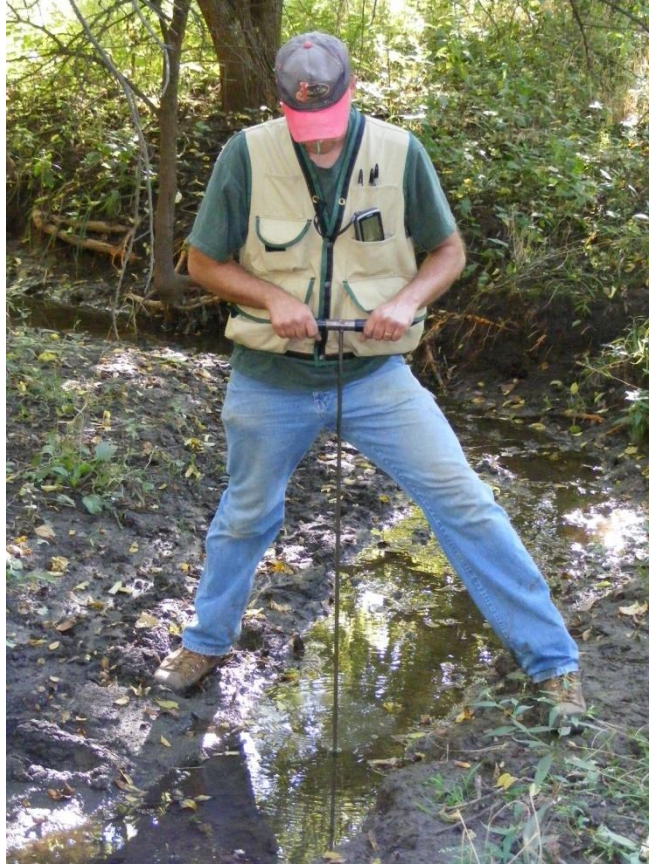
**Photo 11. SR-6 tile probe below confluence (Sept. 2007)**

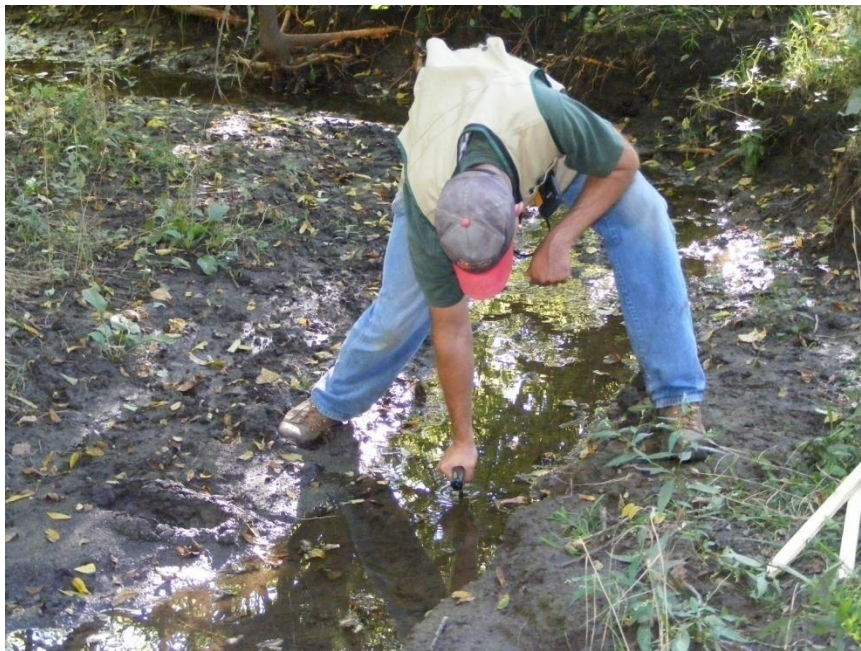
**Photo 12. SR-6 >3ft of fine grain material in channel (Sept. 2007)**

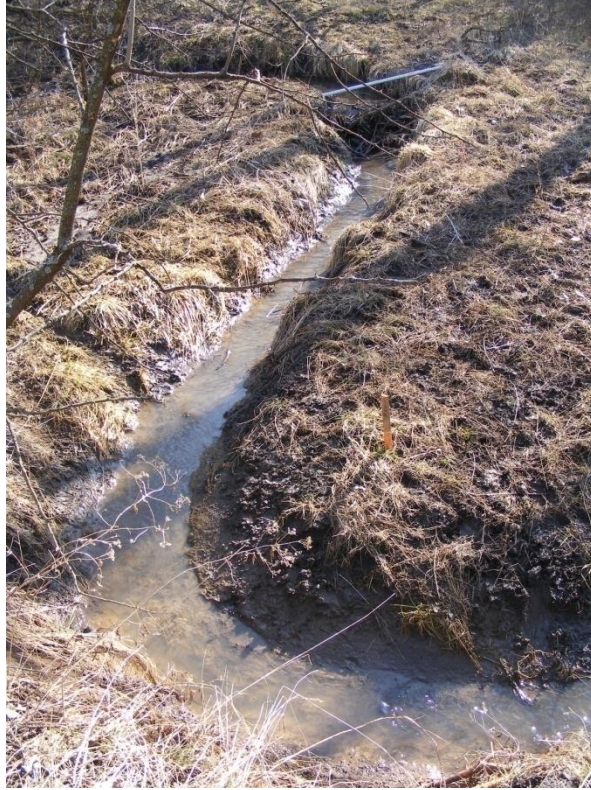
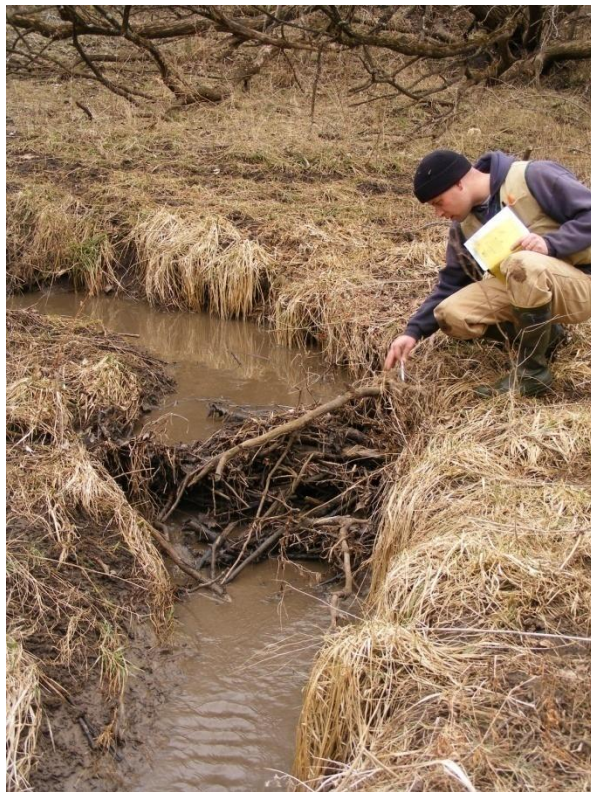
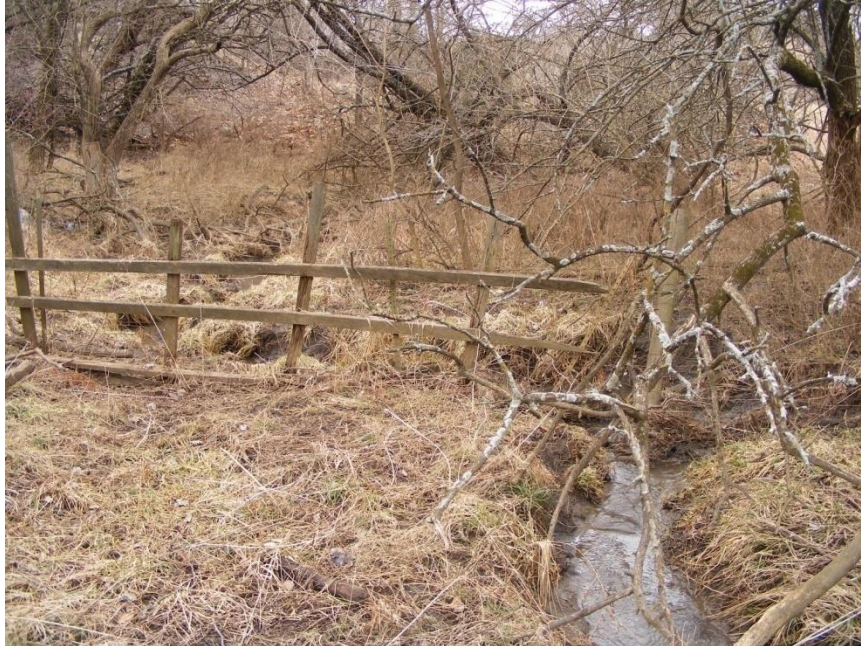
lower due to channel aggradation at this location. In addition, 2 pins were driven horizontally into the top of the active floodplain to measure overbank sedimentation. PA-6 consists of 1 set of 3 vertically spaced pins on a cutbank location 30 feet upstream of the property line (Photos 13, 14 and 15).

**Photo 13. SR-6 looking downstream (Feb. 2008)**

**Photo 14. SR-6 forced riffle (Feb. 2008)**

**Photo 15. End of SR-6 at property line looking downstream (Feb. 2008)**

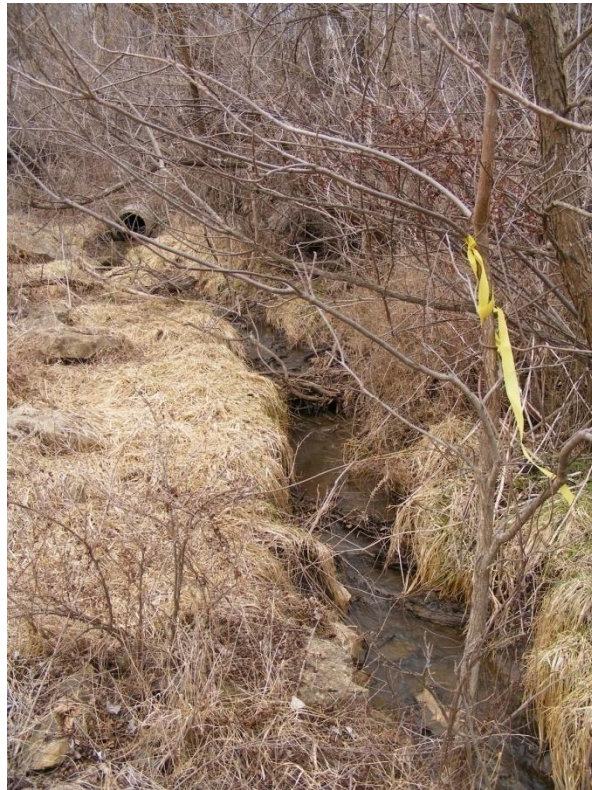
The channel is straight with a bed rock and riffle-pool form that is about 3.7 ft wide and 1 ft deep. The bed is silty with local areas of gravel and cobble. Rubble debris forms the left bank in many places and large blocks and debris provide obstacles to the flow in some places (Photo 16).

**Photo 16. SR-8 begins below rubble dam outlet (Feb. 2008)**

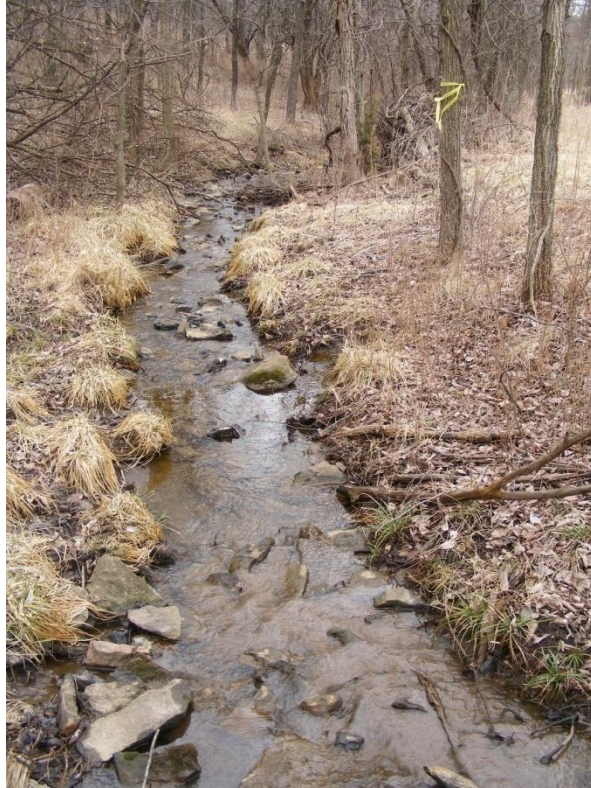
The channel is straight and with a bed rock and riffle-pool form that is about 3.8 wide and 0.8 ft deep. The bed is composed of flat cobble. Quarry debris forms the left bank in many place and large blocks and debris provide obstacles to the flow in some places. The channel flows along the right valley margin here and appears to be locked in place in this location (Photo 17).

**Photo 17. SR-9 looking downstream (Feb. 2008)**

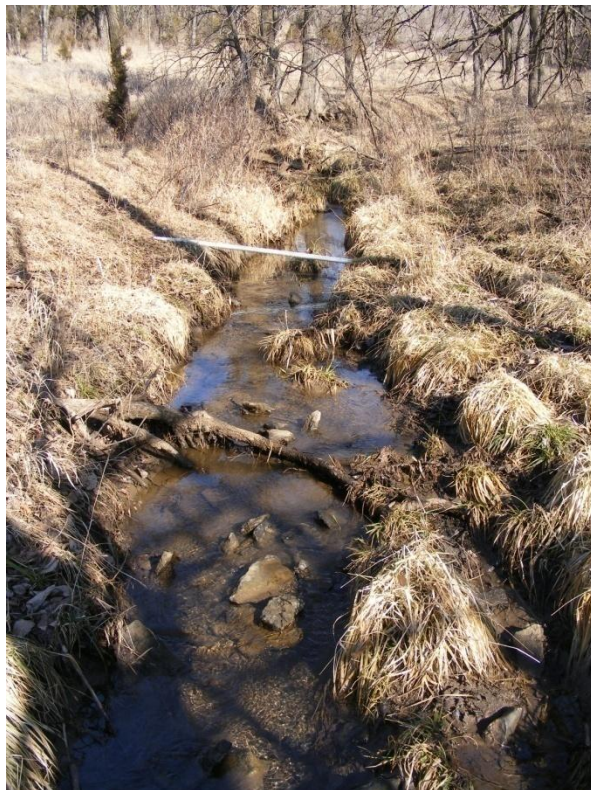
The channel is sinuous with one or two meander bends and with a bed rock and riffle-pool form that is about 3.8 ft wide and 0.8 ft deep. The bed is composed of gravel and cobble that are 70% embedded with fines. PA-7 is located in this sub-reach with 1 set of 3 vertically spaced pins on the cutbank and one in the opposite side in the eroding active floodplain (Photo 18).

**Photo 18. SR-10 looking downstream (Feb. 2008)**

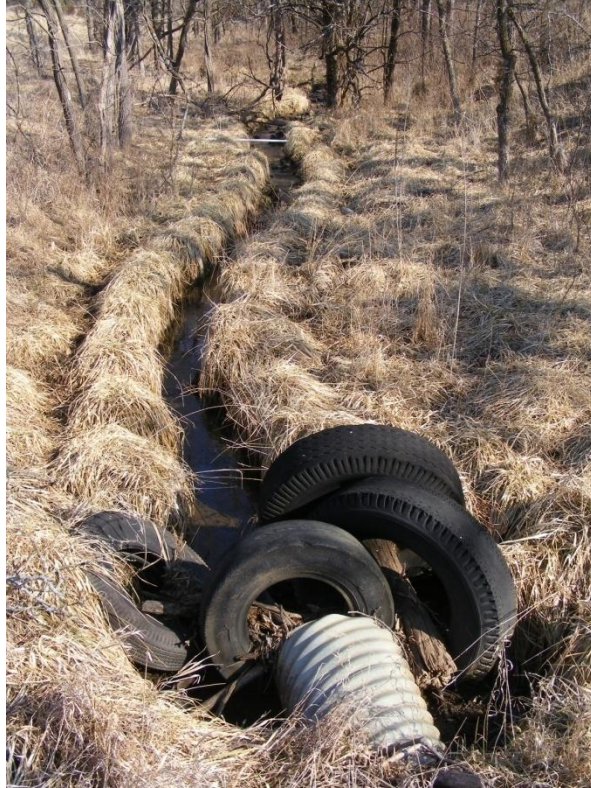
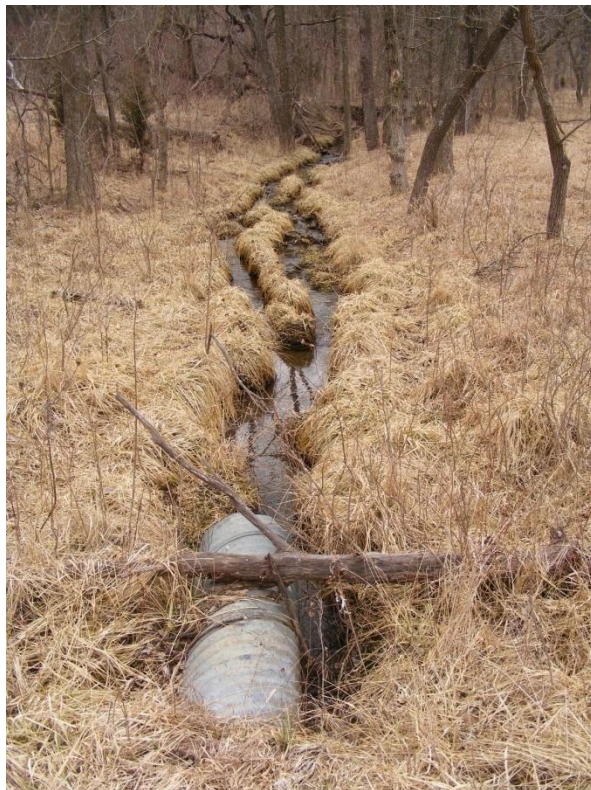
Sub-reach 11 is relatively straight and affected by a low water culvert stream crossing. This reach represents the relatively localized effect of channel and floodplain constriction by a small bridge. Sub-reach 11a is upstream of the bridge where sedimentation and minor aggradation has occurred. The channel is 3 ft wide and 1 ft deep with over 70% of cobble and gravel bed embedded with silt. Sub-reach 11b is below the bridge. The channel is 3.7 ft wide and 0.75 ft deep with less embeddedness. There are more large cobble and boulders in the bed compared to the SR-11a (Photos 19 and 20).

**Photo 19. SR-11a looking upstream from culvert (Feb. 2008)**

**Photo 20. SR-11b looking downstream from culvert (Feb. 2008)**

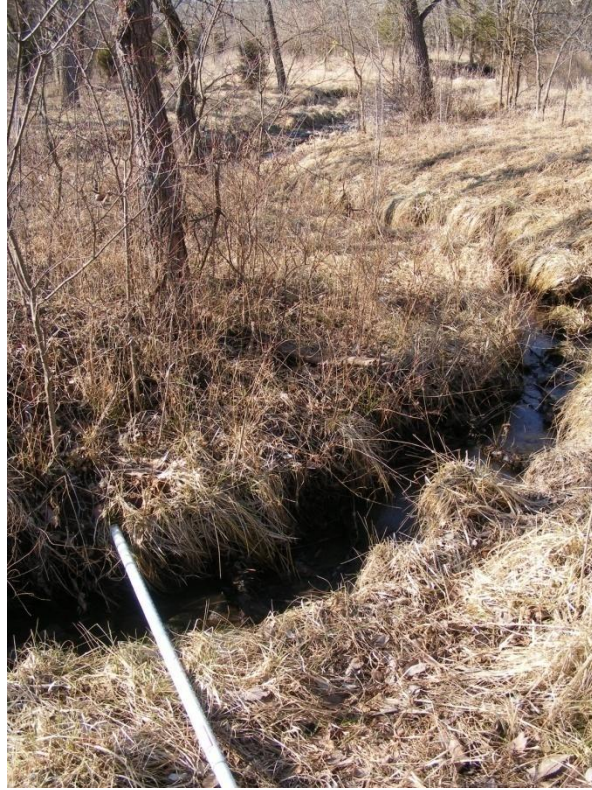
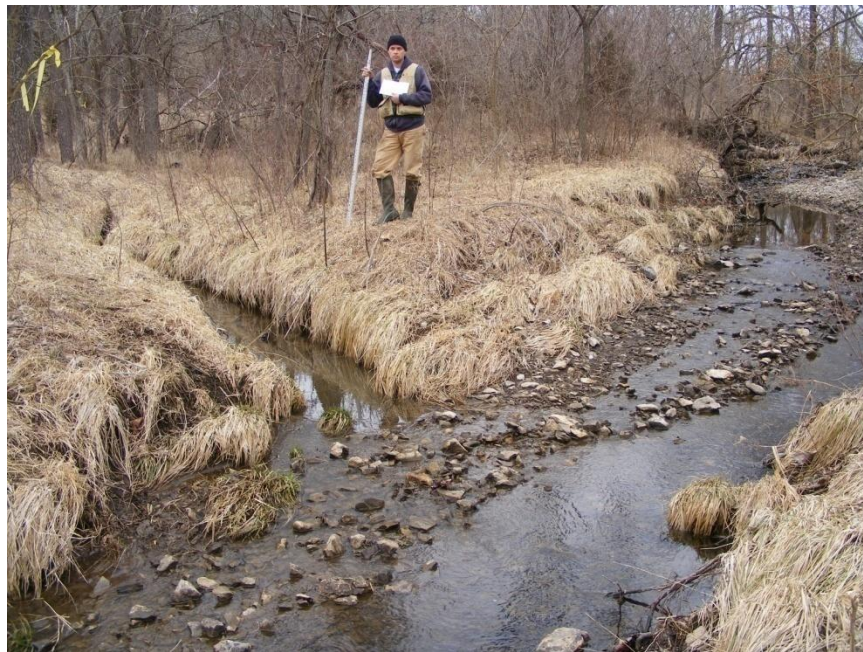
The channel meanders as it is affected by the floodplain control of the larger stream valley. The channel is 2.4 ft wide and 1.1 ft deep with coarse gravel and large cobble on the bed. PA-8 is located in this sub-reach consisting of 2 sets of pins; two vertically spaced pins in the upstream set and three in the downstream set. One pin was positioned in the eroding active floodplain on the inside of the meander at both locations (Photos 21 and 22).

**Photo 21. SR-12 looking downstream to confluence (Feb. 2008)**

**Photo 22. End of SR-12 at confluence with main tributary (Feb. 2008)**

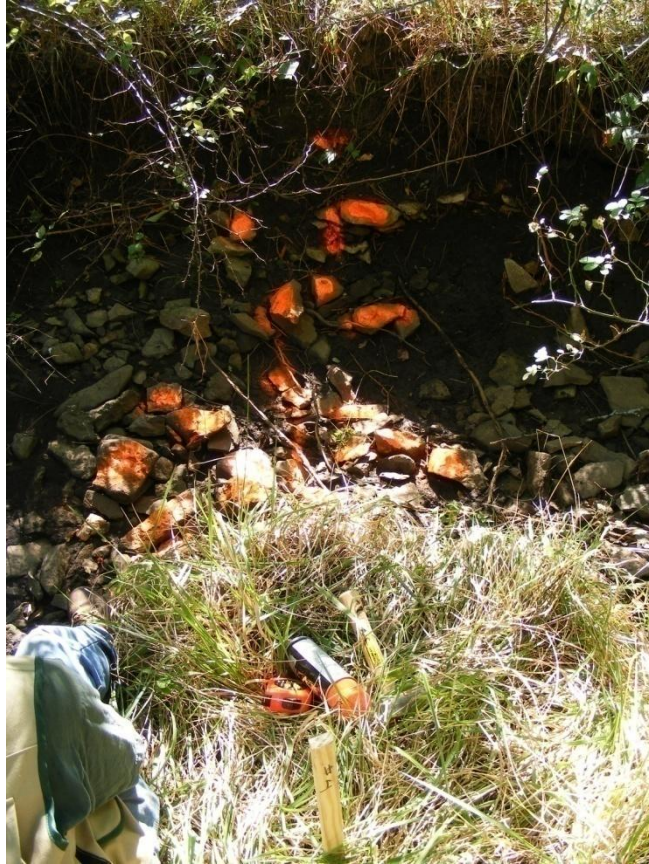
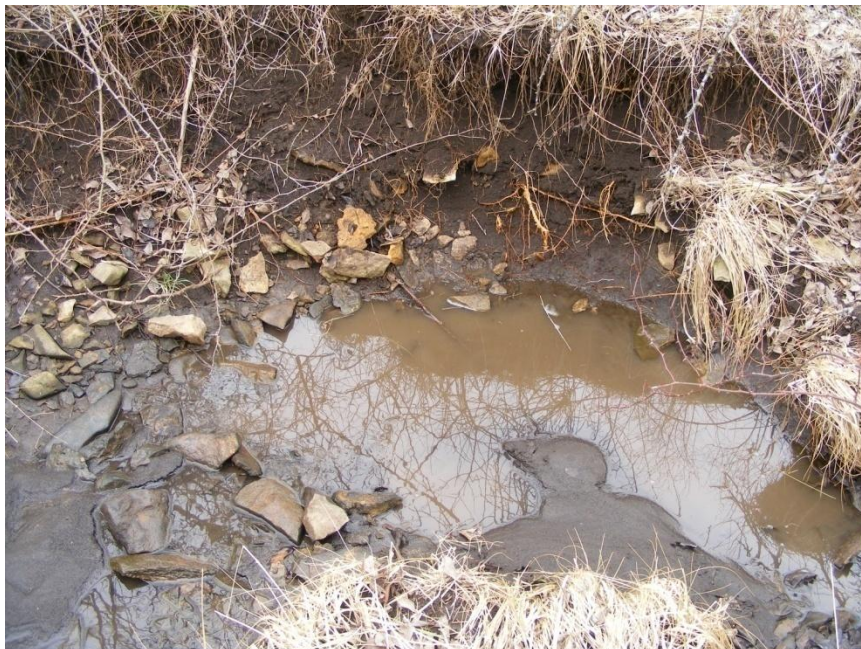
*PA-1* is located in SR-3b where the channel starts to meander. Pins here showed no change over the monitoring period, but the channel did have some fresh fine gravel deposition on the bed (Photos 23 and 24).

**Photo 23. PA-1 installation September 12, 2008**

**Photo 24. PA-1 in Feb. 2008.**

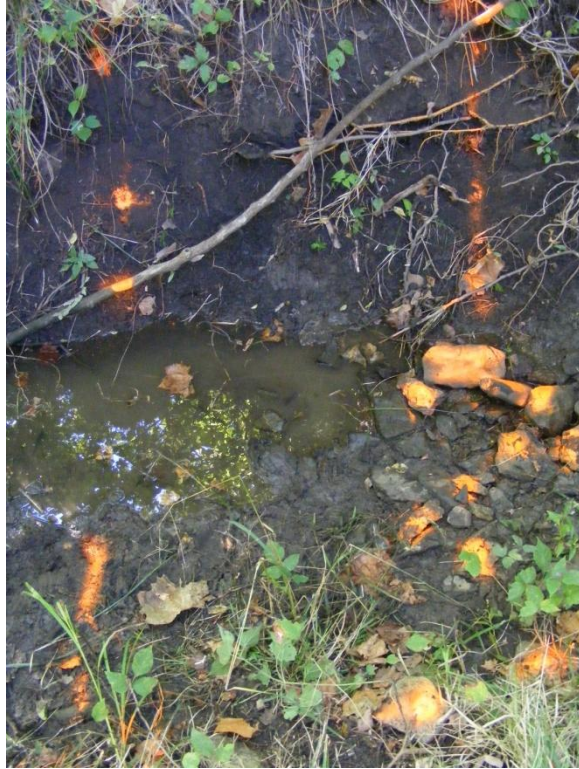
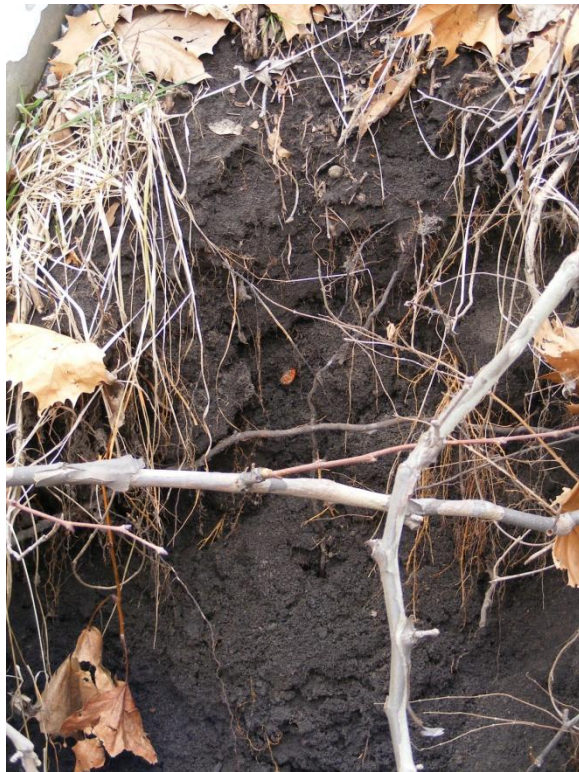
*PA-2* is located in SR-4a which is an alluvial transition reach from a colluvial dominated landscape position. There was less than 0.1 ft of pin exposed in the upper bank and the lower pins were buried by upper bank slump. In addition a large woody debris jam has moved into this reach, but no significant disturbance was observed as of February 2008 (Photos 25 and 26).

**Photo 25. PA-2 installation Sept. 2007.**

**Photo 26. PA-2 as of Feb. 2008 showing upper bank slump.**

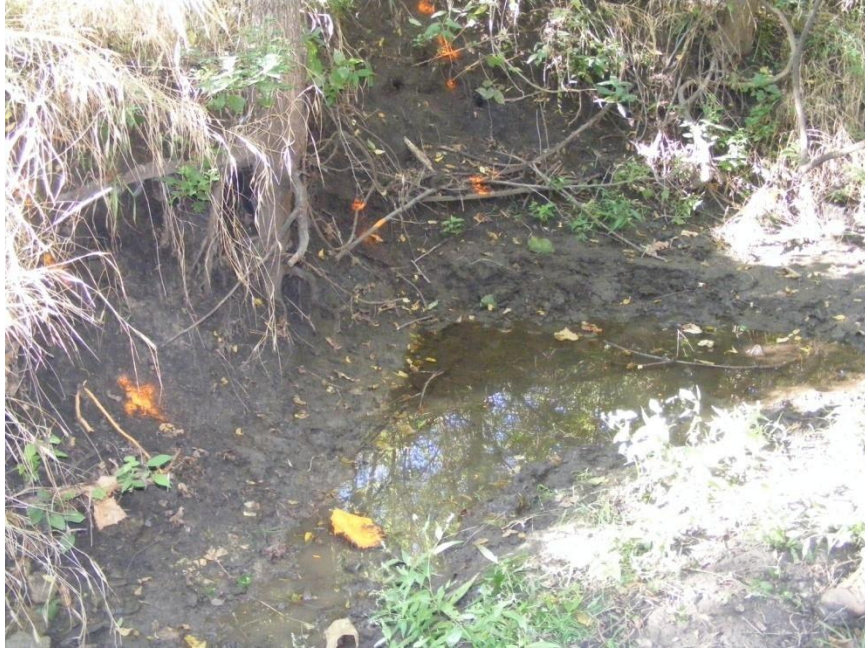
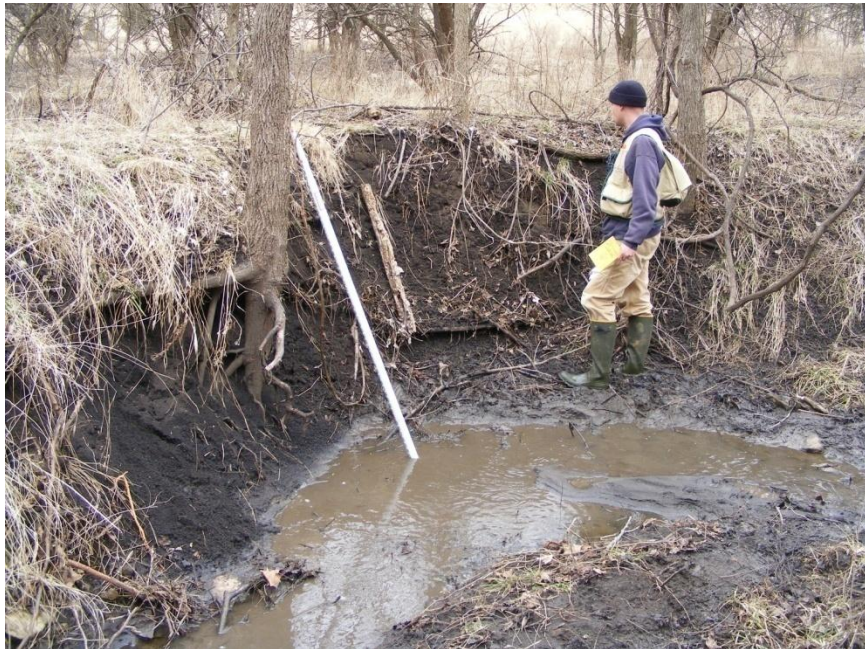
*PA-3* is located in SR-4c where the alluvial transition zone begins to meander. Pins remain unchanged with some upper bank slumping lowering the bank angle (Photos 27 and 28).

**Photo 27. PA-3 installation Sept. 2007**

**Photo 28. PA-3 in Feb. 2008**

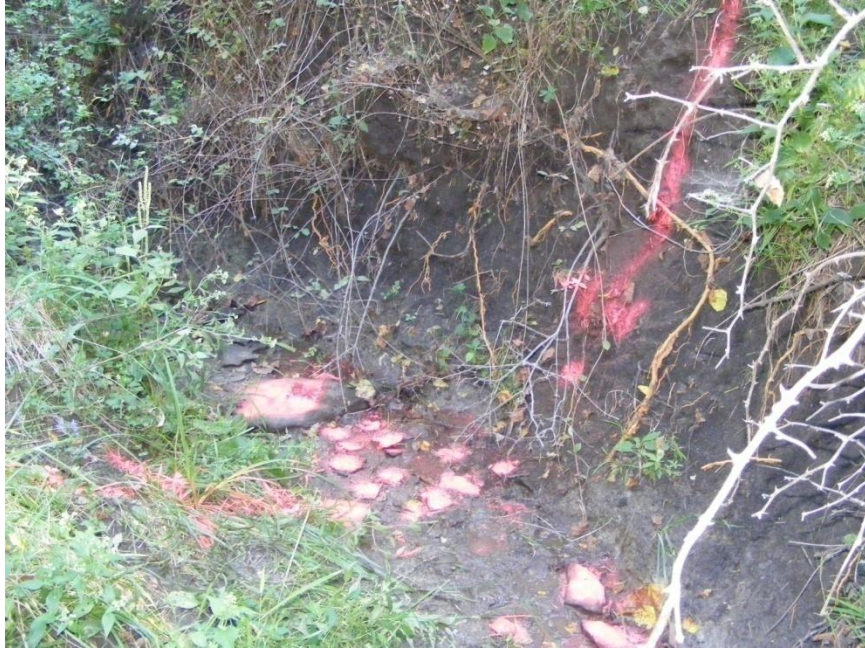
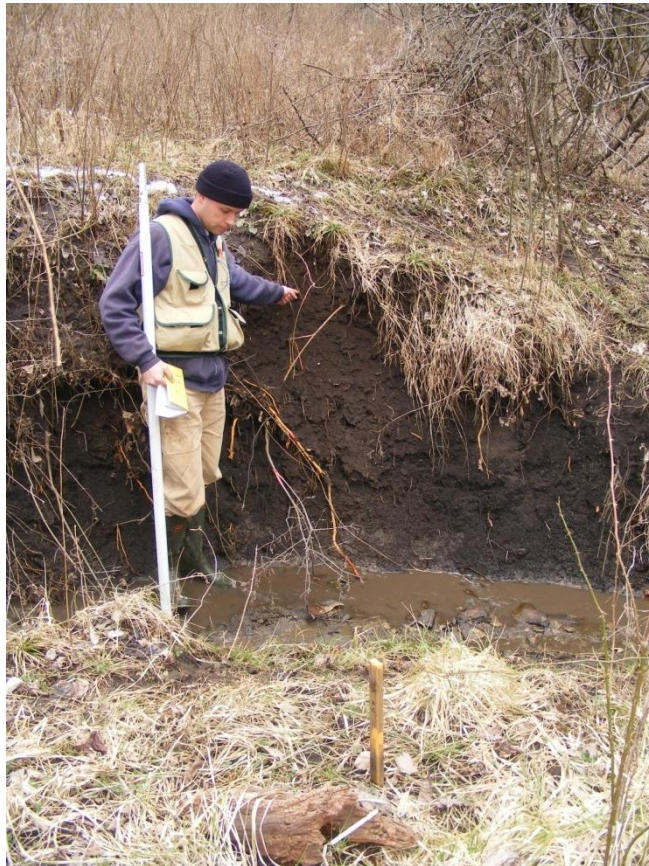
*PA-4* is located in SR-5 above the confluence with the golf course tributary. Approximately 0.1 ft of the pin located in the upper bank has been exposed with the lower bank pin being covered indicating some mass wasting of this bank at this location Photos 29 and 30).

**Photo 29. PA-4 installation Sept. 2007**

**Photo 30. PA-4 as of Feb. 2008.**

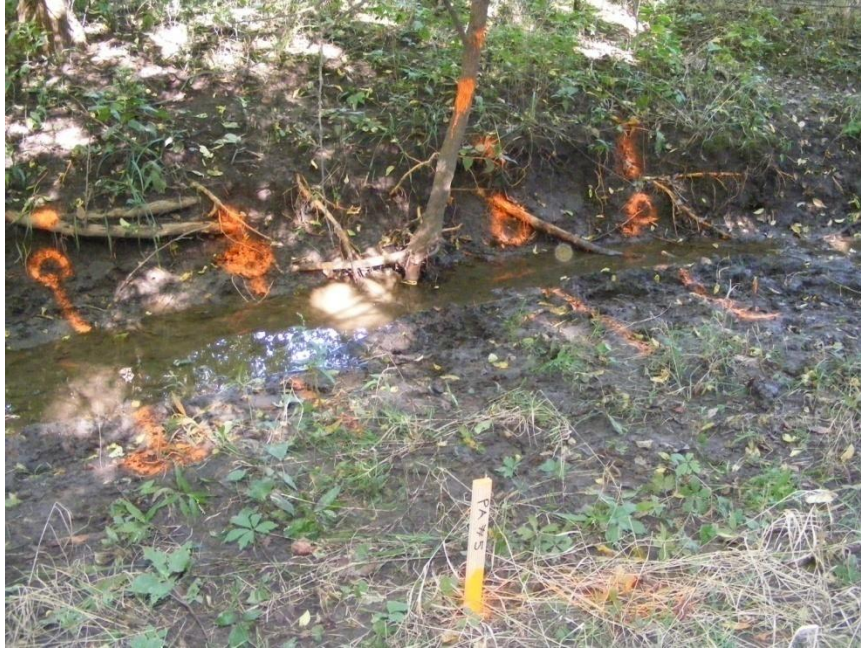
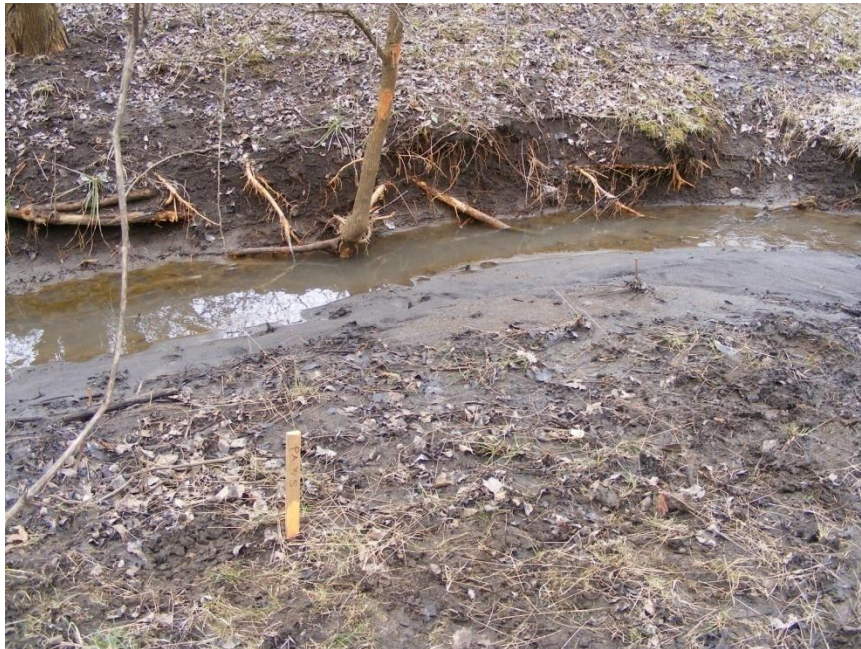
*PA-5* is located in SR-6 where valley fill has caused channel/valley aggradation. The upstream pin had 0.25 ft exposed, the next pin going downstream had < 0.1 ft exposed with the remaining pins having no change (Photos 31 and 32).

**Photo 31. PA-5 installation Sept. 2008**

**Photo 32. PA-5 Feb. 2008**

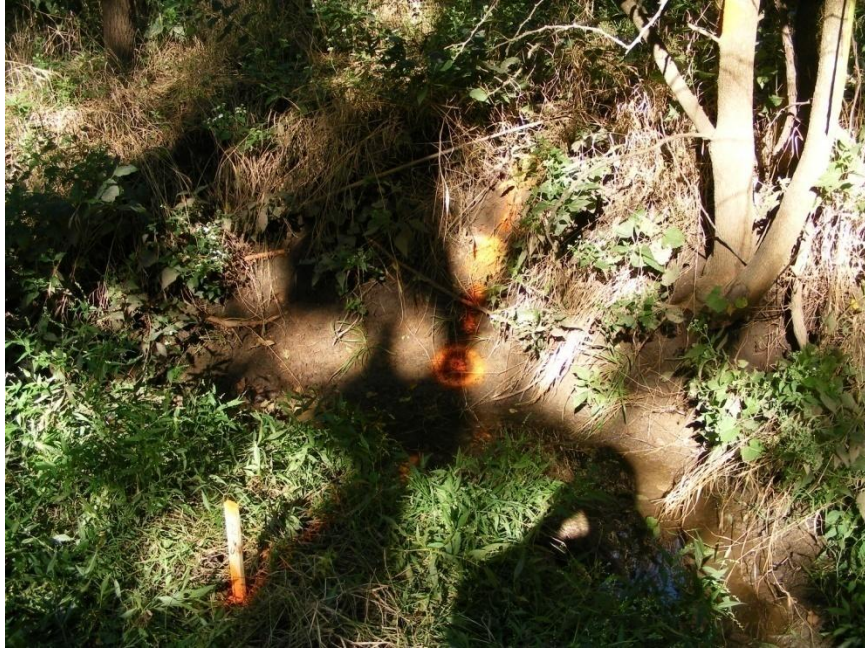
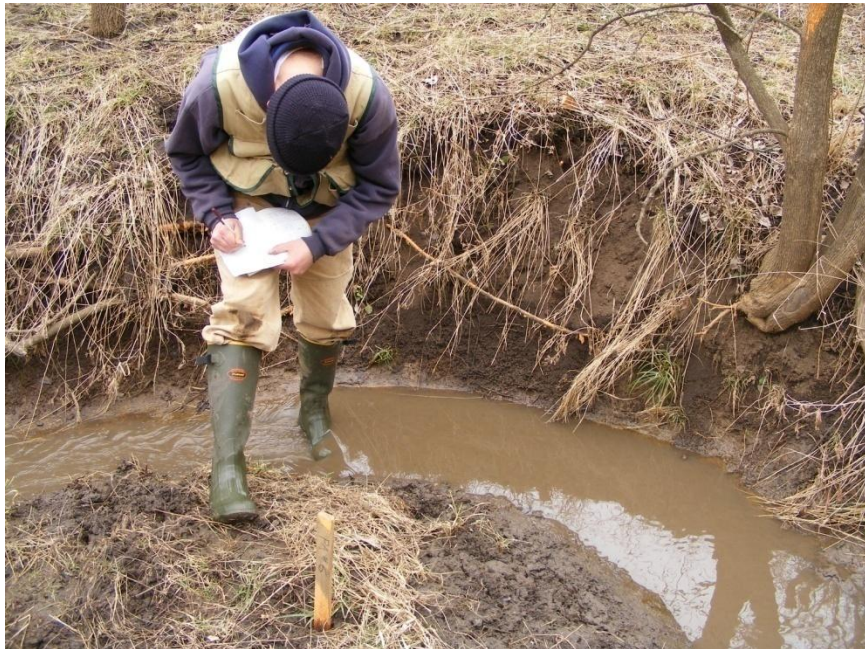
PA-6 is also located in SR-6. Pins at this location showed upper bank slump covering the lower pin decreasing the bank angle at this location (Photos 33 and 34).

**Photo 33. PA-6 installtion Sept. 2007**

**Photo 34. PA-6 Feb. 2008**

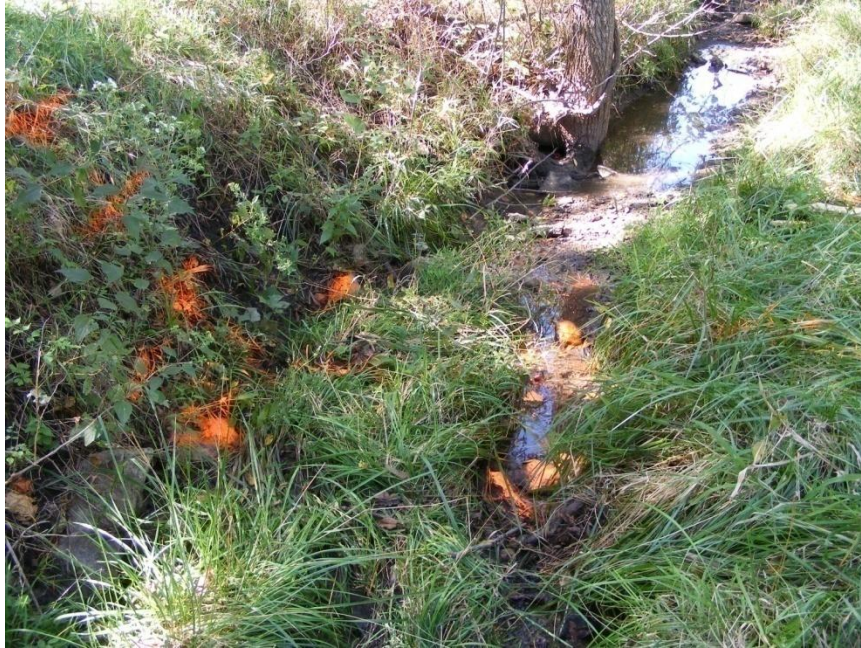
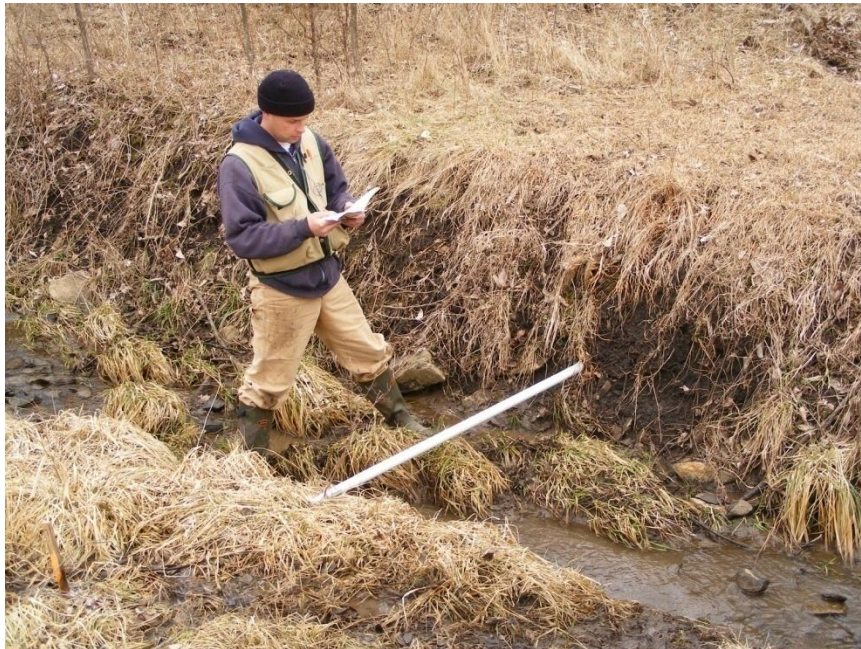
PA-7 is located in SR-10 which is a sinuous stable reach below the valley fill. Pins here had <1 ft of upper bank slump deposition at the toe of the bank (Photos 35 and 36).

**Photo 35. PA-7 installation Sept. 2007**

**Photo 36. PA-7 Feb. 2008**

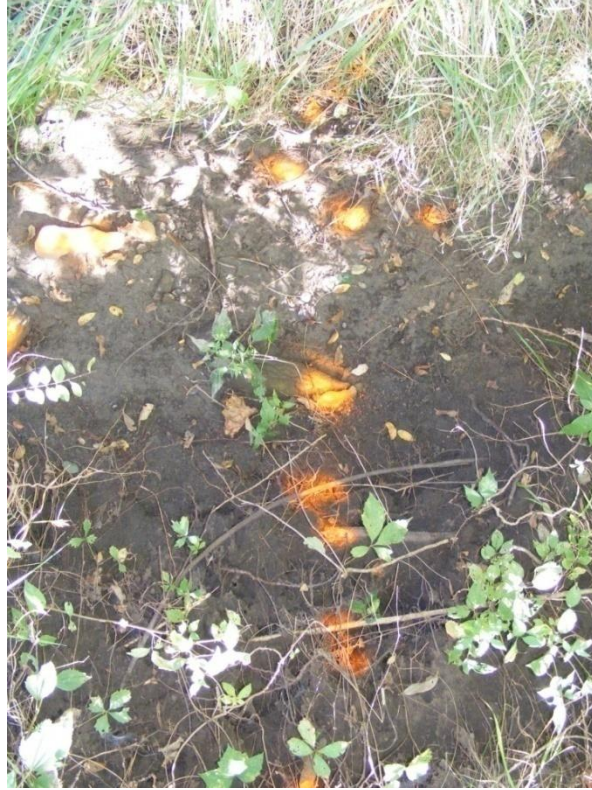
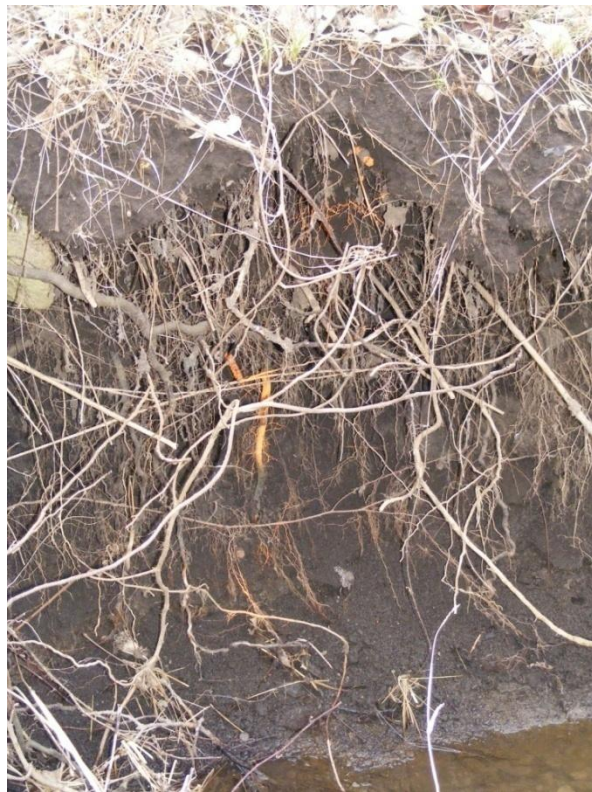
PA-8 is located in SR-12 above the confluence of the main tributary where slope decreases as the channel meets a larger alluvial floodplain. Here, pins showed between 0.1 and 0.25 ft of erosion during the monitoring period (Photos 37 and 38).

**Photo 37. PA-8 installation Sept. 2007**

**Photo 38. PA-8 Feb. 2008**
