Ozarks Environmental and Water Resources Institute (OEWRI)

Geomorphic Assessment of Galloway Branch in Sequiota Park, Springfield, Missouri

April 24, 2009

OEWRI TR-09-002

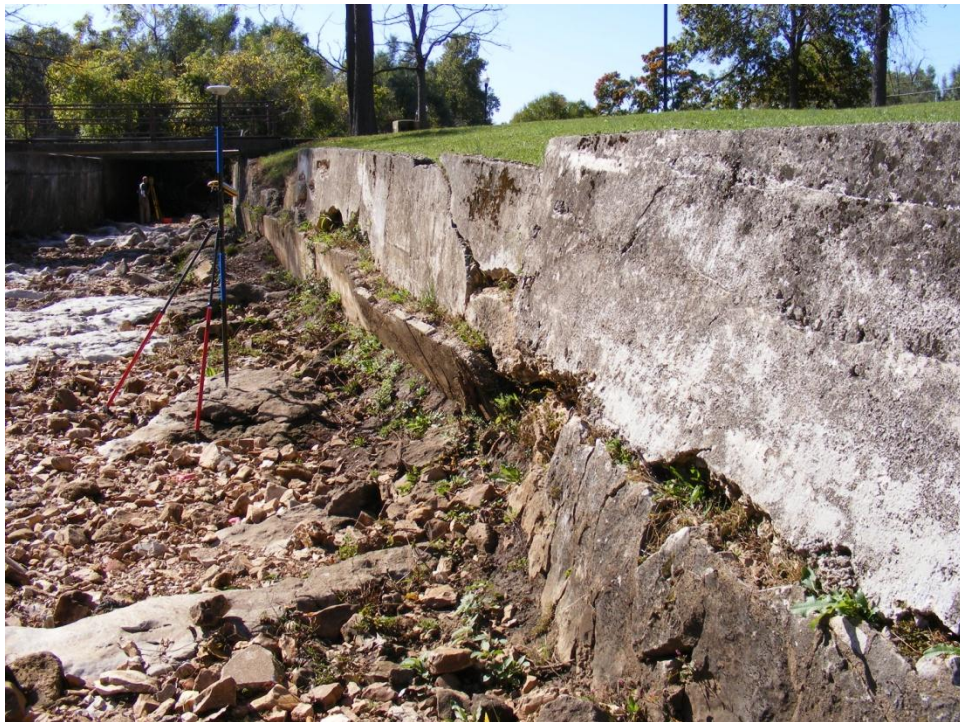
Subreach #3- This reach receives water and sediment directly from reference reach B and runs from stations 1,025 to 1,400 ft on the MSU longitudinal profile. It has a slope of about 0.2% and active width of 15 ft. Bedrock in this reach is relatively smooth and covered by a thin veneer or patches of gravel and cobble material (Photo 1, 2, 3, 25). The D50 for this reach ranges from 20 to 50 mm, D84 from 60 to 90 mm, and maximum mobile clast size from 118 to 222 mm (Photo 23). Older channel walls are being undercut and failing in most places (Photo 4, 24, 26).

Photo 4. Looking downstream at SR-3 near station 1,050 feet (10/16/2008)

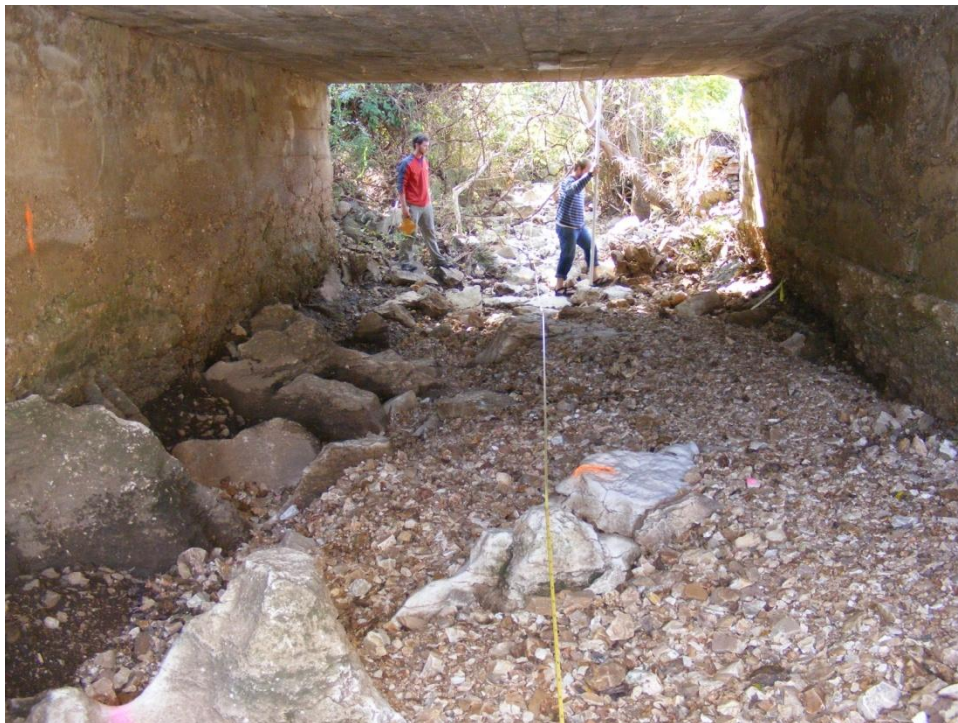
Subreach #2- This reach is severely affected by bedrock control, rough bedrock pinnacles are exposed throughout and its slope is 3 to 5 times greater than subreaches 1 and 2 (Table 9; Photo 6, 7, 9, 18, 27). Subreach #2 runs from stations 600 to 1,025 ft on the MSU longitudinal profile. It has a slope of about 1% and active width of 16 ft. Bedrock in this reach is relatively rough and pinnacle-shaped with depressions and pits trapping patches of gravel and cobble material (Photo 5, 8, 28, 29). Substrate size is variable and controlled by bed roughness, falling limb trapping, and local source inputs. Maximum mobile clast diameter is >300mm.

Photo 6. Looking downstream at SR-2 near station 900 feet (10/16/2008)

Flows in subreach 2 will achieve higher velocities and shear stress due to increased bed slope. In addition, increased flow turbulence due to pinnacle obstruction is common in this subreach. Therefore, channel designs for this reach should address this situation in contrast to the lower slope condition of subreaches 1 and 3. Larger diameter rock and a more confined channel cross-section will probably be required in subreach 2.

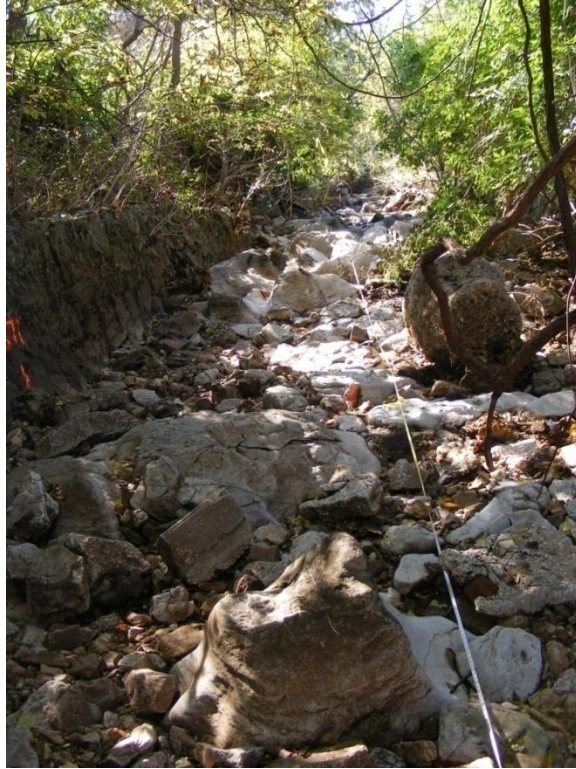
Photo 7. Looking downstream at SR-2 near Station 800 feet (10/16/2008)

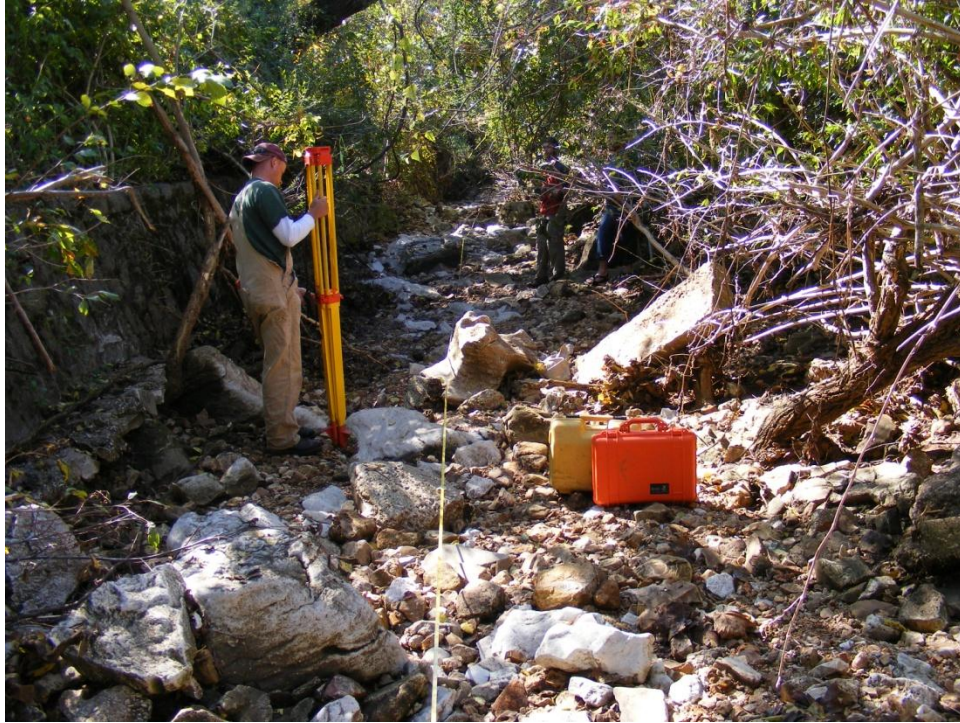
Photo 9. Looking downstream at SR-2 near station 700 feet (10/16/2008)

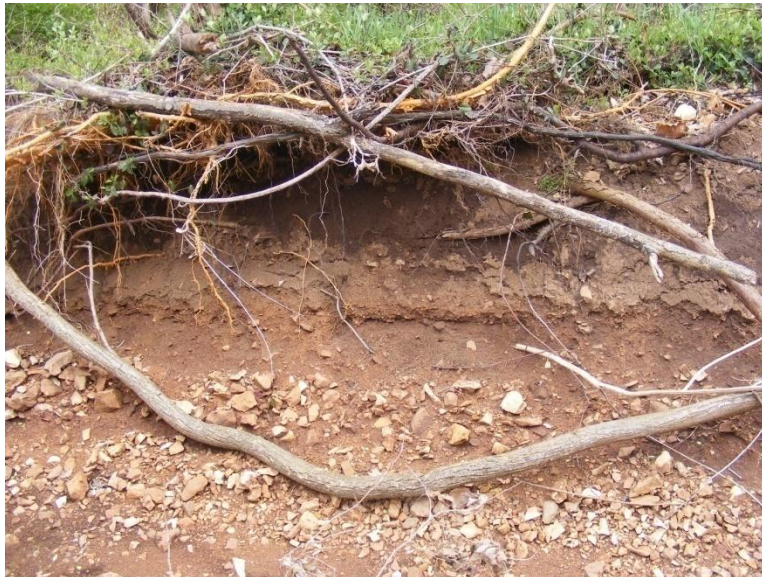
Photo 20. Bank erosion downstream of Lacuna bridge in reference reach B (4/6/09)

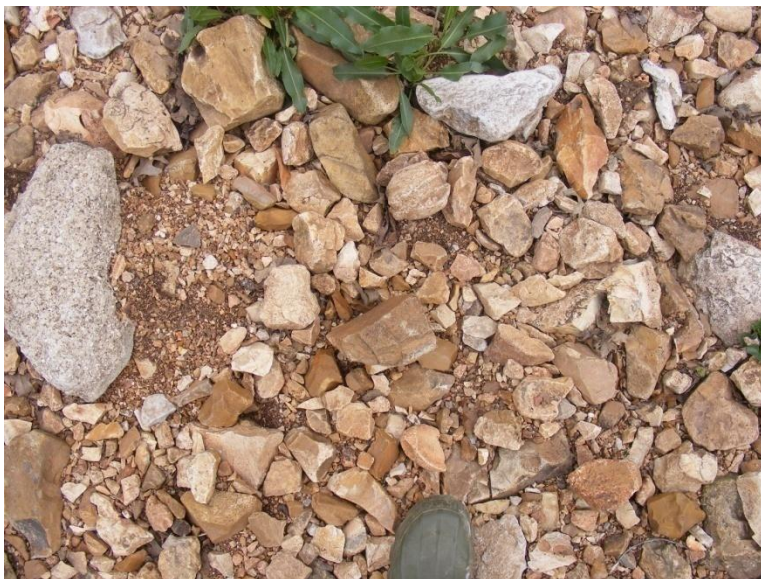
Photo 23. Bed material near station 1,200 feet SR-3 (4/6/09)

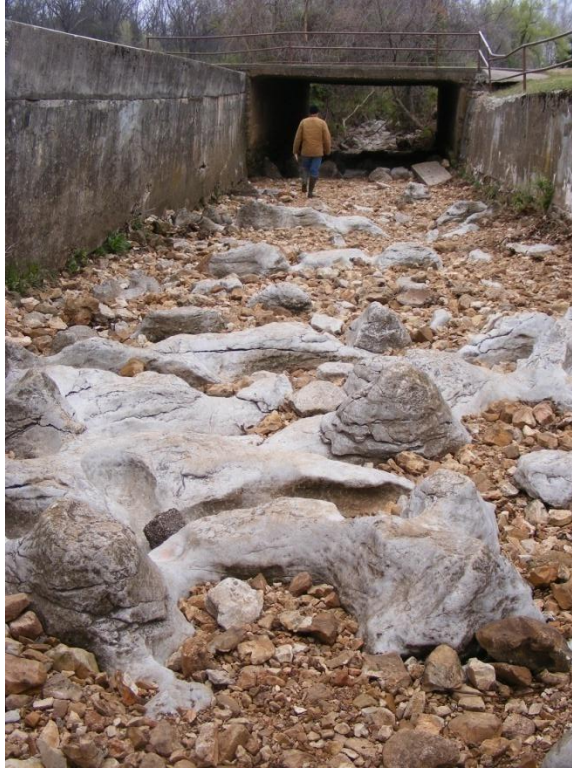
Photo 28. Bedrock pinnacles near station 900 feet looking downstream SR-2 (4/6/09)

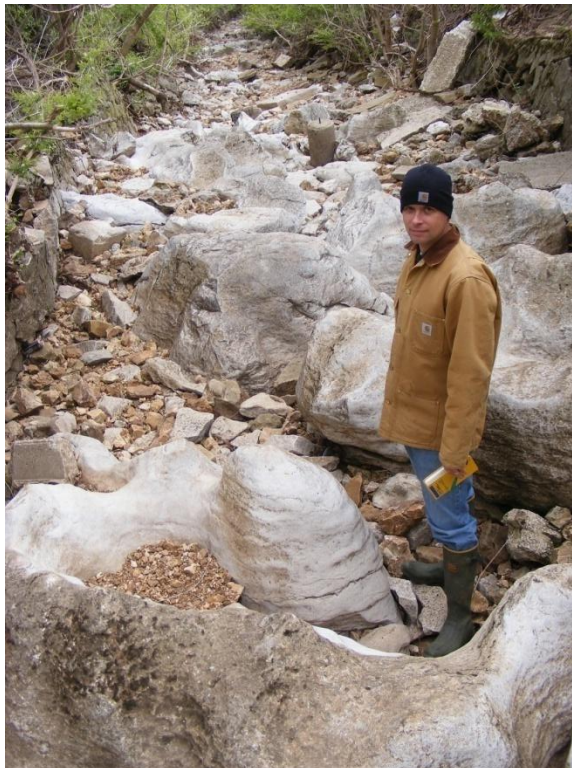
Photo 29. High bedrock pinnacles near station 600 feet looking downstream of SR-2 to SR-1 (4/6/09)
