# Ozarks Environmental and Water Resources Institute (OEWRI)

## Geomorphic Assessment of Galloway Branch in Sequiota Park, Springfield, Missouri

**April 24, 2009**

**OEWRI TR-09-002**

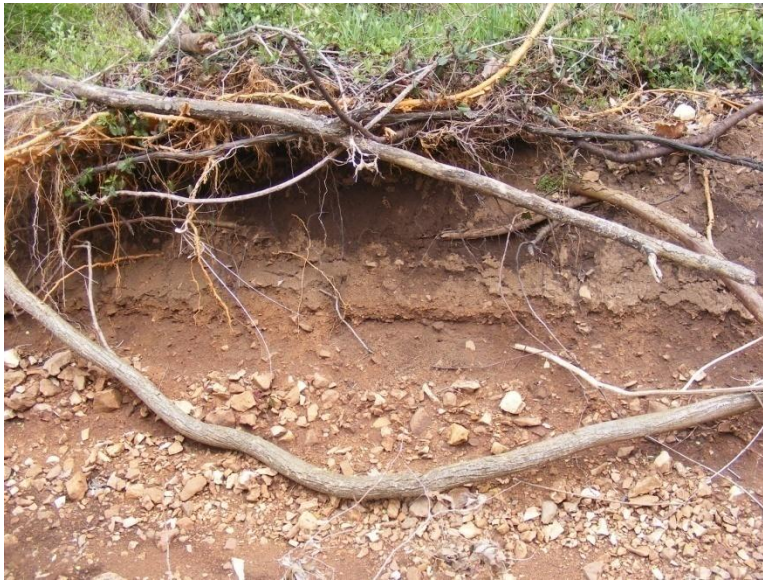
Bank materials are largely composed of cohesive materials of silt loam to silty clay loam in texture. In some places the banks are composite in form with finer overbank deposits over gravelly channel deposits. Tree roots and thick ground cover protects the bank from erosion in some places. However, upper banks angles can be steep and near vertical on bends or where obstacles deflect flow toward the bank. Moreover, the frequent occurrence of scour on exposed earth banks reflects the urban hydrology of the watershed.

**Photo 20. Bank erosion downstream of Lacuna bridge in reference reach B (4/6/09)**

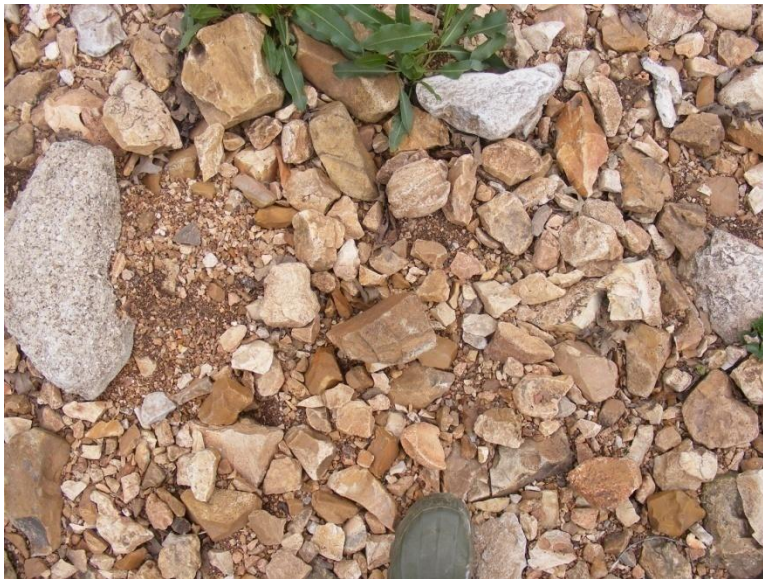
*Subreach #3-* This reach receives water and sediment directly from reference reach B and runs from stations 1,025 to 1,400 ft on the MSU longitudinal profile. It has a slope of about 0.2% and active width of 15 ft. Bedrock in this reach is relatively smooth and covered by a thin veneer or patches of gravel and cobble material (Photo 1, 2, 3, 25). The D50 for this reach ranges from 20 to 50 mm, D84 from 60 to 90 mm, and maximum mobile clast size from 118 to 222 mm (Photo 23). Older channel walls are being undercut and failing in most places (Photo 4, 24, 26).

**Photo 23. Bed material near station 1,200 feet SR-3 (4/6/09)**

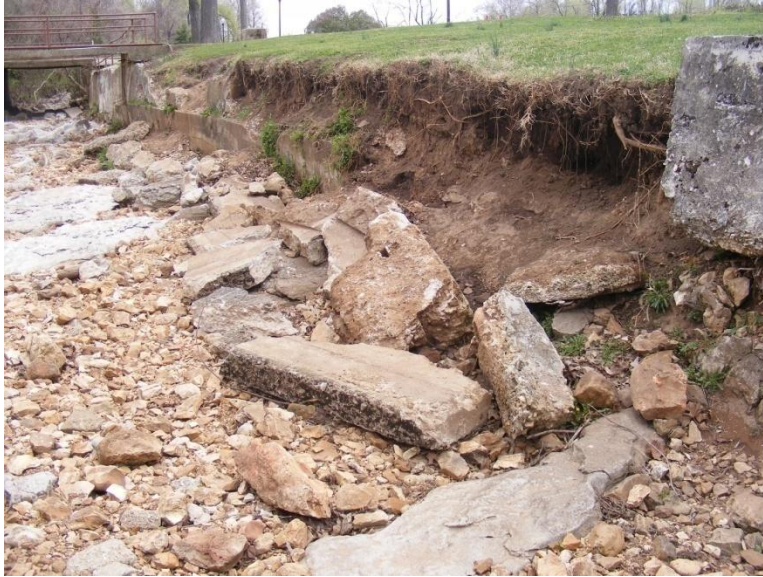
**Photo 26. Failing concrete wall on right bank looking downstream near station 1,200 feet SR-3 (4/6/09)**

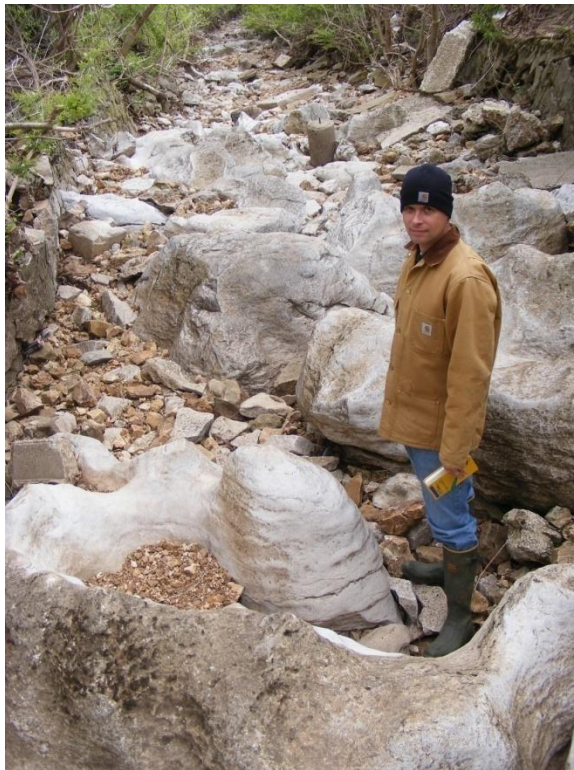
*Subreach #2-* This reach is severely affected by bedrock control, rough bedrock pinnacles are exposed throughout and its slope is 3 to 5 times greater than subreaches 1 and 2 (Table 9; Photo 6, 7, 9, 18, 27). Subreach #2 runs from stations 600 to 1,025 ft on the MSU longitudinal profile. It has a slope of about 1% and active width of 16 ft. Bedrock in this reach is relatively rough and pinnacle-shaped with depressions and pits trapping patches of gravel and cobble material (Photo 5, 8, 28, 29). Substrate size is variable and controlled by bed roughness, falling limb trapping, and local source inputs. Maximum mobile clast diameter is >300mm.

**Photo 29. High bedrock pinnacles near station 600 feet looking downstream of SR-2 to SR-1 (4/6/09)**

Flows in subreach 2 will achieve higher velocities and shear stress due to increased bed slope. In addition, increased flow turbulence due to pinnacle obstruction is common in this subreach. Therefore, channel designs for this reach should address this situation in contrast to the lower slope condition of subreaches 1 and 3. Larger diameter rock and a more confined channel cross-section will probably be required in subreach 2.

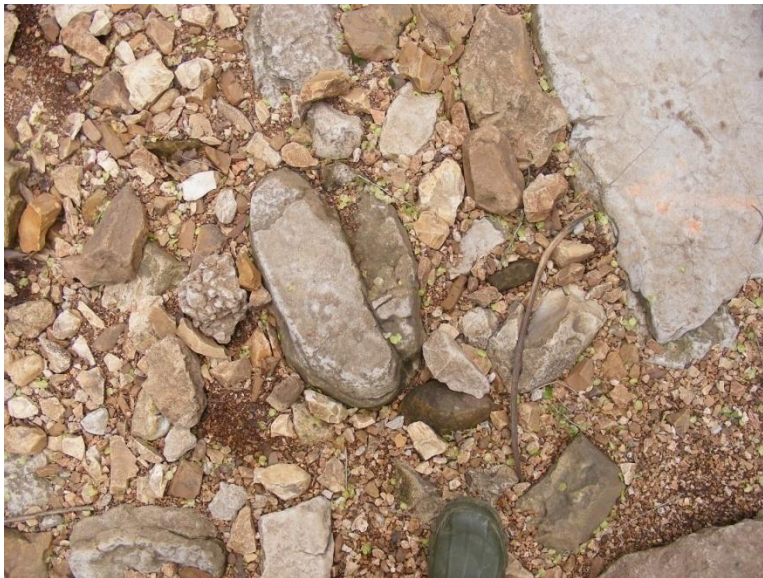
and maximum mobile clast diameter of 326 mm (Photo 31). Older channel walls are being undercut and failing in some places and anthropogenic debris is entering the channel from fill bank erosion (Photo 30). During dry periods, water is observed to enter the channel in this section from under the east wall by pond seepage through the earth berm.

**Photo 31. Fine to medium gravel fill between cobble and boulder size material near station 500 feet SR-1 (4/6/09)**
