**Geomorphic Assessment of Ravenwood Creek  
Lake Springfield Park, Springfield, Missouri**

**Final report to Olsson Associates for  
the City of Springfield, Missouri**

**May 2, 2008**

**OEWRI TR-08-001**

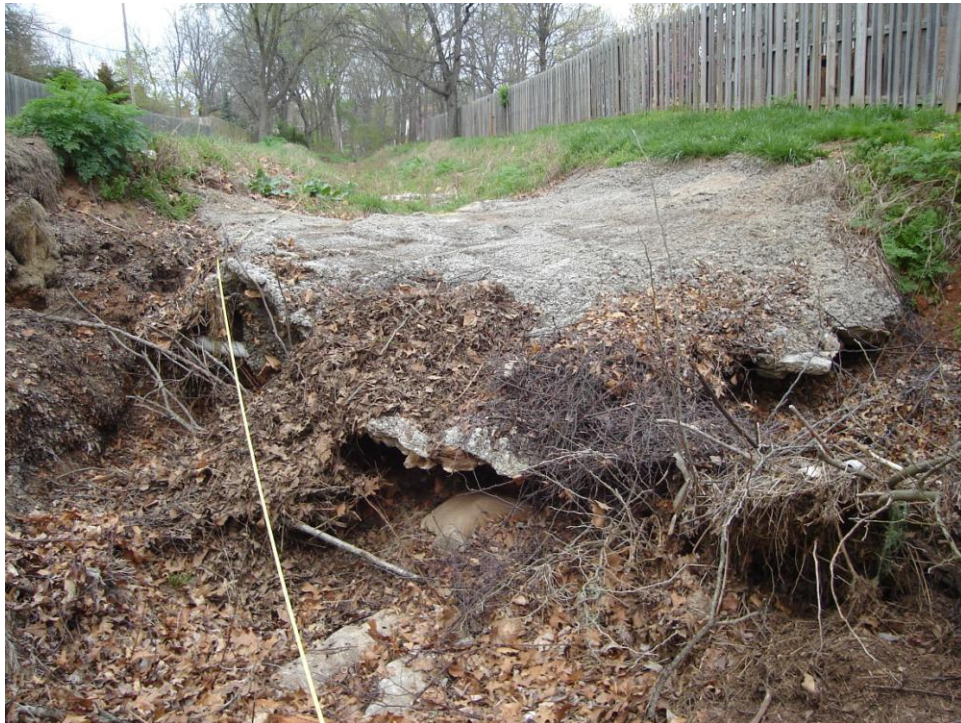
***Sub-reach #2*** extends downstream from stations 667 ft to 530 ft and represents a recently active portion of a headward incising channel or “headcut.” However, upstream migration of the head cut has presently stalled due to inadvertent bed protection by the concrete cover (Figure 5 and Picture 2; note exposed PVC pipe under apron to the left side of the picture). This is a zone of local channel disequilibrium where the bed form is flat or uneven and bed slope approaches zero. There are three zones in sub-reach #2. Sub-reach #2A designates the zone of maximum incision depth immediately below the concrete cover forming a large “plunge pool” between stations 667 ft and 640 ft. Channel bed elevation drops by almost 6 feet over a horizontal distance of a few feet to expose bedrock between 660 ft to 655 ft. Upper bank angles range from 60 to 90 degrees and top bank width is 27 ft across the plunge pool. Top bank height is 9 ft above the bed. Bankfull stage indicators were not identified in this sub-reach. The underground pipe and phone line was almost completed undermined in April 2008 and should be checked by authorities as soon as possible.

**Picture 2** – Concrete bed obstruction/headcut at 670ft (looking upstream)

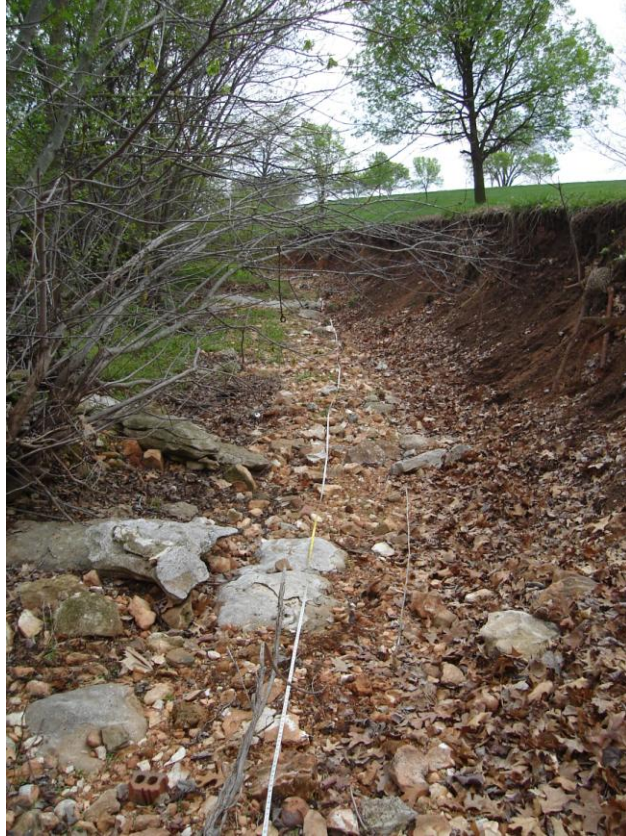
Sub-reach #2B is a zone of scour and sediment transport extending below the core zone of the plunge pool from 640 ft to 575 (Pictures 3 and 4). Bedrock is exposed in some places between patches of gravel sheet deposits. Upper bank angle averages about 60 to 80 degrees and top bank channel width is 25 ft. Top bank heights rise from 5 to 7 ft above the bed, about 5x bankfull stage. Sub-reach #2C is a zone of deposition between stations 575 ft and 530 ft where the erosional energy of the plunge pool has dissipated (Picture #5). The rate of bed load delivery into the project reach from upstream sources is probably relatively low compared to the amount of gravel and cobble released by bed and bank erosion in the plunge pool zone or from channel widening in sub-reaches 2A and 2B. Channel width and depth trends are similar to sub-reach #2B. There are two locations where historical farm artifacts are buried by about 3 ft of alluvial and presently exposed in eroding banks on the right side of the channel. A wagon bed and frame (not really sure, but my best guess) is located at 615 ft and the iron band from around an old wagon wheel is found at 565 ft. These artifacts are presently (April 2008) being unearthed by lateral bank erosion with several pieces already on the channel bed available for transport.

**Picture 3** – Bedrock exposure and bank artifacts on the right side at 600ft (sub-reach #1)

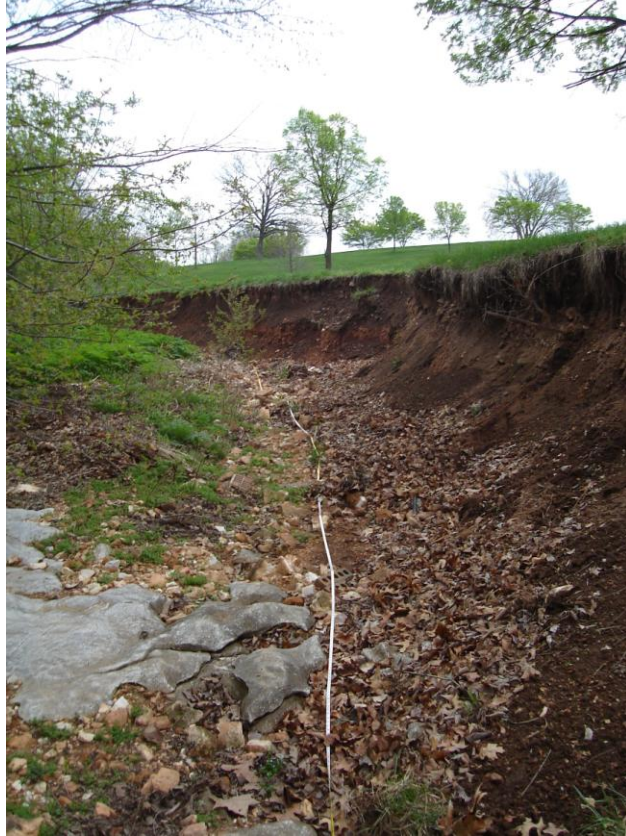
**Picture 5** – Bedrock exposure at 550ft (sub-reach 2b-c)

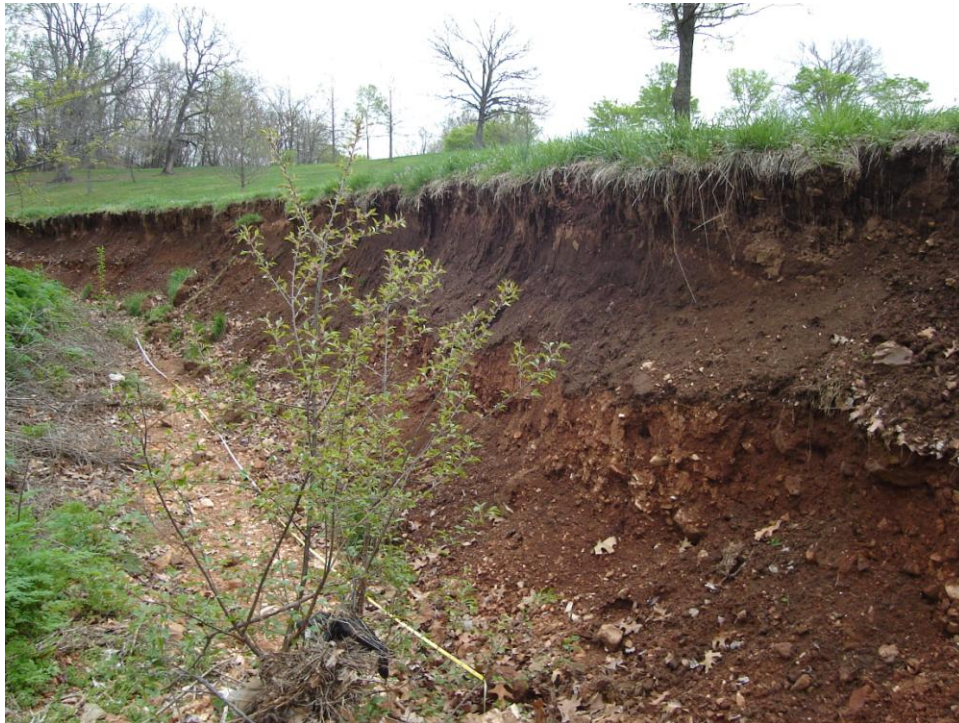
***Sub-reach #3*** extends from 530 ft to 369 feet (Pictures 6 to 8). Channel slope in this reach averages about 0.0063. This is a reach where there is a relatively long bend to the left or north by the channel and a long lateral pool trough has formed along the cut bank as expected between stations 520 ft to 410 ft. There are also several smaller-scale erosional steps at stations 500 ft to 470 ft within the longer pool form (Figure 3). Thus, this reach may reflect the composite influence of both meander pool and secondary knickpoint formation (Figure 5). The top bank width of the channel reaches 30+ ft and bankfull width ranges from 13 ft to 18 ft (Figure 4b). Top bank height ranges from 4 to 7 ft, about 3 to 5 times the bankfull stage. Five riffles, including smaller steps, occur in this sub-reach with an average riffle crest spacing of 40 ft. A poorly developed point bar and incipient floodplain has formed on the inside of the bend with exposed and almost vertical upper banks occurring on the outside bend.

**Picture 6** – Eroding bank along long bend at 500ft (sub-reach #3)

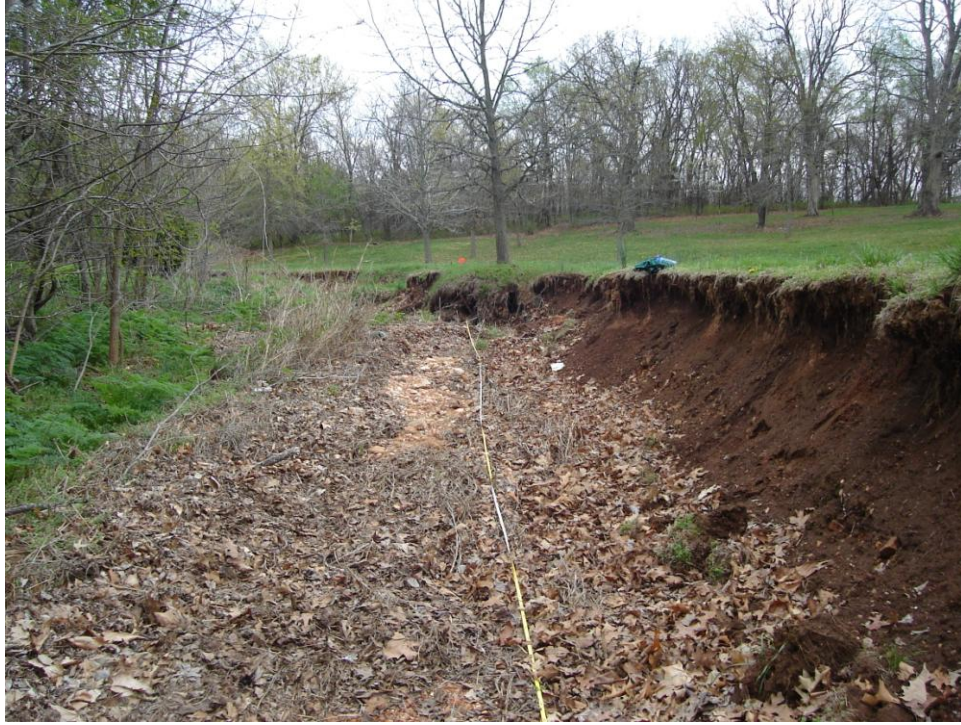
**Picture 7** – Point bar on left (under leaves) at 450ft (lower end of sub-reach #3)

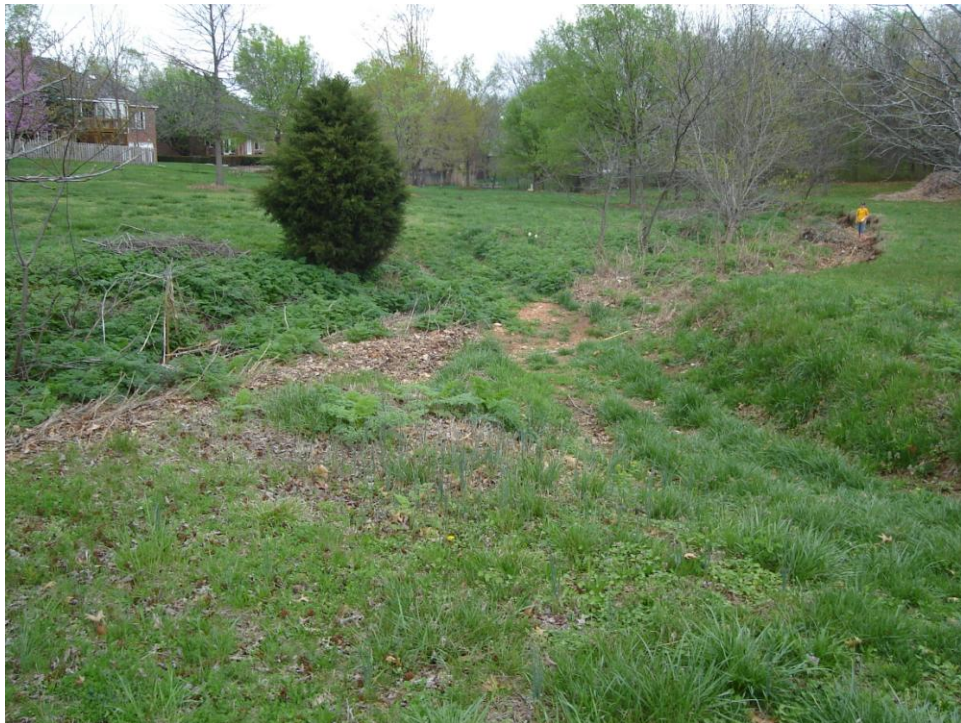
**Picture 10** – Stream crossing at ~310ft (sub-reach #4a)

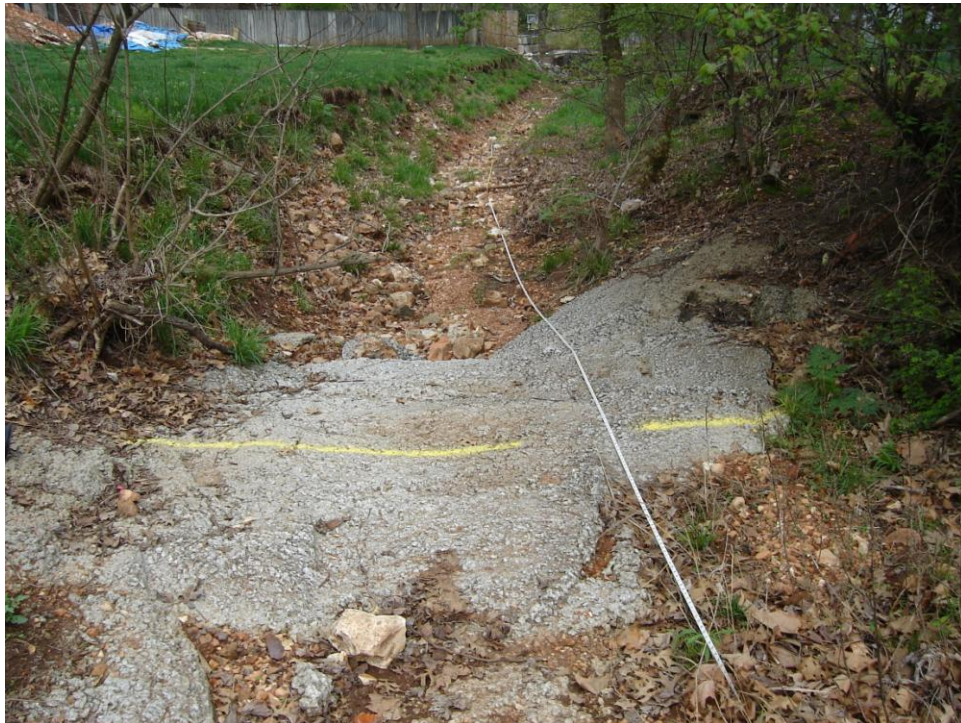
**Sub-reach #5** occurs between stations 19 ft and zero ft. The form of this reach is largely controlled by the large concrete apron at station zero where the stream flows off park property (Picture 14).

**Picture 14** – Concrete bed obstruction marking end of study reach at 0ft

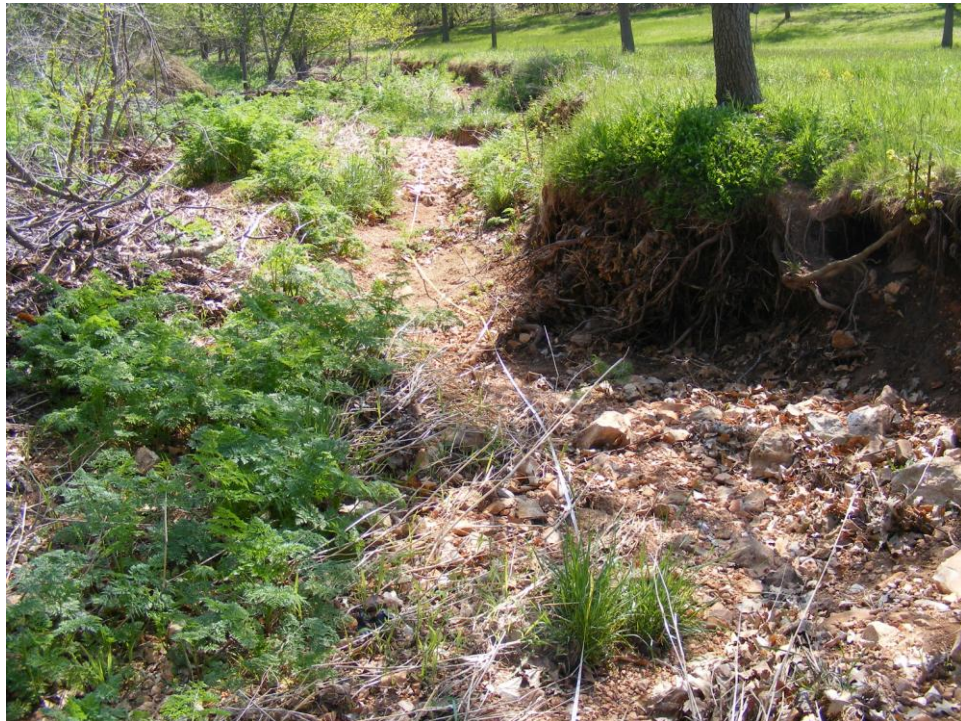
**Picture 24** - Scour pool around a tree root at 310 to 340 ft (4-29-08)

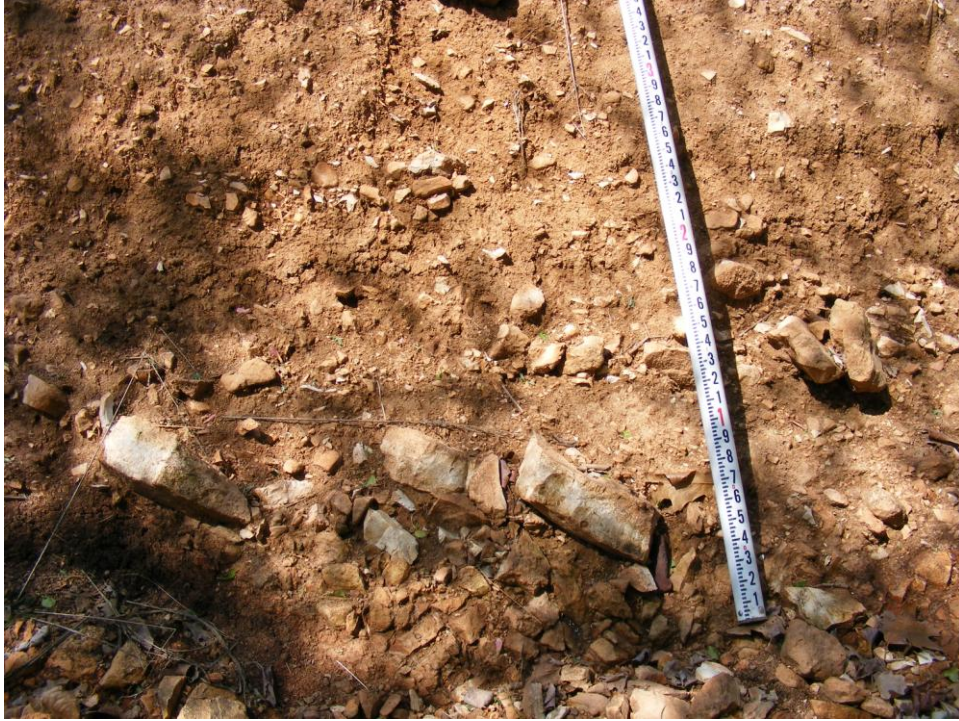
the base of the right bank at around the 600 ft point at the same elevation of the present degraded bed. These paleo-channel bed lag deposits suggest that significant channel incision occurred at this location prior to 1800 due to climate change or natural sediment supply variations. This is more evidence of the fact that this location is prone to periodic incision and cut-and-fill cycles.

**Picture 25** - Imbricated cobbles indicating the elevation of the bed of a pre-settlement paleo-channel (4-29-08)

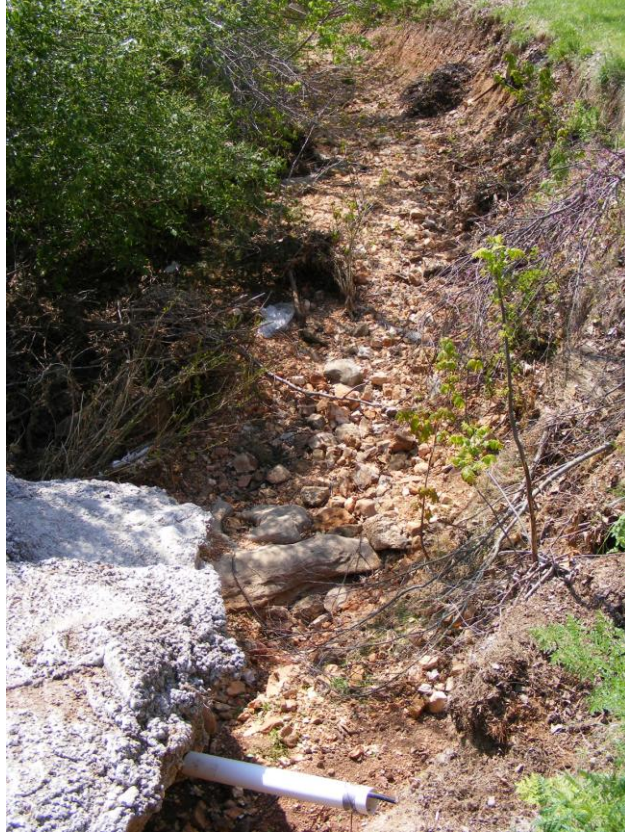
**Picture 29** - Plunge pool (SR #2a+b) (4-29-08)

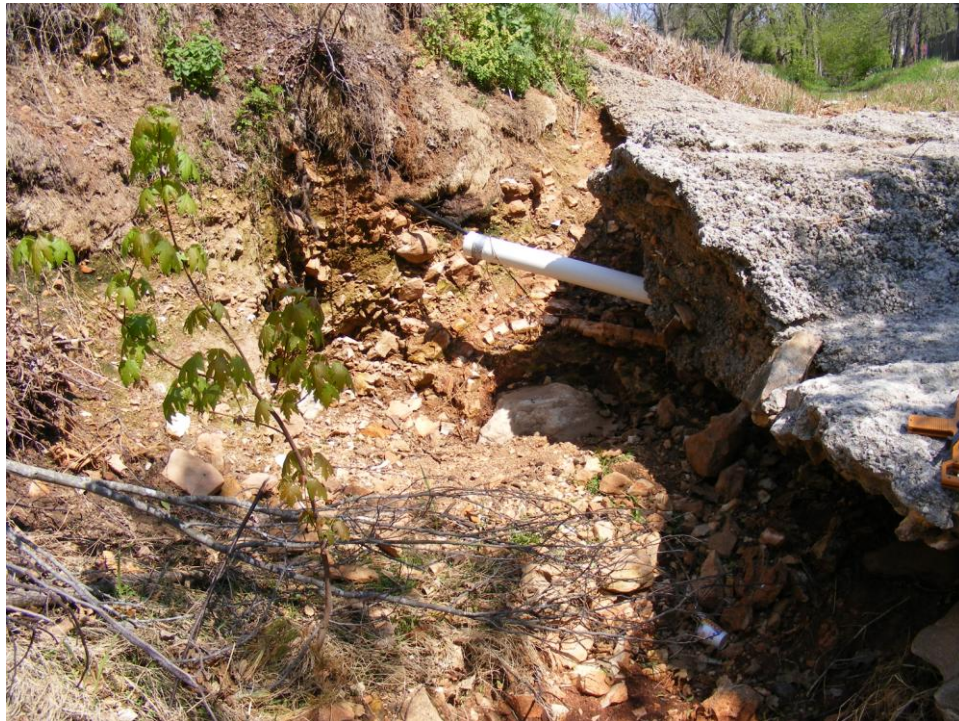
a negative sediment budget. The head cut has stalled at location of the concrete phone line cover and the amount of sediment being introduced to the stream from plunge pool erosion and channel widening may have decreased significantly.

**Picture 30** - Exposed phone line (4-29-08)

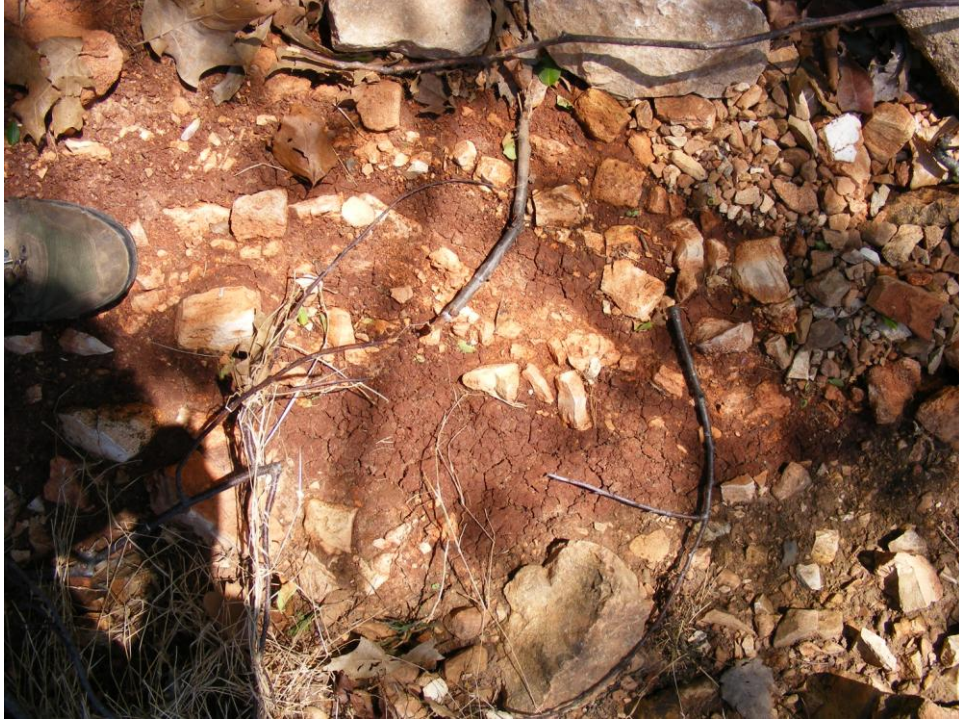
**Picture 31 - Scoured residuum in plunge pool (4-29-08)**
