**Geomorphic Assessment of Ravenwood Creek
Lake Springfield Park, Springfield, Missouri**

**Final report to Olsson Associates for
the City of Springfield, Missouri**

May 2, 2008

OEWRI TR-08-001

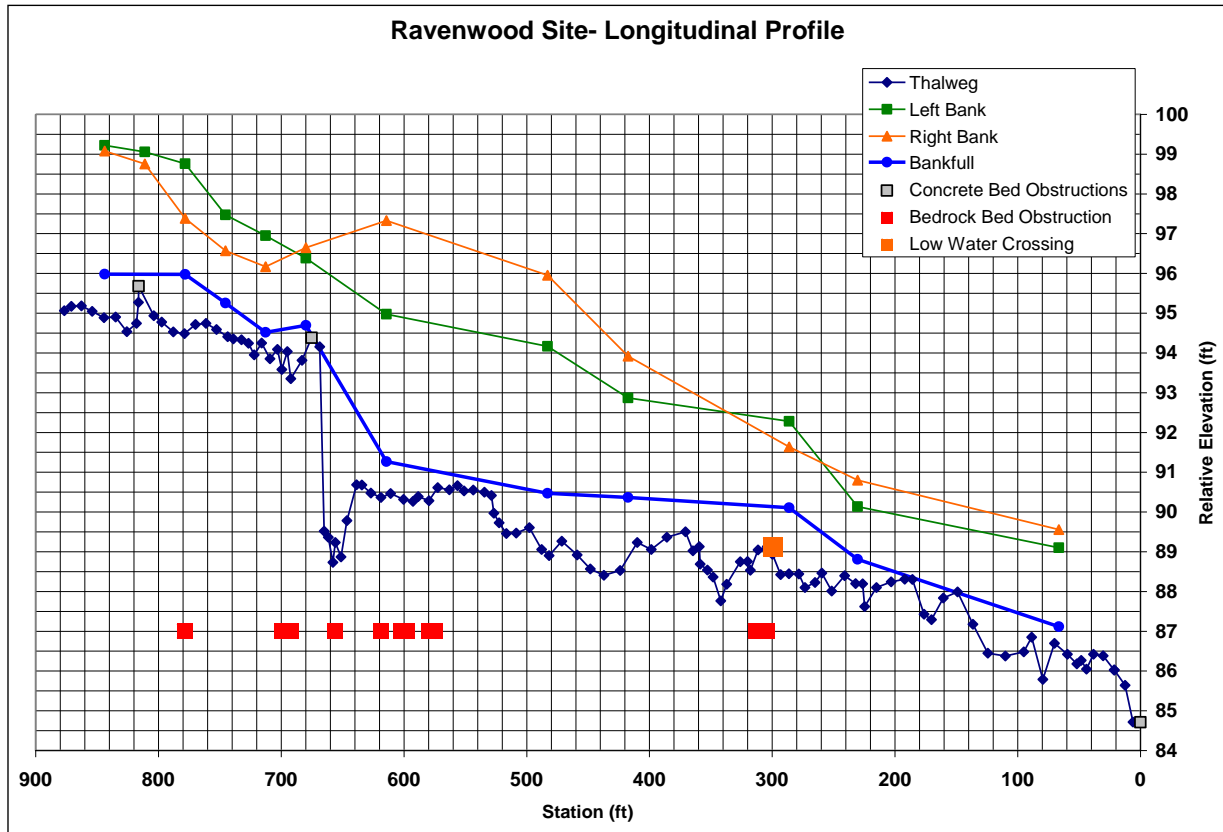
Figure 3: Longitudinal Profile

The profile of the channel thalweg shows that slope varies downstream according to the degree of channel incision and substrate condition from 0.002 to 0.013 ft/ft (Figure 3). The upstream grassed channel has a slope of 0.009 taken from the tops of the concrete utility covers that cross the channel bed. The channel cross-section also varies within the project channel south of the park boundary from 9 ft to 18 ft in bankfull width, 20 ft to 30 ft in top bank width, and 6ft² to 11 ft² in bankfull area (Table 2, Figure 4). The grassed channel has an average bankfull width of 10 ft and area of 5 ft². A classical model of knick point migration and head cut form can be used to interpret the dominant geomorphic processes controlling the form and instability of this reach (Schumm et al. 1987) (Figure 5). Based on this model and other field observations, a sub-reach classification of the project channel follows below.

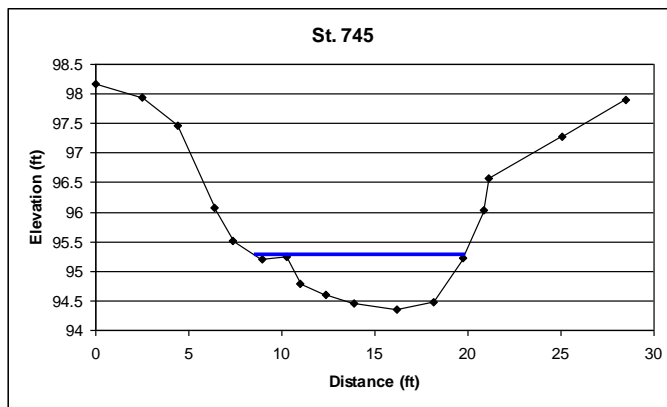
Figure 4a: Cross-section in Subreach #1.

Sub-reach #1 occurs between stations 878 ft to 667 ft and directly drains the residential community in a grass-lined channel (Figure 4a and Picture 1). The upper bank angle along this reach is relatively low ranging from 30 to 40 degrees and top bank width averages about 18 ft. The top bank surface is 3 to 5 ft above the channel bed or about 3x the bankfull stage. Channel slope ranges from 0.0068 along the channel bed to 0.0106 between the crests of the two concrete utility covers. The bed is stable and has been scoured or graded to bedrock in several places. Typical bankfull channel dimensions are 10 ft in width, 0.6 feet in mean depth, and 6ft² in area (Table 2). This reach is analogous to the zone of the “oversteepened reach” below the “precursor knickpoint” (Figure 5). However, erosional affects are attenuated by the protection of the two concrete utility covers in this reach. In Spring 2008 after several >20 year storms had hit the

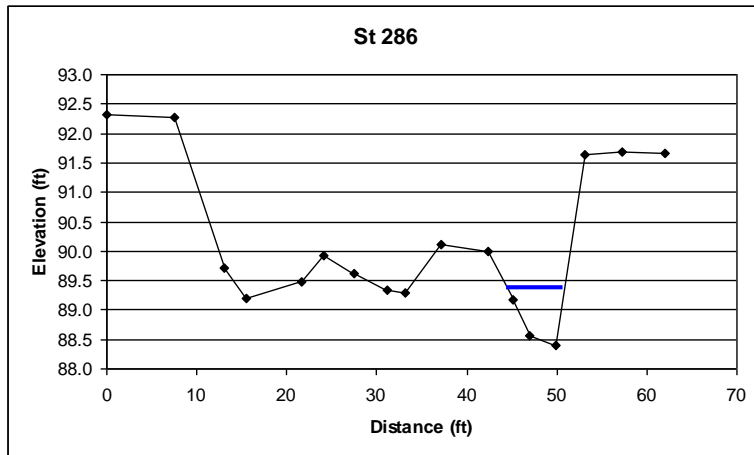
Figure 4c: Cross-section in Subreach #4a.

Sub-reach #4A extends from 369 ft to 92 ft. Here the channel is relatively wide with low banks (Figure 4c). Top bank width is 25 ft and bankfull width is 8 ft. The top bank height is only 2 to 3 ft or 2+ times the bankfull height. The planform of the channel changes to a split or double thalweg habit in this reach. One channel thread tends to be the primary thalweg (on the right side) while the other appears to be a secondary chute channel (left side). Deposition of sediment into a mid-channel bar form or bench occurs between these channels. **Sub-reach #4B** occurs from 92 ft to 19 ft. The channel is still double-threaded but the primary channel thread switches from the right to left side of the channel. The channel narrows in this sub-reach to a top channel width of 21 ft and a bankfull width of 4 ft (Figure 4b). Top bank height is about 3 to 4 ft from the bed of channel or about 3x the bankfull stage. The bed elevation and slope of sub-reach #4B may reflect that of the pre-incision channel and bed slope increases to 0.0125 slightly below station 144 ft. Eight riffles were identified between stations 369 ft and 40ft for an average riffle crest spacing of 41 ft.

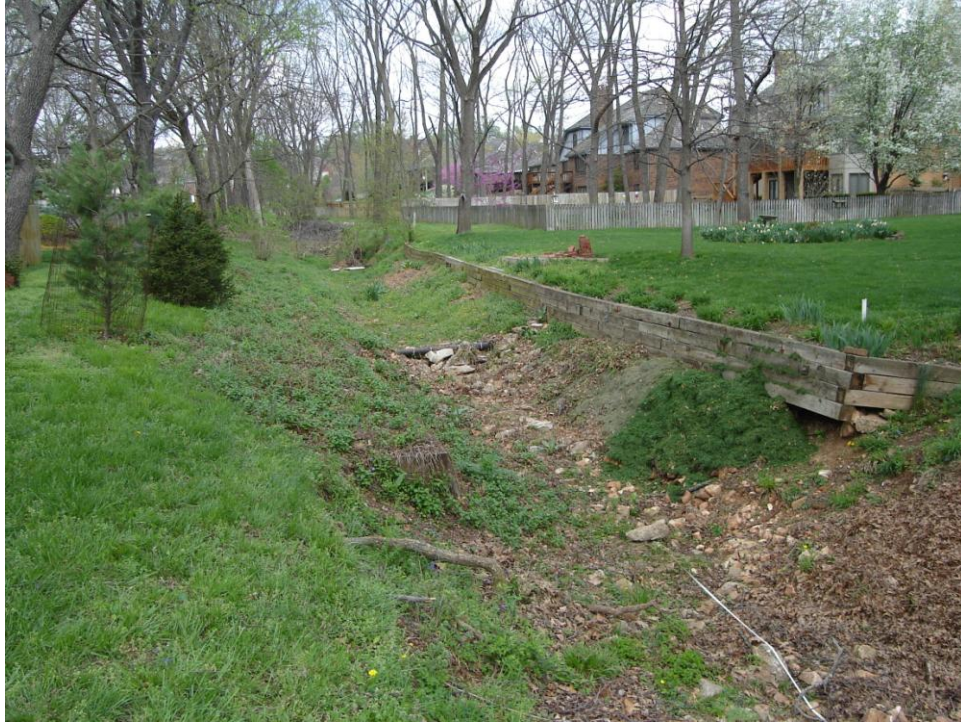
Picture 1 – Looking upstream at 800ft (sub-reach #1)

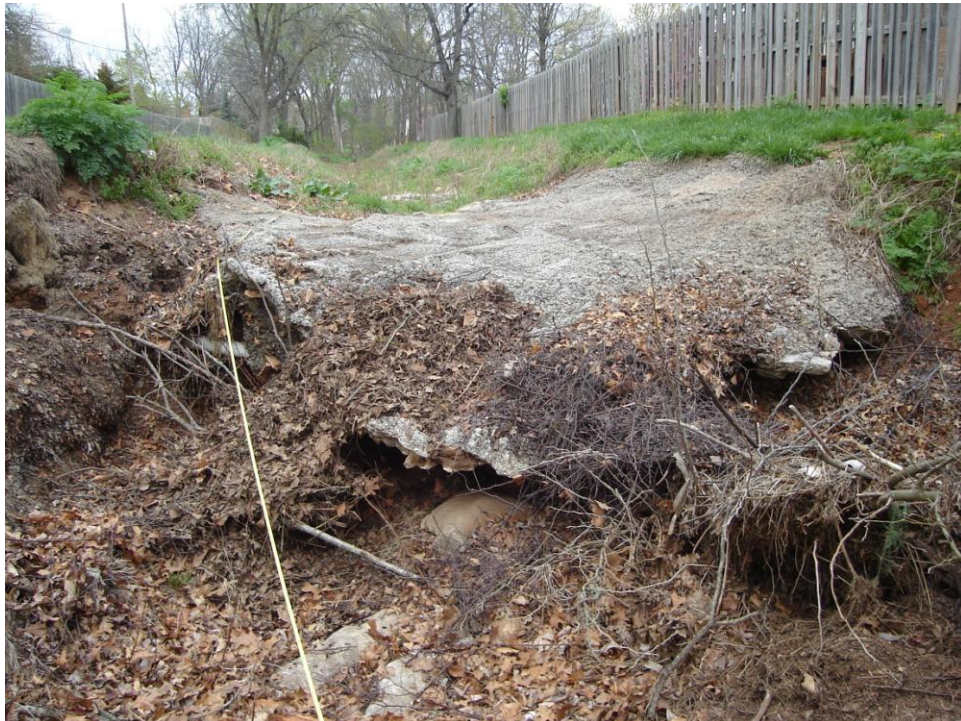
Sub-reach #2 extends downstream from stations 667 ft to 530 ft and represents a recently active portion of a headward incising channel or “headcut.” However, upstream migration of the head cut has presently stalled due to inadvertent bed protection by the concrete cover (Figure 5 and Picture 2; note exposed PVC pipe under apron to the left side of the picture). This is a zone of local channel disequilibrium where the bed form is flat or uneven and bed slope approaches zero. There are three zones in sub-reach #2. Sub-reach #2A designates the zone of maximum incision depth immediately below the concrete cover forming a large “plunge pool” between stations 667 ft and 640 ft. Channel bed elevation drops by almost 6 feet over a horizontal distance of a few feet to expose bedrock between 660 ft to 655 ft. Upper bank angles range from 60 to 90 degrees and top bank width is 27 ft across the plunge pool. Top bank height is 9 ft above the bed. Bankfull stage indicators were not identified in this sub-reach. The underground pipe and phone line was almost completed undermined in April 2008 and should be checked by authorities as soon as possible.

Picture 2 – Concrete bed obstruction/headcut at 670ft (looking upstream)

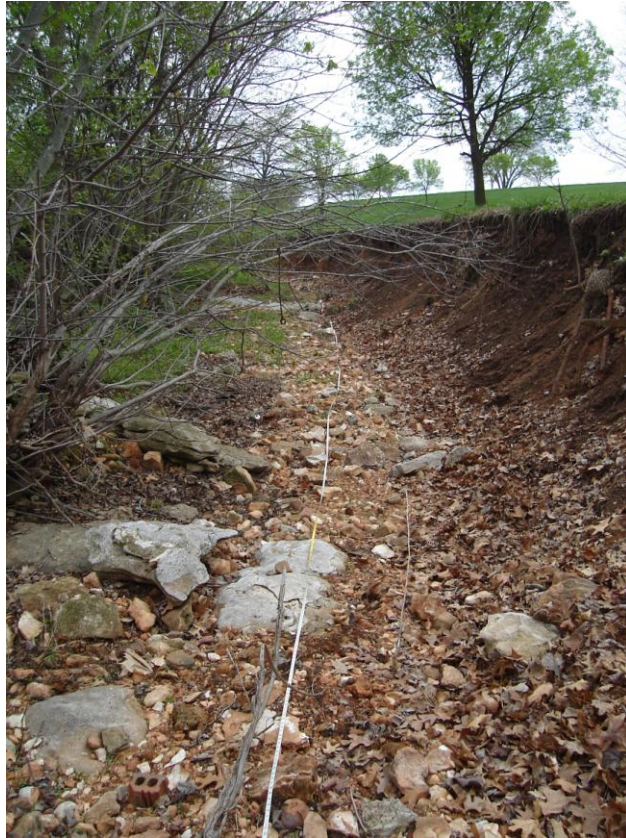
Sub-reach #2B is a zone of scour and sediment transport extending below the core zone of the plunge pool from 640 ft to 575 (Pictures 3 and 4). Bedrock is exposed in some places between patches of gravel sheet deposits. Upper bank angle averages about 60 to 80 degrees and top bank channel width is 25 ft. Top bank heights rise from 5 to 7 ft above the bed, about 5x bankfull stage. Sub-reach #2C is a zone of deposition between stations 575 ft and 530 ft where the erosional energy of the plunge pool has dissipated (Picture #5). The rate of bed load delivery into the project reach from upstream sources is probably relatively low compared to the amount of gravel and cobble released by bed and bank erosion in the plunge pool zone or from channel widening in sub-reaches 2A and 2B. Channel width and depth trends are similar to sub-reach #2B. There are two locations where historical farm artifacts are buried by about 3 ft of alluvial and presently exposed in eroding banks on the right side of the channel. A wagon bed and frame (not really sure, but my best guess) is located at 615 ft and the iron band from around an old wagon wheel is found at 565 ft. These artifacts are presently (April 2008) being unearthed by lateral bank erosion with several pieces already on the channel bed available for transport.

Picture 3 – Bedrock exposure and bank artifacts on the right side at 600ft (sub-reach #1)

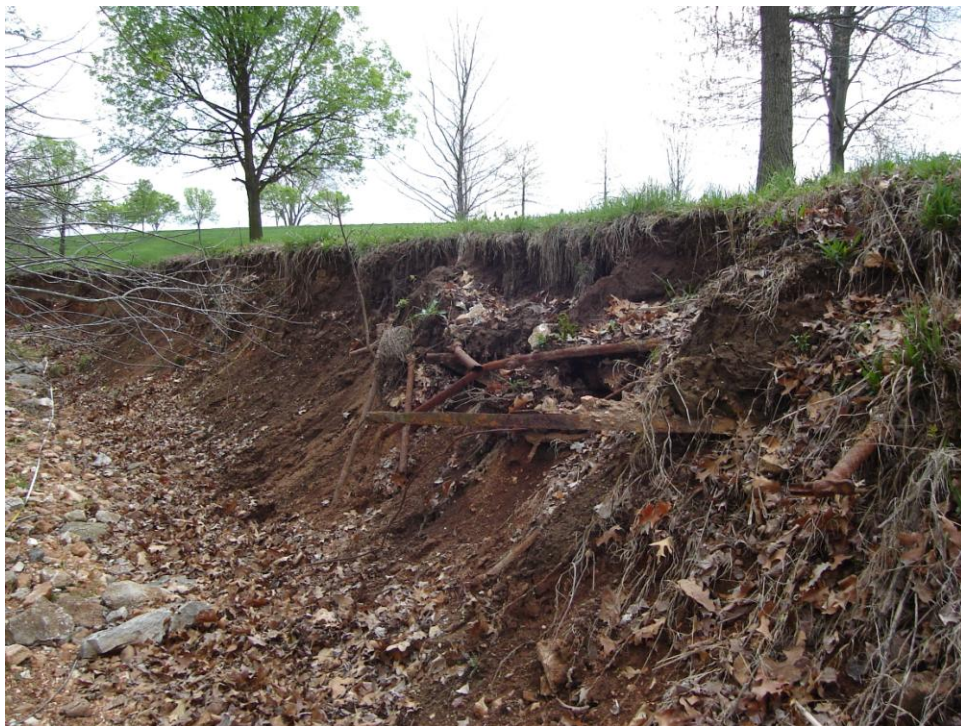
Picture 4 – Historical wagon(?) artifacts buried in alluvium at 615ft.

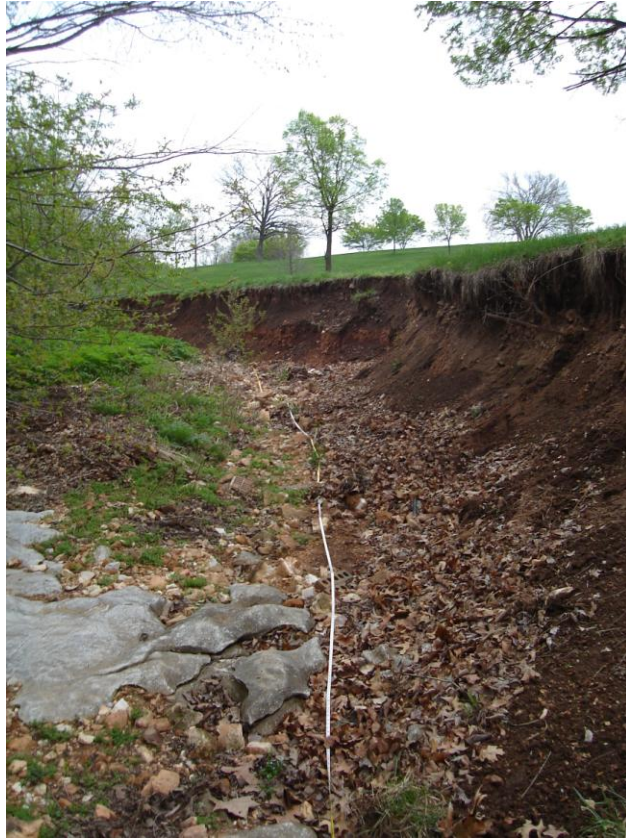
Picture 5 – Bedrock exposure at 550ft (sub-reach 2b-c)

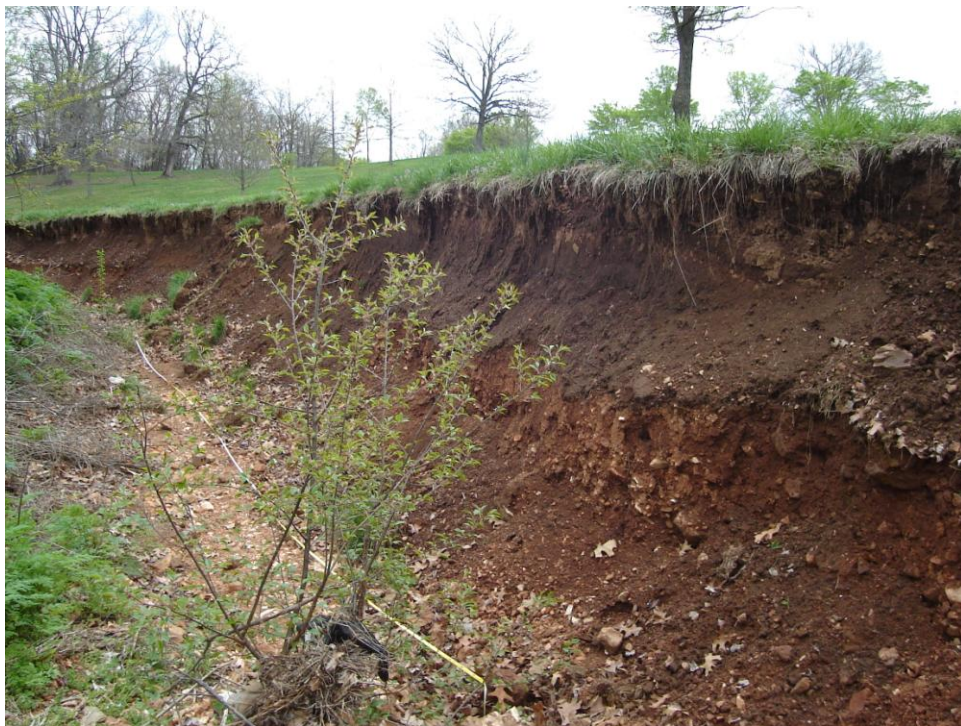
Sub-reach #3 extends from 530 ft to 369 feet (Pictures 6 to 8). Channel slope in this reach averages about 0.0063. This is a reach where there is a relatively long bend to the left or north by the channel and a long lateral pool trough has formed along the cut bank as expected between stations 520 ft to 410 ft. There are also several smaller-scale erosional steps at stations 500 ft to 470 ft within the longer pool form (Figure 3). Thus, this reach may reflect the composite influence of both meander pool and secondary knickpoint formation (Figure 5). The top bank width of the channel reaches 30+ ft and bankfull width ranges from 13 ft to 18 ft (Figure 4b). Top bank height ranges from 4 to 7 ft, about 3 to 5 times the bankfull stage. Five riffles, including smaller steps, occur in this sub-reach with an average riffle crest spacing of 40 ft. A poorly developed point bar and incipient floodplain has formed on the inside of the bend with exposed and almost vertical upper banks occurring on the outside bend.

Picture 6 – Eroding bank along long bend at 500ft (sub-reach #3)

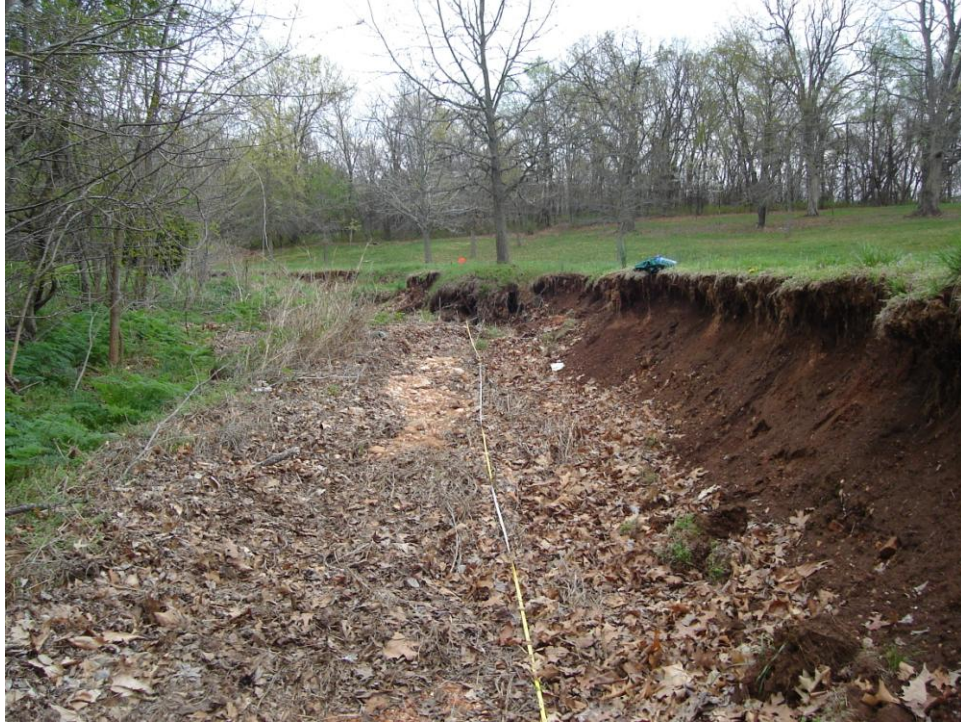
Picture 7 – Point bar on left (under leaves) at 450ft (lower end of sub-reach #3)

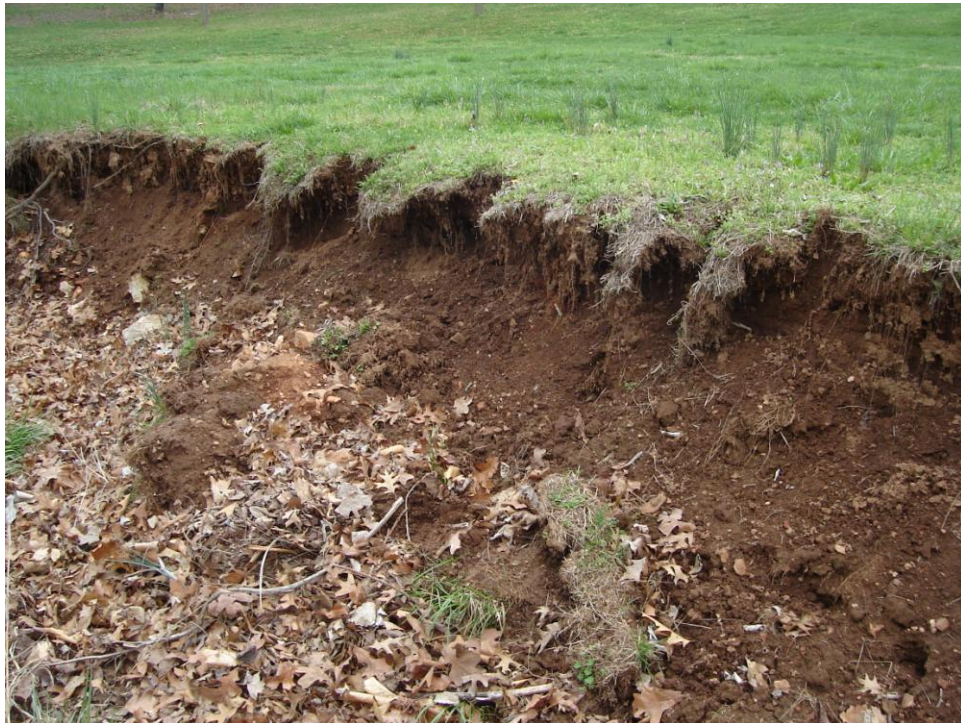
Picture 8 – Eroding bank at 400ft (sub-reach #3)

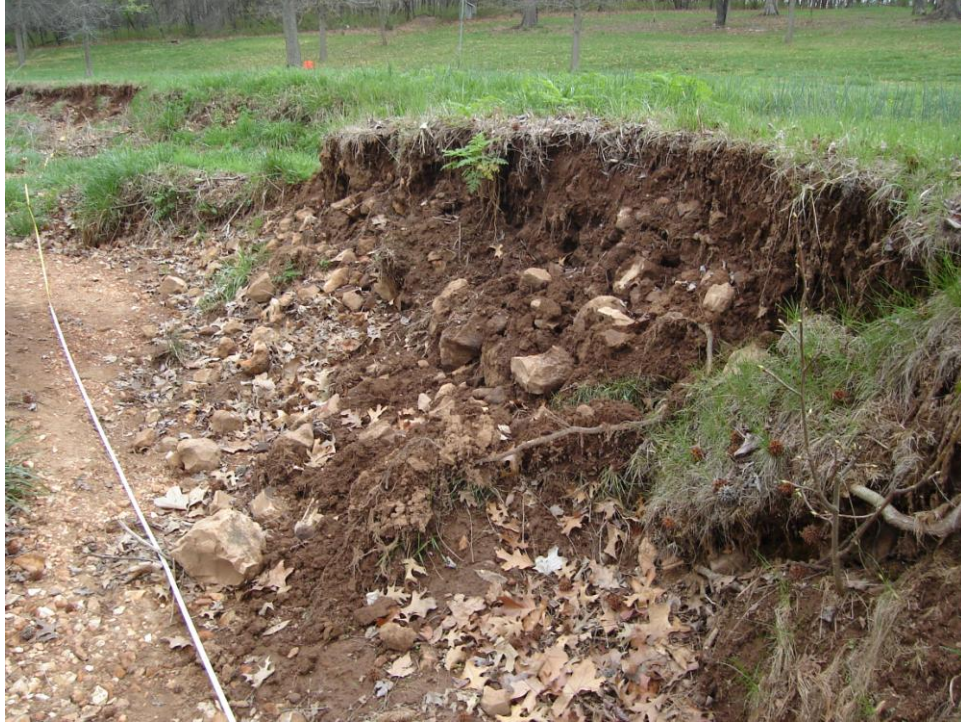
Picture 9 – Slumping, failing bank just above stream crossing at ~320ft (Sub-reach #4)
Notice: Maybe old channel bed deposits collapsing into the present channel.

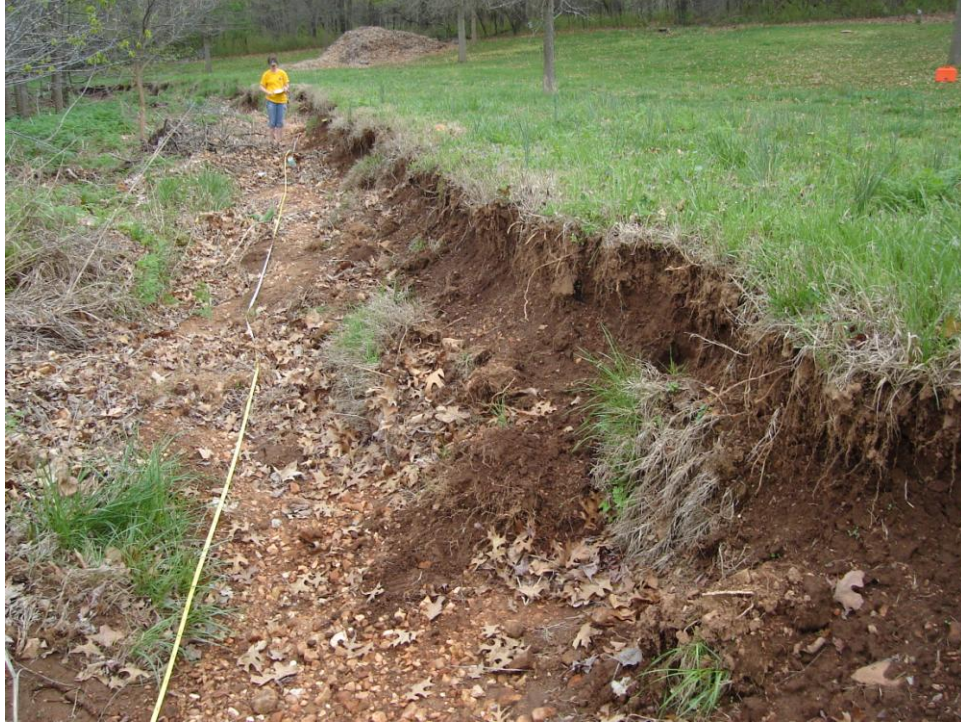
Picture 11 – Lower channel banks at 300ft (sub-reach #4)

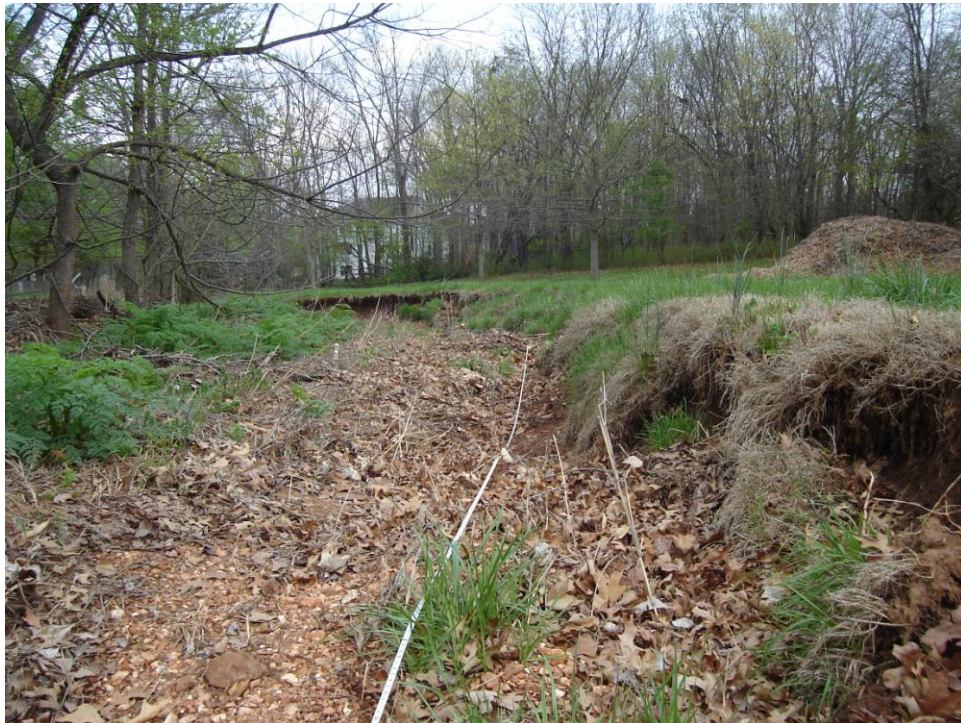
Picture 12 – Wide and shallow channel with “double thalweg” at 200ft (sub-reach #4)

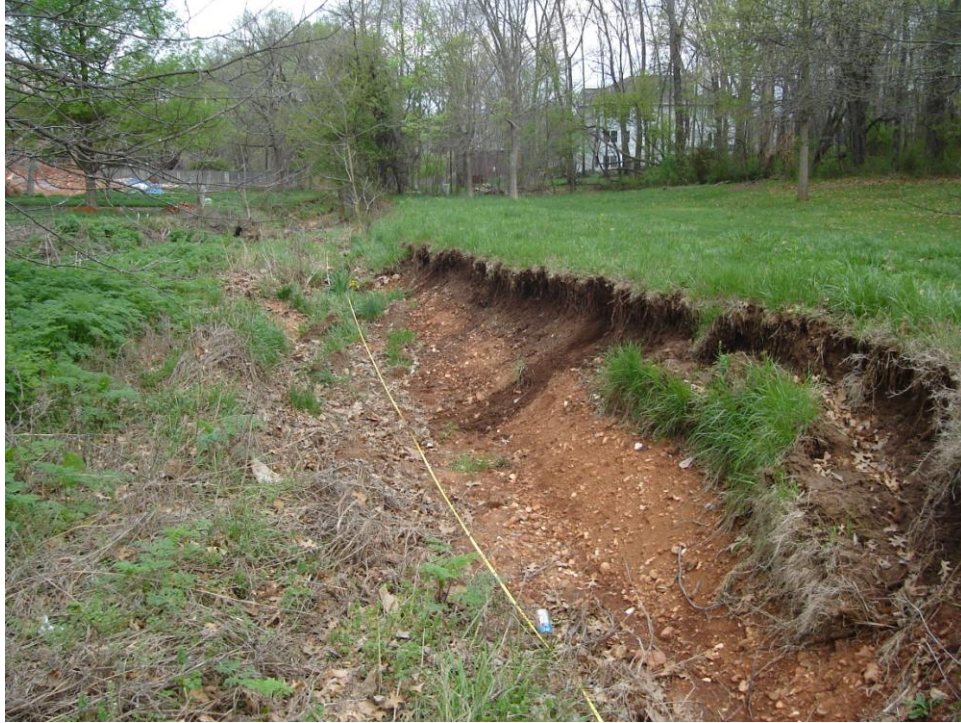
Picture 13 – Lower on of “double thalweg” at 100ft (sub-reach #4b)

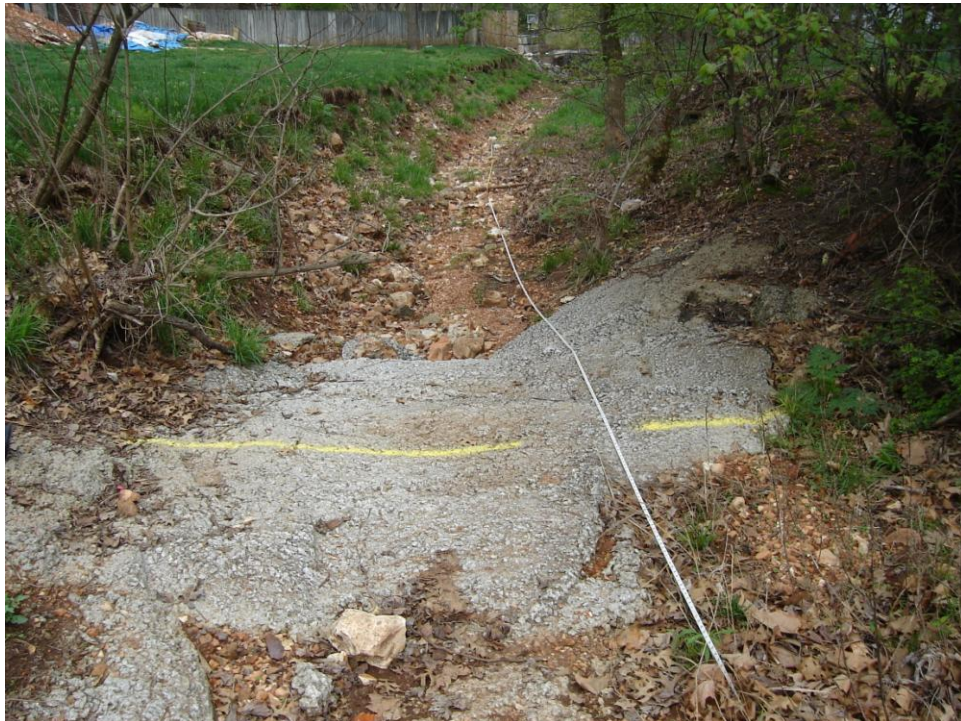
Sub-reach #5 occurs between stations 19 ft and zero ft. The form of this reach is largely controlled by the large concrete apron at station zero where the stream flows off park property (Picture 14).

Picture 14 – Concrete bed obstruction marking end of study reach at 0ft

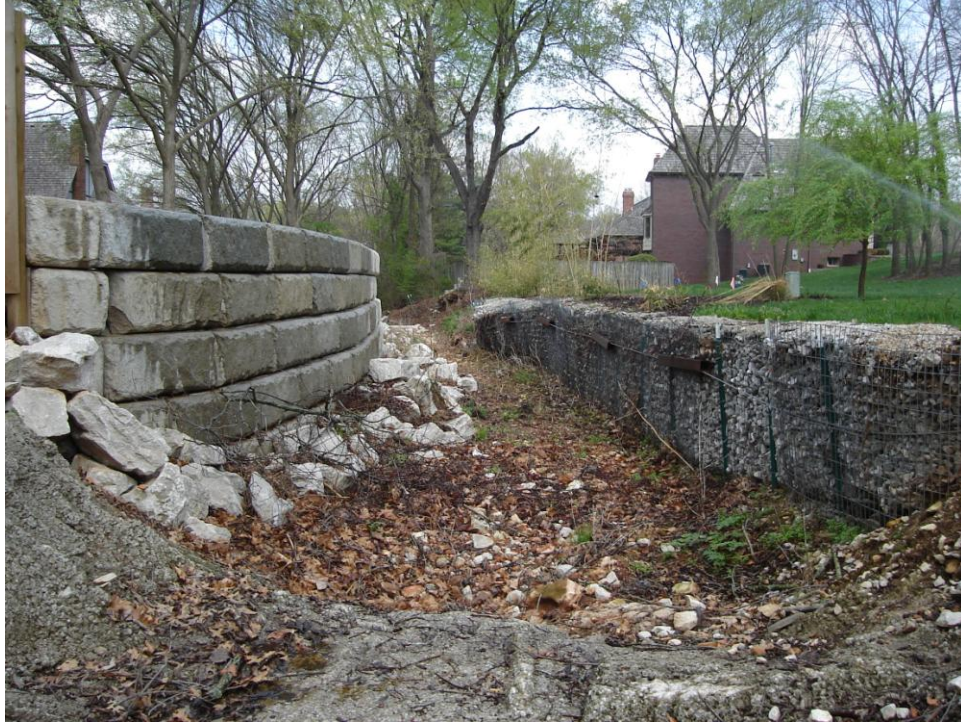
Sub-reach #6 occurs from zero to -140 ft (notice negative sign indicating that this sub-reach is downstream of station zero) (Picture 15). This reach is not on park property but was visually evaluated for geomorphic stability. Upper banks are steep and top bank heights are about 4 to 5 ft off the bed, or about 2 to 3x bankfull stage height. Top bank width is 17 ft and active bank width is about 4 ft. Fill from residences infringe on the channel area on both sides in some places. A 12” white PVC line is exposed on the channel bed at station -108 ft. On April 29, 2008, construction of a new channel with stone bed and banks was in progress at the end of sub-reach #6.

Picture 15 – Engineered channel -140ft downstream of 0ft on survey (end of sub-reach #6)

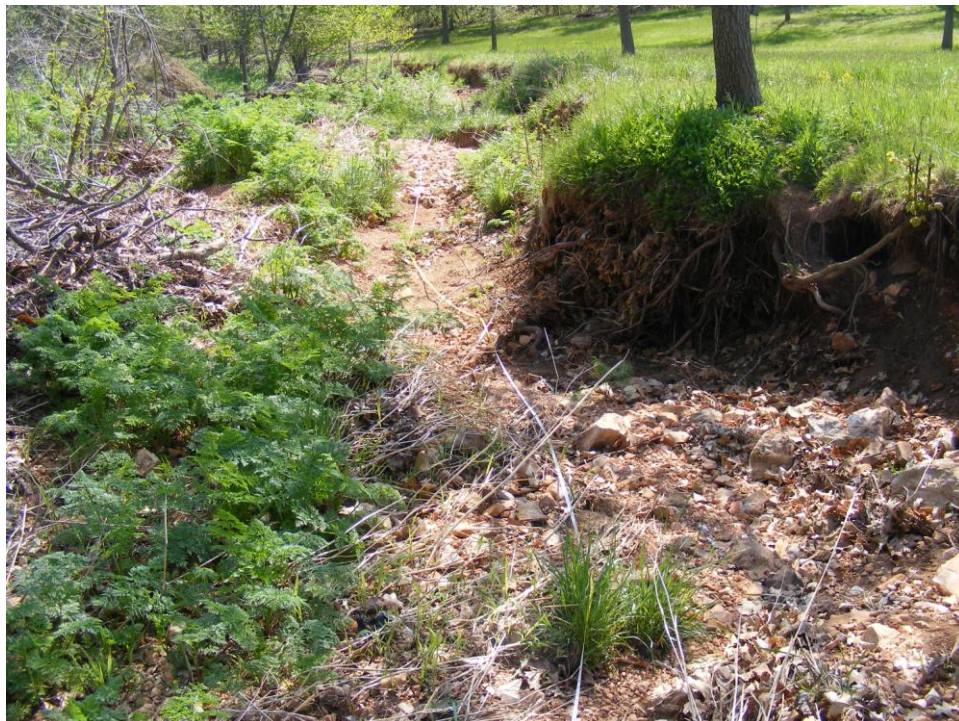
Picture 24 - Scour pool around a tree root at 310 to 340 ft (4-29-08)

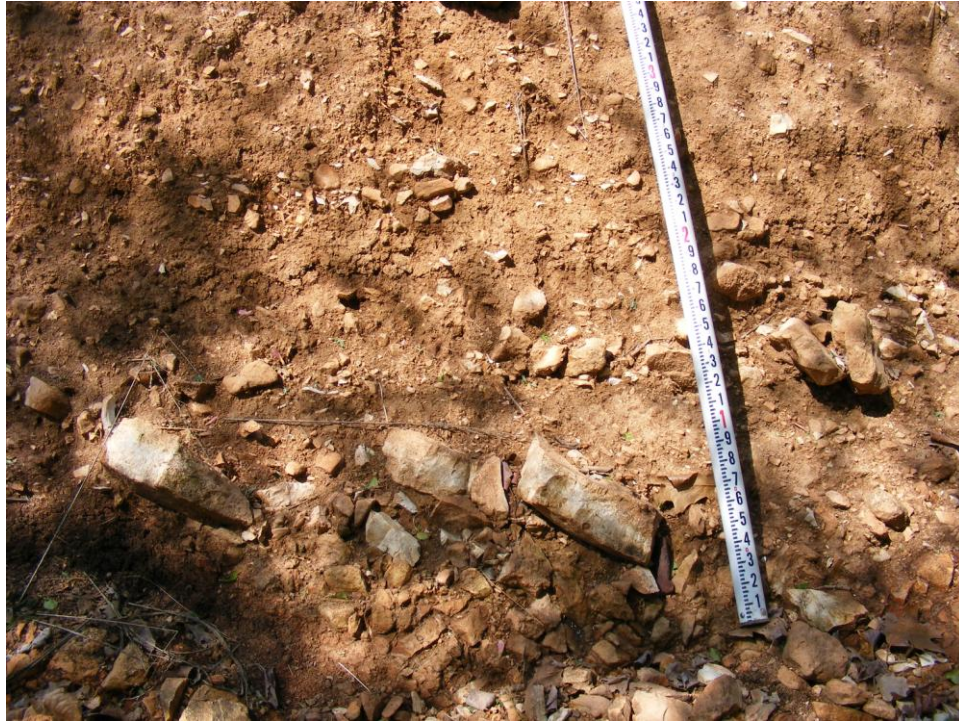
the base of the right bank at around the 600 ft point at the same elevation of the present degraded bed. These paleo-channel bed lag deposits suggest that significant channel incision occurred at this location prior to 1800 due to climate change or natural sediment supply variations. This is more evidence of the fact that this location is prone to periodic incision and cut-and-fill cycles.

Picture 25 - Imbricated cobbles indicating the elevation of the bed of a pre-settlement paleo-channel (4-29-08)

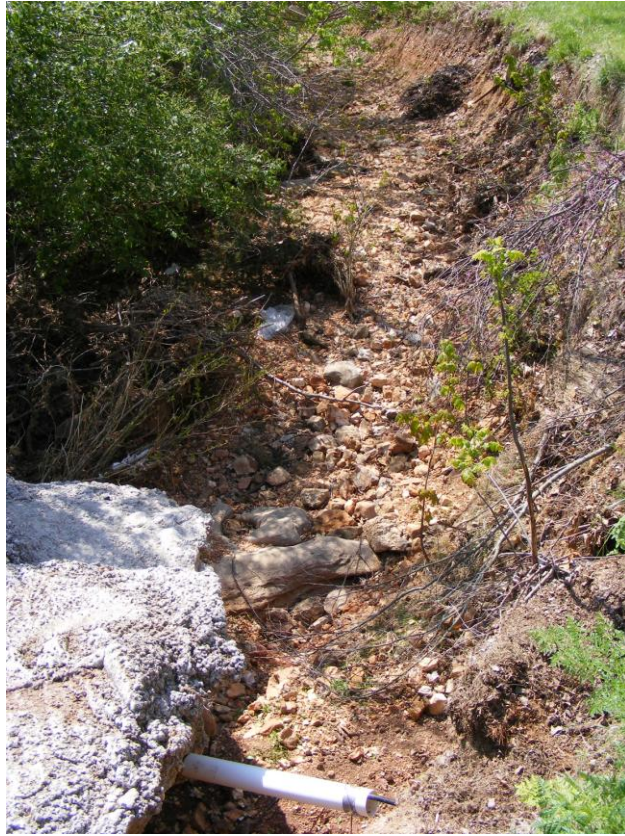
Picture 29 - Plunge pool (SR #2a+b) (4-29-08)

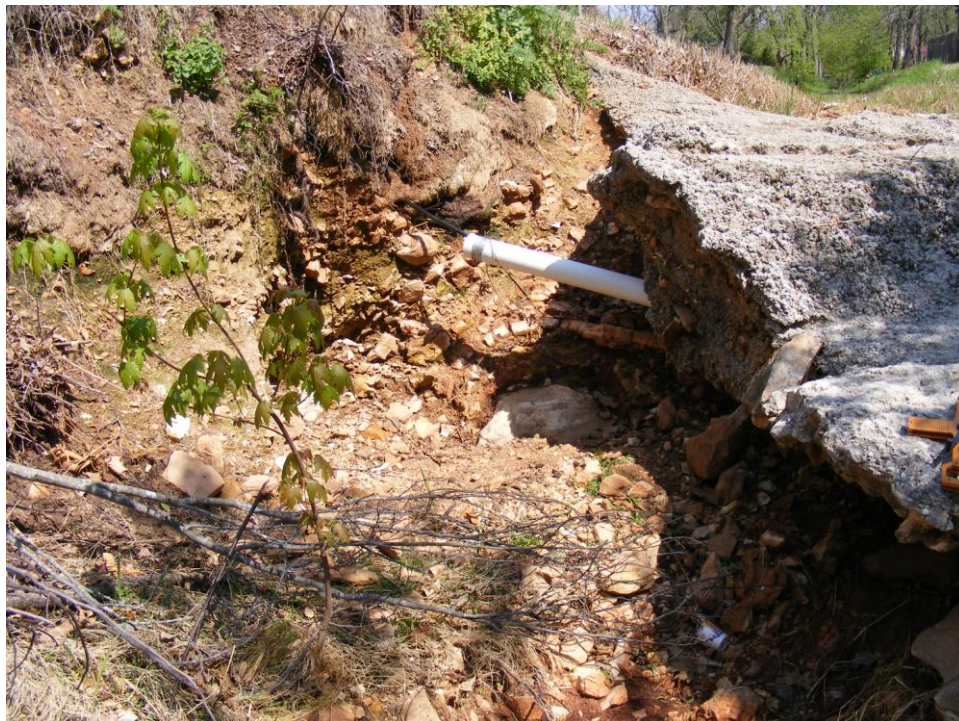
a negative sediment budget. The head cut has stalled at location of the concrete phone line cover and the amount of sediment being introduced to the stream from plunge pool erosion and channel widening may have decreased significantly.

Picture 30 - Exposed phone line (4-29-08)

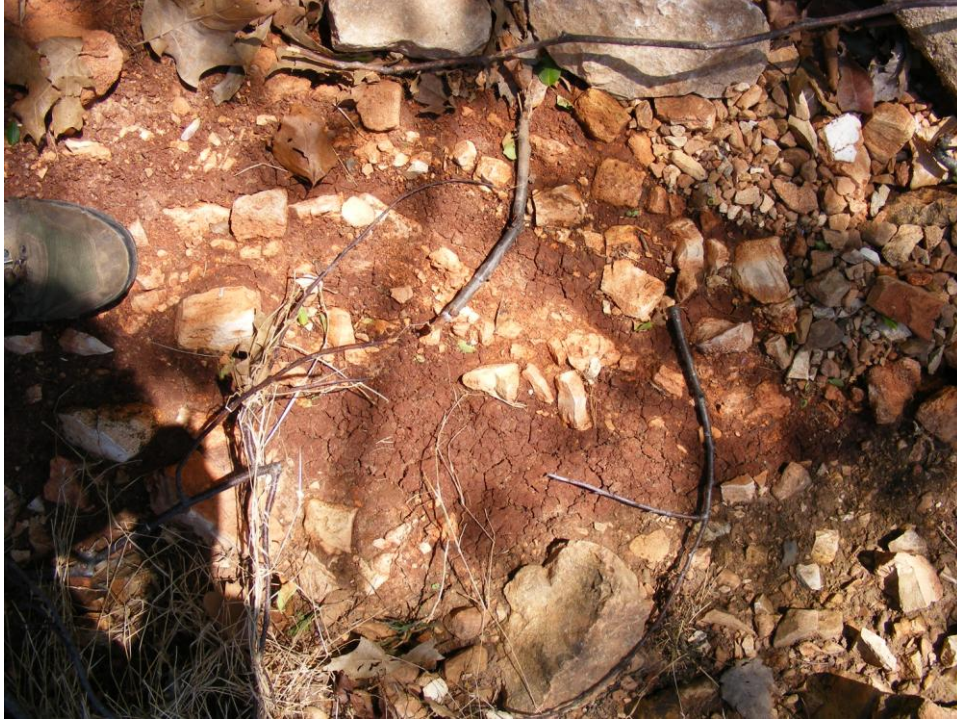
Picture 31 - Scoured residuum in plunge pool (4-29-08)
