Geomorphic Assessment of the South Dry Sac River below Valley Water Mill

By: Robert T. Pavlowsky, Ph.D.
Ozarks Environmental and Water Resources Institute
Missouri State University

Submitted to the Watershed Committee of the Ozarks on March 15, 2006

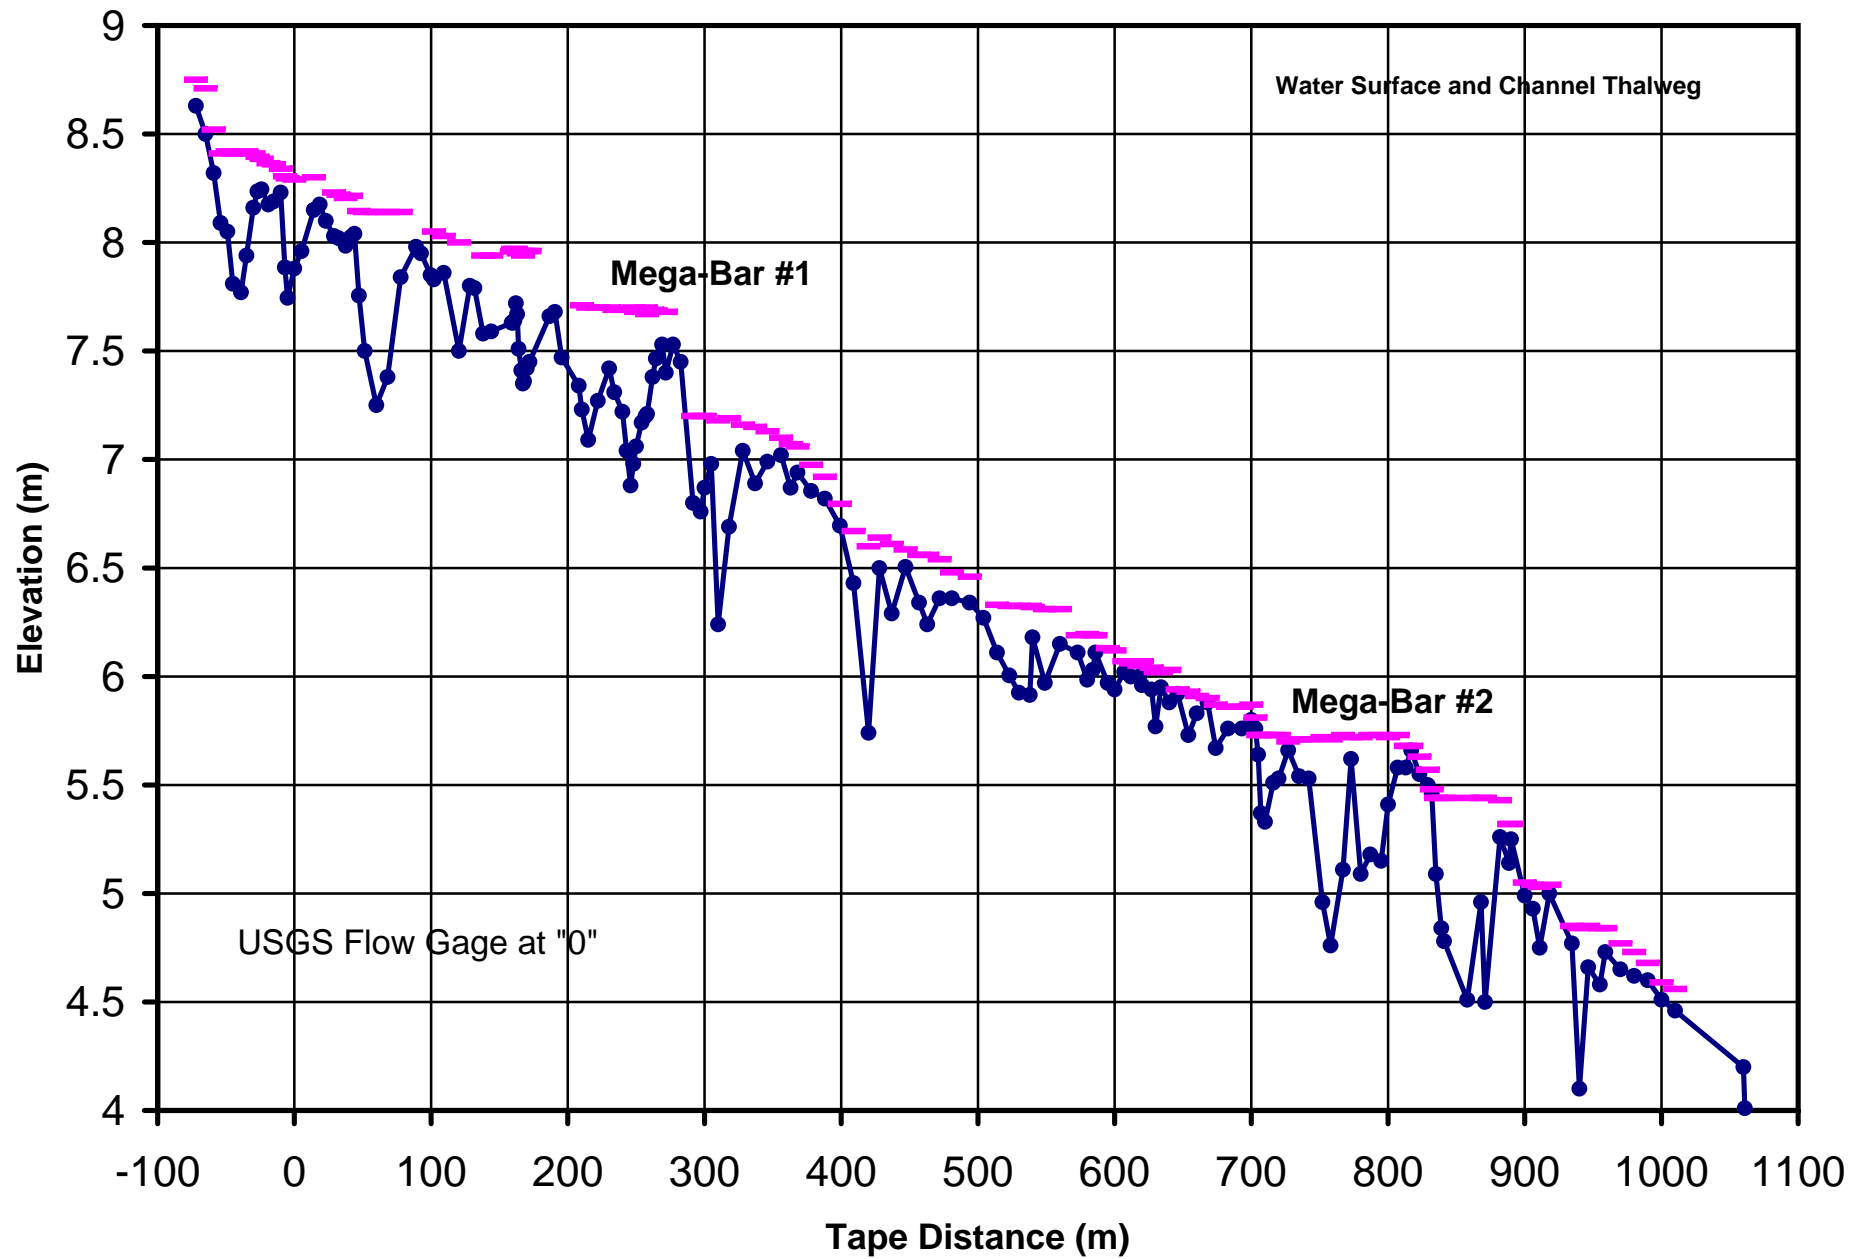
Figure 1: Longitudinal Survey

The longitudinal profile of the stream tends to step down over short distances at 200 to 400 meter intervals indicating the effects of bedrock control (Figure 1). Bank heights and longitudinal slopes are fairly consistent among the four geomorphic surfaces evaluated in this study: low terrace, bankfull, riffle crest, and deepest pool point (Figure 2). However, riffle crest slope does vary by sub-reach with zones of very high and very low channel slopes occurring within the study area (Figure 3). Lower slopes tend to occur upstream of mega-bars or in “step” zones between relatively steep reaches. The highest slopes are found downstream of mega-bars (Figure 1).

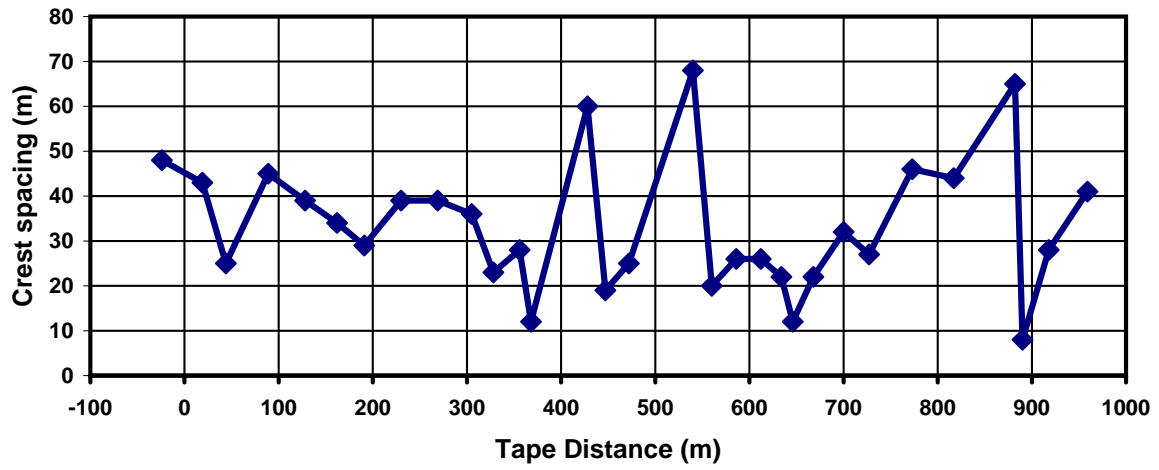
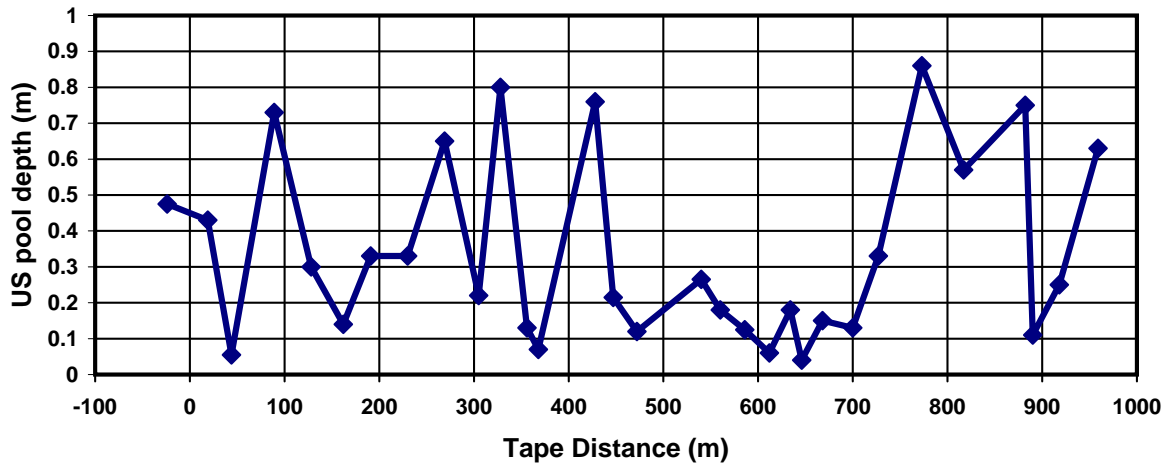
Figure 4: Riffle Spacing and Pool Depth

The bedform profile in the study area usually is composed of riffle crests, riffle/runs, and pools. The average riffle crest-crest spacing in the study area is 33 m +or- 15 m and residual pool depths (at the deepest point relative to the downstream riffle crest) average 0.33 m +or- 0.26 m (Table 1). Longer riffle spacing is found between TD 400 and 550 meters and TD 800 and 900 meters (Figure 4b, Map 3). The deepest pools are found in sub-reaches extending from TM 50 to 280 meters and TM 700 to 880 meters with some other large pools around TD 300 and TD 400 meters (Figure 4, Map 3). A relatively long reach of very shallow pools is found between TD 480 to 700 meters where the channel flows up against a bluff (Figure 4a).

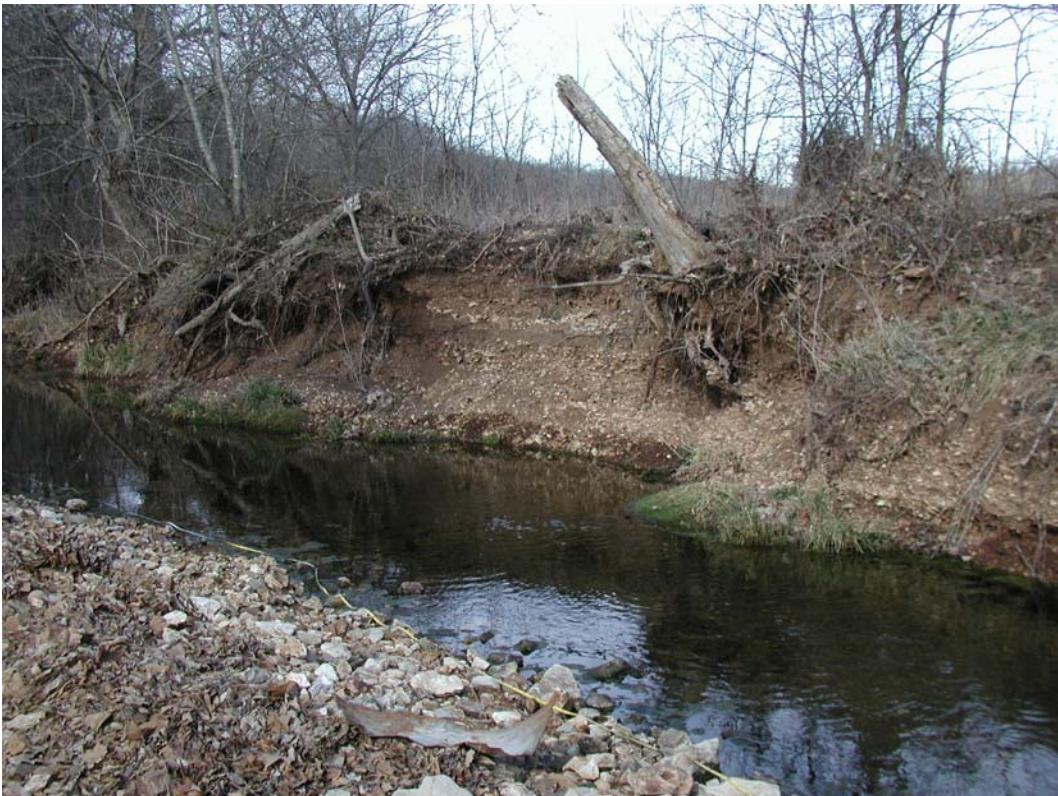
Bank stability was assessed visually by observing upper bank angle, bank height, vegetation cover, and evidence of erosion such as exposed tree roots or recent bank collapse. As mentioned before, channel location has been relatively stable over time so few severely eroding banks were found in the study area. The banks showing the most consistent extent of erosion are located on the floodplain/terrace features on the right side of the stream in locations where flood flows are forced to converge and increase in erosive force as they enter a bluff-lined reach (Map 4). Additional locations for bank erosion occur at relatively tight bends or any bend along a steep reach. Finally, bank erosion is also noticeable at a slight bend being affected by the Grandview tributary and the depositional bar below it (TD 45 m) (Picture 2).

Picture 2. Cutbank at 50 m

4. **Monitor, and maybe stabilize, the Grandview Tributary Confluence sub-reach from TD 12 m to 60 m.** This area is receiving stormwater and sediment from Grandview Tributary that is affected by urbanization. Restoration activities and stormwater BMP implementation should continue in the watershed to decrease the influence on the South Dry Sac River. Controlling sediment clogging of the channel and stabilizing the right bank may also help reduce the instability of this reach. The instability of this reach could possibly lead to downstream instability that may reactivate or remobilize mega-bar #1. Monitoring activities should extend down to TD 100 m to watch for these downstream progressing effects.

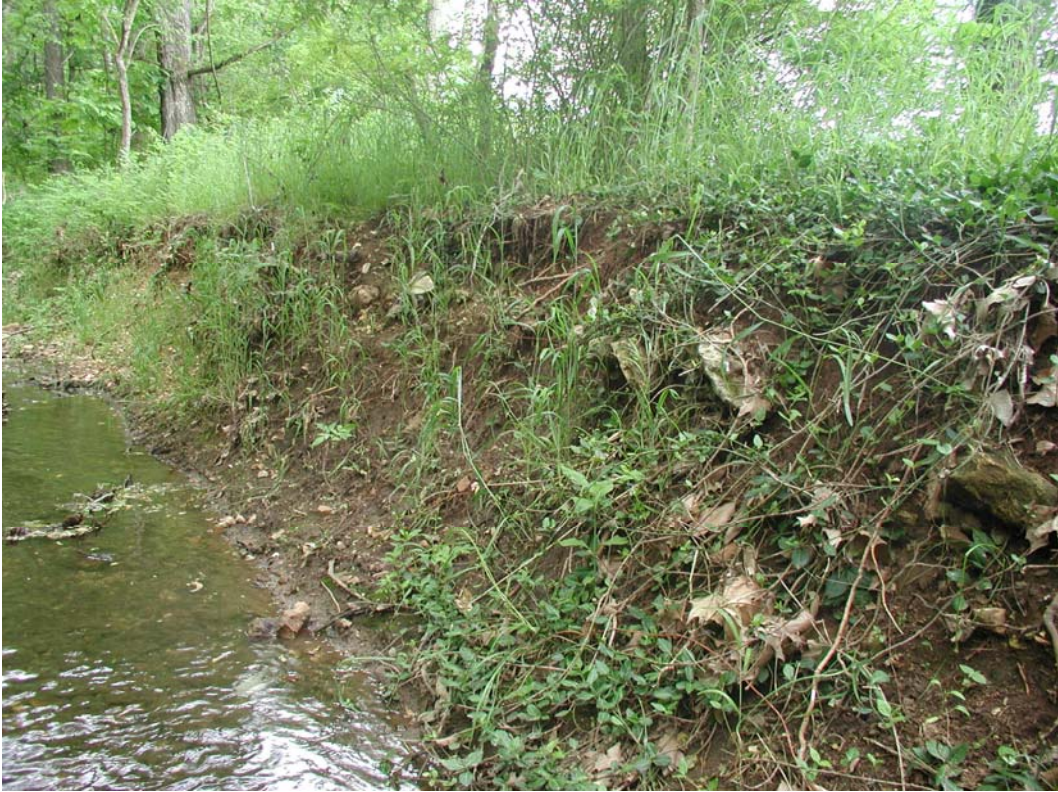
Picture 4. North bank vegetation Spring 2005 (150 m)

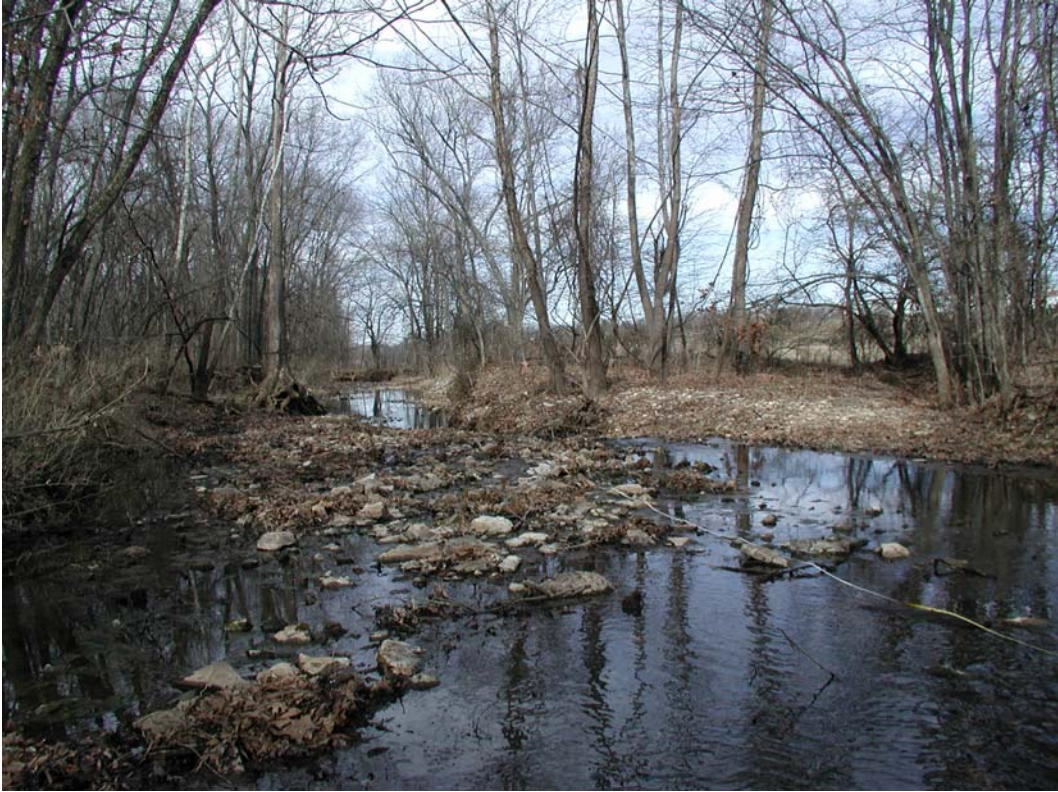
The location of sedimentary bars also indicate areas where present channel conditions are disturbed (i.e. mega bars) or potentially unstable (i.e. middle bars). Mega-bars are found in the study area at TD 260 to 329 meters (Pictures 9-10) and TD 800 to 870 meters (Pictures 21-25) (Map 3, Map 4). These are sub-reaches of major instability and change which form by the excessive deposition of relatively coarse bedload materials in composite bar and riffle forms. Since they effectively clog the channel and force the flow against and out over the banks, evidence for chute channel incision and/or avulsion on flanking floodplains is also found at each of these sites. Both of these disturbance reaches are located at a bend downstream of a relatively long straight reach along the bluff line where there is an ample supply of large clasts from bedrock and colluvium sources.

Picture 9. Riffle at disturbance reach looking downstream (280 m)

1. **Disturbance reach or mega-bar monitoring.** The excessive accumulations of bed sediment in the two disturbance reaches containing mega-bars need to be monitored. In other Ozark streams these features are believed to be formed as a response to past poor land management and the introduction of gravel via soil erosion to the channel system. Unstable conditions such as eroding banks, mid-channel bars, scouring pools, and chute channel erosion are associated with these areas in the study area. There are no simple restoration fixes for these types of areas since they deal more with sediment transport and supply problems at the segment or watershed-scale rather than bed or bank resistance at the sub-reach scale that can be managed on-site.

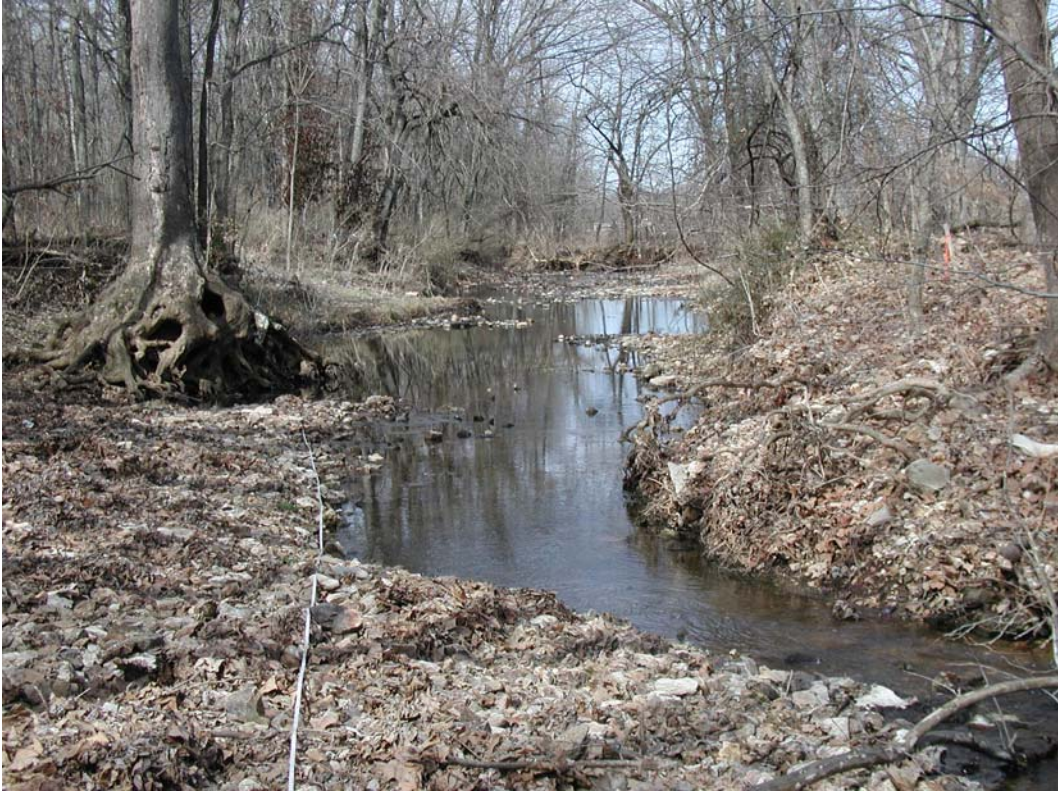
Picture 10. Pool at disturbance reach looking downstream (280 m)

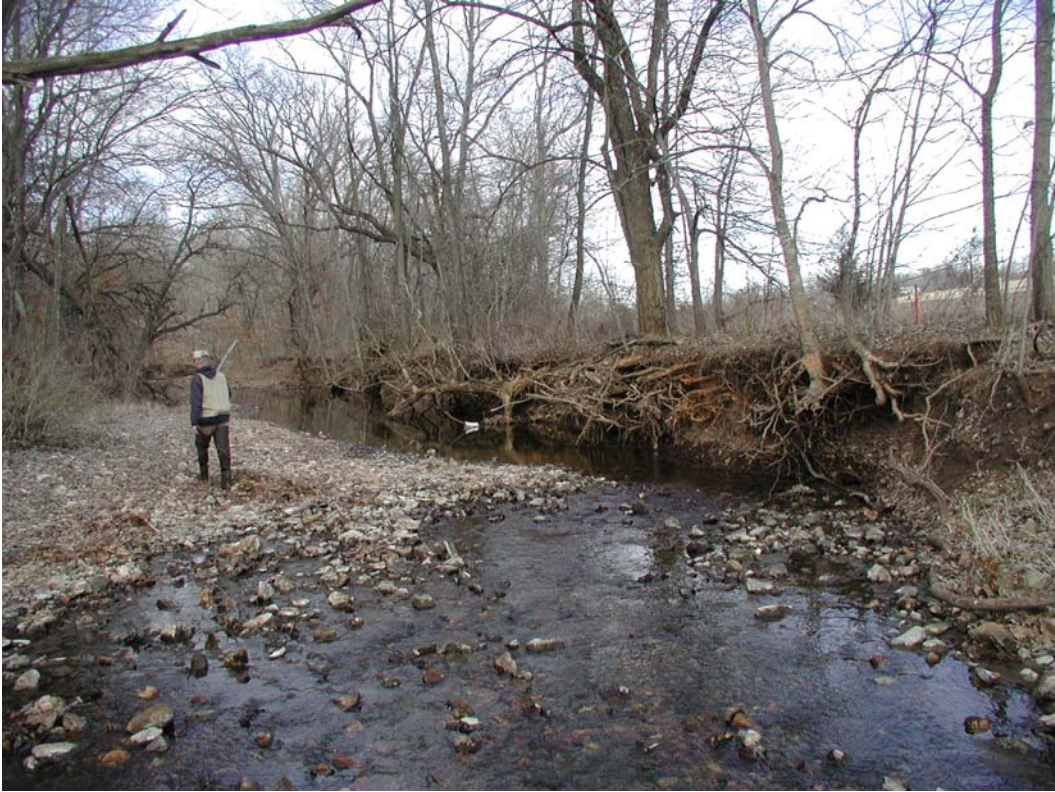
Picture 11. Exposed roots along eroding bank looking downstream (400 m)

- b. The bend at TD 400 m seems to be undergoing a recent episode of erosion where exposed roots have a fresh appearance and mid channel gravel bars are slowly advancing downstream toward it. This reach should be examined for stabilization and restoration action—at the least it needs to be monitored.

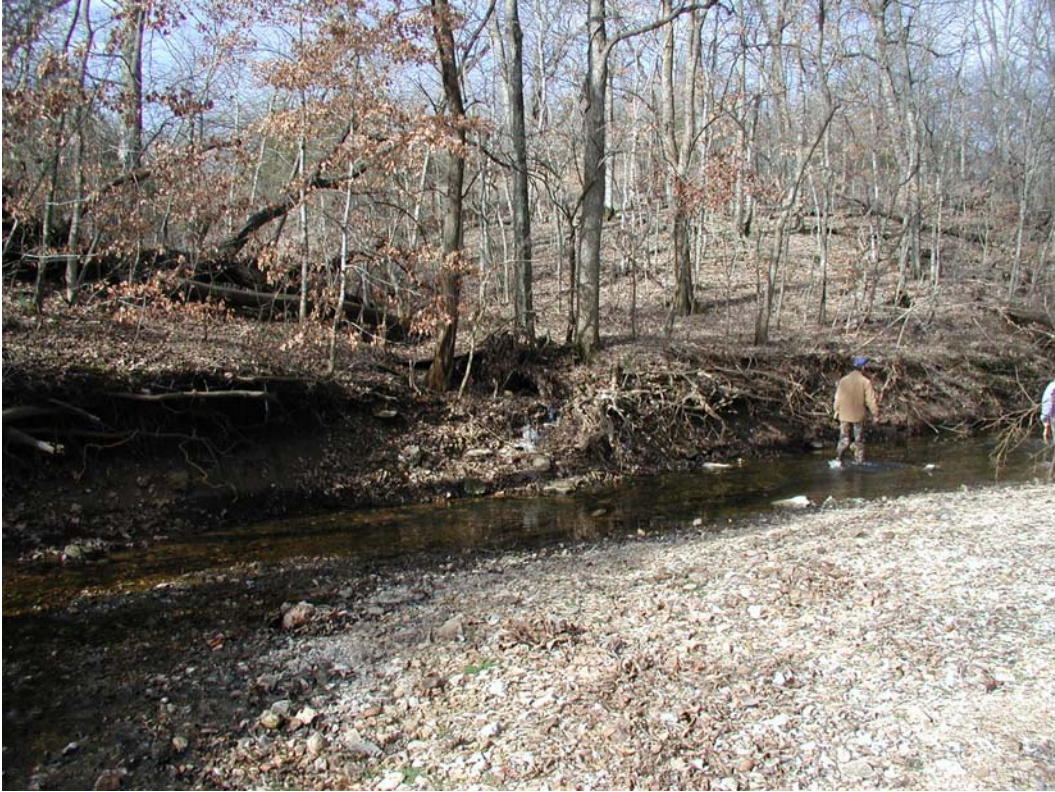
Picture 12. Alluvial fan tributary (south bank) and point bar (500 m)

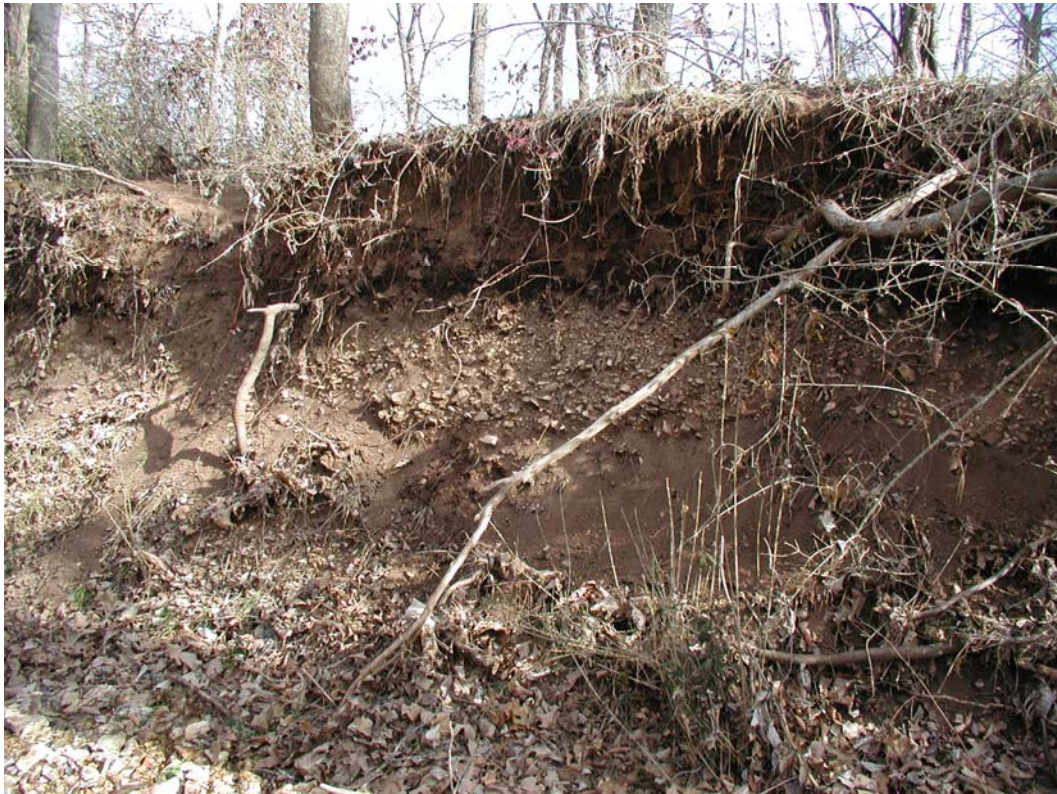
Picture 14. Cutbank at 500 m

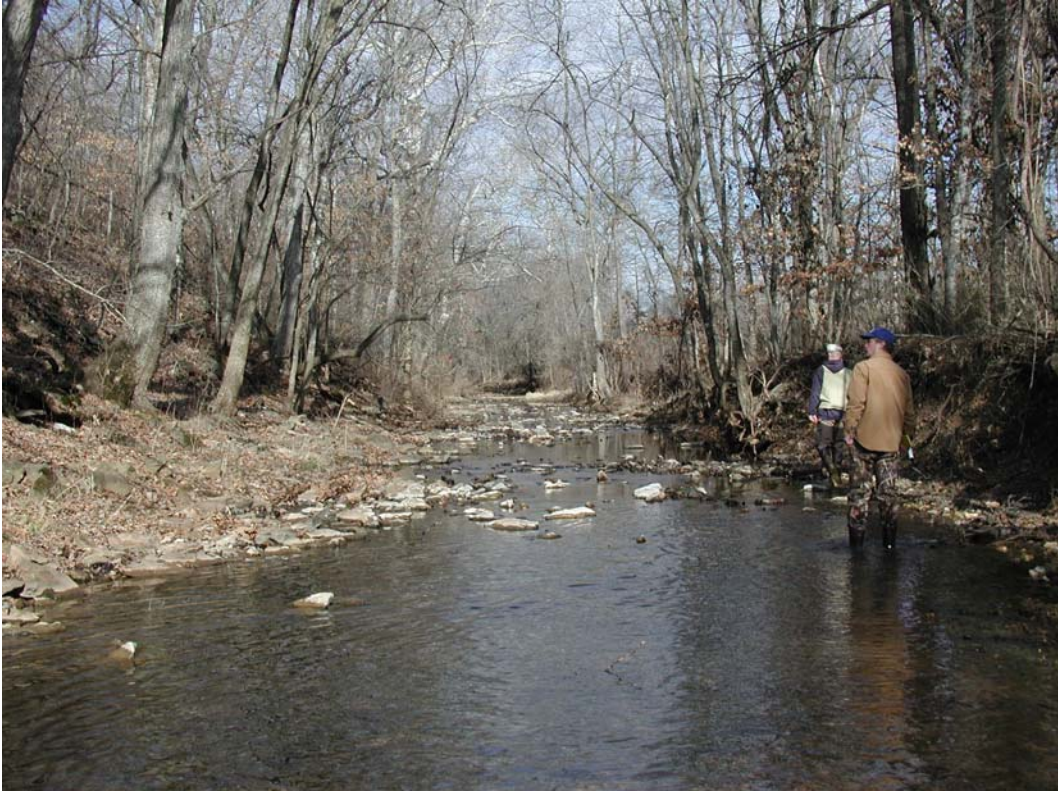
Picture 15. Bluff controlled reach looking downstream (550 m)

2. **Pool enhancement along the TD 500-700 Sub-reach.** This area has very shallow, almost absent, pool forms and thus lacks the hydraulic and habitat values they provide. This area might offer a good location to try and restore riffle and pool habitats with vanes and weir structures. The concept here would be to improve aquatic habitat diversity with restoration measures that stand up to sediment transport and flashy flows. This area also remains flowing throughout the year, so aquatic life will not be limited by dry bed conditions and a variety of vegetation stabilization options would be possible.

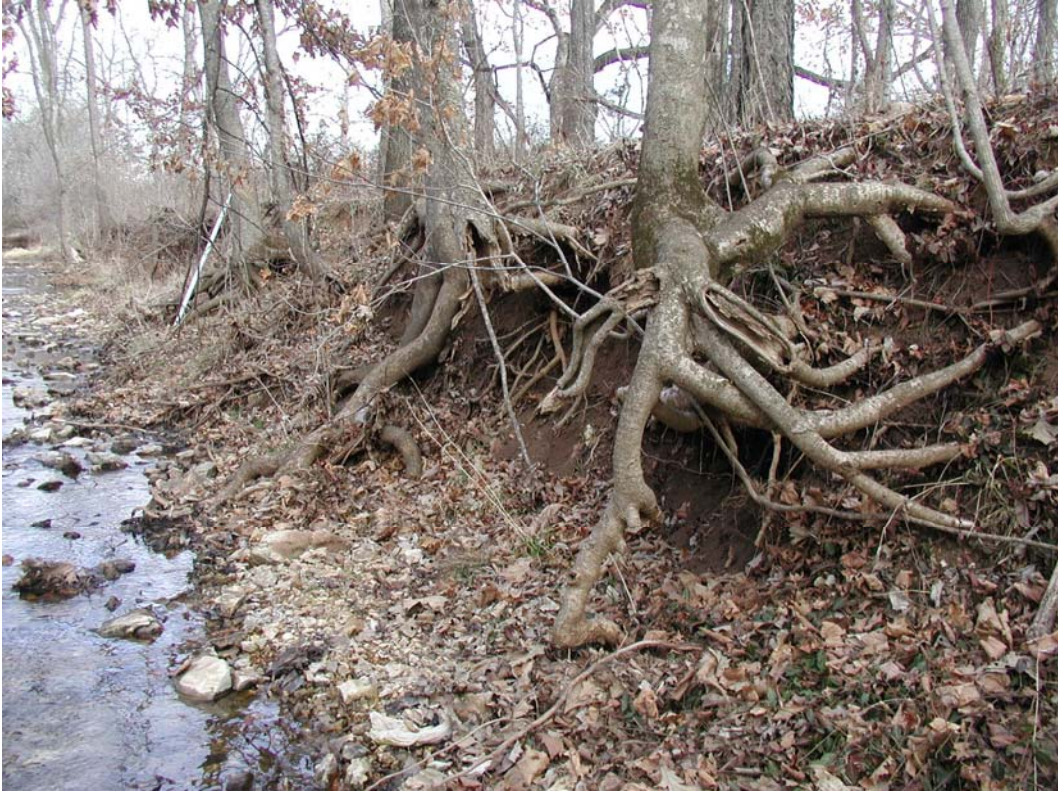
Picture 16. Exposed roots with bark along north bank looking downstream (600 m)

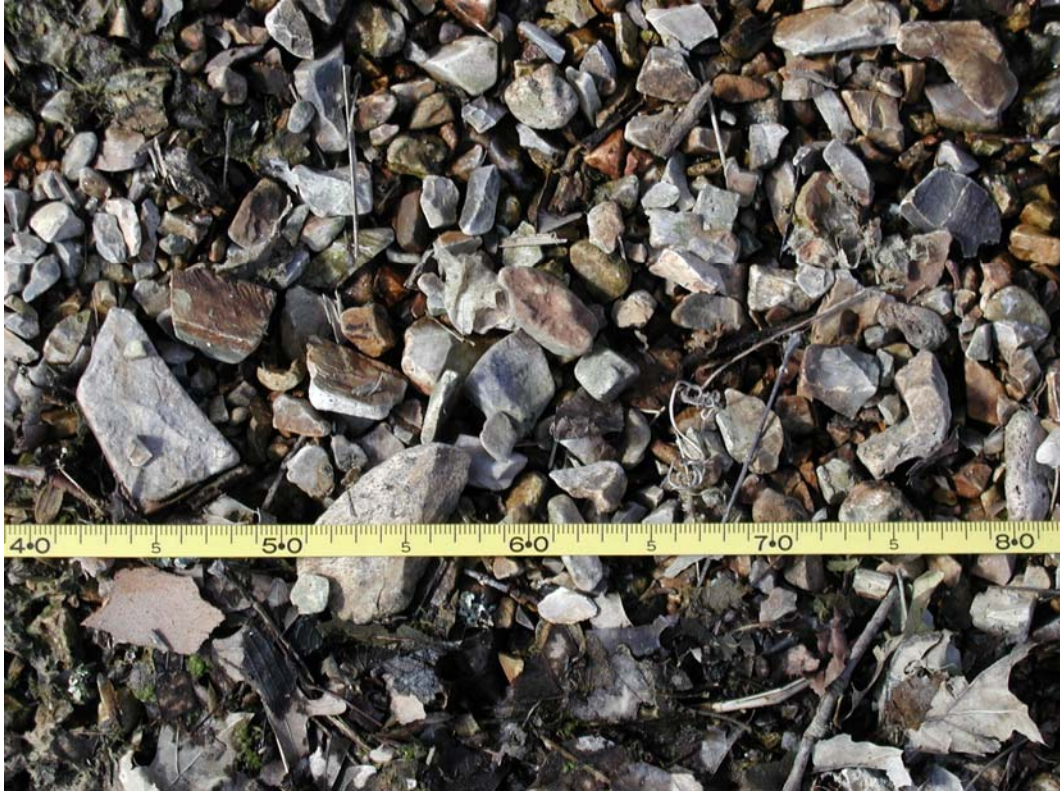
The diameter of bed material is largely controlled by the proximity to bed rock and colluvial clasts along bluff lines where cut banks have formed against bedrock outcrops such as along TD 200-300 m, TD 500-600 m, and TD 800-1,000 m (Figure 8, Map 4). The average maximum riffle clast size for the study area is 218 mm +or- 69 mm and the sub-reach containing the largest bed sediment occurs from TD 882 to 1,000 meters where the bedrock supply of large >300 mm clasts is very high (Table 3, Figure 8, Pictures 26-30). The size of gravel sediment in bar features tends to follow the same patterns as maximum clast size (Figure 8). The median or D50 of the bar pebble counts average 29 mm +or- 13 mm and the D84 averages 54 mm +or- 21 mm for the study area (Table 4, Picture 17).

Picture 17. Mobile bar sediment at 600 m

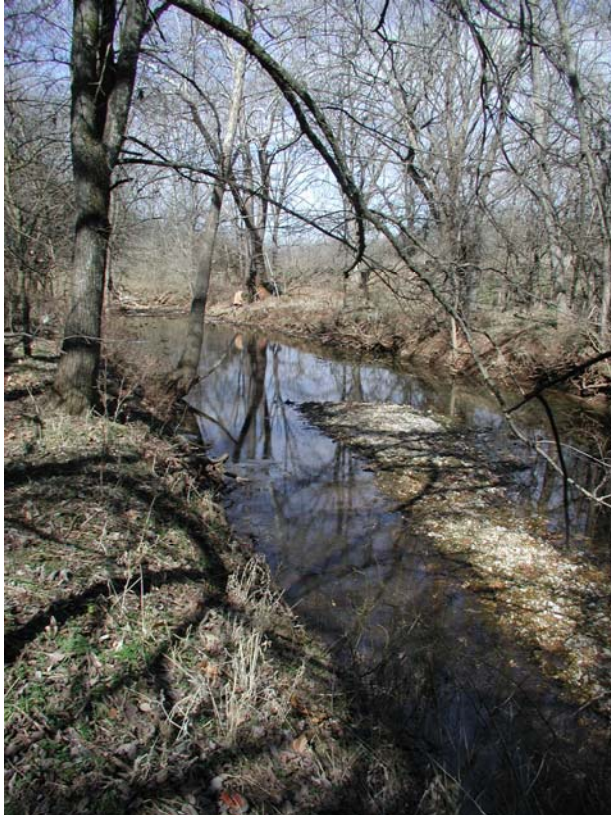
Picture 20. Mid channel bar looking downstream at 700 m

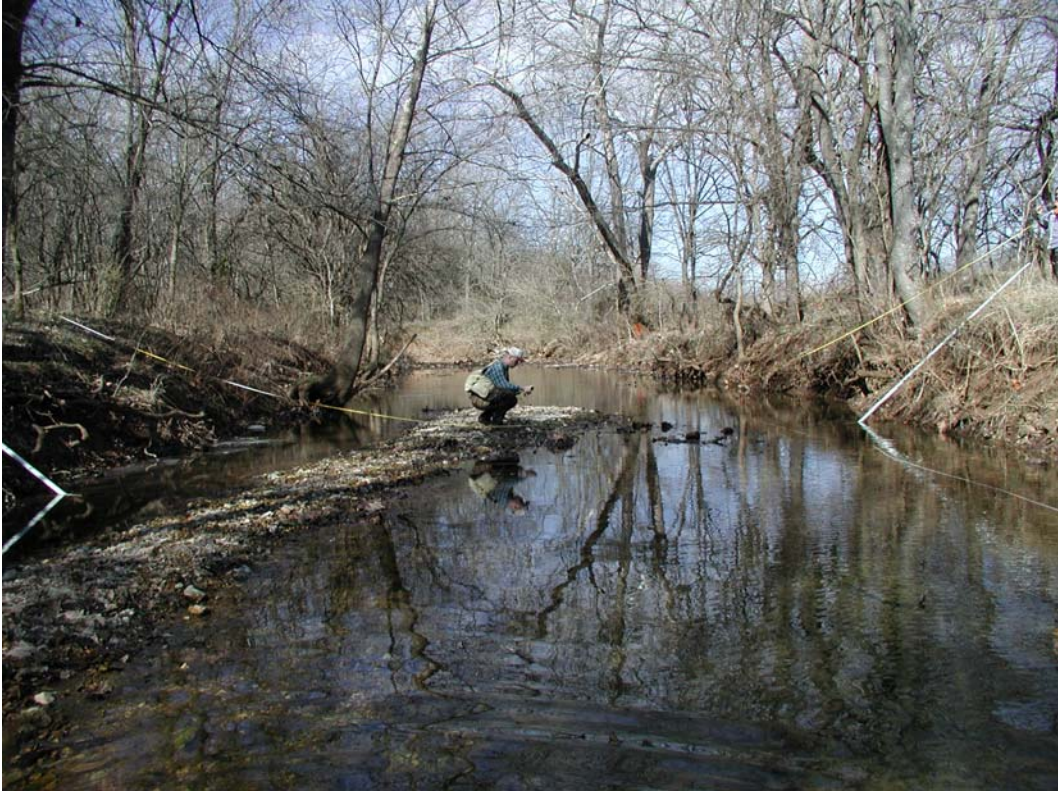
Picture 21. End of mid channel bar at 750 m

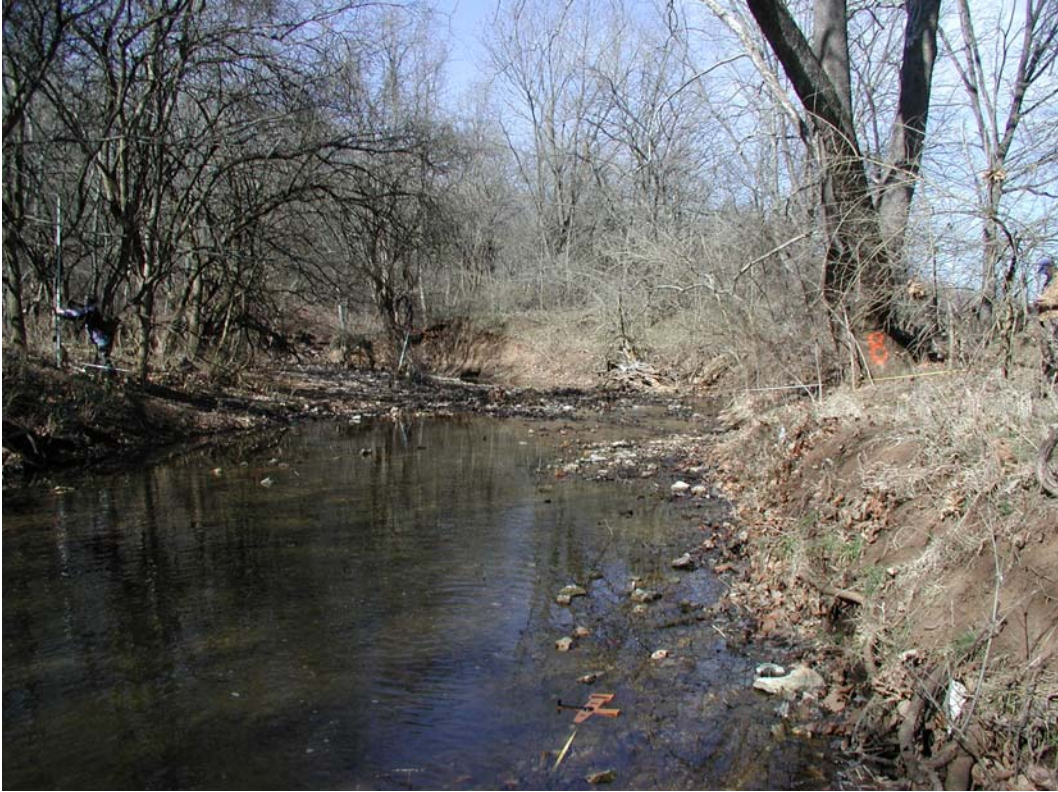
Picture 22. Upstream of disturbance reach riffle at 800 m looking downstream

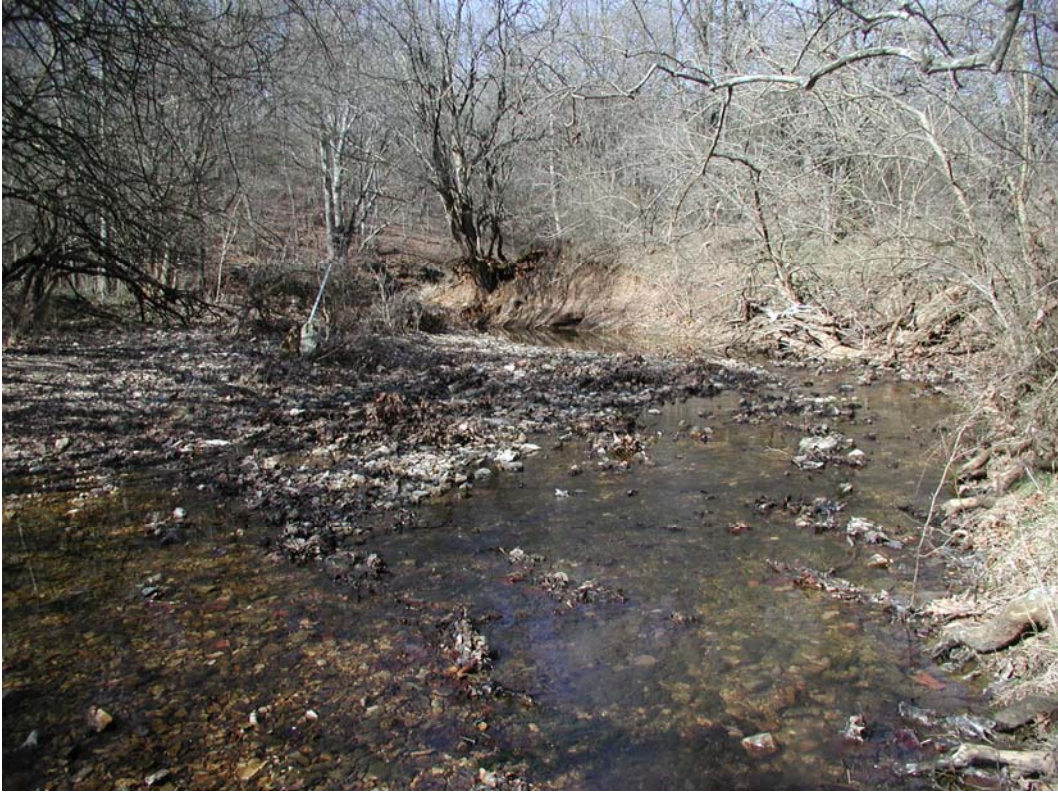
Picture 23. Disturbance reach riffle looking downstream (800 m)

- c. The bend below mega-bar #2 and TD 800 is very unstable. Bank regrading, stabilization, and toe-protection is needed to stabilize this area. Some of the excess energy could be directed around this bend by expanding the chute channel on the low floodplain on the left side of the channel to direct floodwater around it.

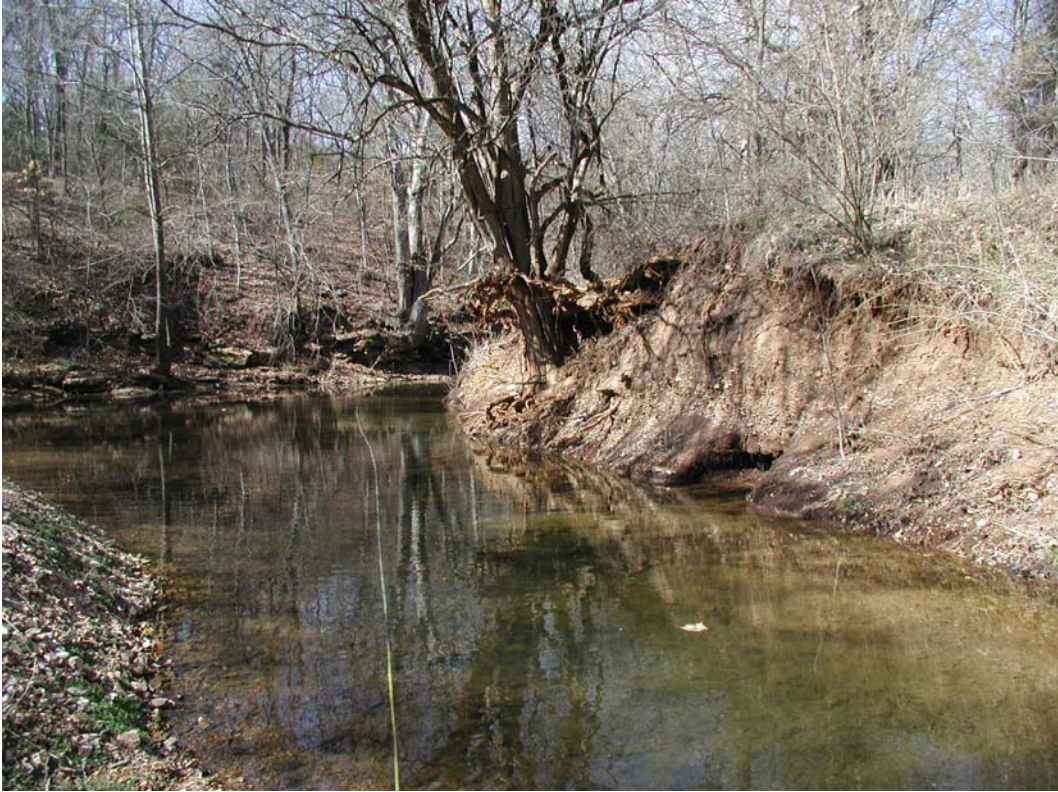
Picture 24. Disturbance reach pool looking downstream (800 m)

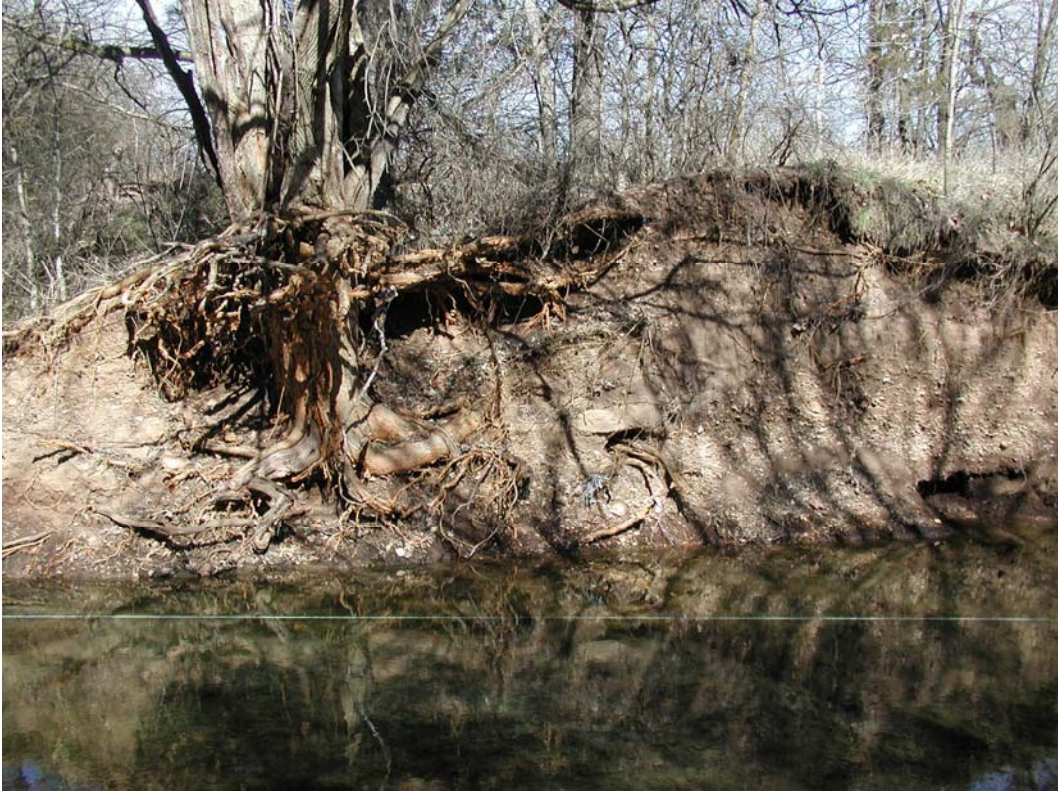
Picture 25. Disturbance reach cutbank (800 m)

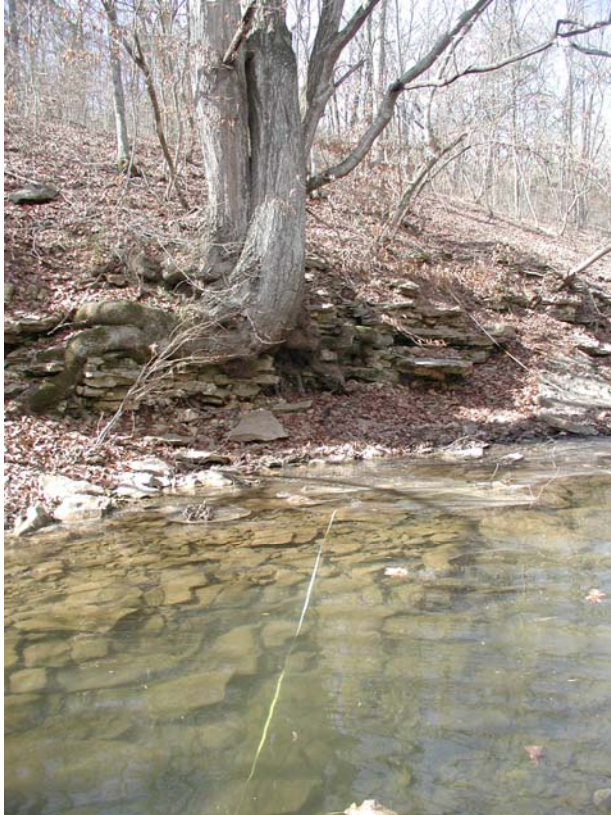
Picture 26. Bedrock bluff and colluvium along south bank (860 m)

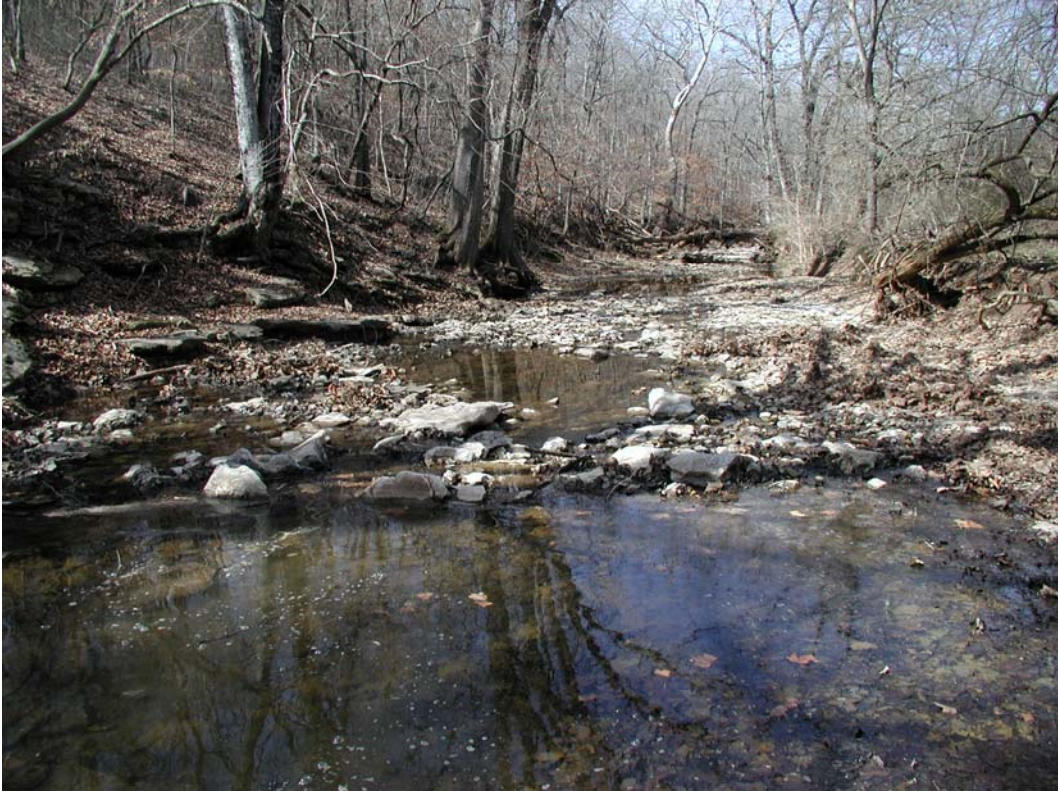
Picture 27. Bluff controlled riffle-pool sequence (880 m)

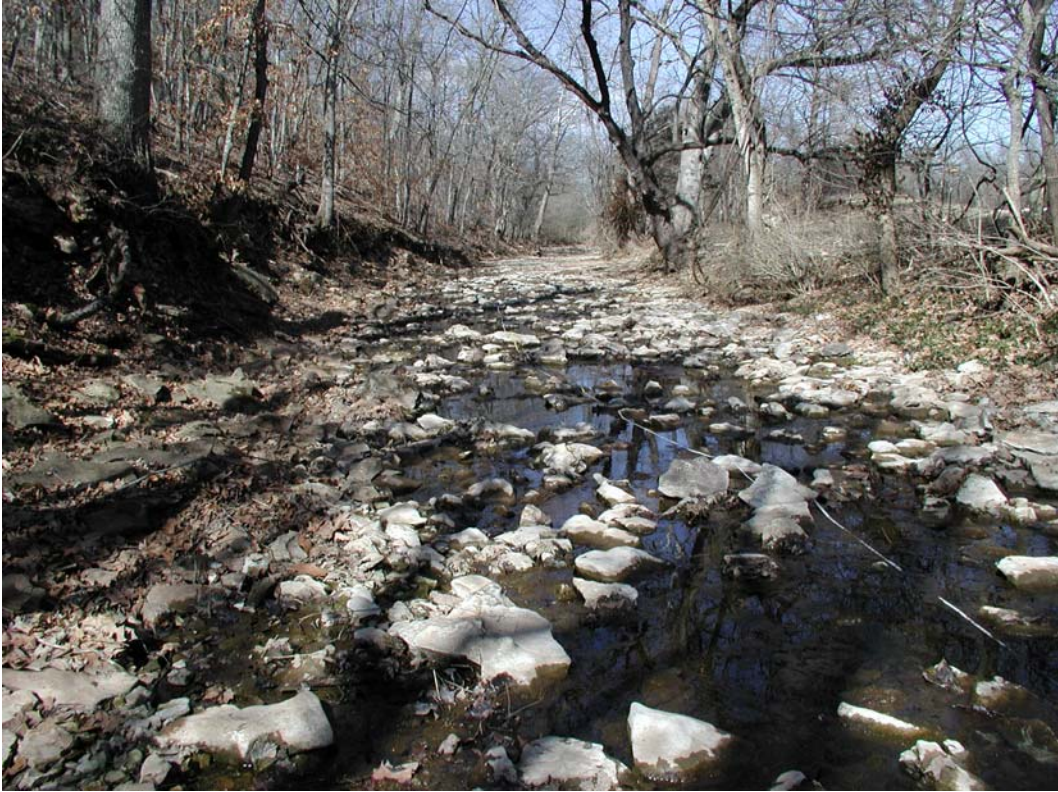
Picture 28. Steep bluff controlled reach looking downstream (950 m)

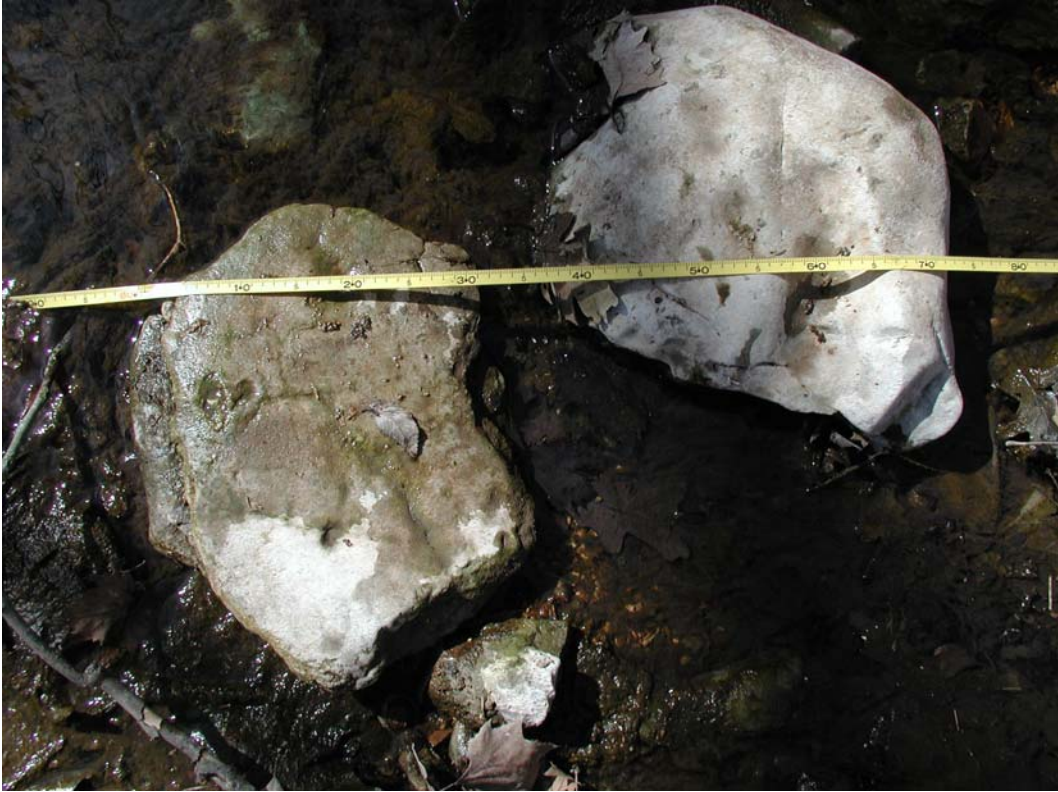
Picture 29. Large bed sediment at 960 m

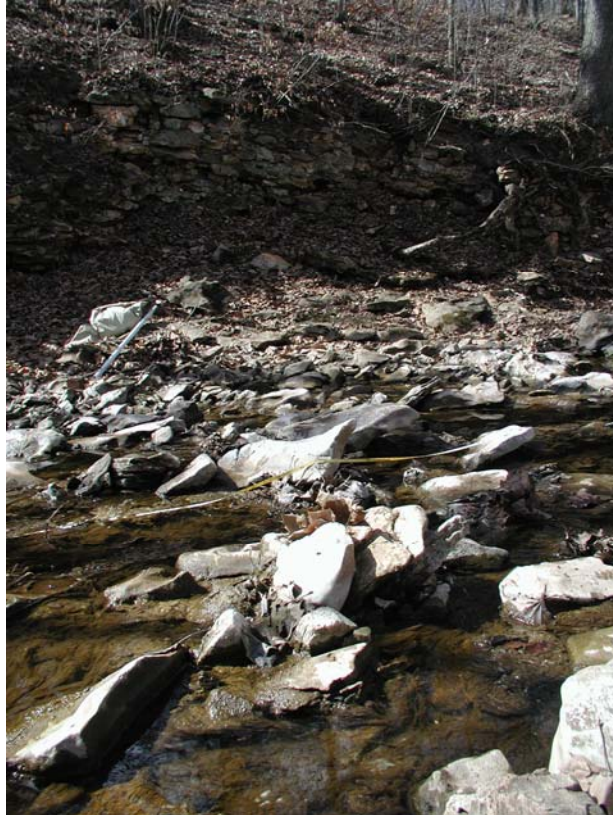
Picture 30. Imbricated bed at 965 m
