Geomorphic Assessment of the South Dry Sac River below Valley Water Mill

By: Robert T. Pavlowsky, Ph.D.
Ozarks Environmental and Water Resources Institute
Missouri State University

Submitted to the Watershed Committee of the Ozarks on March 15, 2006

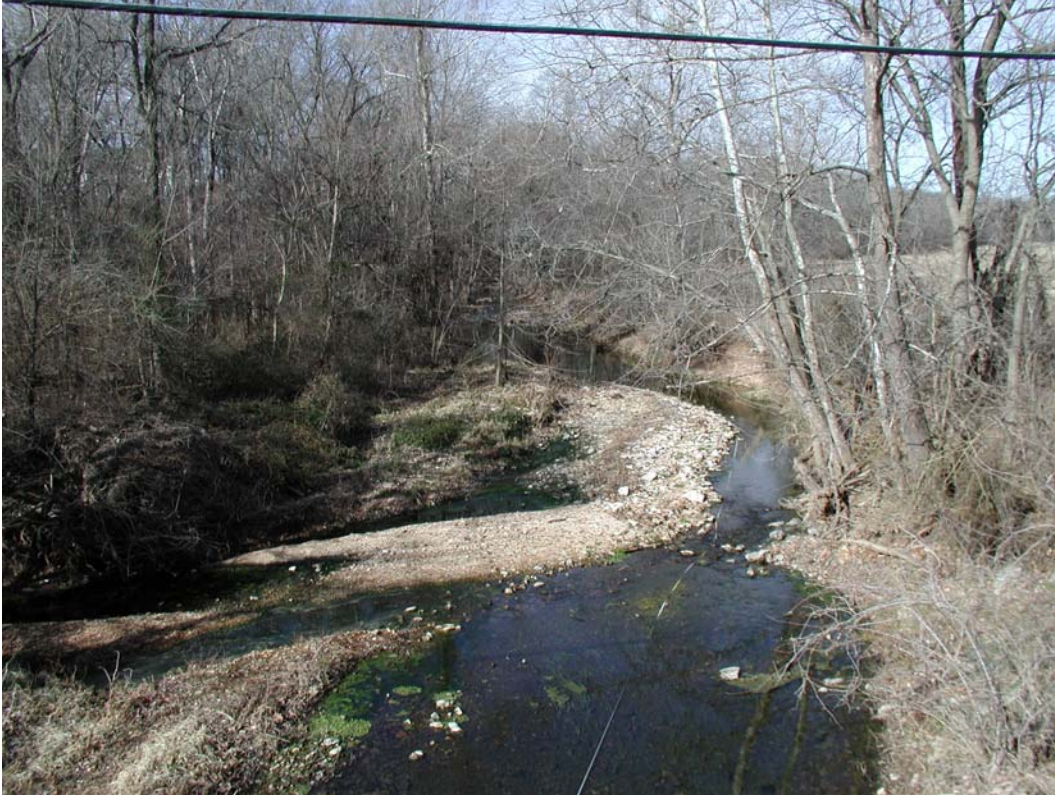
Although historical settlement and agricultural impacts on the river have abated, it is not clear how recent trends in urbanization and suburbanization have influenced the reach and how this influence may be affecting the historical recovery process. In general, urban areas increase the volume and/or duration of runoff to adjacent streams and either of these hydrologic effects can increase bed and bank erosion rates. Field observations indicate that the Grandview Tributary is undergoing extensive bed and bank instability due to development pressure that has probably resulted in forming a relatively large deposit of bed material below its confluence at TD 15 meters to 50 meters that is blocking the left side of the channel and forcing the flow to erode the banks on the right side (Pictures 1 and 2). However, large scour hole and bar formation is typically found below bridges and so in this case it is hard to distinctly separate the influence of urban stream instability and bridge hydraulic interference on the local bed and bank disturbances observed. Rip-rap extends along both banks from TD 0 to 12 meters to protect the bridge from undermining here too. To compound matters, there is a slight bend of the stream to the left at TD 45 which would also cause “natural” bank erosion on the outside bank as is typical to meandering rivers. Nevertheless, the area along the stream extending from the bridge to 60 meters and even slightly further downstream is an area of potential instability that needs to be monitored (Pictures 1-4).

Picture 1. Gravel Bar at Grandview Tributary DS of Farm Road 171 bridge (0 m)

4. **Monitor, and maybe stabilize, the Grandview Tributary Confluence sub-reach from TD 12 m to 60 m.** This area is receiving stormwater and sediment from Grandview Tributary that is affected by urbanization. Restoration activities and stormwater BMP implementation should continue in the watershed to decrease the influence on the South Dry Sac River. Controlling sediment clogging of the channel and stabilizing the right bank may also help reduce the instability of this reach. The instability of this reach could possibly lead to downstream instability that may reactivate or remobilize mega-bar #1. Monitoring activities should extend down to TD 100 m to watch for these downstream progressing effects.

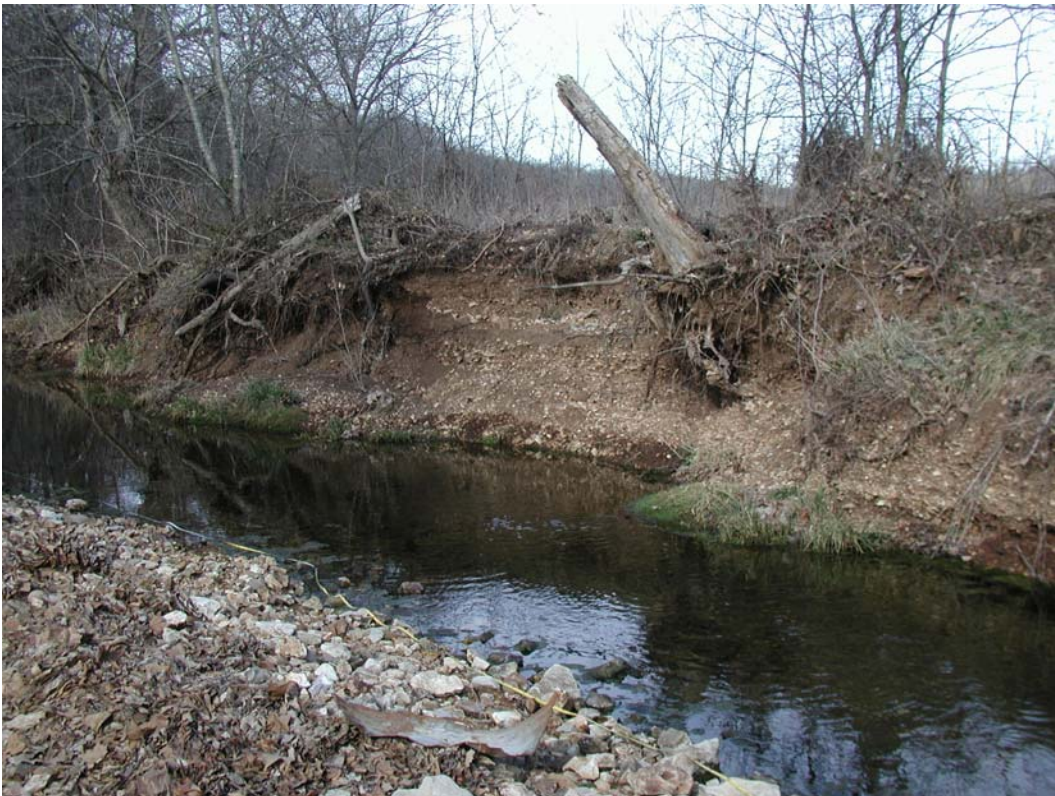
Bank stability was assessed visually by observing upper bank angle, bank height, vegetation cover, and evidence of erosion such as exposed tree roots or recent bank collapse. As mentioned before, channel location has been relatively stable over time so few severely eroding banks were found in the study area. The banks showing the most consistent extent of erosion are located on the floodplain/terrace features on the right side of the stream in locations where flood flows are forced to converge and increase in erosive force as they enter a bluff-lined reach (Map 4). Additional locations for bank erosion occur at relatively tight bends or any bend along a steep reach. Finally, bank erosion is also noticeable at a slight bend being affected by the Grandview tributary and the depositional bar below it (TD 45 m) (Picture 2).

Picture 2. Cutbank at 50 m

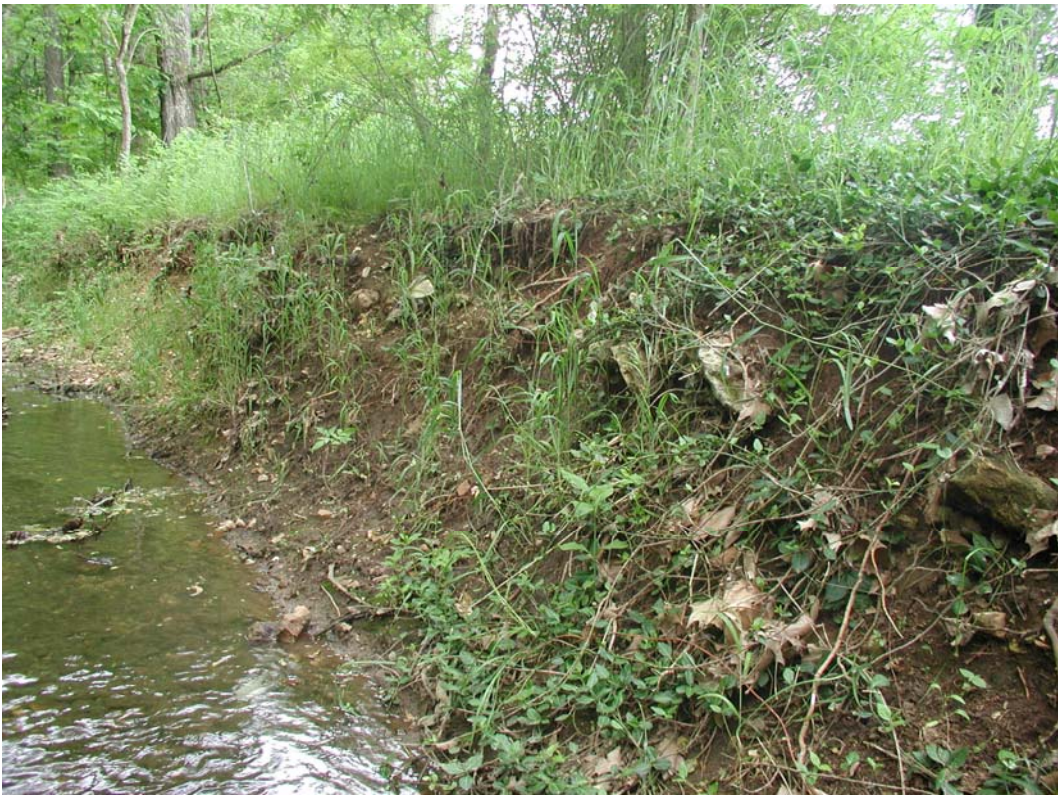
Picture 4. North bank vegetation Spring 2005 (150 m)

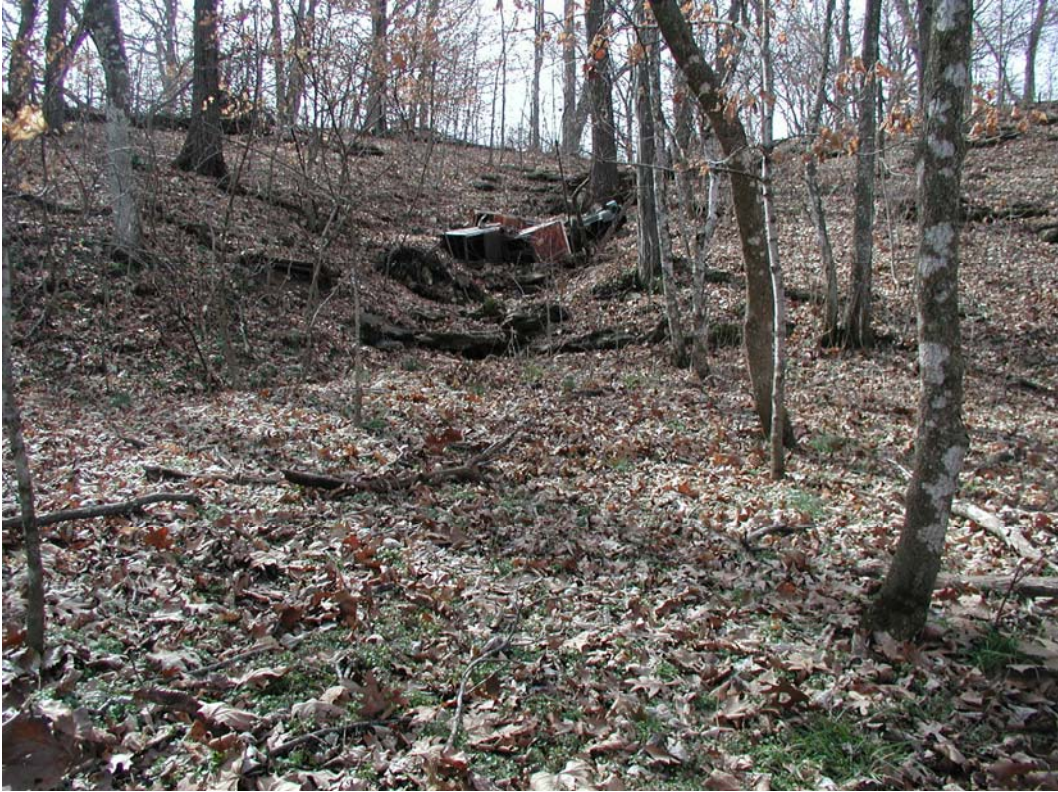
Picture 5. Alluvial fan on south bank (150 m)

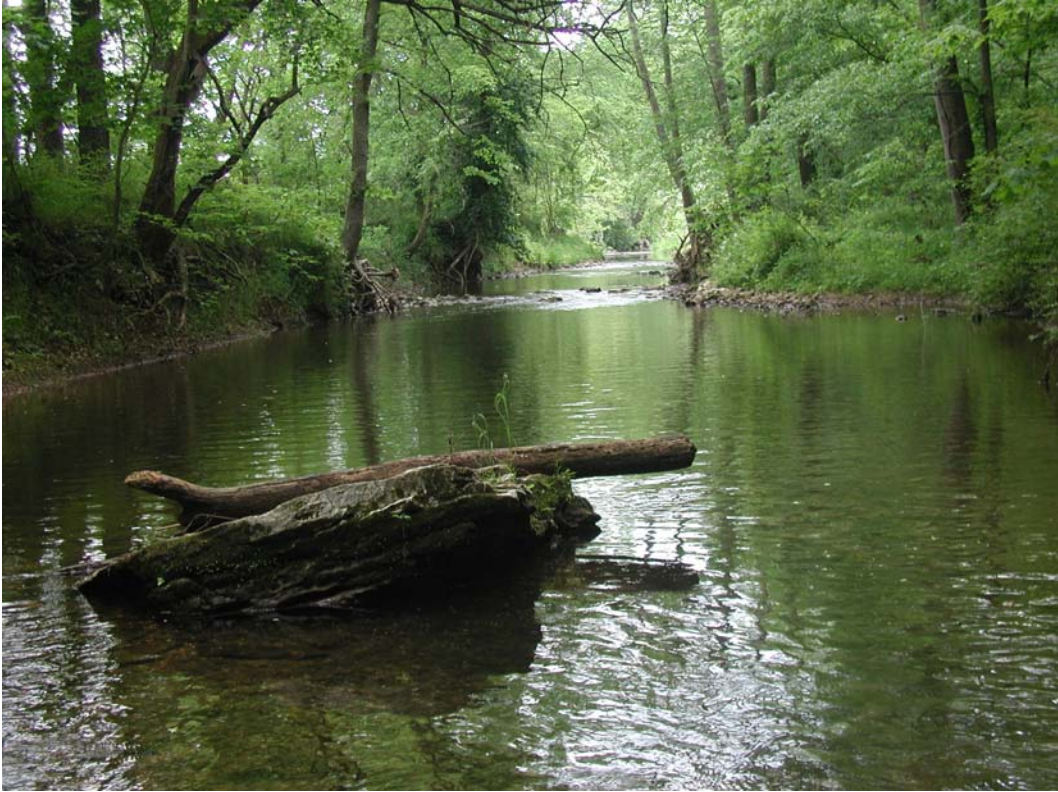
Picture 6. Colluvial block in pool at 160 m looking upstream

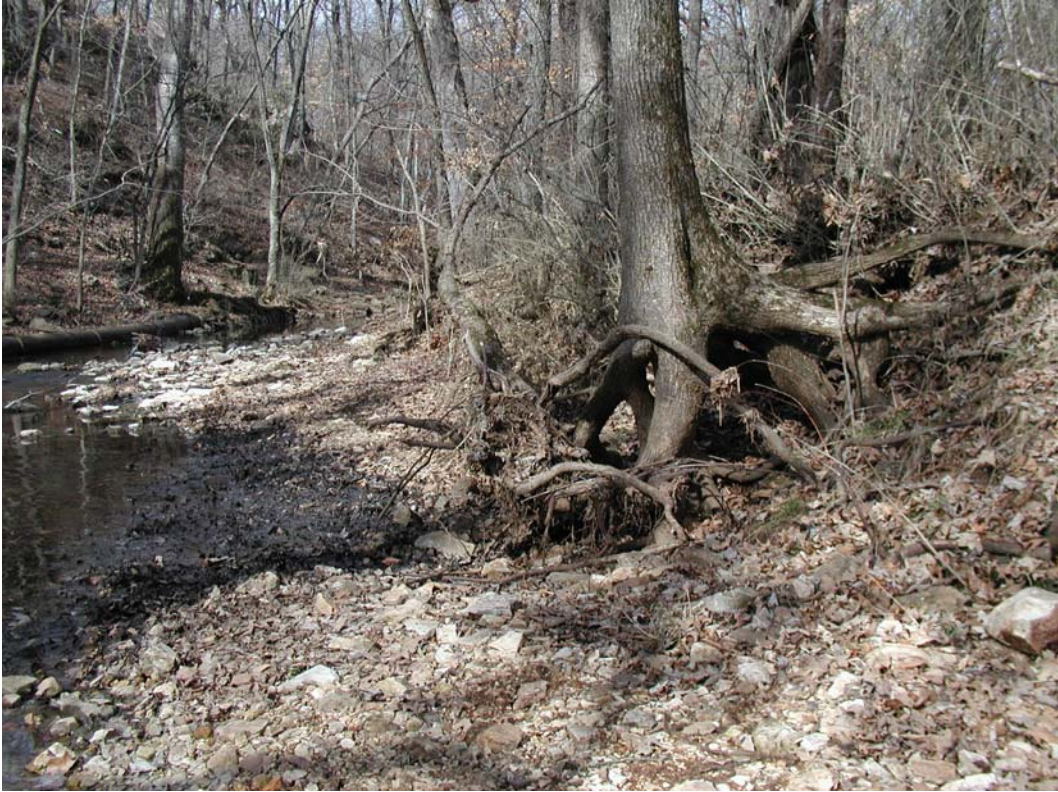
Picture 7. Exposed roots with bark (170 m)

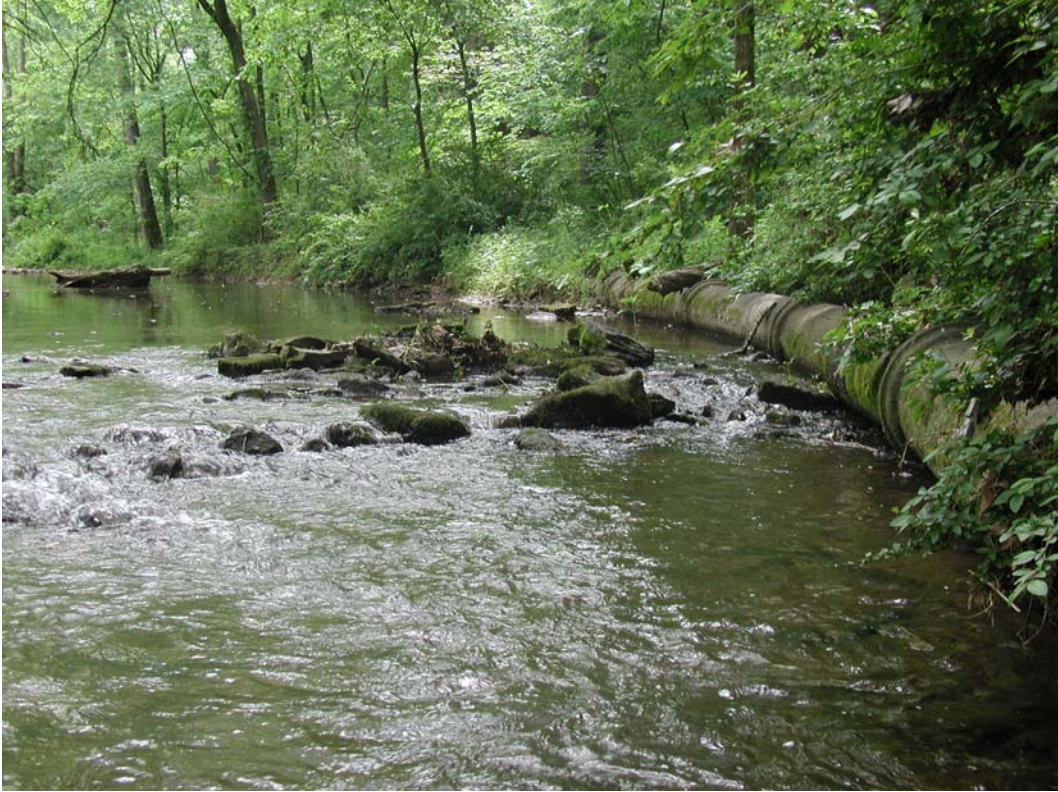
Picture 8. Riffle and exposed pipe at 180 m looking upstream

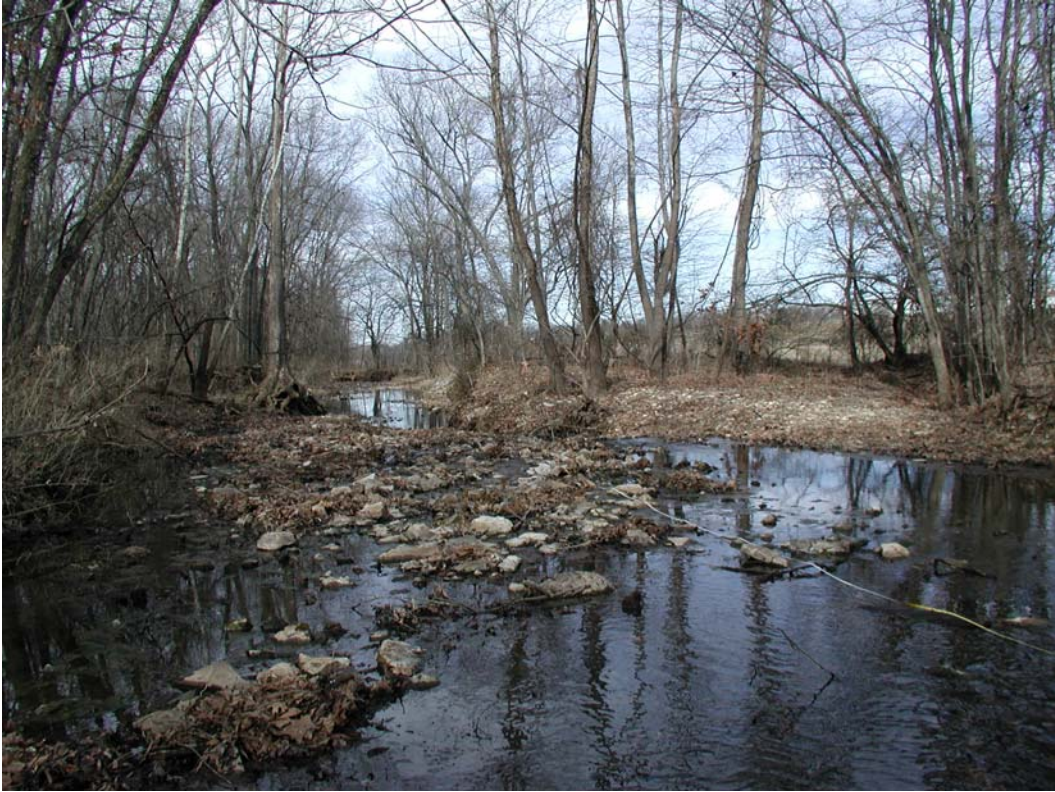
The location of sedimentary bars also indicate areas where present channel conditions are disturbed (i.e. mega bars) or potentially unstable (i.e. middle bars). Mega-bars are found in the study area at TD 260 to 329 meters (Pictures 9-10) and TD 800 to 870 meters (Pictures 21-25) (Map 3, Map 4). These are sub-reaches of major instability and change which form by the excessive deposition of relatively coarse bedload materials in composite bar and riffle forms. Since they effectively clog the channel and force the flow against and out over the banks, evidence for chute channel incision and/or avulsion on flanking floodplains is also found at each of these sites. Both of these disturbance reaches are located at a bend downstream of a relatively long straight reach along the bluff line where there is an ample supply of large clasts from bedrock and colluvium sources.

Picture 9. Riffle at disturbance reach looking downstream (280 m)

1. **Disturbance reach or mega-bar monitoring.** The excessive accumulations of bed sediment in the two disturbance reaches containing mega-bars need to be monitored. In other Ozark streams these features are believed to be formed as a response to past poor land management and the introduction of gravel via soil erosion to the channel system. Unstable conditions such as eroding banks, mid-channel bars, scouring pools, and chute channel erosion are associated with these areas in the study area. There are no simple restoration fixes for these types of areas since they deal more with sediment transport and supply problems at the segment or watershed-scale rather than bed or bank resistance at the sub-reach scale that can be managed on-site.

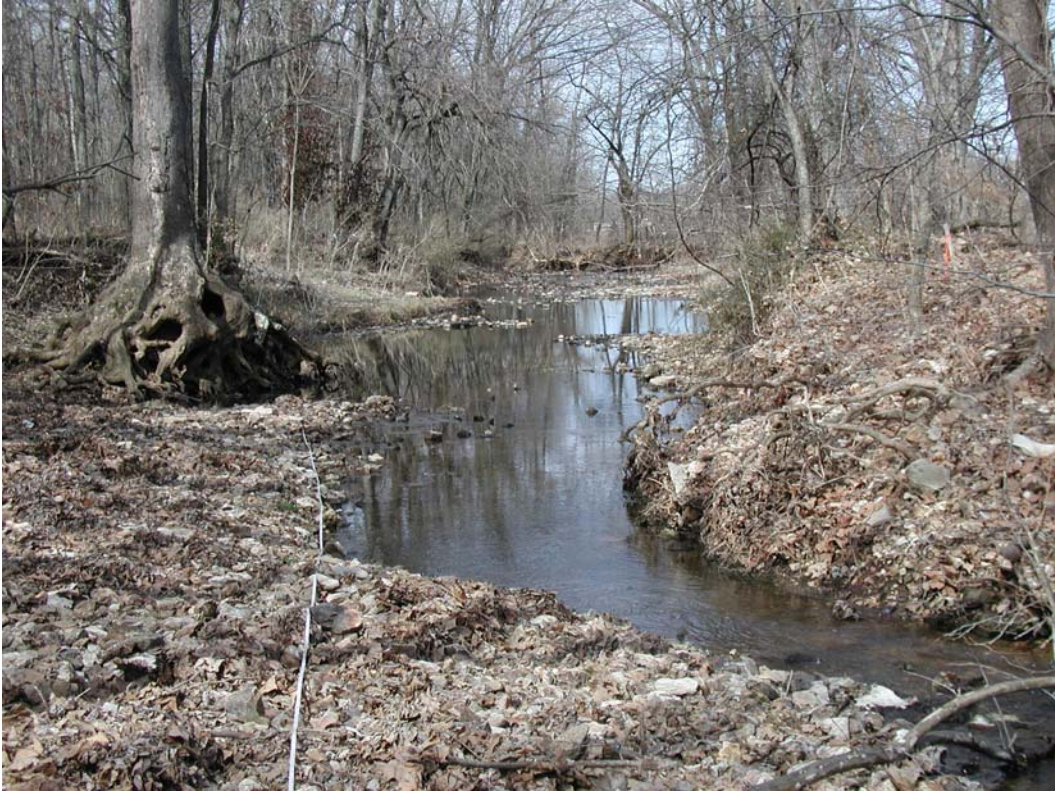
Picture 10. Pool at disturbance reach looking downstream (280 m)

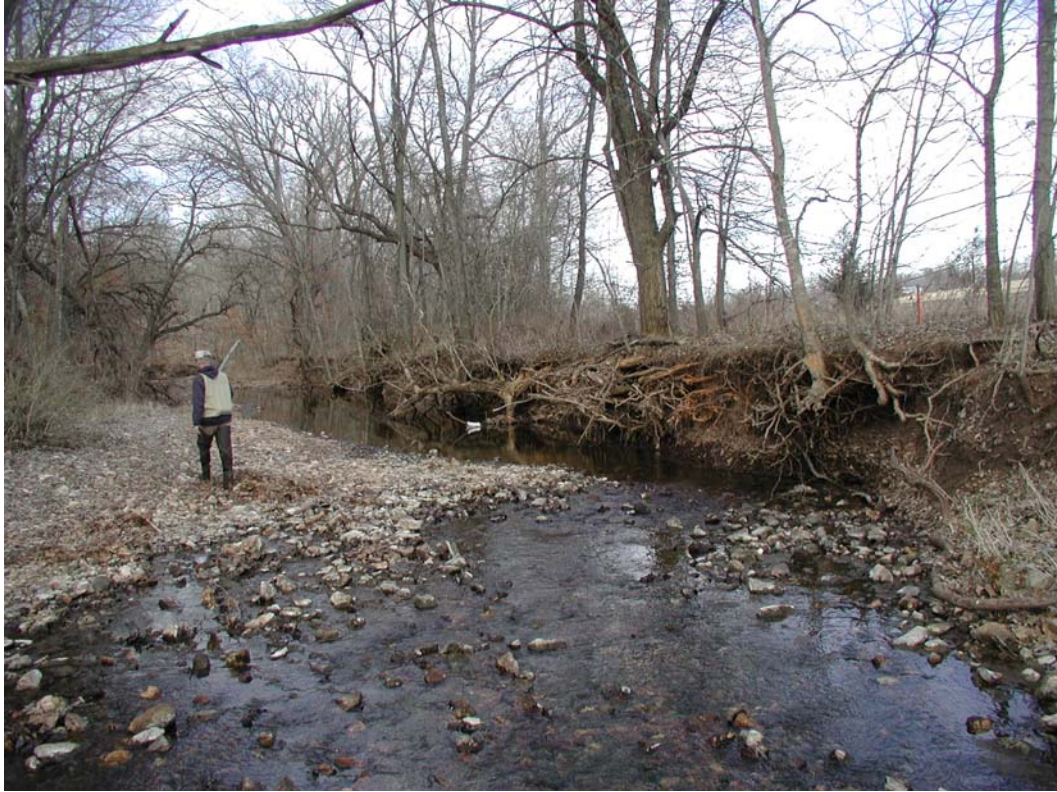
Picture 11. Exposed roots along eroding bank looking downstream (400 m)

- b. The bend at TD 400 m seems to be undergoing a recent episode of erosion where exposed roots have a fresh appearance and mid channel gravel bars are slowly advancing downstream toward it. This reach should be examined for stabilization and restoration action—at the least it needs to be monitored.

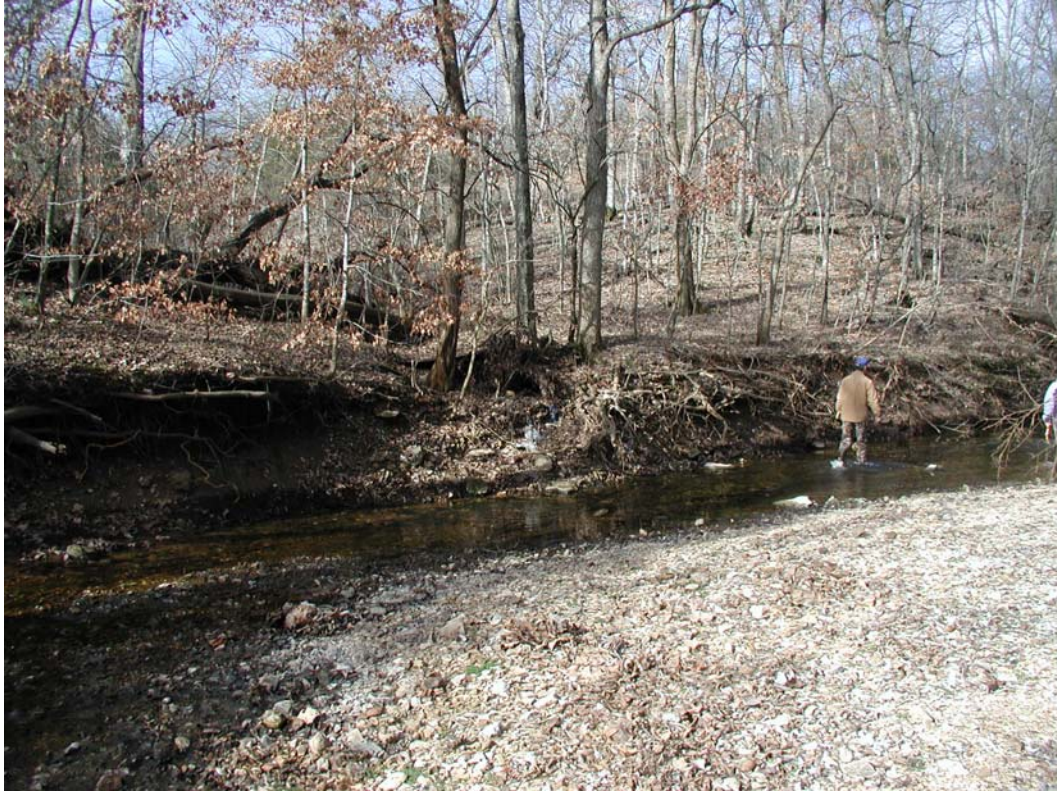
Picture 12. Alluvial fan tributary (south bank) and point bar (500 m)

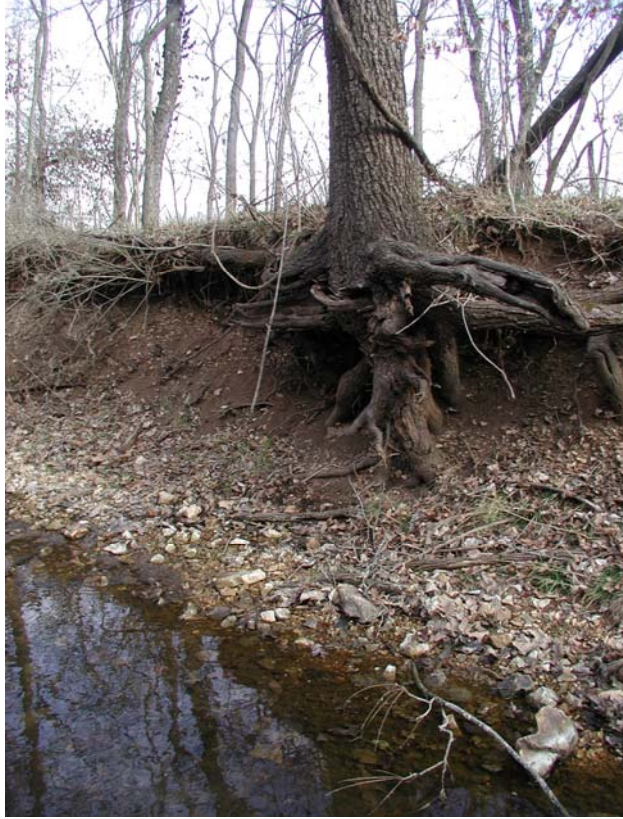
Picture 13. Exposed root with bark cover (500 m)

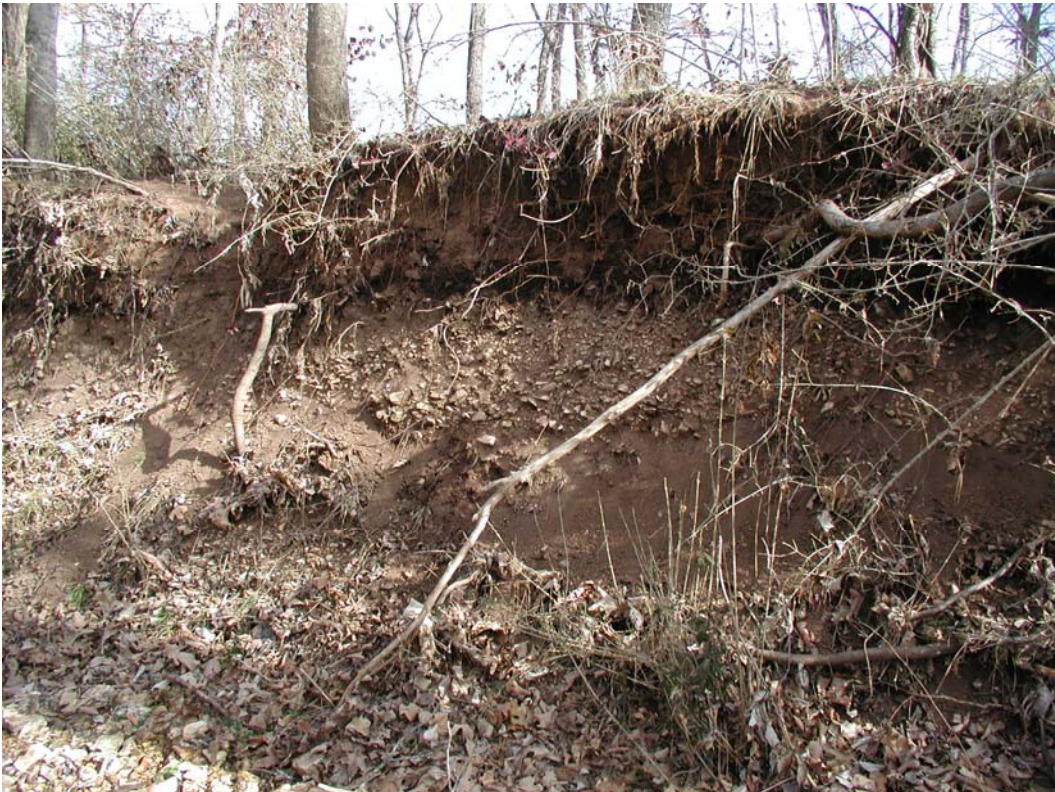
Picture 14. Cutbank at 500 m

2. **Pool enhancement along the TD 500-700 Sub-reach.** This area has very shallow, almost absent, pool forms and thus lacks the hydraulic and habitat values they provide. This area might offer a good location to try and restore riffle and pool habitats with vanes and weir structures. The concept here would be to improve aquatic habitat diversity with restoration measures that stand up to sediment transport and flashy flows. This area also remains flowing through out the year, so aquatic life will not be limiting by dry bed conditions and a variety of vegetation stabilization options would be possible.

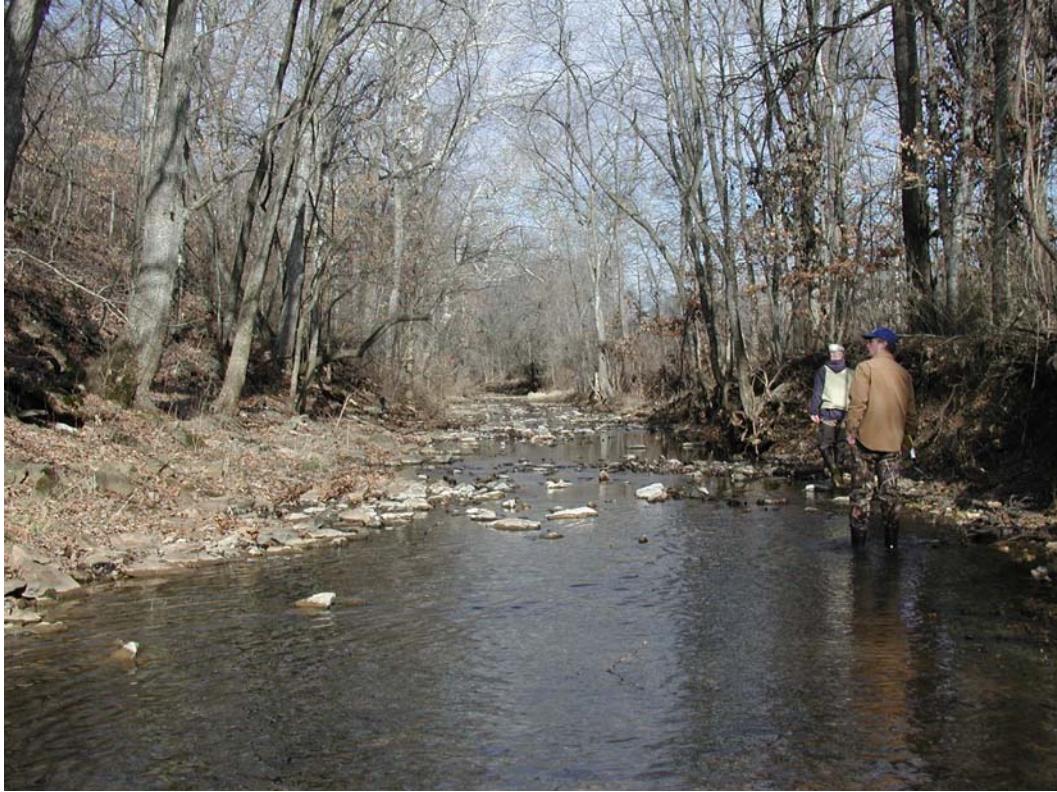
Picture 15. Bluff controlled reach looking downstream (550 m)

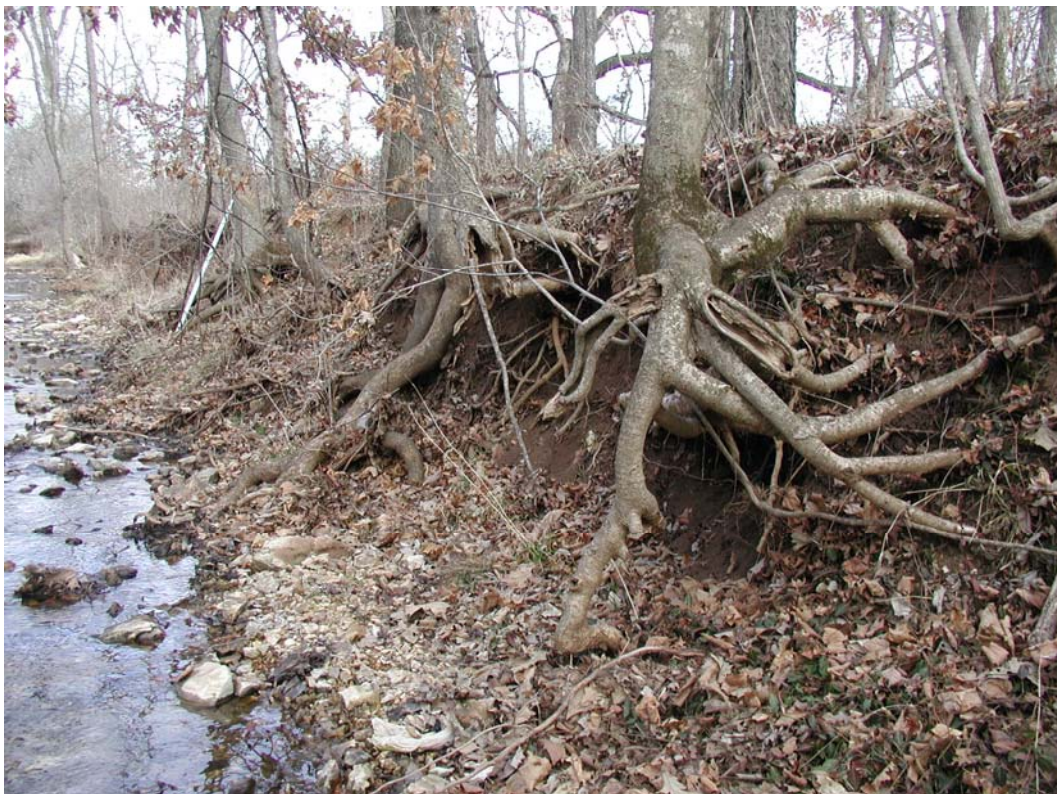
Picture 16. Exposed roots with bark along north bank looking downstream (600 m)

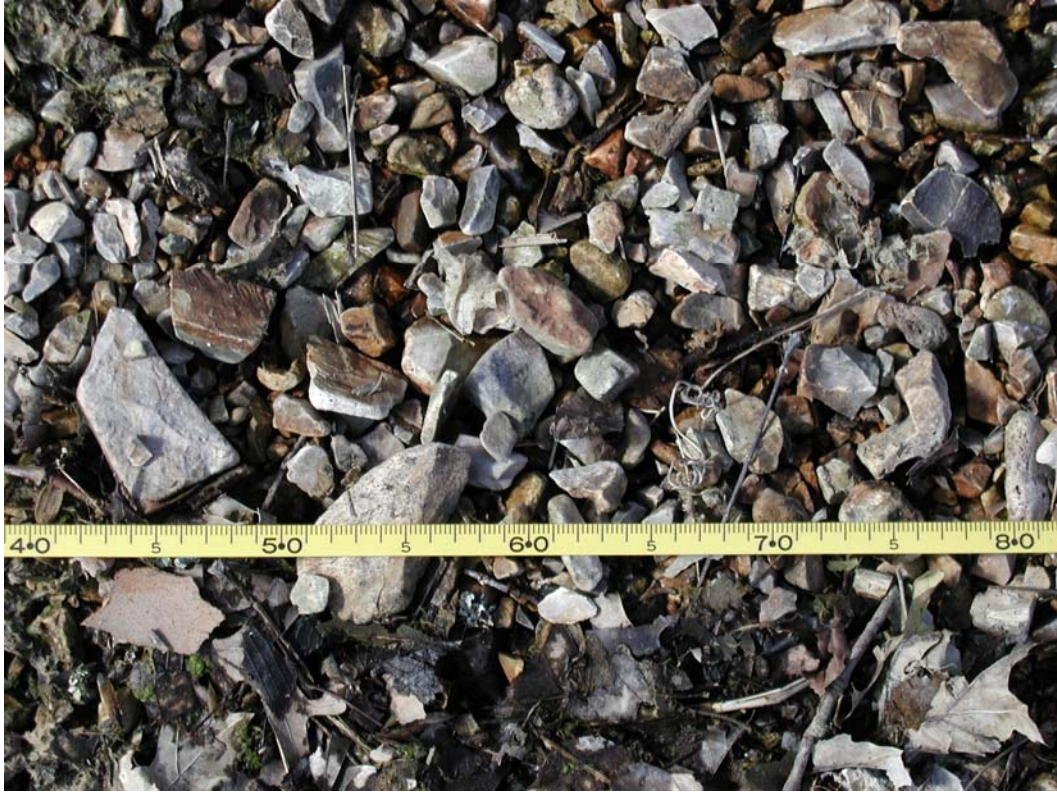
The diameter of bed material is largely controlled by the proximity to bed rock and colluvial clasts along bluff lines where cut banks have formed against bedrock outcrops such as along TD 200-300 m, TD 500-600 m, and TD 800-1,000 m (Figure 8, Map 4). The average maximum riffle clast size for the study area is 218 mm +or- 69 mm and the sub-reach containing the largest bed sediment occurs from TD 882 to 1,000 meters where the bedrock supply of large >300 mm clasts is very high (Table 3, Figure 8, Pictures 26-30). The size of gravel sediment in bar features tends to follow the same patterns as maximum clast size (Figure 8). The median or D50 of the bar pebble counts average 29 mm +or- 13 mm and the D84 averages 54 mm +or- 21 mm for the study area (Table 4, Picture 17).

Picture 17. Mobile bar sediment at 600 m

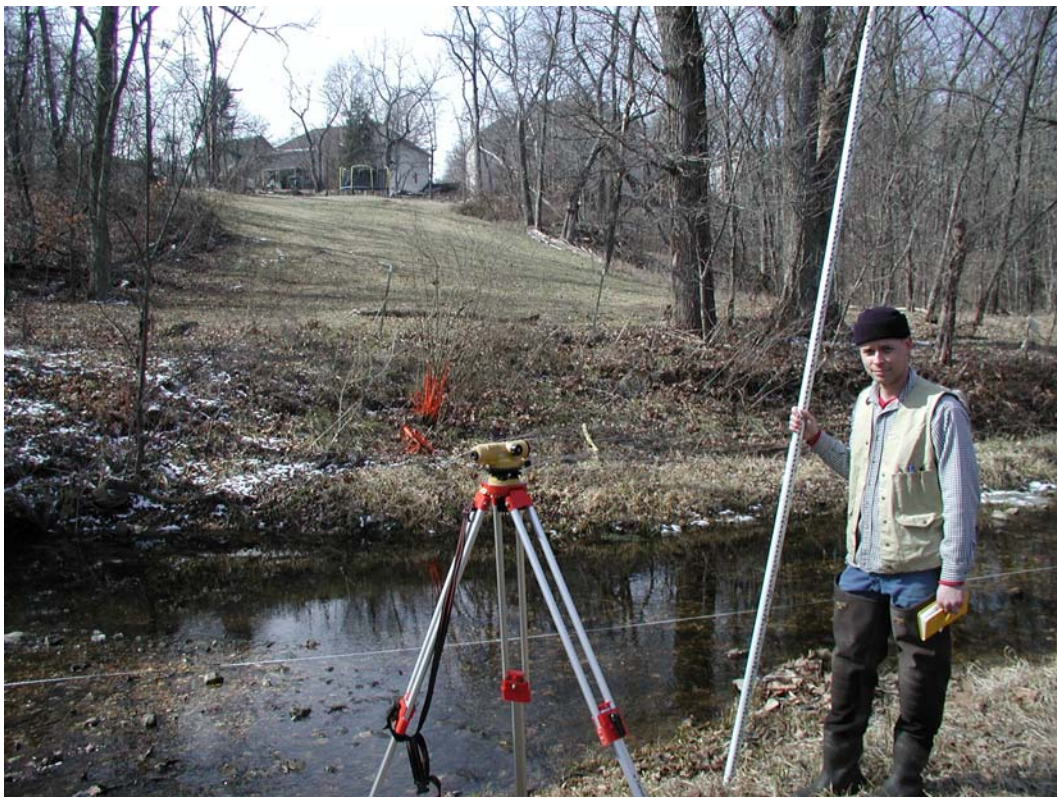
Land use of the watershed is about 11% urban, 72% pasture/grassland, and 17% forest above the study area (Horton, 2003). The south or left side of the river is dominated by a steep bluff with frequent bedrock exposures upon which residential development is occurring. The Grandview Tributary drains some of these areas and its watershed contains almost 50% urban area. The north or right side of the river is mainly pasture grassland over rolling and gently-sloped terraces and uplands. The forested riparian corridor typically ranges from 5 to 10 meters in width on the right side of the river, but is much wider on the left side due to the effects of the bluff in blocking access. There are two small grassed access points coming down from subdivisions to access the river on the left side, but these do not seem to coincide with channel instability problems (Picture 18).

Picture 18. Utility crossing and subdivision along south bank (670 m)

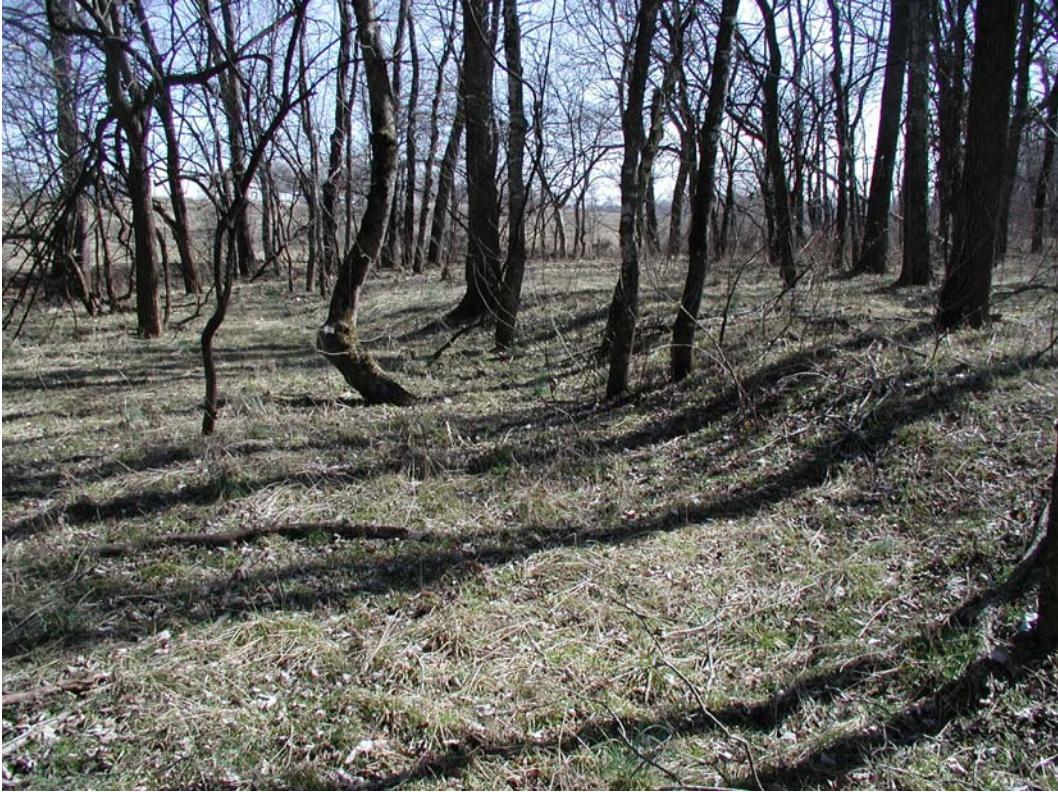
Picture 19. Paleomeander along south bank at 700 m

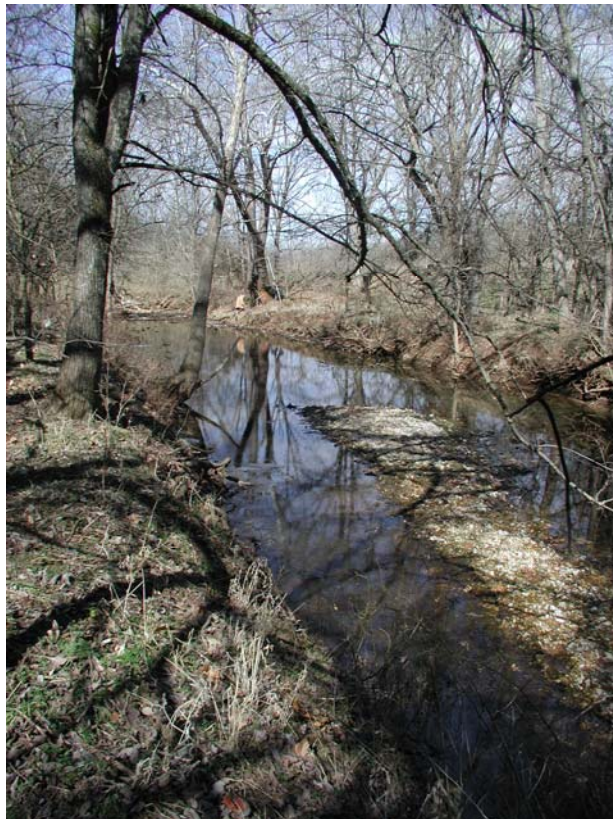
Picture 20. Mid channel bar looking downstream at 700 m

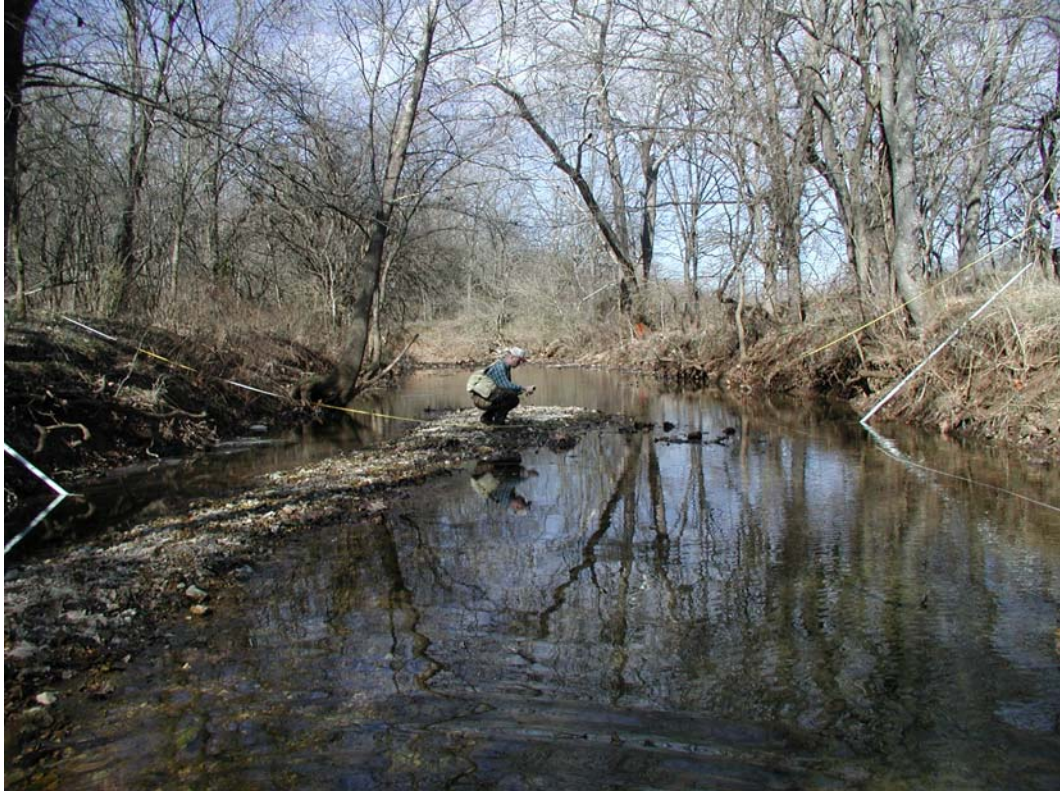
Picture 21. End of mid channel bar at 750 m

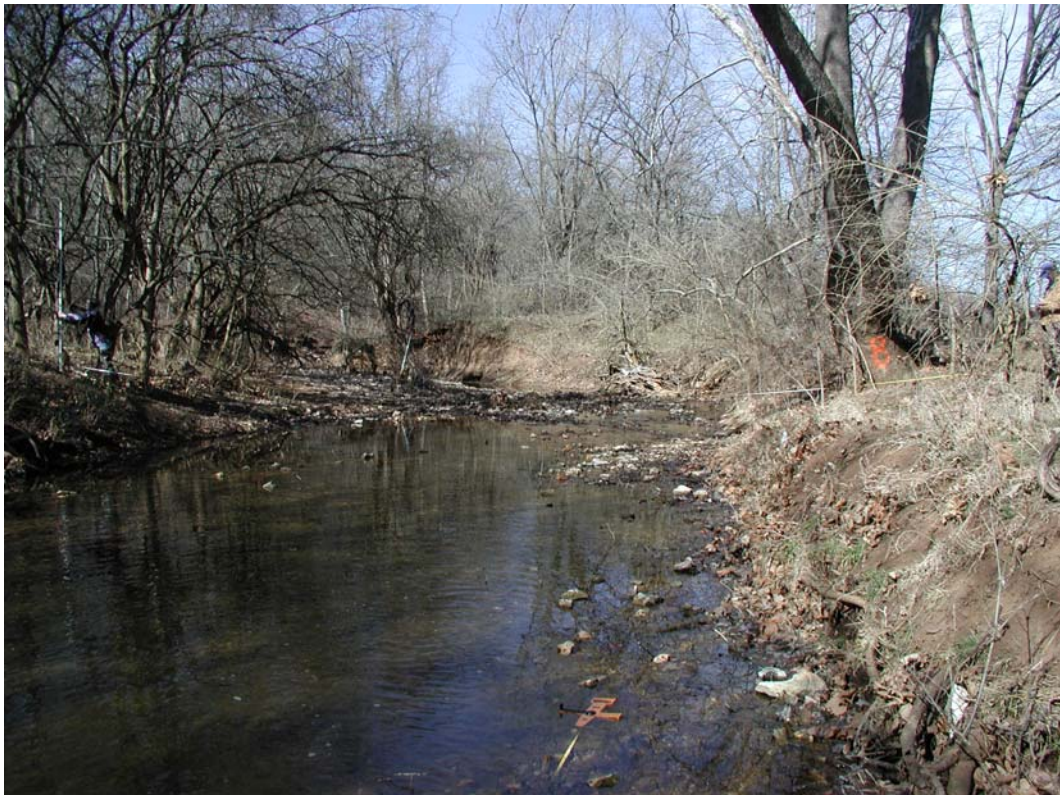
Picture 22. Upstream of disturbance reach riffle at 800 m looking downstream

- c. The bend below mega-bar #2 and TD 800 is very unstable. Bank regrading, stabilization, and toe-protection is needed to stabilize this area. Some of the excess energy could be directed around this bend by expanding the chute channel on the low floodplain on the left side of the channel to direct floodwater around it.

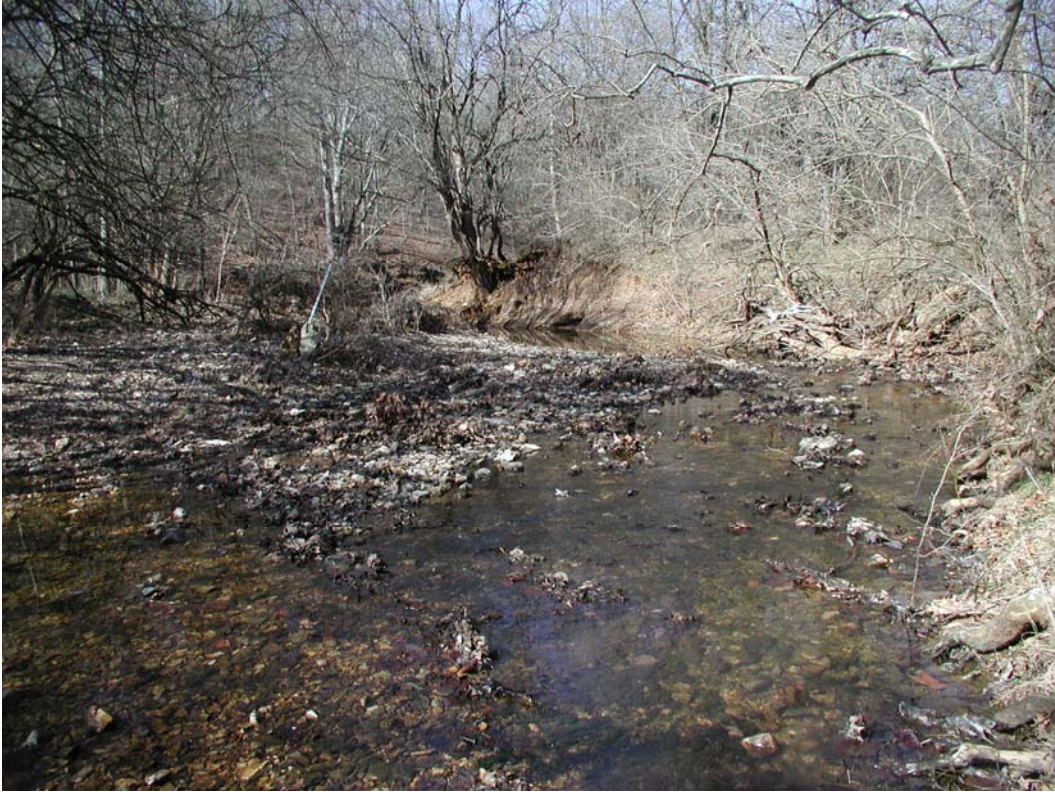
Picture 23. Disturbance reach riffle looking downstream (800 m)

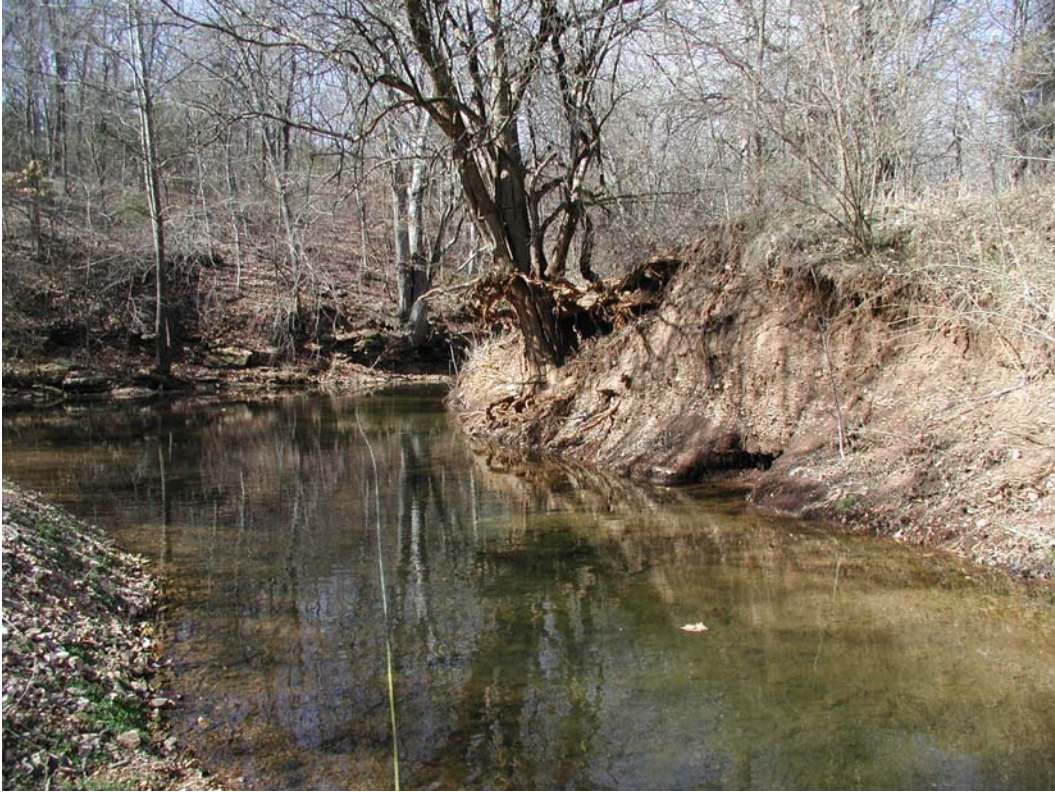
Picture 24. Disturbance reach pool looking downstream (800 m)

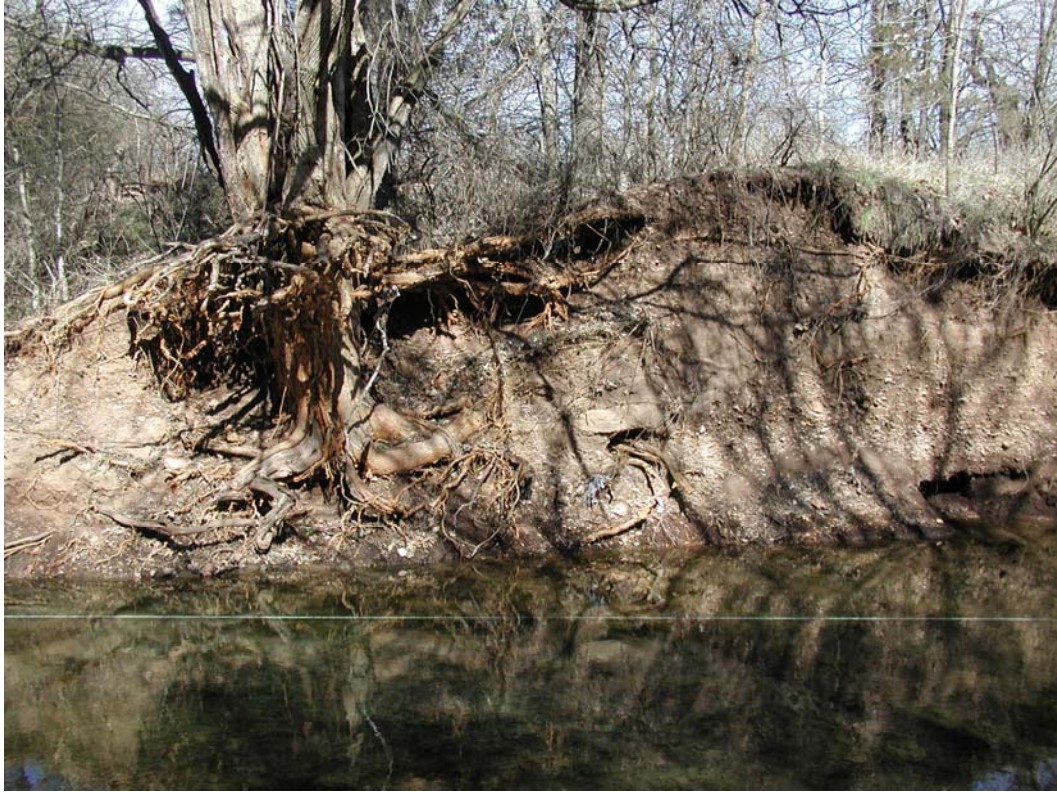
Picture 25. Disturbance reach cutbank (800 m)

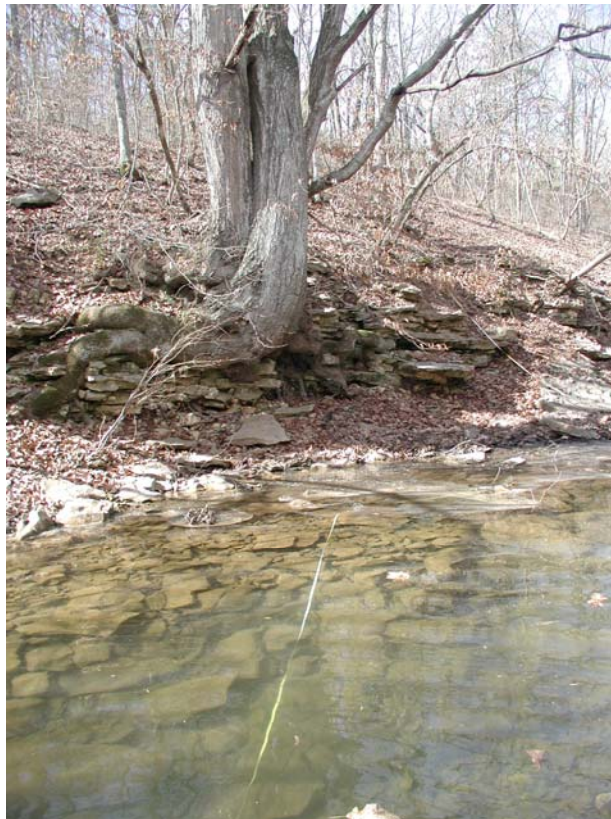
Picture 26. Bedrock bluff and colluvium along south bank (860 m)
