Geomorphic Assessment of the South Dry Sac River below Valley Water Mill

By: Robert T. Pavlowsky, Ph.D.
Ozarks Environmental and Water Resources Institute
Missouri State University

Submitted to the Watershed Committee of the Ozarks on March 15, 2006

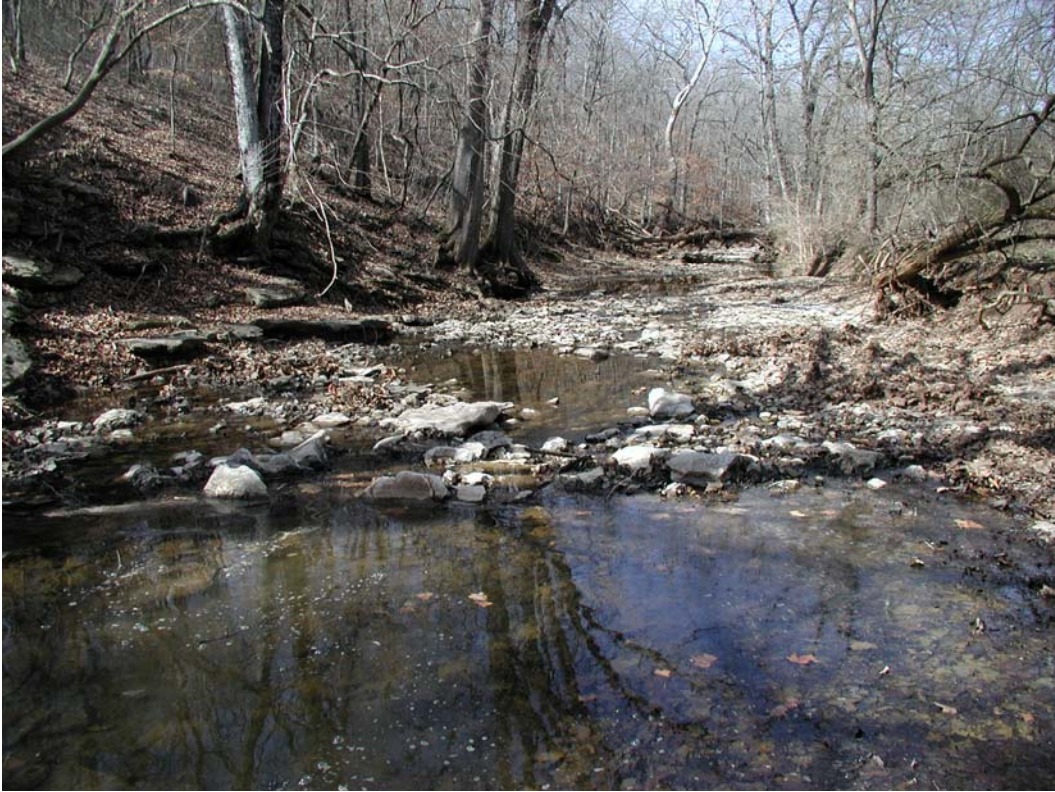
Picture 27. Bluff controlled riffle-pool sequence (880 m)

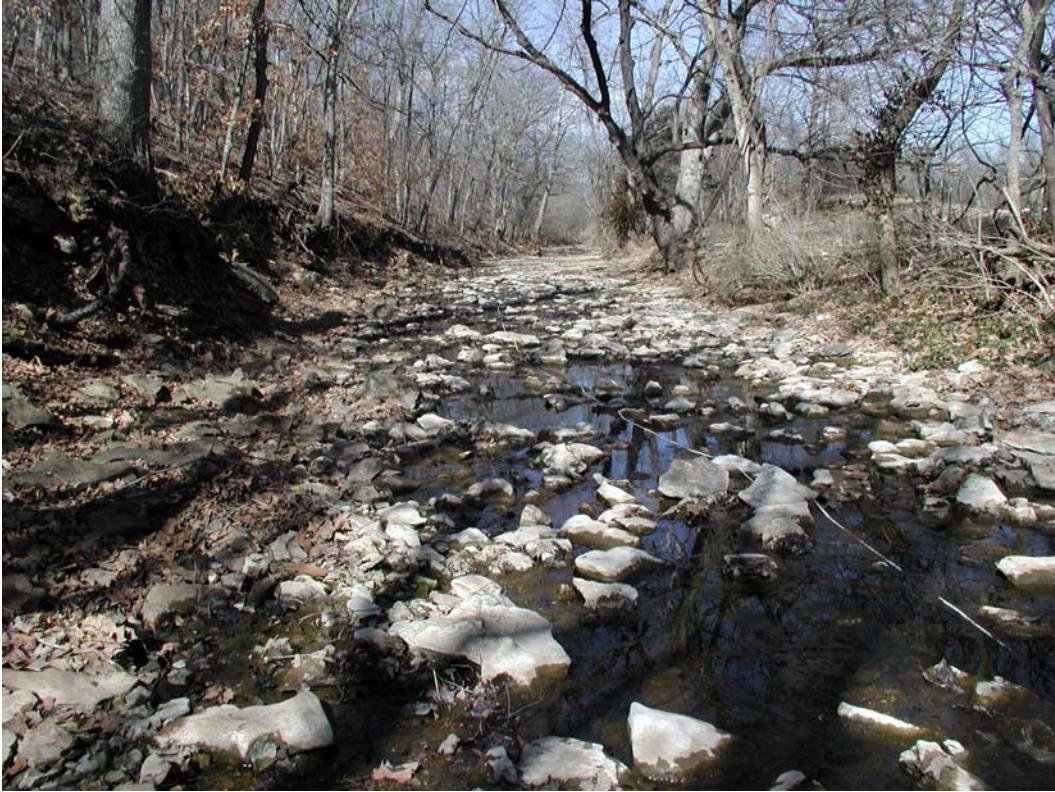
Picture 28. Steep bluff controlled reach looking downstream (950 m)

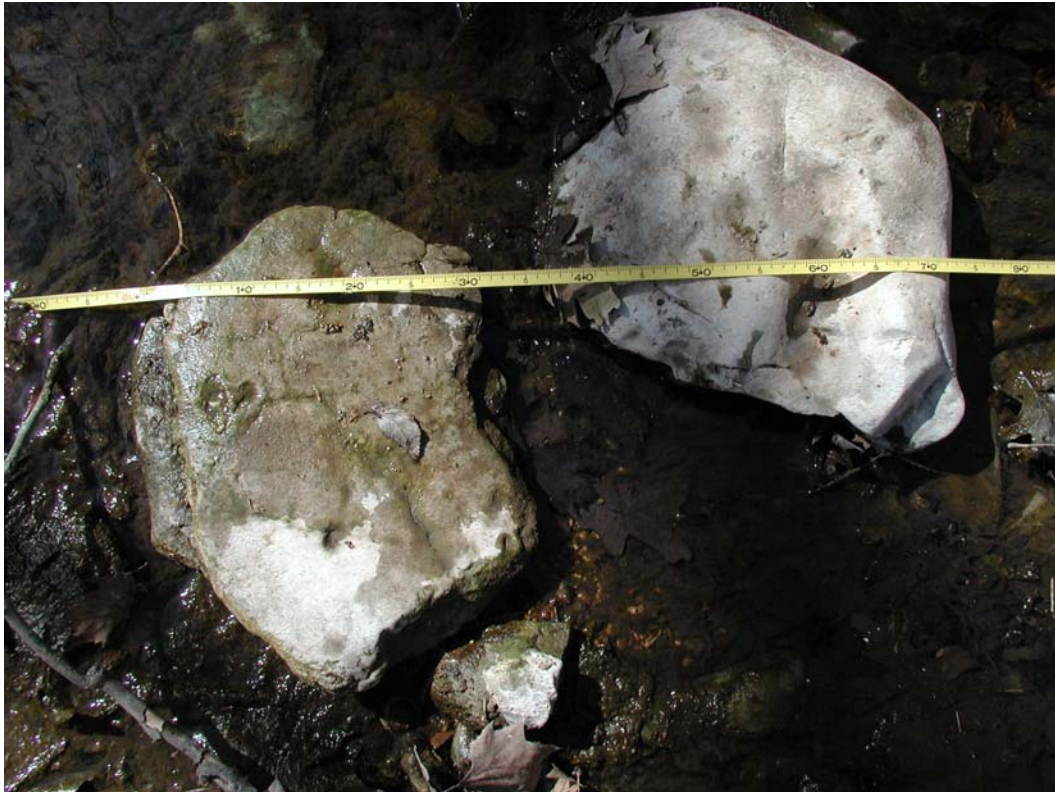
Picture 29. Large bed sediment at 960 m

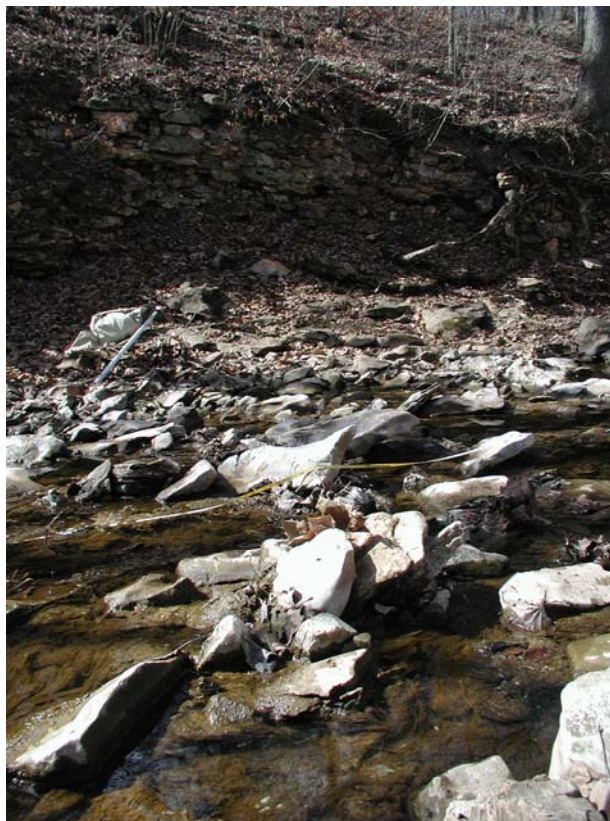
Picture 30. Imbricated bed at 965 m
