**Geomorphic Assessment of Upper Wards Branch,
Springfield, Missouri**

**Final report to Olsson Associates for
the City of Springfield, Missouri**

OEWRi EDR-10-006

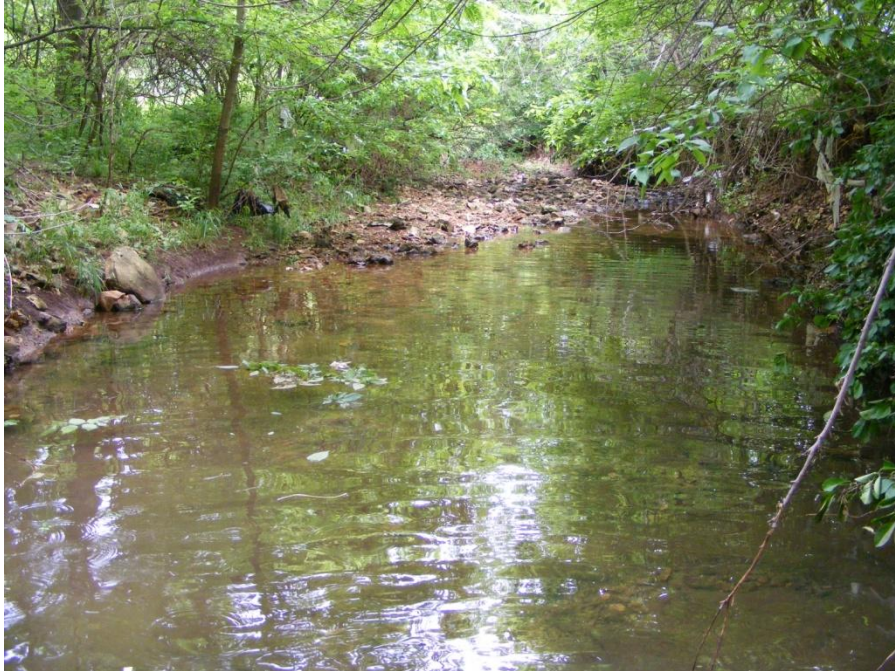
Sub-Reach 2 – (115 – 300 ft) Located upstream of concrete liner. Water pools behind sewer line which may contribute to bank instability due to saturation (Photo 5 and 6). Sub-reach has a bedrock bed with gravel/cobble veneer suggesting this reach transports gravel during floods and there is also evidence of incision along both banks (Photos 7 and 8). **There is a spring upwelling at station 200 feet.** Cross-section #2 located at station 225 feet.

Photo 5. SR-2 cross-section #2 (station 225 ft) looking upstream.

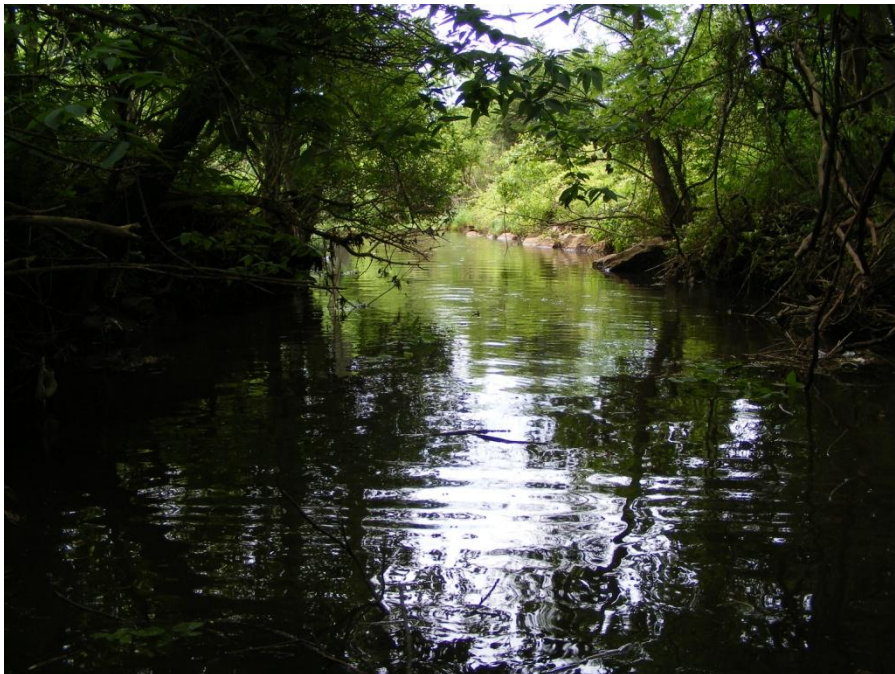
Photo 6. SR-2 pooled area upstream of concrete liner at cross-section #2 (station 225 ft) looking downstream.

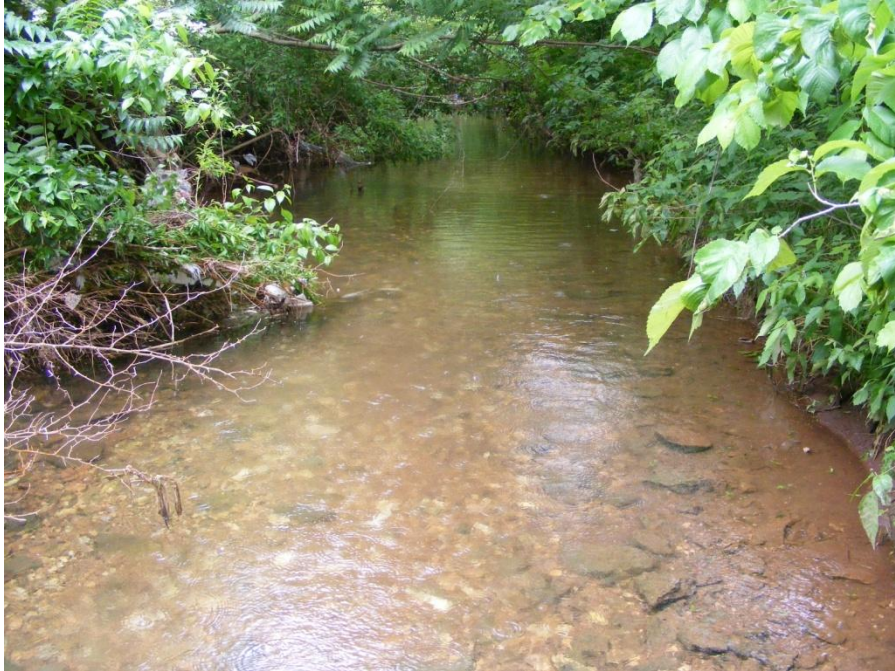
Sub-Reach 4 – (420 – 570 ft) This area is pooled upstream of mega-bar complex (Photos 11 and 12). This reach has bank erosion along the left bank with a floodplain beginning to form along the right bank (Photos 13 and 14). Cross-section #3 located at station 460 feet. Between stations 420 ft and 520 ft the risk to the detention basin embankment is more moderate as the distance from the top of the embankment is 50 ft from the edge of the vertical stream bank.

Photo 11. SR-4 cross-section #3 (station 460 ft) looking upstream.

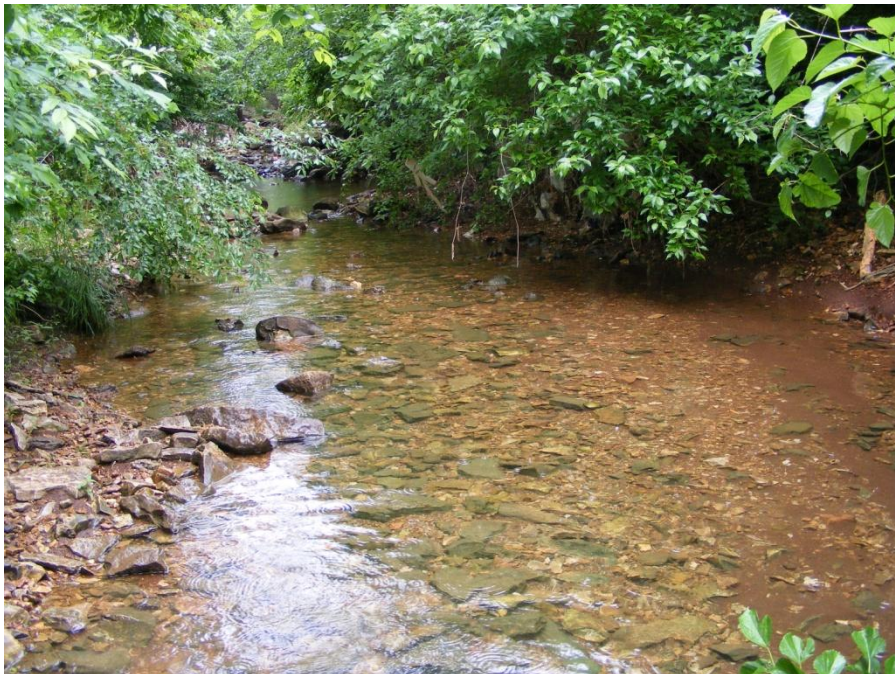
Photo 12. SR-4 cross-section #3 (station 460 ft) looking downstream.

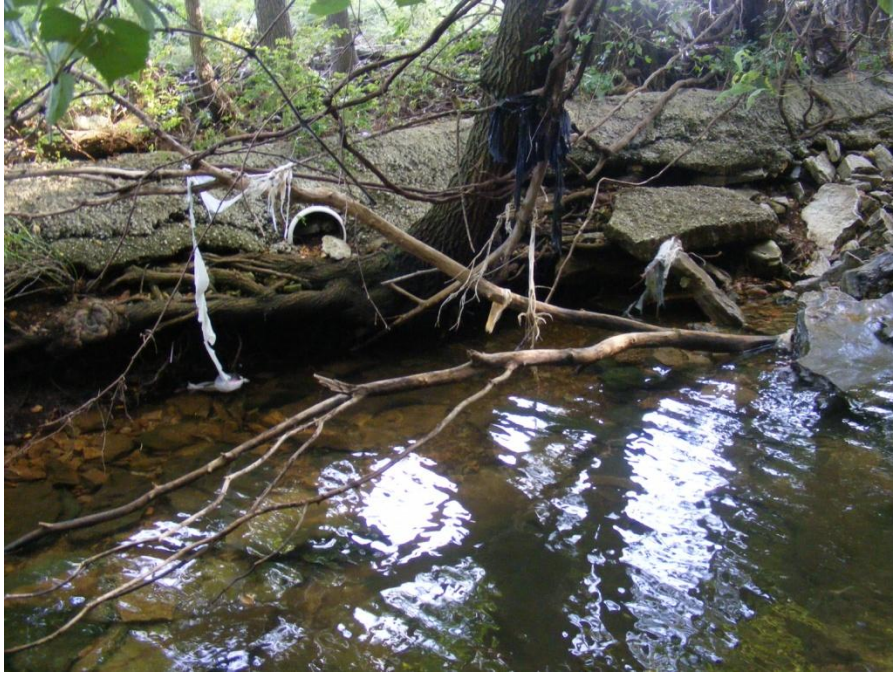
- 3.) Right bank erosion between stations 750-850 is exposing and undermining the sanitary sewer casing that crosses the channel at station 850 ft. In some places the channel is 2.5 ft lower than the bottom of the exposed sewer casing. Broken concrete from the casing, unconsolidated supporting rock, and limestone aggregate from the trench are eroding out from underneath the sewer line. Additionally, the angle of flow at the sewer crossing appears to be eroding along the back of the sewer line at higher flows that will continue to expose more of the sewer through this reach.

Photo 19. SR-5 undercut concrete sewer casing starting to fail (station 750 ft)

- 4.) **Sewer Line Casing and Block Wall** - Directly below James River Expressway a concrete cased sewer line crosses the stream and is exposed along the north bank of the stream. The stream has undercut the sewer line as much as 2.5 ft downstream of the crossing and unconsolidated rock and limestone aggregate supporting the sewer is being washed away. The concrete is starting to deteriorate in some places as the stream is trying to cut north of the pipe which will continue to be exposed on both sides. Additionally, the left stream bank is 10 ft from a block wall that is probably supported by bedrock that is close to the surface here. Checking the depth of the footing and adding protection may be necessary.

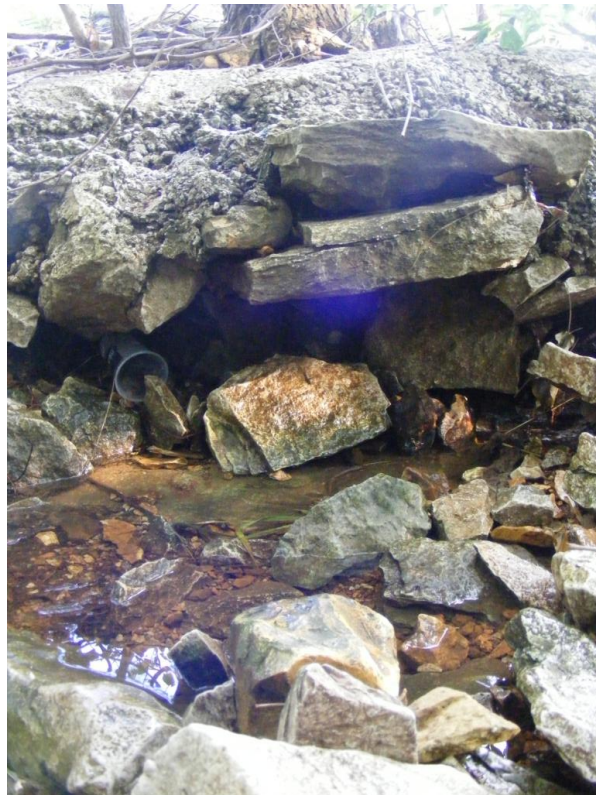
Photo 20. Unconsolidated material supporting sewer casing is washing away (station 750 ft)

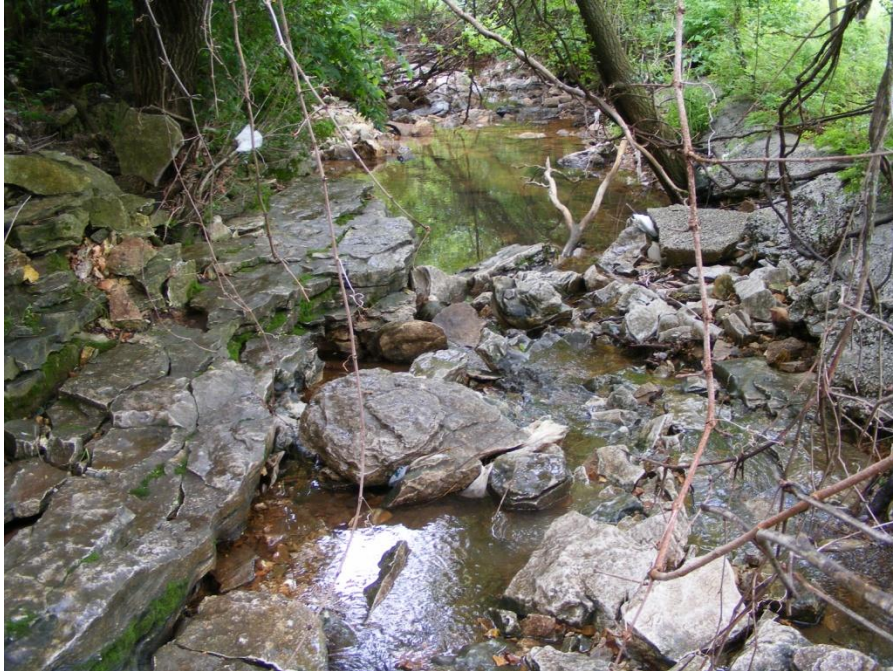
- 4) SR-5: Bedrock knickpoint. It is slowly breaking apart and releasing relatively large material to the downstream disturbance reach. Increased slope, velocity, and boulder supply may be the original cause of the disturbance zone (at SR-3). Sewer line crosses at the top of this reach also causes further increase in slope during floods. Concrete sewer casing exposed in the bed and right bank is undercut as much as 2.5 ft and appears to be losing supporting material and will continue to deteriorate as more is uncovered as the channel cuts north.

Photo 21. SR-5 bedrock knick point assemblage, boulders (>700 mm) appear to be transported in this reach (station 800 ft).

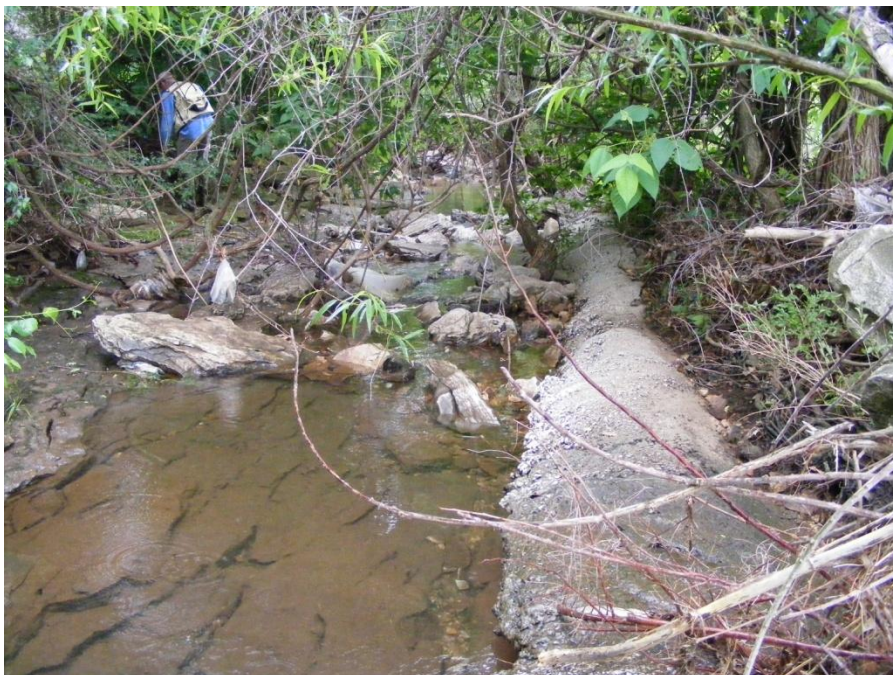
Photo 22. SR-5 sewer line casing exposed along right bank through bedrock knick point assemblage. Stream is cutting north (right bank) that will continue to expose more of the sewer line (station 830 ft).

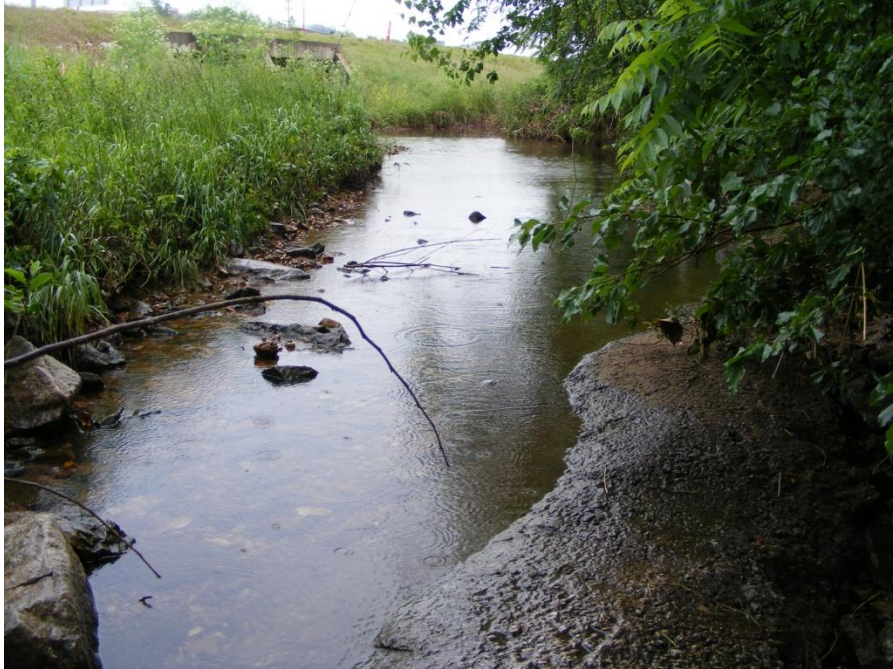
Sub-Reach 6 – (850 – 976 ft) This reach extends from the downstream face of the James River Expressway culvert to the **sewer line crossing** (Photo 27). This reach includes a confluence with the tributary running along the southside of the west bound lane of James River Expressway. The bed consists of gravel and cobble and gravel splays and flood channels are found on the floodplain (Photo 28).

Photo 27. SR-6 above sewer crossing at station 850 ft to downstream face of James River Expressway culvert.

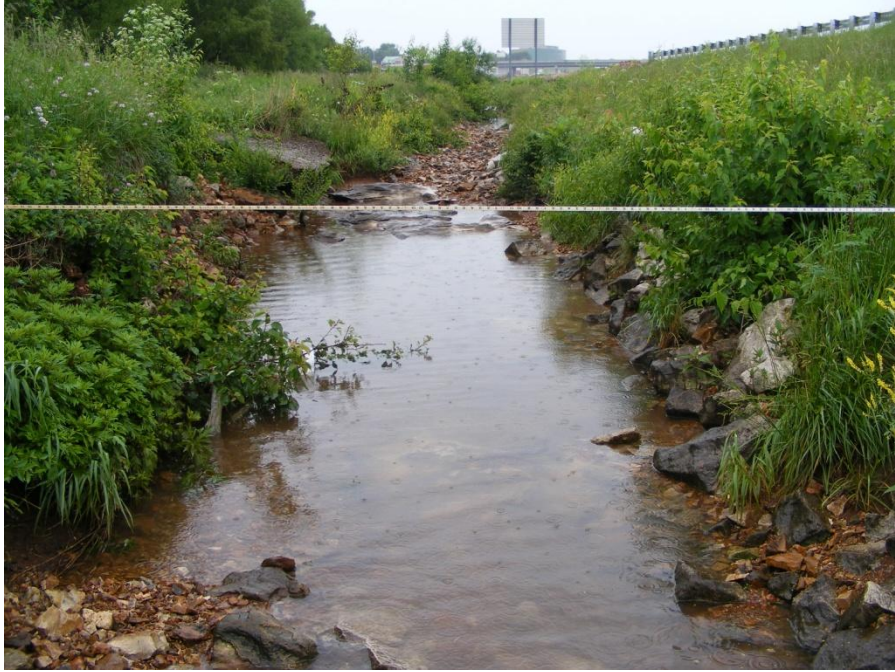
Sub-Reach 8 – (1,246 – 1,390 ft) This reach consists of a gravel and cobble bed with failing grouted rip-rap along the right bank located below the outfall located at 1,390 feet (Photos 29 and 30). Cross-section #5 located at station 1,340 feet (Photos 31 and 32).

Photo 29. SR-8 cross-section #5 (station 1,340 ft) looking upstream.

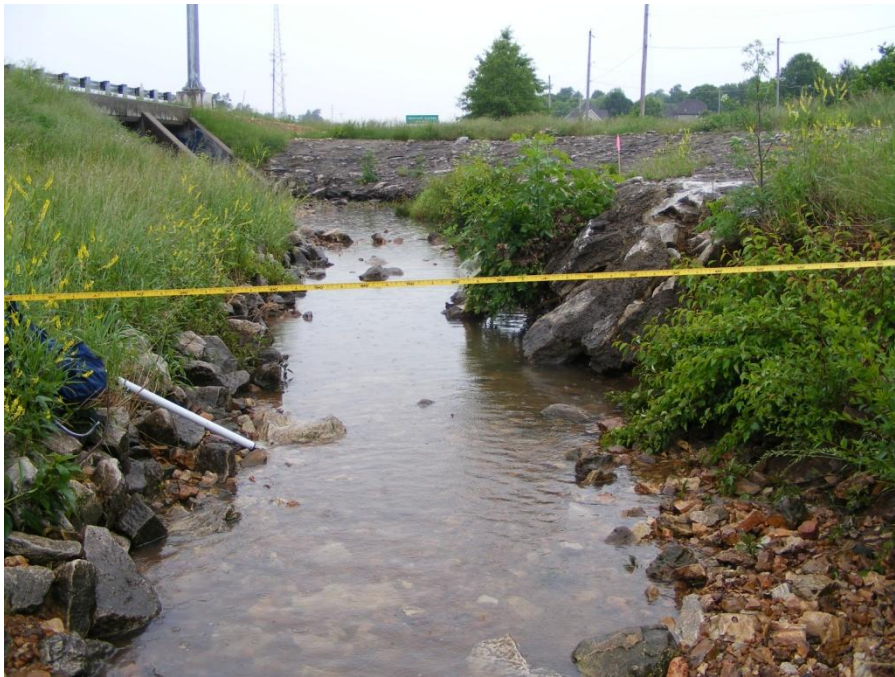
Photo 30. SR-8 cross-section #5 (station 1,340 ft) looking downstream.

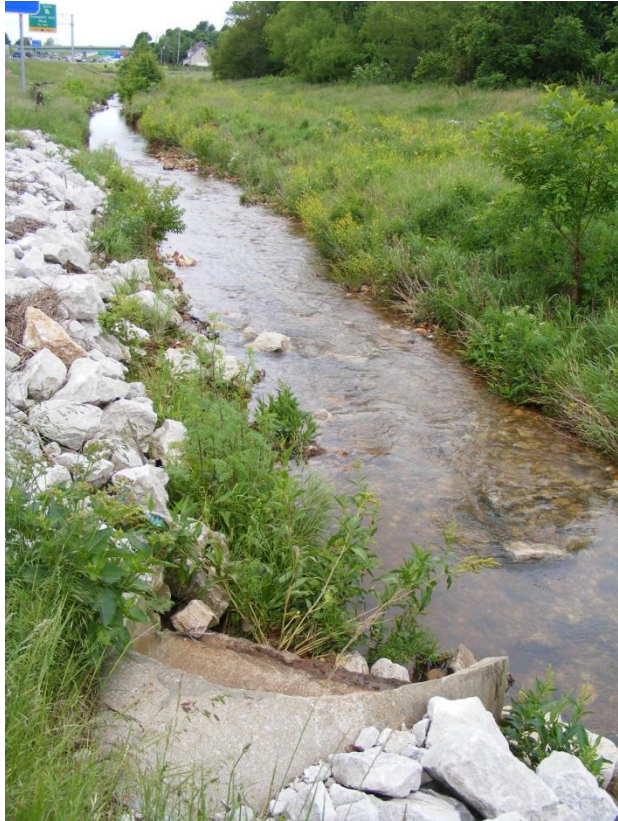
Sub-Reach 10a – (1,760 – 1,840 ft) **Loose rip-rap** located along the left bank is falling into the stream (Photo 39). Smaller softball-size material can be found downstream below the James River Expressway. The bed consists of fresh gravel located below the outfall of storm pipe at station 1,840 feet around which local erosion has occurred (Photo 40). Continued bank erosion threatens National Ave off-ramp embankment. The toe of the stream bank is 7.5 ft lower in elevation and 22 ft horizontal distance from the edge of pavement.

Photo 39. SR-10a located below storm pipe at station 1,840 ft.

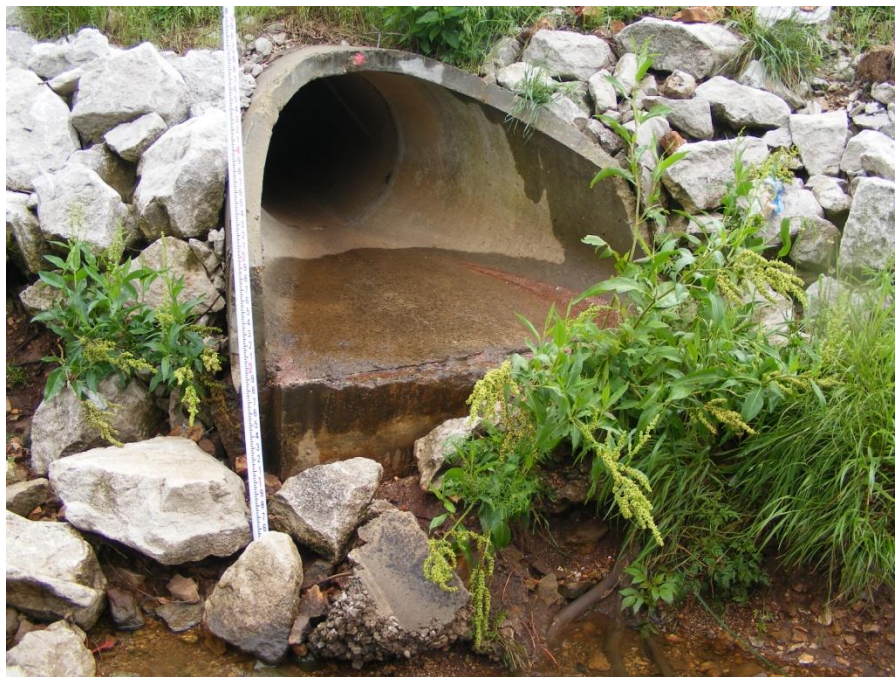
Photo 40. SR-10a local scour around storm pipe outfall at station 1,840 ft.

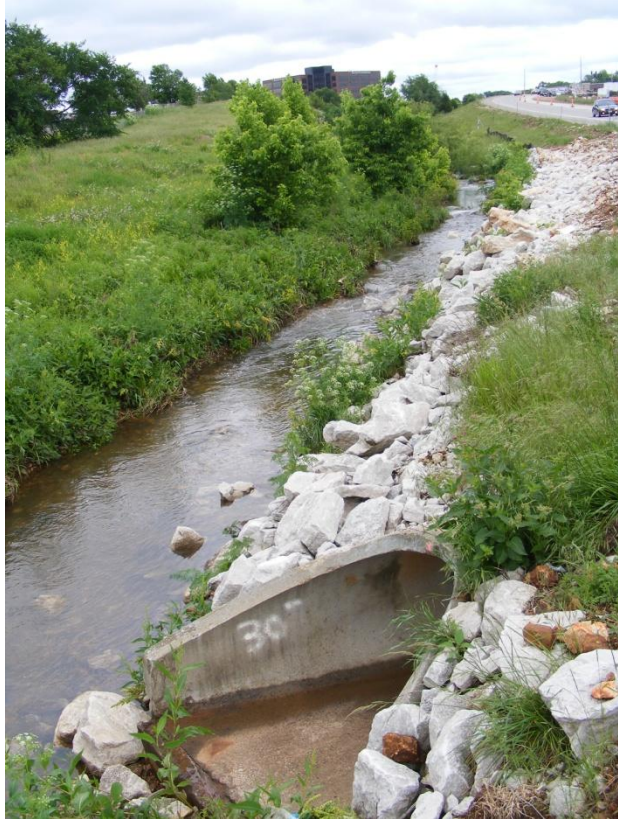
Photo 41. SR-10b looking upstream from station 1,840 ft with rip-rap along left bank falling into channel.

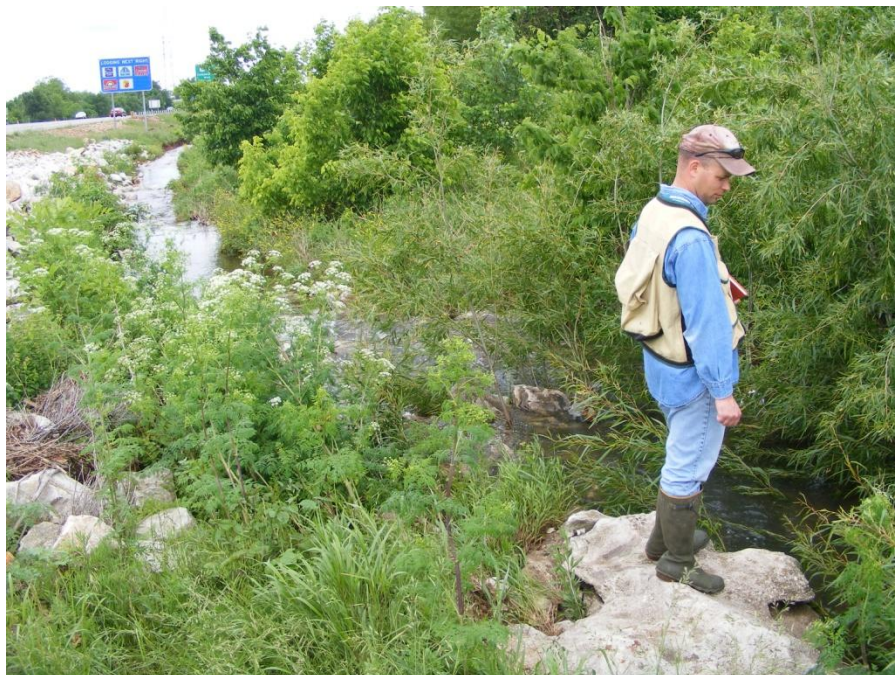
Photo 42. SR-11 bedrock knick point at stations 2,000-2,050 ft.

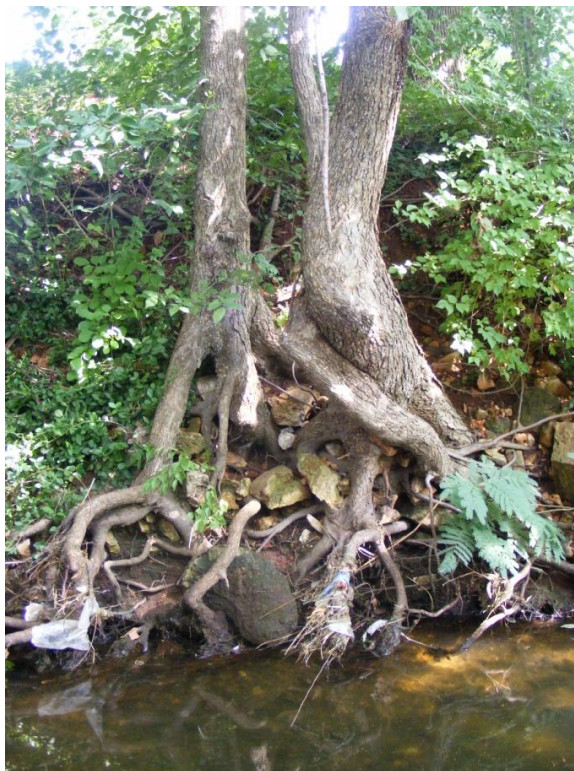
Photo 54. SR-15 "surf" trees with barked roots are evidence of mass wasting of bank material in the past. Suspended root crowns suggest wedge failure is slowly eroding and these trees could fall into the stream causing future instability (station 3,850 ft).

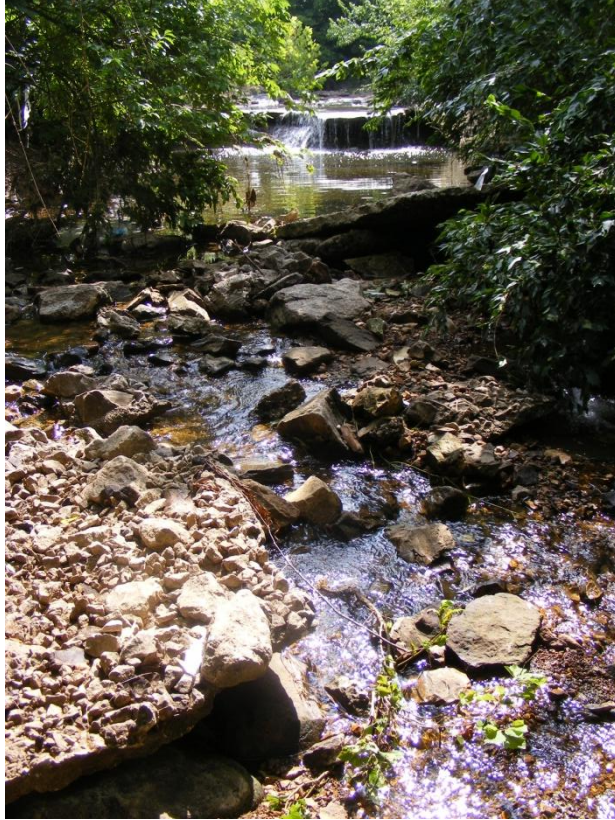
Photo 59. SR-15 looking upstream toward the Bradford Lake spillway with busted pieces of concrete in the channel downstream of the scour hole below the apron (station 3,940 ft).

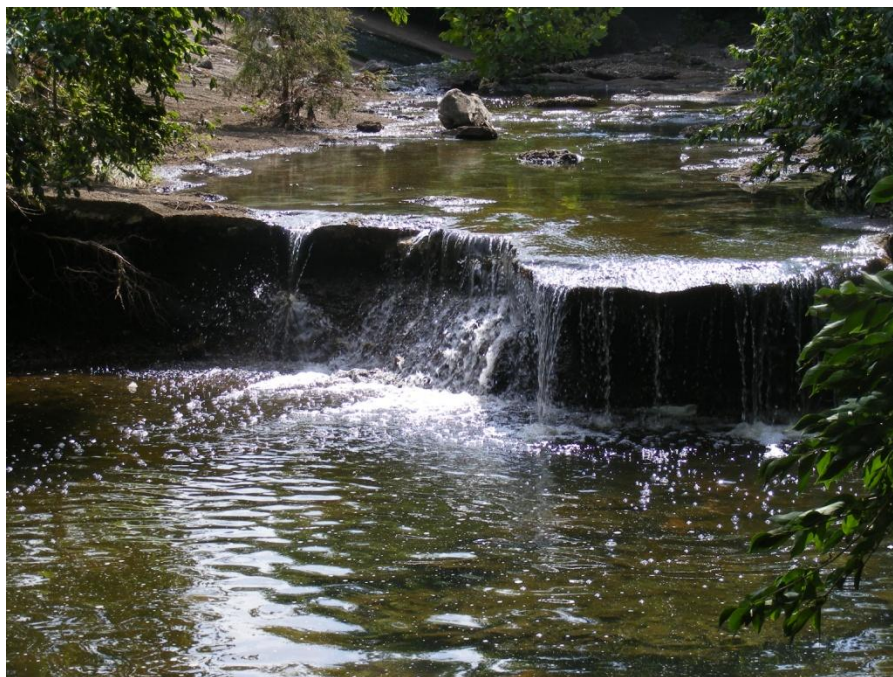
be moved downstream. The condition of the spillway appears to be getting worse as the cherty-clay fill that appears to be supporting the structure is actively eroding.

Photo 60. SR-15 scour hole below concrete apron appears to be supported by compacted cherty-clay fill material that is being undercut (station 4,025 ft).

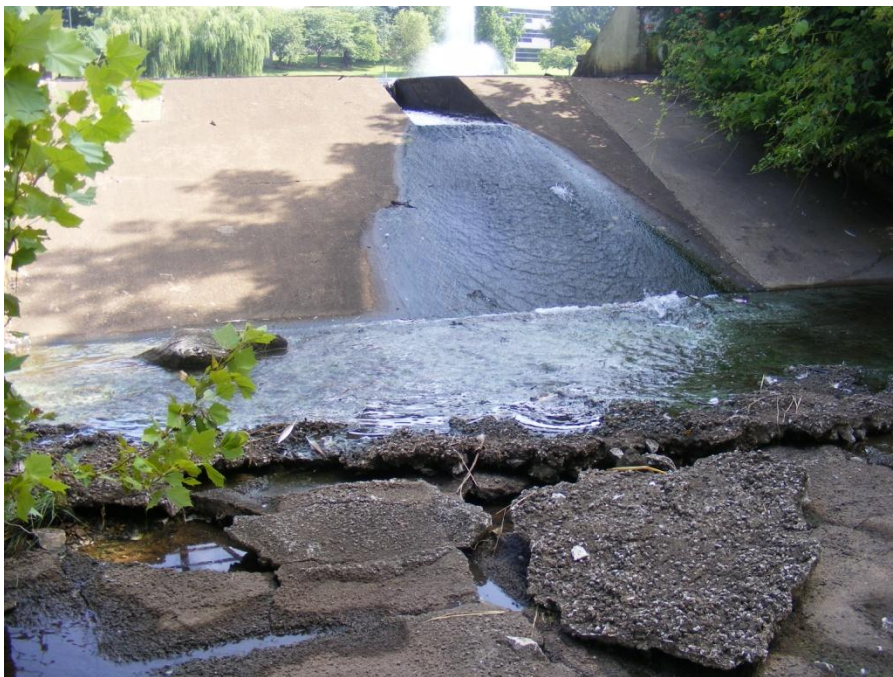
Photo 62. SR-15 downstream of Bradford Lake outlet structure concrete slabs are being pulled off the floor of the spillway.
