**Geomorphic Assessment of Upper Wards Branch,  
Springfield, Missouri**

**Final report to Olsson Associates for  
the City of Springfield, Missouri**

**OEWRI EDR-10-006**

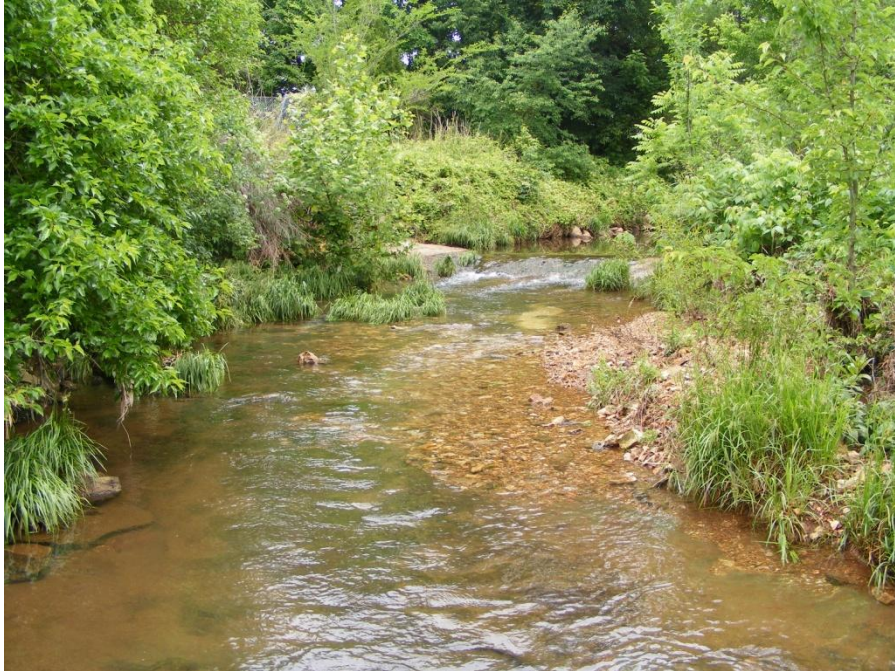
Sub-Reach 1 – (0 – 115 ft) Bedrock reach below concrete channel liner (Photo 1) at station 115 ft indicating gravel is transported during floods. Grouted rip-rap on right bank in bridge embankment (Photo 2 and 3). **Eroding high right bank** upstream of the culvert threatens west wing-wall and embankment. Cross-section #1 at located station 35 feet.

**Photo 1. SR-1 cross-section #1 (station 35 ft) looking upstream at concrete liner.**

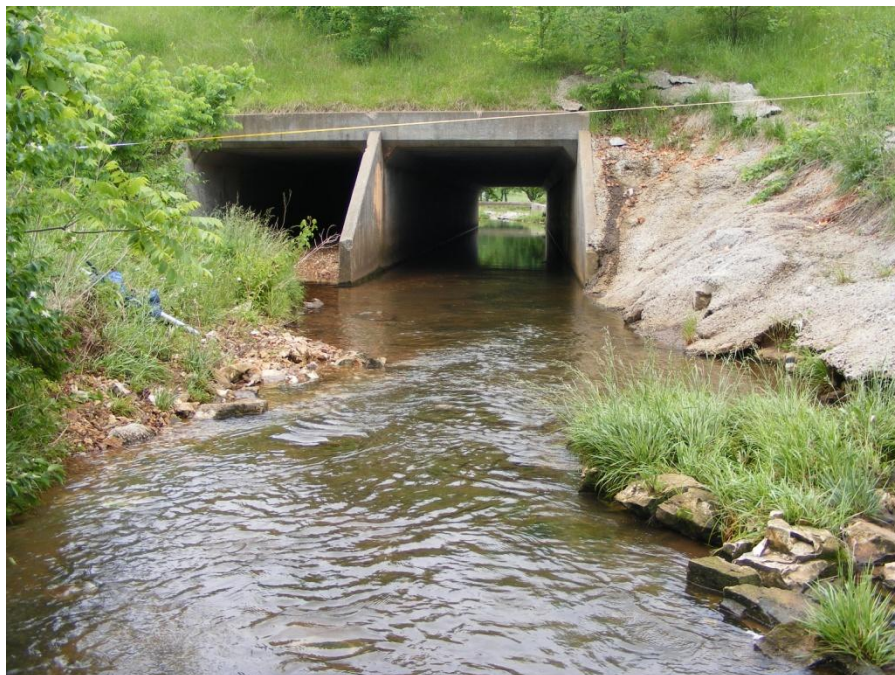
**Photo 2. SR-1 cross-section #1 (station 35 ft) looking downstream at Republic Road culvert.**

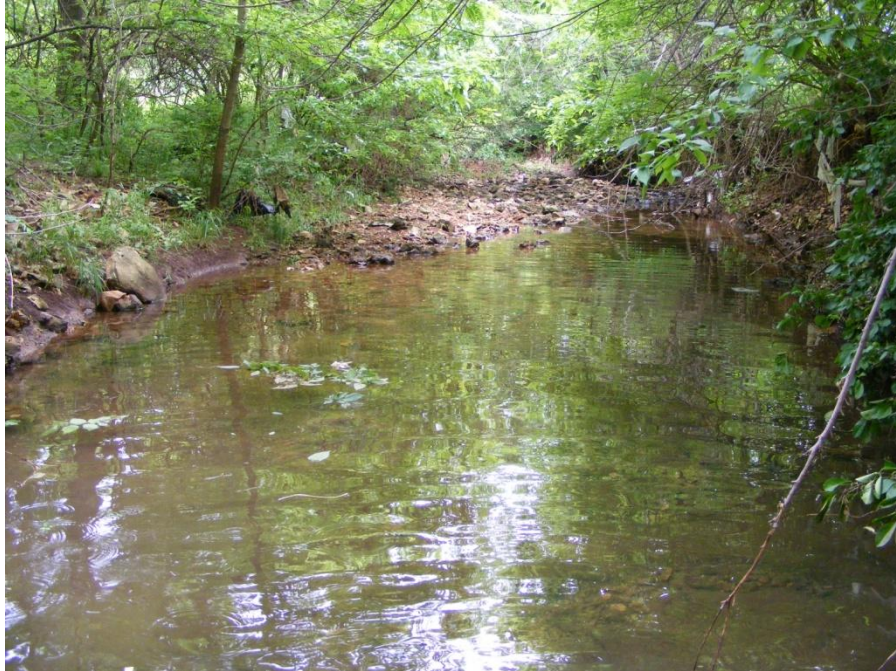
Sub-Reach 2 – (115 – 300 ft) Located upstream of concrete liner. Water pools behind sewer line which may contribute to bank instability due to saturation (Photo 5 and 6). Sub-reach has a bedrock bed with gravel/cobble veneer suggesting this reach transports gravel during floods and there is also evidence of incision along both banks (Photos 7 and 8). **There is a spring upwelling at station 200 feet.** Cross-section #2 located at station 225 feet.

**Photo 5. SR-2 cross-section #2 (station 225 ft) looking upstream.**

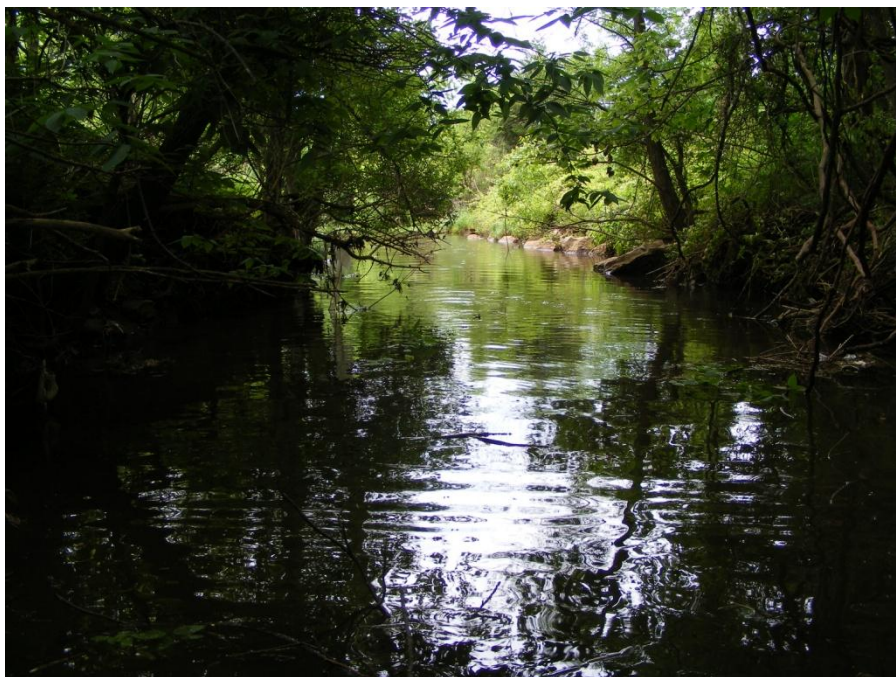
**Photo 6. SR-2 pooled area upstream of concrete liner at cross-section #2 (station 225 ft) looking downstream.**

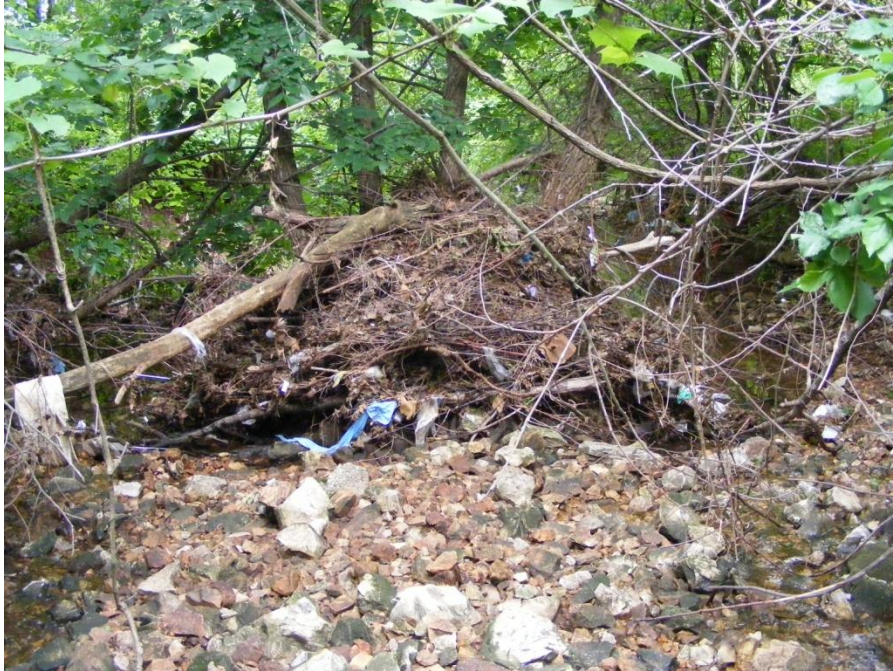
Sub-Reach 3 – (300 – 420 ft) This is a **disturbance reach** located below the detention basin outfall from the south. Trees and LWD located within the channel cause the channel to split and widen (Photo 9). Bank erosion released gravel/cobble that helped form a mega-bar complex located here (Photo 10). Bank erosion on the left bank has undercut the detention basin outfall spillway and appears to be eroding into the north embankment. The highest risk areas are between stations 350 and 420 ft where the top of the embankment is 12 ft above the stream and 20 ft from the edge of the stream bank.

**Photo 9. SR-3 large woody debris jam and mega bar formation (station 350 ft).**

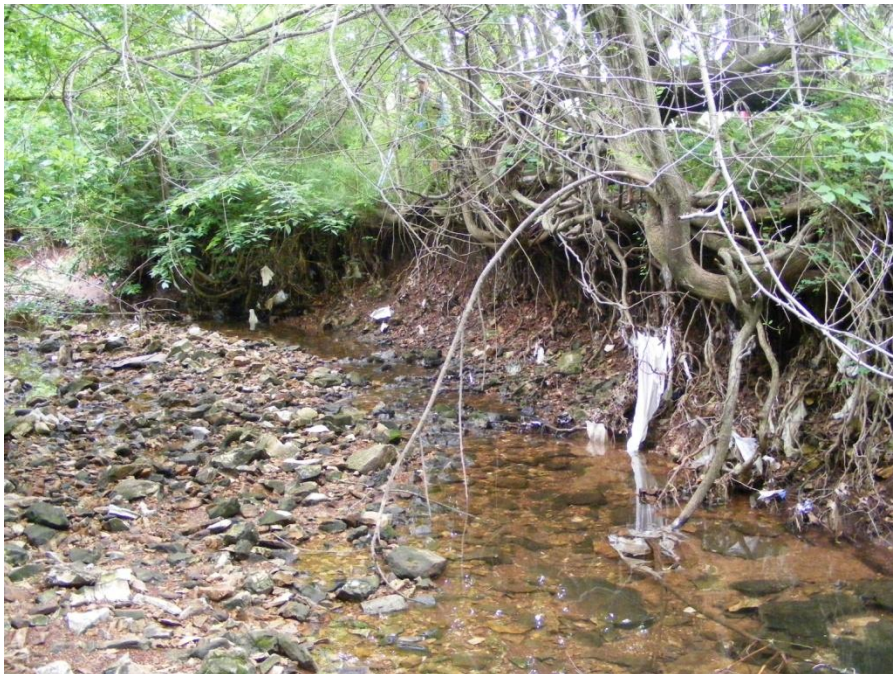
**Photo 10. SR-3 bank erosion and gravel/cobble deposition in disturbance reach (station 350 ft).**

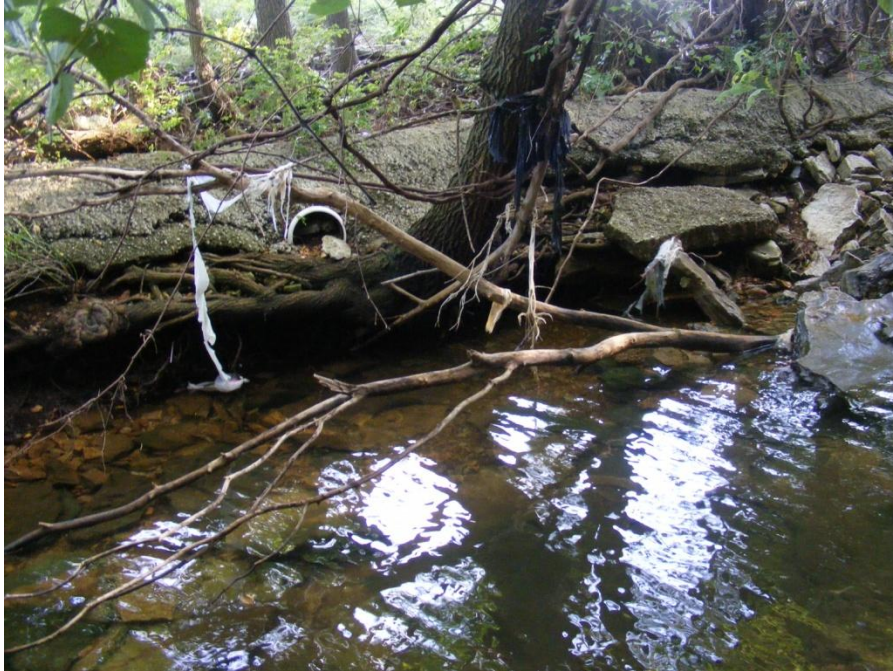
- 3.) Right bank erosion between stations 750-850 is exposing and undermining the sanitary sewer casing that crosses the channel at station 850 ft. In some places the channel is 2.5 ft lower than the bottom of the exposed sewer casing. Broken concrete from the casing, unconsolidated supporting rock, and limestone aggregate from the trench are eroding out from underneath the sewer line. Additionally, the angle of flow at the sewer crossing appears to be eroding along the back of the sewer line at higher flows that will continue to expose more of the sewer through this reach.

**Photo 19. SR-5 undercut concrete sewer casing starting to fail (station 750 ft)**

- 4.) **Sewer Line Casing and Block Wall** - Directly below James River Expressway a concrete cased sewer line crosses the stream and is exposed along the north bank of the stream. The stream has undercut the sewer line as much as 2.5 ft downstream of the crossing and unconsolidated rock and limestone aggregate supporting the sewer is being washed away. The concrete is starting to deteriorate in some places as the stream is trying to cut north of the pipe which will continue to be exposed on both sides. Additionally, the left stream bank is 10 ft from a block wall that is probably supported by bedrock that is close to the surface here. Checking the depth of the footing and adding protection may be necessary.

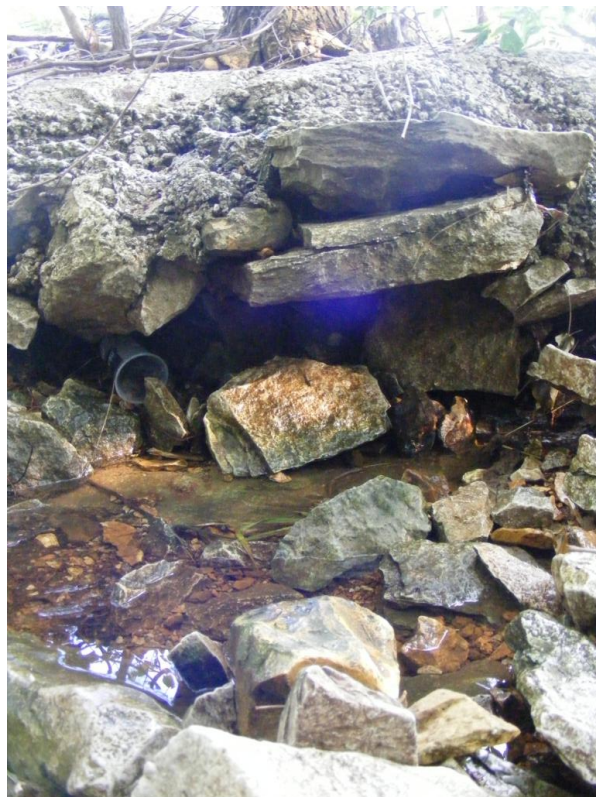
**Photo 20. Unconsolidated material supporting sewer casing is washing away (station 750 ft)**

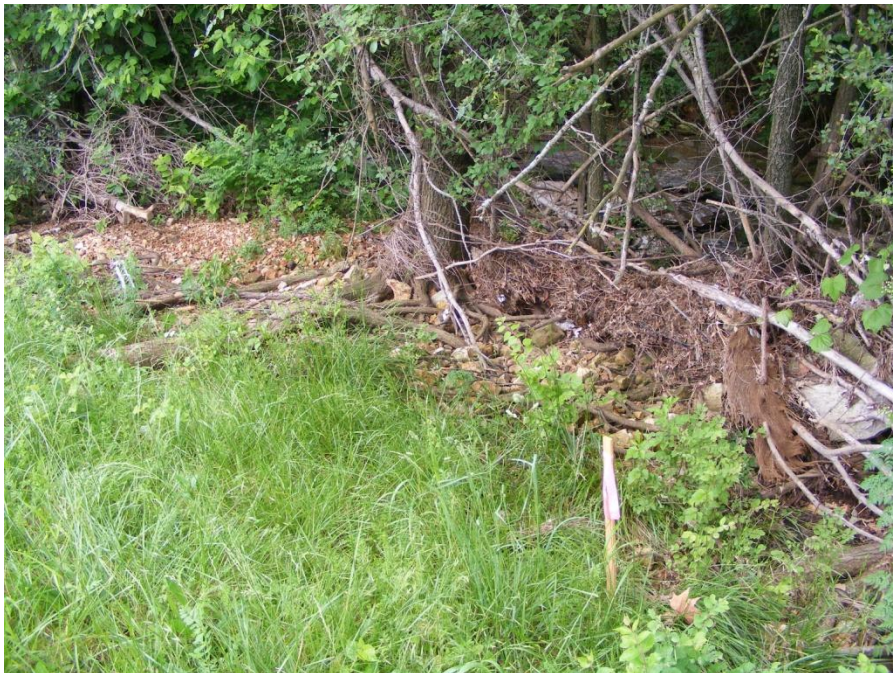
Sub-Reach 6 – (850 – 976 ft) This reach extends from the downstream face of the James River Expressway culvert to the **sewer line crossing** (Photo 27). This reach includes a confluence with the tributary running along the southside of the west bound lane of James River Expressway. The bed consists of gravel and cobble and gravel splays and flood channels are found on the floodplain (Photo 28).

**Photo 28. SR-6 gravel splay on the right bank near station 900 ft.**

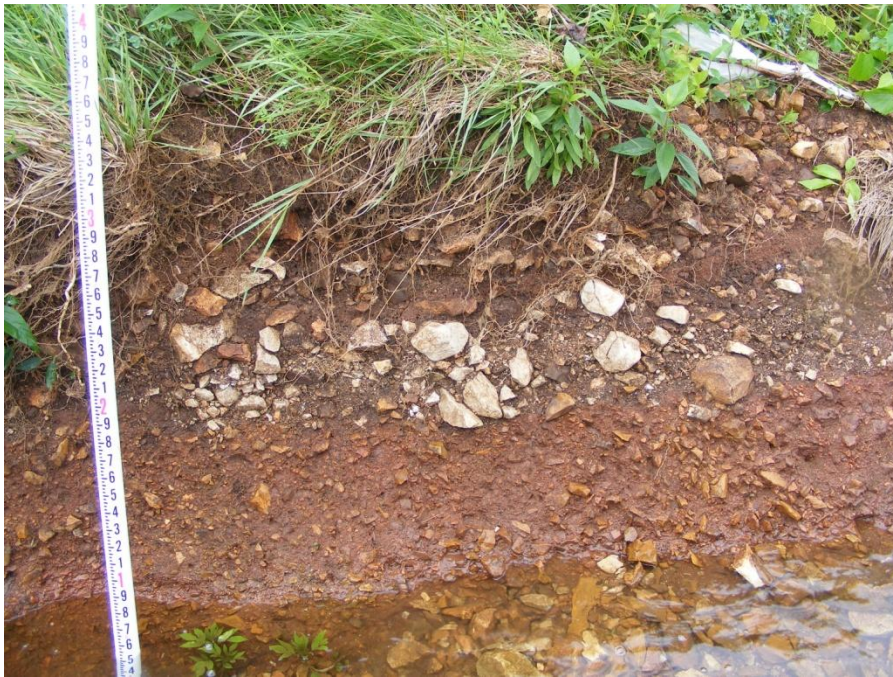
**Photo 34. SR-9a bank erosion at station 1,500 ft.**

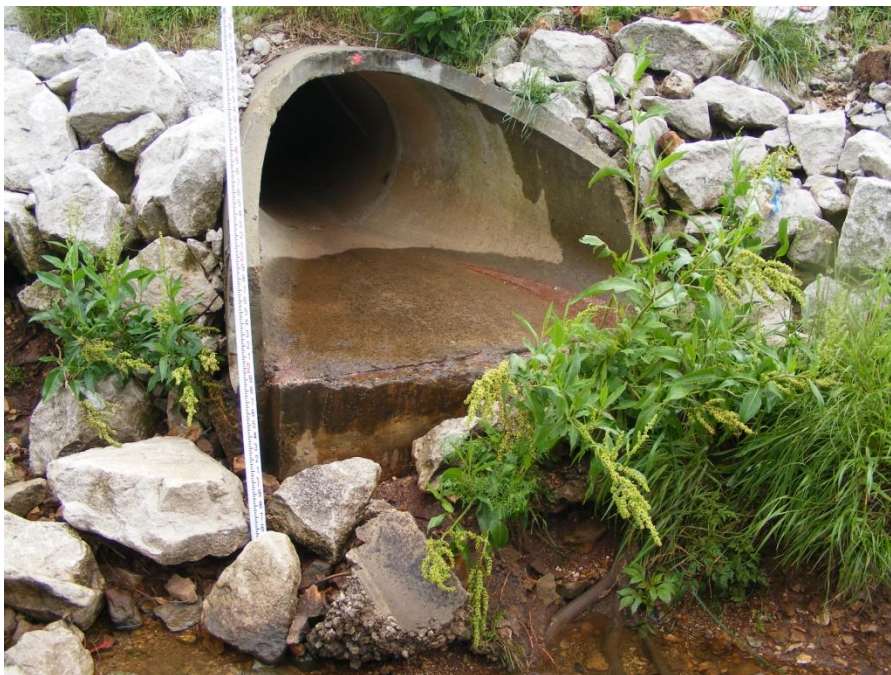
**Photo 40. SR-10a local scour around storm pipe outfall at station 1,840 ft.**

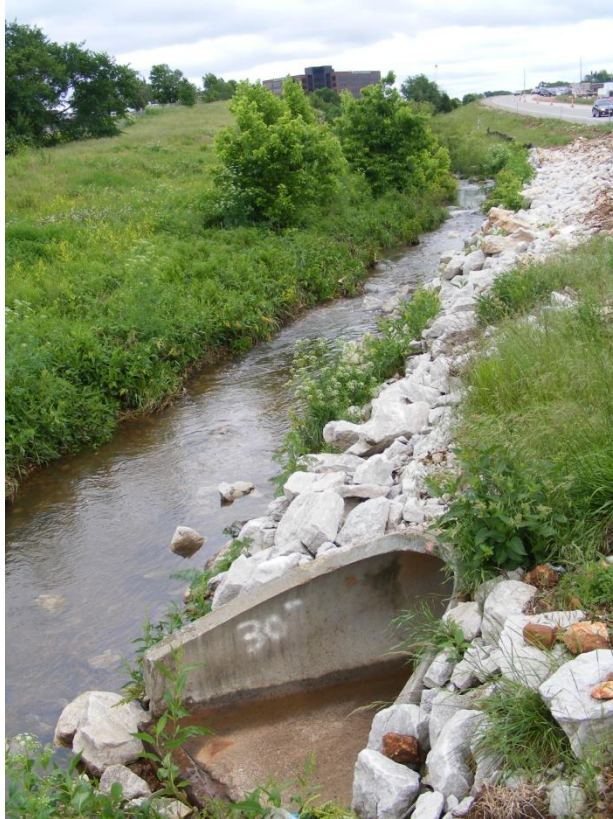
**Photo 41. SR-10b looking upstream from station 1,840 ft with rip-rap along left bank falling into channel.**

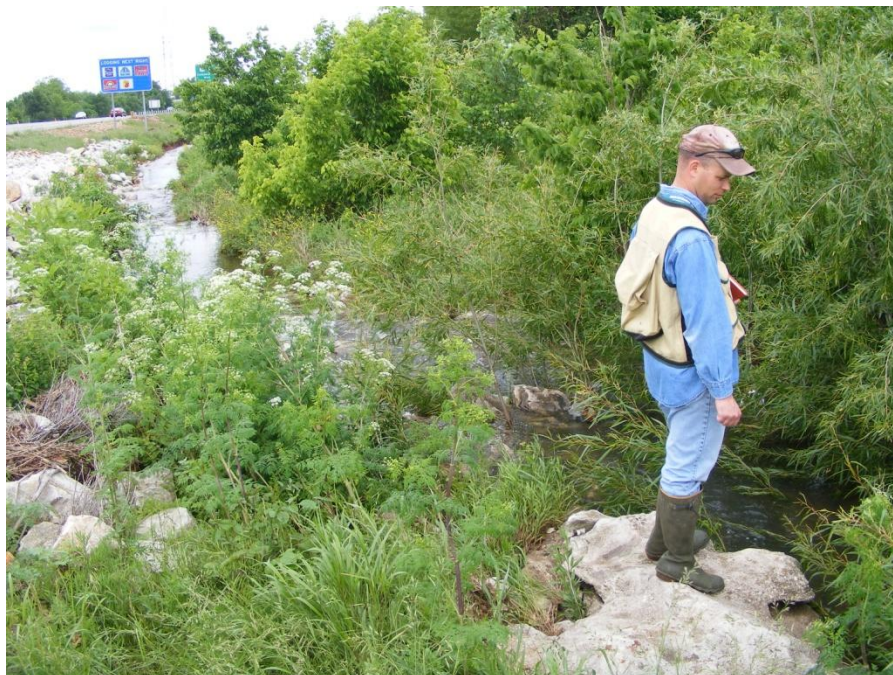
**Photo 42. SR-11 bedrock knick point at stations 2,000-2,050 ft.**

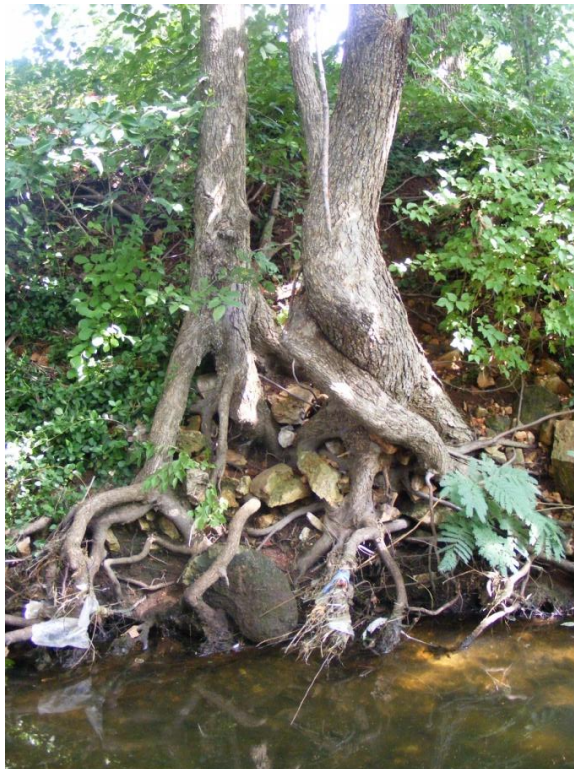
Upstream of the construction reach (stations 3,750-4,000) both banks are high and steep, suggesting a period of stream bed incision in the past. The right bank appears to be the most susceptible to failure due to its height ( $\approx 9.5$  ft) and angle (up to  $90^\circ$ ). The right bank supports Bradford Parkway and utilities installed behind the curb that is between 20-30 ft from the top of bank. Bank material appears to be chert-clay fill and construction debris including large boulders. Additionally, bed incision cause ponding from the floor of the Independence Road

**Photo 54. SR-15 "surf" trees with barked roots are evidence of mass wasting of bank material in the past. Suspended root crowns suggest wedge failure is slowly eroding and these trees could fall into the stream causing future instability (station 3,850 ft).**

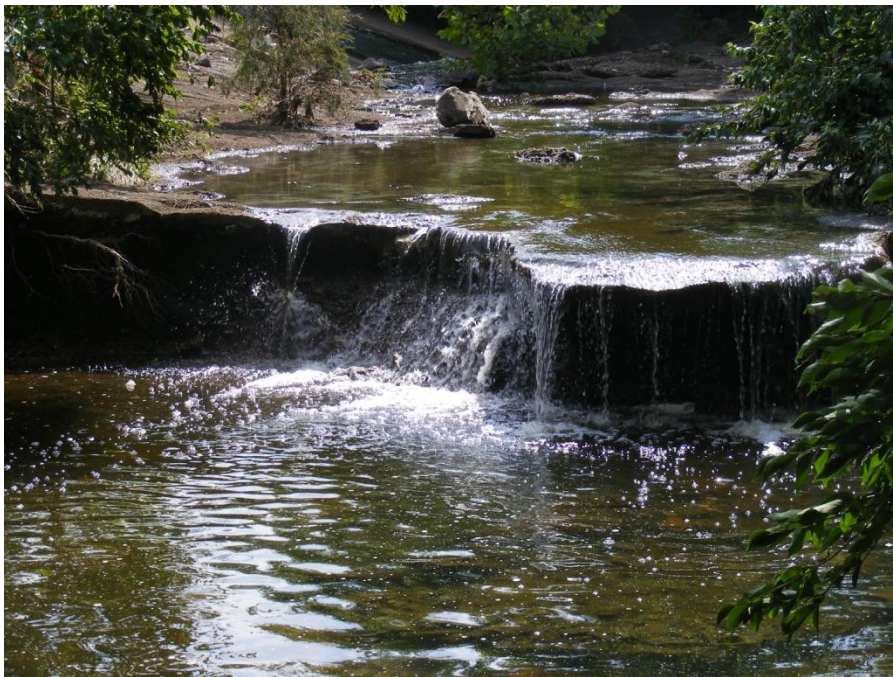
be moved downstream. The condition of the spillway appears to be getting worse as the cherty-clay fill that appears to be supporting the structure is actively eroding.

**Photo 60. SR-15 scour hole below concrete apron appears to be supported by compacted cherty-clay fill material that is being undercut (station 4,025 ft).**

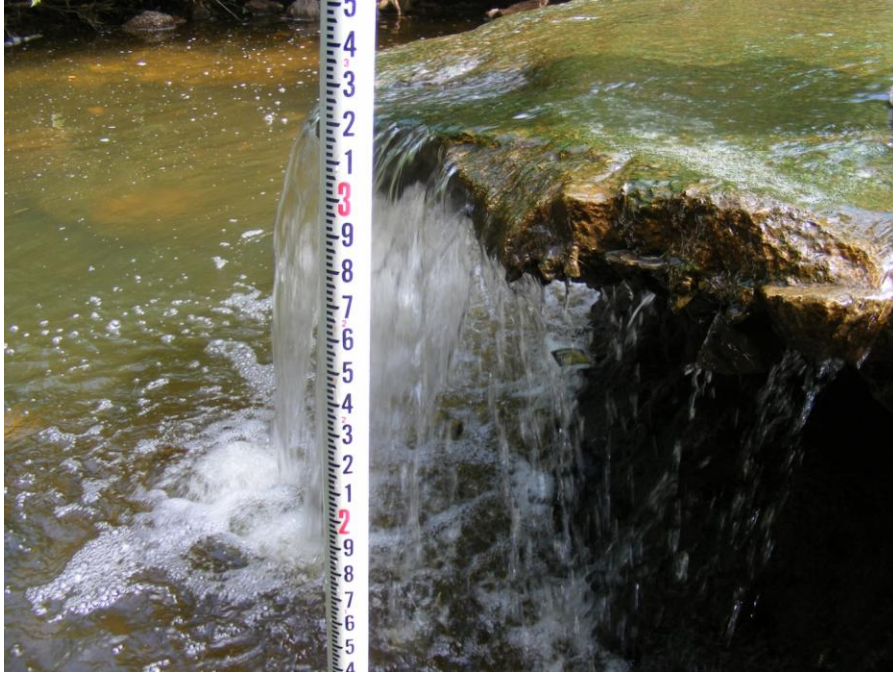
**Photo 61. SR-15 concrete apron of spillway is undercut around 3 ft (station 4,025 ft).**
