WARD BRANCH STREAM RESTORATION PROJECT

POST-CONSTRUCTION ASSESSMENT

FINAL REPORT

OEWRi EDR-08-004

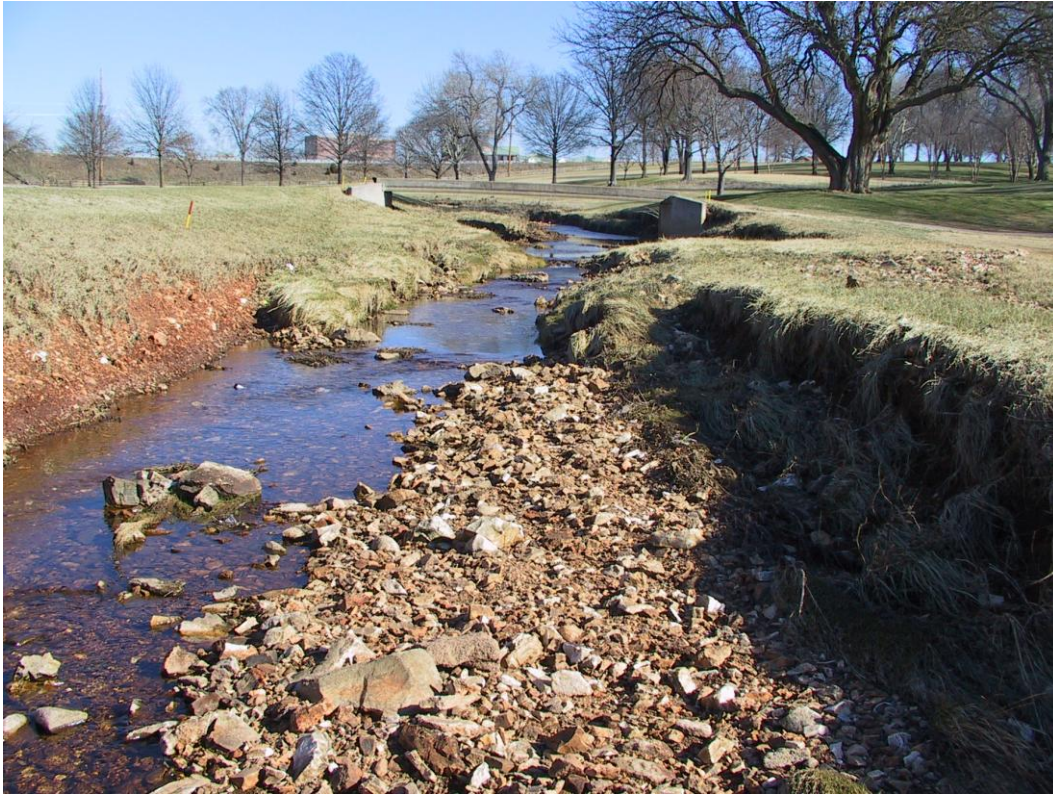
Picture 13. BEFORE - Riffle crest, bank failure, poor riparian conditions below second cart bridge looking upstream December 2004 (St. 850 feet)

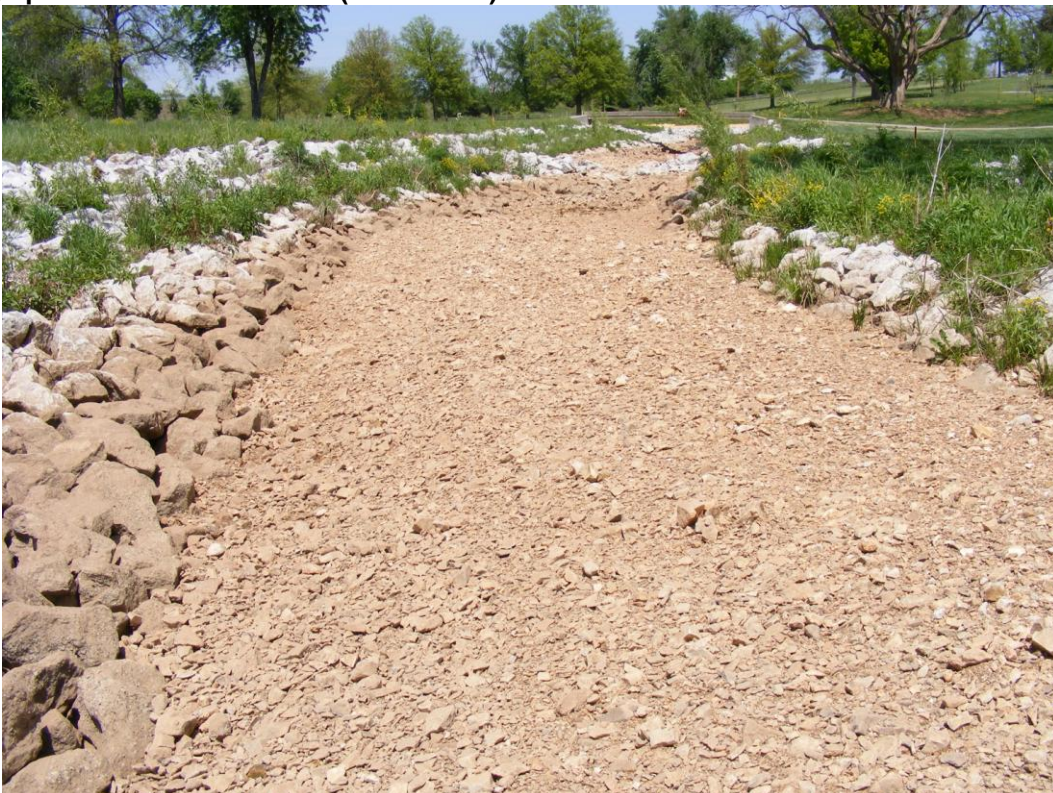
Picture 14. AFTER - Maintained riffle crest position, bank protection and enhanced riparian corridor May 2008 (St. 900 feet)

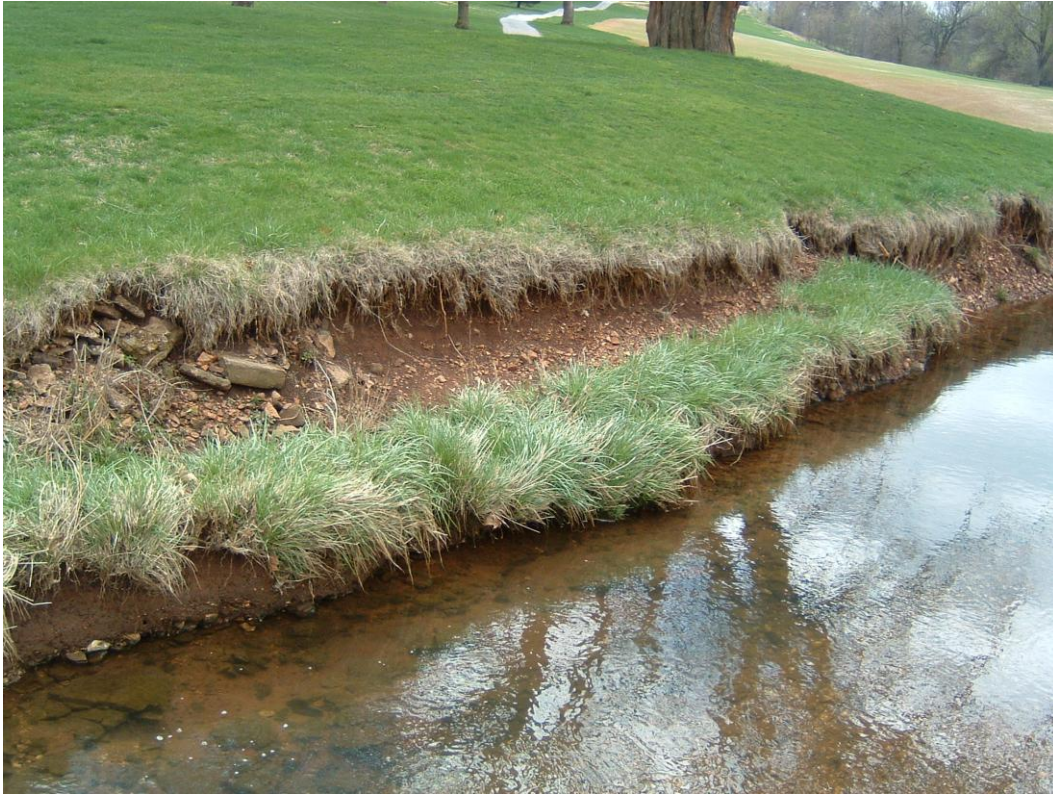
Picture 15. BEFORE - High bank angle collapse above second cart bridge looking downstream August 2005 (St. 700 feet)

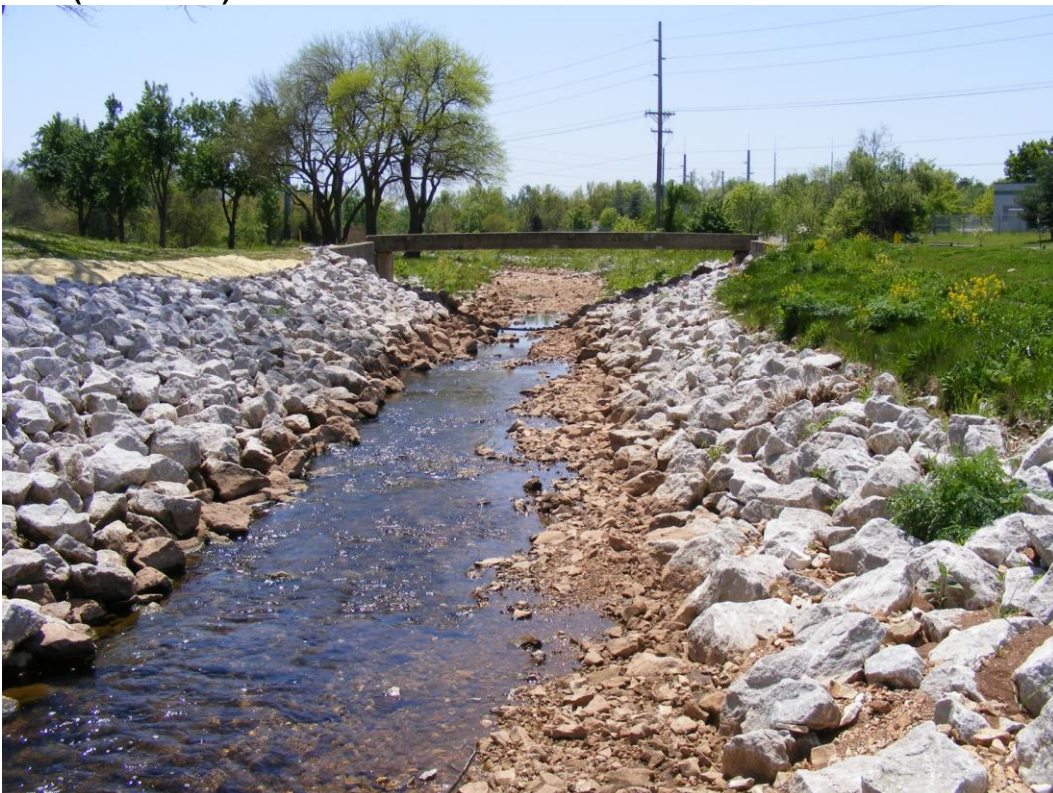
Picture 16. AFTER - Bank angle lower and toe rock above second cart bridge looking downstream May 2008 (St. 800 feet)

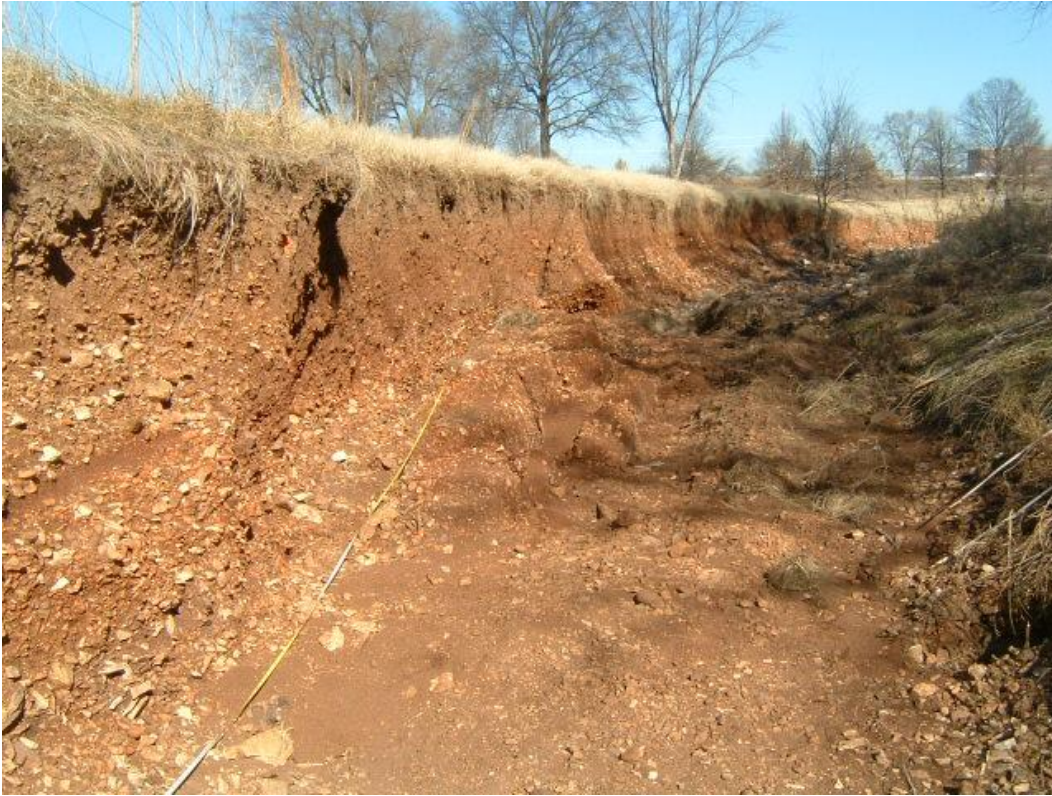
Picture 17. BEFORE - High west bank failure looking upstream January 2006 (St. 1,050 feet)

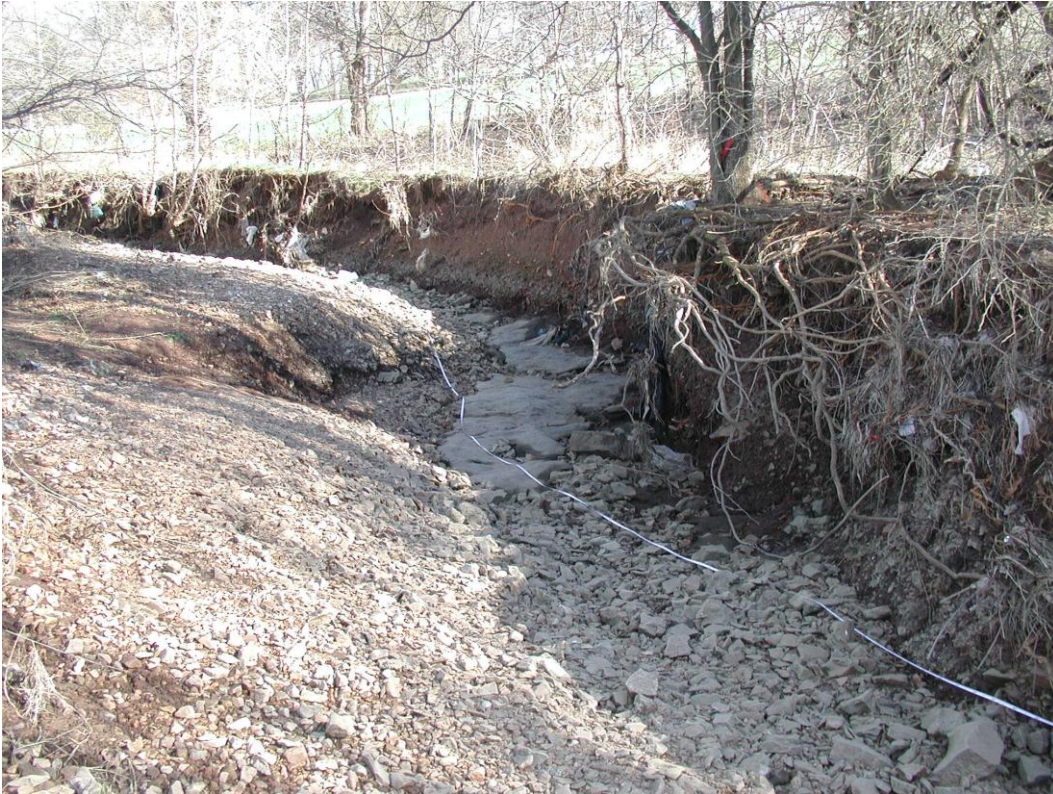
Picture 19. BEFORE - Eroding bank of meandering reach looking upstream December 2004 (St. 1,550 feet)

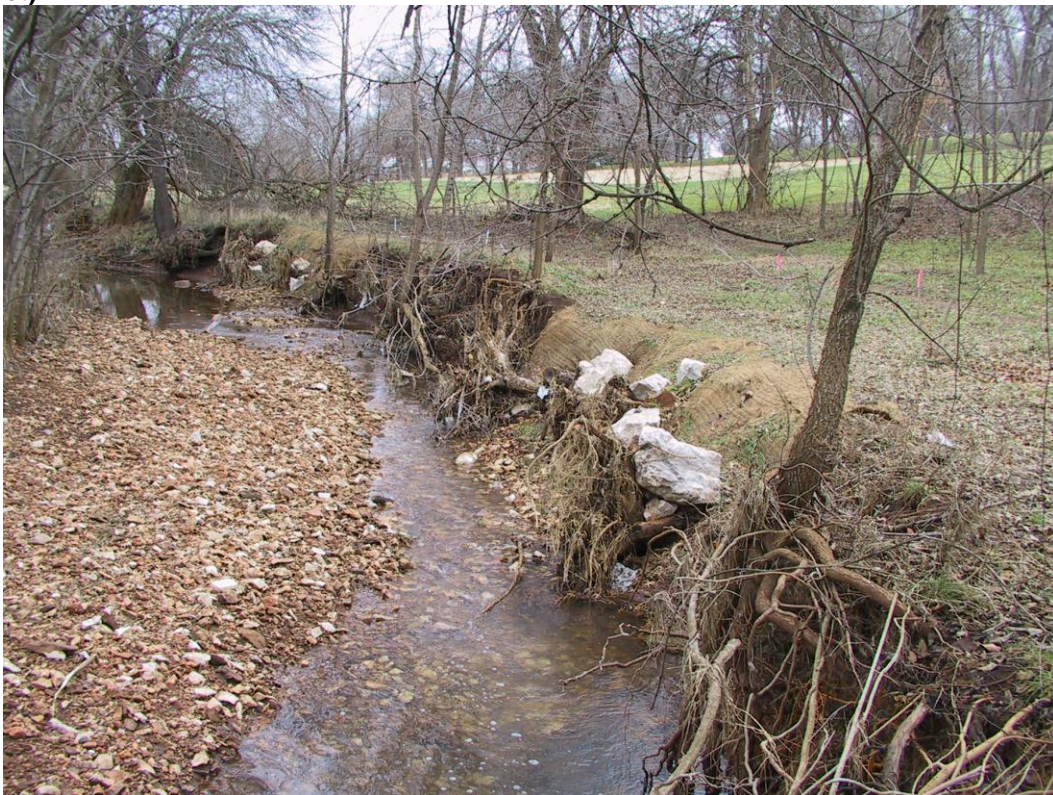
Picture 20. AFTER - Root wads installed along meandering reach looking upstream March 2007 (St. 1,500 feet)

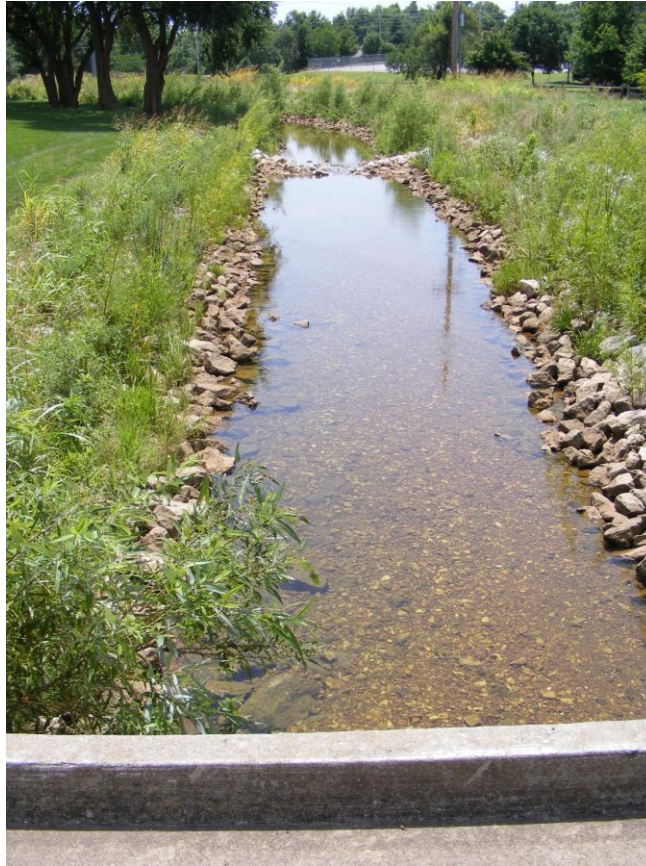
Picture 23. Vegetation growth in composite revetment, July 2008 (St. 750 ft)

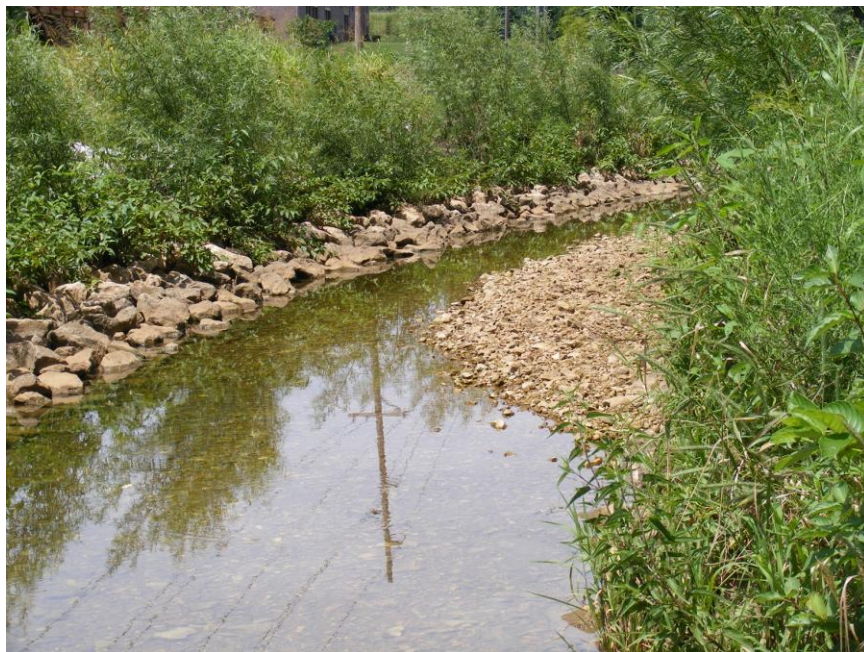
Picture 24. Gravel bar formation at bankfull bench, July 2008 (St. 950 ft)

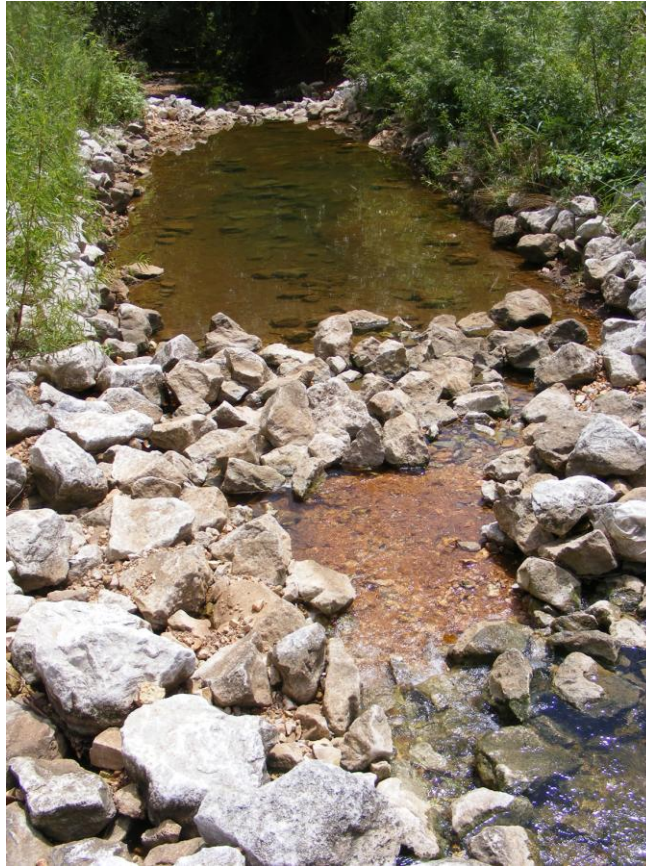
Picture 25. Undermined grade control structure exposing residuum, July 2008 (St. 1,120 ft)

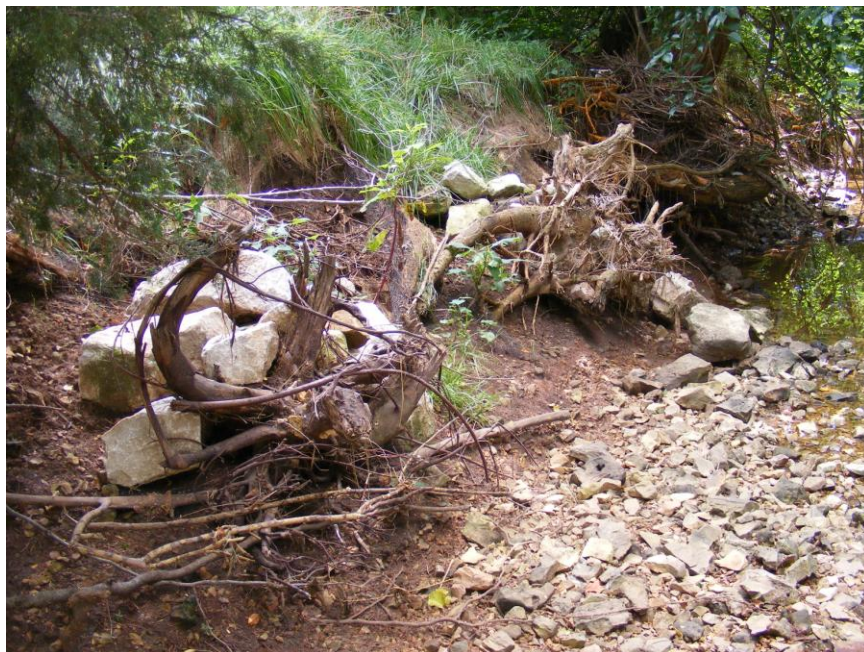
Picture 26. Possible bed elevation lowering at root wad structures, July 2008 (St. 1,320 ft)

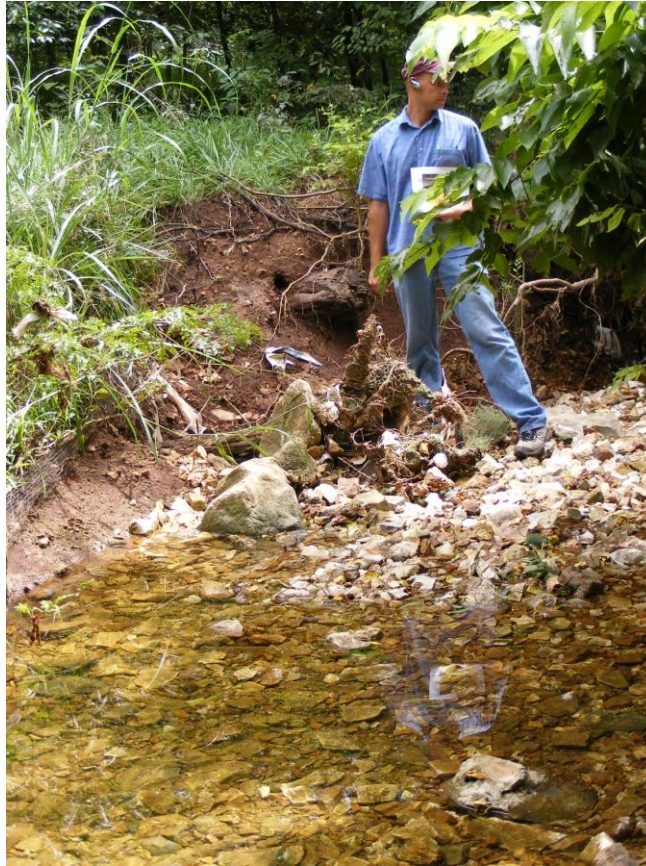
Picture 27. Aggrading bed at root wad structures, July 2008 (St. 1,500 ft)

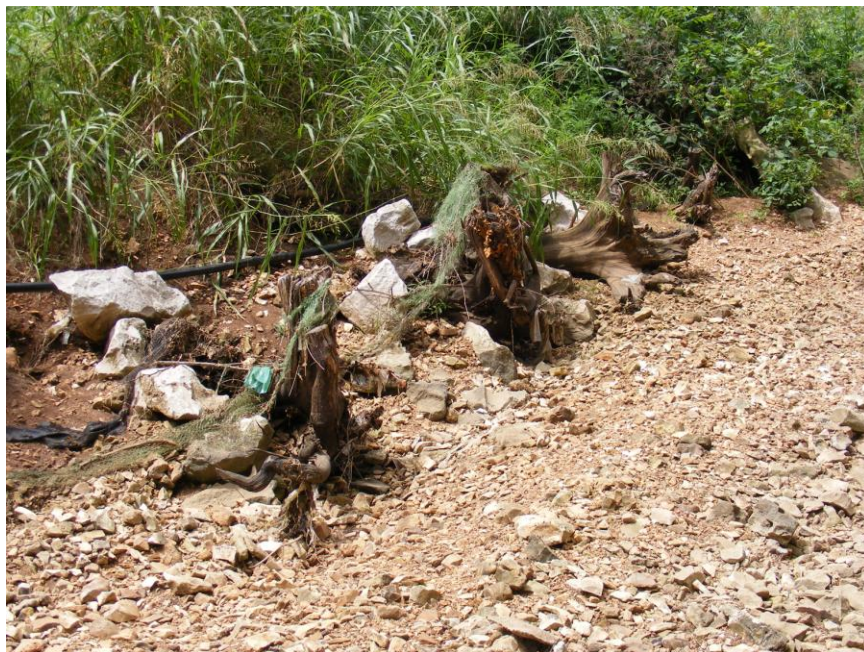
4. Some root wad structures are failing with missing header logs and banks are failing along the backhoe trenches. The buried phone cable is being uncovered

Picture 28. Phone cable exposed behind root wads, July 2008 (St. 1,580 ft)

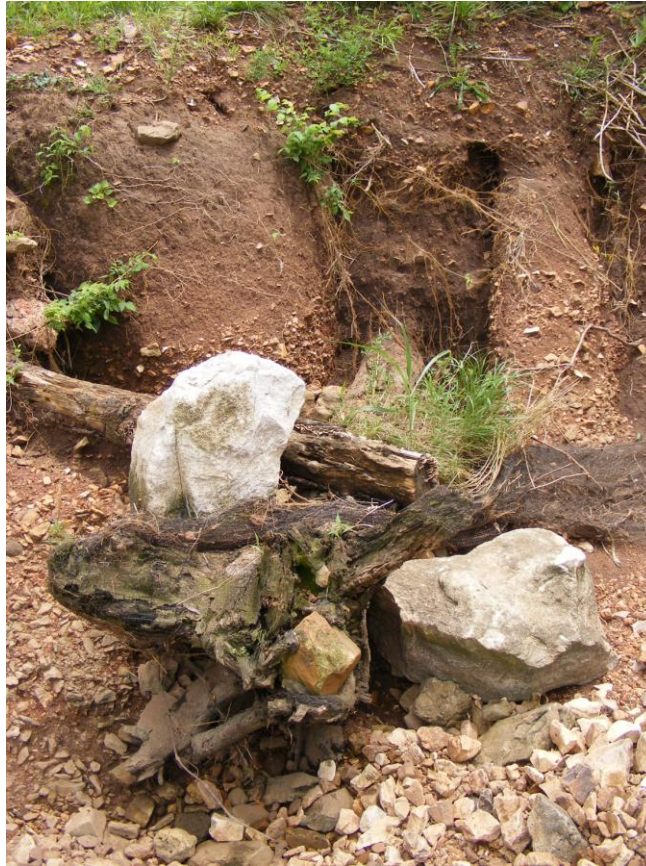
Picture 29. Bank failing at backfilled trench behind root wads, July 2008 (St. 1,660 ft)

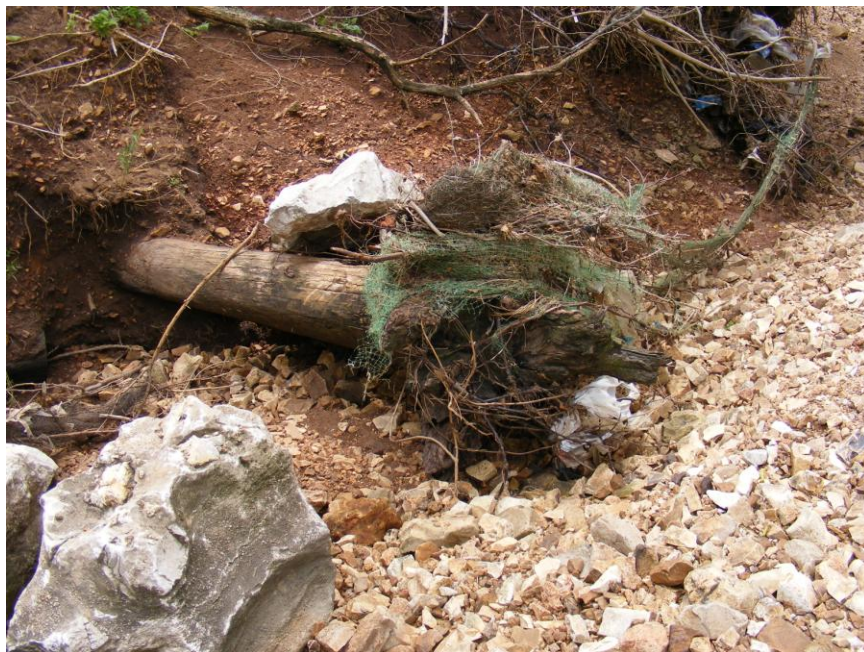
Picture 30. Missing header log at root wad structure, July 2008 (St. 1,660 ft)
