The Ozarks Environmental and Water Resources Institute (OEWRi)

PRE-CONSTRUCTION REPORT FOR THE WARD BRANCH STREAM RESTORATION PROJECT

Completed for: **Greene County, Missouri**

November 14, 2007

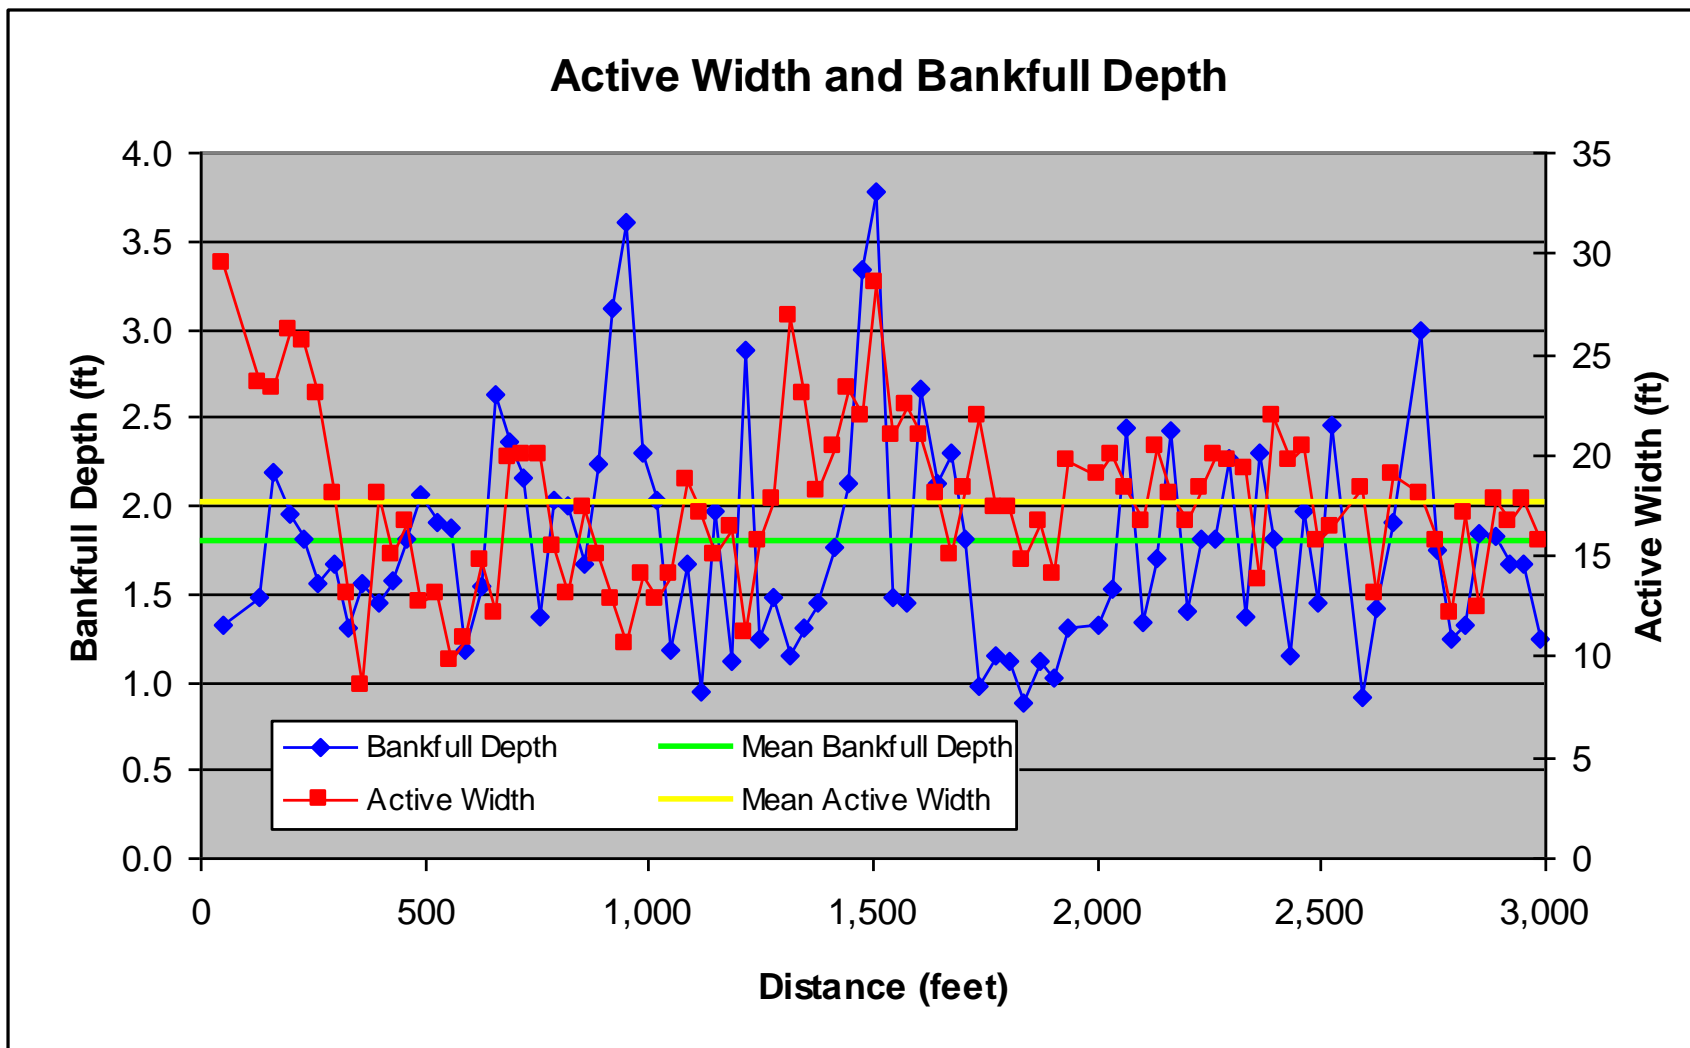
Figure 4. Bankfull Depth and Active Width

The mean bankfull active width for the entire study reach is 17.7 feet (Figure 4). Higher active bankfull widths are found below the Republic Road culvert from 0-200 feet and in the meander sections of the disturbance reach at stations 1,300-1,500 feet. High widths found below the culvert are probably due to construction of the culvert, but the high widths in the disturbance reach are probably due to a geomorphic response. In this section, sediment transport potential should be low and sediment accumulation would be expected causing flow to spread against the banks and widening the channel. Channel bend increases shear against the steep high banks.

The average bankfull depth of this reach is 1.8 feet (Figure 4). High bankfull depths are found in the reach at stations 1,000 and 1,500 feet. High bankfull depths indicate areas

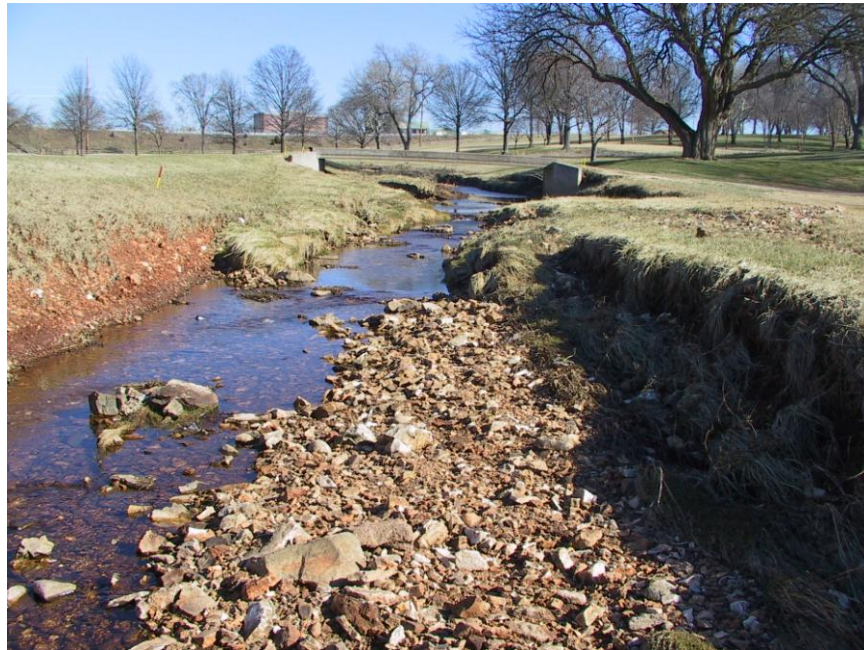
Photo 2. Bottom of steep reach at station 800 feet

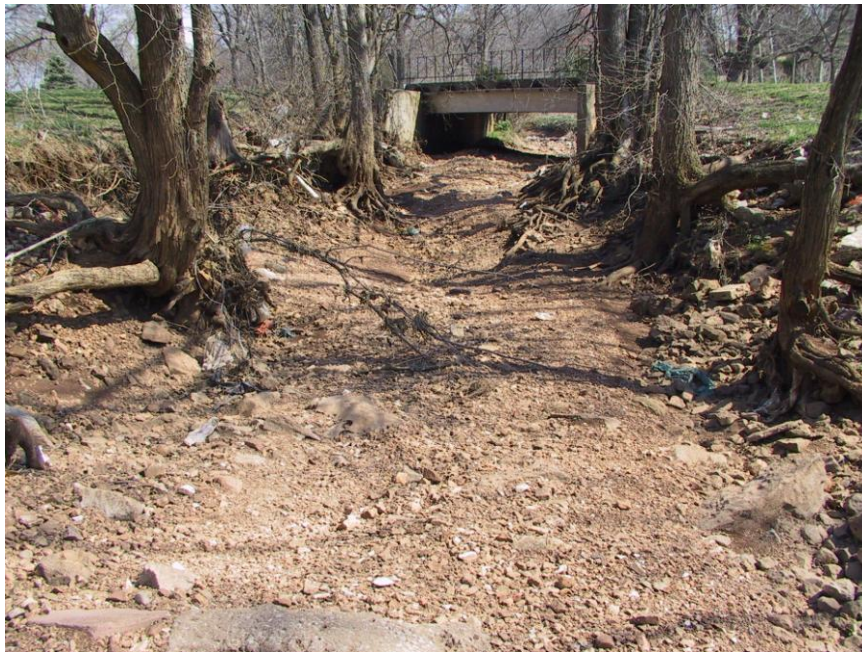
Photo 4. Scour hole at station 2,100 feet

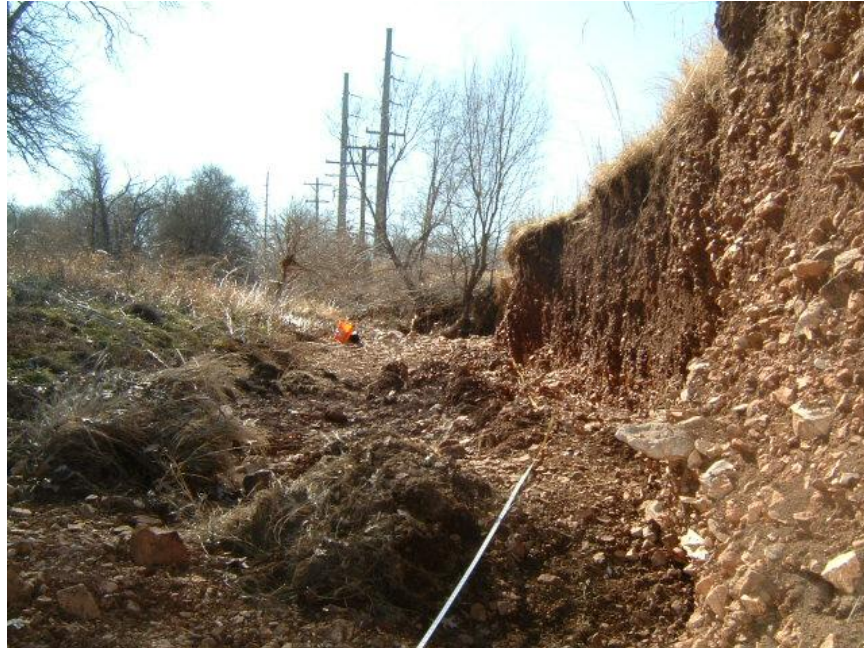
Photo 3. Bank material lying in the stream after collapse
