Quantifying the Effectiveness of Cedar Revetment in Mitigating Bank Erosion in Riceford Creek, Minnesota

A Master's Thesis

Master of Science, Geospatial Sciences

December 2019

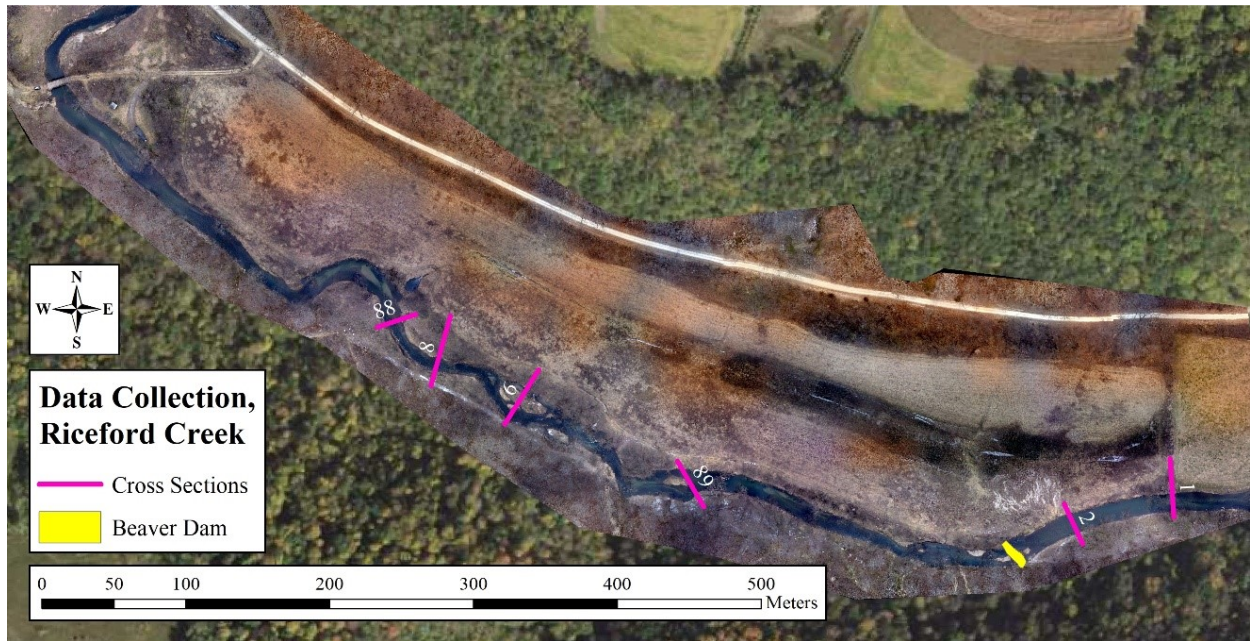
During field work in 2016 it was noted that there was a beaver dam just downstream of cross-section 2 (Fig. 28). The dam did not exist in 2013/2014 when the stream bank prioritization and revetment installation occurred. The beaver dam created a pool that extended upstream approximately 180 m and completely submerged revetment 1 (Fig. 29).

Figure 28. Locations of Cross-Sections in Lea and Sinclair reaches. A beaver Dam was downstream of cross-section 2 in 2016. It had been washed out by the 2017 field season.

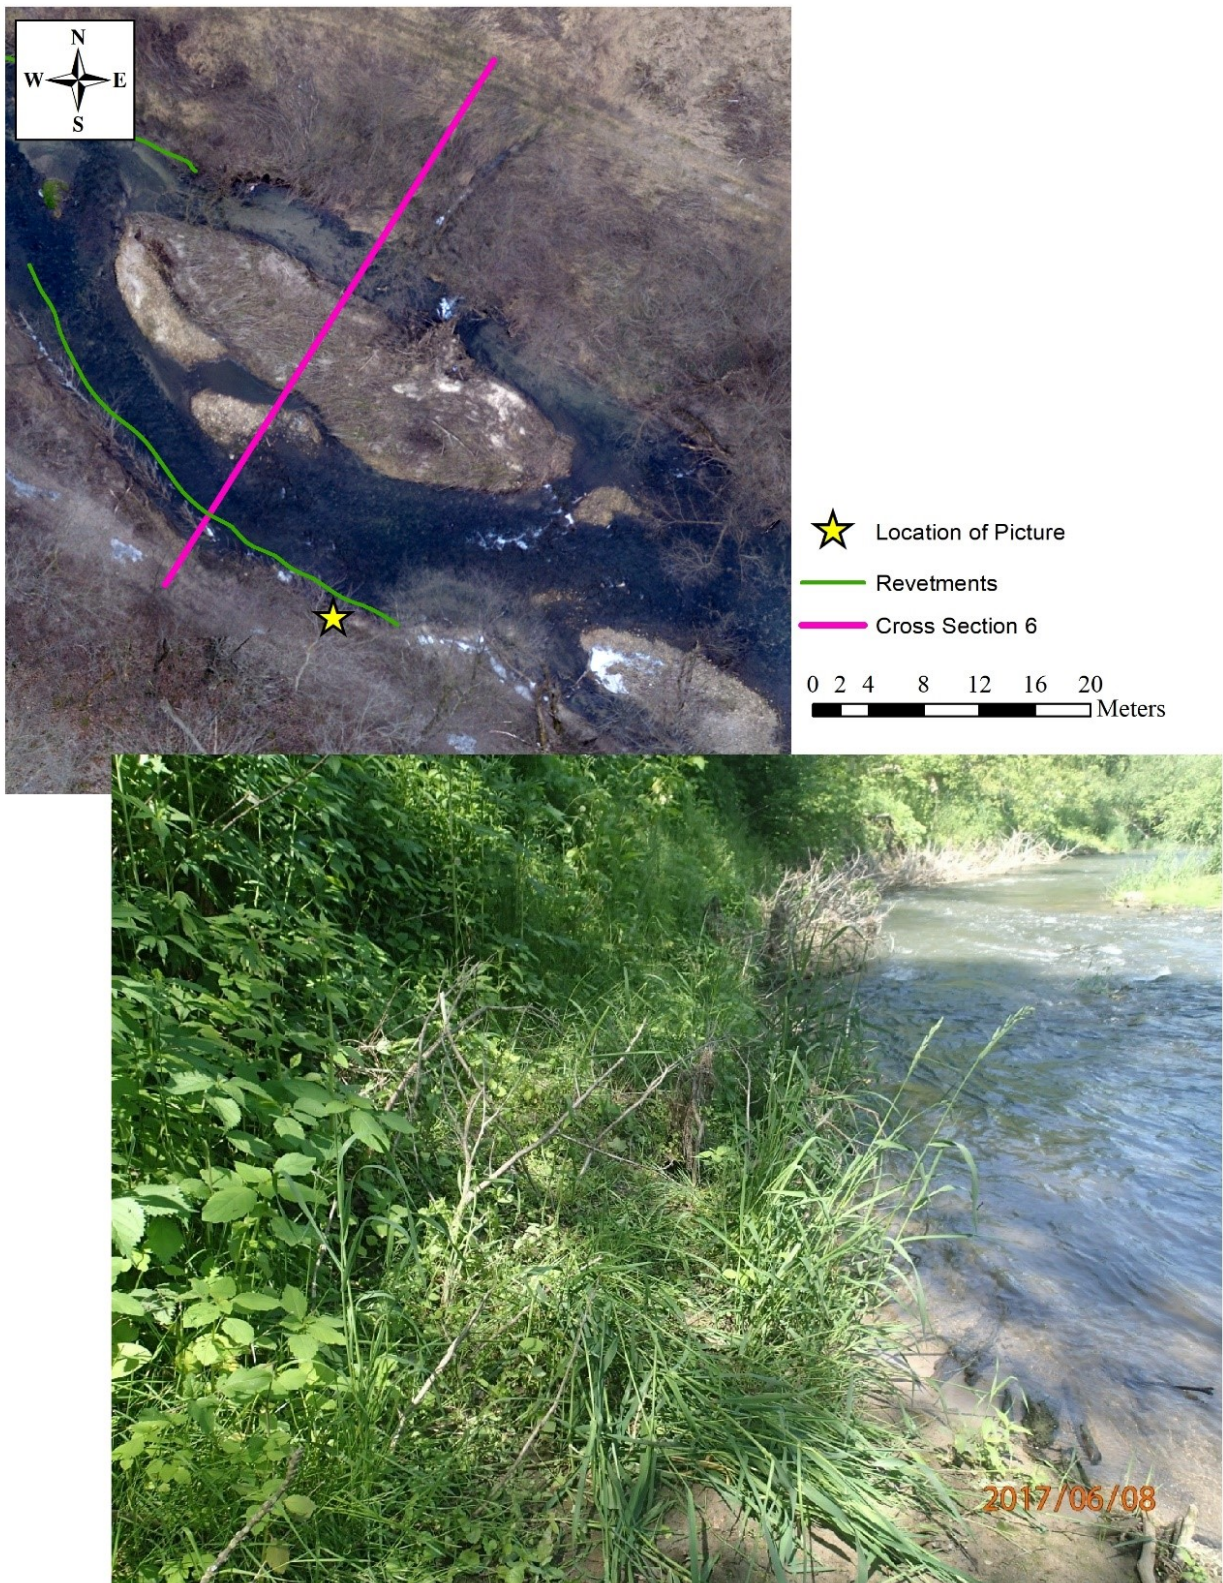
Figure 33. Revetment 3, just upstream of cross-section 6. The picture is taken looking downstream on the DSL bank. The revetment is being incorporated into the stream bank.

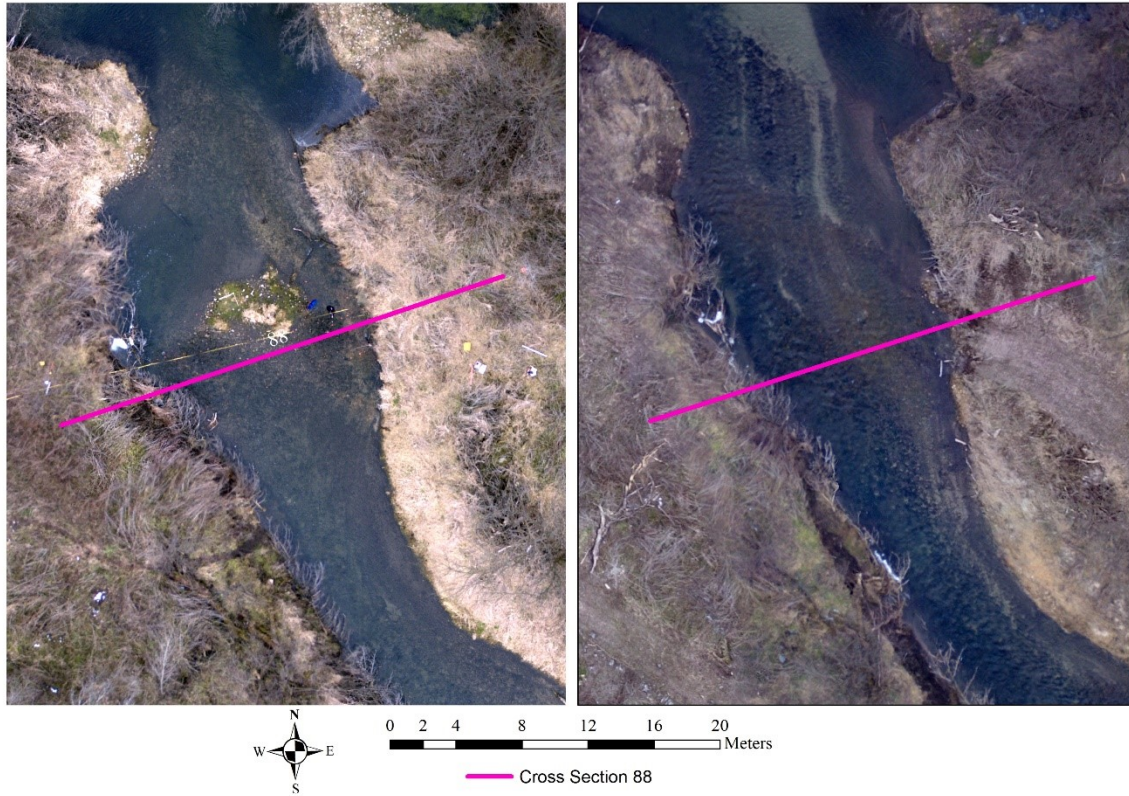
DSR slope became shallower by about 40°. There was a deep scour in the stream bed on the DSL side of the channel in 2016 which is no longer present in the 2017 cross-section. During field work it was noted that the scour had moved about 1 m downstream of the cross-section. This cross-section also had a shallow medial gravel bar in 2016, which was almost completely washed out in 2017 (Fig. 37).

Figure 37. Drone imagery of cross-section 88, showing the presence of a medial gravel bar in 2016. In 2017 the gravel bar was washed out.

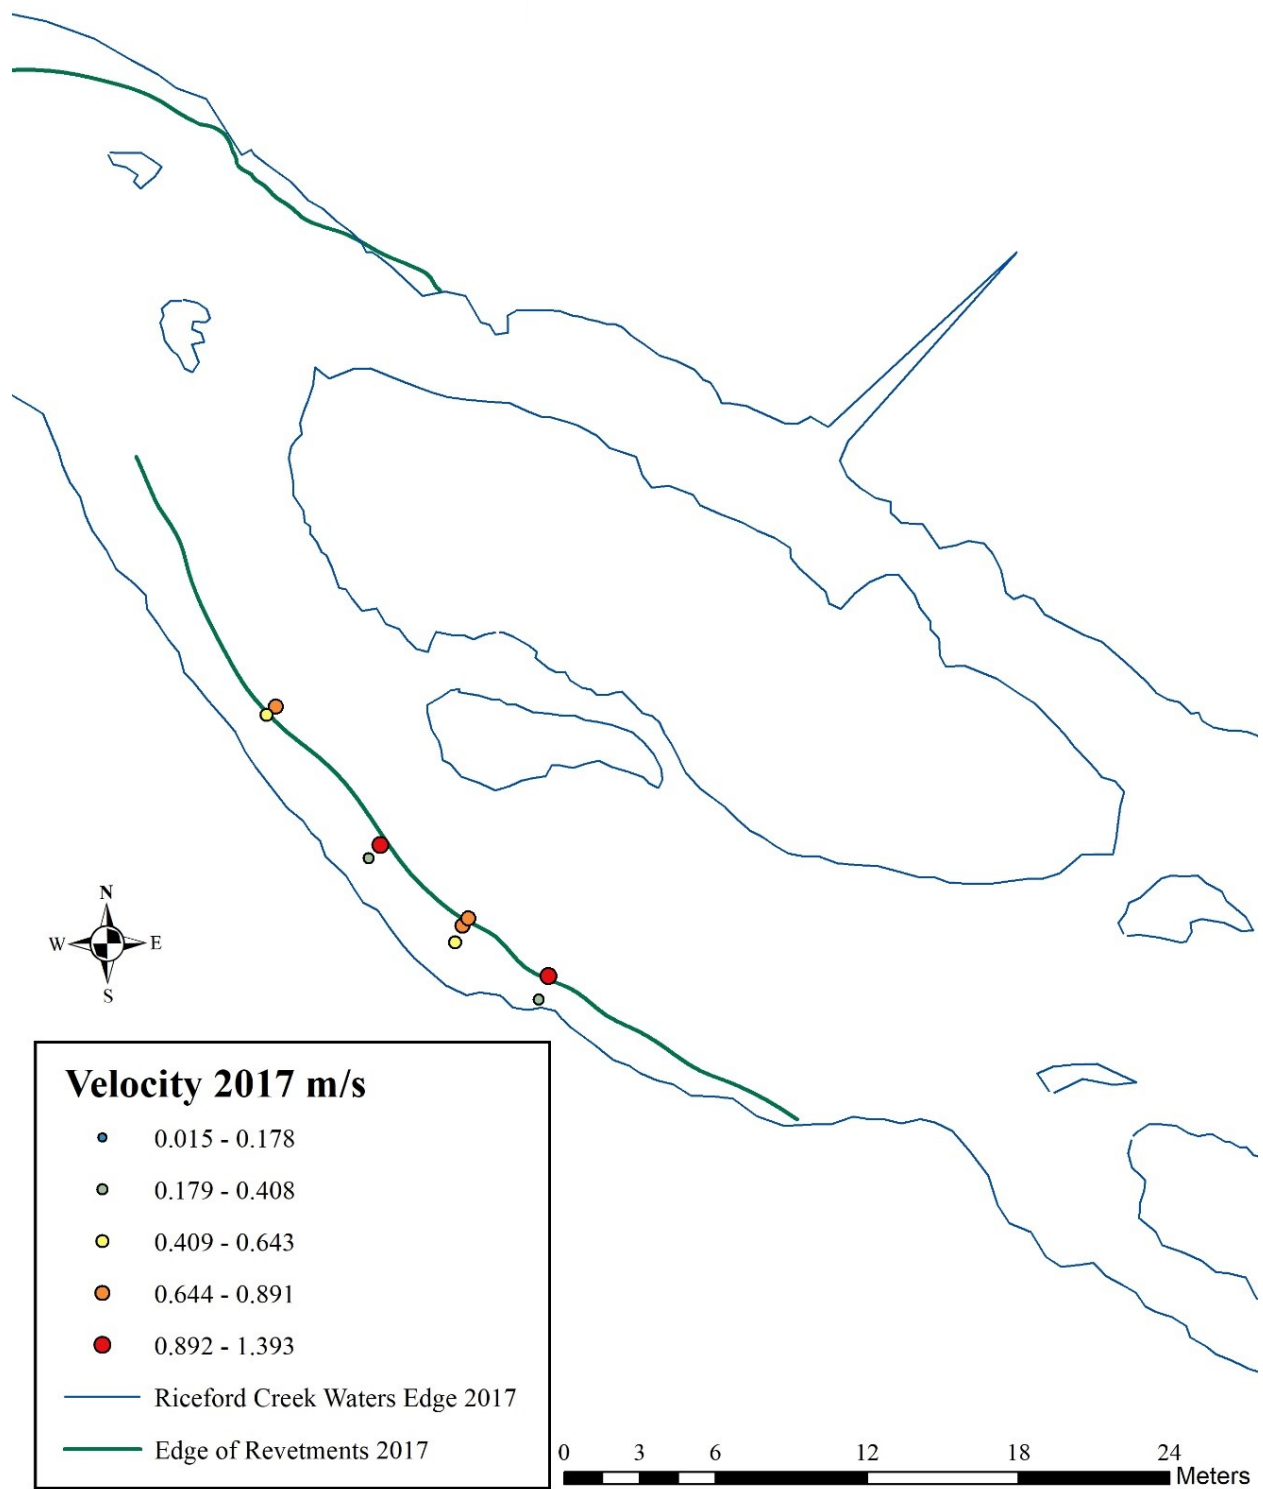
Figure 40. Velocity near Cross-section 6. Velocities are very high near and outside of the cedar revetment line but drop when measured inside the influence of the revetments. Only 2017 data are available.

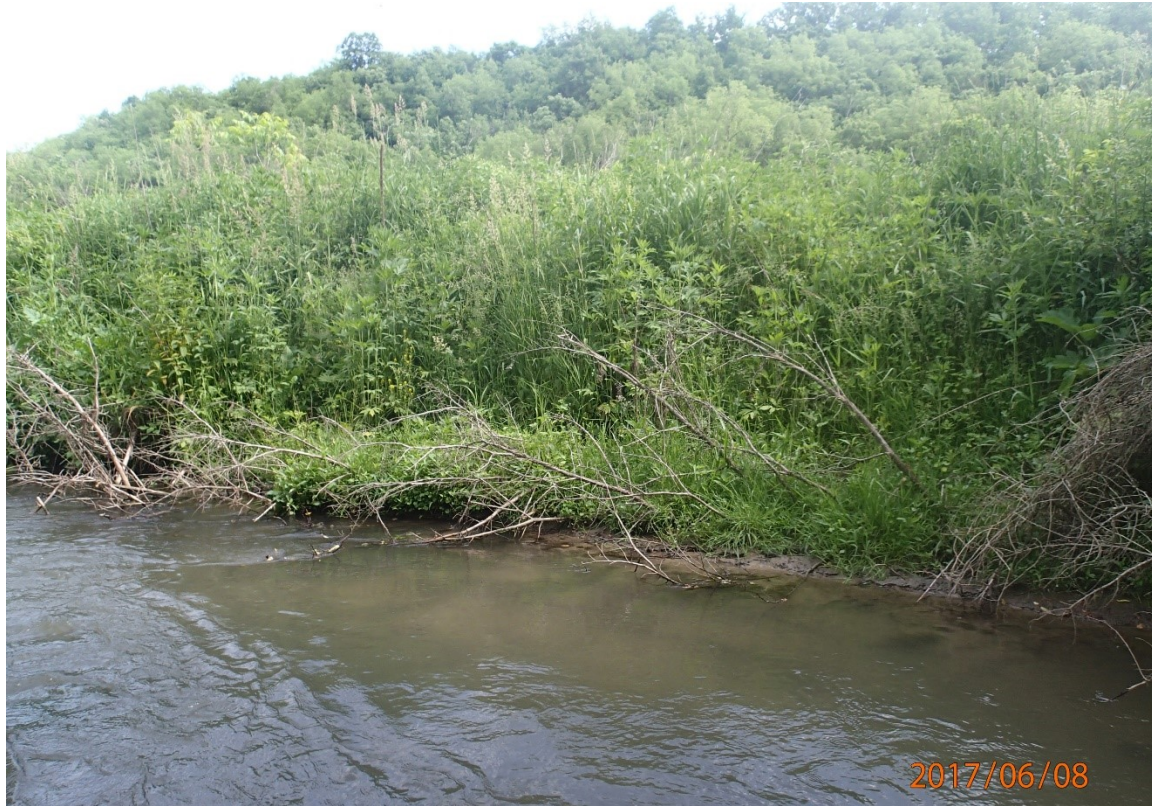
Figure 53. Working Revetment with embedded tree branches, low angle bank slope, and grasses/vegetation growing. This is in Revetment 4.

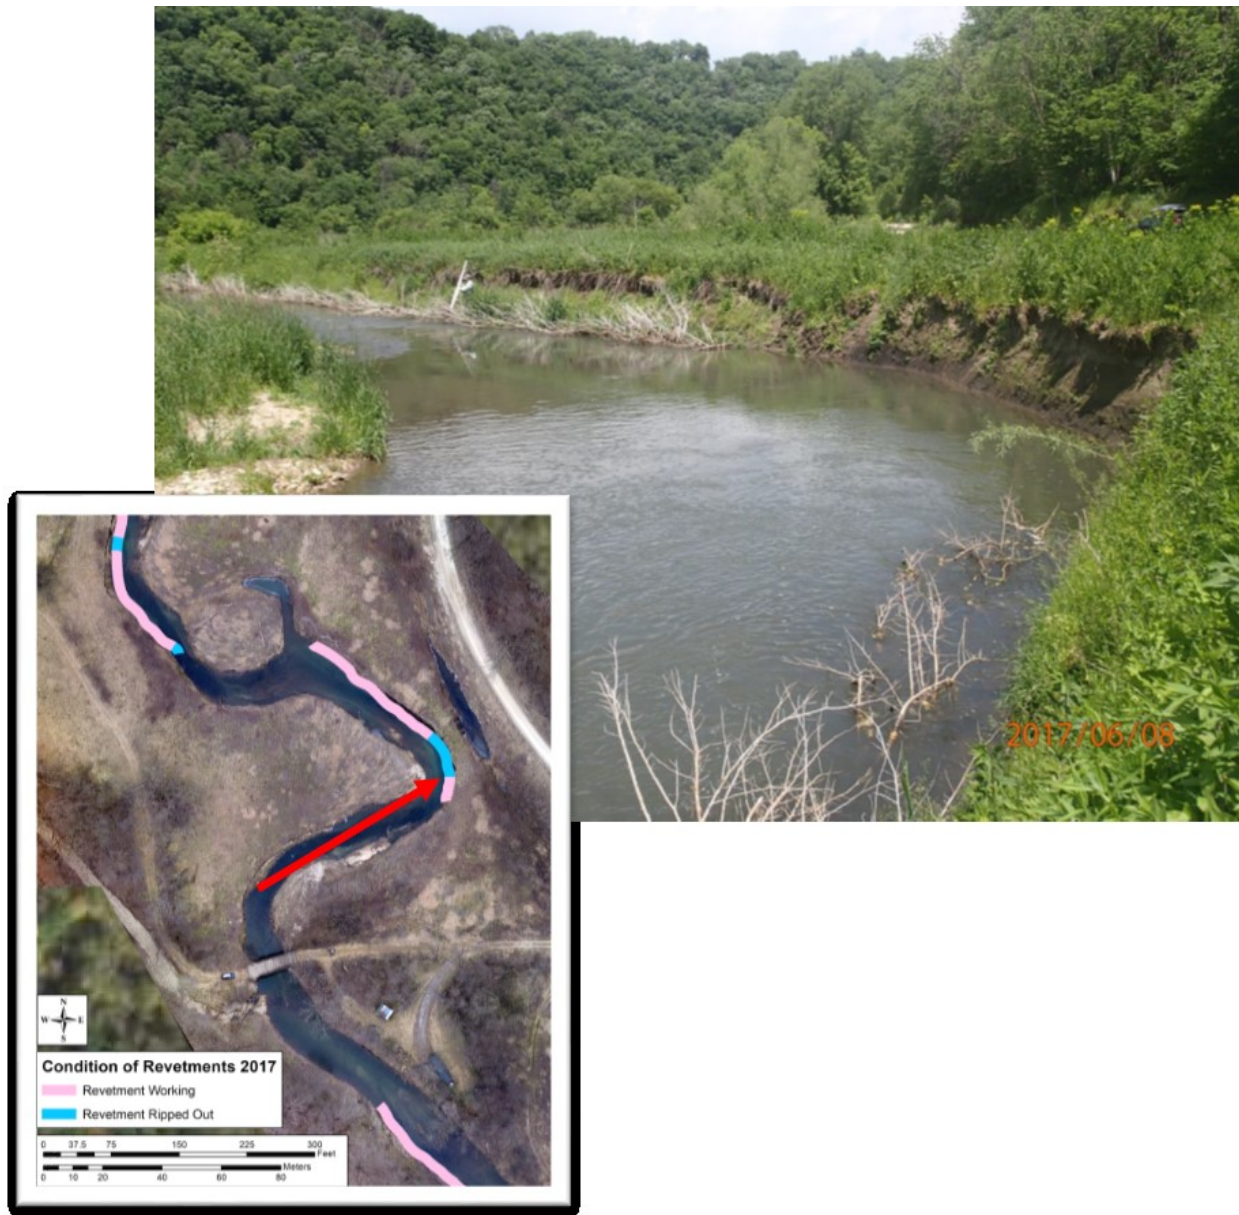
during a flood. The blue polygon outlines where revetment was ripped out during the 2016 flood. Notice that downstream of the blue, the revetment is still in place. It is hypothesized that during high flow events a great deal of energy is focused on a small area of the bank (at the arrow tip). This energy washes out the shelf that forms at the toe of the bank in that spot (Fig. 55), undermining the revetment and cutting back into the bank. This compromises the strength of the anchor. The anchor eventually fails, and the revetment is ripped out exposing the bank to the direct erosive force of the water. A few meters downstream the flow is no longer aimed at the revetment, thus only a few meters are compromised. Figure 55 shows the models for both revetment success and failure.

Figure 54. A stream bank revetment at Sinclair 1 that partially failed during the September 2016 flood. The photo is facing downstream and is from the south end of the Sinclair Reach, around the first bend from the bridge. The water coming from upstream travels along a long straight portion of the channel headed straight for the upstream portion of the revetment that failed (as indicated by the red arrow in the inset photo).

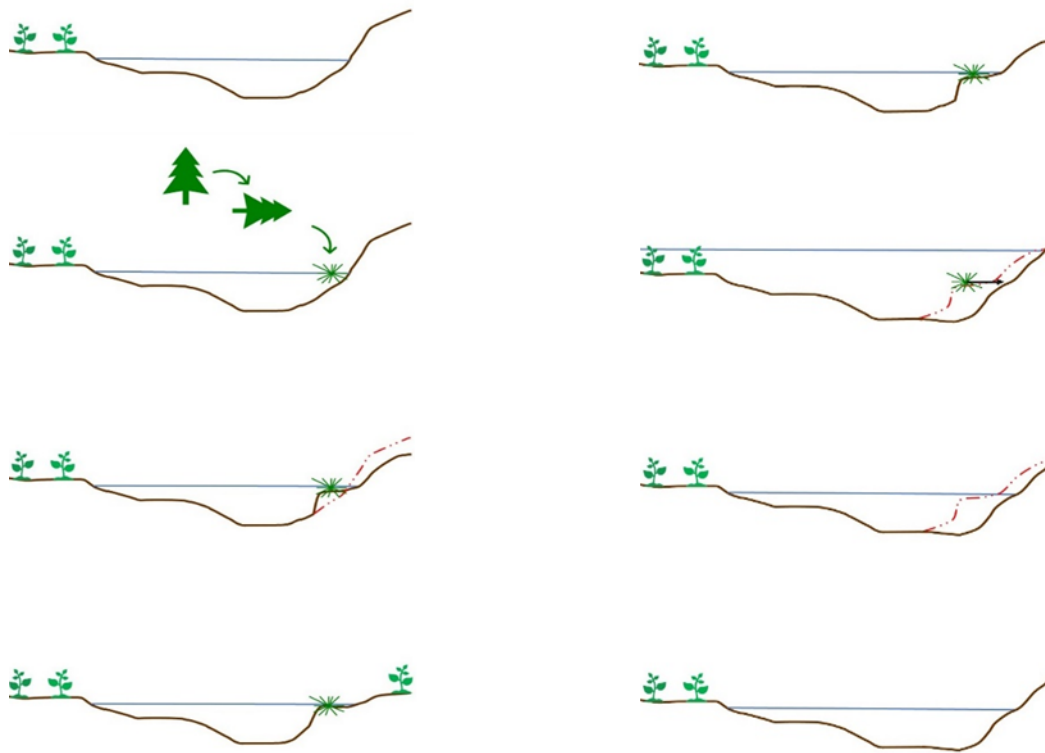
The failure in revetment 9 is the only one that does not fit the model. Revetment 9 is on the outside of a curve that turns the river 180°s and has a series of 3 small failures along it. It is also just downstream of a large failure in revetment 8. It is likely that debris from revetment 8 and other debris hit against this curve repeatedly during the flood. This combined with increased erosive force from the flood waters flowing directly toward the bank in these locations likely knocked out the revetments in Revetment 9.

Figure 55. Diagram for Revetment Success (left) and Failure (right) based on observations made after an approximately 50-year flood event. Cedars are anchored to the bank (see Figure 9) stabilizing the toe and allowing material to collapse from the bank without bank retreat. The material forms a shelf of sediment under and around the cedar and once the bank is shallow enough, grasses and other small vegetation grow on the bank and provide protection during subsequent floods. The right image shows that the shelf is washed out during a high flow. When this loosens the anchor, it can wash out the cedar as well. Then the bank starts to step back again instead of becoming shallower and stabilizing.
