Final Report

Geomorphic Assessment of South Creek between National and Campbell Avenue, Springfield, Missouri

OEWRI TR-14-004

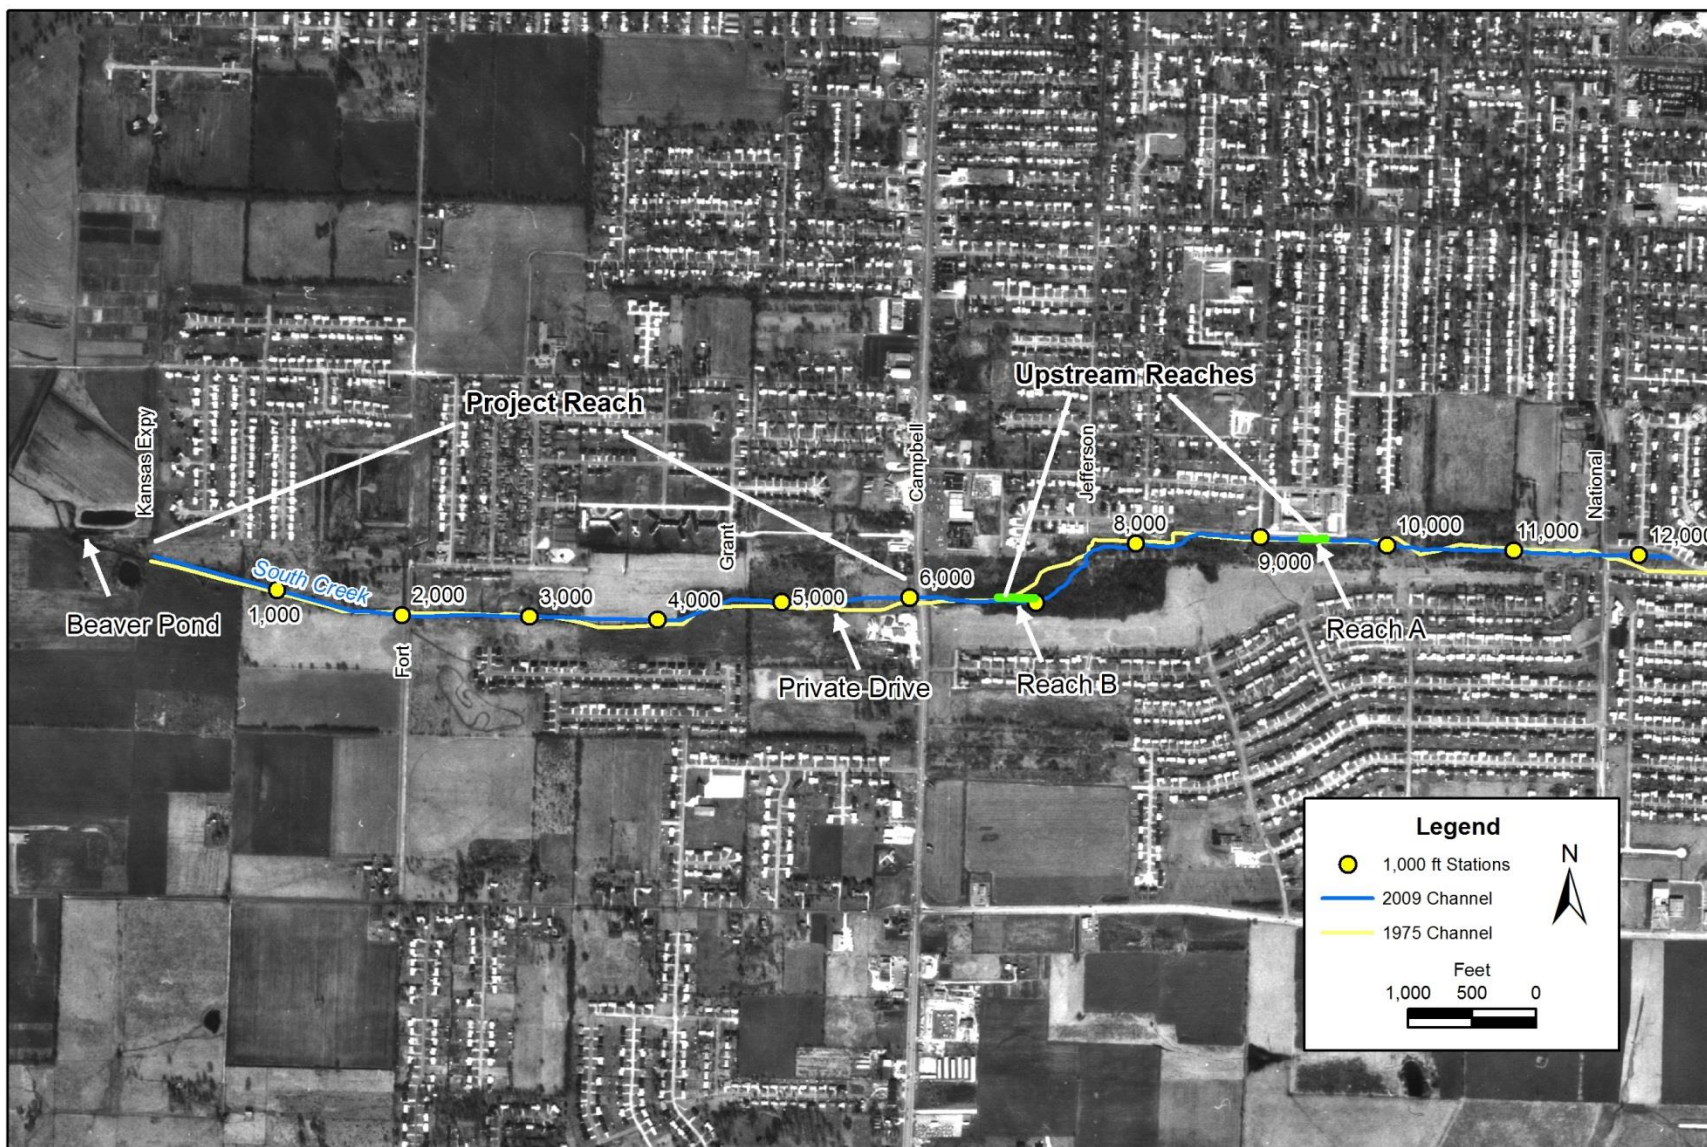
The 1975 aerial photograph shows significantly more development and that more channelization occurred since 1953. Between 1953 and 1975, the South Creek watershed transformed from being rural to predominantly urban, particularly in the upper portions of the drainage basin (Figure 10). Downstream of Campbell, the channel was moved and straightened into a position

similar to the channel location today. Upstream of Campbell the stream was channelized from about station 8,000 ft upstream through what was a more natural channel.

Figure 10. 1975 aerial of project and upstream reaches.
