**The Ozarks Environmental and Water Resources Institute (OEWRI)
Missouri State University (MSU)**

FINAL REPORT

**Nonpoint Source Bank Erosion and Load Reduction
Assessment for the Wilson Creek 319 Riparian
Corridor Easement Site, Greene County, Missouri**

Field work completed April 2014- May 2015

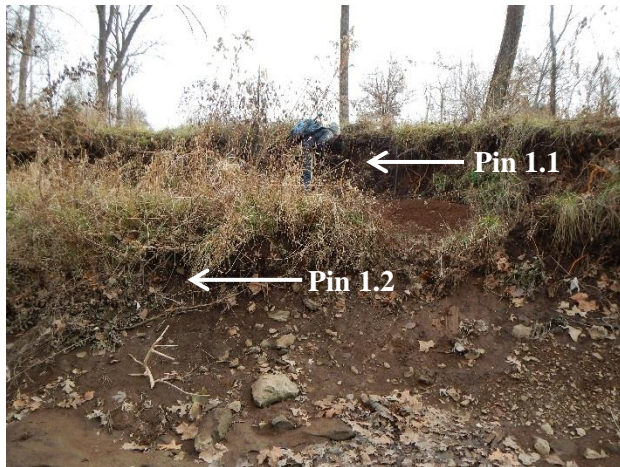
Pin Array 1. Erosion measurements by date.

Pin #	6/20/2014	9/4/2014	10/8/2014	11/10/2014	12/3/2014	1/16/2015	2/25/2015	5/5/2015	Total Erosion (cm)
1.1	0	10	11.5	0	0	0	0	0	21.5
1.2	6	0	1.8	0.2	1	4	2.5	4	19.5
1.3	2	0	0.6	7	0.2	0.5	0	0	10.3
1.4	2	0	0	0	0	0	0.5	0	2.5

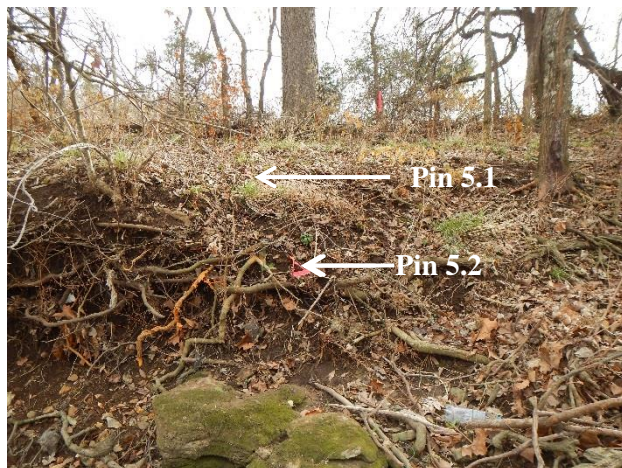
Pin Array 5. Erosion measurements by date.

Pin #	6/20/2014	9/4/2014	10/8/2014	11/10/2014	12/3/2014	1/16/2015	2/25/2015	5/5/2015	Total Erosion (cm)
5.1	1	0	0	5	0	0	0	0	6
5.2	1	0	1.5	0.5	3	0	0	0	6
5.3	11	3	4	0	0	0	0	0	18
5.4	0	0	3	0.8	0.2	0	0	4	8

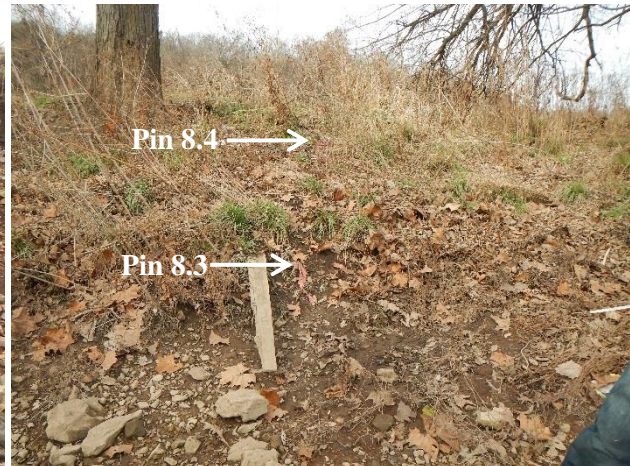
Pin Array 8. Erosion measurements by date.

Pin #	6/20/2014	9/4/2014	10/8/2014	11/10/2014	12/3/2014	1/16/2015	2/25/2015	5/5/2015	Total Erosion (cm)
8.1	22	0	1.5	0	0	0	0	16	39.5
8.2	4	0	0	5.5	0	0	0	0	9.5
8.3	0	2	0	3	0	0	0.5	1	6.5
8.4	0	0	4.5	0	5.2	0	0	0	9.7

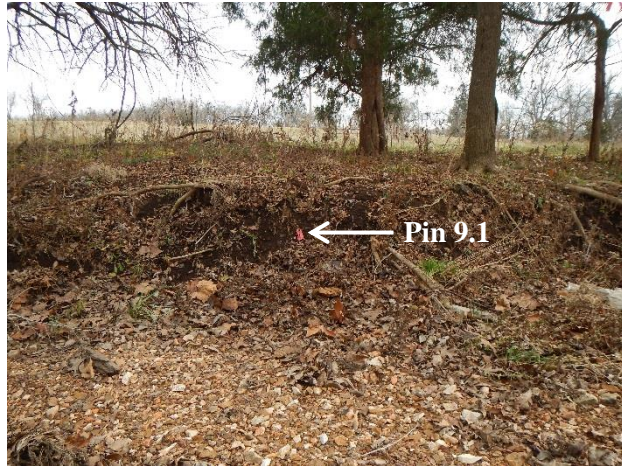
Pin Array 9. Erosion measurements by date.

Pin #	6/20/2014	9/4/2014	10/8/2014	11/10/2014	12/3/2014	1/16/2015	2/25/2015	5/5/2015	Total Erosion (cm)
9.1	5	0	1.6	0	0.2	0	0	2.5	9.3
9.2	4	2	3	1.3	0	0	2	12	24.3
9.3	8	0	3	1	0	3	0	4.5	19.5

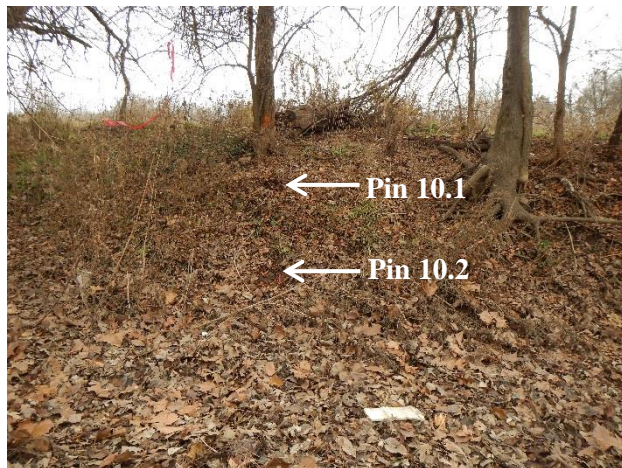
Pin Array 10. Erosion measurements by date.

Pin #	6/20/2014	9/4/2014	10/8/2014	11/10/2014	12/3/2014	1/16/2015	2/25/2015	5/5/2015	Total Erosion (cm)
10.1	0	0	2	0.8	0	0	1	2.5	6.3
10.2	7	0	0	8	0	0	0	0	15
10.3	0	4	3	0	0.3	0.7	4	7	19
10.4	5	9	1	2.3	0	0	2	10	29.3

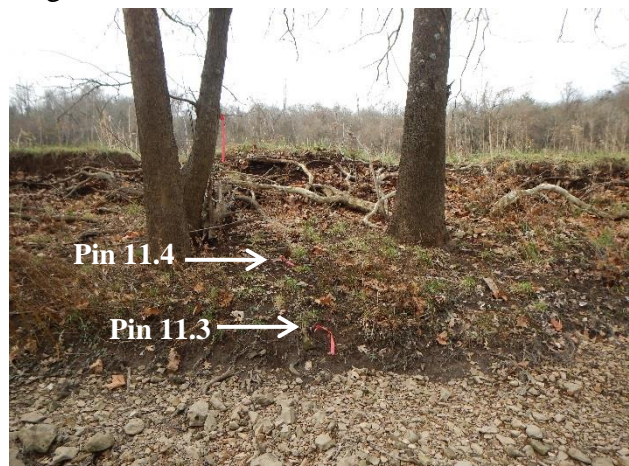
Pin Array 11. Erosion measurements by date.

Pin #	6/20/2014	9/4/2014	10/8/2014	11/10/2014	12/3/2014	1/16/2015	2/25/2015	5/5/2015	Total Erosion (cm)
11.1	0	17	0	3	0	0	0	1.13	21.13
11.2	4	0	0	0	0	0	3	3	10
11.3	5	0	1.7	0.5	0	0.3	0	1	8.5
11.4	3	0	3.3	0.8	0	0	0	3.5	10.6

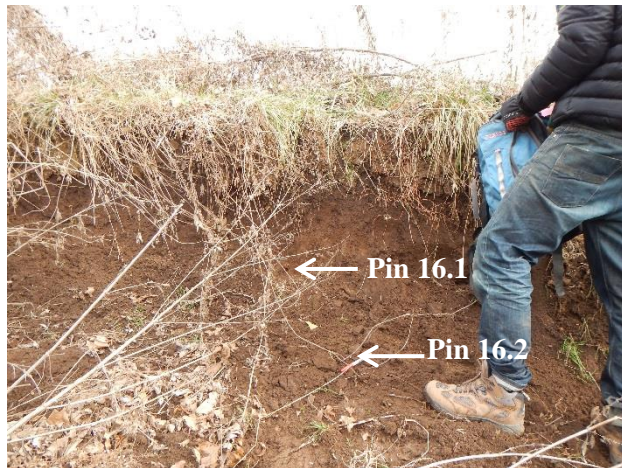
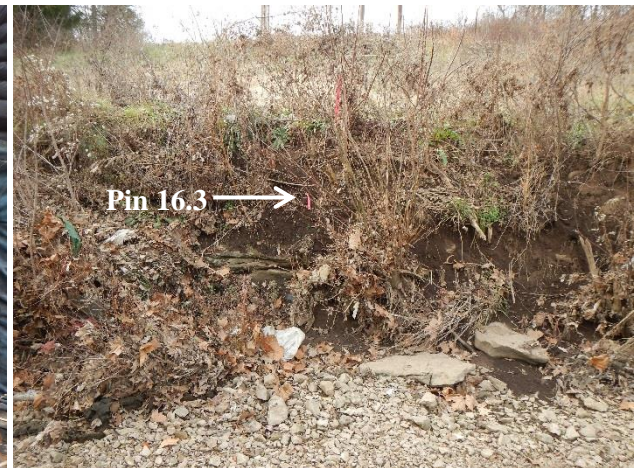
Pin Array 16. Erosion measurements by date.

Pin #	6/20/2014	9/4/2014	10/8/2014	11/10/2014	12/3/2014	1/16/2015	2/25/2015	5/5/2015	Total Erosion (cm)
16.1	24	0	1	0.5	0	4	0	0	29.5
16.2	0	0	2.2	1	0	0	13	4	20.2
