**Ozarks Environmental and Water Resources Institute (OEWRI)
Missouri State University (MSU)**

**Flow and Water Quality Assessment of the
Jordan Creek Underground, Springfield,
Missouri**

FINAL REPORT

February 28, 2019

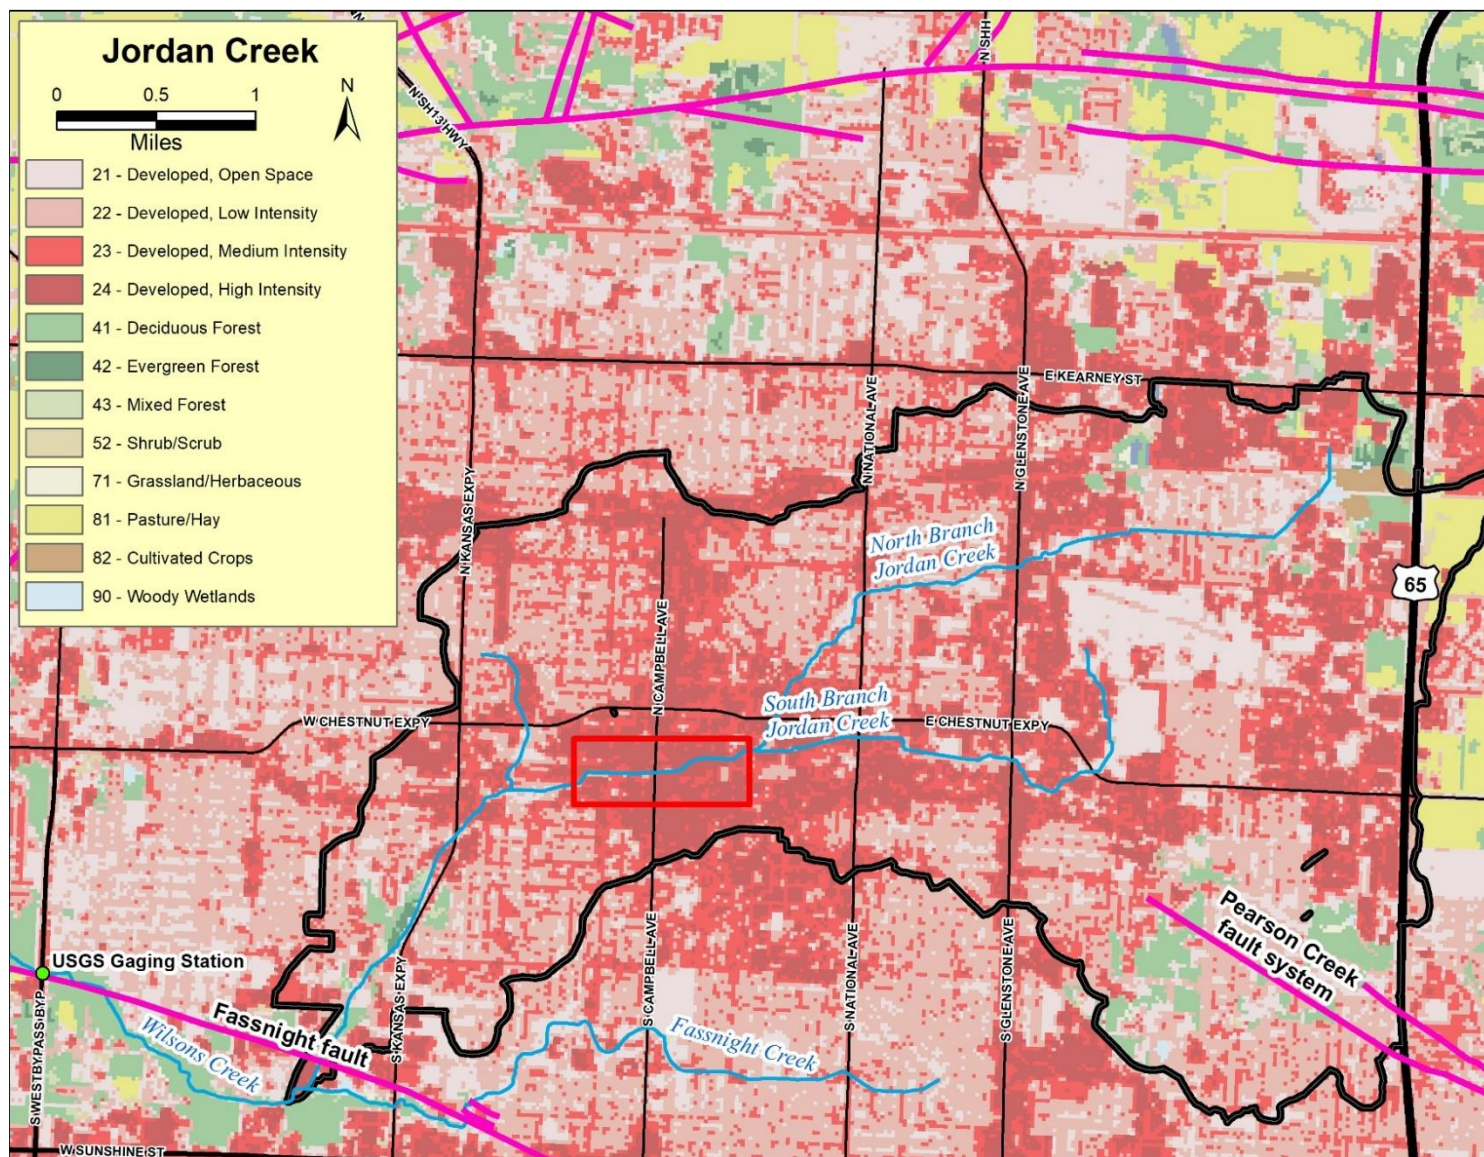
Figure 1. Jordan Creek watershed and land use with study area noted in red.

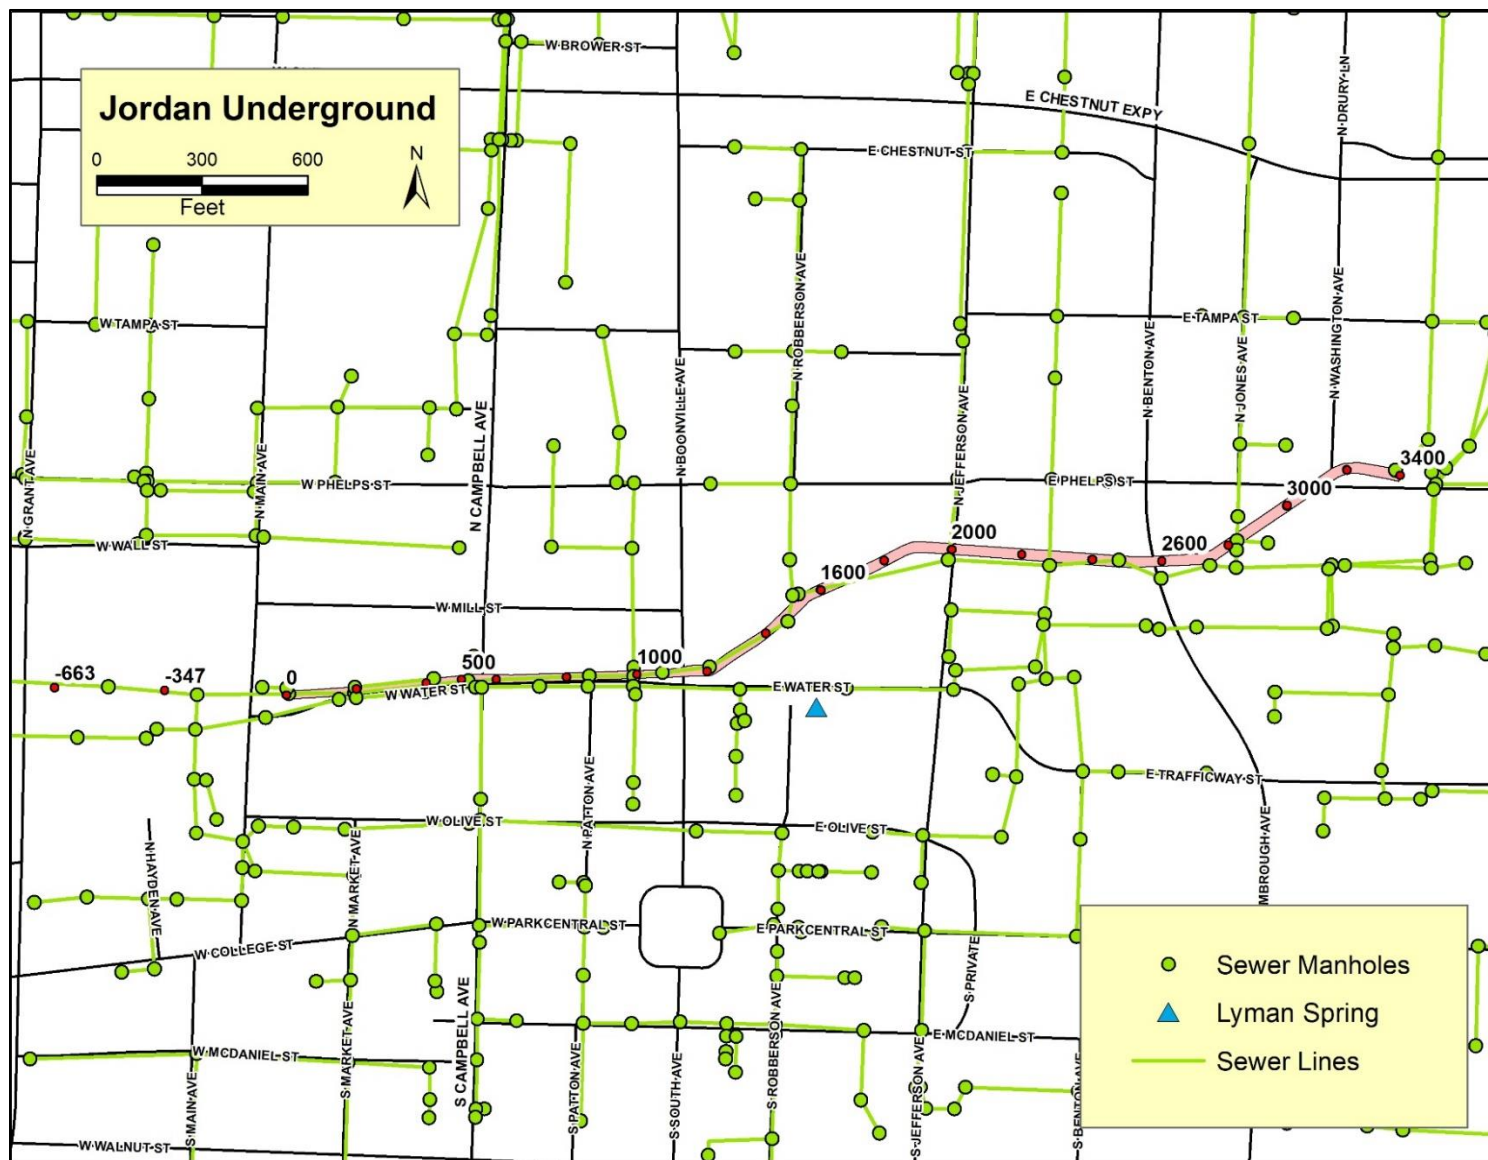
Figure 2. Jordan Creek Underground with sewer infrastructure noted.

This study focused on an approximately 4,400 ft reach of Jordan Creek between Sherman Parkway and Grant Ave. including the approximately 3,300 ft box culvert known as the Jordan Creek Underground (Figure 2). The original culvert was built to alleviate flooding between Boonville and Main Avenues in 1928 and was expanded upstream to Washington Ave. in 1934 (Oliver, 1939). The structure includes two separate culverts (north and south) that generally separates inflows from the two branches during low flow conditions. However, the two culverts do join together in two reaches where the middle partition wall is absent between Robberson and Boonville Avenues and again at Campbell Ave. In addition, several holes and archways (<4 ft wide) also occur in the partition wall allowing water to mix locally between the north and south culverts. Therefore, low flow discharges that enter the culvert upstream in separate culverts can mix to varying degrees at different points along the underground culvert.

The source risk assessment identified multiple potential exfiltration source locations along the study reach using GIS data provided by the City of Springfield. A sewer line is mapped directly below the floor of the box culvert from Robberson Avenue near station 1,500 ft to Main Avenue downstream of the outlet at station -100 ft (Figure 2). Through this reach sewer lines join the main trunk line in five places, at stations 0 ft, 200 ft, 510 ft, 990 ft, and 1,500 ft. Additionally, a sewer line runs parallel to the box culvert along Water St. from station 1,200 ft to the end of the box culvert at 0 ft. Lyman Spring is located near the corner of Robberson Ave. and Water St. approximately 200-300 ft south of the culvert. Upstream of Robberson Ave. the main sewer line generally runs along the south side of the box and sewers cross the culvert at five locations at stations 1,600 ft, 2,000 ft, 2,300 ft, 2,475 ft, and 2,825 ft.

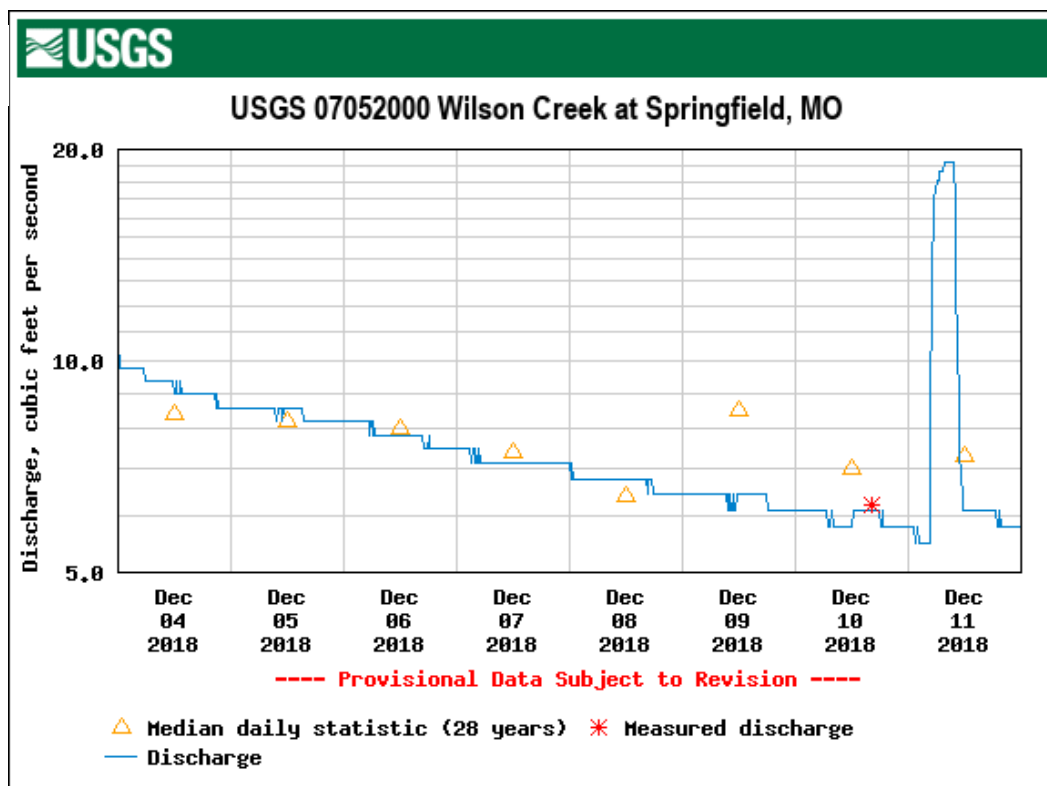
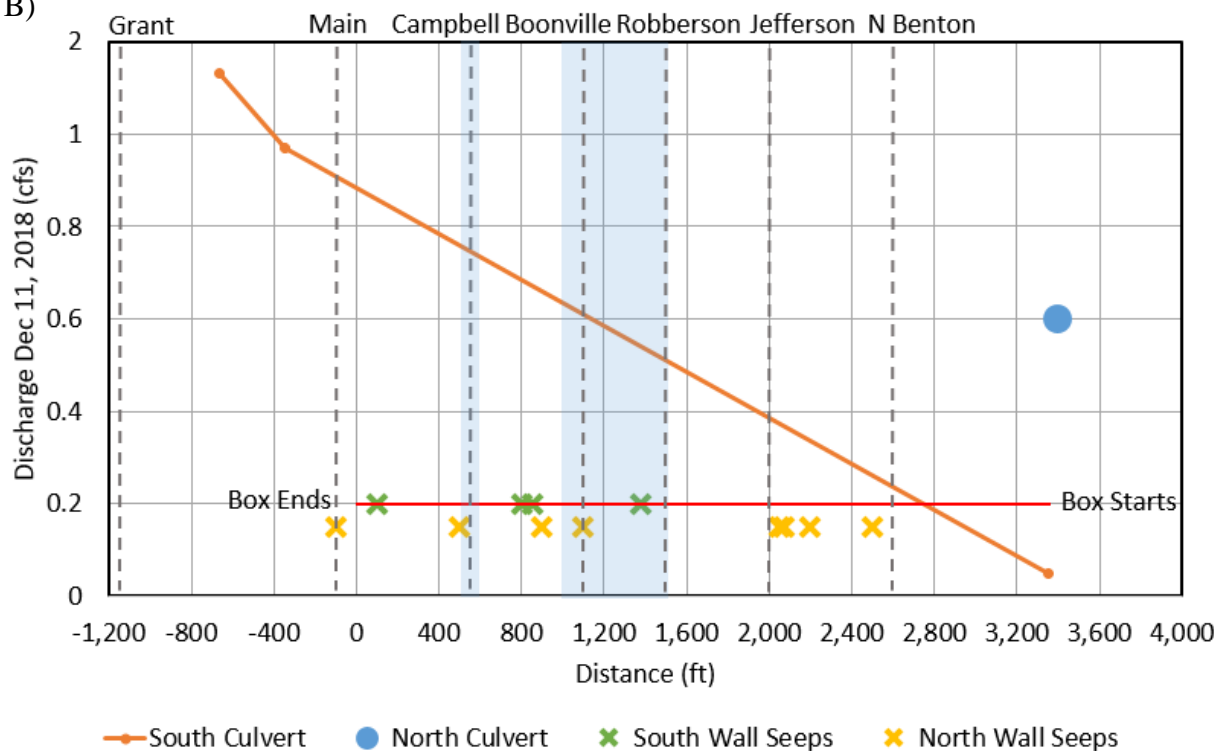
Figure 3. A) Stage and discharge at the USGS gaging station on Wilson Creek at Springfield for one week prior to sampling on December 11, 2018 and B) downstream changes in discharge collected during sampling.

Discharge measurements were collected at both the upstream and downstream ends of the culvert and at Grant St. on December 11th (Table 1). The December 11th sampling was during a period of very low base flow conditions with no rainfall during the week prior to sampling. Discharge at the USGS gaging station on Wilson Creek at Scenic Ave during this sampling period was around 5.8 ft³/s with no high flows being recorded the week prior (Figure 3). The discharge entering the culvert was 0.65 ft³/s with the majority of the flow entering in the north culvert. At Main Ave., discharge was 0.97 ft³/s, which is about a 50% increase in flow. Since flow was measured during base flow conditions, the increase in discharge in the box is likely due to seepage into the box culvert at some point along its length. Discharge at Grant Ave. increases to 1.13 ft³/s which is in a section where the bed is natural downstream open culvert, which is about 19.5% of the flow at the USGS age downstream. Observations of flow through the culvert

during sampling suggests discharge increased near Robberson Ave. where the north and south culverts come together.

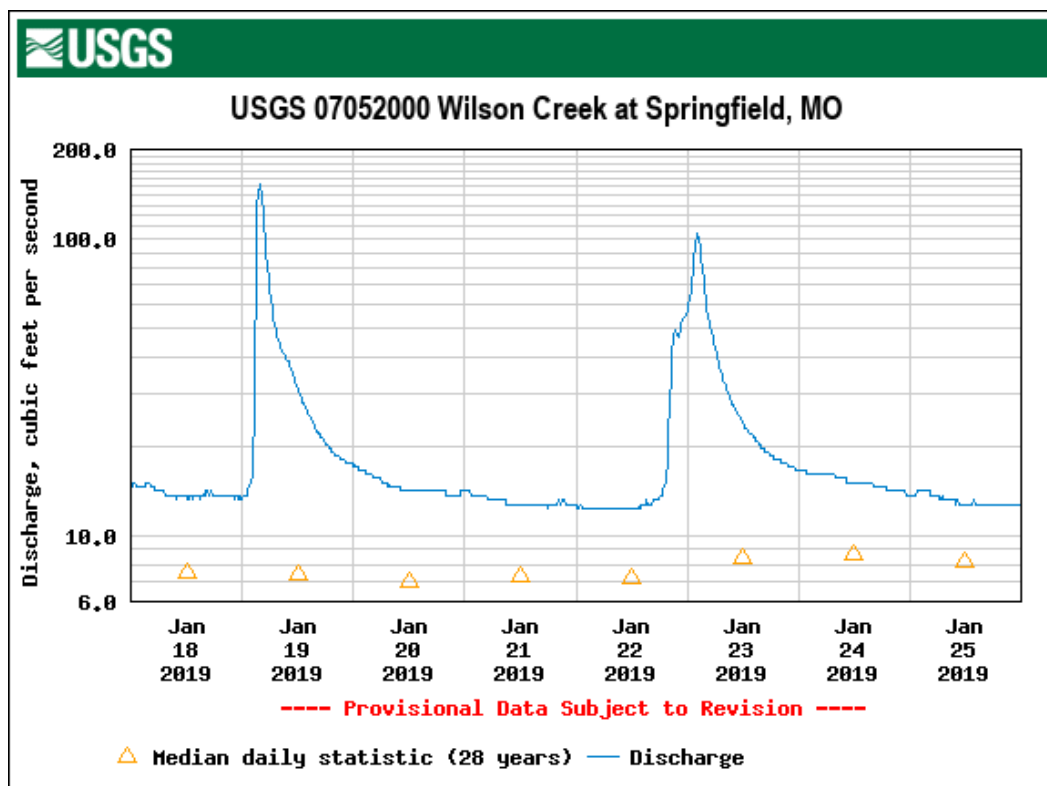
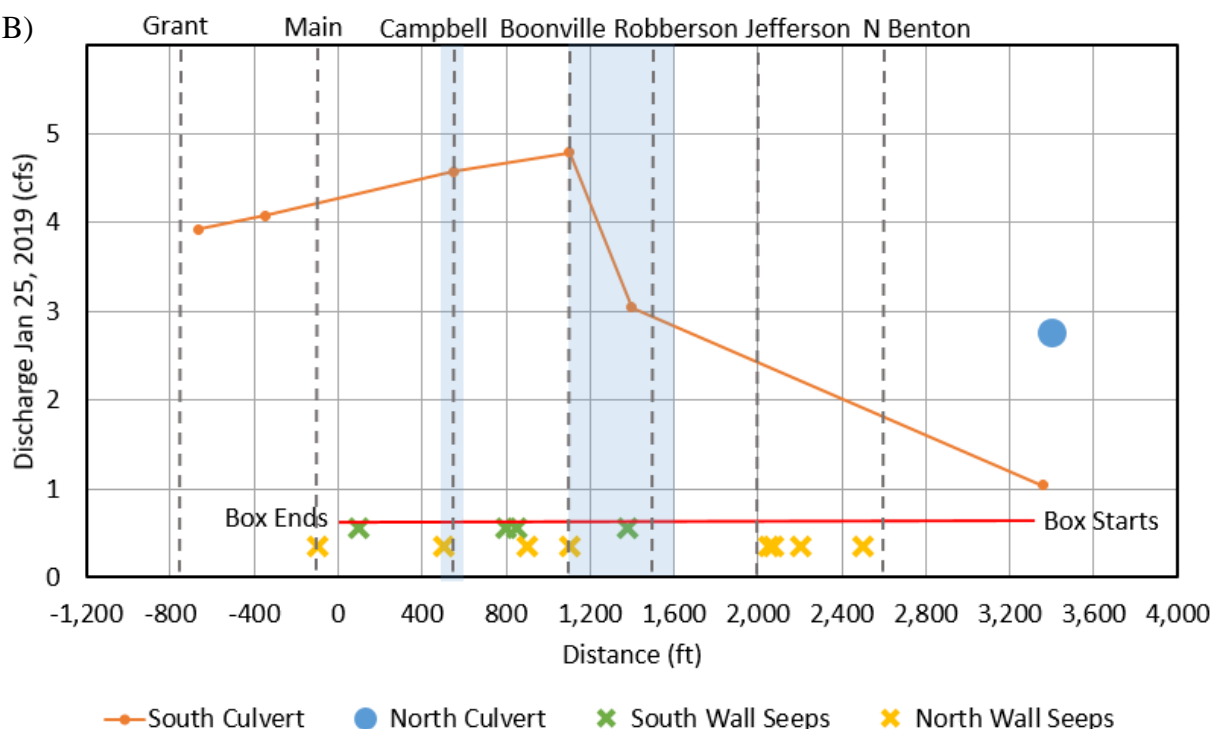
Figure 4. A) Stage and discharge at the USGS gaging station on Wilson Creek at Springfield for one week prior to sampling on January 25, 2019 and B) downstream changes in discharge collected during sampling.

A second round of discharge measurements were collected on January 25th inside the culvert to try and quantify the observed increase within this section of the culvert. This sampling was conducted during a relatively high base flow period after a series of small rain events occurred a week prior to collection (Figure 4). There was a total of 0.79" of rainfall the week prior to sampling, with 0.32" of rainfall recorded three days prior to sampling. Discharge at the USGS gaging station during this sampling period was around 13.0 ft³/s. The observed increase in flow in the larger combined culvert from the initial sampling was verified. Discharge increased about 60% in the large combined culvert going from 3.04 ft³/s at station 1,400 ft near Robberson to 4.79 ft³/s at station 1,100 ft near Boonville (Table 1). While the source of this additional water is unknown it could be connected to the spring located just south of the culvert near Robberson Ave. and Water St. Furthermore, a "flush pipe" was identified at 1,380 ft and likely supplies water to the stream from a sump pump from an overhead building but the volume is unknown. The 4.79 ft³/s measured inside the culvert is about 37% of the flow at the USGS gage downstream.

2. **There is a possible influx of groundwater from stations 1,400 ft to 1,100 ft within the large single culvert between Robberson and Boonville Ave.** Observations of discharge in this area show a 60% increase in flow between stations 1,100 ft and 1,400 ft in the combined culvert between Robberson and Boonville. Temperature increased and chloride concentrations decreased within this area indicating a groundwater source here rather than an exfiltration source. Possible sources may be Lyman Spring located just south of this location and the “flush pipe” observed at station 1,380 ft.

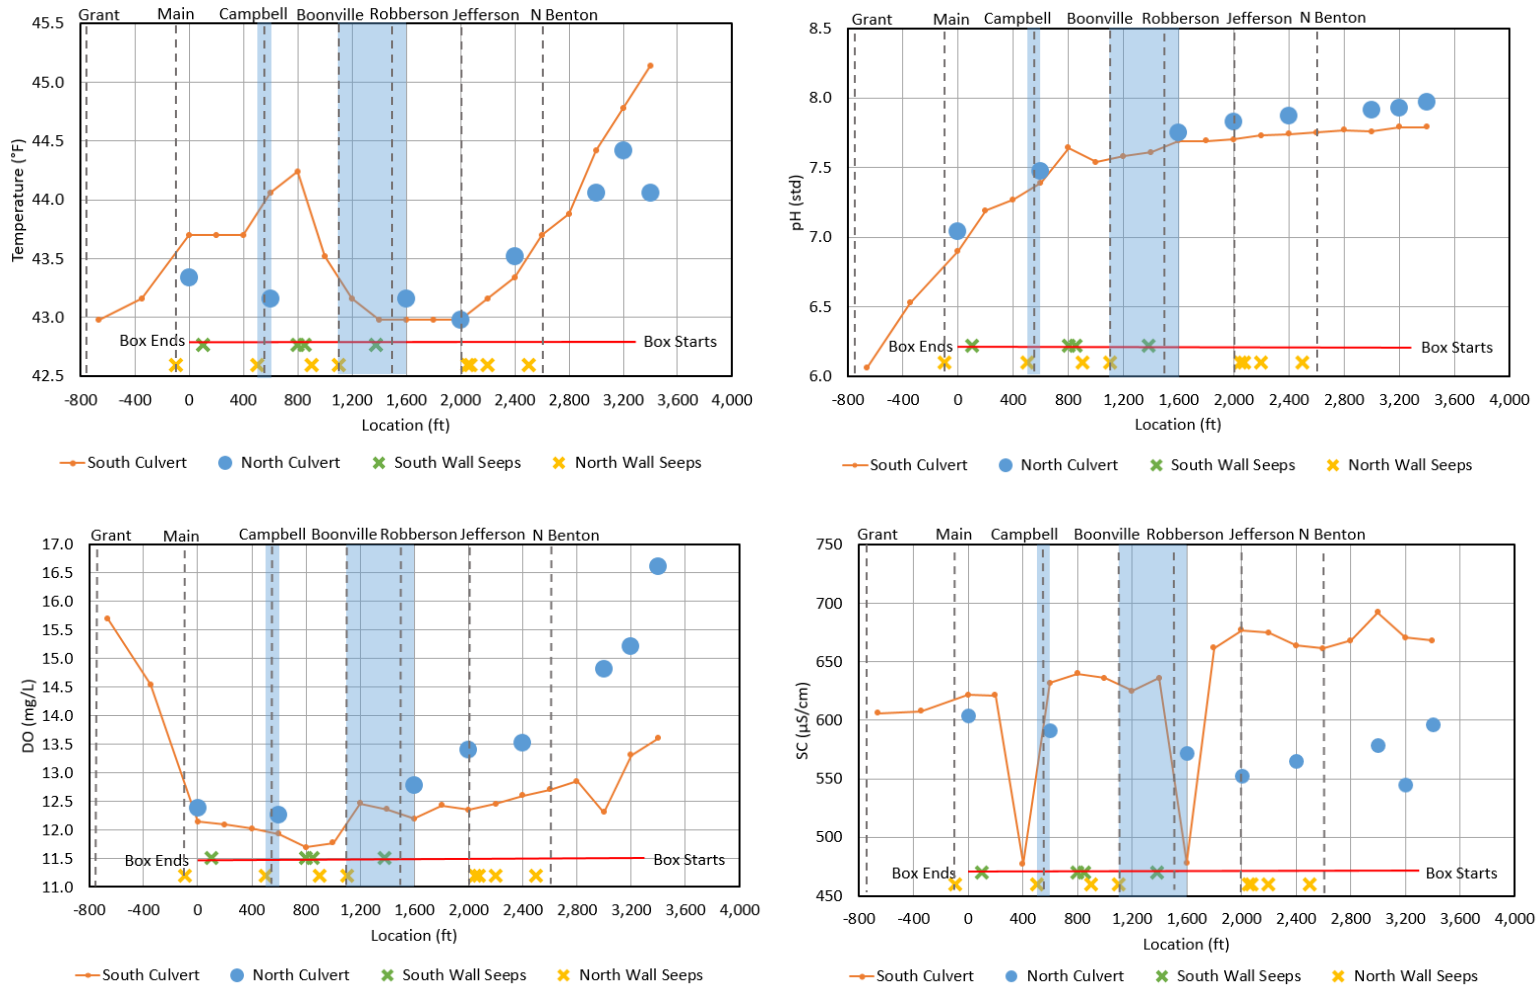
Figure 5. Downstream trends of physical water parameters from December 11, 2018. Combined culverts noted in blue.

Measurements of DO, pH, and SC decreased downstream through the culvert, while T also decreased downstream to station 1,600 ft, it then increased to the outlet. The pH decreased downstream in both north and south culverts (Table 2, Figure 5). Readings of DO were higher in the north culvert compared to the south culvert, but after flow mixes in the single culvert room

near Robberson, DO concentration in both culverts remains similar. SC in the north culvert is lower than the south culvert where flow enters the culvert and mix in the combined culvert. Values for T were similar in both culverts upstream of the culvert and decrease until station 1,600 ft, here the two culverts mix and start to warm as flow moves downstream. This is an indication that there may be an influx of warmer groundwater entering the culvert near Robberson at station 1,600 ft. Some of the outliers in the dataset, such as the very low SC numbers, are likely the result of poor readings due shallow water depth. Therefore, any odd extreme values were taken into consideration in the analysis.

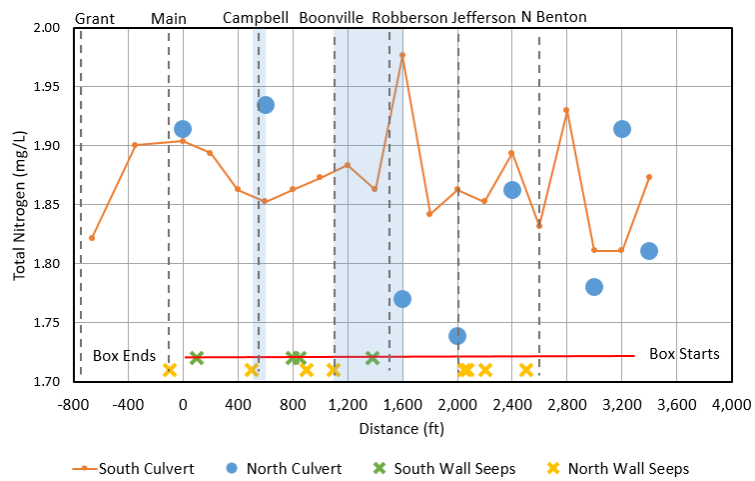
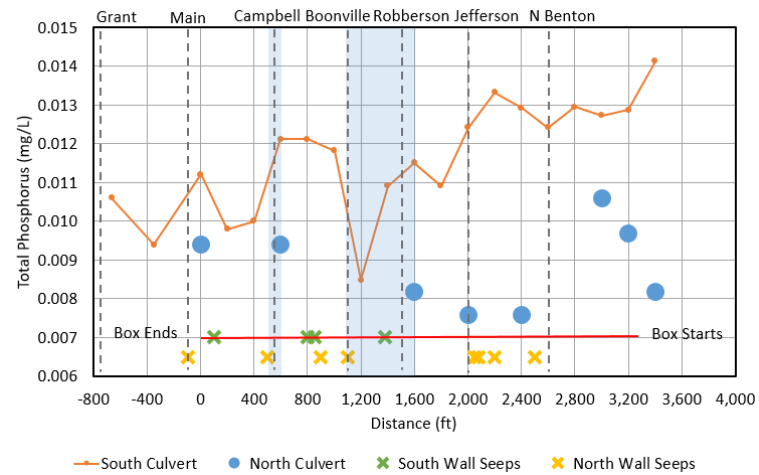
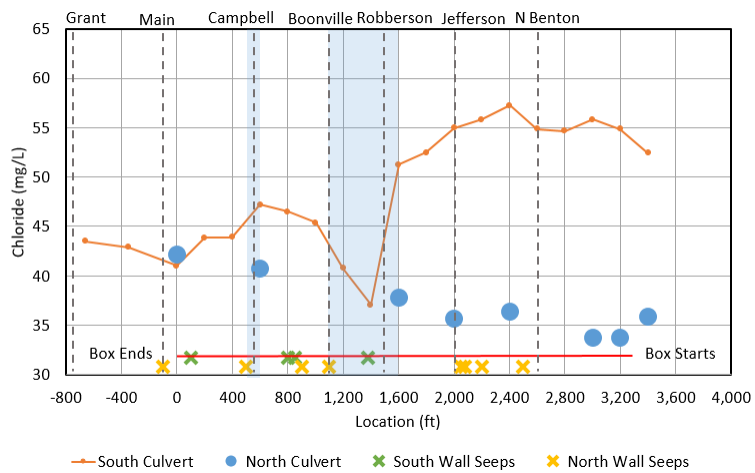
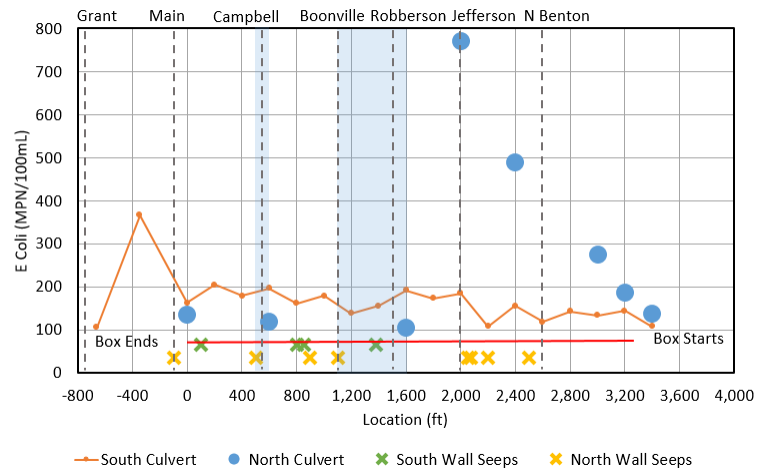
Figure 6. Downstream trends of nutrients and chloride from December 11, 2018. Combined culvert noted in blue.

Total nitrogen concentrations increase and total phosphorus concentration decrease downstream through the study reach. At base flow, sources of nutrients to the underground would likely be from sewer exfiltration or other types of point sources (Vystavana et. al 2018). However, TN concentrations have been known to be high at base flow in urban streams within Springfield (Miller 2006, Owen and Pavlowsky 2014, Owen et al. 2015). Nutrient concentrations from this study were relatively low compared to a previous water quality study in the mid-2000s (Miller, 2006). In the present study, TN concentrations ranged from 1.74-1.98 mg/L in both culverts with average concentrations of 1.87 mg/L in the south culvert and 1.84 mg/L in the north culvert (Table 2). In general, TN concentrations increase through the box culvert with a spike near station 1,600 ft suggesting perhaps an influx of groundwater in the vicinity near Robberson Ave. (Figure 6). Total phosphorus concentrations ranged from 0.008-0.014 mg/L in the two culverts with an average of 0.009 mg/L in the north culvert and 0.012 mg/L in the south culvert. In 2004-2005, base flow TN in December and January ranged from 2.55-3.35 mg/L and 0.017-0.023 mg/L for TP at Main Ave. (Miller, 2006). Nutrient concentrations from this study are low compared to winter base flow nutrient concentrations from other area urban streams. In recent studies of other urban streams in Springfield, winter base flow concentrations of TN ranged from 1.54-3.53 mg/L and TP concentrations ranged from 0.009-0.023 mg/L (Owen and Pavlowsky 2014, Owen et al. 2015).

Chloride concentrations decrease downstream through the underground with the south culvert having higher concentrations than the north culvert until they mix together near Robberson Ave. At base flow, sources of chloride to the underground would likely be from either sewer exfiltration, application of road salt in the winter, and from treated water in the distribution system (Vystavana et. al 2018). Concentrations of Cl range from 37.0-57.2 mg/L in the south culvert with an average of 48.8 mg/L (Table 2). In the north culvert, concentrations range from 33.7-42.1 mg/L with an average of 37.0 mg/L. In general, concentrations are >50 mg/L in the south culvert and <40 mg/L in the north culvert until they mix in the large room near Robberson Ave. and stay in the 40-50 mg/L range to the end of the study reach (Figure 6). The abrupt

decrease in CI at station 1,600 ft near Robberson suggests dilution from water in the south culvert but also may indicate an influx of relatively “clean” groundwater at this location.

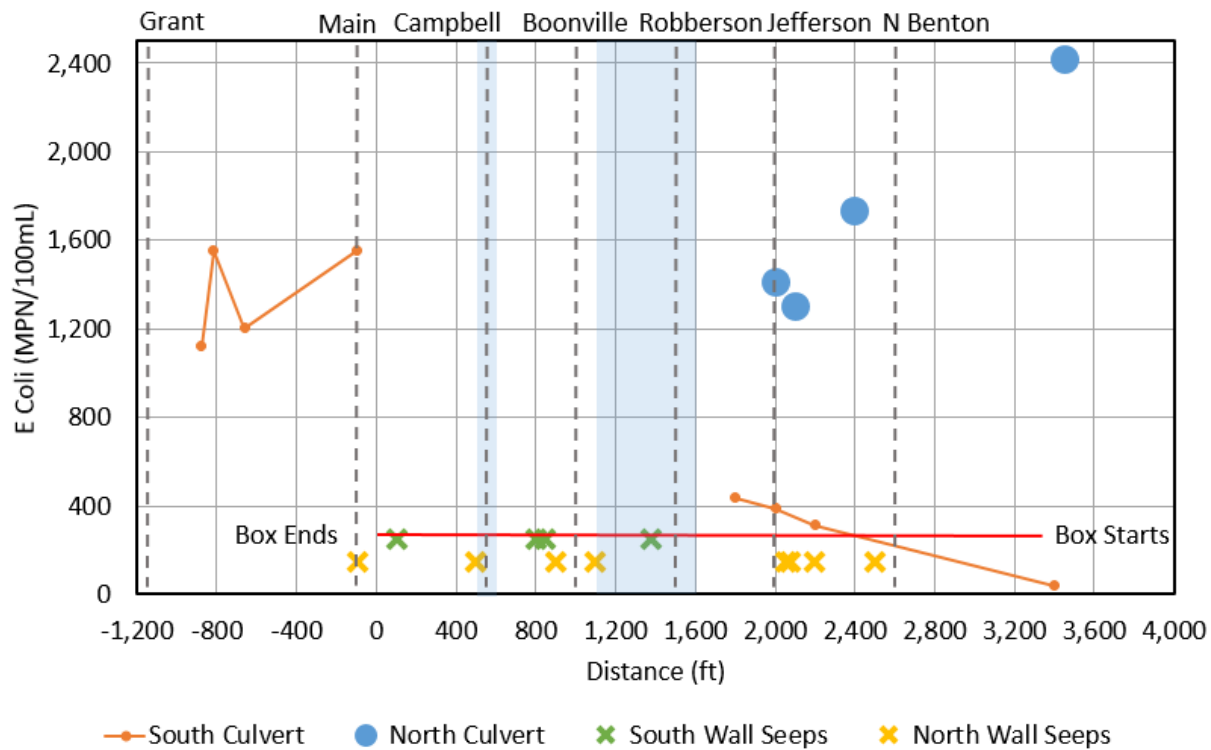
Figure 7. Downstream trend of E. coli from January 25, 2019. Combined culvert noted in blue.

During the second sampling event on January 25, 2019, *E. coli* concentrations were much higher overall and exhibited different trends, particularly for the North Branch and culvert samples, compared to those previously observed during low flow conditions in December. *E. coli* concentrations along the south/combined culvert ranged from 38-1,553 MPN/100 mL with an average of 825 MPN/100 mL (Table 3). Peak concentrations were again measured downstream stream of the underground outlet near Main and Grant Avenues at levels near 1,600 MPN/100 mL (Figure 7). In contrast, North Branch and culvert *E. coli* concentrations ranged from 1,300-2,240 MPN/100 mL with an average of 1,716 MPN/100 mL. Peak concentrations at 2,400 MPN/100 mL were measured in North Branch above the underground inlet and then decreased to to about 1,400 MPN/100 mL at station 2,000 ft. near Jefferson Avenue (Figure 7). Results from this second round of sampling were considerably higher than the December 11, 2018 sampling. Since the concentrations were 5-6x higher than the first sampling, downstream peaks are not apparent in the dataset. Furthermore, these trends show the North Branch of Jordan Creek delivering relatively high *E. coli* concentrations almost two orders of magnitude higher than from the South Branch of Jordan Creek at the time of sampling. These results suggest that bacteria transport and flow concentration in Jordan Creek may be highly variable over discharge/stage and potentially between the rising and falling limbs for runoff hydrographs.

3. **E. coli concentrations appear to be much higher in the North Branch of Jordan compared to the South and downstream peaks suggest possible wastewater exfiltration in the north culvert near station 2,000 ft and near Grant Ave.** During the December 11, 2018 sampling the highest concentrations of E coli inside the underground were found in the north culvert at station 2,000 ft and downstream of the outlet near Grant Ave. This suggests a possible exfiltration source along the north culvert near Jefferson and downstream of the MS4 channel west of Main Ave. The attempt to replicate these findings during a January 25, 2019 sample collection were unsuccessful as very high E. coli concentrations coming down the N. Branch of Jordan Creek which were 5-6 times higher than the December 11, 2018 samples overwhelmed the downstream trends. However, concentrations coming into the culvert from the S. Branch of Jordan Creek were only 38 MPN/100 mL.

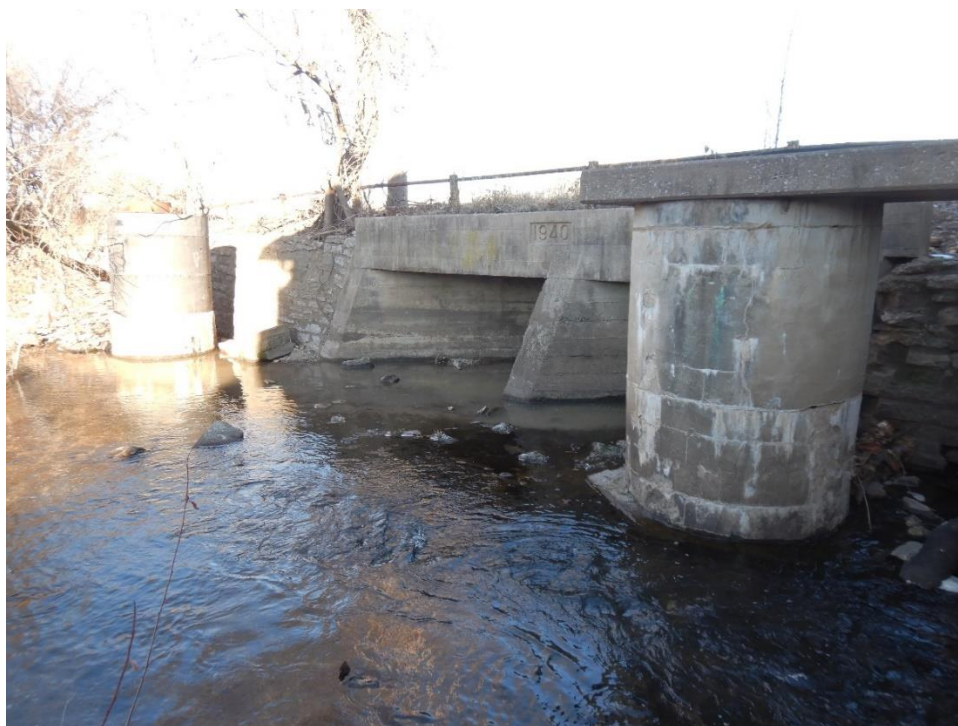
Photo 1. Two sewer manholes and a large culvert located at 876 feet downstream of the underground along the north bank. (Photo taken January 25, 2019)

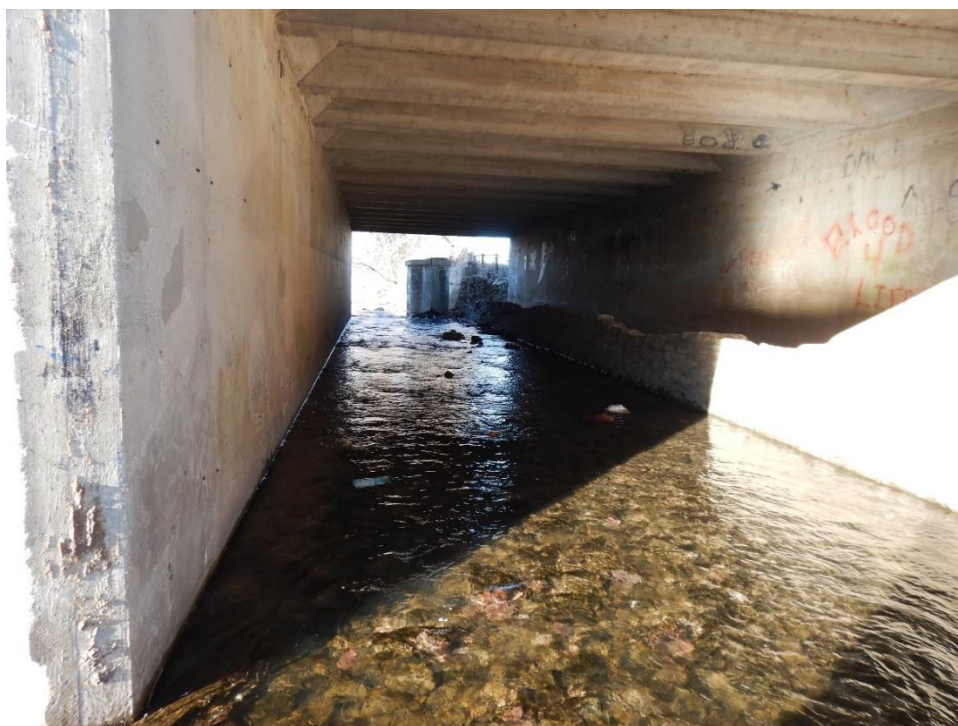
Photo 2. Building over creek located 816 feet downstream of the underground looking upstream. (Photo taken January 25, 2019)

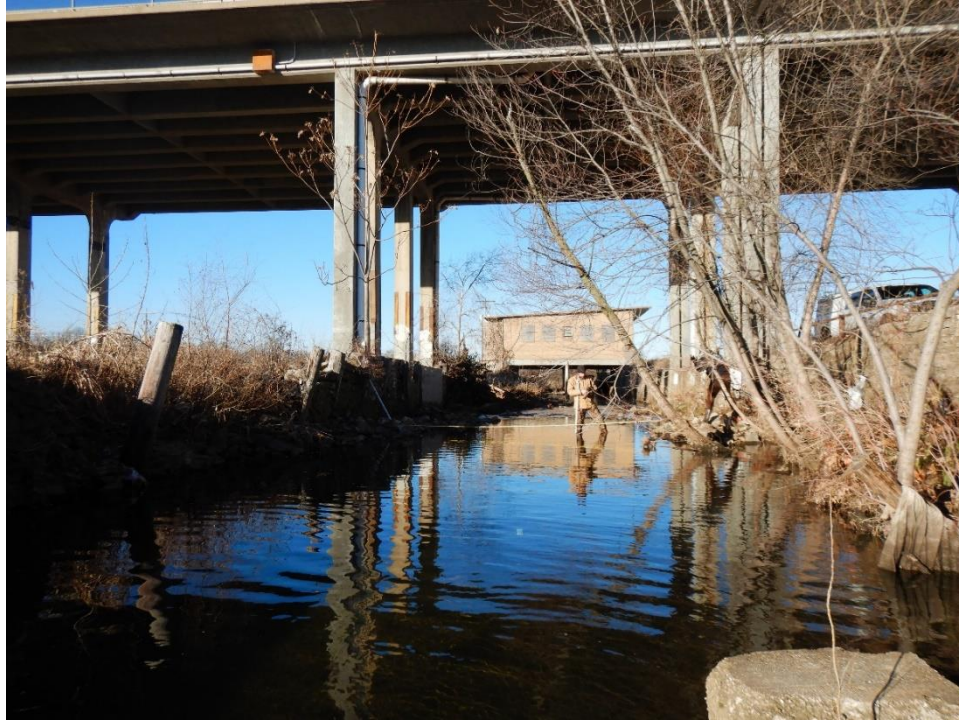
Photo 3. Grant Ave Bridge located 663 feet downstream of the underground looking upstream. (Photo taken January 25, 2019)

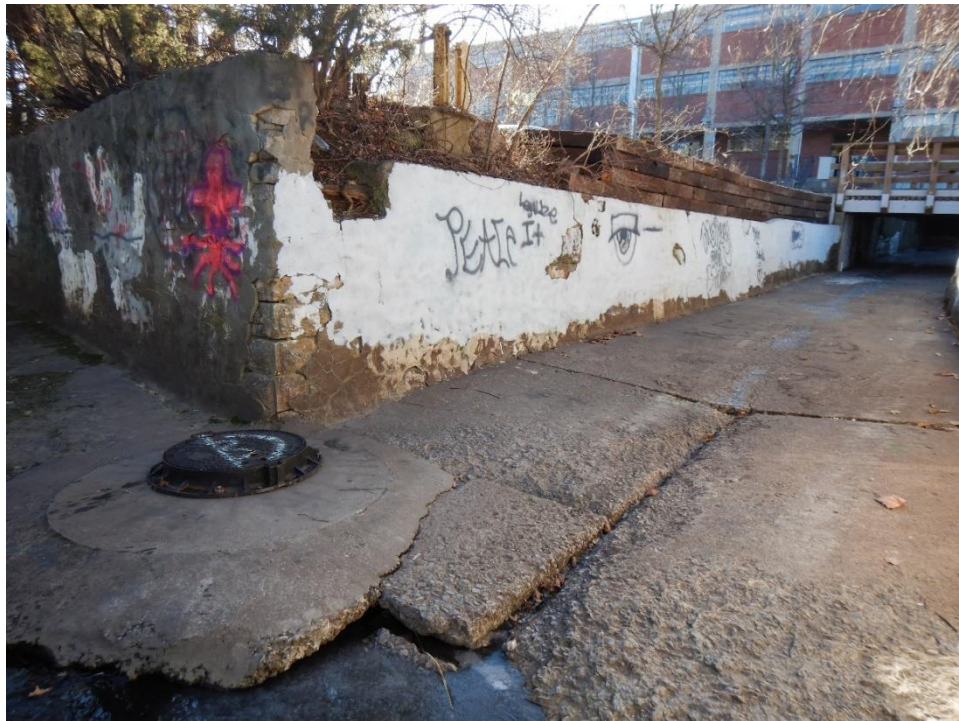
Photo 4. MS4 channel near Main Ave. located 256 ft downstream of the underground on south bank. (Photo taken January 25, 2019)

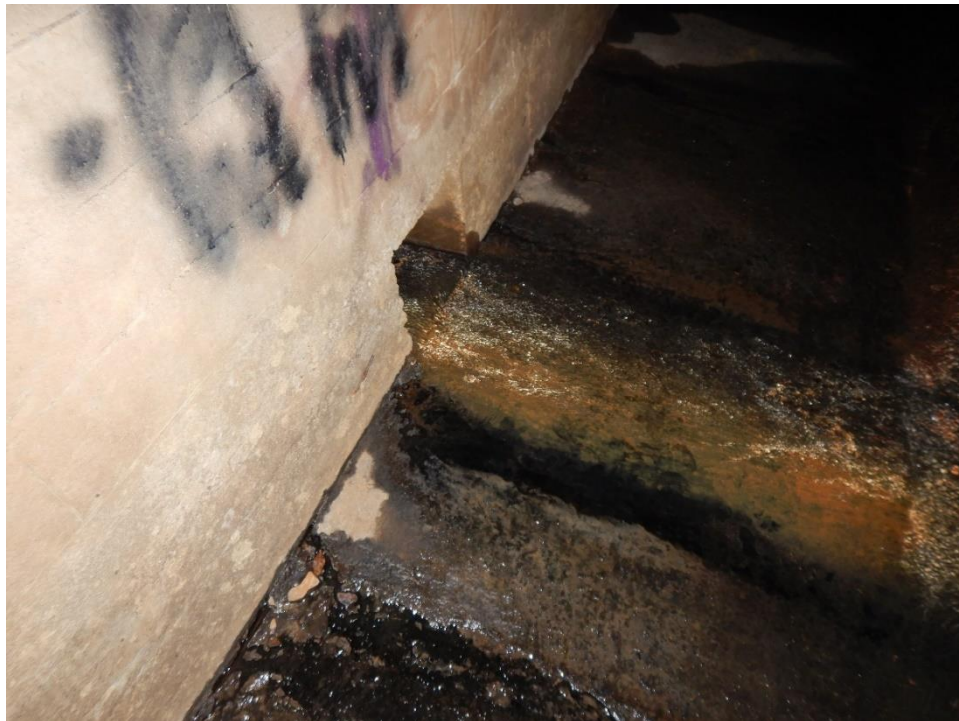
Photo 6. Larger drain at 800 ft in the south culvert along south exterior wall. Several other drains and seeps enter the south culvert downstream of Campbell Ave. (Photo taken January 25, 2019)
