**National Water Quality Initiative (NWQI)  
Watershed Assessment for:**

**Headwaters Petite Saline Creek  
Watershed (HUC-103001020401)**

**Deliverable # 1 – Inventory of the Watershed  
Deliverable # 2 – Resource Analysis of the Watershed  
Deliverable # 3 – Final Report: Identification of  
Conservation Needs on Vulnerable Acres**

**OEWRI EDR-19-005**

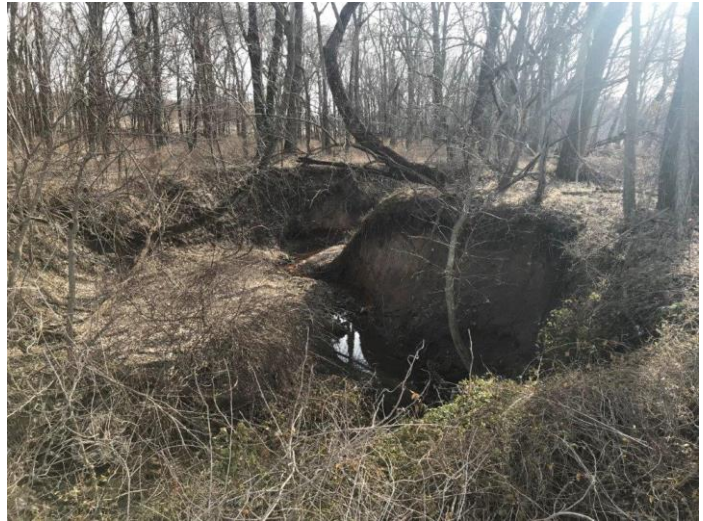
### Site # 51: Downstream

Channel condition	1	<b>Overall Score</b> 4.2
Hydrologic alteration	1	
Riparian zone	8	
Bank stability	1	
Canopy cover	10	
Manure presence

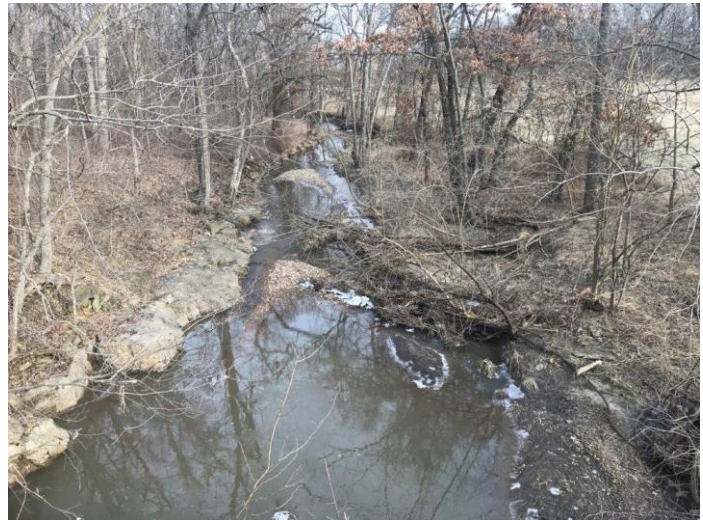
### Site # 47: Downstream

Channel condition	8	<b>Overall Score</b> 7.8
Hydrologic alteration	8	
Riparian zone	5	
Bank stability	8	
Canopy cover	10	
Manure presence

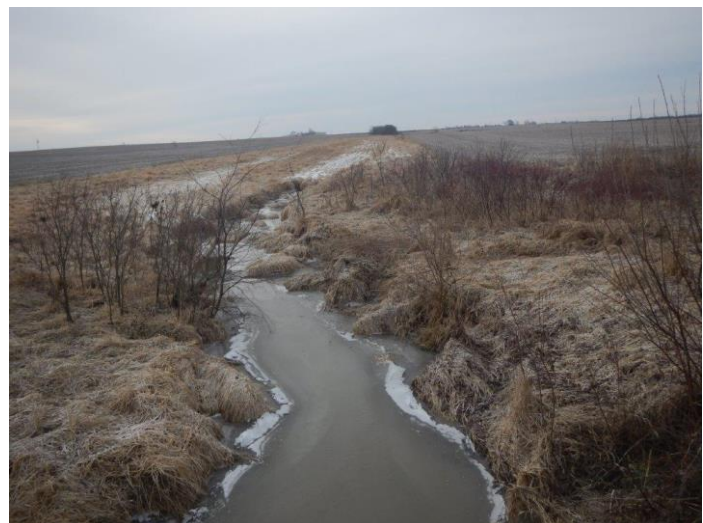
### Site # 1: Upstream

Channel condition	3	<b>Overall Score</b> 5.4
Hydrologic alteration	3	
Riparian zone	10	
Bank stability	10	
Canopy cover	1	
Manure presence

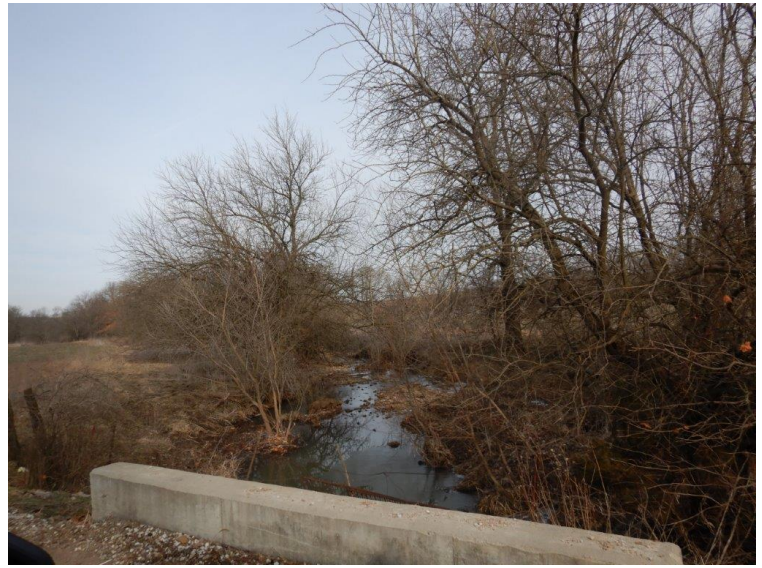
### Site # 24: Downstream

Channel condition	<input type="text" value="10"/>	<b>Overall Score</b> 6.7
Hydrologic alteration	<input type="text" value="9"/>	
Riparian zone	<input type="text" value="5"/>	
Bank stability	<input type="text" value="8"/>	
Canopy cover	<input type="text" value="3"/>	
Manure presence	<input type="text" value="5"/>

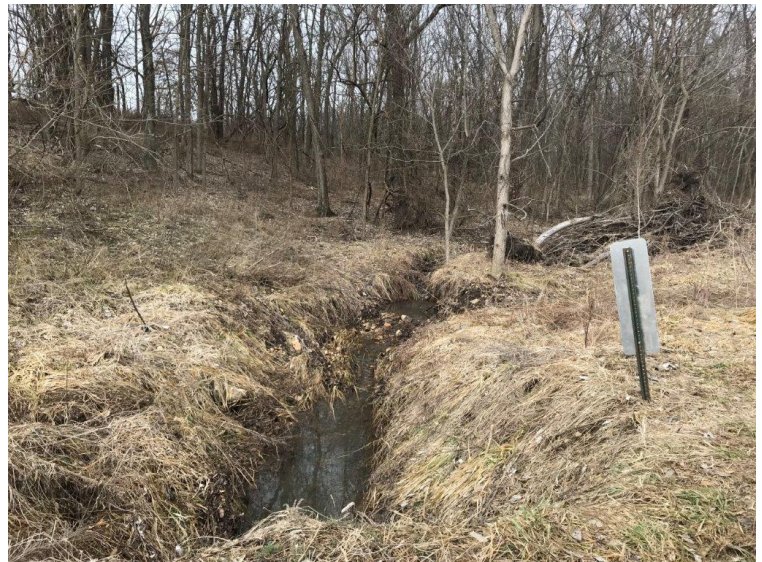
### Site # 61: Downstream

Channel condition	<input type="text" value="3"/>	<b>Overall Score</b> 6.0
Hydrologic alteration	<input type="text" value="9"/>	
Riparian zone	<input type="text" value="10"/>	
Bank stability	<input type="text" value="9"/>	
Canopy cover	<input type="text" value="2"/>	
Manure presence	<input type="text" value="3"/>

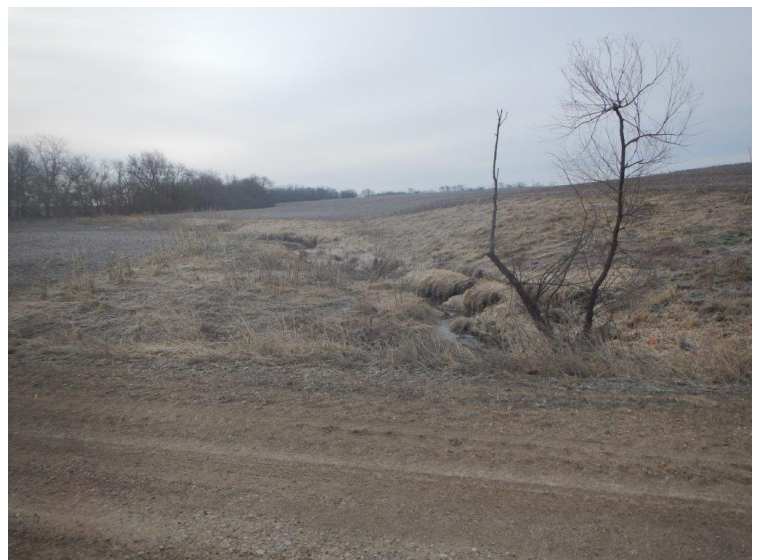
### Site # 22: Upstream

Channel condition	<input type="text" value="7"/>	<b>Overall Score</b> 5.4
Hydrologic alteration	<input type="text" value="8"/>	
Riparian zone	<input type="text" value="5"/>	
Bank stability	<input type="text" value="5"/>	
Canopy cover	<input type="text" value="2"/>	
Manure presence	<input type="text"/>

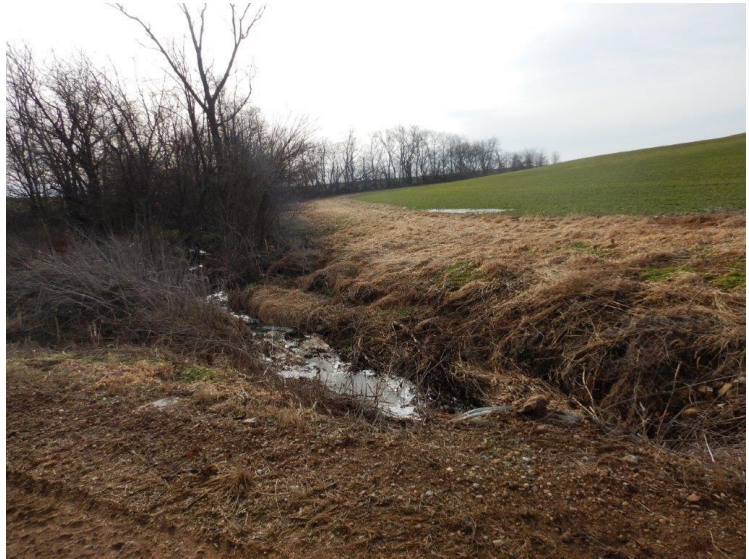
### Site # 27: Upstream

**Overall  
Score**  
8.2

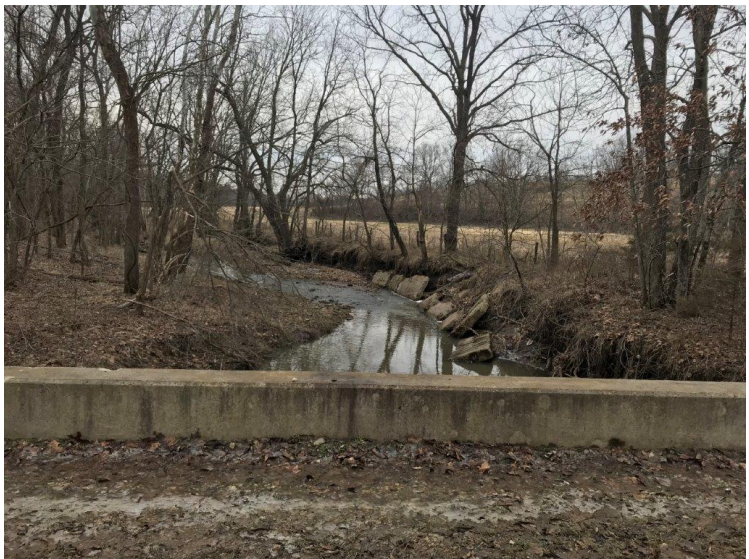
### Site # 68: Upstream

**Overall  
Score**  
5.2

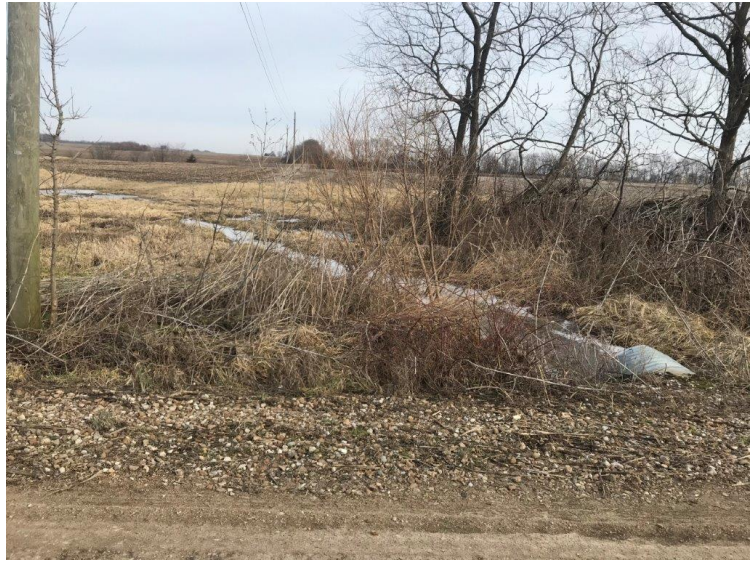
### Site # 46: Downstream

Channel condition	<input type="text" value="1"/>
Hydrologic alteration	<input type="text" value="1"/>
Riparian zone	<input type="text" value="1"/>
Bank stability	<input type="text" value="10"/>
Canopy cover	<input type="text" value="1"/>
Manure presence	<input type="text"/>

**Overall  
Score**  
2.8

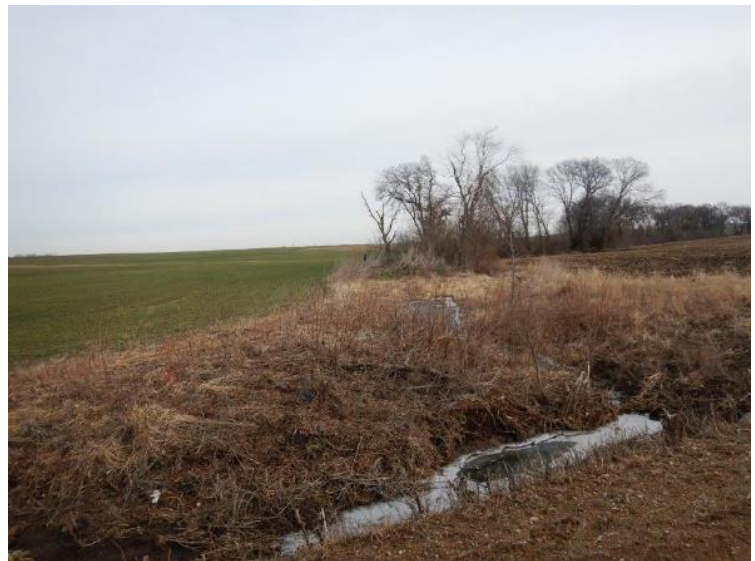
### Site # 34: Downstream

Channel condition	<input type="text" value="10"/>
Hydrologic alteration	<input type="text" value="10"/>
Riparian zone	<input type="text" value="9"/>
Bank stability	<input type="text" value="9"/>
Canopy cover	<input type="text" value="10"/>
Manure presence	<input type="text"/>

**Overall  
Score**  
9.6

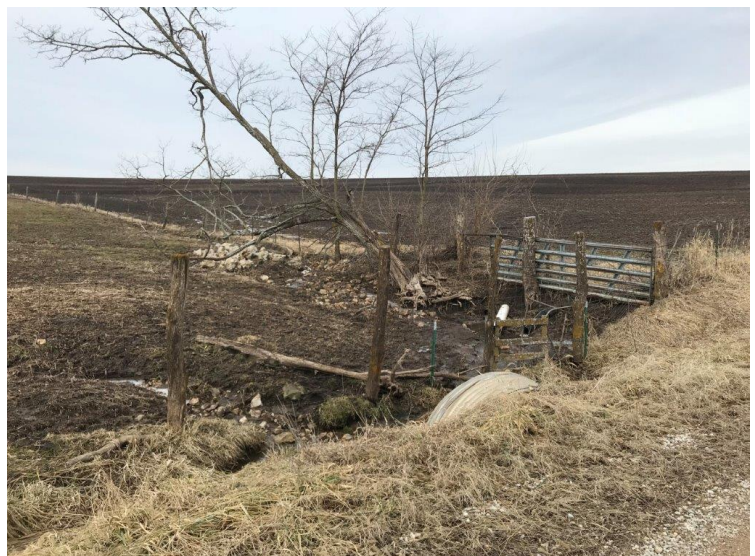
### Site # 57: Upstream

Channel condition	<input type="text" value="1"/>
Hydrologic alteration	<input type="text" value="1"/>
Riparian zone	<input type="text" value="0"/>
Bank stability	<input type="text" value="3"/>
Canopy cover	<input type="text" value="1"/>
Manure presence	<input type="text" value="1"/>

**Overall  
Score**  
1.2

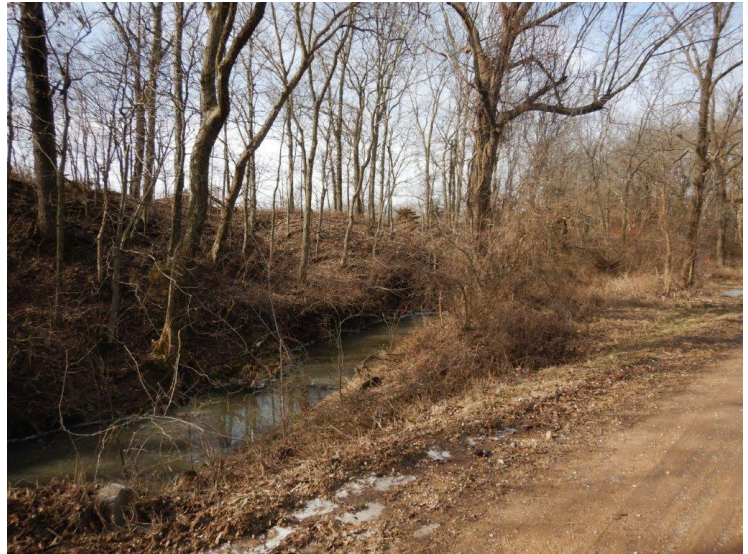
### Site # 36: Upstream

Channel condition	<input type="text" value="10"/>	<b>Overall Score</b> 6.4
Hydrologic alteration	<input type="text" value="3"/>	
Riparian zone	<input type="text" value="5"/>	
Bank stability	<input type="text" value="7"/>	
Canopy cover	<input type="text" value="7"/>	
Manure presence	<input type="text"/>

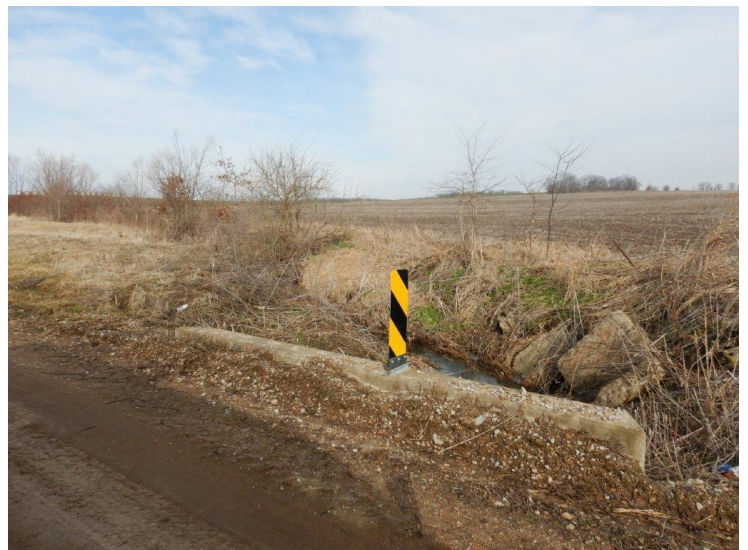
### Site # 38: Upstream

Channel condition	<input type="text" value="3"/>	<b>Overall Score</b> 3.8
Hydrologic alteration	<input type="text" value="5"/>	
Riparian zone	<input type="text" value="4"/>	
Bank stability	<input type="text" value="5"/>	
Canopy cover	<input type="text" value="2"/>	
Manure presence	<input type="text"/>

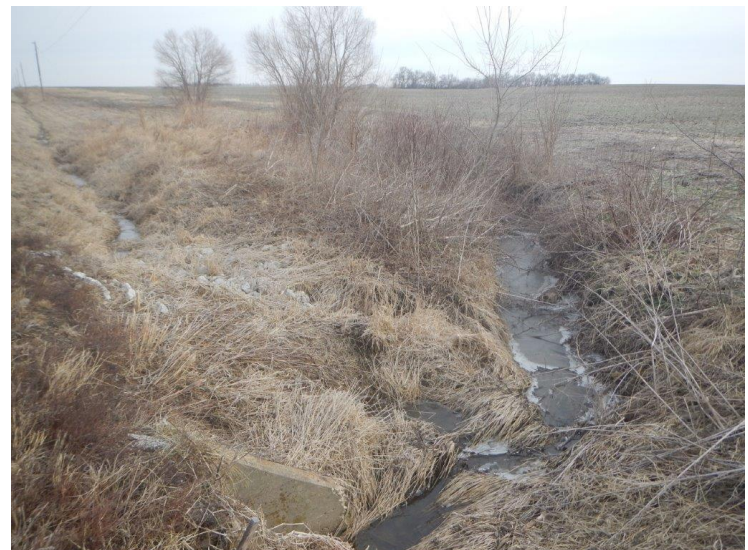
### Site # 30: Downstream

Channel condition	<input type="text" value="10"/>	<b>Overall Score</b> 9.0
Hydrologic alteration	<input type="text" value="8"/>	
Riparian zone	<input type="text" value="9"/>	
Bank stability	<input type="text" value="9"/>	
Canopy cover	<input type="text" value="9"/>	
Manure presence	<input type="text"/>

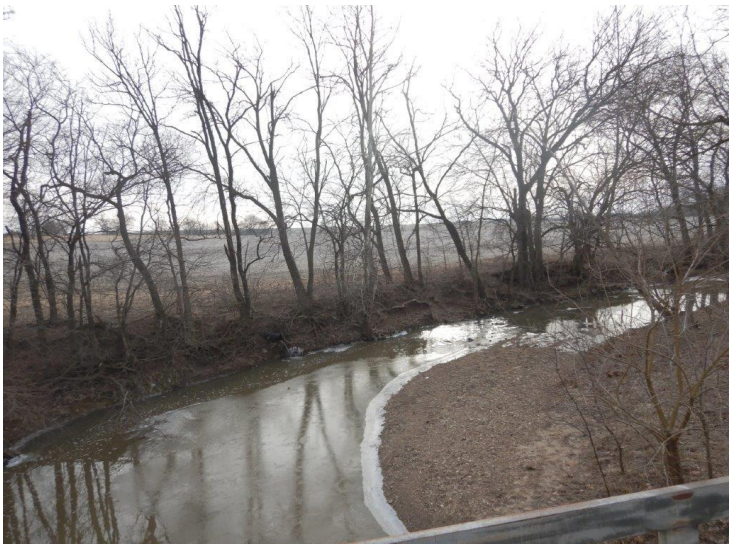
### Site # 13: Upstream

Channel condition	<input type="text" value="10"/>
Hydrologic alteration	<input type="text" value="3"/>
Riparian zone	<input type="text" value="1"/>
Bank stability	<input type="text" value="3"/>
Canopy cover	<input type="text" value="7"/>
Manure presence	<input type="text" value="5"/>

**Overall  
Score**  
4.8
