**The Ozarks Environmental and Water Resources Institute (OEWRI)
Missouri State University (MSU)**

**Mississippi River Basin Healthy Watersheds Initiative (MRBI)
Watershed Assessment for:**

**Long Branch Watershed (HUC-10280103204)
Spring Branch-Elk Creek Watershed (HUC-102801031302)
Turkey Creek Watershed (HUC-102801031301)**

**Deliverable # 1 – Inventory of the Watershed
Deliverable # 2 – Resource Analysis of the Watershed
Deliverable # 3 – Identification of Conservation Needs
on Vulnerable Acres**

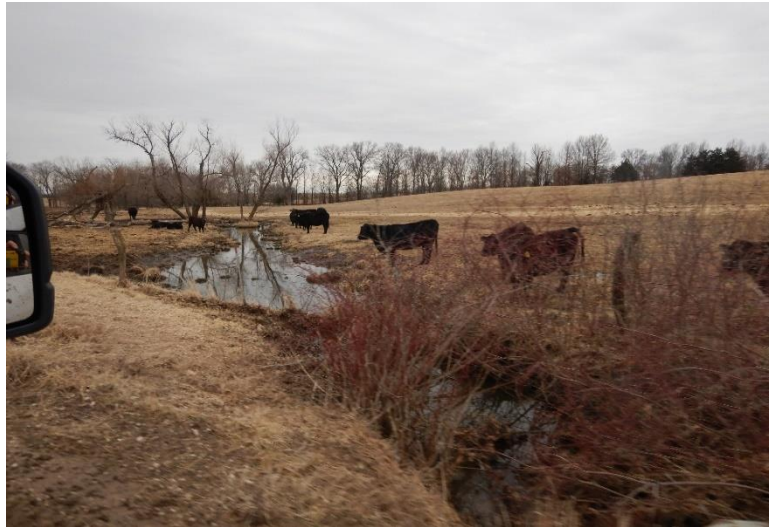
Site # 57: Downstream

Channel condition	10
Hydrologic alteration	3
Riparian zone	1
Bank stability	1
Canopy cover	1
Manure presence	5

**Overall
Score
3.5**

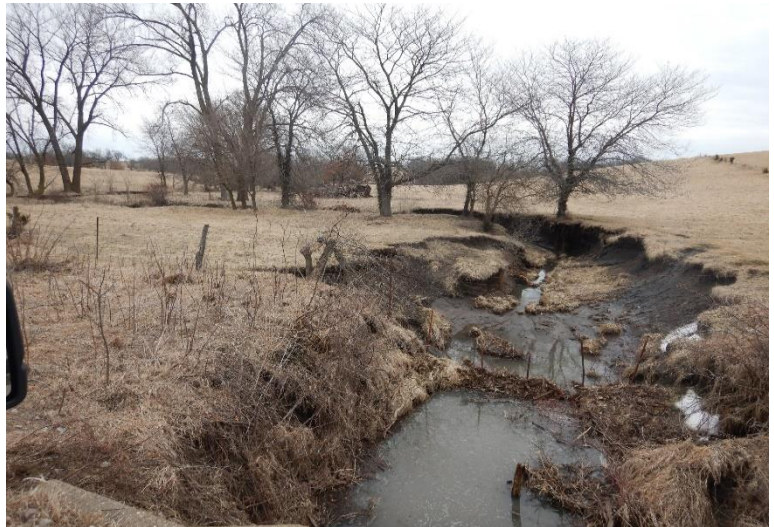
Site # 157: Upstream

Channel condition	1
Hydrologic alteration	1
Riparian zone	1
Bank stability	1
Canopy cover	1
Manure presence	1

**Overall
Score
1.0**

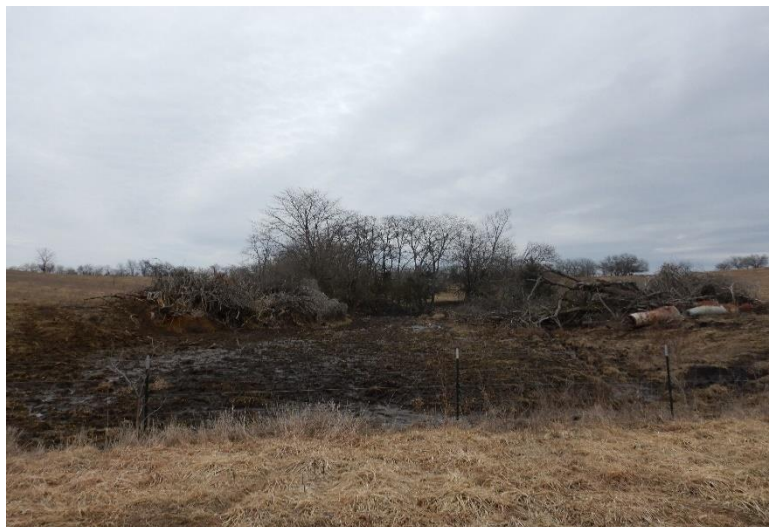
Site # 101: Downstream

Channel condition	10
Hydrologic alteration	5
Riparian zone	1
Bank stability	3
Canopy cover	1
Manure presence	3

**Overall
Score**
4.0

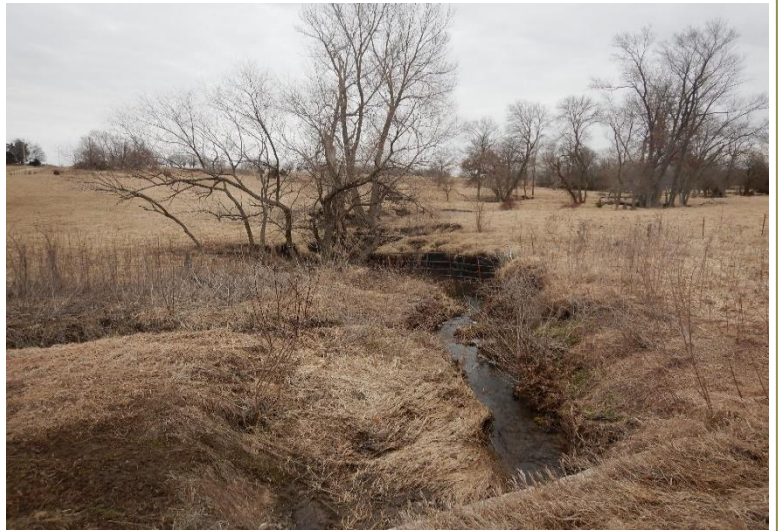
Site # 12: Upstream

Channel condition	10
Hydrologic alteration	5
Riparian zone	8
Bank stability	5
Canopy cover	10
Manure presence	5

**Overall
Score**
7.0

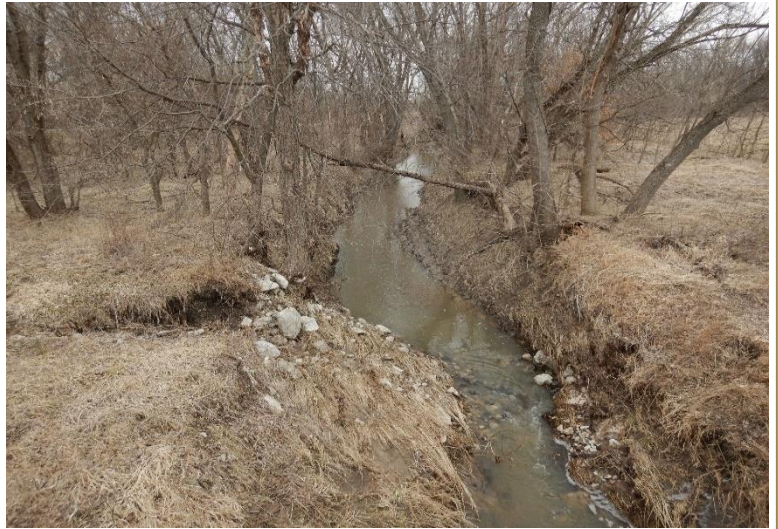
Site # 12: Downstream

Channel condition	10
Hydrologic alteration	10
Riparian zone	10
Bank stability	10
Canopy cover	3
Manure presence	0

**Overall
Score**
8.6

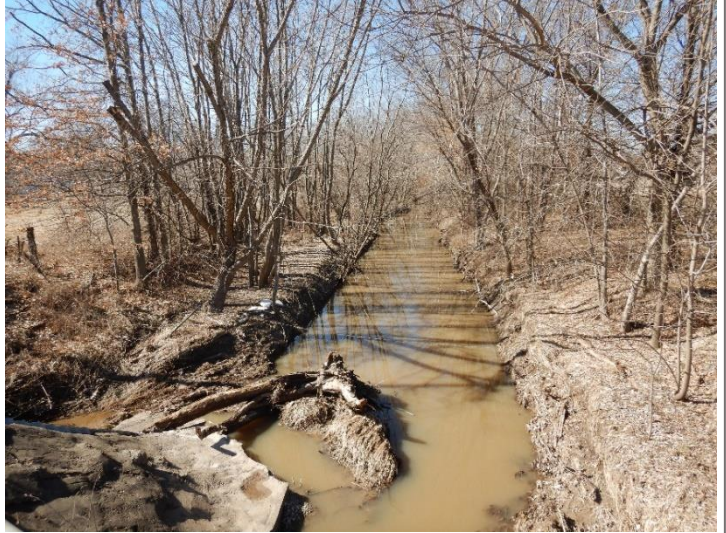
Site # 15: Downstream

Channel condition	<input type="text"/>
Hydrologic alteration	<input type="text"/>
Riparian zone	<input type="text"/>
Bank stability	<input type="text"/>
Canopy cover	<input type="text"/>
Manure presence	<input type="text"/>

**Grass
Waterway**

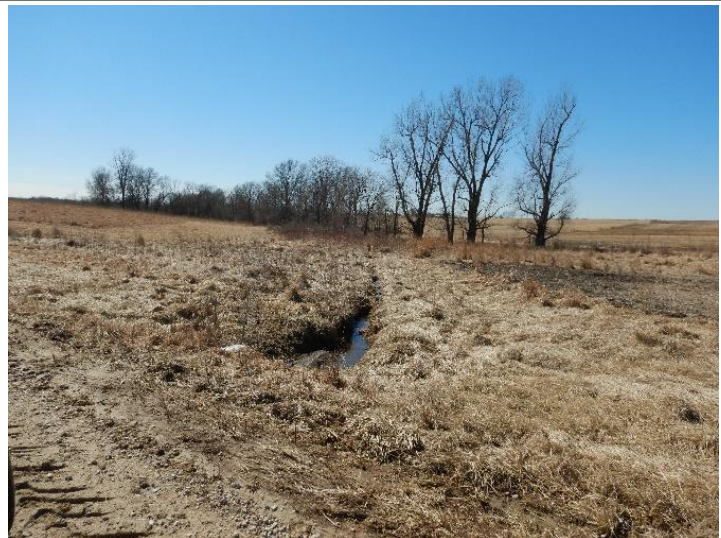
Site # 99: Upstream

Channel condition	<input type="text" value="1"/>
Hydrologic alteration	<input type="text" value="1"/>
Riparian zone	<input type="text" value="1"/>
Bank stability	<input type="text" value="5"/>
Canopy cover	<input type="text" value="1"/>
Manure presence	<input type="text" value="1"/>

**Overall
Score**
1.7

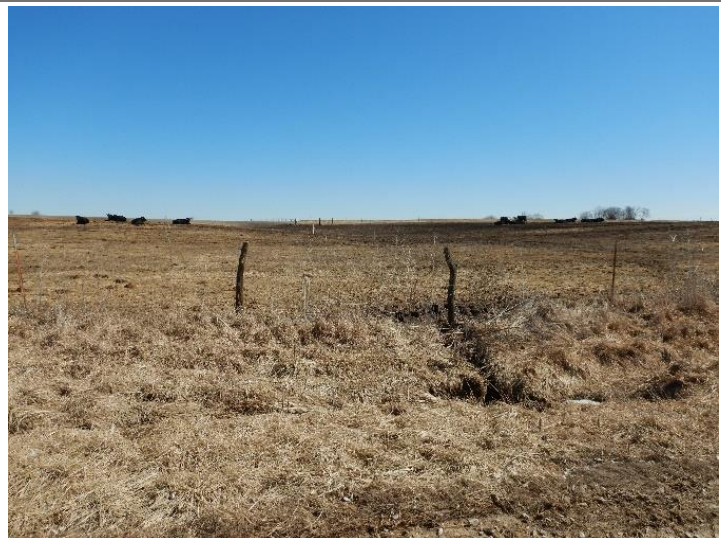
Site # 45: Downstream

Channel condition	<input type="text" value="10"/>
Hydrologic alteration	<input type="text" value="7"/>
Riparian zone	<input type="text" value="9"/>
Bank stability	<input type="text" value="8"/>
Canopy cover	<input type="text" value="9"/>
Manure presence	<input type="text"/>

**Overall
Score**
8.6
