**Mississippi River Basin Healthy Watersheds Initiative (MRBI)  
Watershed Assessment for:**

**Cane Creek Watershed (HUC-071401070404)**

**Dry Creek Watershed (HUC-071401070406)**

**FINAL REPORT**

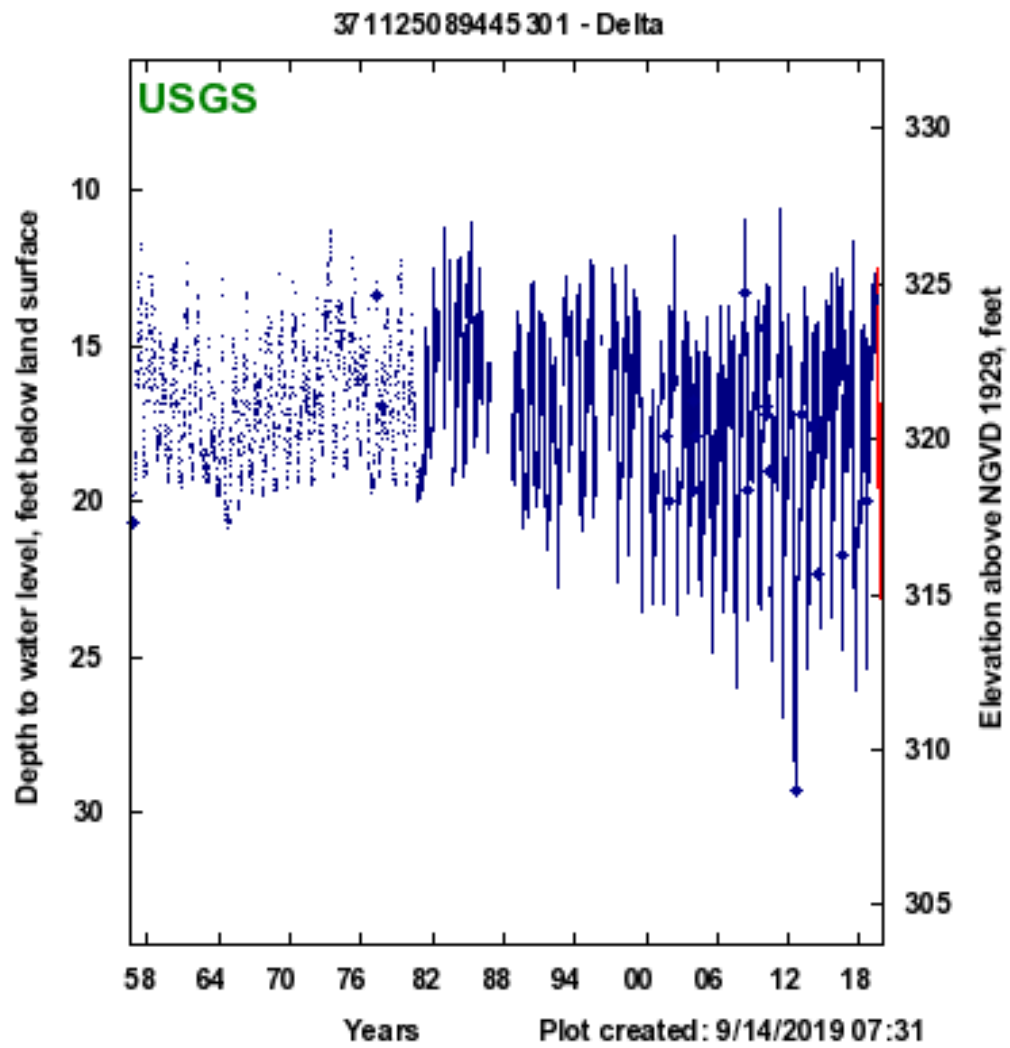
Figure 16. Groundwater level change for Delta (1958-2018).

possible locations would be on Cane Creek at Hwy 51 (UTM Zone 15N Northing: 4,117,881.62 Easting: 769,554.99), Dry Creek at Hwy 91 (UTM Zone 15N Northing: 4,118,069.18 Easting: 771,189.44), and/or on The Diversion Channel at State Hwy “N” (UTM Zone 15N Northing: 4,122,324.30 Easting: 779,625.30). Additionally, there is a ground water monitoring station in Delta, approximately 5 miles southeast and outside of the Dry Creek watershed (Site Number: 371125089445301). This well has been operating since 1956 and data from this station shows an overall decline of about 3 feet in ground water levels in this area and becoming more variable since 2000 (Figure 16).

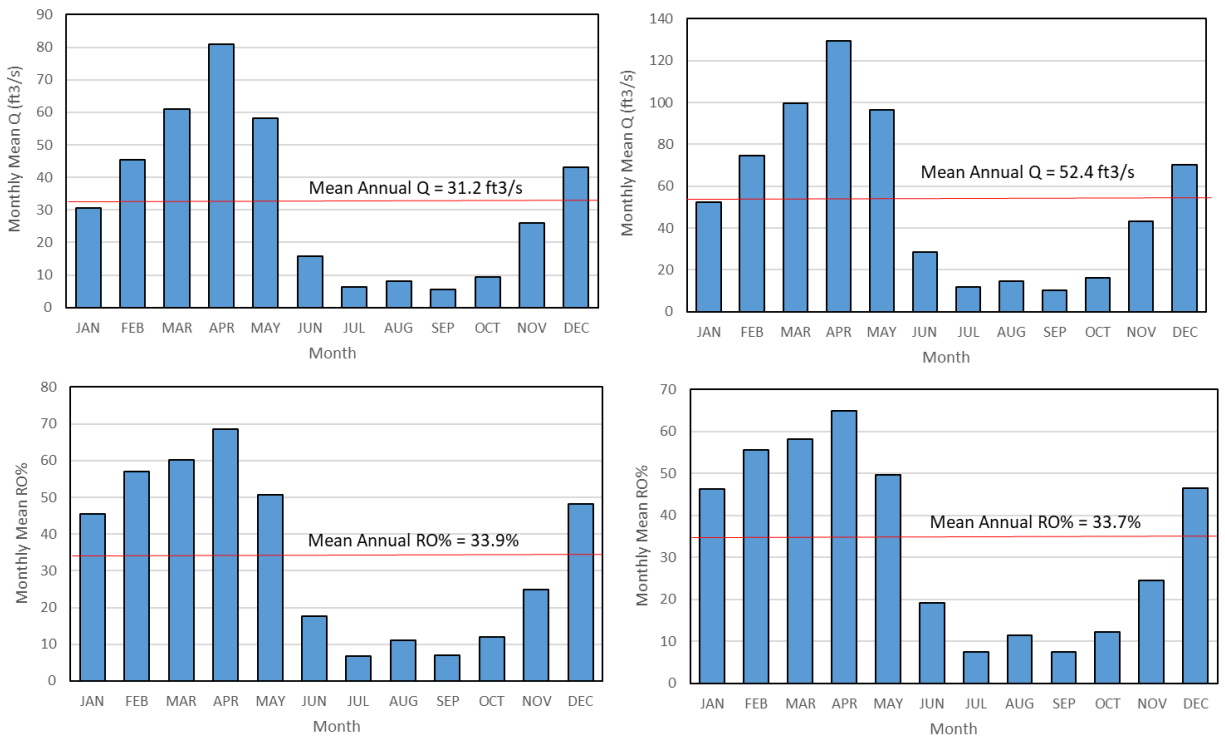
Figure 23. Mean monthly discharge and runoff percentage for the Cane Creek and Dry Creek watersheds

Annual and monthly runoff rates for the selected for the Dry and Cane Creek watersheds were estimated using equations developed from 21 USGS gaging stations in the region. Monthly runoff rates are important for understanding the seasonal variability and how rainfall-runoff relationships correspond to land management and annual runoff rates will be used to help validate the STEPL model hydrology results. A list of the equations used for this analysis of monthly mean discharge values can be found in Appendix E. Mean annual discharge for the Cane Creek watershed is 31.2 ft<sup>3</sup>/s and 52.4 ft<sup>3</sup>/s for Dry Creek (Figure 23). Total runoff volume

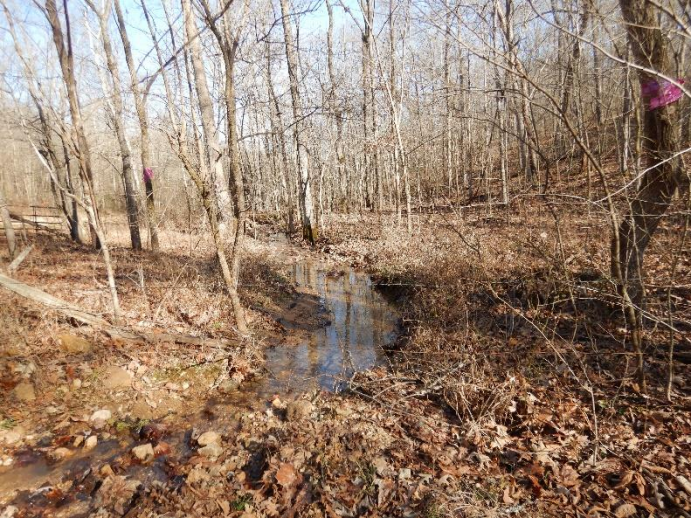
Channel condition	10		
Hydrologic alteration	10		
Riparian zone	10		
Bank stability	8		
Canopy cover	10		
Manure presence	-		
		<b>Overall Score</b>	9.6

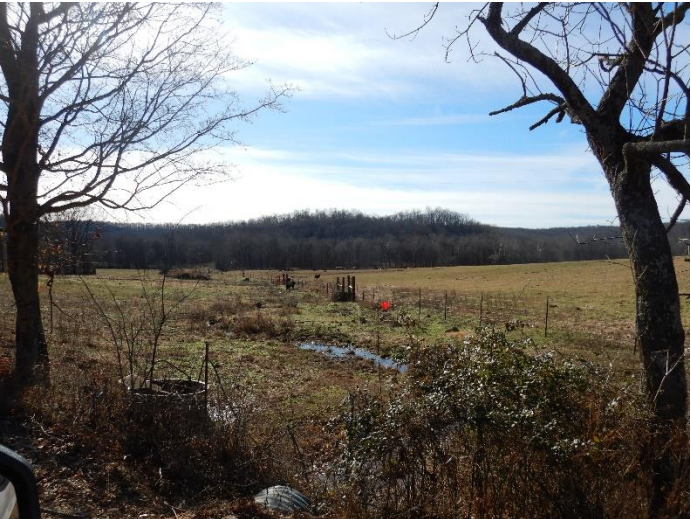
Channel condition	10		
Hydrologic alteration	10		
Riparian zone	1		
Bank stability	10		
Canopy cover	1		
Manure presence	2		
		<b>Overall Score</b>	5.7

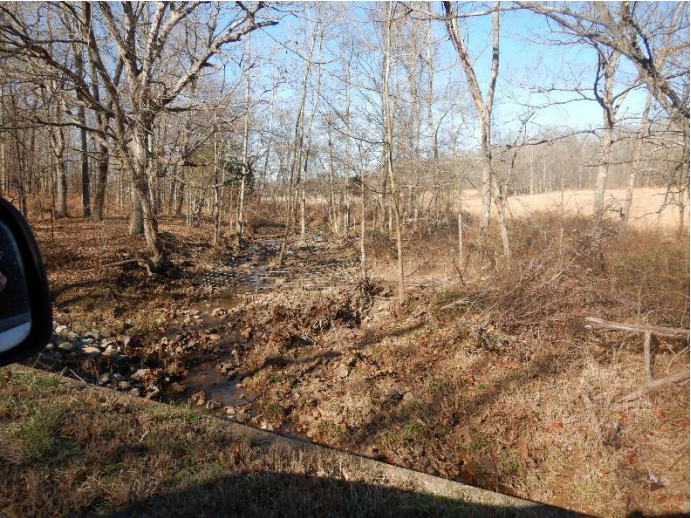
Channel condition	10		
Hydrologic alteration	9		
Riparian zone	7		
Bank stability	8		
Canopy cover	8		
Manure presence	-		
		<b>Overall Score</b>	8.4

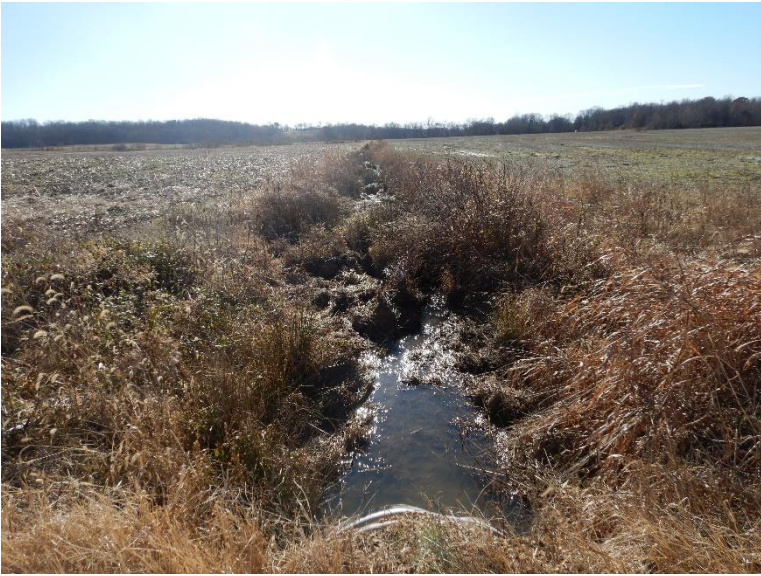
<p>Channel condition <input type="text" value="1"/></p> <p>Hydrologic alteration <input type="text" value="3"/></p> <p>Riparian zone <input type="text" value="5"/></p> <p>Bank stability <input type="text" value="8"/></p> <p>Canopy cover <input type="text" value="1"/></p> <p>Manure presence <input type="text" value="-"/></p> <p><b>Overall Score</b> 3.6</p>

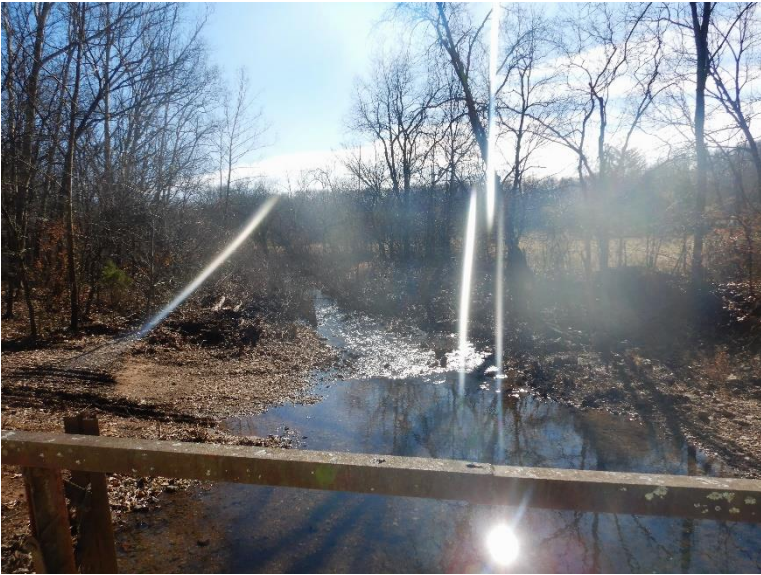
<p>Channel condition <input type="text" value="10"/></p> <p>Hydrologic alteration <input type="text" value="10"/></p> <p>Riparian zone <input type="text" value="6"/></p> <p>Bank stability <input type="text" value="10"/></p> <p>Canopy cover <input type="text" value="10"/></p> <p>Manure presence <input type="text" value="-"/></p> <p><b>Overall Score</b> 9.2</p>

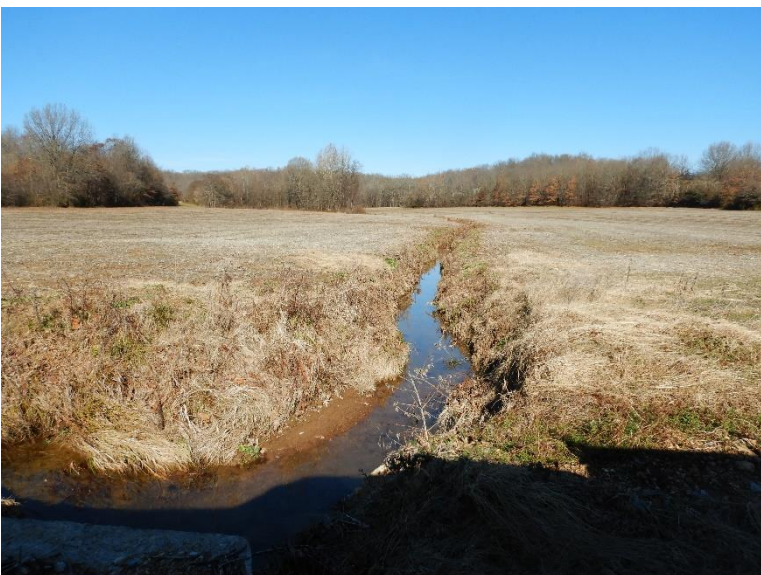
<p>Channel condition <input type="text" value="1"/></p> <p>Hydrologic alteration <input type="text" value="1"/></p> <p>Riparian zone <input type="text" value="1"/></p> <p>Bank stability <input type="text" value="5"/></p> <p>Canopy cover <input type="text" value="1"/></p> <p>Manure presence <input type="text" value="-"/></p> <p><b>Overall Score</b> 1.8</p>
