## Stream Bank Erosion Trends and Sediment Contributions in a Southwestern Missouri River

Ezekiel Allen Kuehn

A Masters Thesis

Master of Science, Geospatial Sciences in Geography, Geology, and Planning

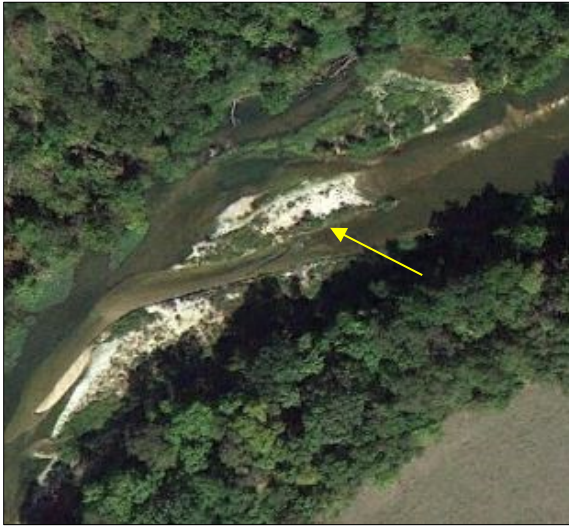
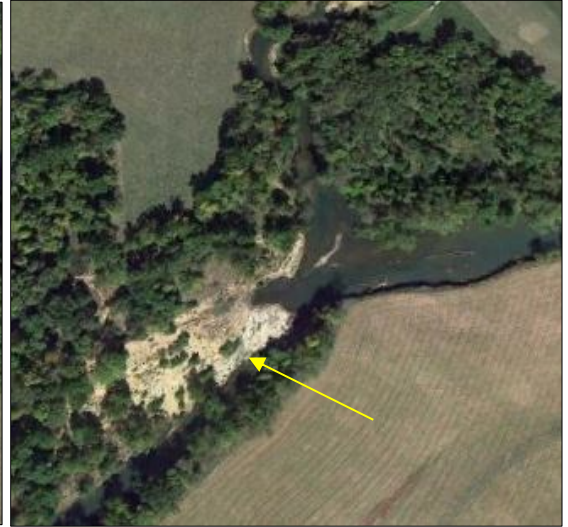
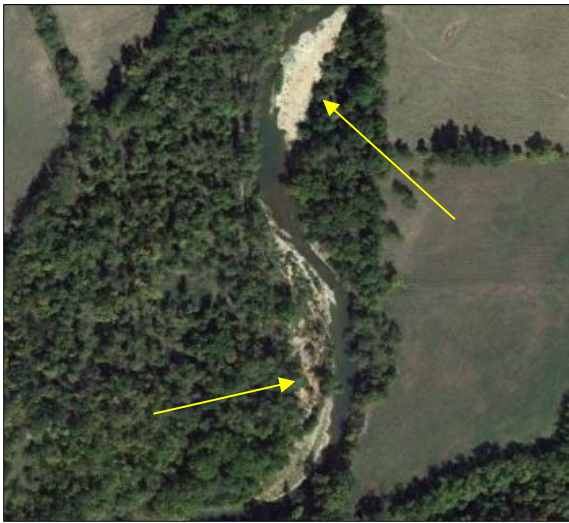
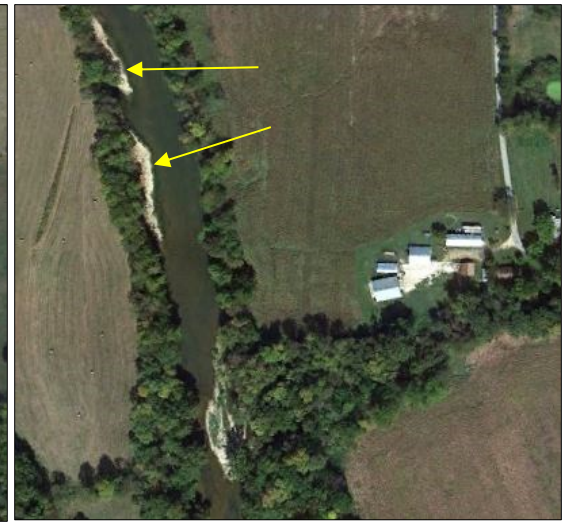
Mid Channel Bars

Delta Bar

Point Bars

Side Bars

Figure 11. Gravel bar types (Rosgen, 1996). Note: Gravel bar features shown in photographs are not in the study segment and are used for reference only.

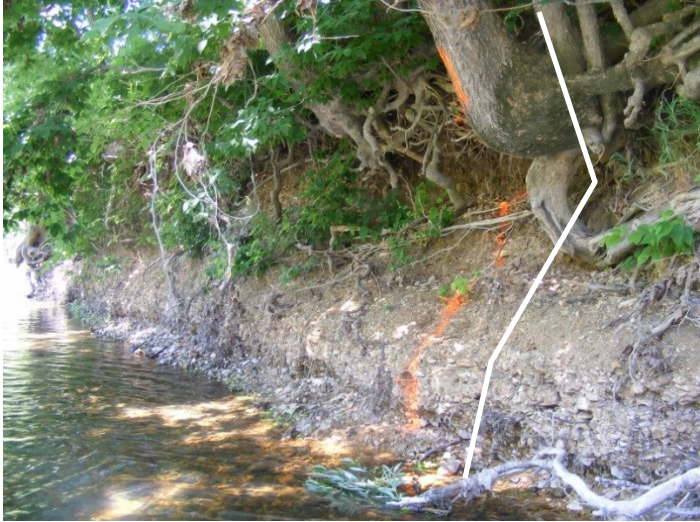
Pin arrays one and two. The bank profile is very steep and over hung in areas. (July, 2012)

Figure 35. Reach scale study areas with different channel geometry.

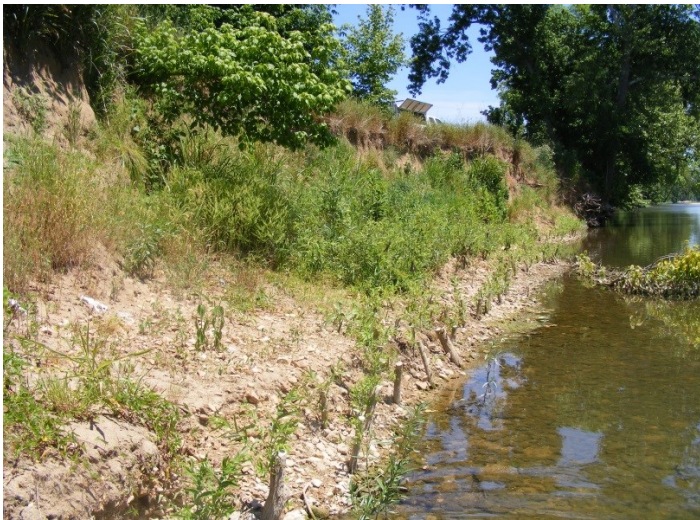
Looking upstream from pin array six, the bank has gentle transitions from bed to toe and toe to the upper section of the bank. This type of bank profile can dissipate energy better than the upper and lower parts of the reach remaining stable through the study period (Knighton, 1998; Czarnomski et al., 2012). (July, 2012)

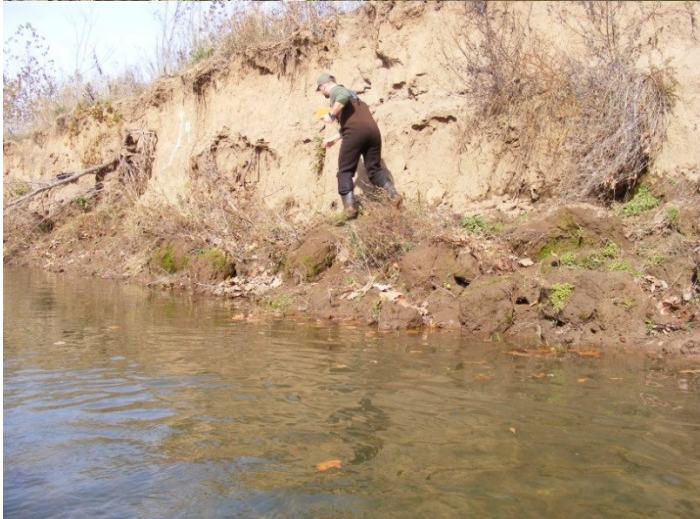
Looking downstream from pin array nine, the bank profile is very steep increasing the potential for erosion (Rosgen, 2001). (October, 2012)

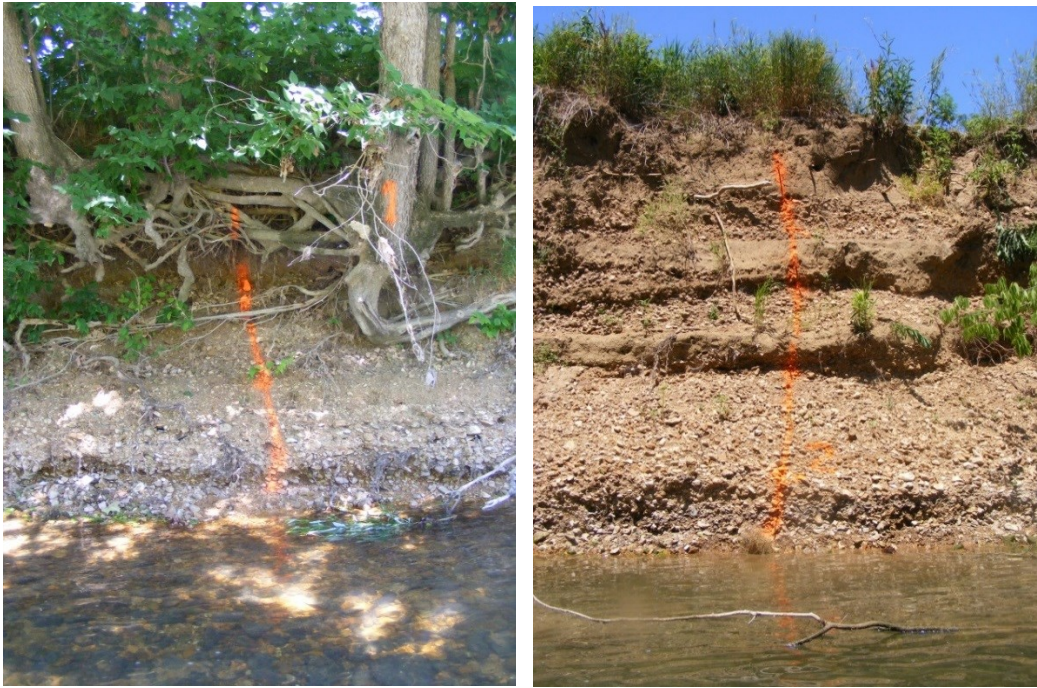
Figure 36. Pin arrays one and two. This area of the bank was composed of previously deposited gravel that can lead to higher erosion rates (August, 2012).
