Geomorphic and ecological disturbance and recovery from two small dams and their removal

Geomorphic and Ecological Disturbance and Recovery from Two Small Dams and Their Removal

Desirée D. Tullós^{1*}, Debra S. Finn², Cara Walter¹

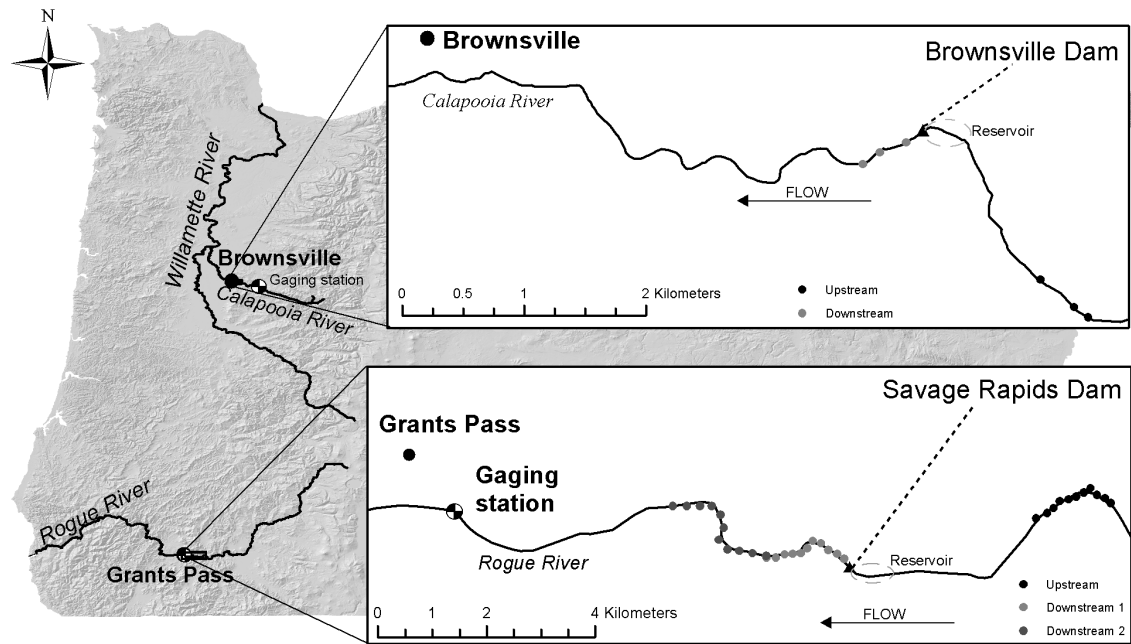
Figure 1. Site locations. Each dot represents a macroinvertebrate sampling location: 3 riffles per reach on the Calapooia River, and 11 transects per reach on the Rogue River.

The Calapooia River runs 121 km west from Tidbits Mountain in the Western Cascade Range to Albany, Oregon where it joins the Willamette River (Figure 1). Brownsville Dam ($122^{\circ}56'0.05''\text{W}$ $44^{\circ}23'15.67''\text{N}$) was a run of river, low-head dam (Table 1). The dam was originally built as a log crib dam in the late 1800s as a diversion and was rebuilt after failure in the 1964 flood [45–46]. The study area includes two reaches: 1) a 0.67 km control reach (C-US), a length equal to twenty times active channel width, that was located 2 km upstream from the dam; and 2) a 0.67 km (C-DS) impact reach starting immediately downstream of the dam (Figure 1). Permission for access was not necessary since work was conducted within the high-water elevation of the river.

The Rogue River flows 346 km west from springs on Mount McLoughlin in the Cascade Range near Crater Lake to the Pacific Ocean at Gold Beach, Oregon (Figure 1). Savage Rapids Dam ($123^{\circ}13'46.85''\text{W}$ $42^{\circ}25'14.30''\text{N}$) was built in 1921 as an irrigation diversion (Table 1) [47] during the summer, passing peaks flows during winter rainfall and spring snowmelt runoff [48] unregulated. Decommissioning of Savage Rapids Dam began with the removal of the right bays of the dam in April–June 2009 during which time there was a small release of sediment associated with drawdown and the partial failure of the coffer dam [49]. The coffer dam remained in place and flow was forced through the left bays and fish ladder until October–November 2009, when the coffer dam and remaining infrastructure was removed, a pilot channel was constructed, and the river was returned to a free flowing river [50]. The study area consisted of three reaches (Figure 1): 1) a 1.5 km control reach (R-US), approximately 40 times summer wetted width, located 4 km upstream from the dam; 2) one 1.8 km impact reach, starting immediately downstream of the dam (R-DS1); and 3) a second 2.4 km impact reach (R-DS2), starting immediately below R-DS1. Permission for access was not necessary since work was conducted within the high-water elevation of the river.

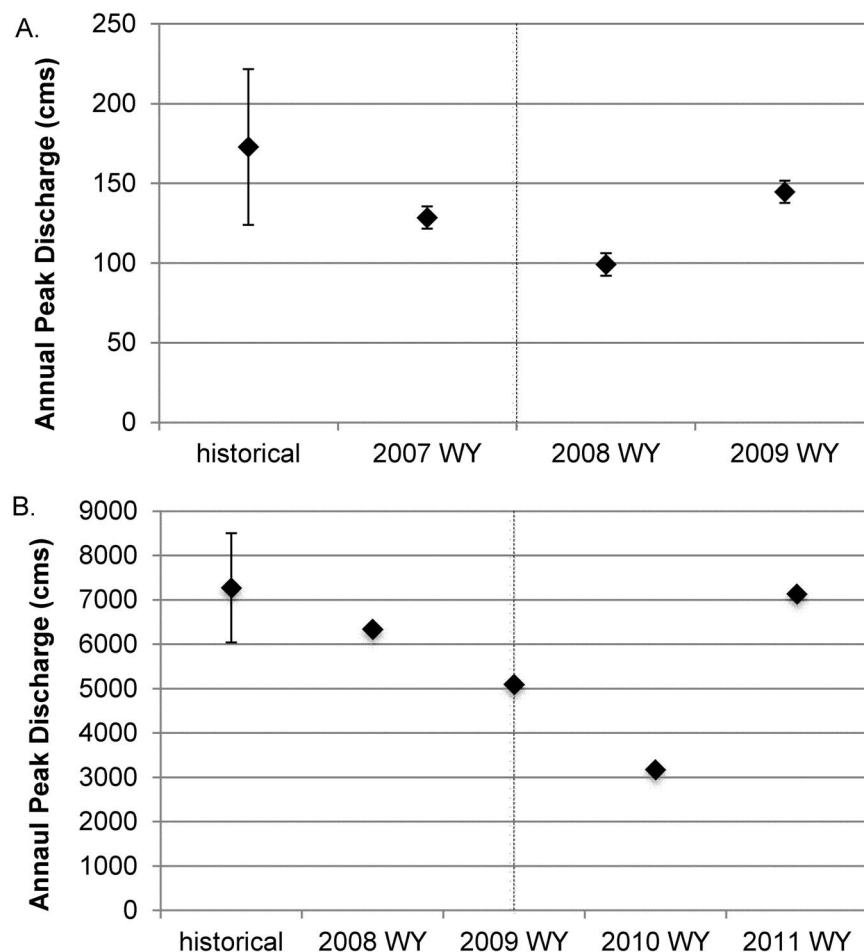
Figure 2. Annual peak discharge for the historical period of record and over the study period for the a) Calapooia at Holley, located 16 km upstream of Brownsville Dam, and b) Rogue River at Grants Pass located 8.6 km downstream of Savage Rapids Dam. Error bars on historical annual peaks represent 2 standard errors. Error bars for the Calapooia River for study years reflect estimation error associated with multiple regression estimate of peak discharge. Vertical dashed lined indicates approximate date of dam removal.
doi:10.1371/journal.pone.0108091.g002

flow at both study sites for context. Hydrologic records were summarized as the annual peak discharge for the historical and study time periods (Figure 2). For the Calapooia River, there has not been a published record of discharge since the U.S. Geological Survey (USGS) stopped gaging the Calapooia River at Holley (#14172000), 16 km upstream of Brownsville Dam, in 1990. Therefore, we used two nearby USGS gages, South Santiam below Cascadia (#14185000) and Mohawk River at Springfield (#14165000), in basins of similar hydrogeology and land uses, to create a log-transformed regression model for annual peak flow for the Calapooia at Holley based upon 35 years of concurrent historical annual peaks [51]. The Rogue River is gauged by the USGS at Grants Pass (#14361500), 8.6 km downstream from the Savage Rapids Dam.

On the Calapooia River, all three years of the study period experienced peak flows that were lower than the historical mean (Figure 2A). The first year post-removal was exceptionally low as it was less than two standard errors below the mean, whereas the pre-removal and second year post-removal experienced an annual peak flow that, while still low, were more typical of the historical peaks. The Rogue River experienced nearly the average annual peak flow in 2008, prior to dam removal, and an average annual peak flow in 2011, two years post-removal. Water year 2009, the year of the removal, experienced a peak flow of average magnitude whereas the lowest annual peak flow occurred in the water year following the dam removal.

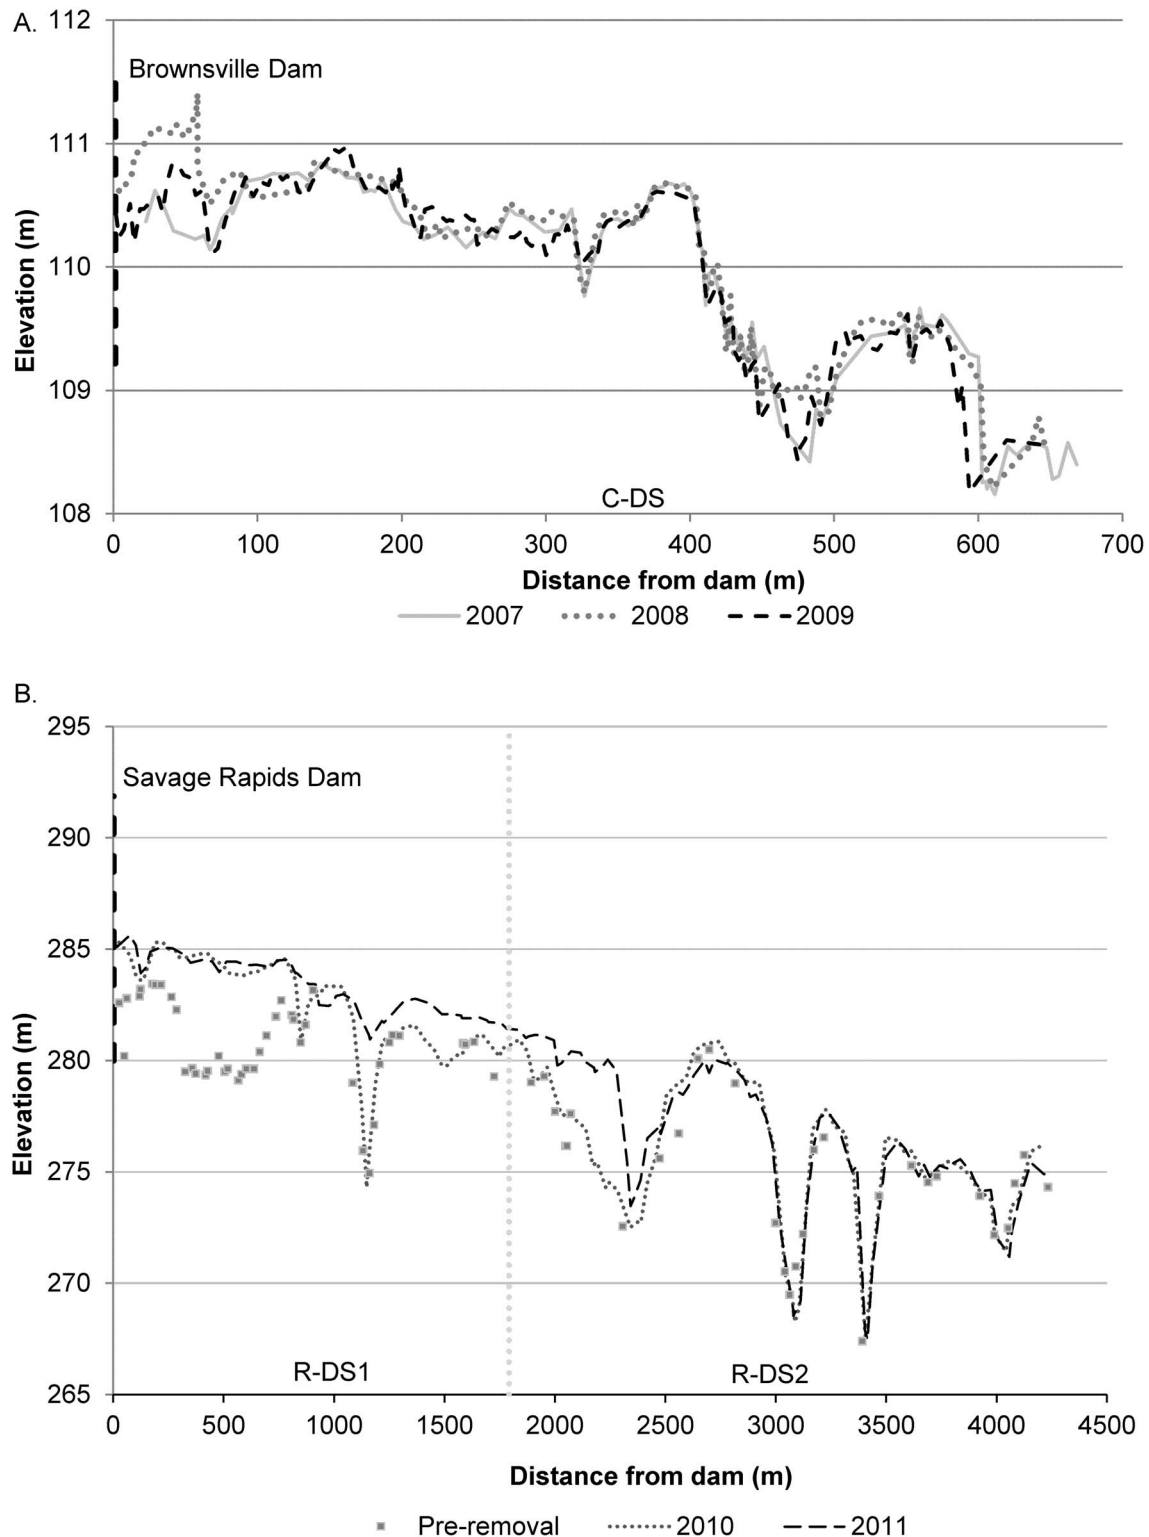
Figure 3. Longitudinal profiles downstream from the dams over time at a) Calapooia River and b) Rogue River. On the Rogue River, no longitudinal profile was collected during 2009, and the pre-removal profile is a compilation of surveys from 1999 in the farthest US and DS reaches and from 2002 for the main reservoir, both conducted by the US Bureau of Reclamation.
doi:10.1371/journal.pone.0108091.g003

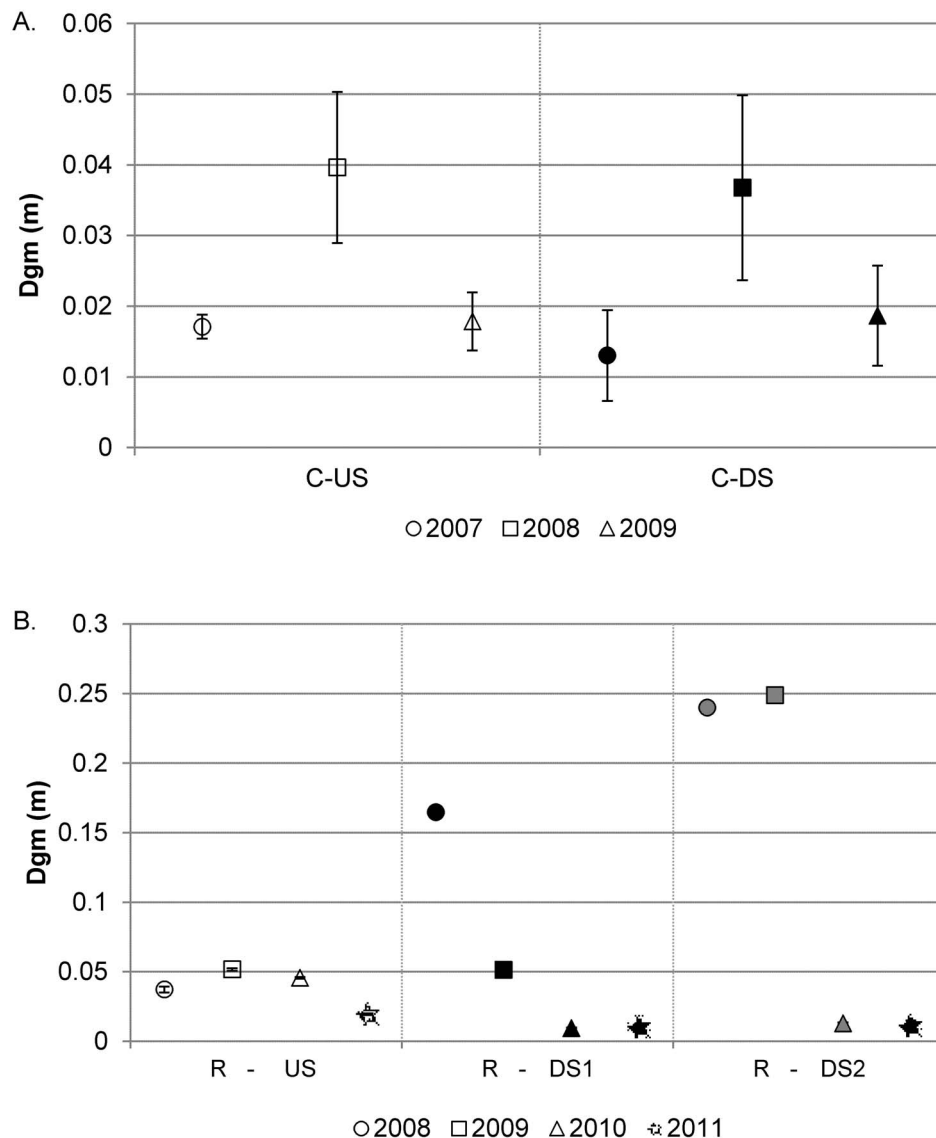
Figure 4. Plot of geometric mean grain size by reach over time at a) Calapooia River and b) Rogue River. Symbols represent the mean value, and lines represent two standard errors from the mean.
doi:10.1371/journal.pone.0108091.g004

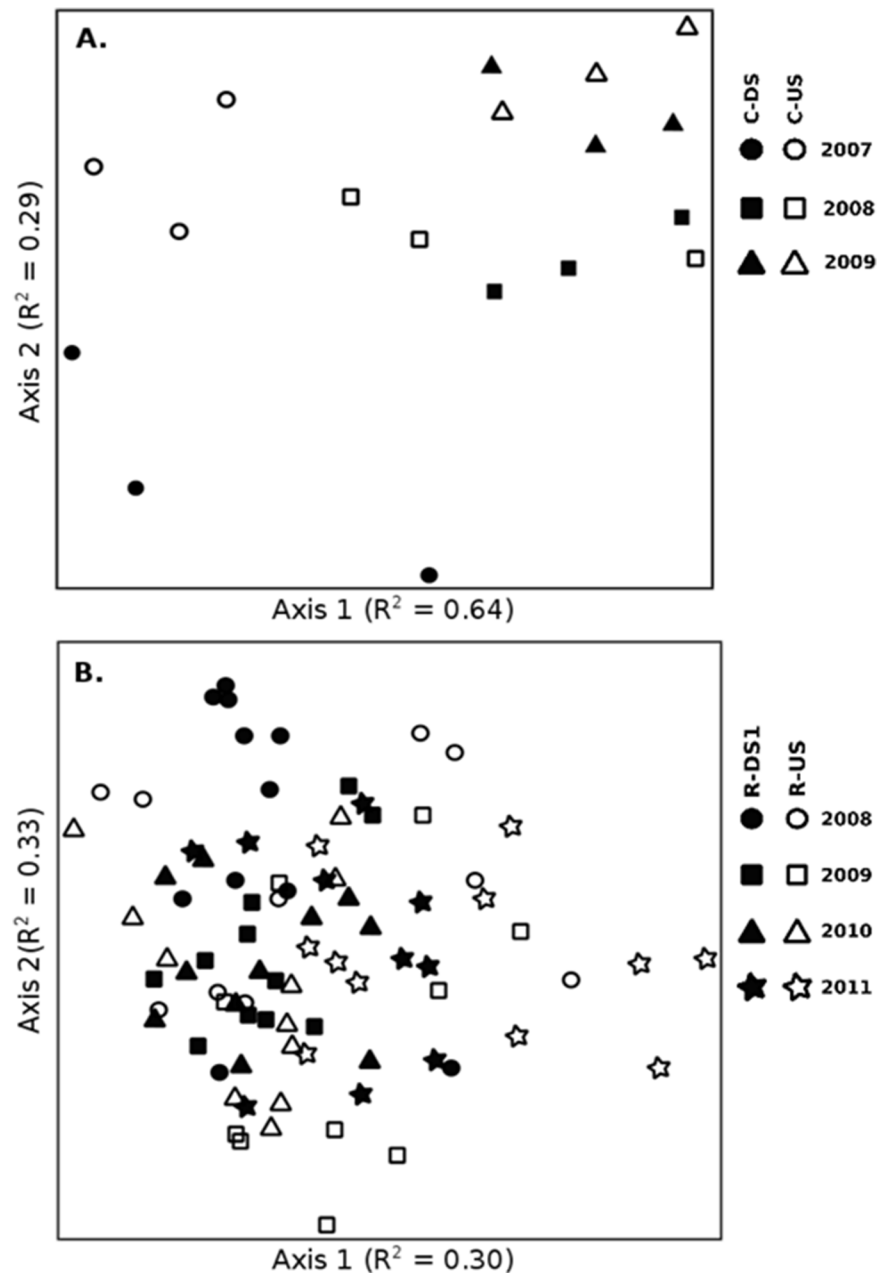
Figure 5. NMS ordination plot according to the taxonomic structure of A) 3 upstream and 3 downstream riffles associated with the Brownsville Dam removal on the Calapooia River over three collection years, and B) 11 upstream and 11 downstream transects associated with the Savage Rapids Dam removal on the Rogue River over four collection years. Note that the 11 transects from reach “DS2” have been removed from the figure to reduce clutter (see Table 3 for MRPP analysis of these data, including the DS2 reach). A) Final stress for the two-dimensional solution = 10.1. B) Final stress for a three-dimensional solution was 15.2, and the unpictured third axis had $R^2 = 0.21$. doi:10.1371/journal.pone.0108091.g005

To some extent, the differences observed in the pre- and post-removal assemblages were illustrated in the NMS plots. Taxonomic structure clearly delineated C-US and C-DS on the Calapooia River prior to dam removal along Axis 2, whereas the post-removal sites were not separated in ordination space (Figure 5A). Similar results are observed with ordinations of the functionally defined assemblages, with upstream and downstream sites on the Calapooia River clearly separated in ordination space prior to dam removal but not following dam removal (Figure 6A). In contrast, the pre-removal taxonomic distinction between R-US and R-DS1 is not evident on the Rogue River (Figure 5B), although upstream and downstream sites were separated to some extent along Axis 1 for the functionally defined assemblages (Figure 6B) prior to, but not following, dam removal.

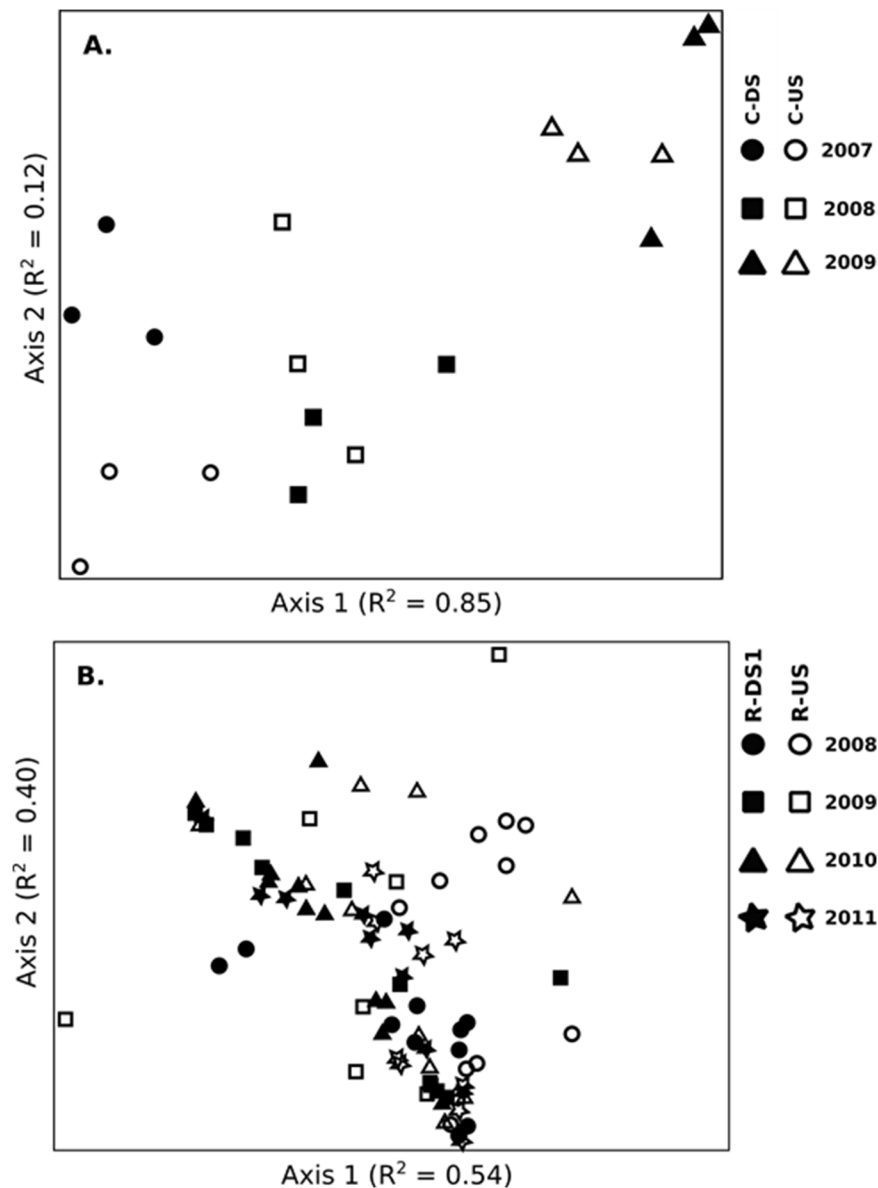
Figure 6. NMS ordination plot according to the functional community structure (based on 20 benthic insect traits) of A) 3 upstream and 3 downstream riffles associated with the Brownsville Dam removal on the Calapooia River over three collection years, and B) 11 upstream and 11 downstream transects associated with the Savage Rapids Dam removal on the Rogue River over four collection years. Note that the 11 transects from reach R-DS2 have been removed from the figure to reduce clutter (see Table 4 for MRPP analysis of these data, including the R-DS2 reach). The symbols follow the same explanation as in Figure 2. A) Final stress for the two-dimensional solution = 6.4. B) Final stress for the two-dimensional solution was 13.2. doi:10.1371/journal.pone.0108091.g006

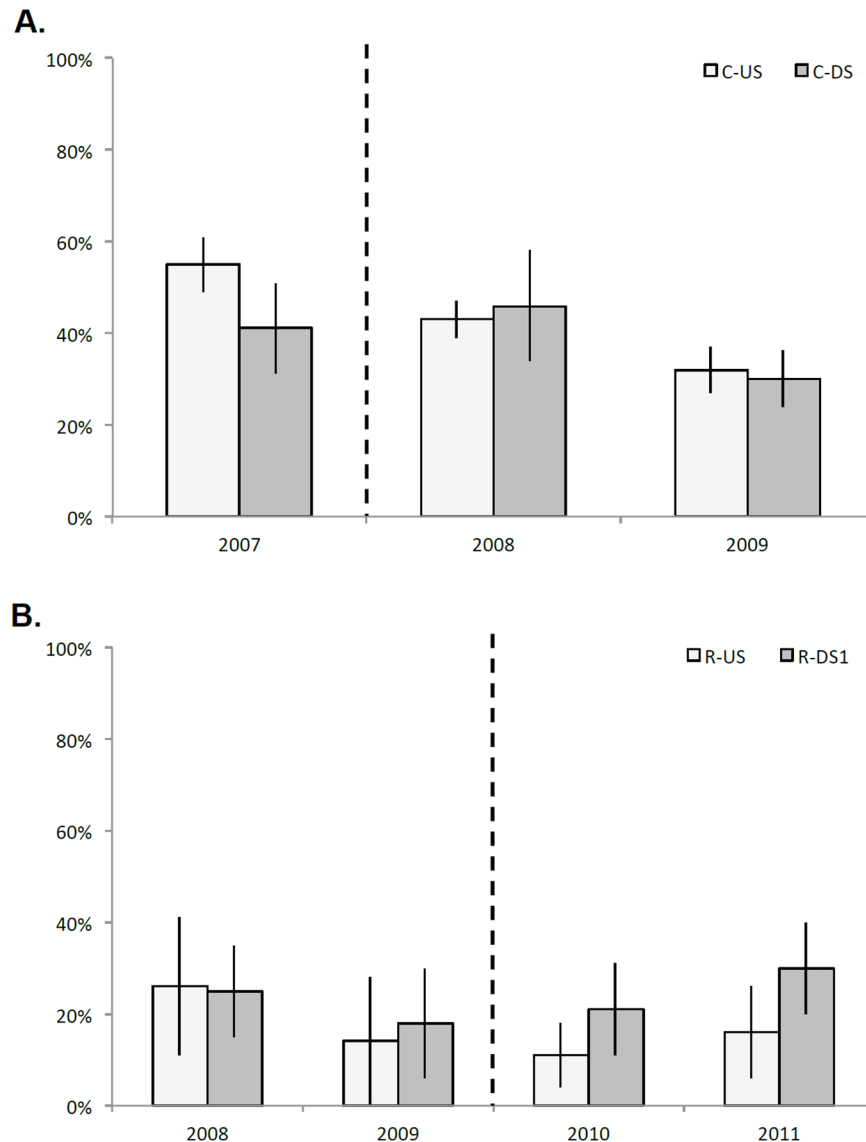
doi:10.1371/journal.pone.0108091.g007

Figure 7. Mean %clingers (expressed as relative abundance, ± 2 standard errors) per reach across A) riffle sample units on the Calapooia, and B) transects sampled on the Rogue. In both panels, year is on the x-axis, and lighter-colored bars represent the upstream reaches. Vertical dashed line shows timing of dam removal. Note that, in the interest of space, the second downstream reach is not plotted for the Rogue due to the lack of change over time.

The univariate indicators %clingers (Figure 7) and %EPT (Figure 8) illustrate upstream-downstream trends across years, particularly in the Calapooia River, although only one of the within-year *t*-tests produced significant differences. With no statistical difference in % EPT across the years on the Calapooia River (Figure 8A), the only statistically significant difference on the Calapooia River was greater %clingers in C-DS than C-US in 2007, the year prior to dam removal (Figure 7A). In the two years following dam removal, the two reaches on the Calapooia River became statistically indistinguishable for %clingers. Values of %EPT were greater, though nonsignificant (*p* = 0.11), in C-US relative to C-DS for the Calapooia River prior to dam removal,

followed by convergence of these reaches in the two years following dam removal. Year-to-year trends were difficult to assess and were nonsignificant on the Rogue River due to high reach-scale variability for both %EPT and %clingers (Figures 7B, 8B).

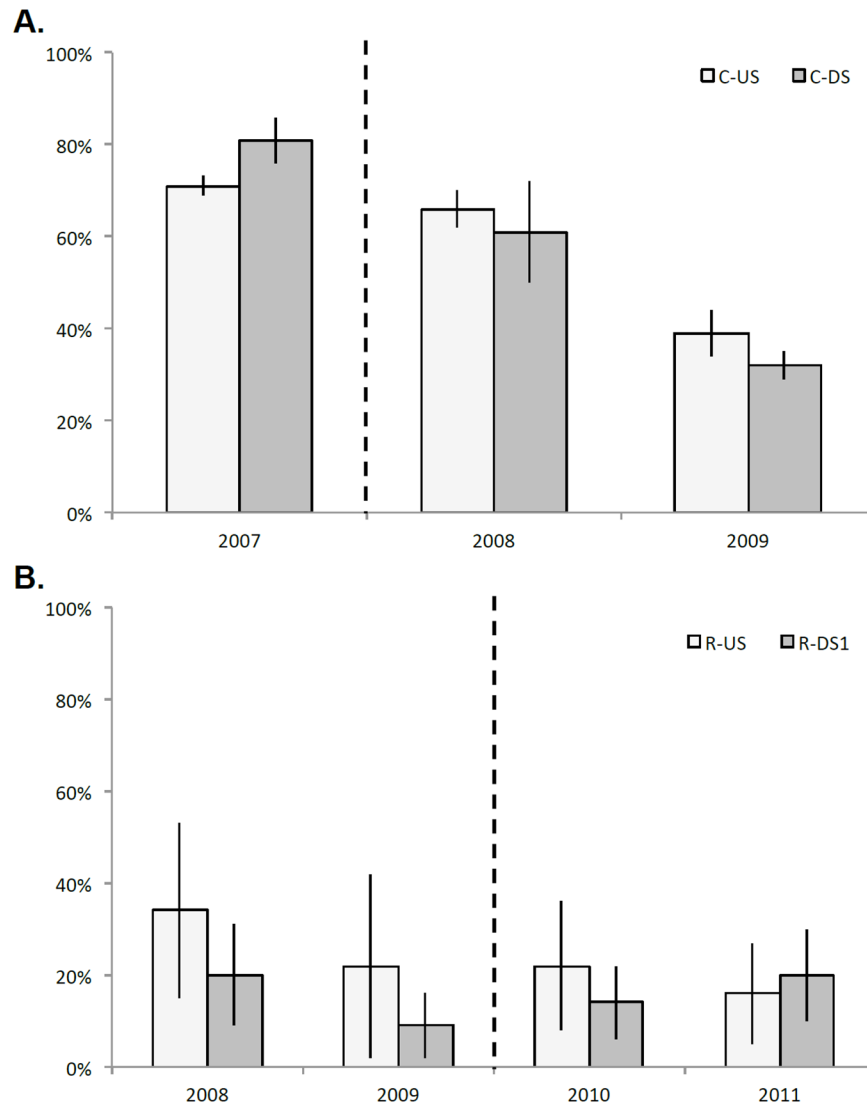
doi:10.1371/journal.pone.0108091.g008

Figure 8. Mean %EPT (expressed as a proportion, ± 2 standard errors) per reach across A) riffle sample units on the Calapooia, and B) transects sampled on the Rogue. In both panels, year is on the x-axis, and lighter-colored bars represent the upstream reaches. Vertical dashed line shows timing of dam removal. Note that the second downstream reach is not plotted for the Rogue River due to the lack of change over time.
