Geomorphic Response to Catastrophic Flooding in a Karst Mountain Stream System, Brighton-Blue Hole Watershed, Southwest Jamaica

A Master's Thesis

Master of Science, Geospatial Sciences in Environmental Geology

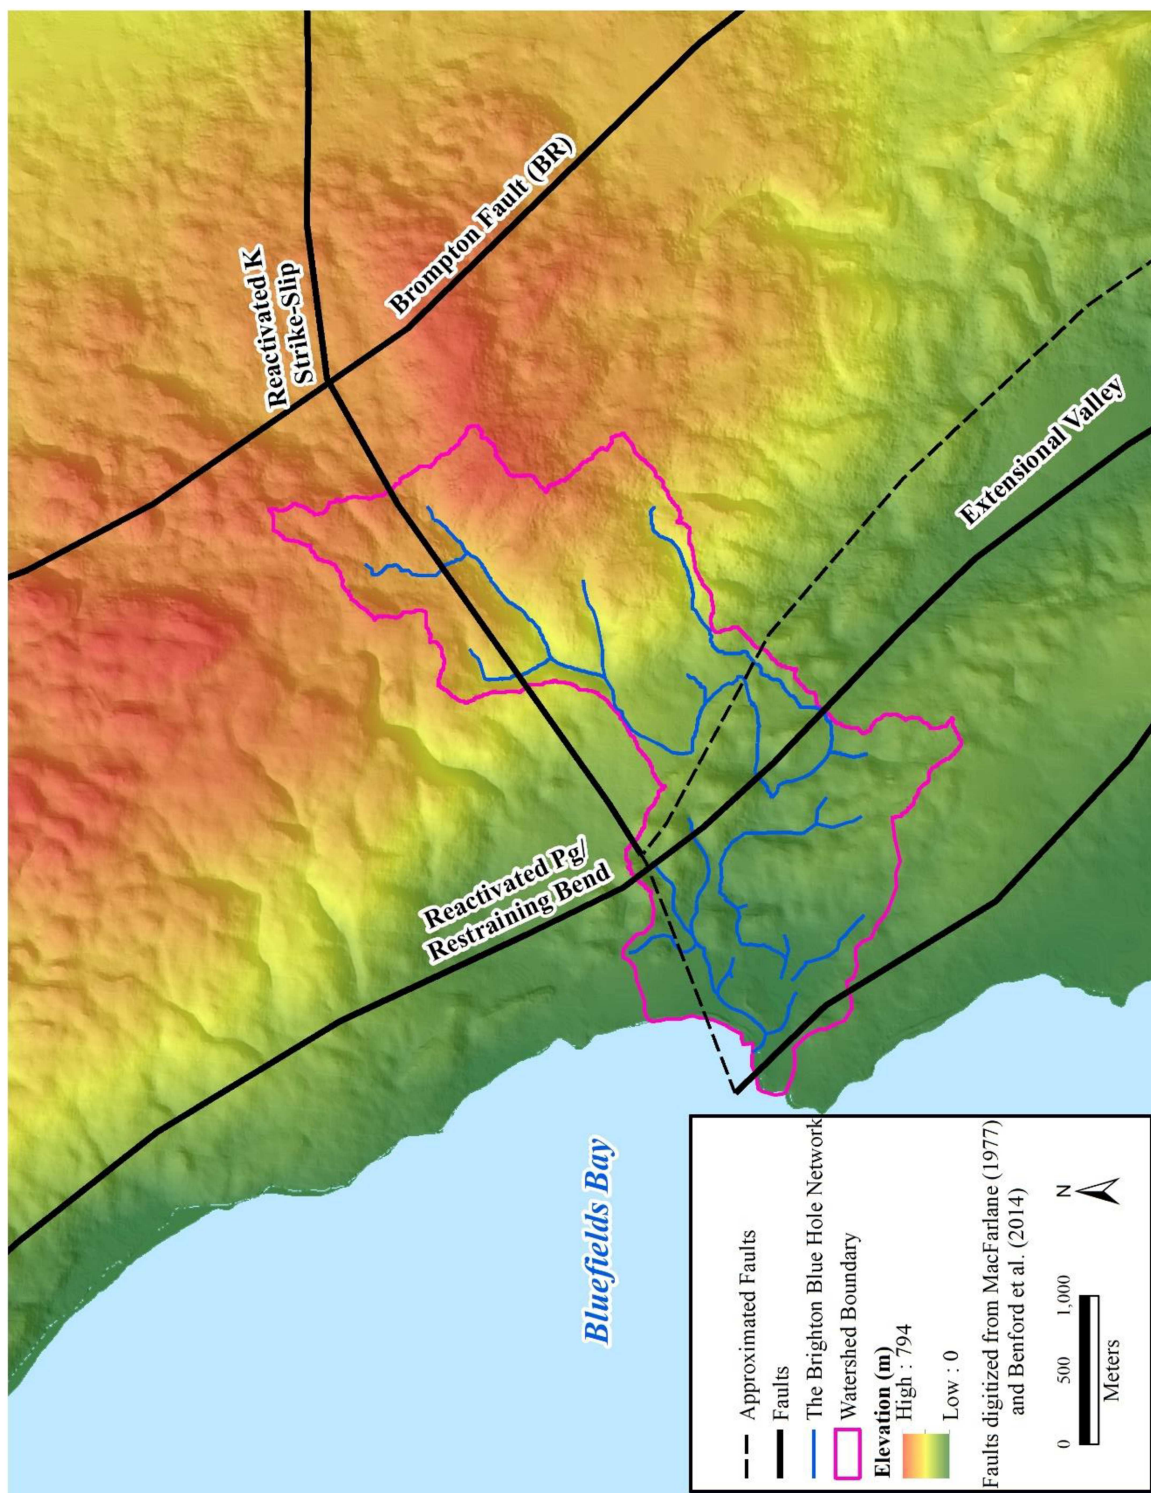
Figure 4. Faults and structural landforms in the BBHW

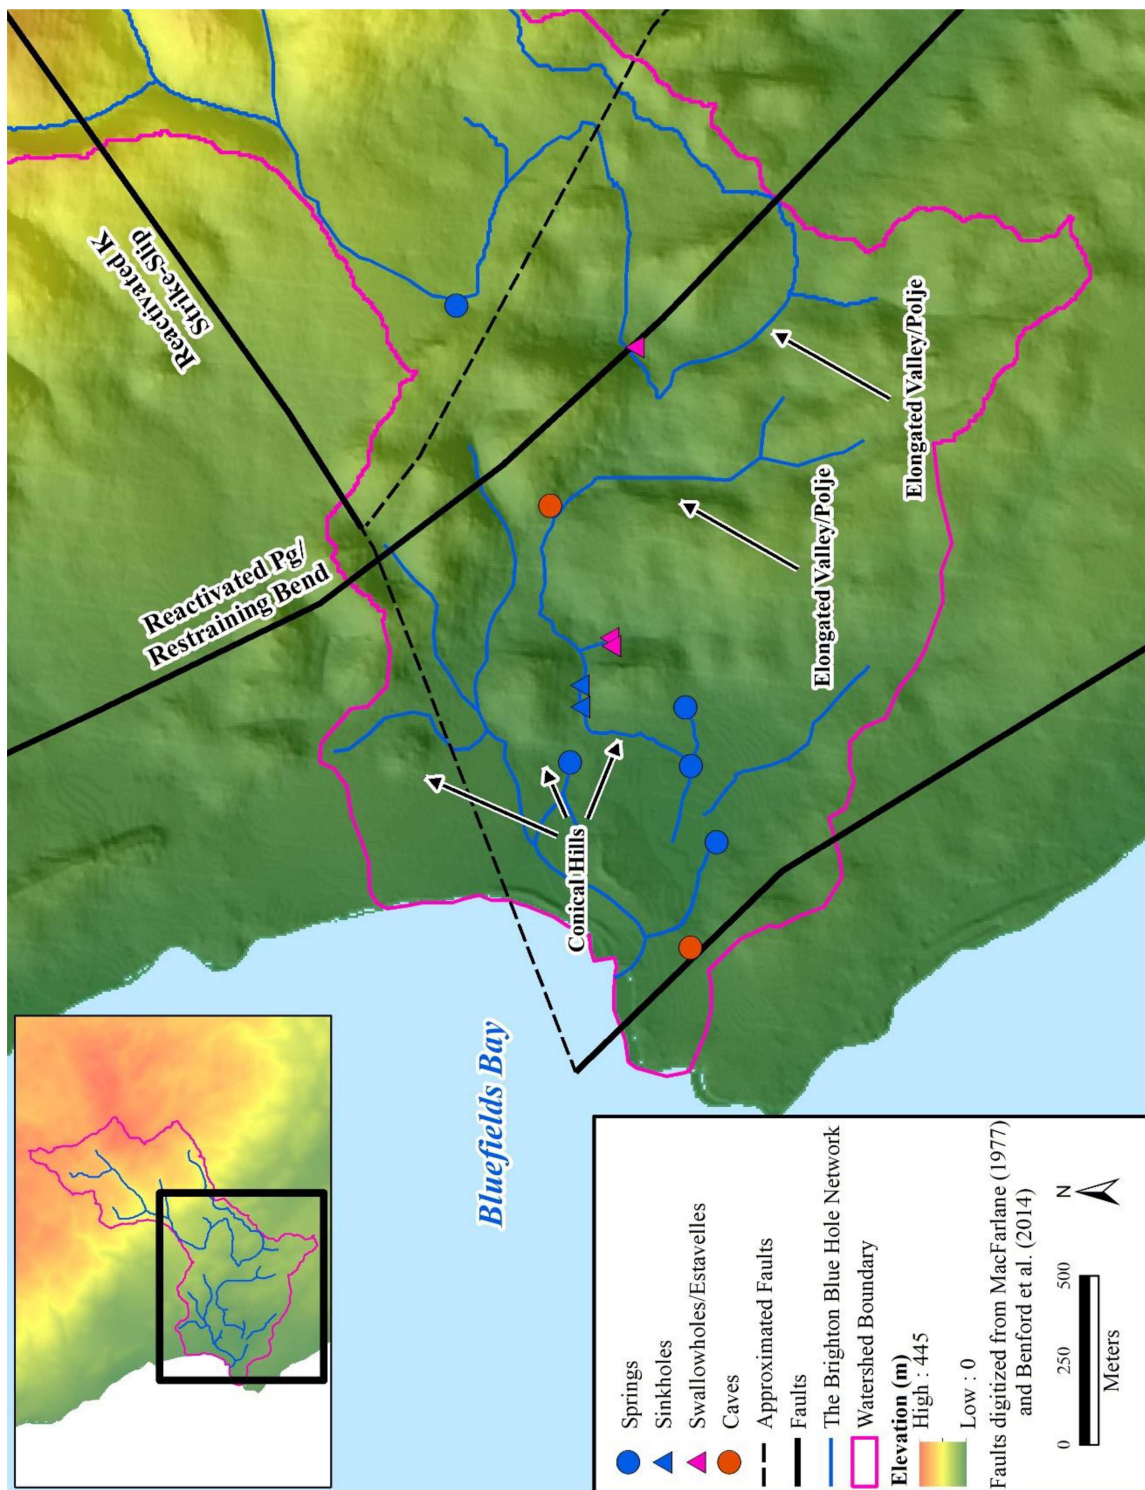
Figure 5. Karst landforms and related tectonics in the BBHW

The heavily dissected Bonny Gate member has led to the formation of a well-developed karst system in the BBHW (Fig. 5). The term “well-developed” is used here to describe a landscape where surface depressions and springs are common. Surface depressions in the BBHW are varied in shape and hydrology. Depressions which are round and enclosed are referred to as sinkholes (Sweeting, 1958; Day, 2010). After a rainfall event, runoff collects in these depressions as it slowly percolates through fractures in the limestone bedrock into underground conduits and the low points of these depressions are commonly devoid of vegetation and some even support small, semi-permanent ponds (Day, 1976). These depressions can become easily denuded during floods due to low infiltration rates (Day, 1976; Day, 2007; Day, 2010). Elongated valleys in BBHW, which have formed parallel to NNW structural trends and represent down-faulted blocks can in some cases be interpreted as polje (Mitchell et al., 2003). These flat-bottomed valleys drain via swallow holes, also called ponors, which are open surface connections to underground conduits by which water can flow directly underground (Mitchell et al., 2003; Lyew-Ayee et al., 2007). These polje are usually long or irregular in shape and during

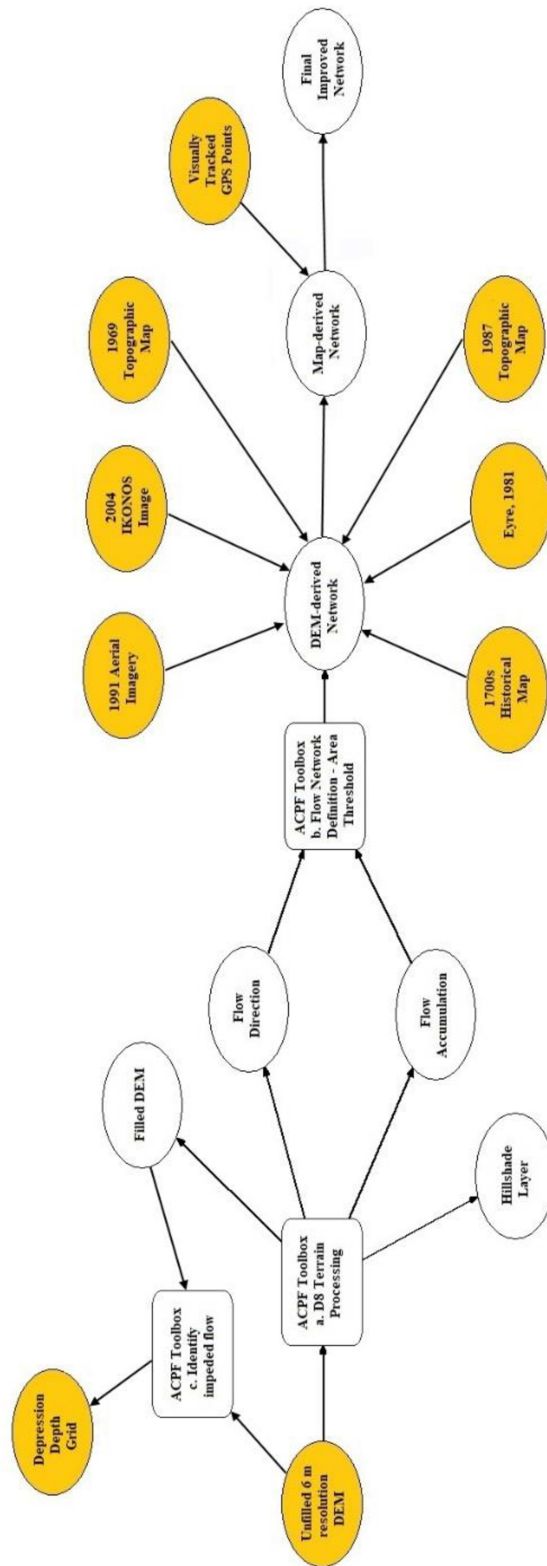
Figure 9. GIS workflow for drainage network generation and improvement

depressions in the well-developed karst landscape. The D8 Terrain processing tool of this toolbox runs Fill, Flow Direction, Flow Accumulation, and Hillshade on an unfilled DEM as a single operation. The Flow Direction and Flow Accumulation output rasters were used with the Flow Network Definition Area Threshold tool which applies a user-defined area threshold, or area of upstream drainage in acres. The tool was run using a decreasing area threshold, from 100 – 5 acres. The flow line created with an area threshold of 30 acres was found to represent the appropriate amount of detail, but when compared to the other sources of stream data this network was found to be associated with some error due to the complexity of the landscape in BBHW. The DEM-derived flow network underrepresented small coastal streams, directed flow into road depressions, represented complex underground karstic connections as surface flow, and to reroute flow around artificial topographic highs formed by high vegetation. This toolbox also contains the tool Manual Cutter, which allows flow under roads and through culverts to be accurately represented (USDA, 2017). This tool was not selected for use in this study because of the complex hydrology of the watershed. The hydrological conditions at roads is not well understood at each road crossing within the watershed. Many valleys located near roads likely overfill during floods and water either pools behind the road or crosses underneath it via culverts or karst conduits.

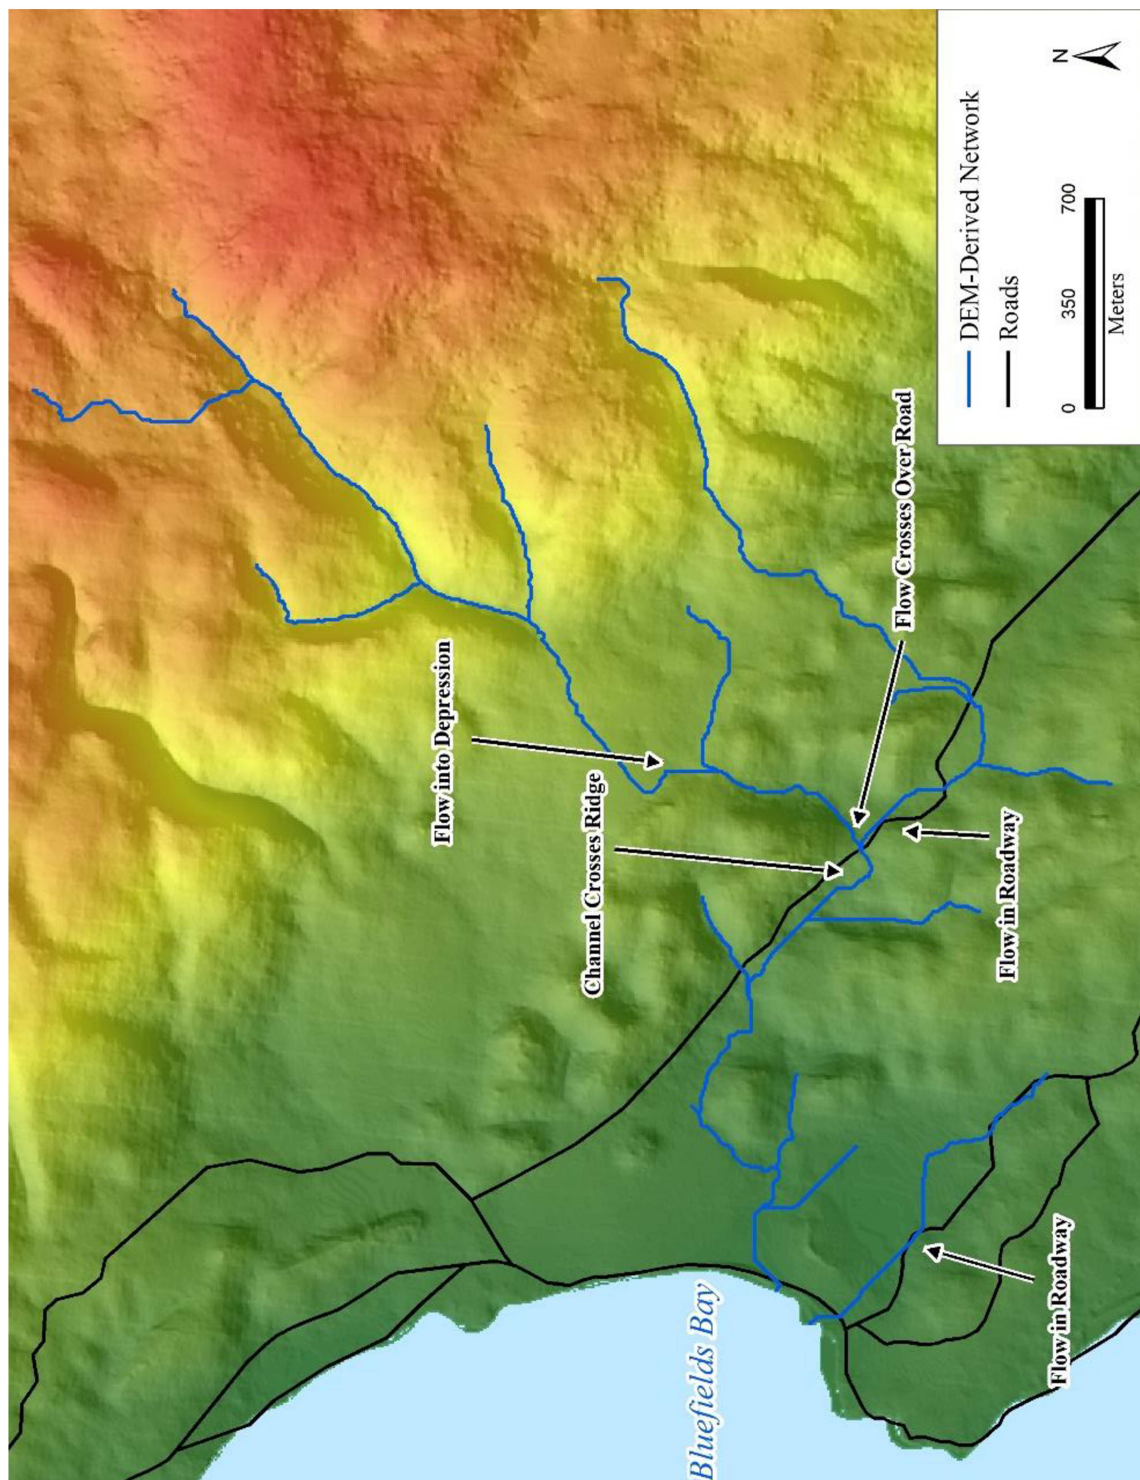
Figure 10. Flow network generated using the ACPF toolbox with selected errors noted

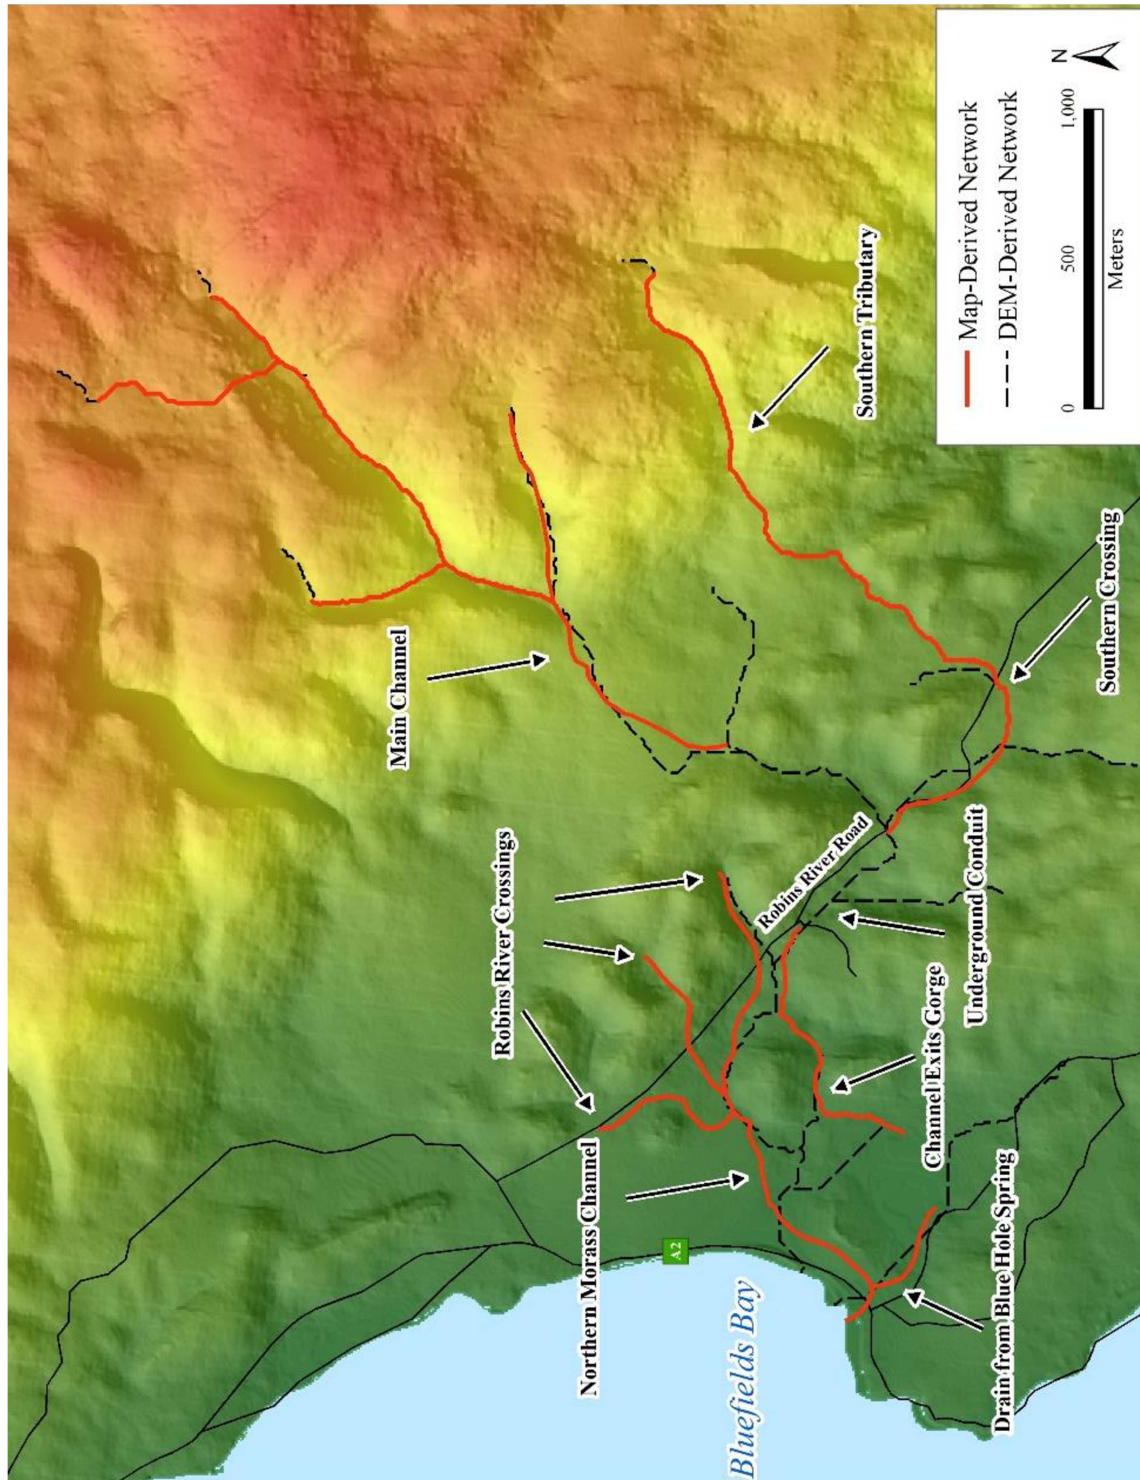
Figure 11. Flow network improvements made using comparisons to GIS raster layers

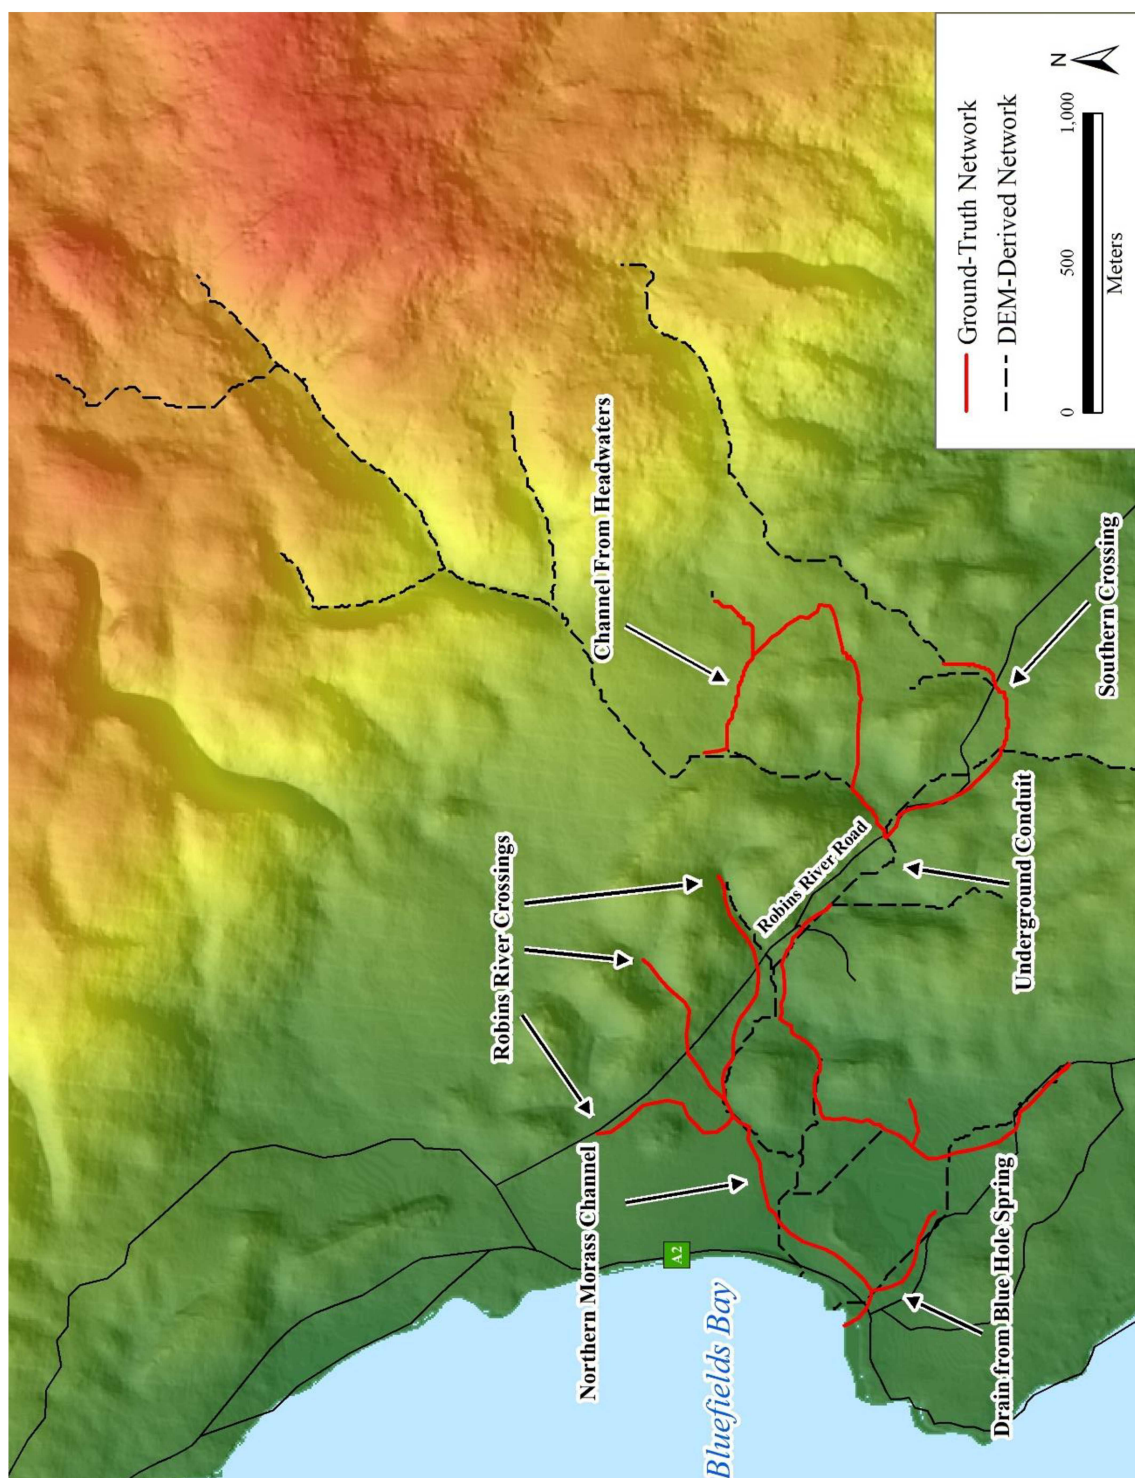
Figure 12. Flow network improvements made using GPS points from field surveys

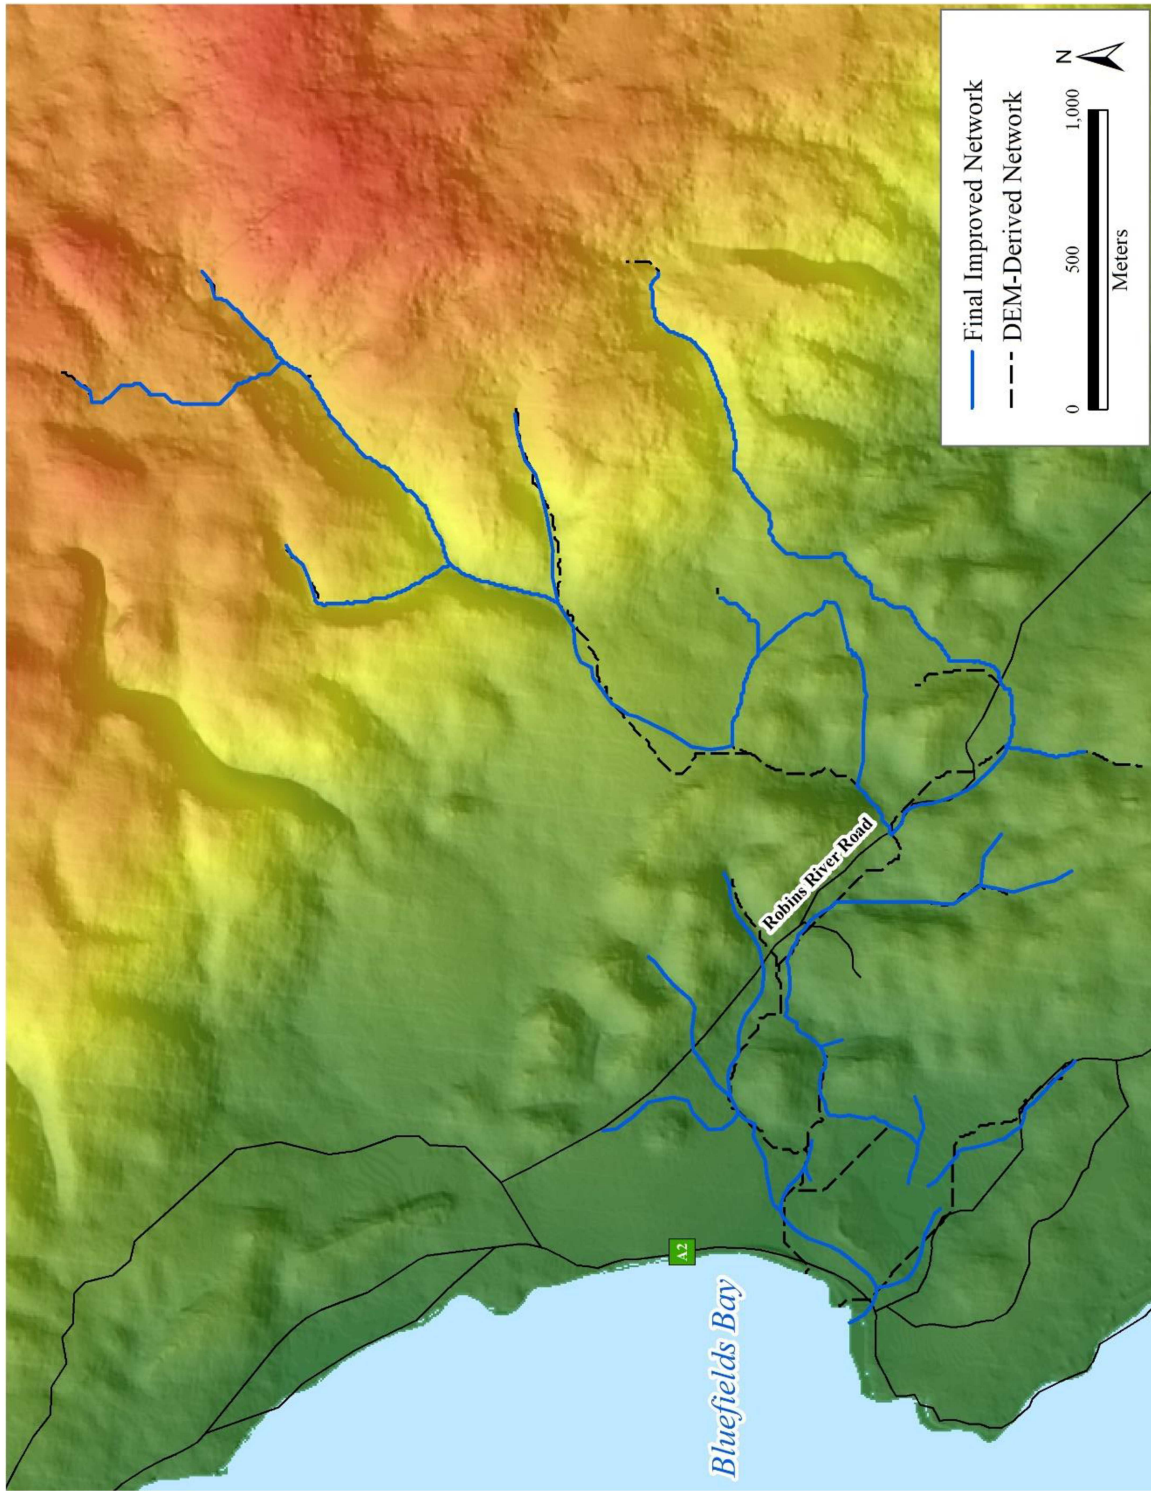
Figure 13. Final, improved flow network

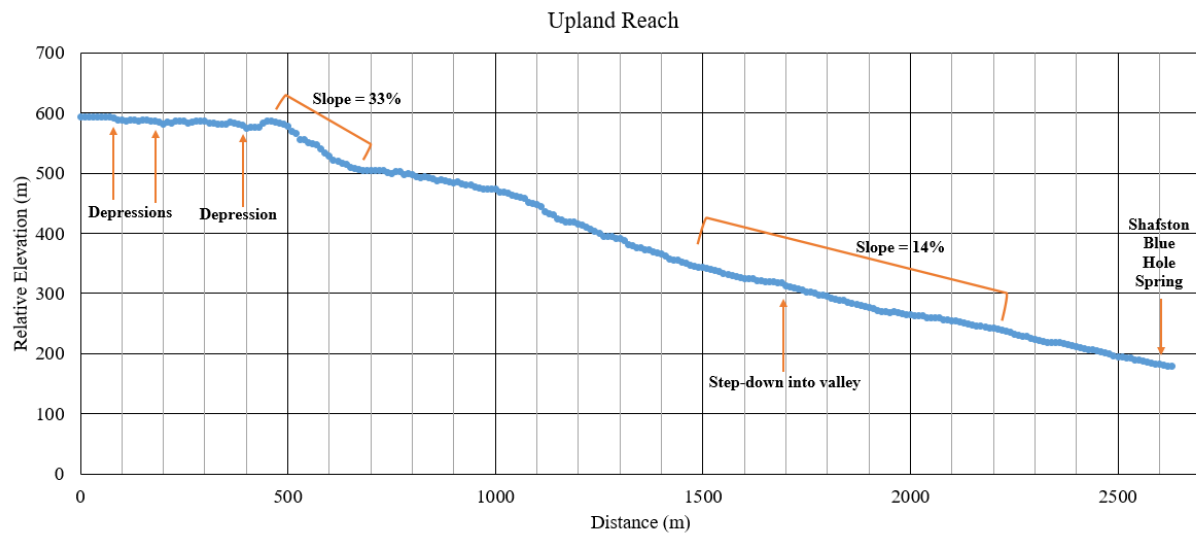
Figure 15. Longitudinal profile of the upland reach of the main channel

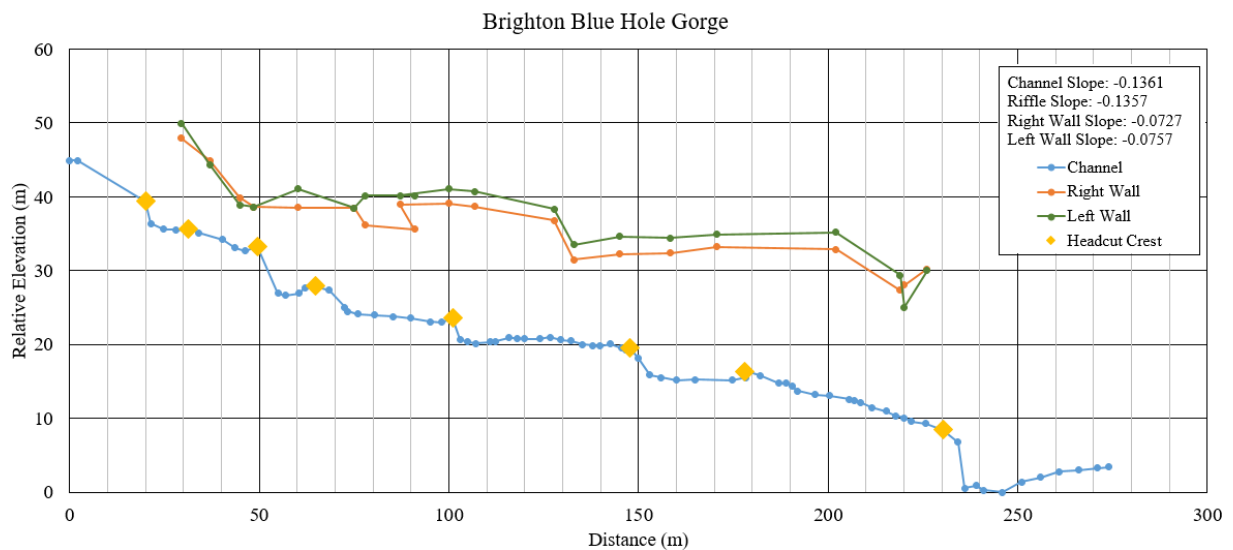
Figure 19. Longitudinal profile of Brighton-Blue Hole Gorge

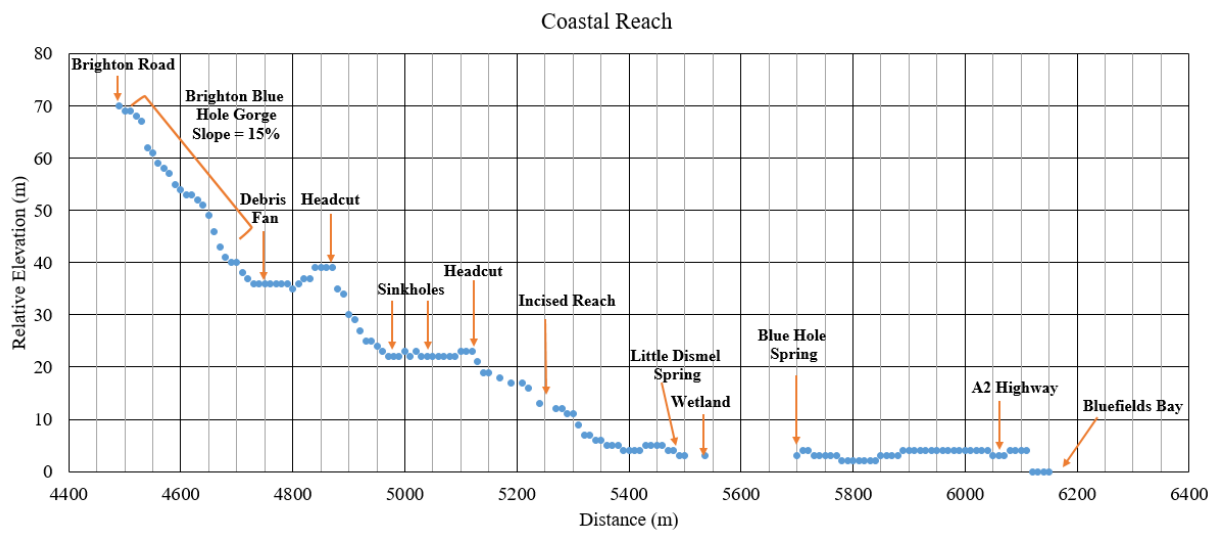
Figure 21. Longitudinal profile of the coastal reach of the main channel

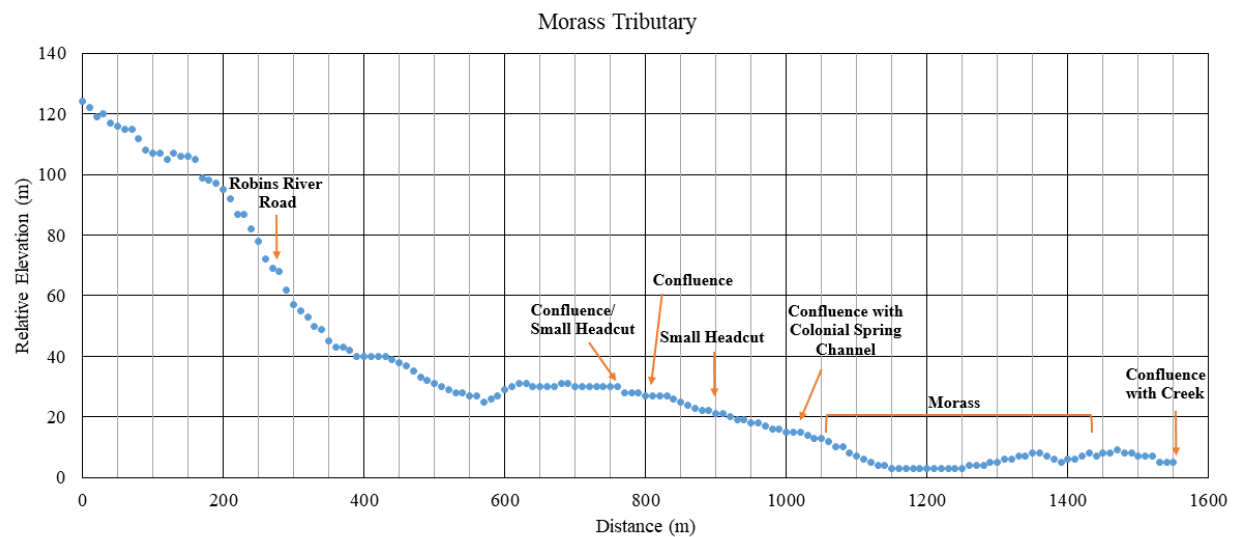
Figure 23. Longitudinal profile of Morass Tributary subwatershed

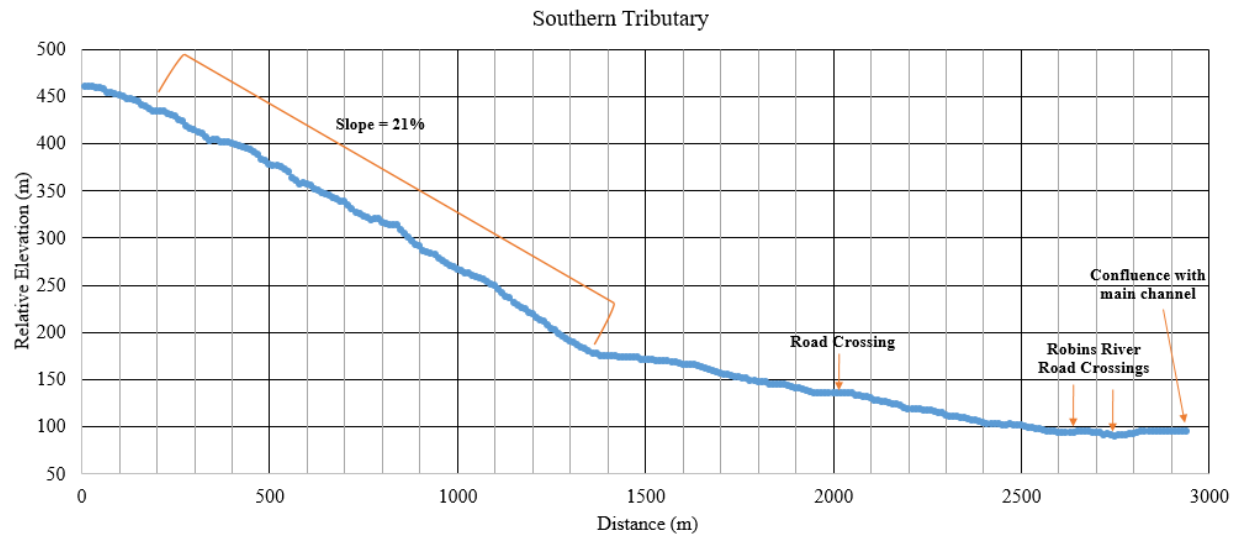
Figure 25. Longitudinal profile of Southern Tributary subwatershed

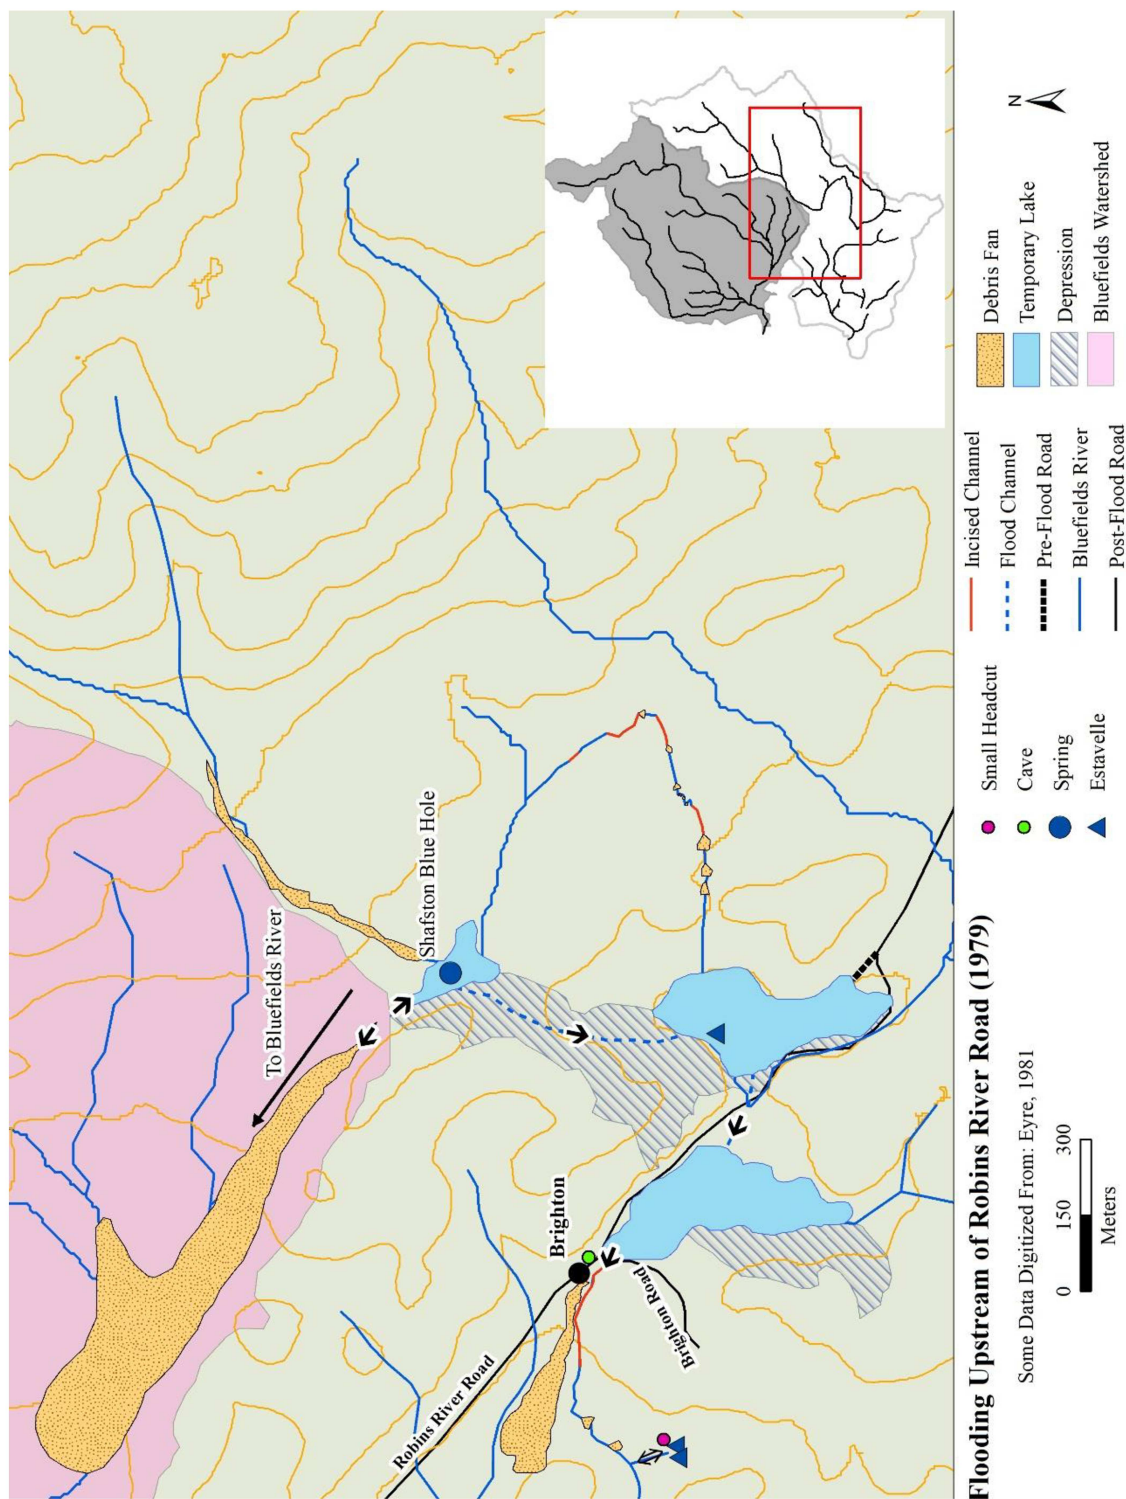
Figure 26. Flooding during the June 12, 1979 flood upstream of the Robins River Road

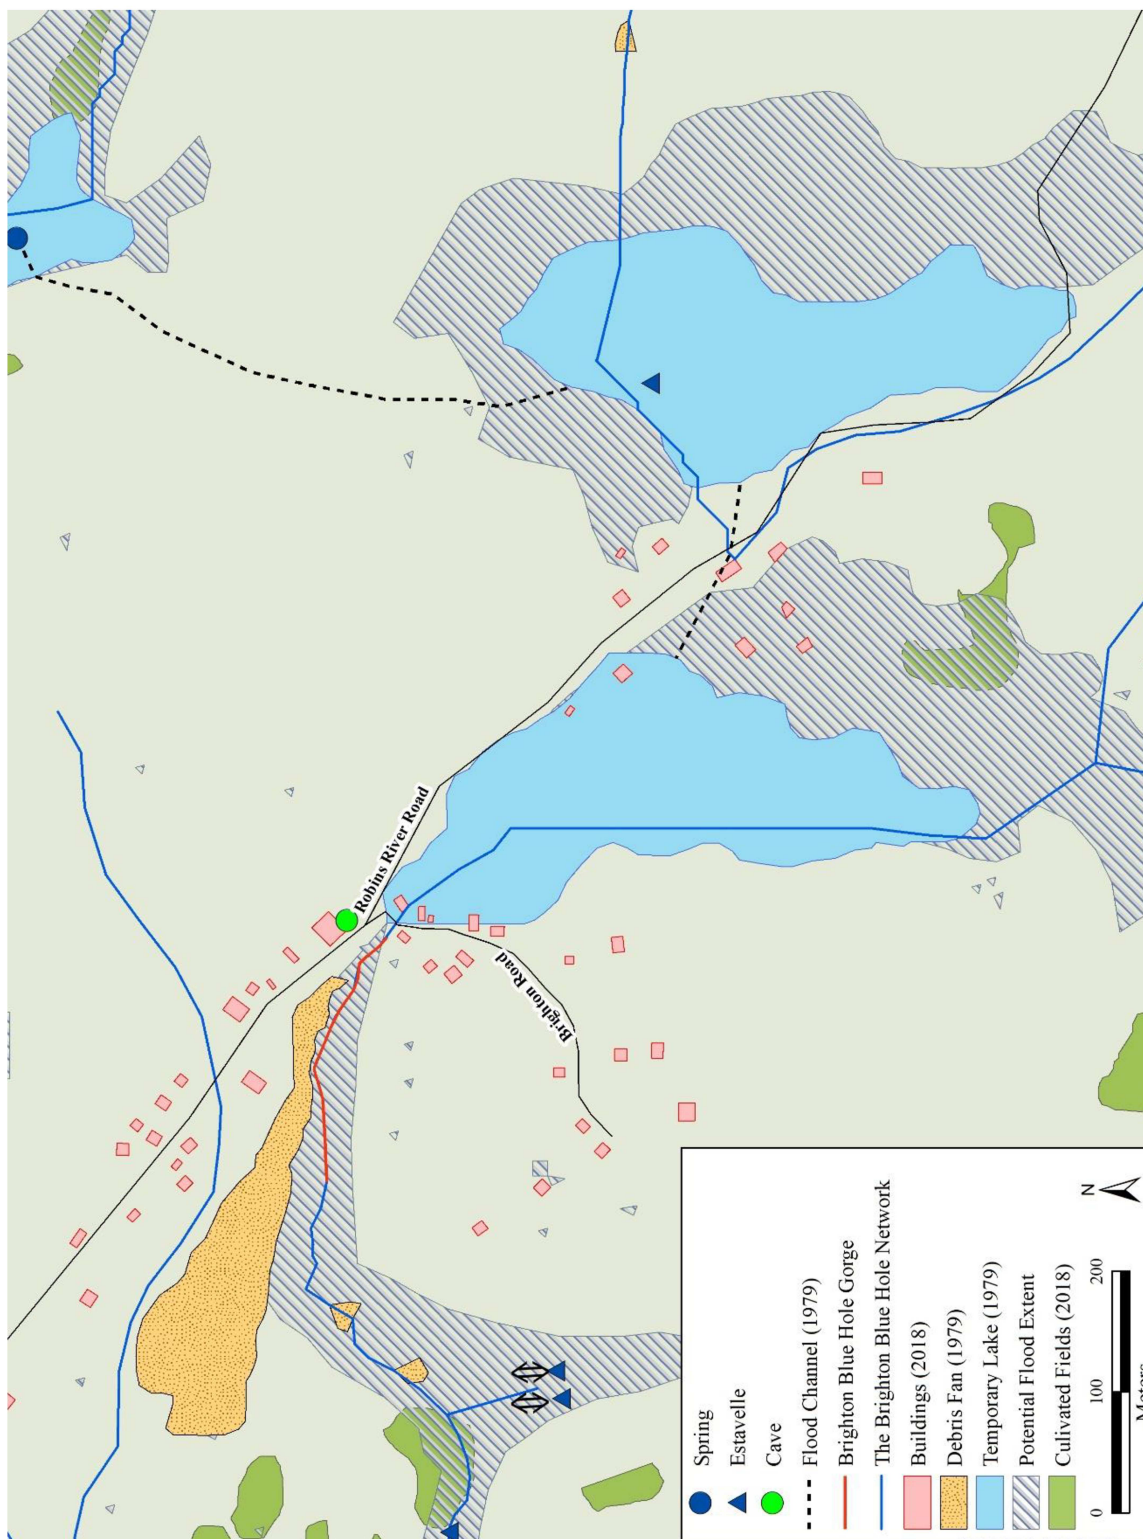
Figure 27. Flood risk map for the village of Brighton

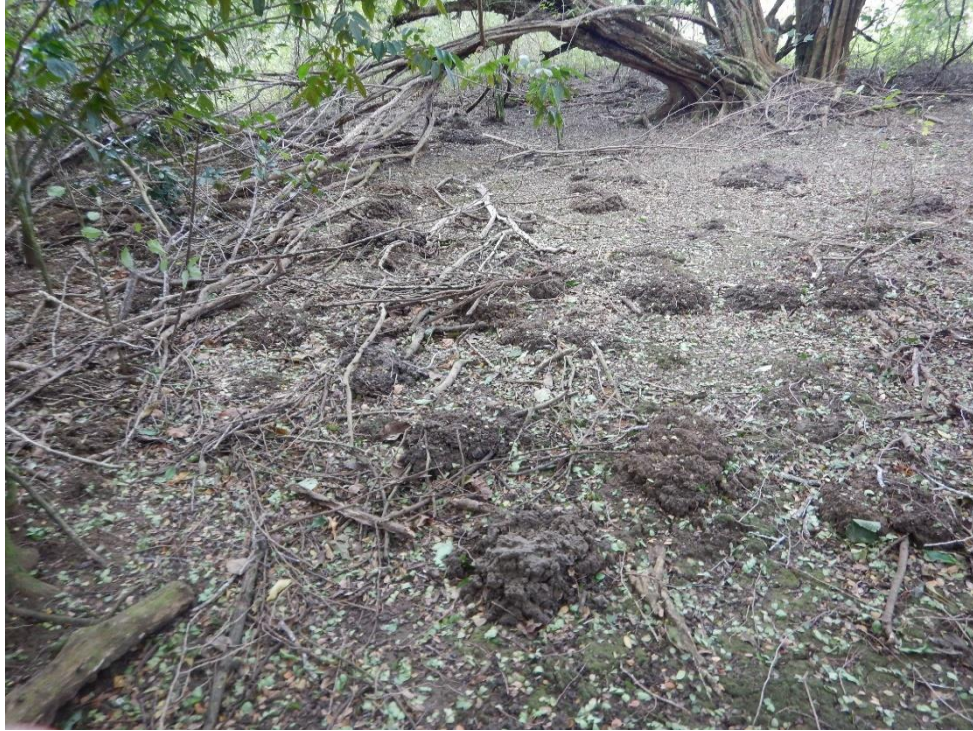
Appendix B-7. Point 4 – Depression, This Area Is Filled with Fine, Clay Sediment That Was Likely Deposited Here During the 1979 Flood

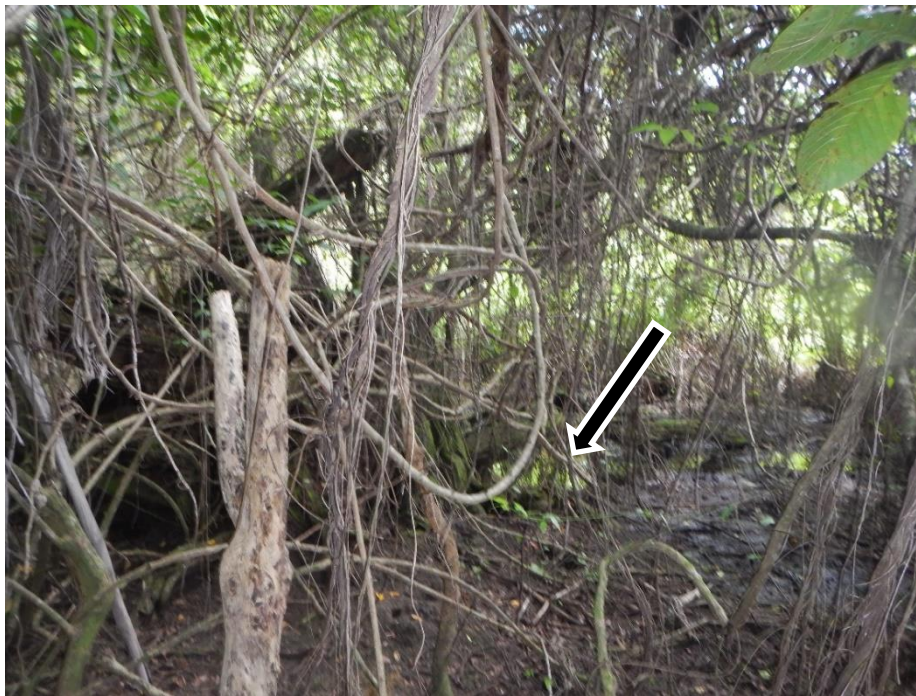
Appendix B-8. Point 5 – Little Dismel Spring, This Spring Is Difficult to See on the Surface Because of Overfilling with Fine Sediment. Disturbed Vegetation Is Anthropogenic

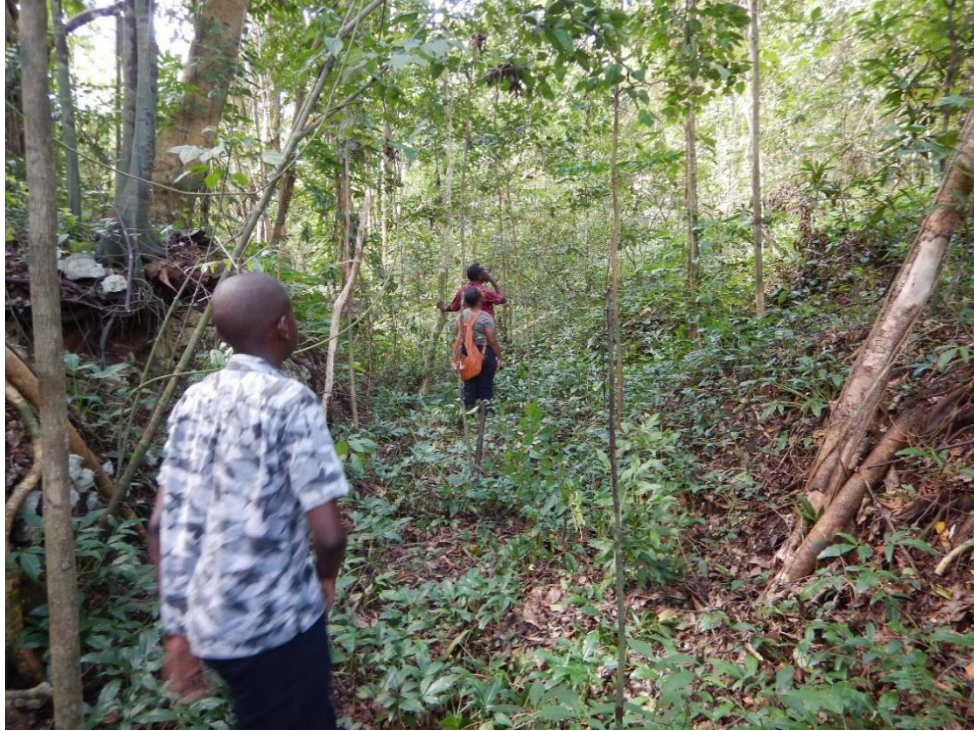
Appendix B-11. Point 8 – Incised Channel Downstream of Lower Sinkhole. This Reach Incised 3 M and Delivered Fine Sediment to the Little Dismel Spring and Wetland

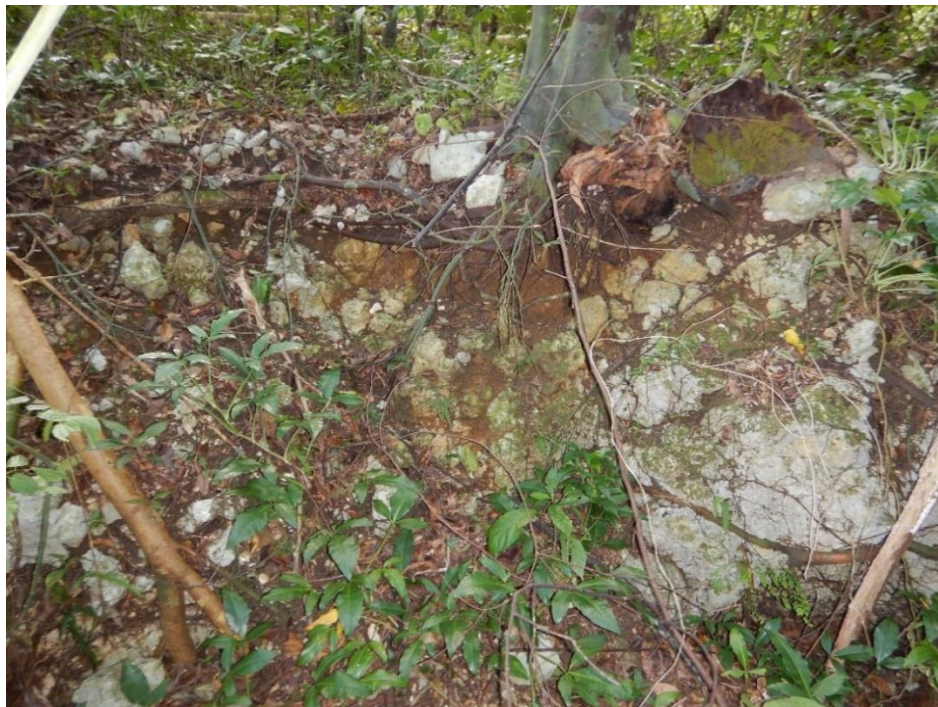
Appendix B-12. Point 9 – Bedrock Wall on Left Bank of Incised Channel, Fine Sediment Within the Channel Was Eroded in 1979

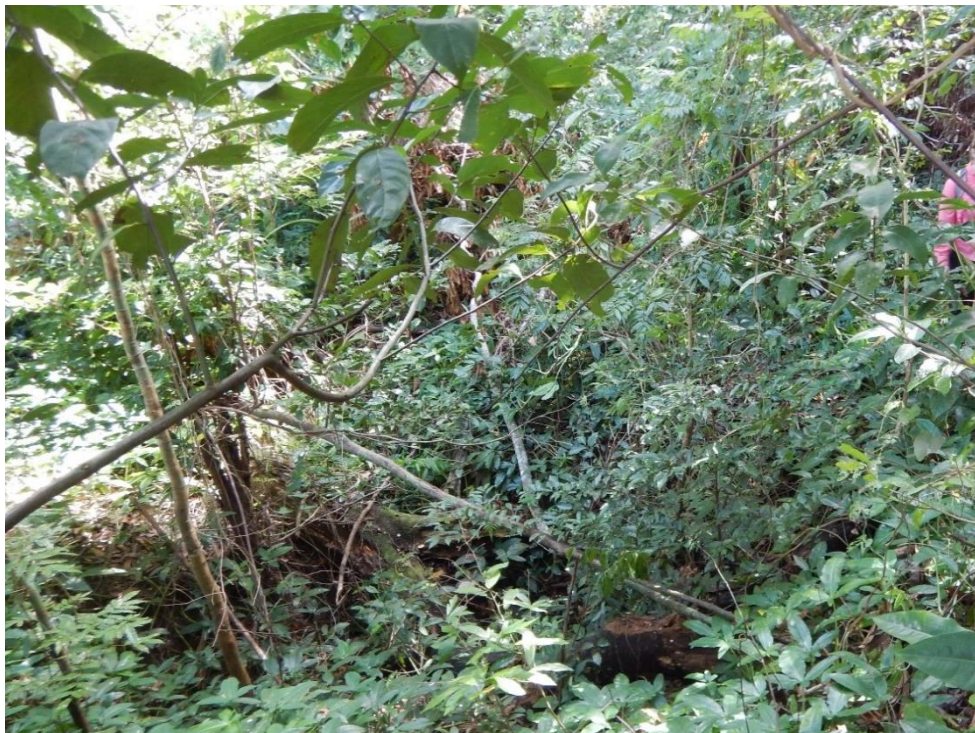
Appendix B-14. Point 11 – Estavelle, Can Deliver Groundwater to the Surface at High Flood Stages

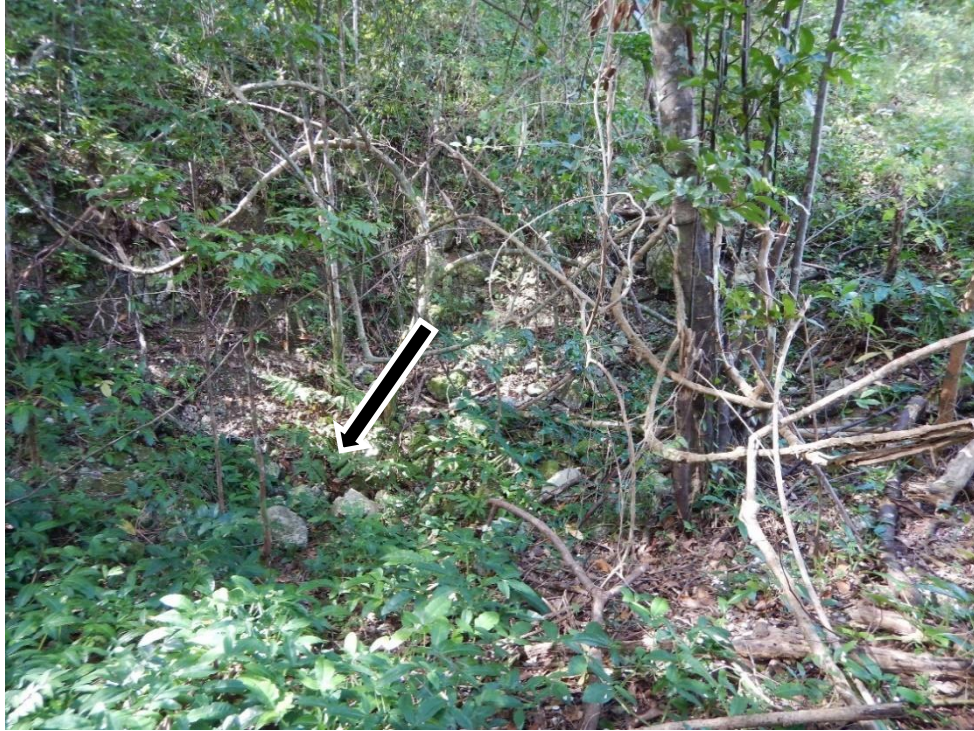
Appendix B-15. Point 12 – Estavelle, at Low Flood Stages Functions as an Open Conduit Leading Underground
