Geomorphic Response to Catastrophic Flooding in a Karst Mountain Stream System, Brighton-Blue Hole Watershed, Southwest Jamaica

A Master's Thesis

Master of Science, Geospatial Sciences in Environmental Geology

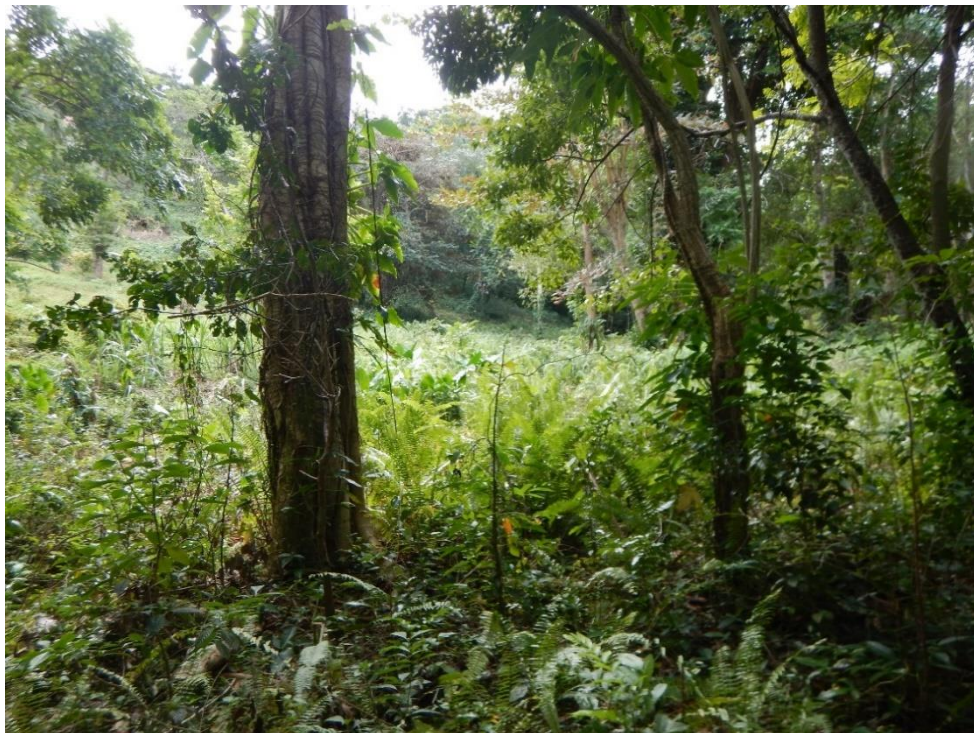
Appendix B-16. Point 13 – The Confined Valley Which Caused Channel Incision Downstream of the Brighton-Blue Hole Gorge

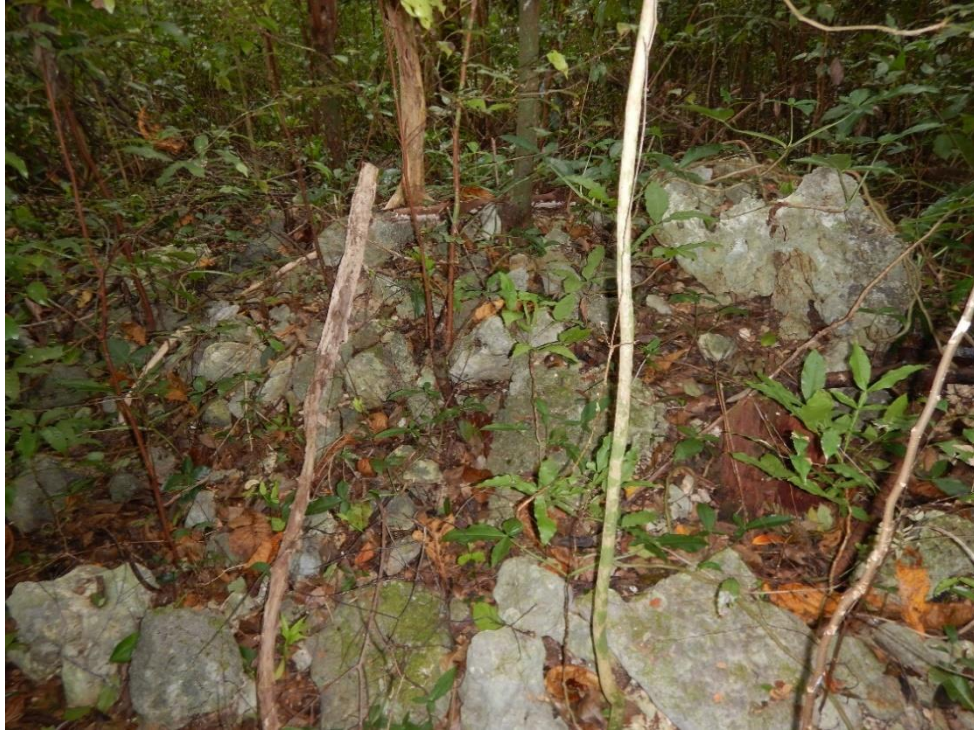
Appendix B-17. Point 14 – Boulder Bar, This Debris Flow Is Made up of Large Boulders Which Were Likely Moved from the Brighton-Blue Hole Gorge 50 m Upstream.

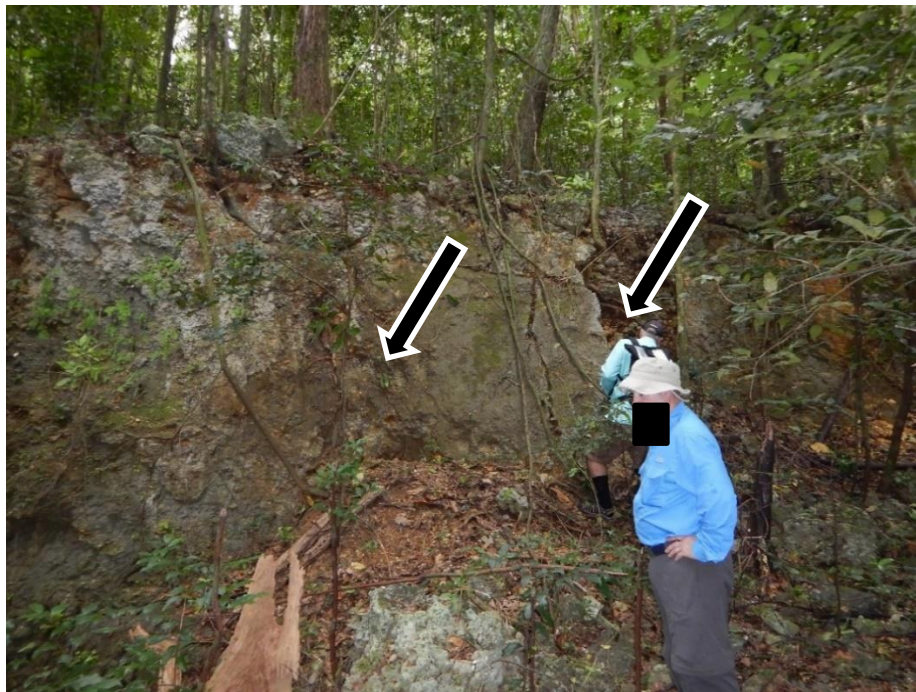
Appendix B-18. Point 15 – The Gorge Wall of the Brighton-Blue Hole Gorge, Noted Fractures Indicate Structural Control of This Landform

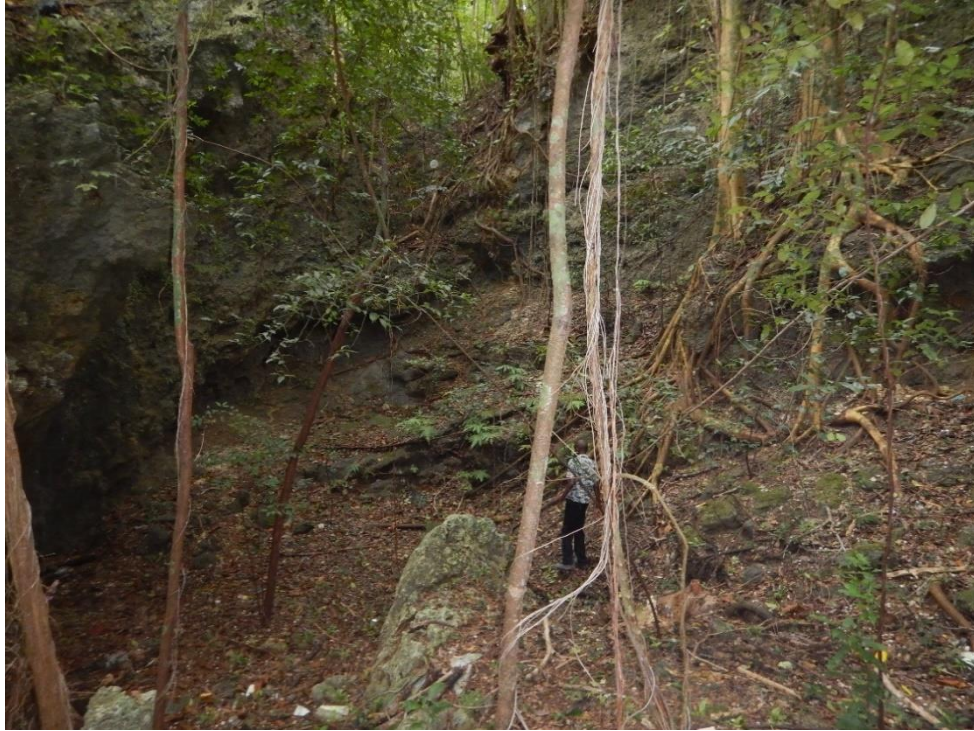
Appendix B-19. Point 16 – Headcut/bedrock Knickpoint Within the Brighton-Blue Hole Gorge Facing Upstream from the Bottom of Pool 7, a Difference of 9 m

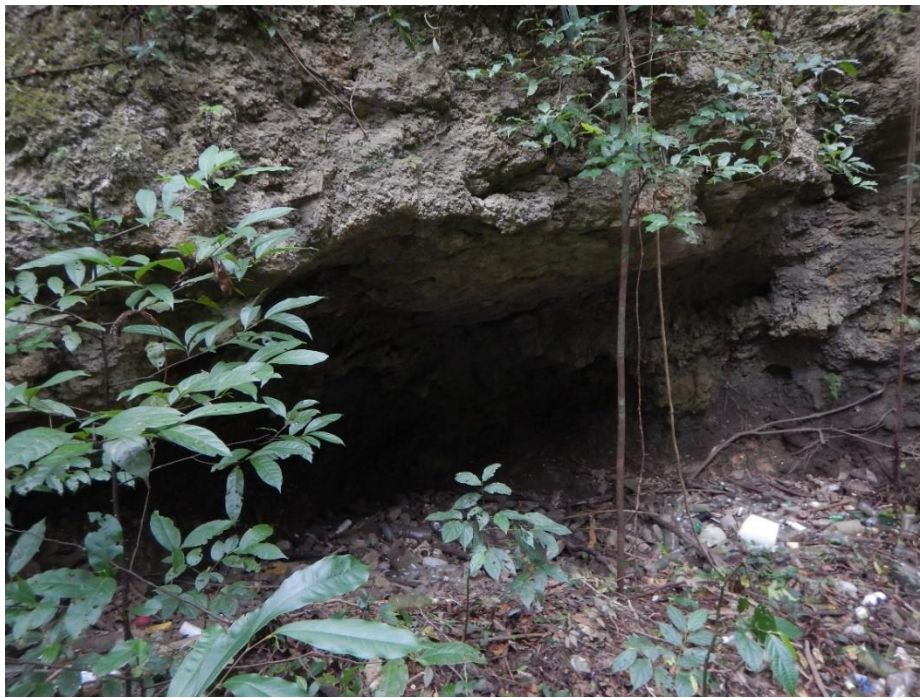
Appendix B-20. Point 17 – A “Scour Cave” on the Wall of the Brighton-Blue Hole Gorge Is an Erosional Feature Which Indicates the Removal of Wall Material Along Fractures

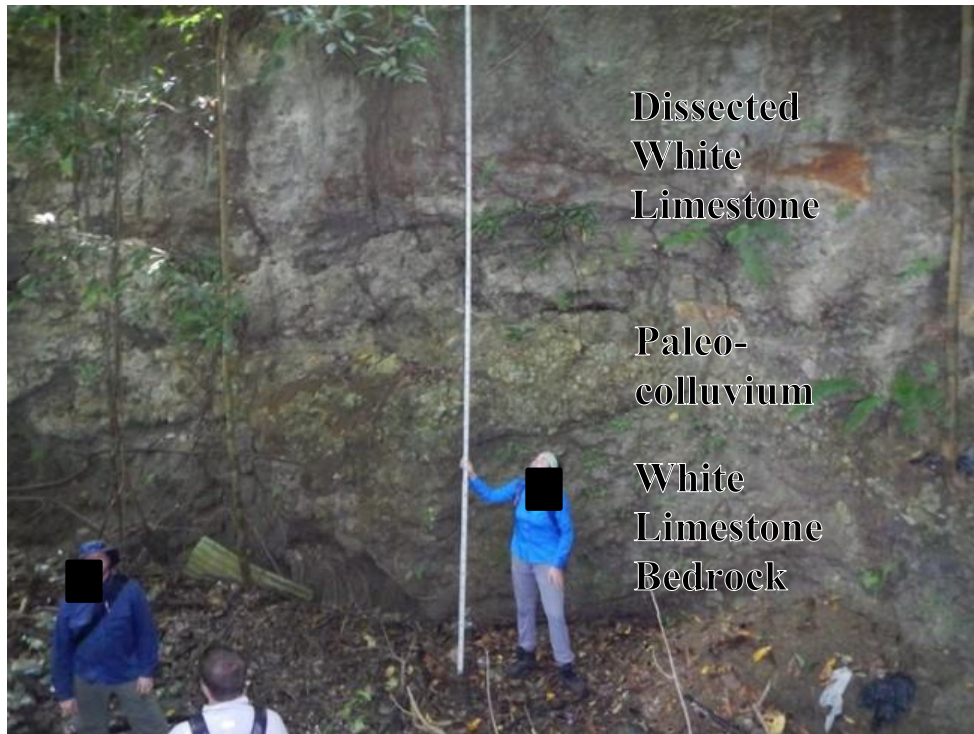
Appendix B-21. Point 18 – Brighton-Blue Hole Gorge Wall, Walls Are Made up of Limestone Bedrock Which Is Difficult to Erode Layered with More Friable Material

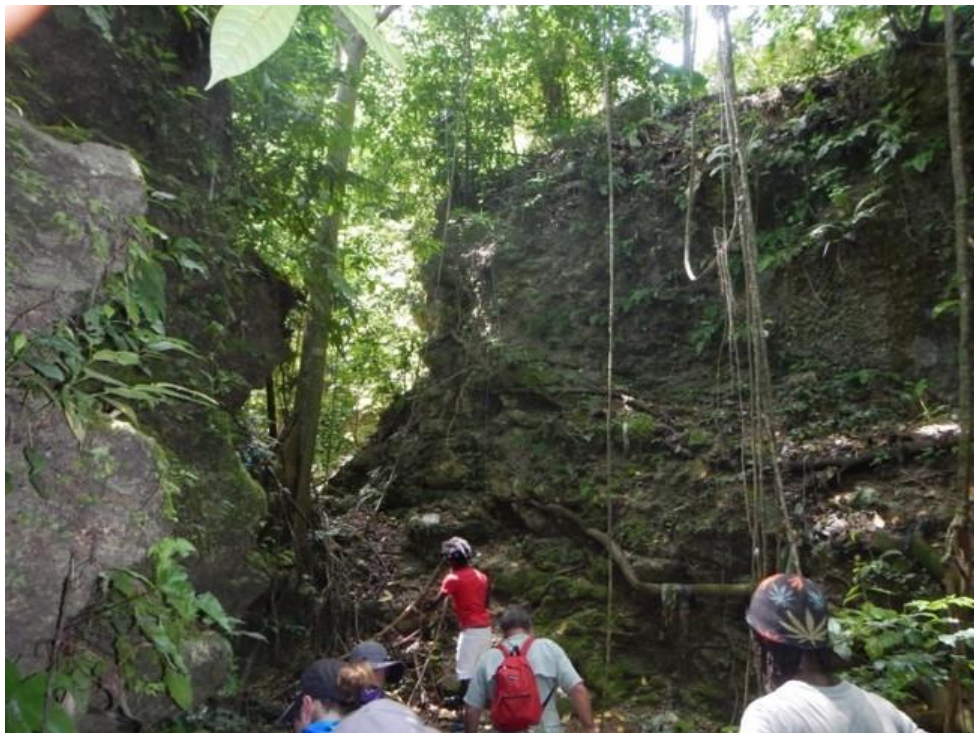
Appendix B-22. Point 19 – Brighton-Blue Hole Gorge Headcut Facing Downstream from the Bottom of Pool 3, a Difference of 5 m

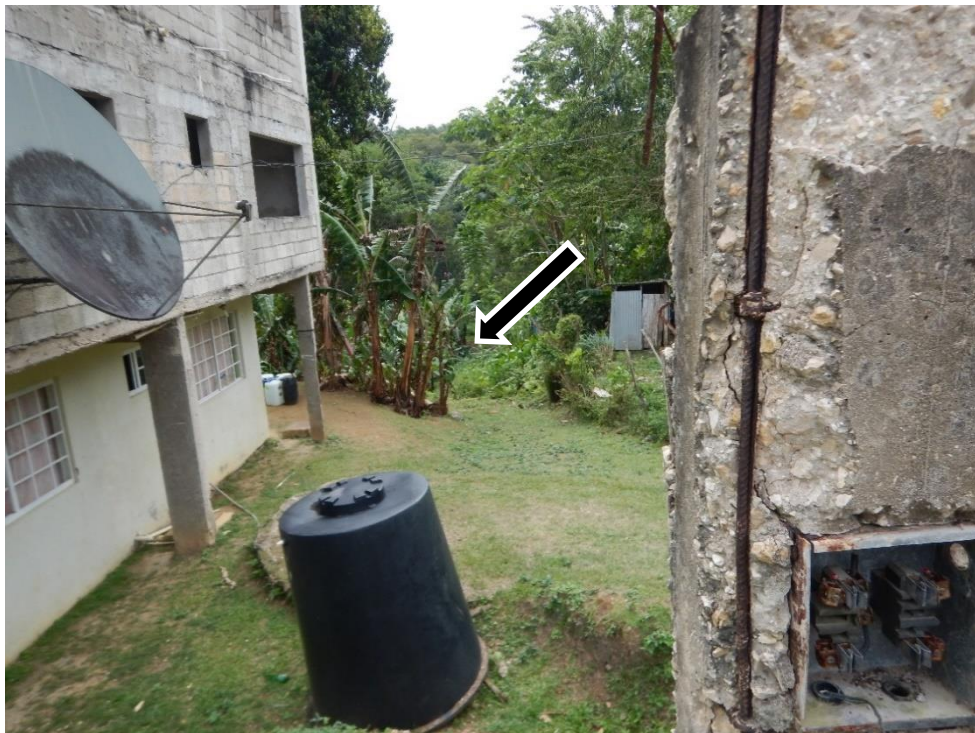
Appendix B-26. Point 22 – Upstream of Brighton Road Where the Saddle Cut in the Village of Brighton Occurred, the Depression Overfilled and Spilled over the Road

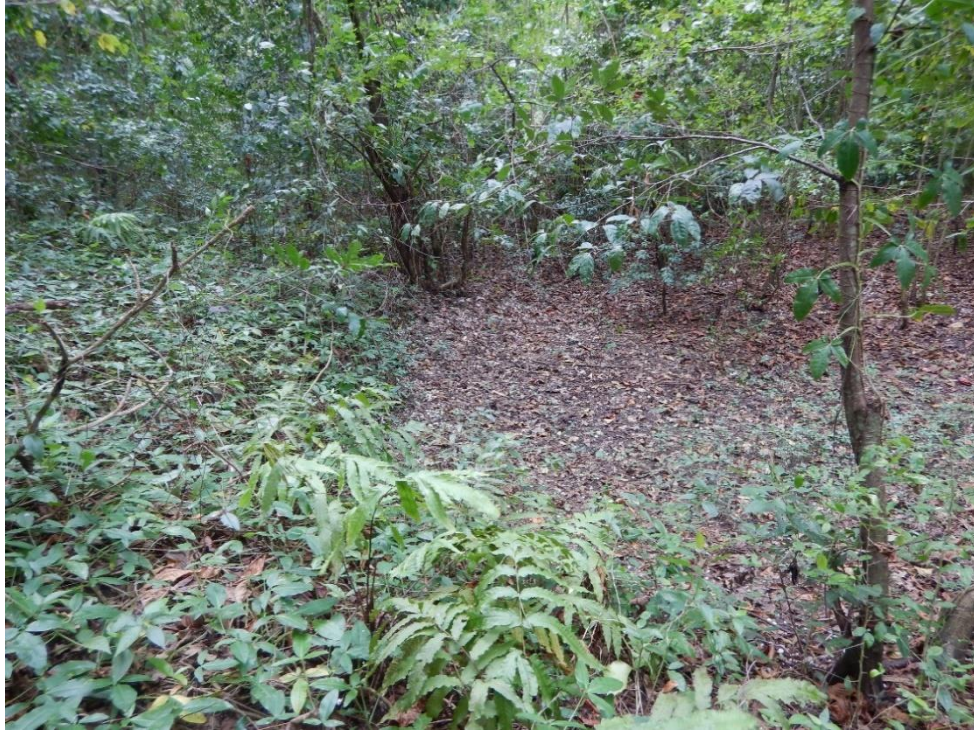
Appendix B-29. Point 24 – Estavelle Directly Upstream of Robins River Road Which Contributed to Overfilling in the Polje Valley It Drains

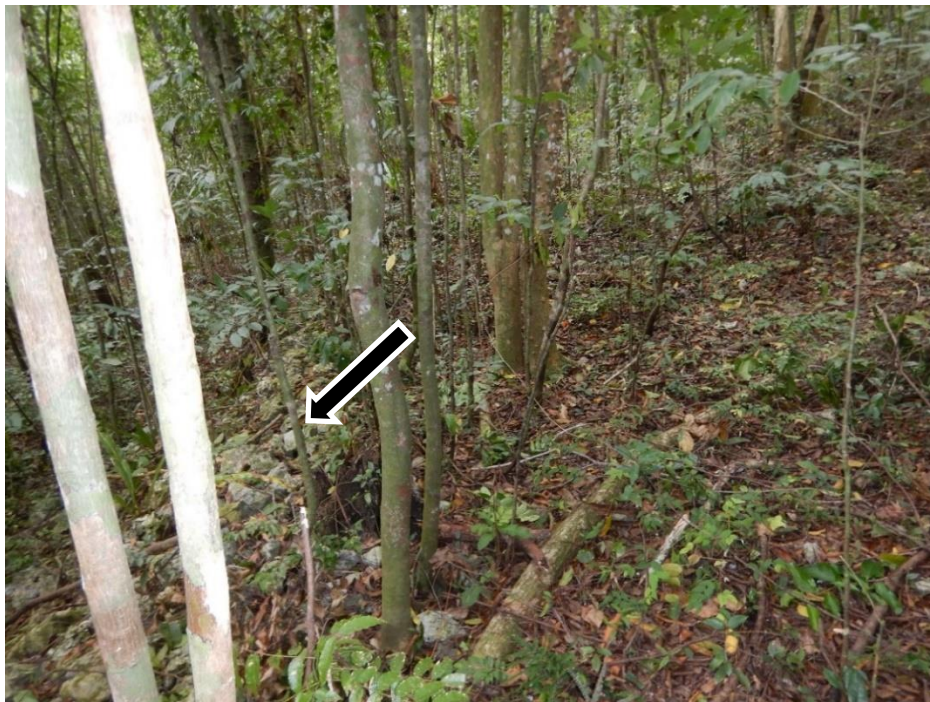
Appendix B-30. Point 25 – Channel/Boulder Bar, the Coarse Material Deposited Here Was Generated by Incised Channels Flowing Through Bonnygate and Union Hall Soils

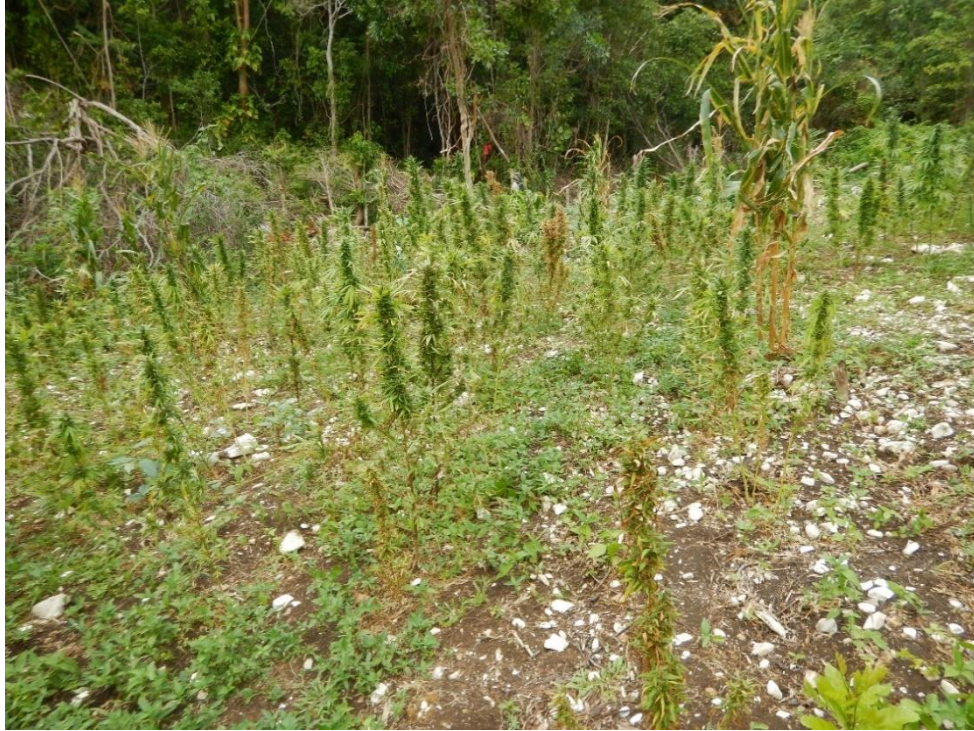
Appendix B-33. Point 28 – A Debris Fan Composed of Unsorted Fine and Coarse Sediment. These Fans Are Used as Isolated Farm Fields Today

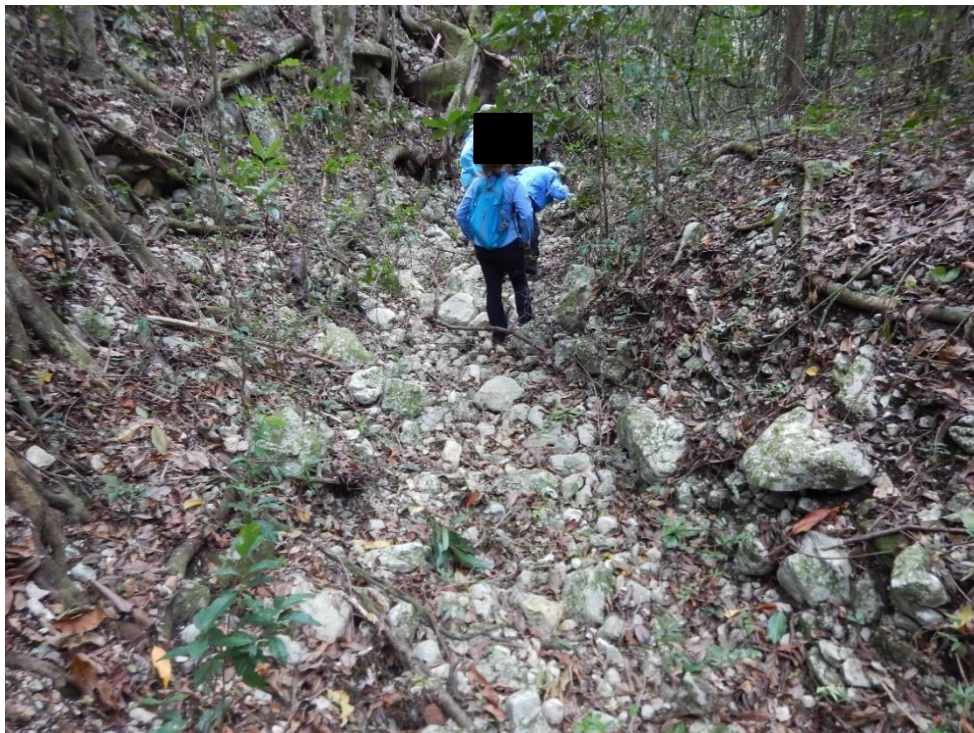
Appendix B-34. Point 29 – Incised Channel in Coarse Material Delivered Large Clasts to Boulder Bars Downstream

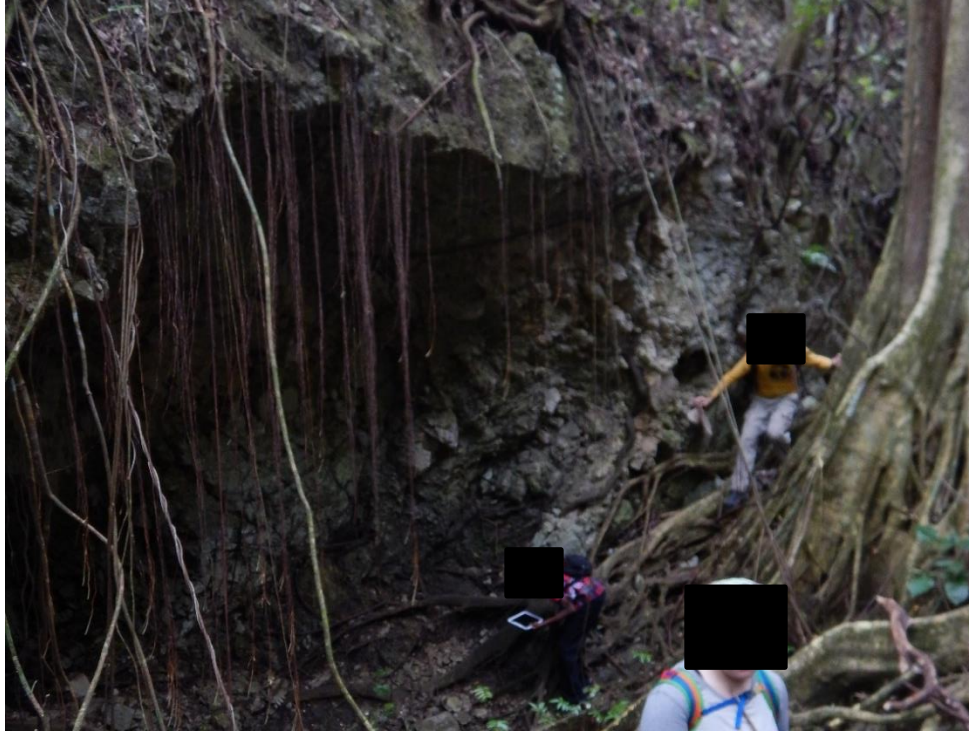
Appendix B-35. Point 30 – A “Scour Cave” on the Wall of a Bedrock Channel Along the Mid-Valley Reach Where Material Was Eroded from the Wall

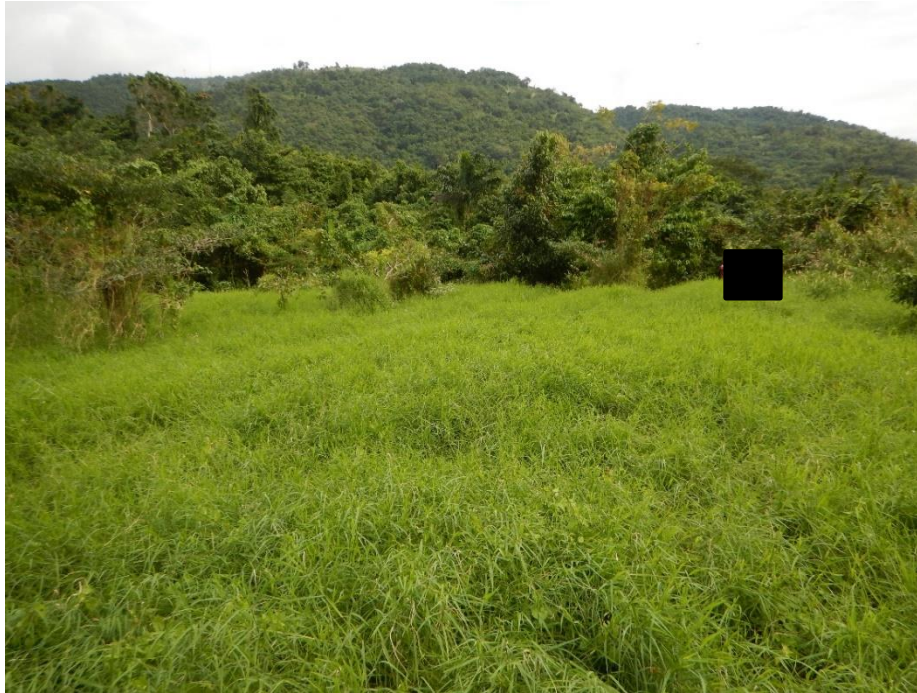
Appendix B-39. Point 34 – The Depression of the Shafston Blue Hole Spring. the Spring Is No Longer Visible at the Surface and May Have Been Filled with Sediment in 1979
