## Stream Channel Morphology and Riparian Forest Response to a 500-year Flood in the Missouri Ozarks

**STREAM CHANNEL MORPHOLOGY AND RIPARIAN FOREST RESPONSE TO  
A 500-YEAR FLOOD IN THE MISSOURI OZARKS**

A Master's Thesis

Master of Science, Geospatial Sciences in Geography and Geology

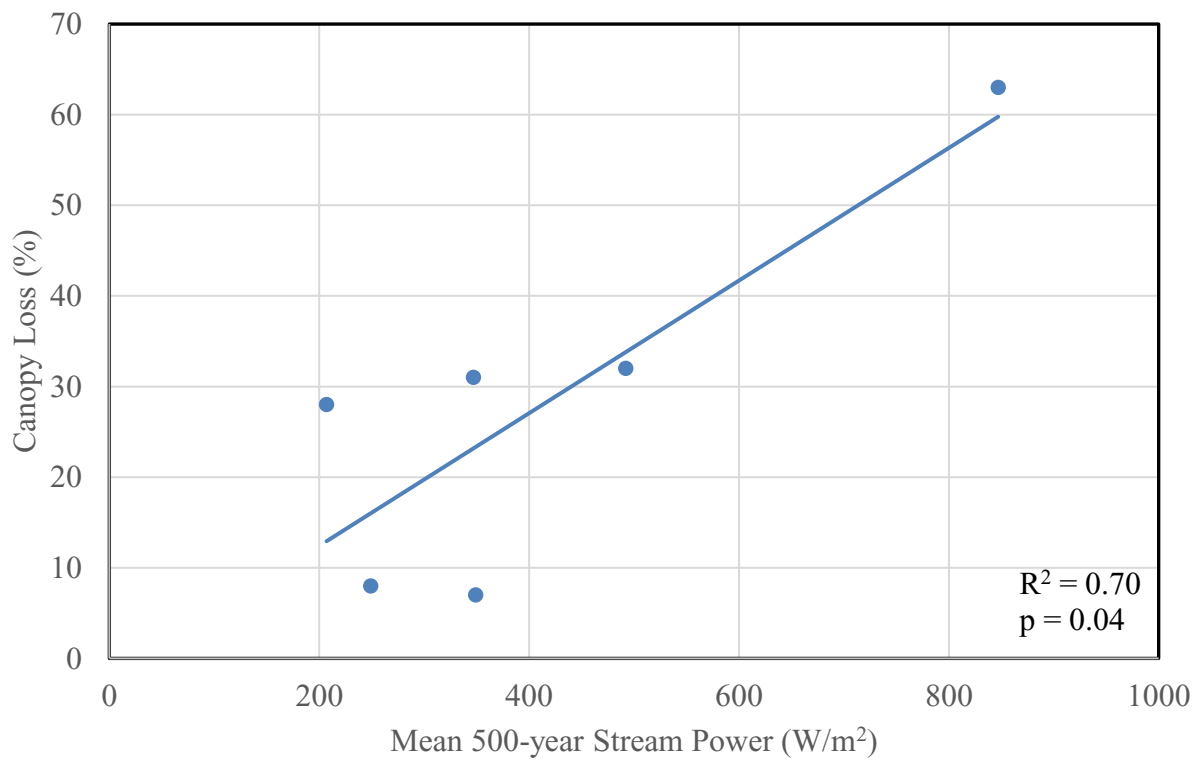
Fig. 8a. Mean 500-year Stream Power (W/m²) Compared to Canopy Loss (%)

**Geomorphic Relationships with Forest Damage.** Mean and cross-sectional 500-year stream power explained the greatest amount of variance in canopy loss and total damaged tree volume, typically as stream power increased so did forest damage (Fig. 8a, 8b, 9a, 9b). Mean 500-year stream power accounted for 70% of the variance in canopy loss and 67% of the variance in total damaged tree volume and was statistically significant in both cases (Fig. 8a and 8b). Mean 500-year stream power accounted for less than 20% of the variance in damaged tree volume per hectare ( $p = 0.39$ ). Cross-sectional stream power accounted for 90% of the variance in total damaged tree volume and 73% of the variance in canopy loss and was statistically

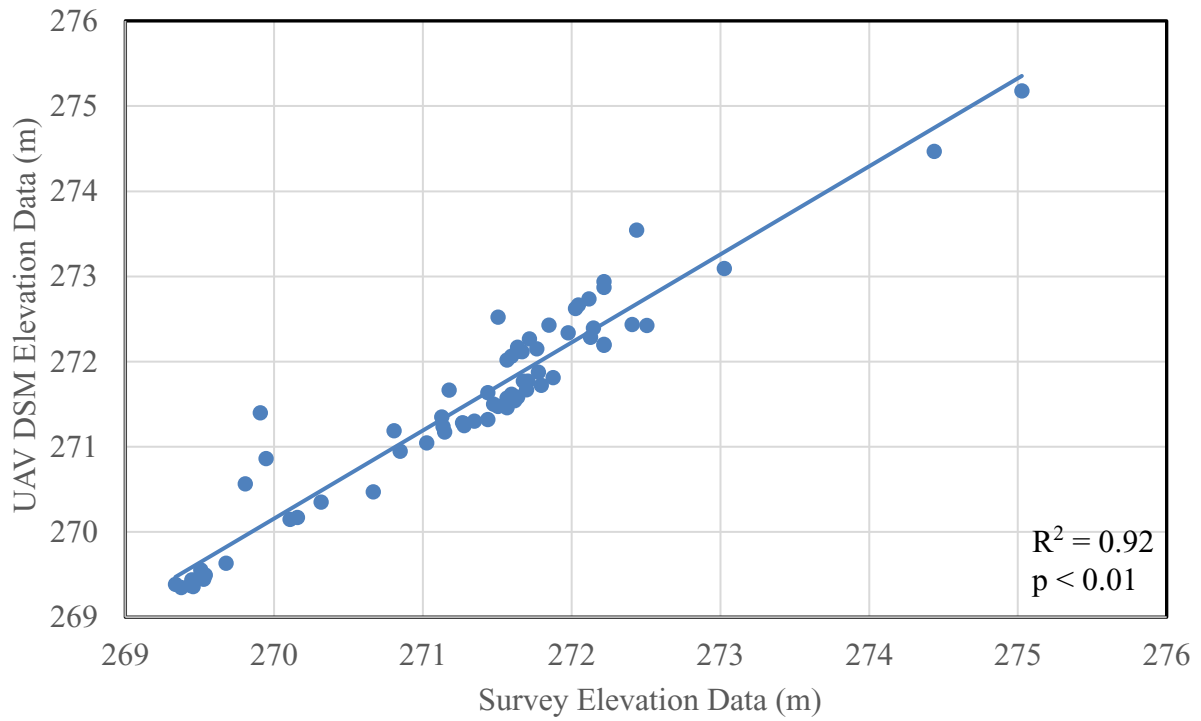
Fig. 12b. Regression Analysis of UAV DSM and Survey Elevation Data at Dry Creek

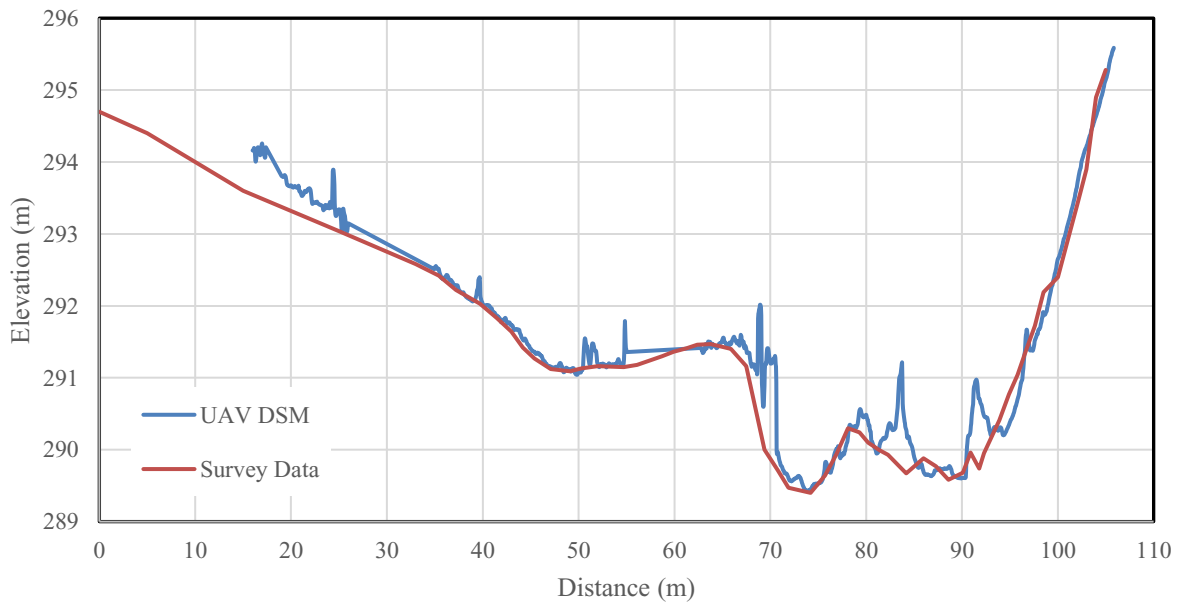
Fig. 13a. Cross-Section of Upper Tabor Creek using UAV DSM and Survey Data

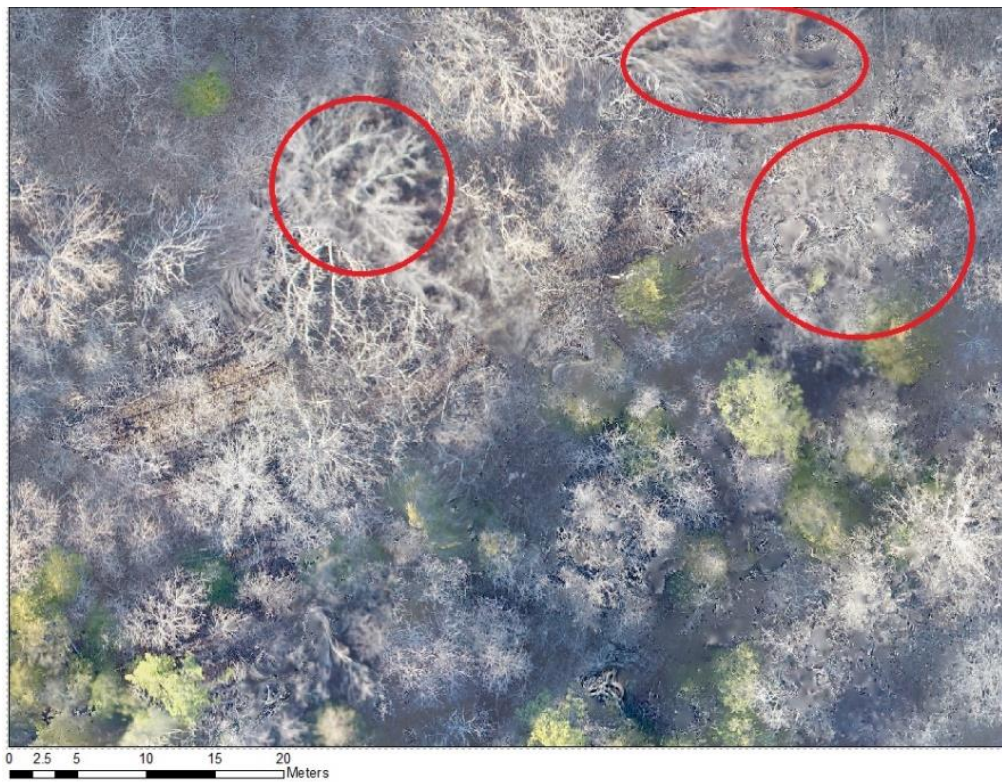
Fig. 14. Blurred Spots on the UAV Imagery from the Image Processing

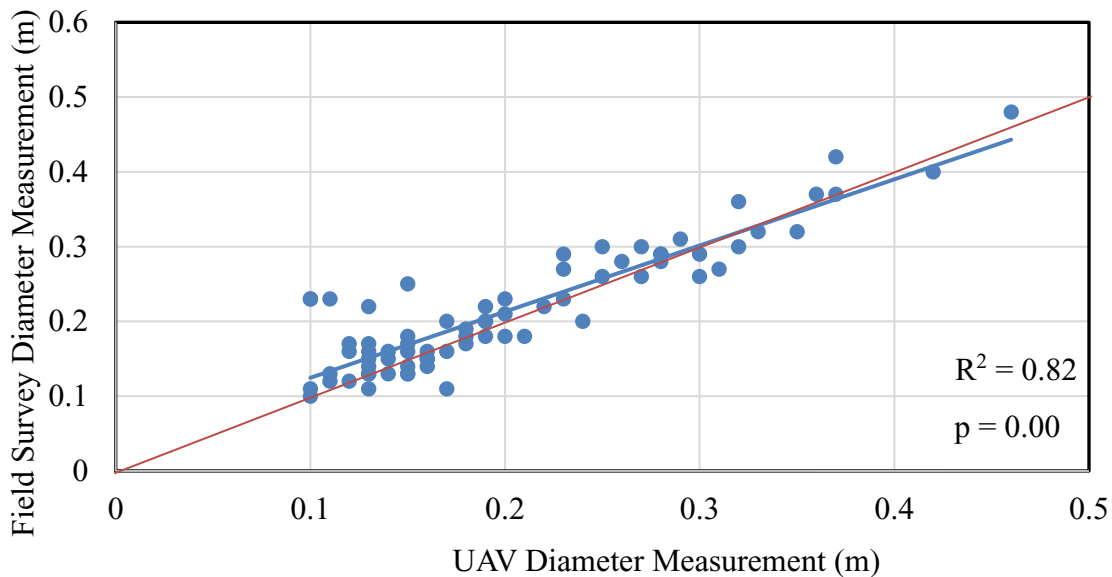
Fig. 15. Preferentially Chosen Survey Diameter Compared to UAV Diameter Measurement

\*Two diameter measurements were taken in the field, for this figure the diameter measurement which was closest to the UAV diameter measurement was compared with the UAV measurement.

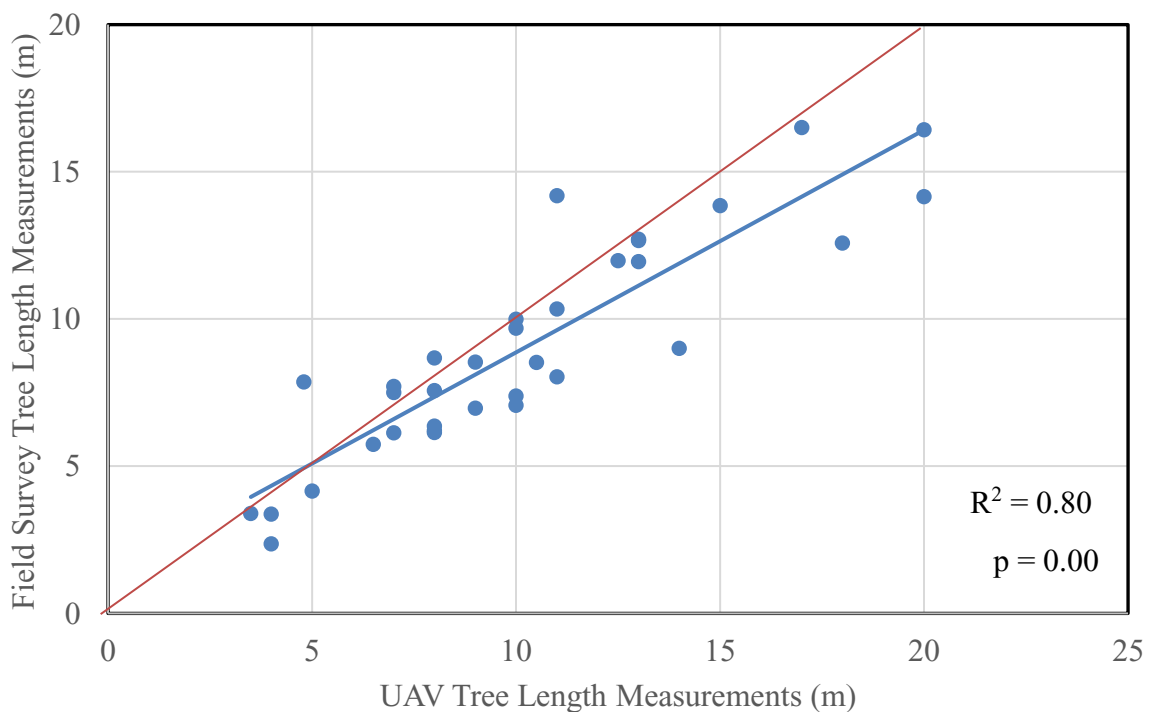
Fig. 16. Field Survey Compared to UAV Tree Length Measurements using only Mostly Visible Trees

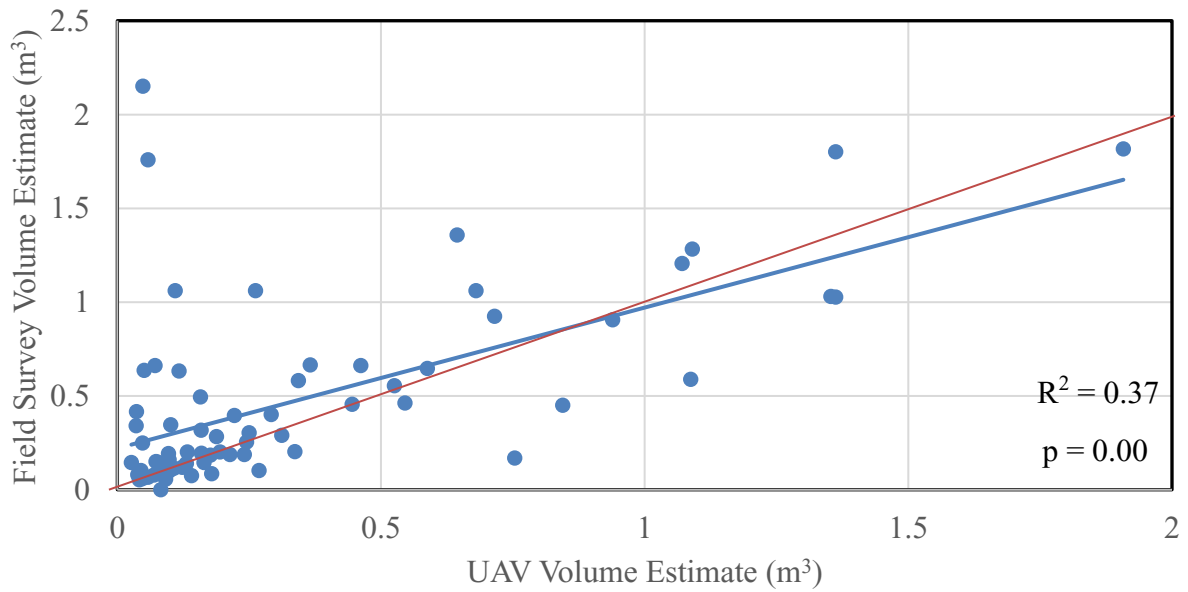
Fig. 18. Field Survey Compared to UAV Volume Estimates (All Trees)

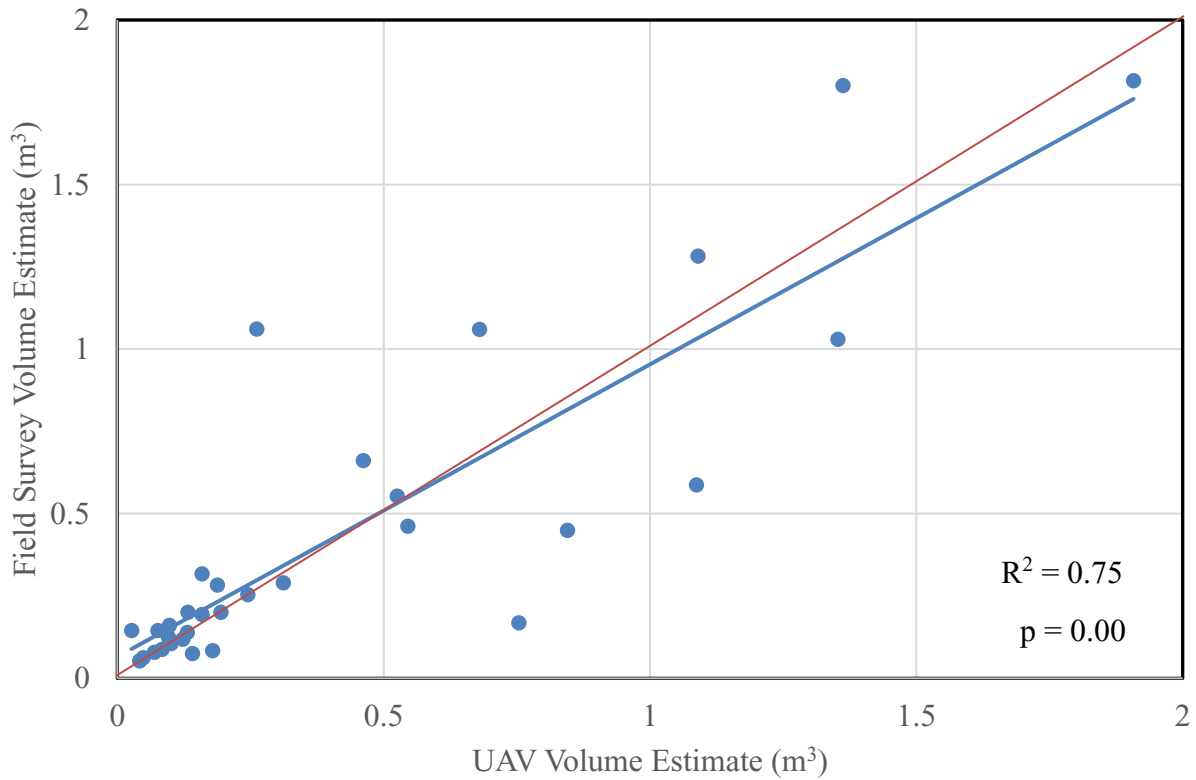
Fig. 19. Field Survey Compared to UAV Volume Estimates Including only Mostly Visible Trees

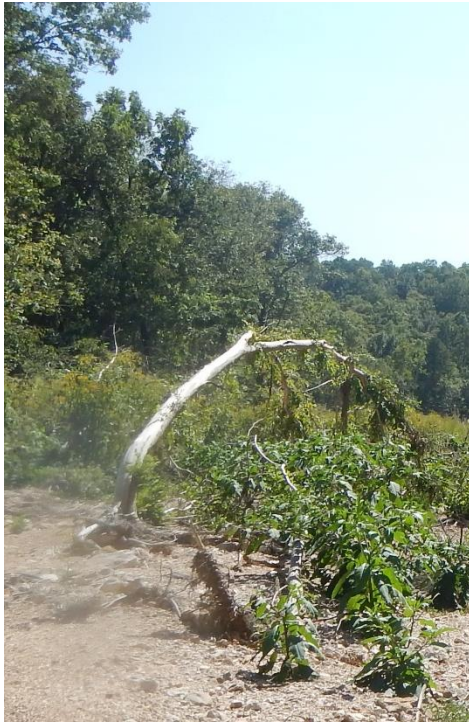
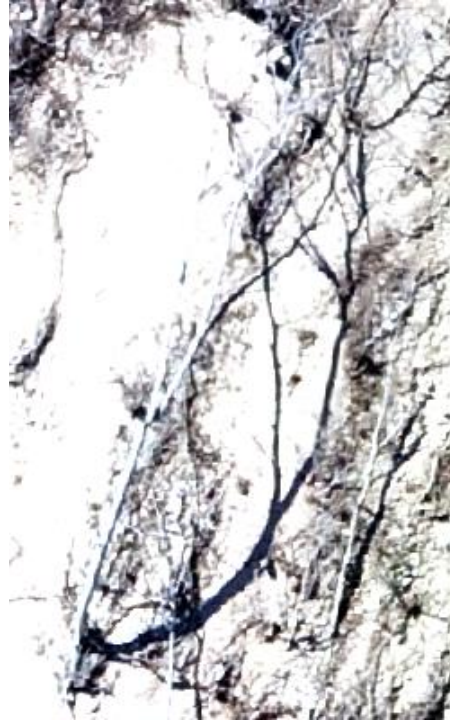
Fig. 21. Toppled Tree Length Underestimated in UAV Imagery. Terrestrial Photograph (left) and UAV Imagery (right) of the Same Tree

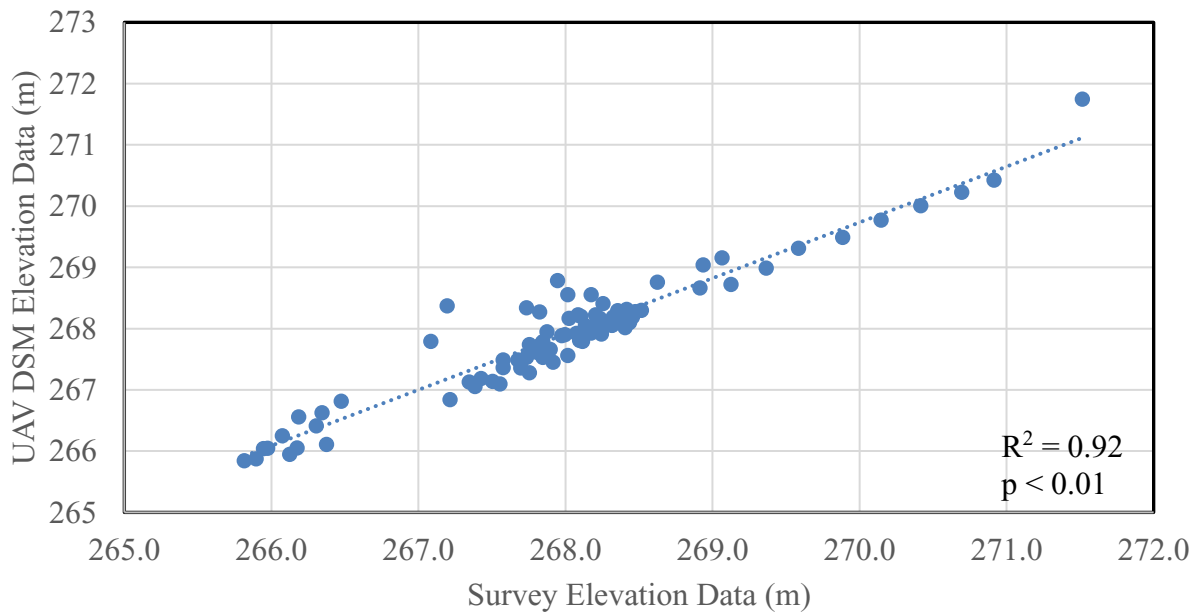
Regression Analysis of UAV DSM and Survey Elevation Data, Lower Tabor Creek, 2017

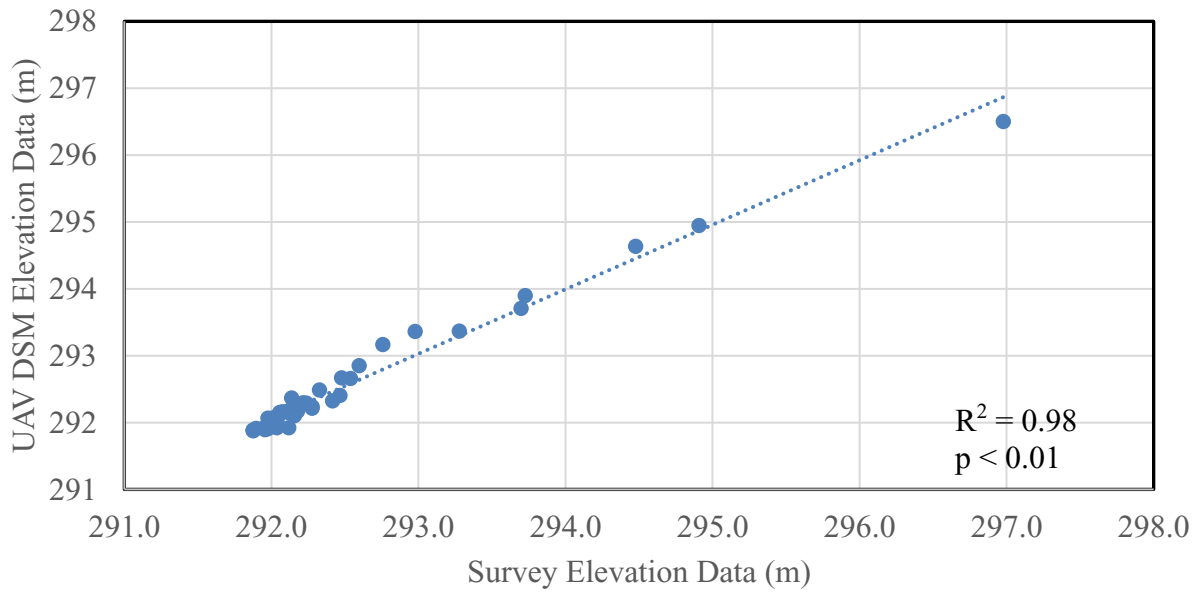
### Regression Analysis of UAV DSM and Survey Elevation Data, Lick Branch, 2017
