Ozarks Environmental and Water Resources Institute (OEWRI)
Missouri State University (MSU)

Wastewater Exfiltration Sources in Pearson Creek, Springfield, Missouri

FINAL REPORT

OEWRI EDR-18-001

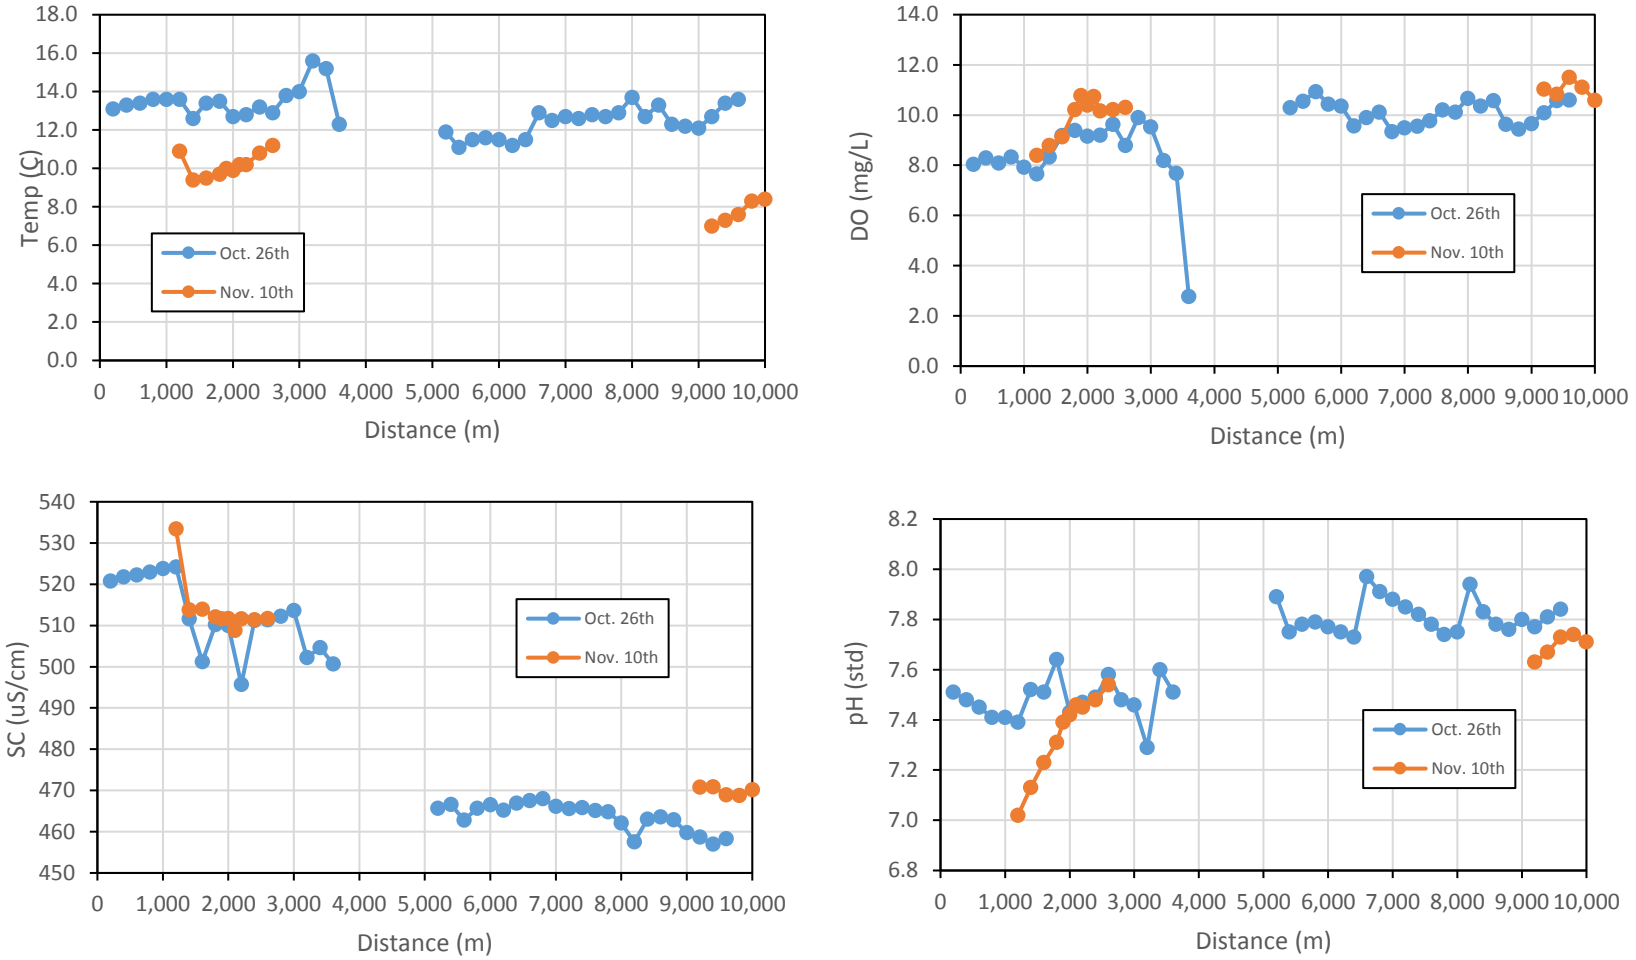
Figure 4. Downstream water parameter trends.

7. Field sampling results downstream of the gaining section at station 3,600 m shows that the chemistry of the water coming back to the surface is different than the water upstream of the losing section at station 5,400 m. Both DO and pH are relatively lower below station 3,600 m than above station 5,400 m, and SC and TN are relatively higher (Figures 4 and 5). While it is likely the water moving underground in the upstream section is resurfacing below, there is definitely a change occurring either by chemical reactions within the karst system or mixing from other sources. Again, karst connections in this area are complicated and poorly understood.

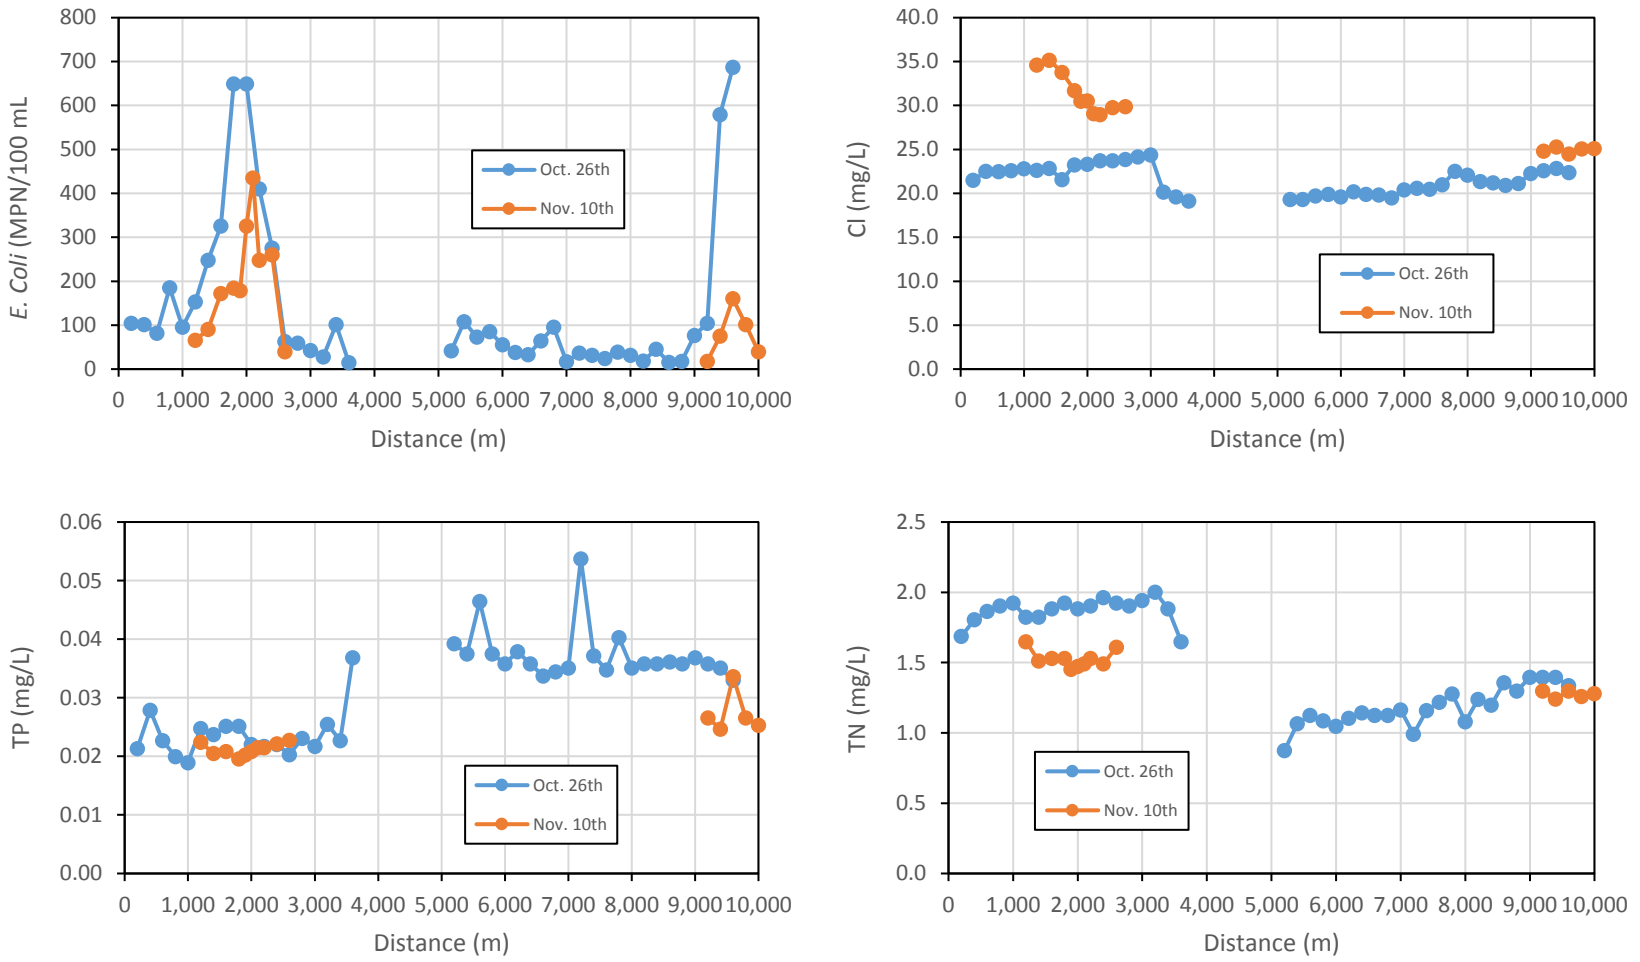
Figure 5. Downstream bacteria, chloride, and nutrient trends

1. The highest and most significant peak detected during this study was at station 2,000 m at FR 148 (USGS gage). There are several potential sources of *E. Coli* contamination at FR 148 including multiple sewer line junctions, a fault line, and livestock access to the stream (Figure 1). Sample results suggest the highest *E. Coli* concentrations are from sewer exfiltration and more moderate sources from cattle access. The peak *E. Coli* concentration occurs near station 2,000 m at a known sewer crossing (Figure 5). However, downstream plots do show *E. Coli* concentrations start to increase upstream of station 2,000 m where cattle do have access to the stream suggesting there may be some influence from nonpoint agriculture sources. Follow-up sampling on Nov. 9th verified this trend.

2. The second highest peak detected during this study occurred at station 9,600 m, but there is no sewer mapped at that location (Figure 1 and 5). However, field workers noted what seemed to be something in the channel made of concrete at that location. Follow-up sampling on Nov. 9th that included further sampling upstream of State Highway YY showed that concentrations of *E. Coli* decreased upstream. These results suggests high concentrations are not due to the cattle operation upstream of State Highway YY. The karst connections at this location are unknown, but this spot may be linked to sewer exfiltration via an underground conduit originating from some other location.

3. There is a lower magnitude *E. Coli* peak associated with a sewer crossing at station 3,400 m located upstream of Catalpa Street. *E. Coli* concentrations increase from less than 20 MPN/100 mL at station 3,600 m to nearly 100 MPN/100 mL at station 3,400 m (Figures 1 and 5). This indicates possible sewer line exfiltration, but the bacteria concentration does not exceed the water quality criteria of 126 MPN/100 mL.

4. A lower magnitude *E. Coli* peak was found near the sewer crossing located at station 6,800 m upstream of Chestnut Street. *E. Coli* concentrations increase from less than 20 MPN/100 mL at station 7,000 m to nearly 100 MPN/100 mL at station 6,800 m (Figure 1 and 5). This may be caused by sewer line exfiltration, but *E. Coli* concentrations do not exceed the water quality criteria of 126 MPN/100 mL at this location.

5. A lower magnitude *E. Coli* peak was identified at the sewer crossing located at station 5,400 m at Cherry Street. *E. Coli* concentrations are about 100 MPN/100 mL at station 5,400 m (Figures 1 and 5). However, the peak gets progressively higher starting at station 6,000 m suggesting other sources of *E. Coli* may be contributing to the increase at this location too. Again, this indicates possible sewer line exfiltration, but the bacteria concentration does not exceed the water quality criteria of 126 MPN/100 mL.

6. The water chemistry of the water entering the main channel from Jones Branch at station 3,200 m is very different than the water from the upstream portion of the study. There are elevated levels of TN and CL, and lower levels of TP coming out of Jones Branch compared to the upstream sections (Figure 5). While *E. Coli* concentrations are low coming from Jones Spring Branch, the elevated levels of TN are at or above the James River total maximum daily load (TMDL) target of 1.5 mg/L (MDNR 2001).

8. There is a site with an elevated TP concentration located at station 7,200 m suggesting a potential nonpoint source pollution risk that is not associated with a sewer crossing (Figure 5).

9. There is another site with a peak TP concentration located at station 5,600 m that is not associated with a sewer crossing (Figure 5). Again, this nutrient increase may be an indication other nonpoint sources are influencing this location.

1. Priority #1 sites are located at stations 2,000 m and 9,600 m and have the highest *E. Coli* concentrations identified during the study and should be the first locations to be addressed. At station 2,000 m, there are several potential sources of *E. Coli* including multiple sewer crossings, a major fault system, and nonpoint agriculture. This site is particularly important since it is located near the USGS gaging station and has a history of very high bacteria concentrations that exceed water quality standards. However, results show that the problem is concentrated locally around station 2,000 m and is not widespread throughout the watershed at base flow. Therefore, addressing bacteria pollution at this site is critical for water quality improvement in the lower Pearson Creek watershed before it enters the James River immediately downstream. At site 9,600, there is a high concentration of *E. Coli*, but does not appear to be directly related to a sewer line. However, it may be connected sewer line exfiltration via an unknown karst conduit.

2. Priority #2 sites are located at 6,800 m, 3,400 m, and 5,400 m have lower magnitude peaks of *E. Coli* that are associated with sewer crossings. These sites are at sewer line crossing locations where *E. Coli* concentrations increased compared to samples collected upstream, but were below the 126 MPN/100 mL limit. These areas are places exfiltration may be occurring, but not to the magnitude of the Priority #1 areas.
