**The Ozarks Environmental and Water Resources Institute (OEWRI)
Missouri State University (MSU)**

FINAL REPORT

**Nonpoint Source Bank Erosion and Water Quality
Impairment Assessment, James River at Rivercut Golf
Course, Greene County, Missouri**

OEWRI EDR-13-003

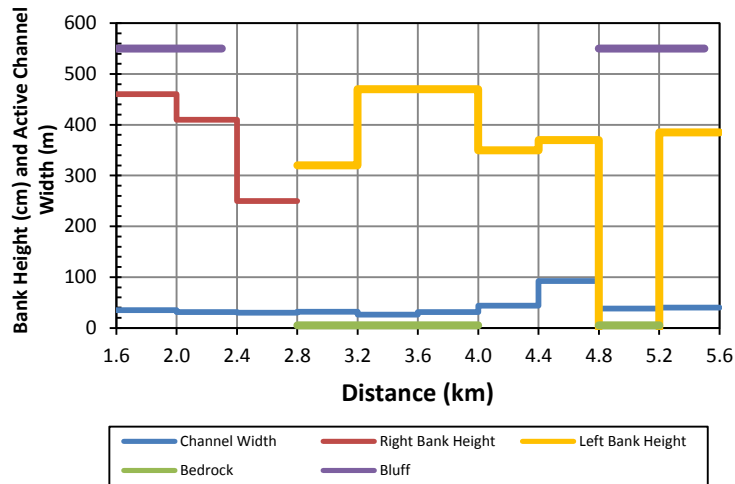
Figure 4. Bank and channel conditions in study reach.

Bedrock bluffs and natural obstructions have a major influence on the channel along the 4 km long study reach. Bluffs and bedrock along the bank toe were observed along the bank of the river along the easement for the majority of the reach length and bedrock can be found along the bed of the river frequently (Figure 4). When it occurs, bedrock in the bed and along bluffs limits the ability of the river to meander and scour the bed and is typical of streams in the Ozarks (Pavlovsky, 2004). Field measurements taken in July 2013 show the active channel width varies from about 26 m from 3.2-3.6 km up to 93 m from 4.4-4.8 km. The active channel refers to both the wetted part of the channel at low flow, but also the gravel bars located adjacent to the water, but set below the bank. The high active channel widths indicate areas where large bars are present in the channel. Bank heights vary from around 2.5-4.7 m through the study reach. Bank heights vary due to the age of the deposit from terraces that could be >10,000 years old to recently formed benches only formed over the last 100 years (Brakenridge 1981; Hajic et al. 2007; Owen et al. 2011). Colluvium/alluvium banks exist at the base of the bluffs along most of the reach with the exception of the bluff adjacent to the river from 4.8-5.2 km. Bank heights measured in the field were used to calculate total sediment volume lost to erosion from the historical aerial photography analysis.

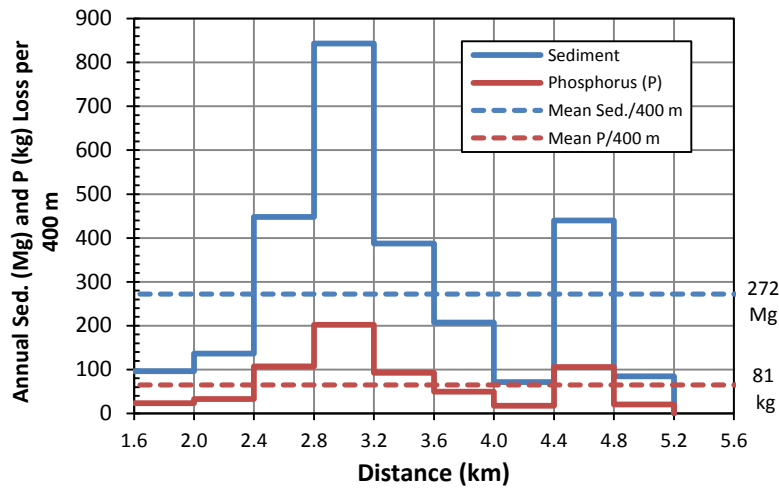
Figure 5. Annual sediment and P loss from bank erosion in study reach.

The majority of bank erosion along the easement property is concentrated in the middle section of the study reach from 2.4-4.0 km and 4.4-4.8 km, while erosion in the remainder of the reach was less significant. Total bank erosion estimated from the aerial photos and field measurements along the property by 400 m cell varied from 0 along the bluffs to 7,782 m³ (10,117 Mg) in the cell between 2.8-3.2 km since 1996 (Table 2). Average erosion for the reach over the 12 years this study covered was 2,506 m³ and 3,258 Mg per cell. Total erosion for the entire 4 km reach was 25,064 m³ and 32,583 Mg over those 12 years. Annual sediment loss ranged from 0-843 Mg/yr by cell for an average of 272 Mg (Figure 5). Results suggest >60% of the total erosion from the easement property is coming from banks located between stations 2.4-4.0 km in an area

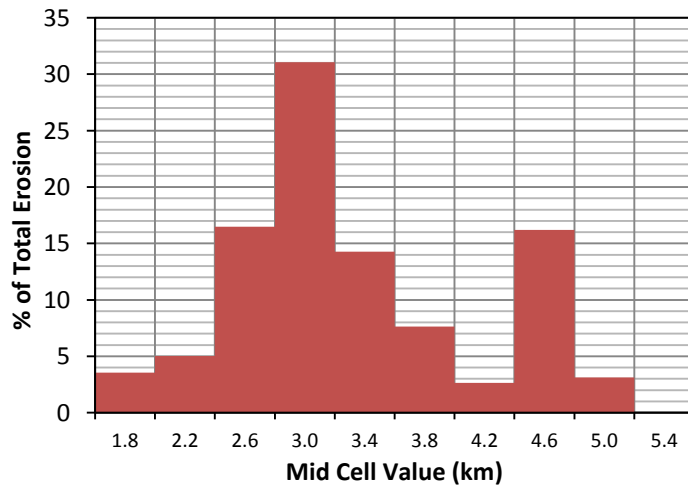
Figure 6. Percent of total erosion by cell.

thought to be experiencing widening over the 12 years between photos (Figure 6). Annual sediment eroded per unit length of stream varies from 0-2.11 Mg/m/year by 400 m cell. The annual average over this period has been 680 Mg/km/yr.

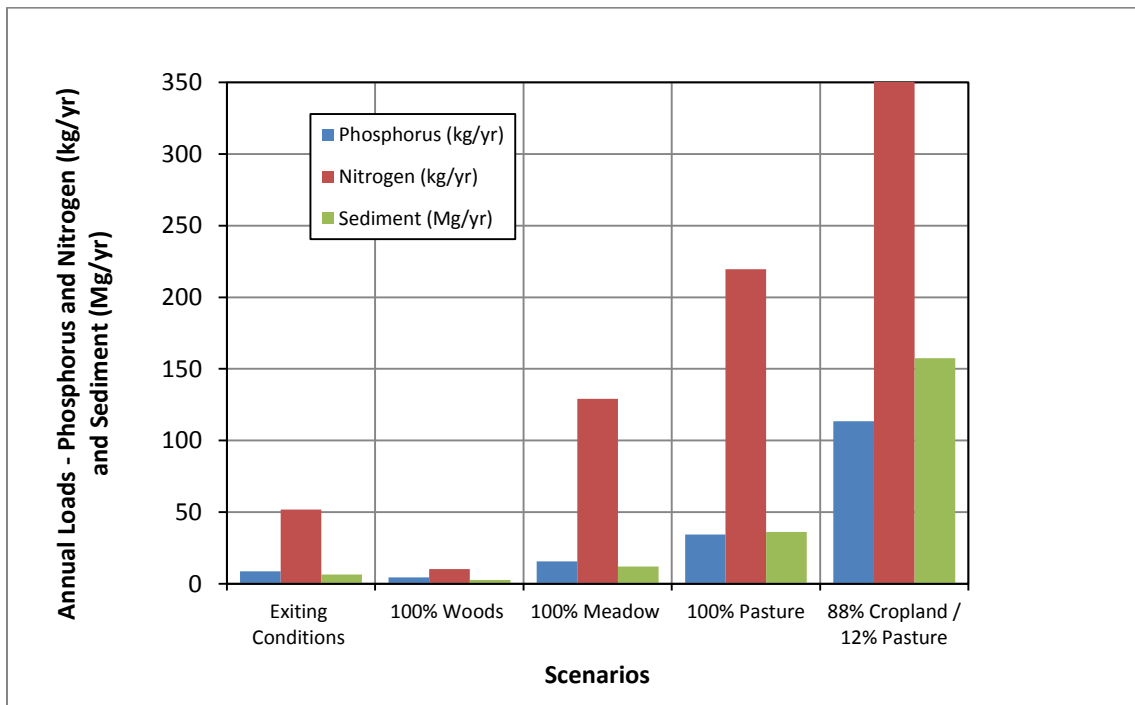
Figure 7. Annual nutrient and sediment loads from easement area from STEPL model.

STEPL results show that most of the nutrients and sediment leaving the existing easement area are coming from the grasslands that are currently being managed for hay. The majority (66%) of the existing land use within the area is in forest, with the remainder in “meadow”. The meadow conditions are described as grasslands protected from grazing and are typically hayed (TR55). Using the existing land use in the model, the nitrogen (N) load is 51.8 kg/yr, the P load is 8.7 kg/yr, and the sediment load is 6.5 Mg/yr (Table 6, Figure 7). Of this 44.9 kg/yr of N, 5.6 kg/yr P, and 4.6 Mg/yr sediment is coming from the grasslands. Areas currently in forest have very low loads.
