**The Ozarks Environmental and Water Resources Institute (OEWRI)
Missouri State University (MSU)**

FINAL REPORT

**Nonpoint Source Bank Erosion and Water Quality
Assessment, James River at River Bluff Farm, Stone
County, Missouri**

OEWRI EDR-13-002

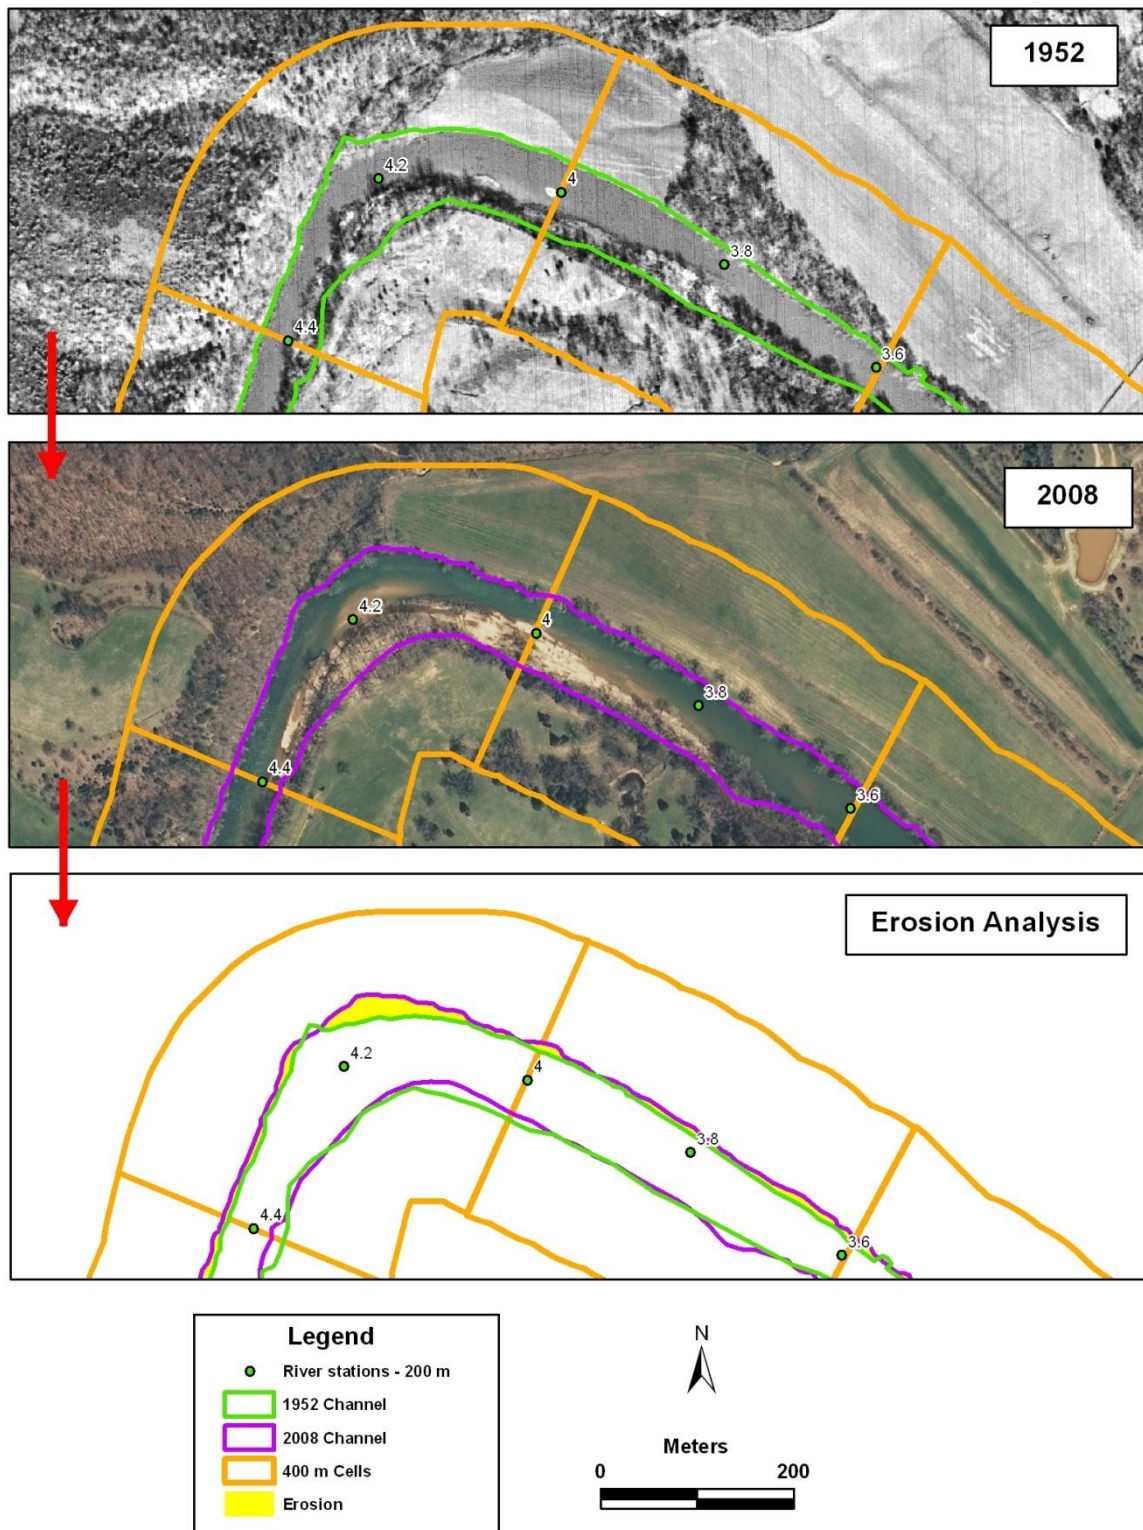
Figure 3. Aerial photo methods to define area of erosion since 1952.

USGS aerial photos from 2008 were used as the base for rectification of 1952 historical aerial photography using a second-order polynomial transformation of 8 ground control points per image (Hughes et al., 2006). Root mean square error was 1 m for all photos with average test point error <2 m. Both banks were digitized for each photo series in ArcGIS for overlay analysis. A 400 m channel cell polygon feature was created with the location of the field-based assessment at the center of the cell (Figure 3). An average erosion rate between each photo series was calculated in each cell by creating an area of erosion within each using the digitized banks from each photo year and dividing that by the cell length. Bank erosion had to exceed the test point error of 2 m to be valid using this method.

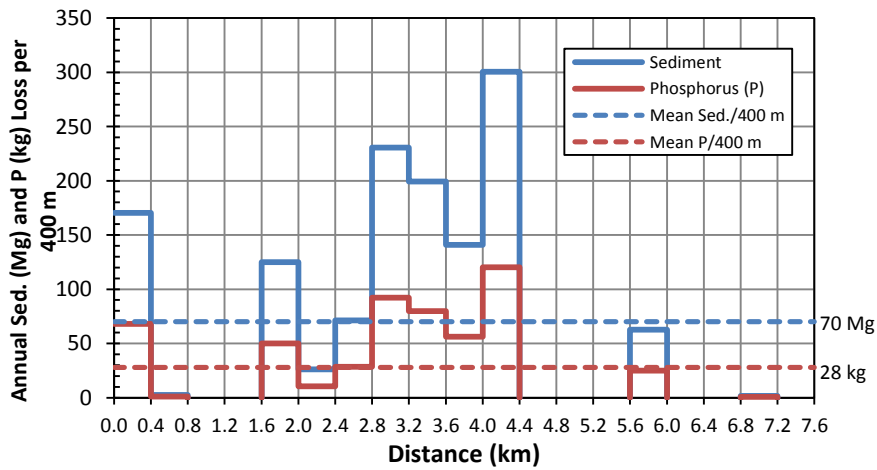
Figure 5. Annual sediment and P loss from bank erosion in study reach.

The majority of bank erosion along the easement property is concentrated in the middle section of the study reach from 1.6-4.4 km, while erosion in the remainder of the reach was relatively low. Total bank erosion estimated from the aerial photos and field measurements along the property by 400 m cell varied from 0 along the bluffs to 12,937 m³ (16,818 Mg) in the cell between 4-4.4 km since 1952 (Table 2). Average erosion for the reach over the last 56 years was 3,017 m³ and 3,921 Mg per cell. Total erosion for the entire 7.6 km reach was 57,314 m³ and 74,508 Mg over the last 56 years. Annual sediment loss ranged from 0-300 Mg/yr by cell for an average of 70 Mg with about 65% coming from the area between 1.6-4.4 km (Figures 5 and 6). Annual sediment eroded per unit length of stream varies from 0-0.75 Mg/m/year by 400 m cell with an average of 0.18 Mg/m/yr.

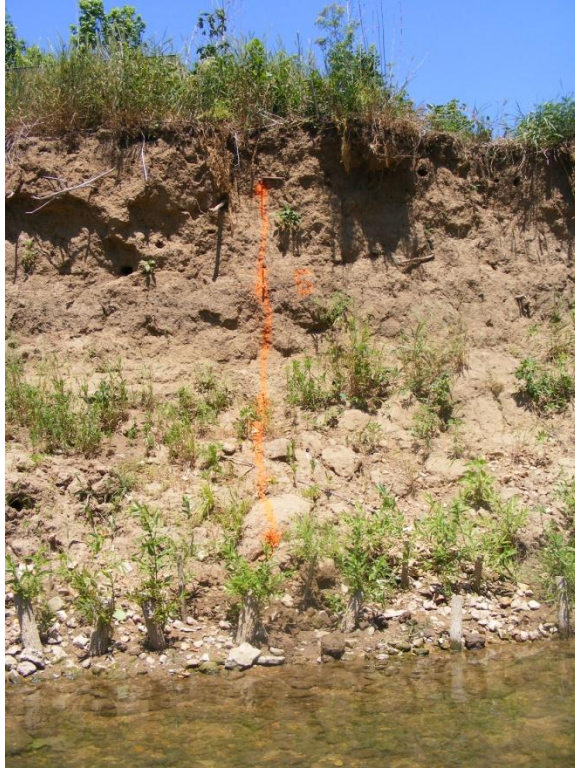
Photo 3. Erosion pin transect with live willow stakes at the base, May 2012.

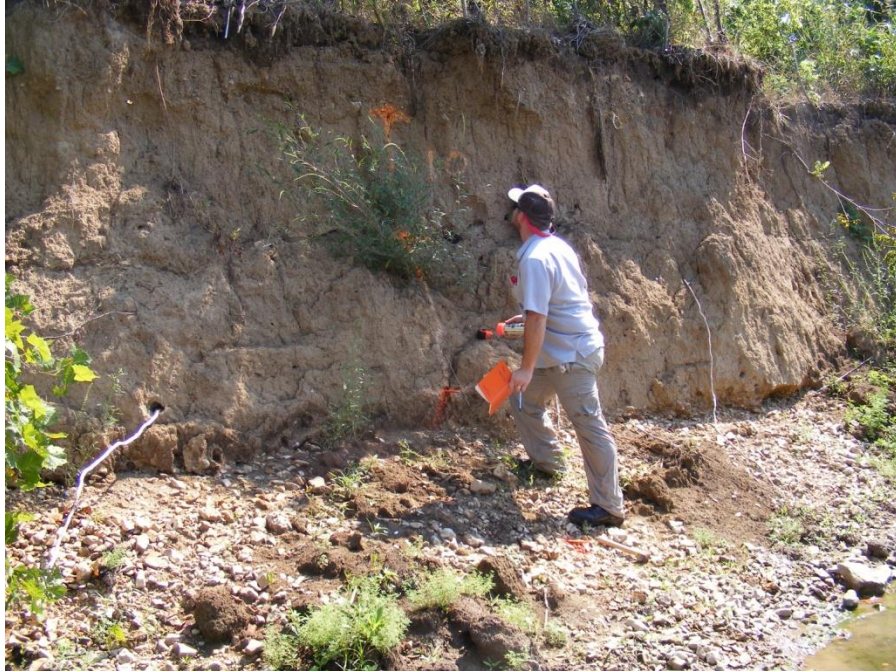
Photo 5. Erosion pin transect 10 at low flow, July 2012.

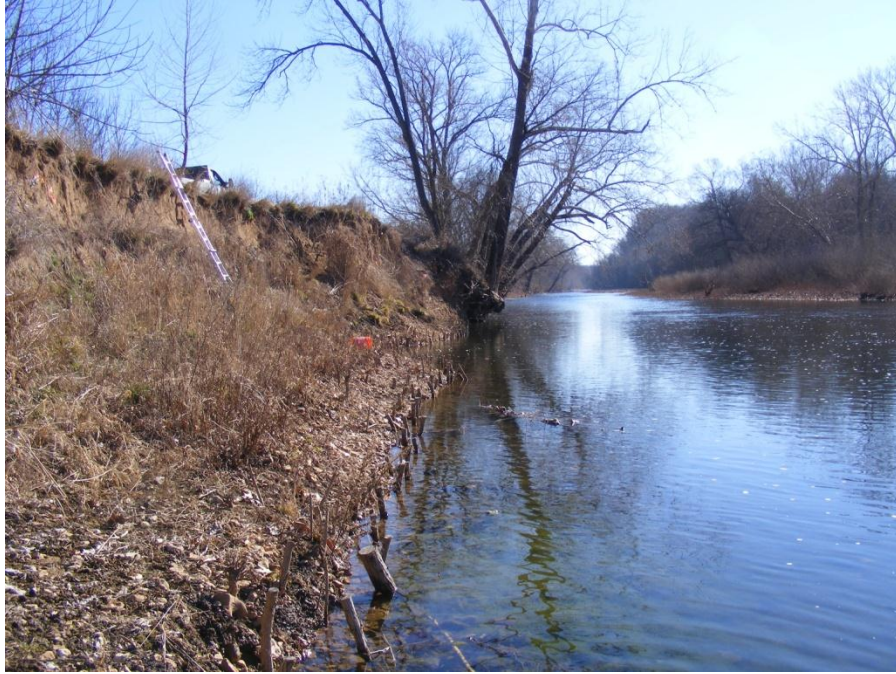
Photo 7. View upstream of transect 5, with dormant willows, January, 2013.
