FINAL REPORT

**Nonpoint Source Bank Erosion and Water Quality
Assessment, James River at River Bluff Farm, Stone
County, Missouri**

Field work completed May 2012- May 2013

OEWRI EDR-13-002

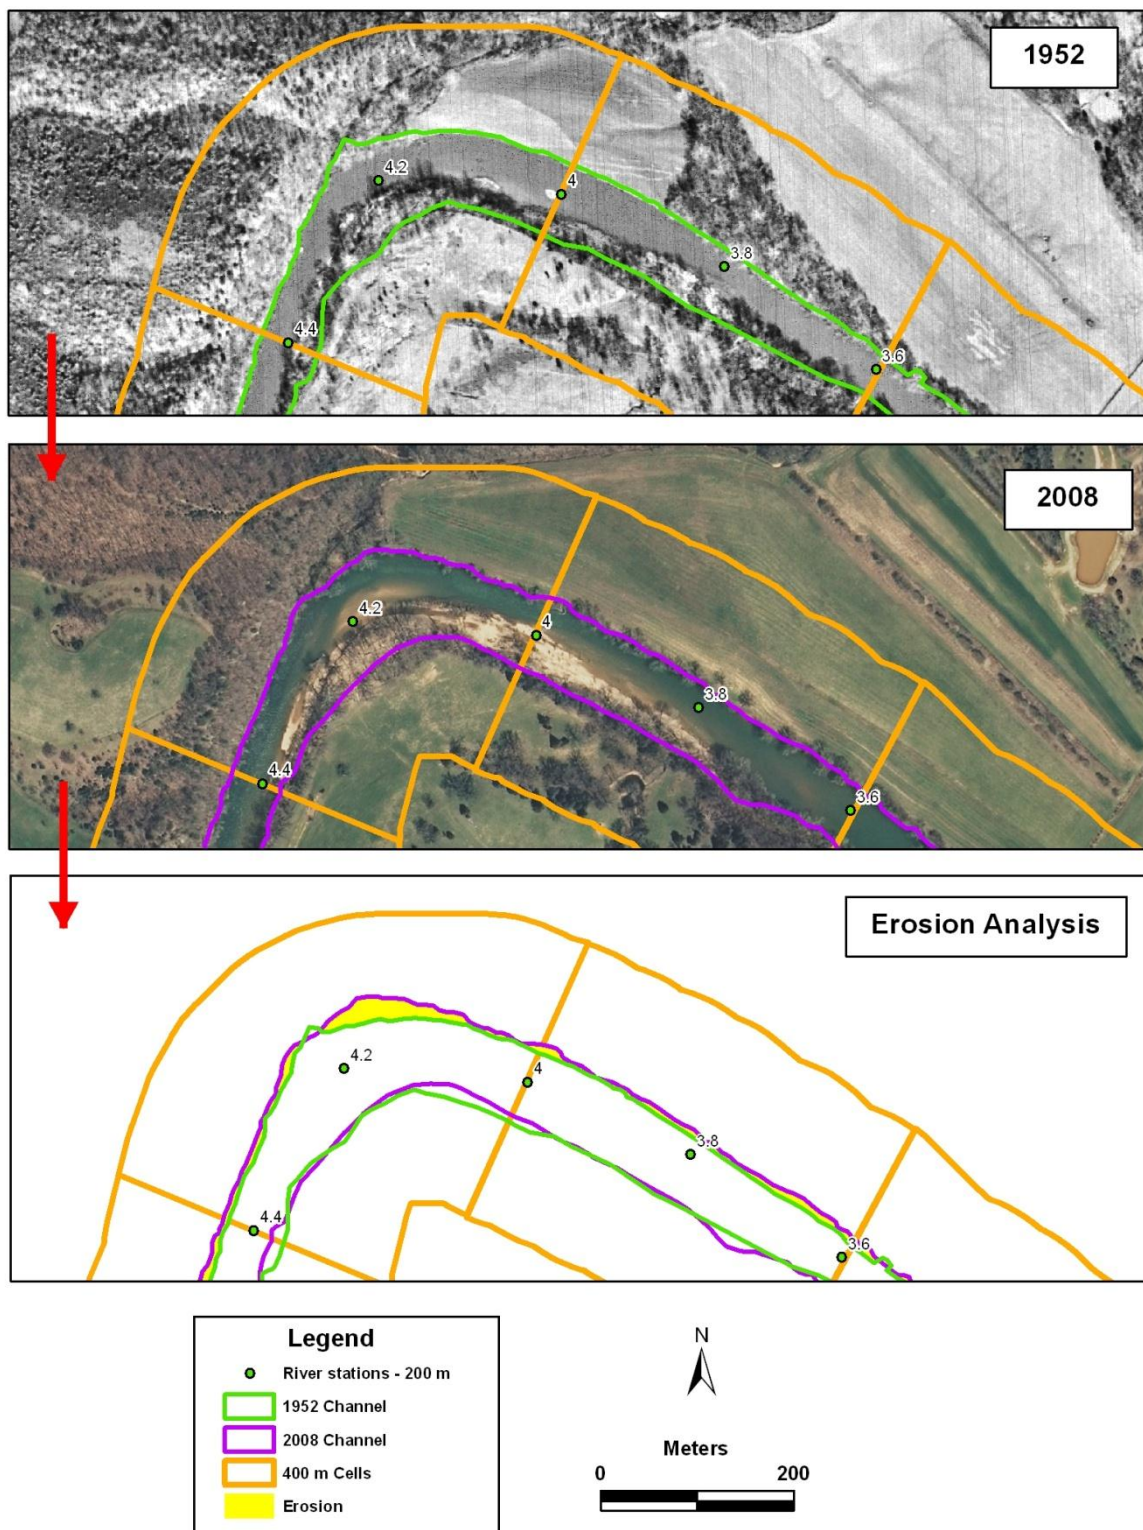
USGS aerial photos from 2008 were used as the base for rectification of 1952 historical aerial photography using a second-order polynomial transformation of 8 ground control points per image (Hughes et al., 2006). Root mean square error was 1 m for all photos with average test point error <2 m. Both banks were digitized for each photo series in ArcGIS for overlay analysis. A 400 m channel cell polygon feature was created with the location of the field-based assessment at the center of the cell (Figure 3). An average erosion rate between each photo series was calculated in each cell by creating an area of erosion within each using the digitized banks from each photo year and dividing that by the cell length. Bank erosion had to exceed the test point error of 2 m to be valid using this method.

Figure 3. Aerial photo methods to define area of erosion since 1952.

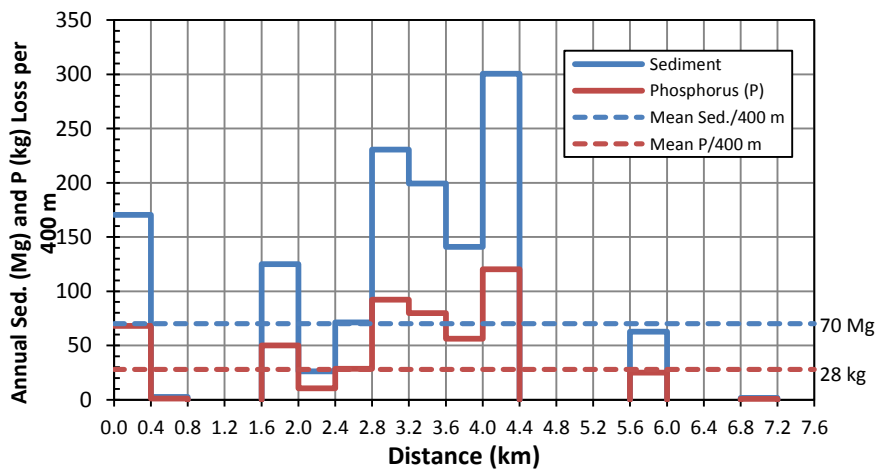
The majority of bank erosion along the easement property is concentrated in the middle section of the study reach from 1.6-4.4 km, while erosion in the remainder of the reach was relatively low. Total bank erosion estimated from the aerial photos and field measurements along the property by 400 m cell varied from 0 along the bluffs to 12,937 m³ (16,818 Mg) in the cell between 4-4.4 km since 1952 (Table 2). Average erosion for the reach over the last 56 years was 3,017 m³ and 3,921 Mg per cell. Total erosion for the entire 7.6 km reach was 57,314 m³ and 74,508 Mg over the last 56 years. Annual sediment loss ranged from 0-300 Mg/yr by cell for an average of 70 Mg with about 65% coming from the area between 1.6-4.4 km (Figures 5 and 6). Annual sediment eroded per unit length of stream varies from 0-0.75 Mg/m/year by 400 m cell with an average of 0.18 Mg/m/yr.

Figure 5. Annual sediment and P loss from bank erosion in study reach.

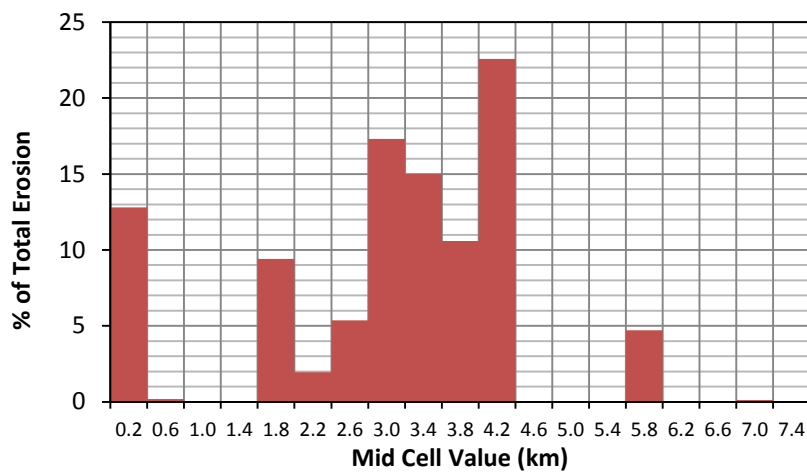
Figure 6. Percent of total erosion by cell.

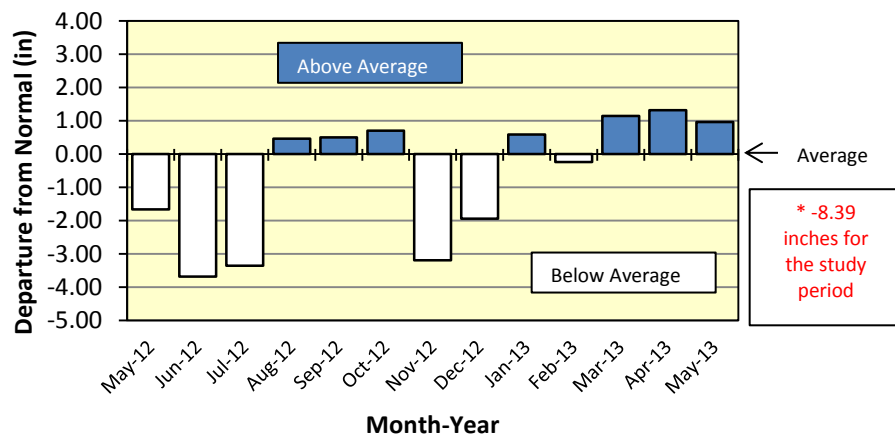
The 13 month study period was drier than normal with nearly 22 cm (8.5 in) lower rainfall totals than the 30 year average (Figure 7). The months of May-July 2012 and November-December 2012 were particularly dry. Rainfall did pick up in January having higher than normal rainfall for 4 out of 5 months in 2013. This rainfall pattern is reflected in the discharge of the river over the study period. Discharge at Galena was very low from May–September 2012 with no major runoff events (Figure 8). Between October and December one significant event that exceeded the 1-yr flood RI occurred (Table 3). However, since January, 4 significant events occurred in the river that exceeded the 1-yr flood RI with 2 events at or near the bankfull stage near the 1.25 and 1.5-yr RI. Discharges > than the 1-yr flood RI would be expected to be able to do the most geomorphic work in the river, such as gravel transport, bank saturation-collapse, and bank erosion along the toe.

Figure 7. Monthly rainfall departure from normal over study period.

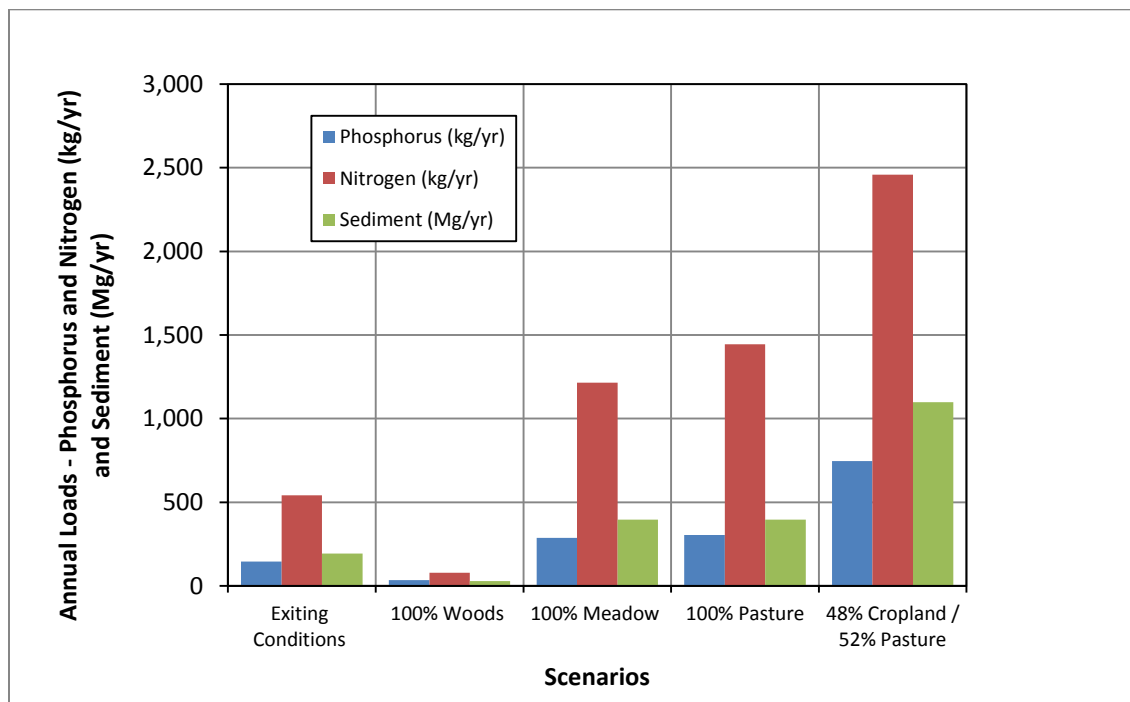
conditions are described as grasslands protected from grazing and are typically hayed (TR55). Using the existing land use in the model, the nitrogen (N) load is 542 kg/yr, the P load is 145 kg/yr, and the sediment load is 194 Mg/yr (Table 6, Figure 11). Of this 496 kg/yr of N, 125 kg/yr P, and 177 Mg/yr sediment is coming from the grasslands in Group 1. Areas currently in forest have very low loads.

Figure 11. Annual nutrient and sediment loads from easement area from STEPL model.

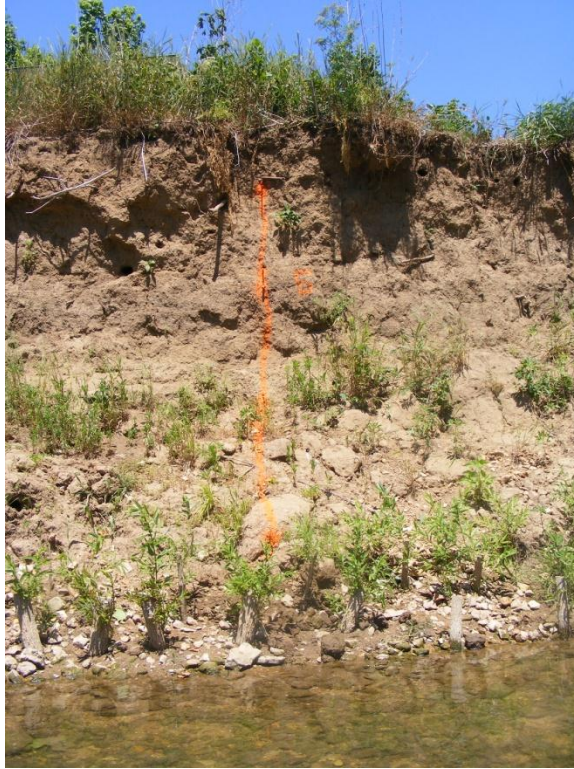
Photo 3. Erosion pin transect with live willow stakes at the base, May 2012.
