Ozarks Environmental and Water Resources Institute (OEWRi)

Geomorphic Analysis of Lackman Tributary, Lenexa, KS.

Final report to Olsson Associates for the City of Lenexa, Kansas

December 17, 2009

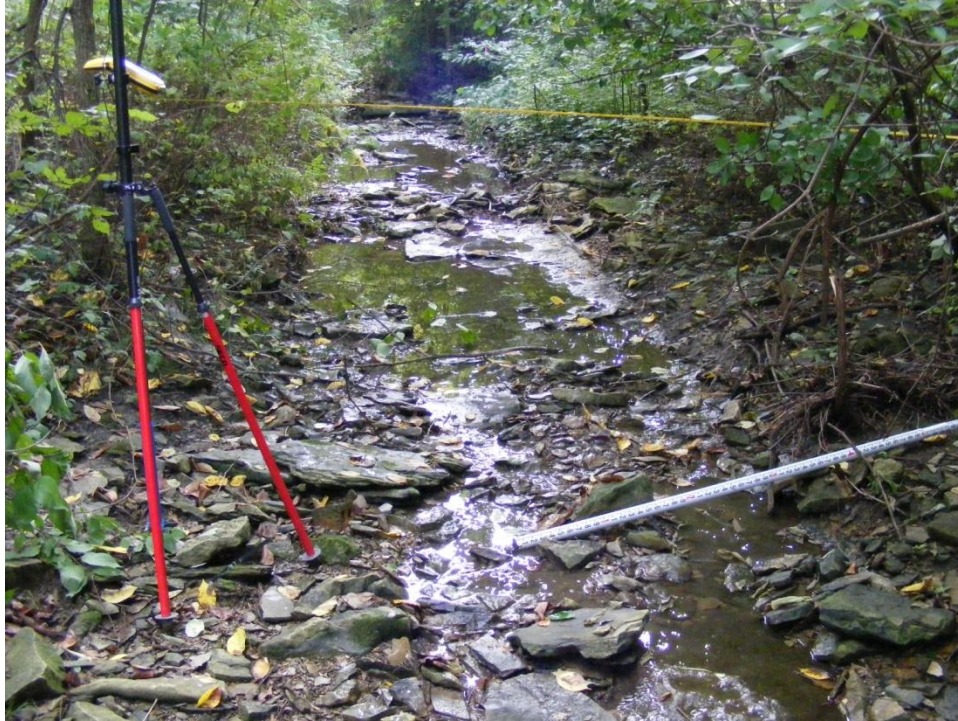
Photo 15. R6-C xs 7 St. 5,280 ft looking upstream (Sept 2009)

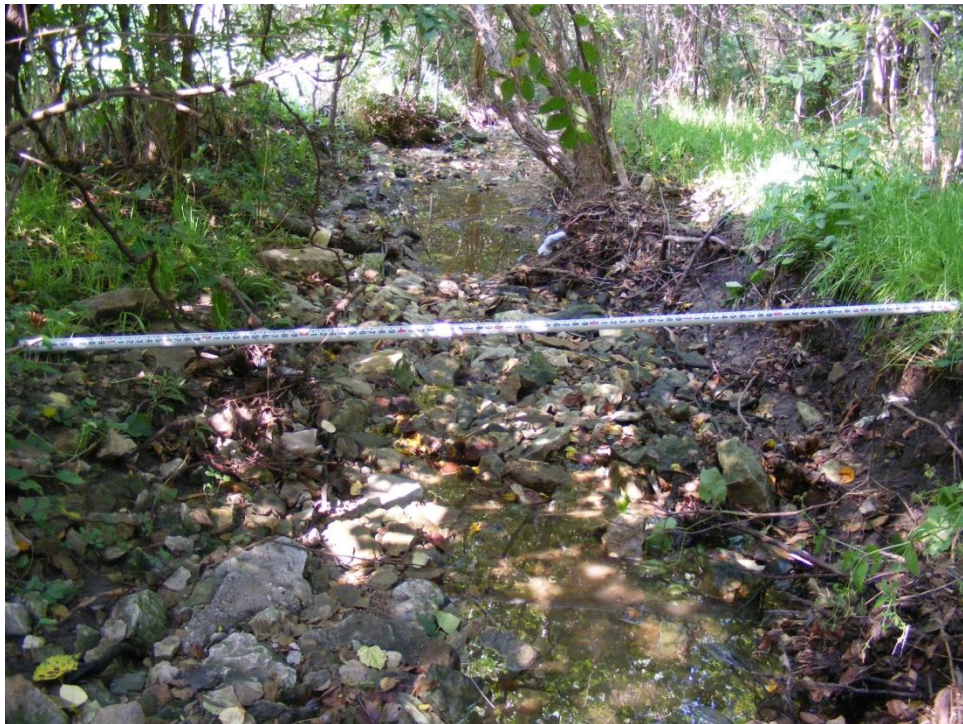
Photo 18. R8-B xs 8 St. 4,750 ft looking downstream (Sept. 2009)

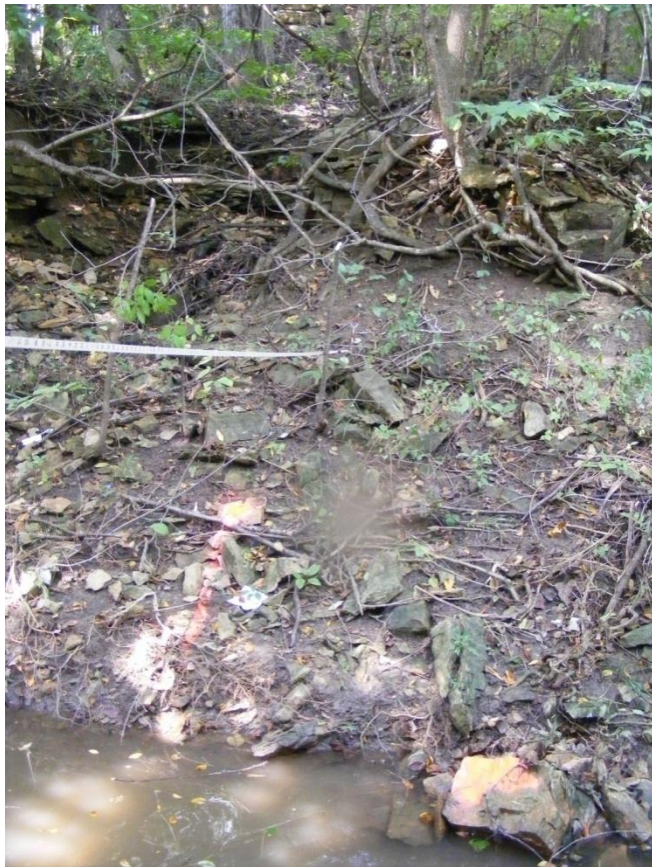
SR-14-C: Riffle-Pool Reach with bedrock control (Station 1,750-1,100 ft)- This sub-reach begins below obvious influence of the knick-point where the valley begins to widen slightly. There are relatively well formed floodplains found in several places along this reach.

Photo 44. R14 – xs 15 St. 1,530 ft left bank (Sept. 2009)
