Geomorphic Analysis of the Main Channel of the Golf Club of Kansas Site in Lenexa, Kansas

By: Dr. Robert T. Pavlowsky
May 22, 2007

Downstream Channel Conditions and Photo Log

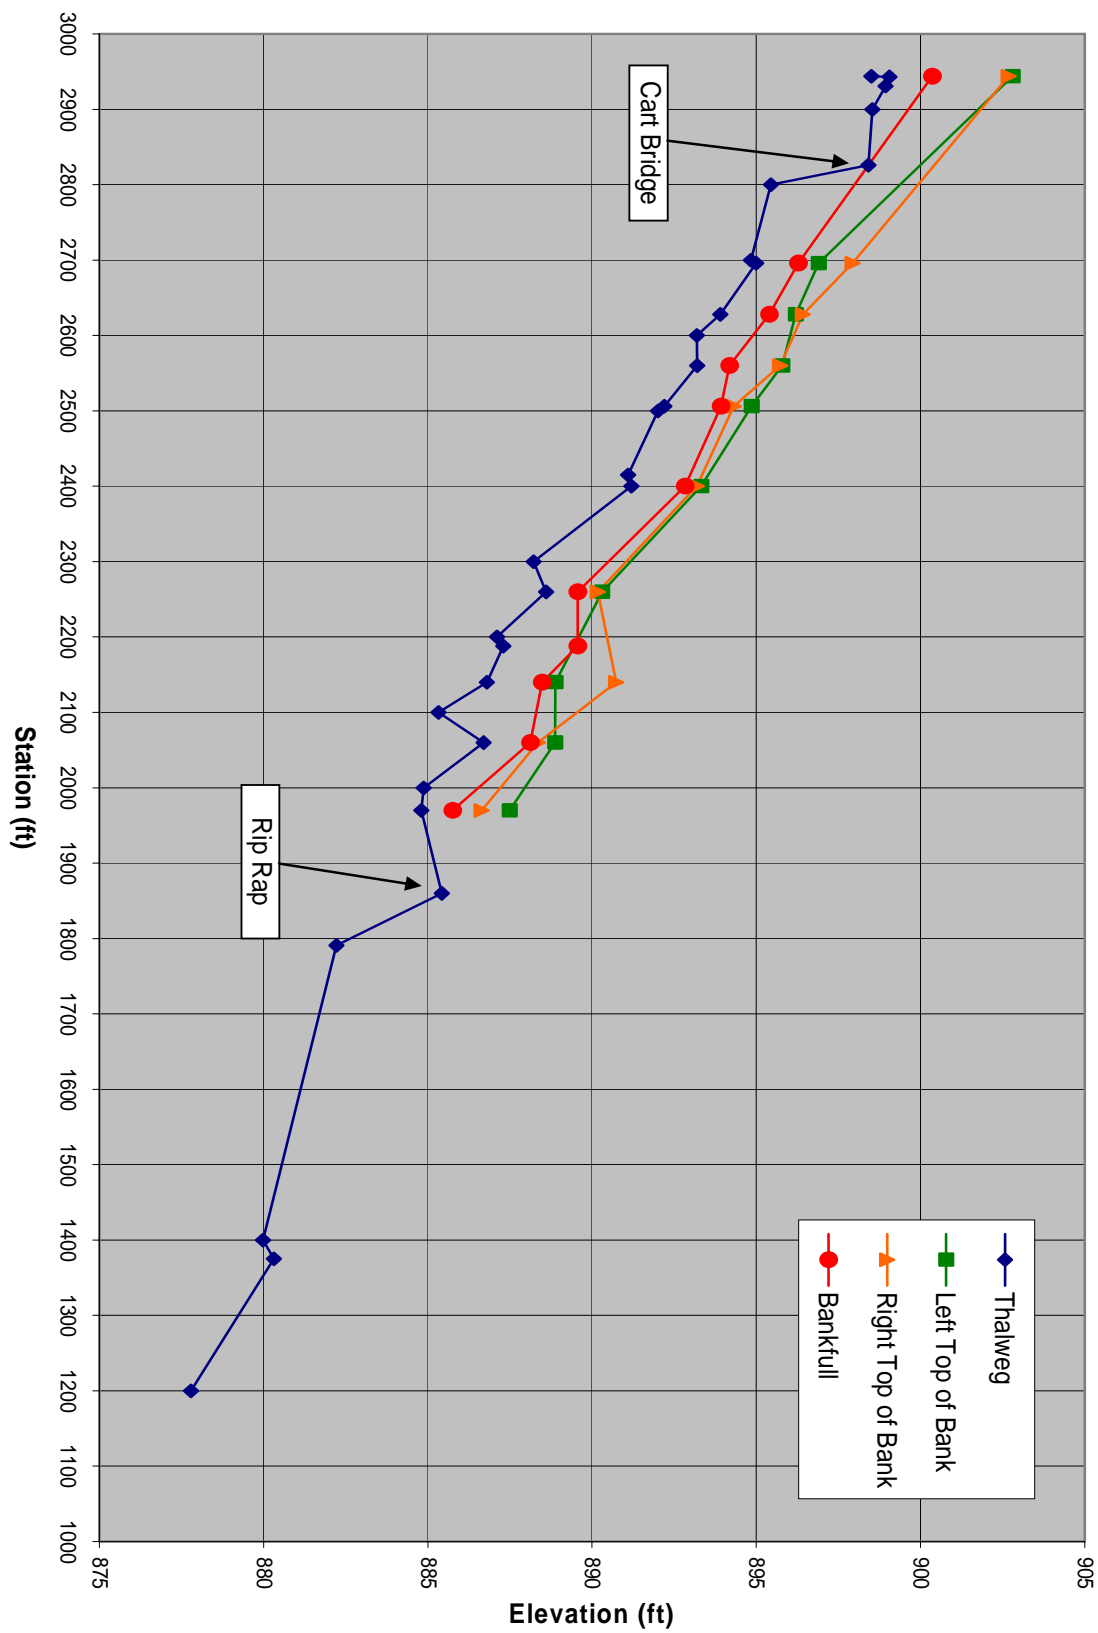
Figure 4. Longitudinal profile for the reference reach.

Since the majority of the channel length on the site was disturbed far beyond its natural form, it was decided that a reference reach approach would be used to determine the size and shape of the new channel. Twelve cross-sections at riffle crests from an on-site reach which had an intact riparian corridor and two cross-sections from the upstream natural area were examined in order to estimate dominant channel dimensions (Figure 3). A longitudinal profile of the bed thalweg, bankfull stage, and top of bank was used to determine slope (Figure 4). The MSU profile correlated very well with the survey performed by Olsson Associates with the reference reach having a mean slope of around 1.3 to 1.5%. Riffle beds had an average slope of around 4%.
