**Geomorphic Assessment of City Center Athletic Club
Development Impacts on Existing Stream Channel
Stability, Lenexa, KS.**

**Final report to Olsson Associates for
the City of Lenexa, Kansas**

**Prepared By:
Robert T. Pavlowsky, PhD
Fluvial Geomorphologist and Professor
Missouri State University
bobpavlowsky@missouristate.edu**

OEWRI TR-09-001

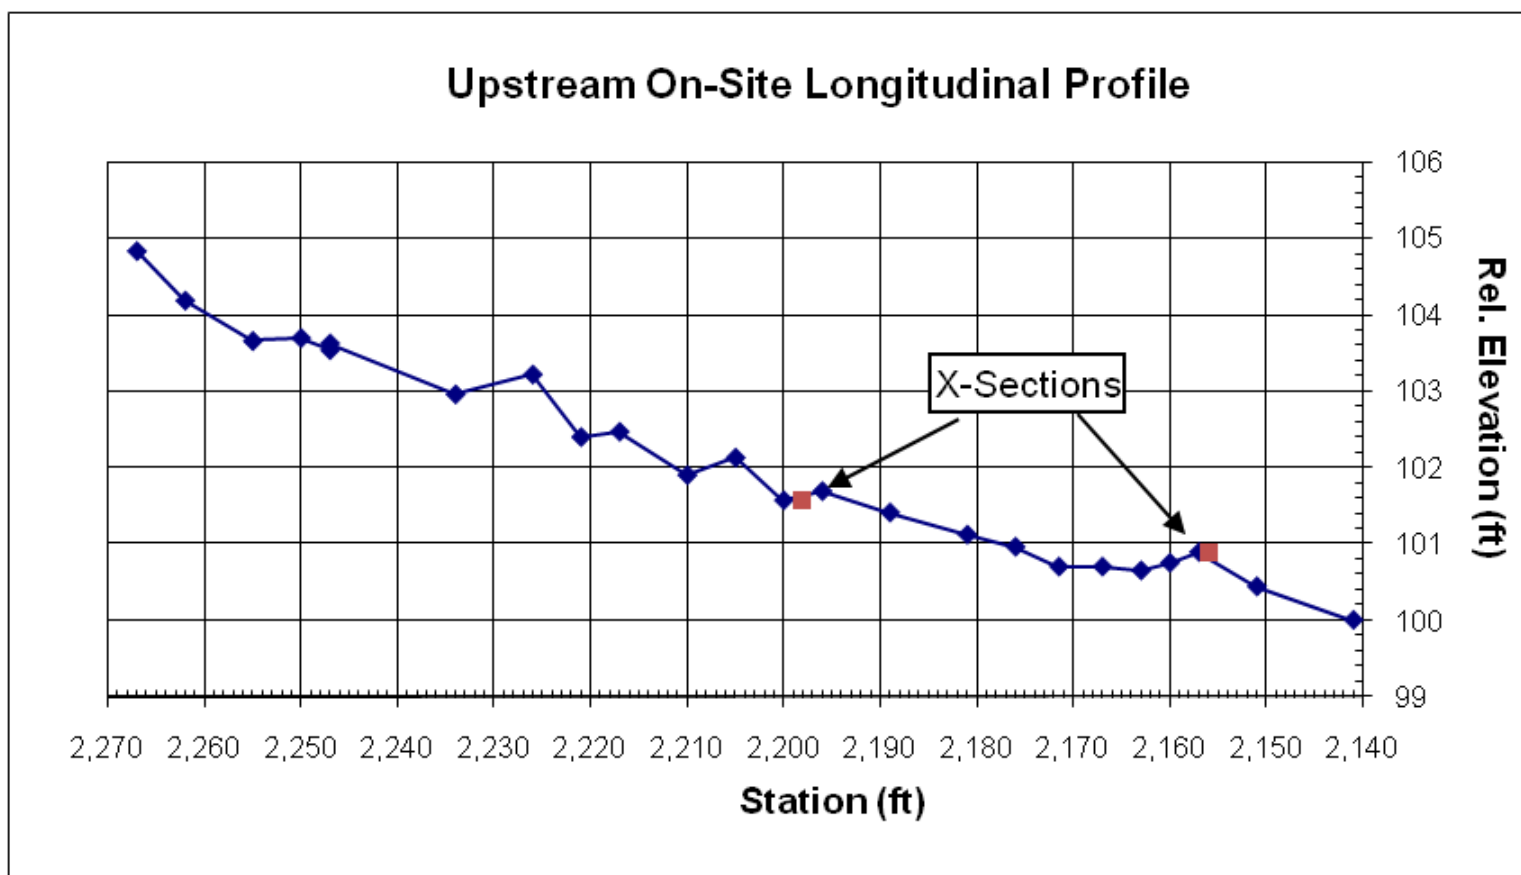
Figure 3. On-site Longitudinal Profile for Typical Reach

The “typical” on-site channel morphology and sediment mobility was evaluated in subreach 3a above the influence of the rubble dam. The mean slope of the reach is approximately 3.5% with riffle slope ranging from 3.4% and 5.3% at the cross-sections (Figure 3). The mean bankfull dimensions at these sections are 9.1 ft wide by 0.7 ft deep at the thalweg (Figures 4 and 5). Mean boundary shear stress estimates in the reach range from 1.07-1.17 lbs/ft² which can transport between the 84 mm to the 171 mm size fraction based on empirical relationships. This sediment distribution is in the small to large cobble range that matches the measured bed sediment in the reach containing a range of substrate from cobble to flat boulders (Table 3).

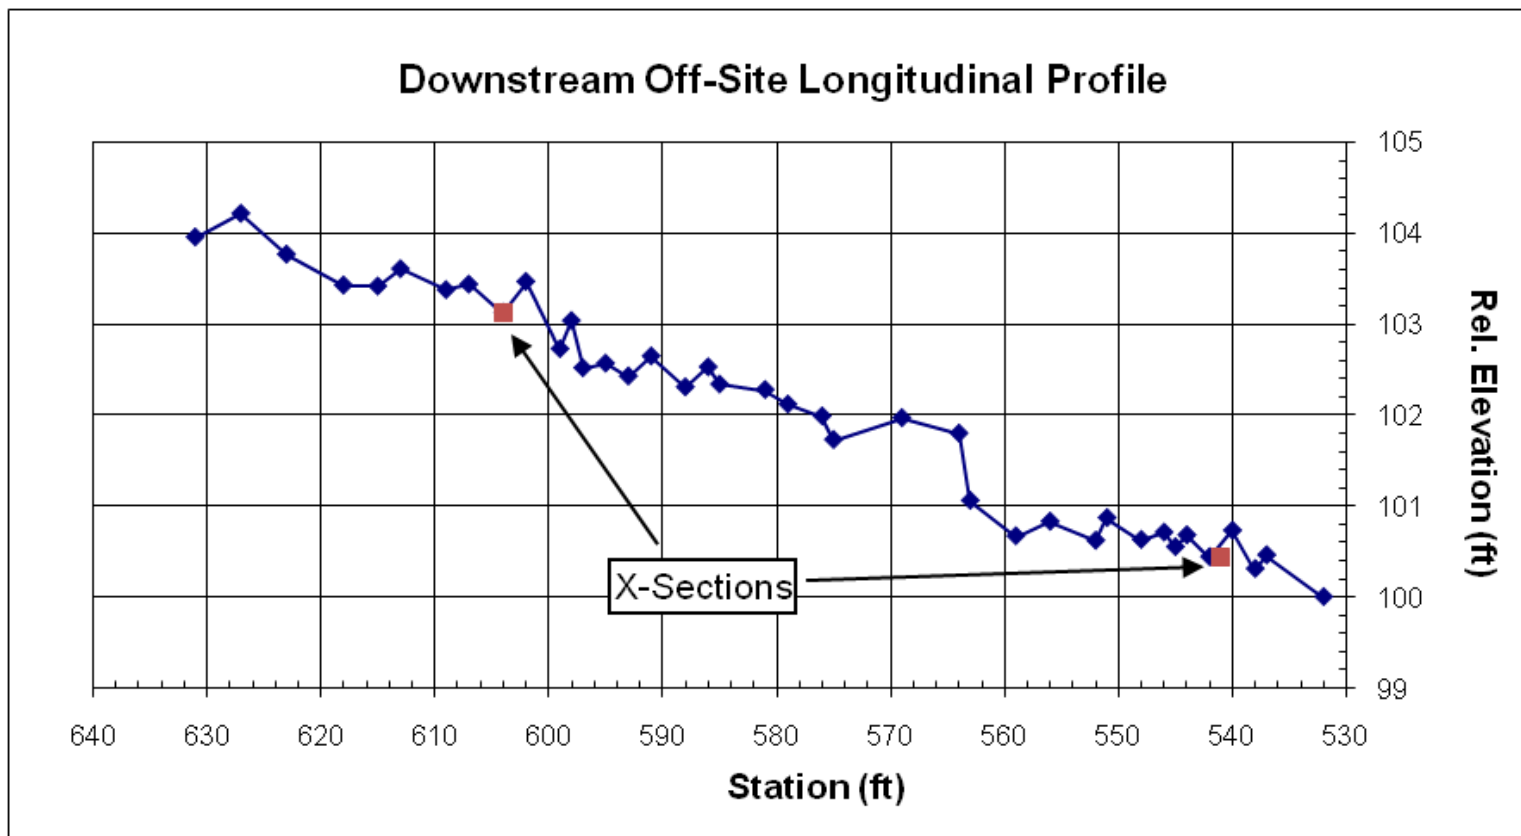
Figure 6. Off-site longitudinal profile downstream of rubble dam.

The analysis of “typical” off-site channel morphology and sediment mobility was conducted in subreach 9 below the rubble dam. The mean slope of this reach is 4.2% with riffle slopes at cross-section locations ranging from 4.2% to 4.4% (Figure 6). The mean bankfull dimensions at these sections are 6.6 ft wide by 0.7 ft deep at the thalweg of the channel (Figure 7 and 8). Mean boundary shear stress estimates in the reach range from 1.22-1.39 lbs/ft² which can transport between the 96 mm to the 193 mm size fraction based on empirical relationships. This sediment distribution is in the small to large cobble range matching the measured bed sediment in this reach (Table 3).

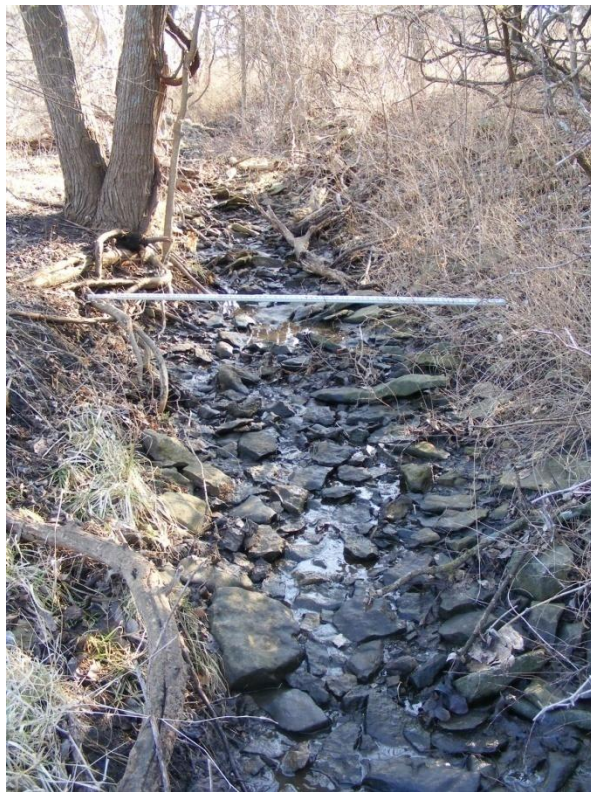
Photo 4. SR-3a looking downstream (Feb. 2008)
