Geomorphic Assessment of the South Dry Sac River below Valley Water Mill

By: Robert T. Pavlowsky, Ph.D.
Ozarks Environmental and Water Resources Institute
Missouri State University

Submitted to the Watershed Committee of the Ozarks on March 15, 2006

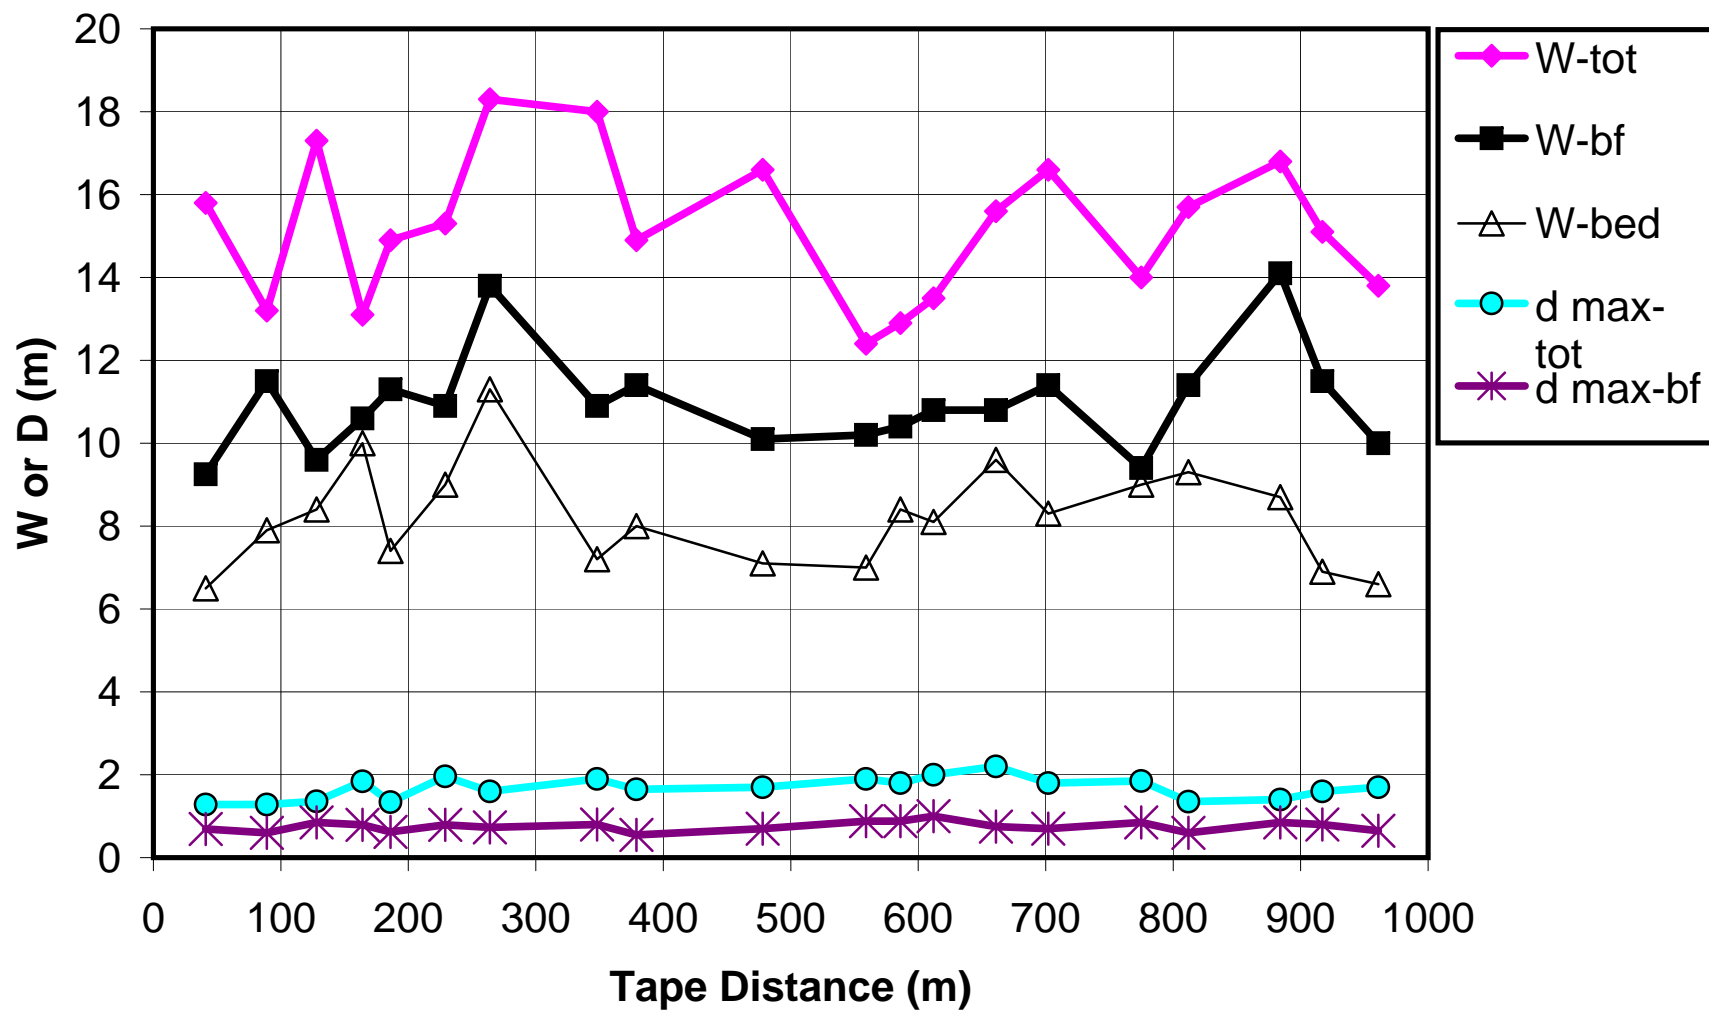
Figure 5: Channel Width and Depth

Channel dimensions vary in the downstream direction due to local factors such as at mega-bar scour zones (TM 300), bend location (TM 900 m), and bluff influence (TM 600-700 m) (Table 2; Figures 5 and 6). The bankfull channel has average dimensions as follows: width at 11 m +or- 1.3 m; mean depth at 0.54 m +or- 0.11 m; area at 5.9 m² +or- 1.4 m²; and width/depth ratio at 21 +or- 5 (Table 2). The total channel (at maximum channel capacity before it floods over the low terrace bank) has average dimensions as follows: width at 15 m +or- 2 m; mean depth at 1.2 m +or- 0.2 m; area at 18.3 m² +or- 2.6 m²; and width/depth ratio at 13 +or- 3 (Table 2).

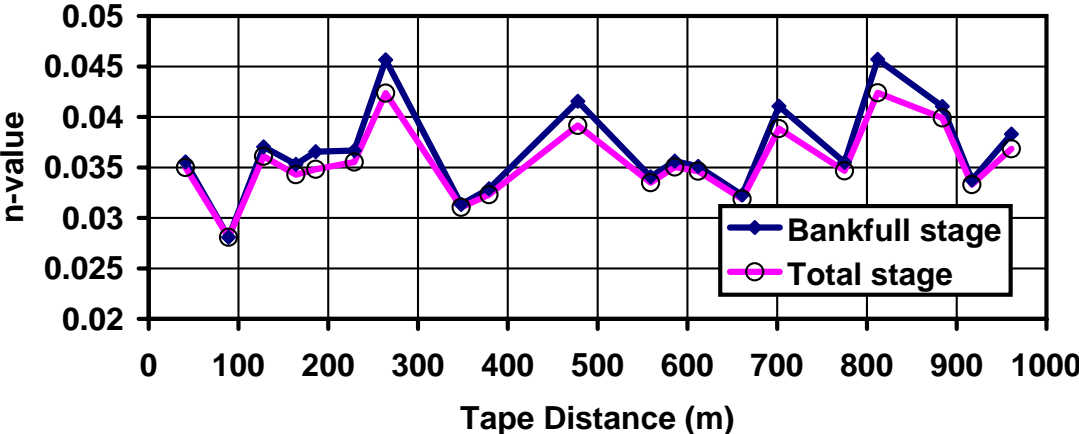
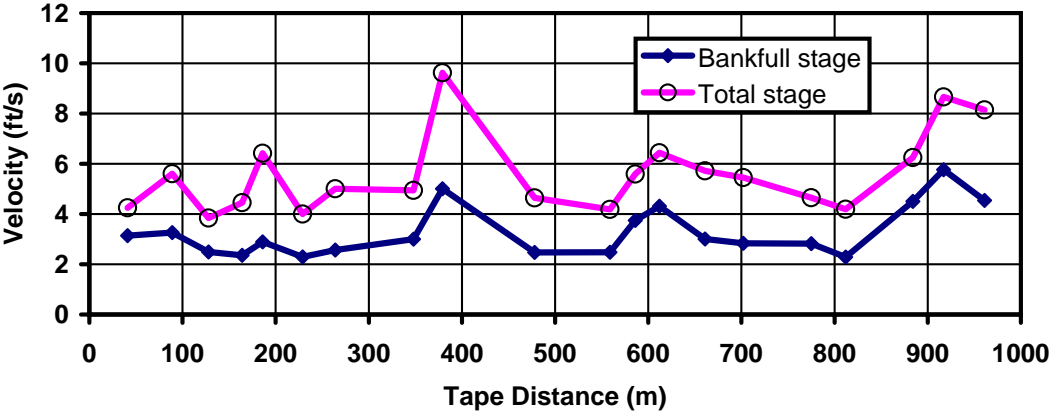
Figure 7: Channel Roughness and Velocity

Applying the cross-section and riffle slope data to hydraulic equations, flow information relating to the flow mechanics and discharge of the study area can be evaluated (Table 5; Figure 7). Channel roughness values of Mannings n tend to range from 0.03 to 0.045 with slightly lower values for the deeper total channel flows (Figure 7a). Mean channel velocity averages 1 m/s +or- 0.3 m/s for the bankfull discharge of 6.1 m³/s +or- 2.9 m³/s (Figure 7). The total channel has an average velocity of 1.7 m/s +or- 0.5 m/s and discharge of 31.5 m³/s +or- 10.5 m³/s (Table 5). Although methods for adequately calibrating flow frequency relationships may not be available for this karst area, it is believed that the total channel can contain the 2 to 10 year flood, while the bankfull flood has a recurrence interval of 1-year or less in the South Dry Sac River system (Horton, 2003). Further, the 2000 flood of record (37 m³/s), with an estimated recurrence interval of 25 to 50 years, could have been contained by only about one third of the cross-sections examined. Thus, given the moderate degree of flooding along the study reach observed in 2000, the total channel capacity estimates in this report seem reasonable.

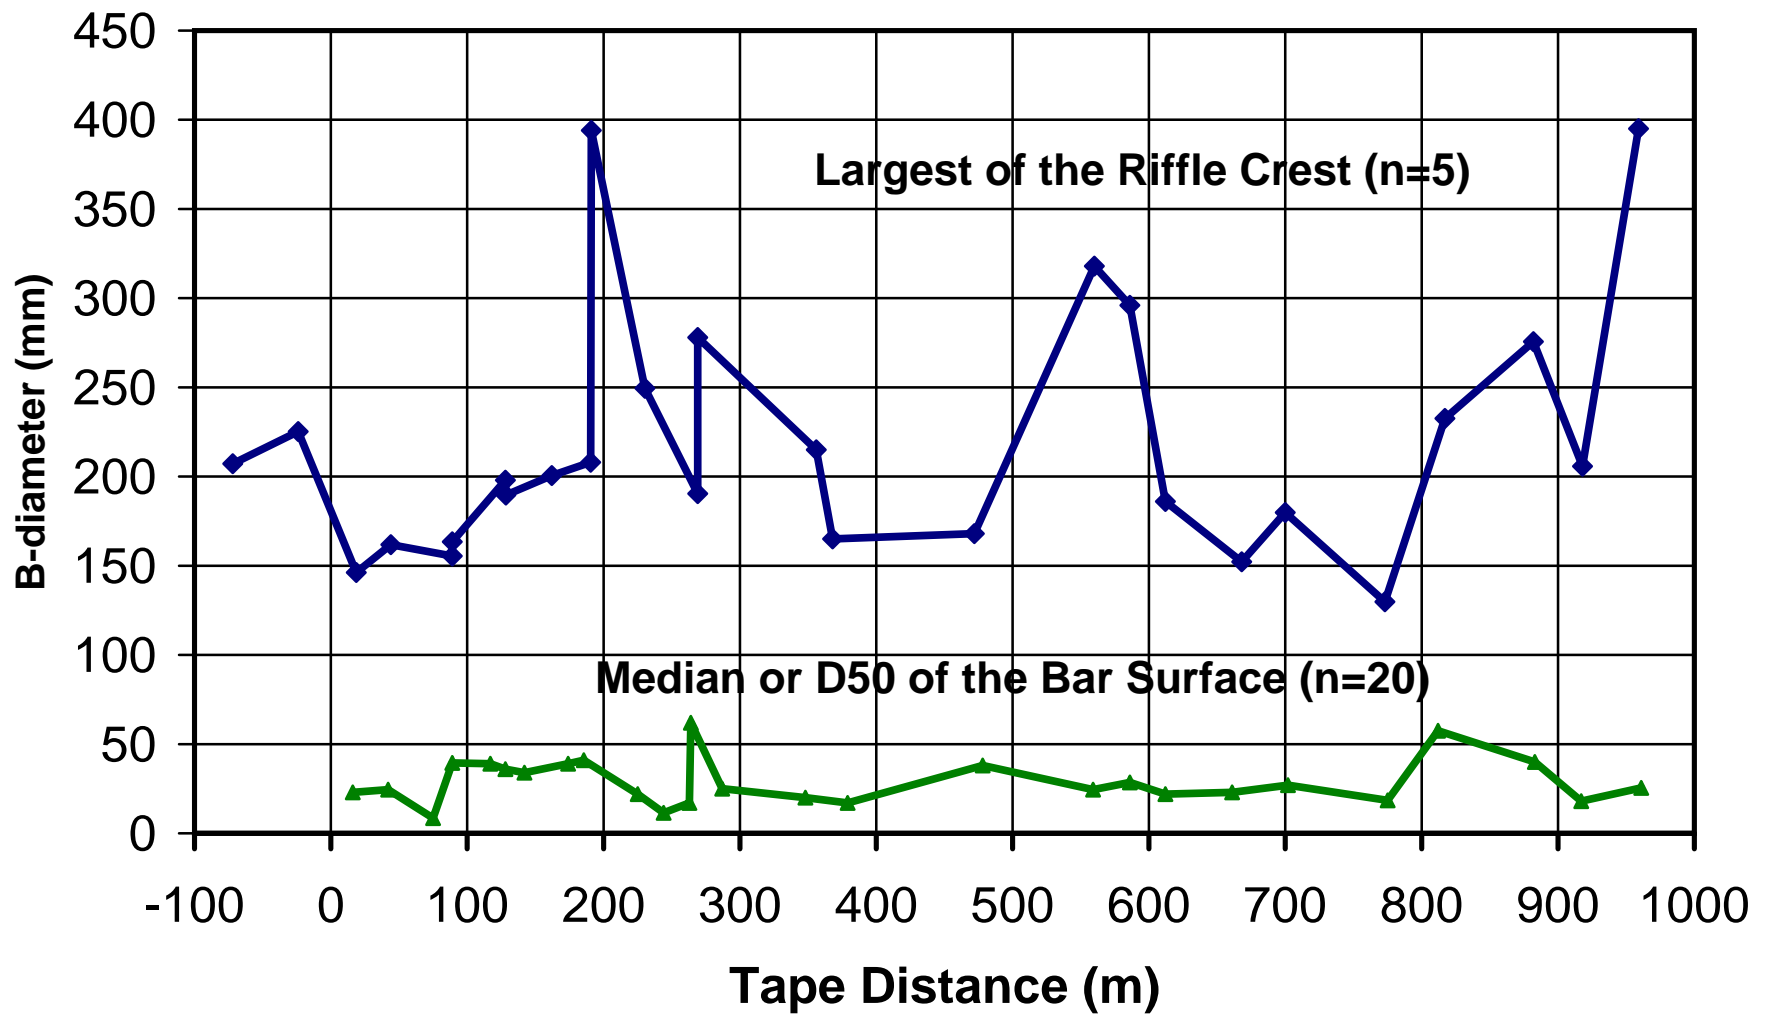
Figure 8: Bed Material Size Trends

The diameter of bed material is largely controlled by the proximity to bed rock and colluvial clasts along bluff lines where cut banks have formed against bedrock outcrops such as along TD 200-300 m, TD 500-600 m, and TD 800-1,000 m (Figure 8, Map 4). The average maximum riffle clast size for the study area is 218 mm +or- 69 mm and the sub-reach containing the largest bed sediment occurs from TD 882 to 1,000 meters where the bedrock supply of large >300 mm clasts is very high (Table 3, Figure 8, Pictures 26-30). The size of gravel sediment in bar features tends to follow the same patterns as maximum clast size (Figure 8). The median or D50 of the bar pebble counts average 29 mm +or- 13 mm and the D84 averages 54 mm +or- 21 mm for the study area (Table 4, Picture 17).
