Geomorphic Assessment of the South Dry Sac River below Valley Water Mill

By: Robert T. Pavlowsky, Ph.D.
Ozarks Environmental and Water Resources Institute
Missouri State University

Submitted to the Watershed Committee of the Ozarks on March 15, 2006

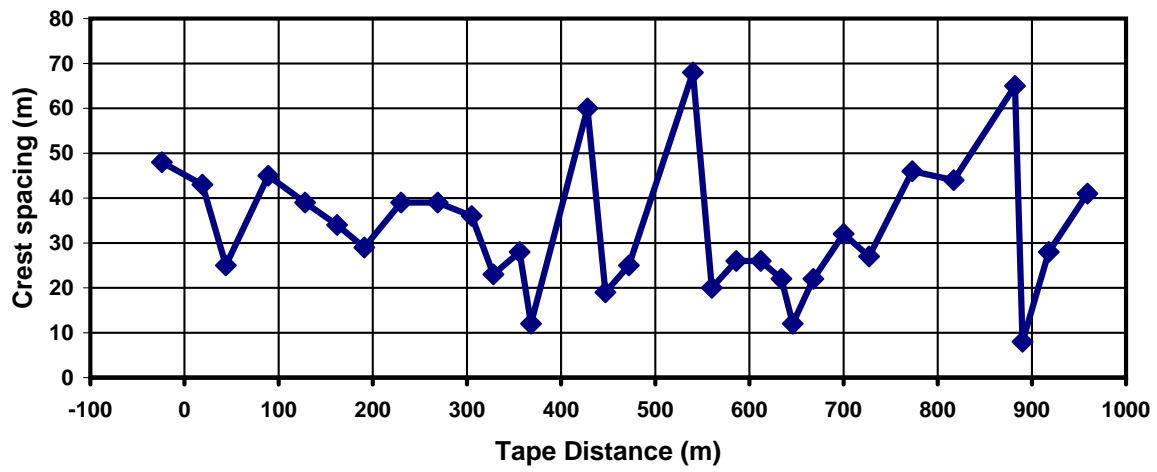
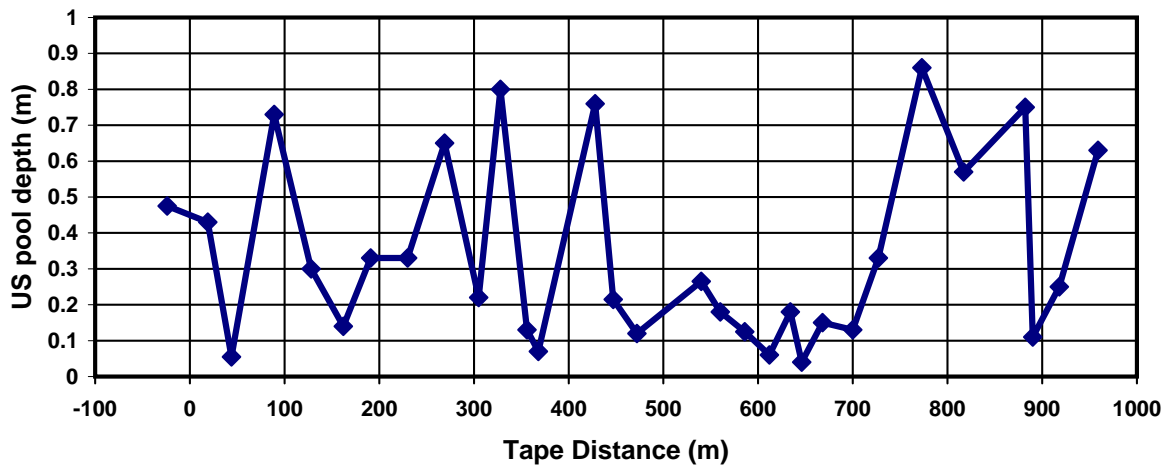
Figure 4: Riffle Spacing and Pool Depth

The bedform profile in the study area usually is composed of riffle crests, riffle/runs, and pools. The average riffle crest-crest spacing in the study area is 33 m +or- 15 m and residual pool depths (at the deepest point relative to the downstream riffle crest) average 0.33 m +or- 0.26 m (Table 1). Longer riffle spacing is found between TD 400 and 550 meters and TD 800 and 900 meters (Figure 4b, Map 3). The deepest pools are found in sub-reaches extending from TM 50 to 280 meters and TM 700 to 880 meters with some other large pools around TD 300 and TD 400 meters (Figure 4, Map 3). A relatively long reach of very shallow pools is found between TD 480 to 700 meters where the channel flows up against a bluff (Figure 4a).

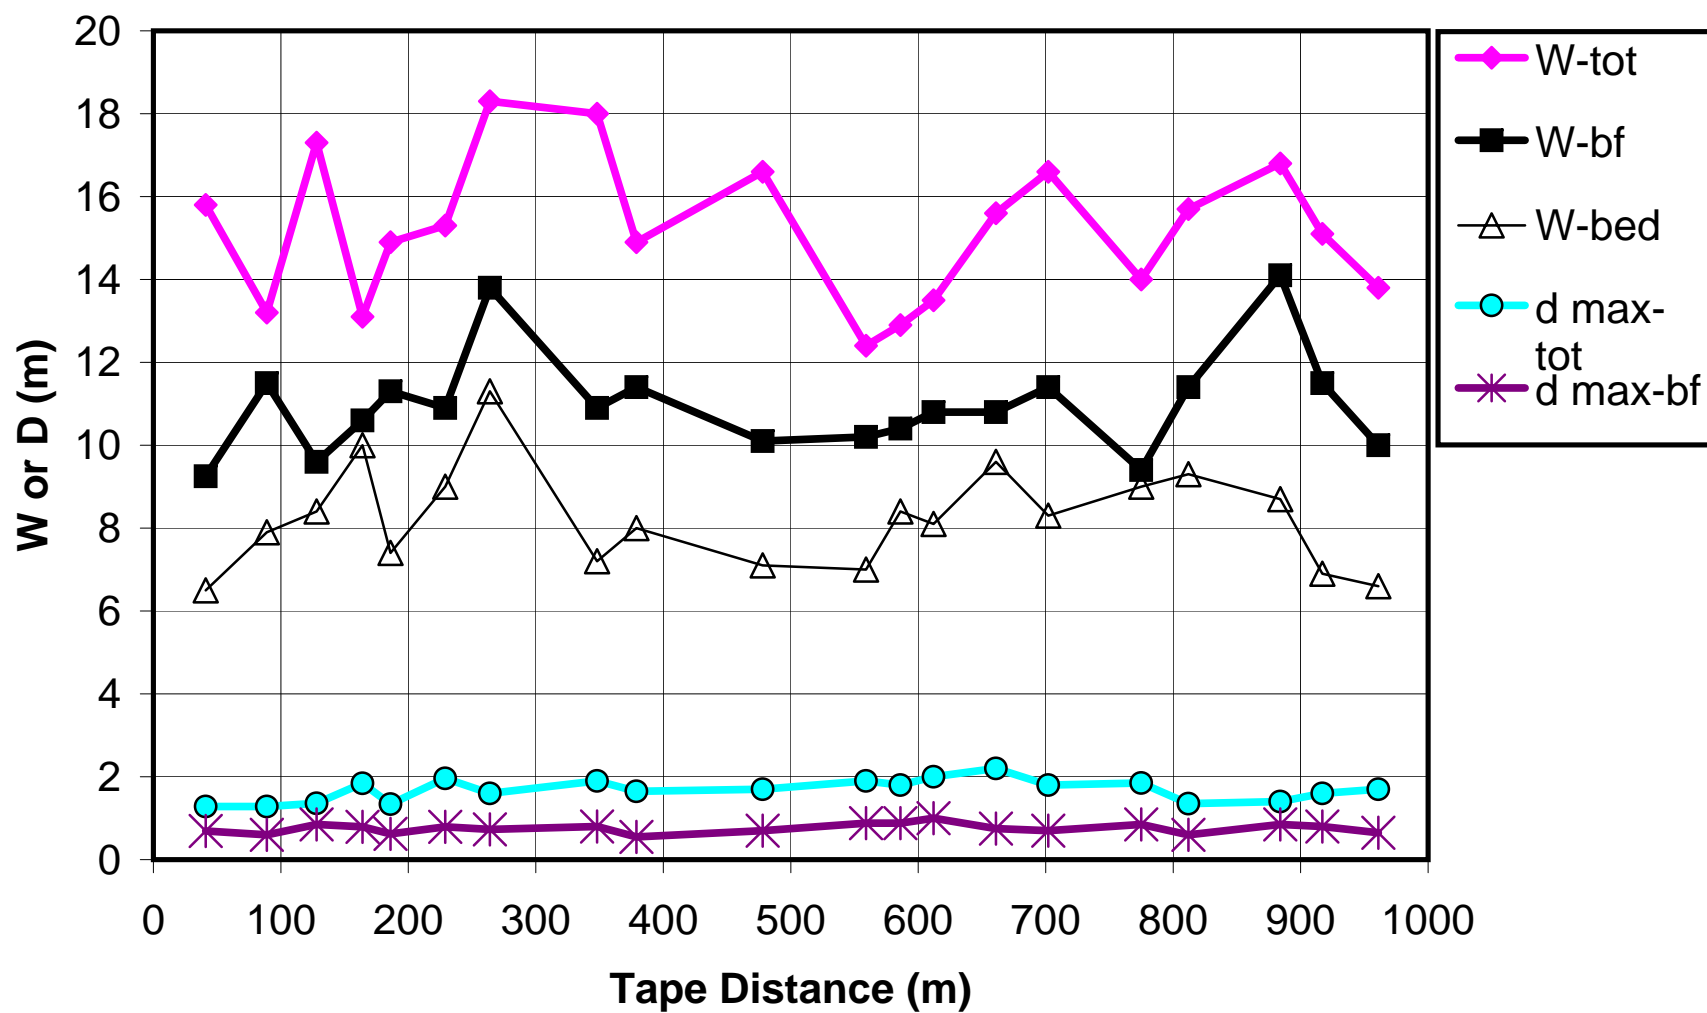
Figure 5: Channel Width and Depth

Channel dimensions vary in the downstream direction due to local factors such as at mega-bar scour zones (TM 300), bend location (TM 900 m), and bluff influence (TM 600-700 m) (Table 2; Figures 5 and 6). The bankfull channel has average dimensions as follows: width at 11 m +or- 1.3 m; mean depth at 0.54 m +or- 0.11 m; area at 5.9 m² +or- 1.4 m²; and width/depth ratio at 21 +or- 5 (Table 2). The total channel (at maximum channel capacity before it floods over the low terrace bank) has average dimensions as follows: width at 15 m +or- 2 m; mean depth at 1.2 m +or- 0.2 m; area at 18.3 m² +or- 2.6 m²; and width/depth ratio at 13 +or- 3 (Table 2).

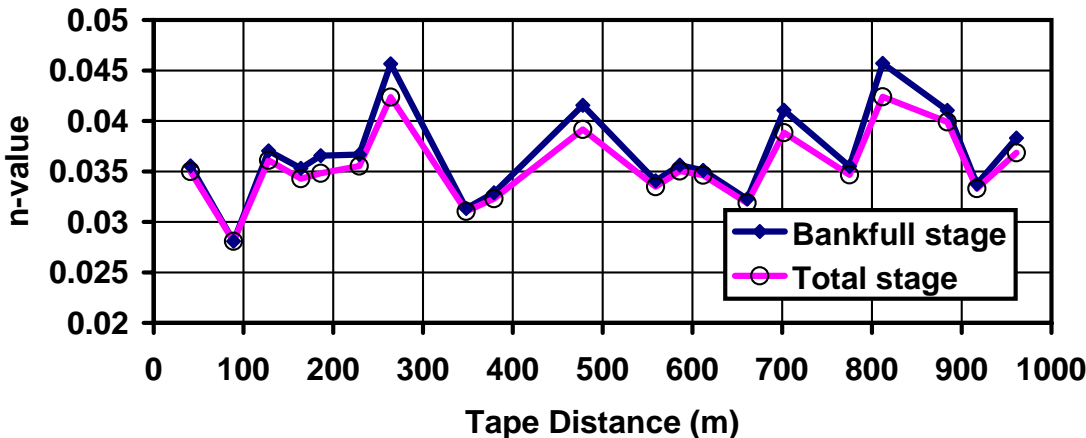
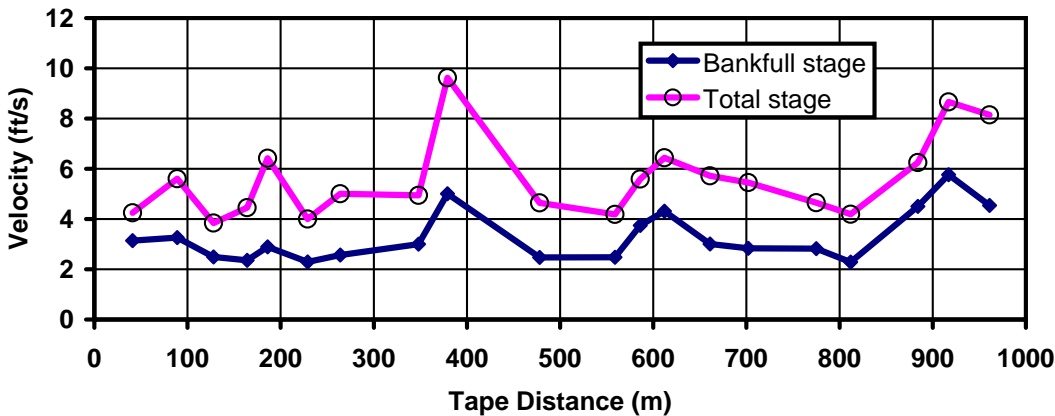
Figure 7: Channel Roughness and Velocity

Applying the cross-section and riffle slope data to hydraulic equations, flow information relating to the flow mechanics and discharge of the study area can be evaluated (Table 5; Figure 7). Channel roughness values of Mannings n tend to range from 0.03 to 0.045 with slightly lower values for the deeper total channel flows (Figure 7a). Mean channel velocity averages 1 m/s +or- 0.3 m/s for the bankfull discharge of 6.1 m³/s +or- 2.9 m³/s (Figure 7). The total channel has an average velocity of 1.7 m/s +or- 0.5 m/s and discharge of 31.5 m³/s +or- 10.5 m³/s (Table 5). Although methods for adequately calibrating flow frequency relationships may not be available for this karst area, it is believed that the total channel can contain the 2 to 10 year flood, while the bankfull flood has a recurrence interval of 1-year or less in the South Dry Sac River system (Horton, 2003). Further, the 2000 flood of record (37 m³/s), with an estimated recurrence interval of 25 to 50 years, could have been contained by only about one third of the cross-sections examined. Thus, given the moderate degree of flooding along the study reach observed in 2000, the total channel capacity estimates in this report seem reasonable.

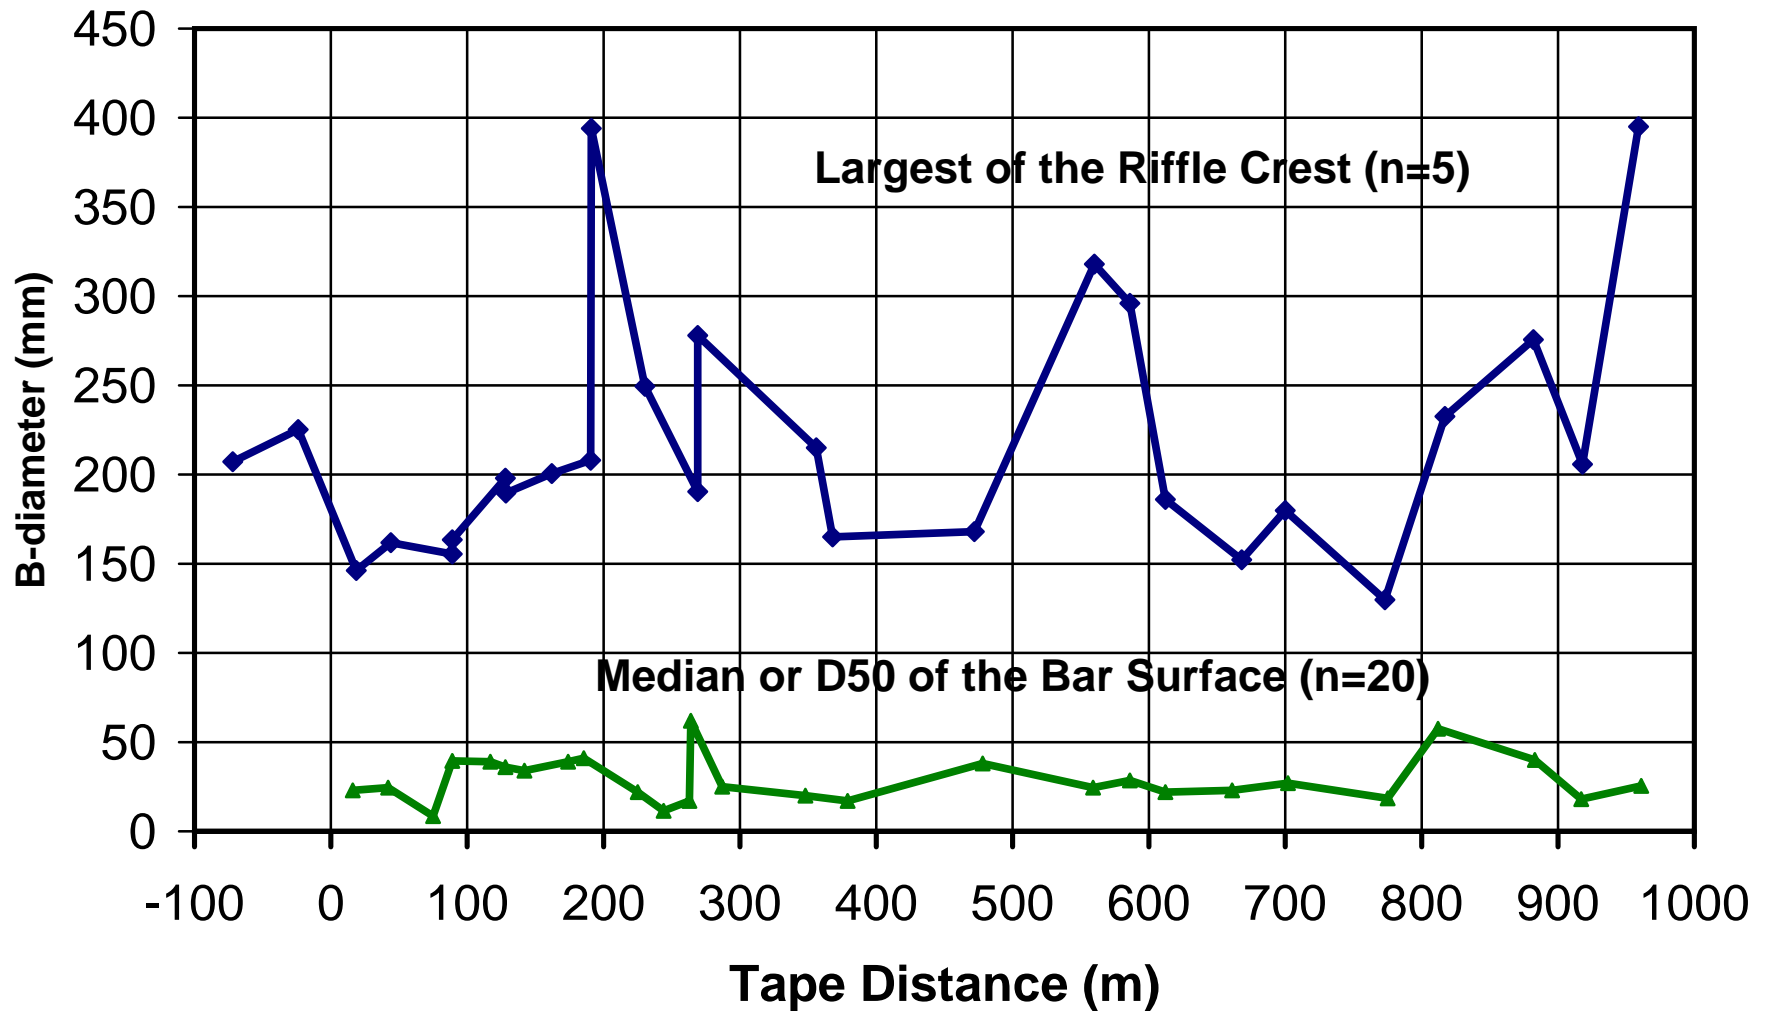
Figure 8: Bed Material Size Trends

The diameter of bed material is largely controlled by the proximity to bed rock and colluvial clasts along bluff lines where cut banks have formed against bedrock outcrops such as along TD 200-300 m, TD 500-600 m, and TD 800-1,000 m (Figure 8, Map 4). The average maximum riffle clast size for the study area is 218 mm +or- 69 mm and the sub-reach containing the largest bed sediment occurs from TD 882 to 1,000 meters where the bedrock supply of large >300 mm clasts is very high (Table 3, Figure 8, Pictures 26-30). The size of gravel sediment in bar features tends to follow the same patterns as maximum clast size (Figure 8). The median or D50 of the bar pebble counts average 29 mm +or- 13 mm and the D84 averages 54 mm +or- 21 mm for the study area (Table 4, Picture 17).

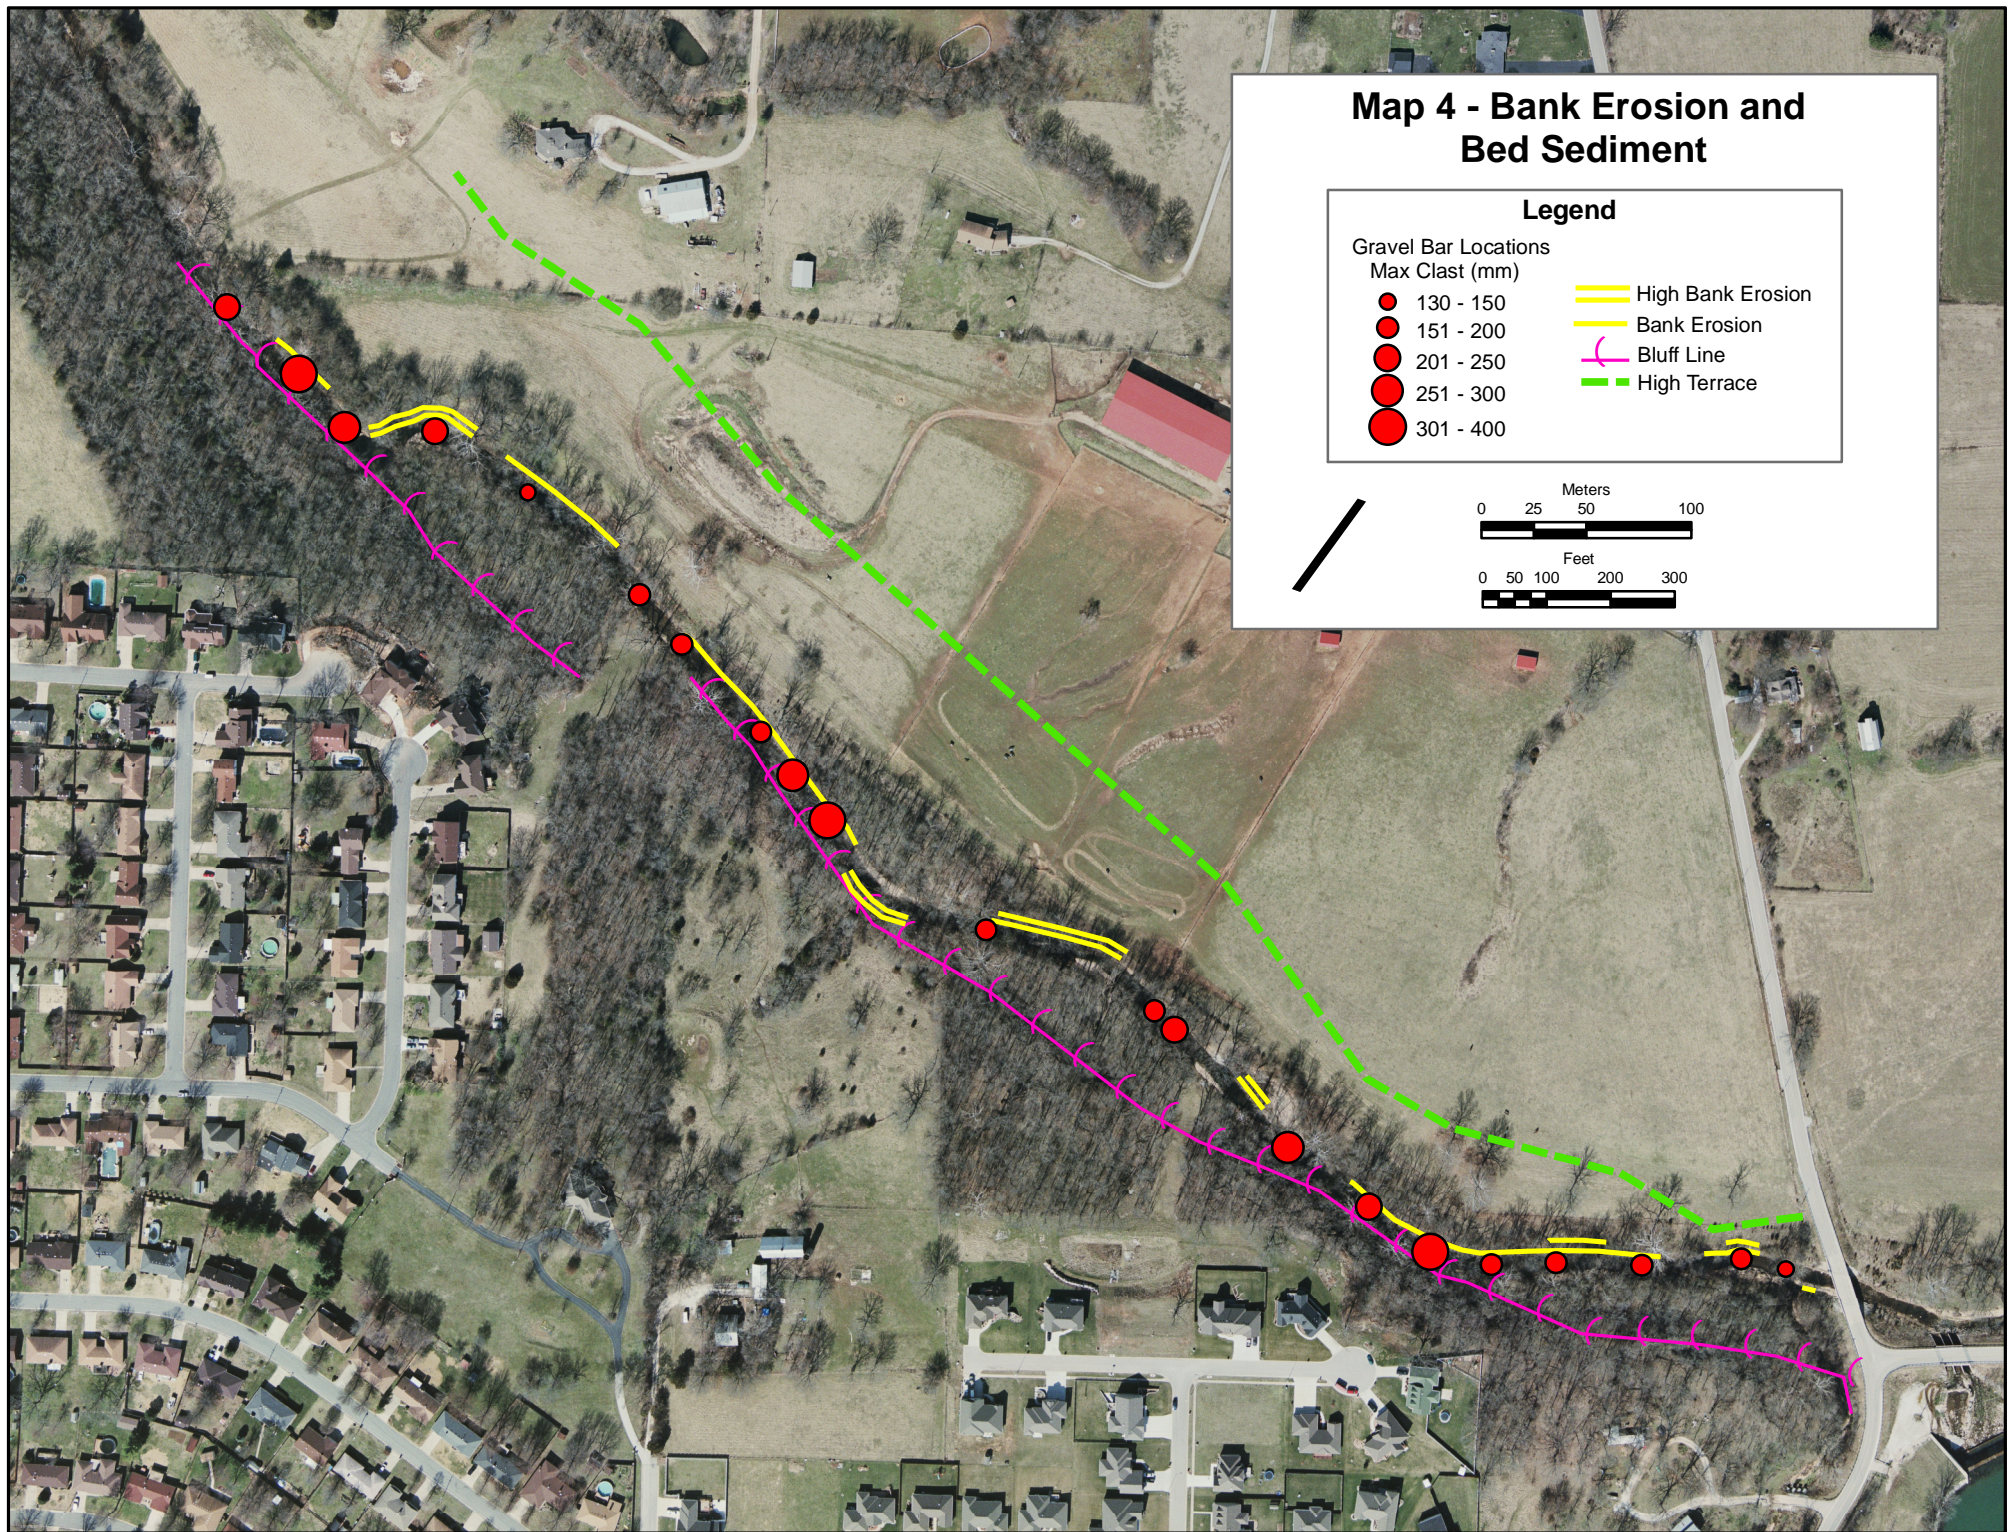
Map 4 - Bank Erosion and Bed Sediment

Bank stability was assessed visually by observing upper bank angle, bank height, vegetation cover, and evidence of erosion such as exposed tree roots or recent bank collapse. As mentioned before, channel location has been relatively stable over time so few severely eroding banks were found in the study area. The banks showing the most consistent extent of erosion are located on the floodplain/terrace features on the right side of the stream in locations where flood flows are forced to converge and increase in erosive force as they enter a bluff-lined reach (Map 4). Additional locations for bank erosion occur at relatively tight bends or any bend along a steep reach. Finally, bank erosion is also noticeable at a slight bend being affected by the Grandview tributary and the depositional bar below it (TD 45 m) (Picture 2).
