**Geomorphic Assessment of Upper Wards Branch,
Springfield, Missouri**

**Final report to Olsson Associates for
the City of Springfield, Missouri**

OEWRi EDR-10-006

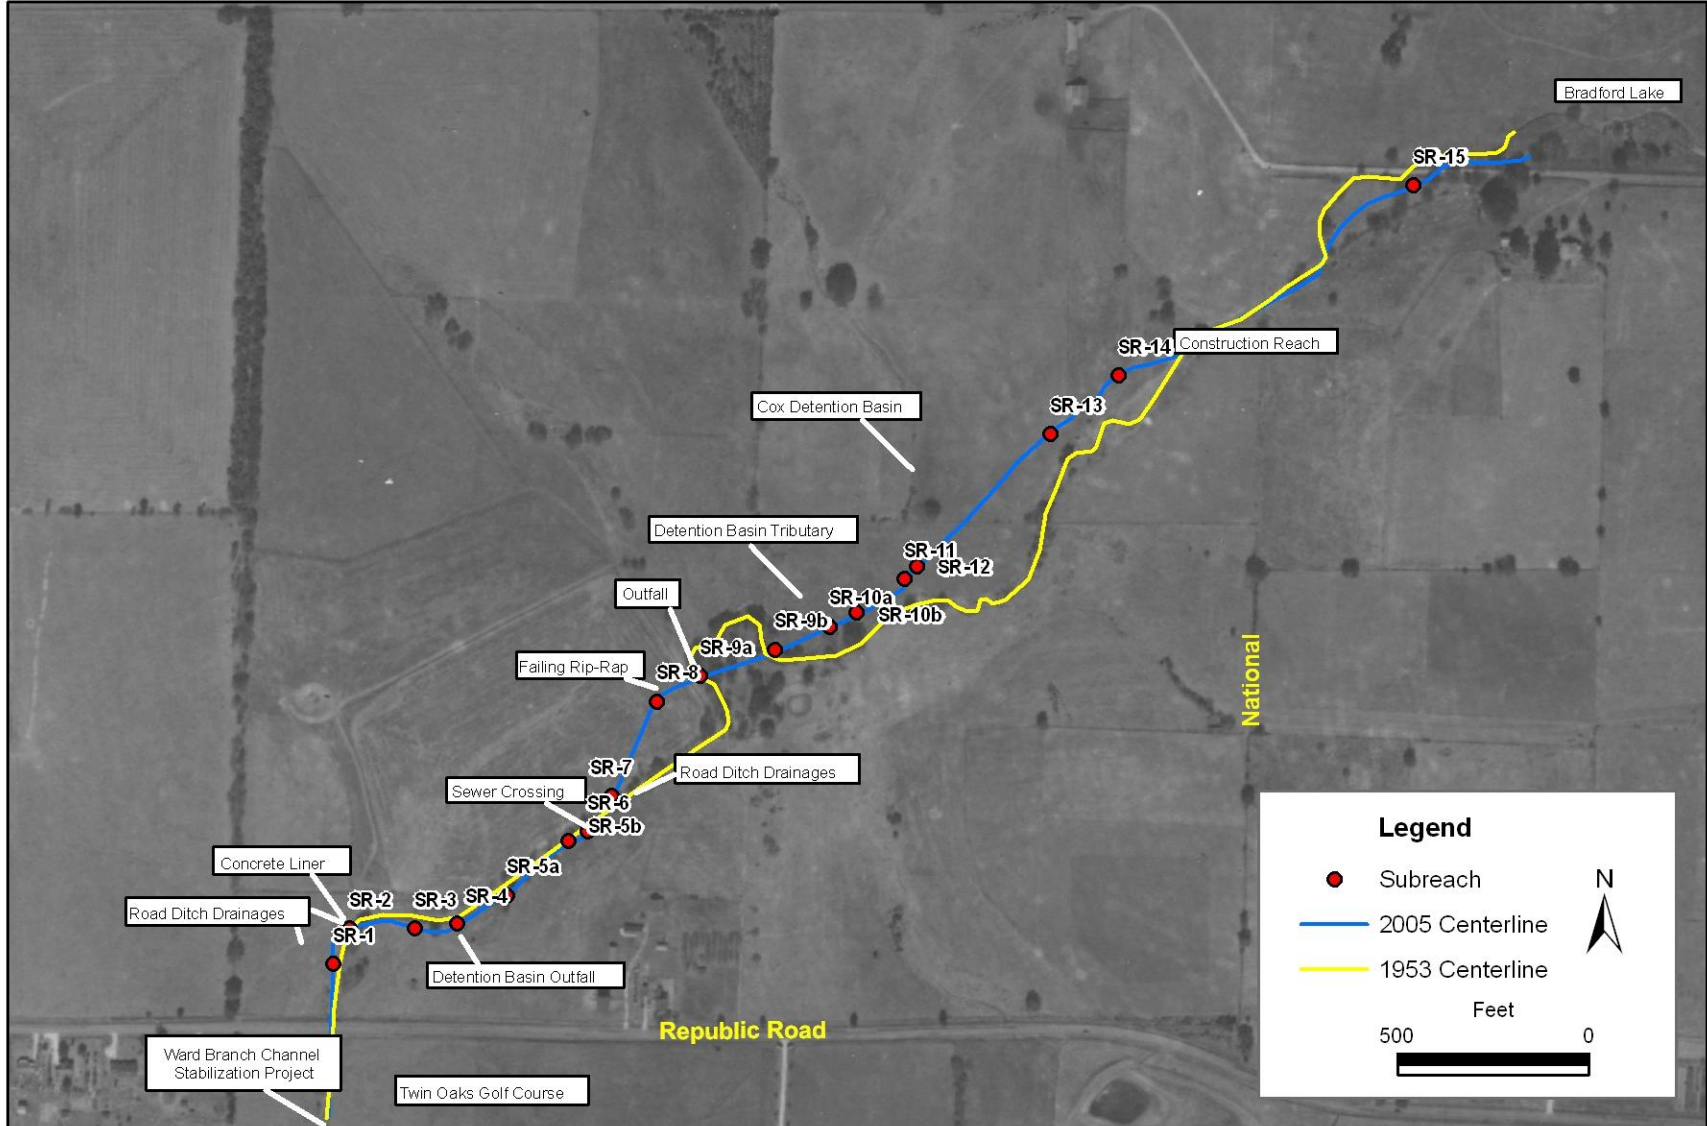
Figure 3. 1953 Aerial with Centerline and 2005 Centerline

The channel at this location has a long history of human disturbance and it is possible there is no segment that is in its original position. Aerial photos from the 1930s show the stream was probably channelized when this area was under cultivation for row crops in the late 1800s and early 1900s. The most significant disturbance in the last 70 years for the study reach is the relocation of the channel during the construction of the James River Expressway (Figure 3). The channel between stations 976-2,800 ft was moved to the north between 50-200 feet on top of a bedrock slab that was left over from the road cut to construct the west bound off-ramp from National. The existing channel was approximately 2,260 ft long with areas of meandering at present stations 1,390-1,600 ft near the approach to the upstream face of the James River Expressway culvert. Channel relocation shortened the reach to 1,820 ft and the meanders were channelized to align to the face of the culvert. A remnant of the old channel position still exists downstream of the James River Expressway that has become part of the road ditch along the south side of the highway. Additionally, it appears the stream was also relocated at some point above National to align with the culvert or during development around that intersection.

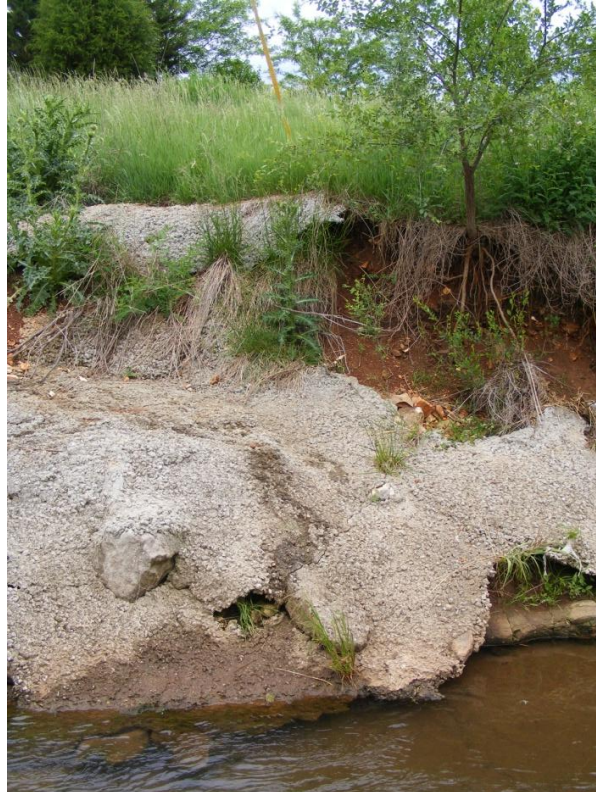
Sub-Reach 1 – (0 – 115 ft) Bedrock reach below concrete channel liner (Photo 1) at station 115 ft indicating gravel is transported during floods. Grouted rip-rap on right bank in bridge embankment (Photo 2 and 3). **Eroding high right bank** upstream of the culvert threatens west wing-wall and embankment. Cross-section #1 at located station 35 feet.

Photo 3. SR-1 cross-section #1 (station 35 ft) right bank.

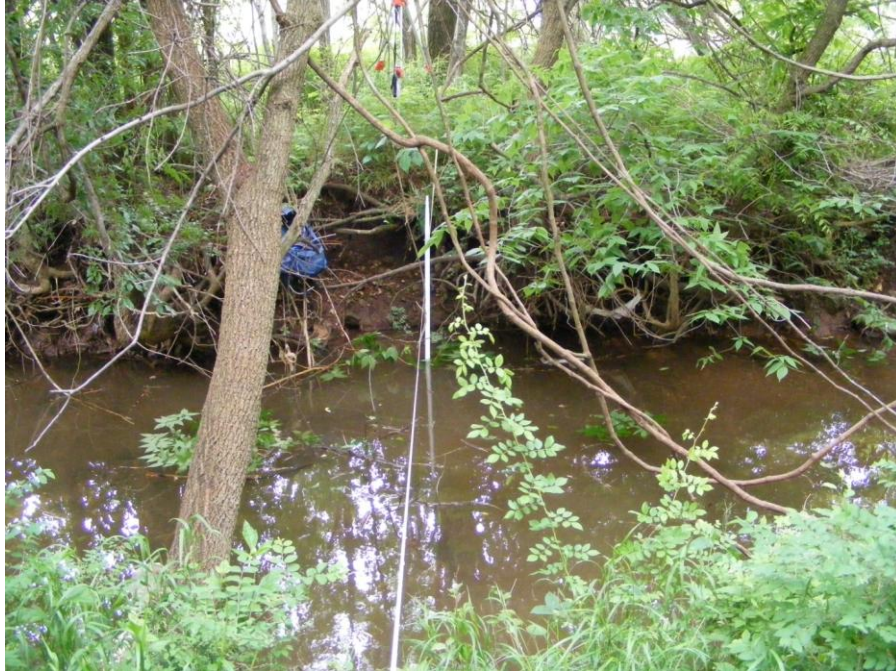
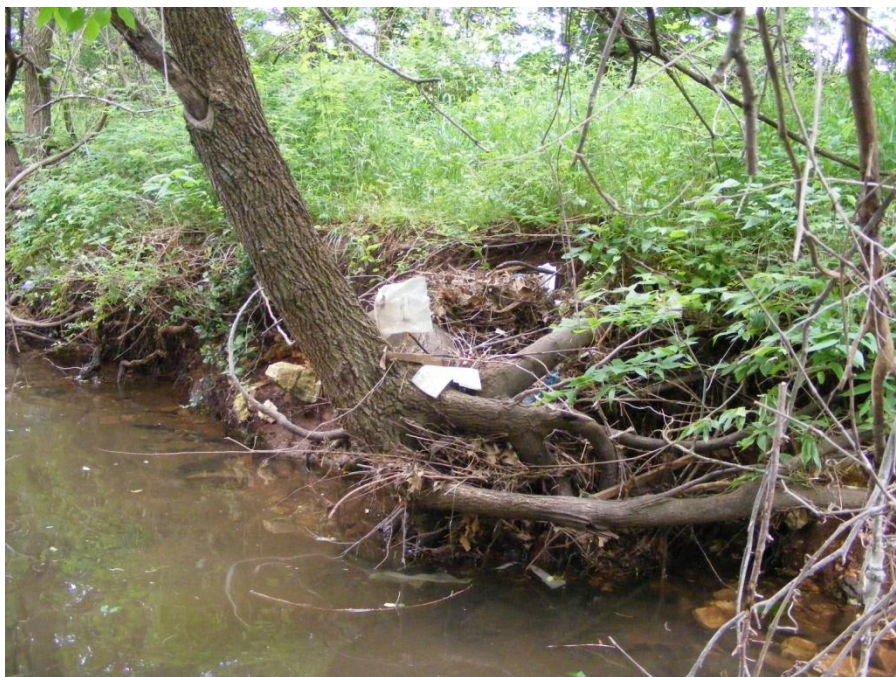
Sub-Reach 2 – (115 – 300 ft) Located upstream of concrete liner. Water pools behind sewer line which may contribute to bank instability due to saturation (Photo 5 and 6). Sub-reach has a bedrock bed with gravel/cobble veneer suggesting this reach transports gravel during floods and there is also evidence of incision along both banks (Photos 7 and 8). **There is a spring upwelling at station 200 feet.** Cross-section #2 located at station 225 feet.

Photo 7. SR-2 cross-section #2 (station 225 ft) right bank.

Photo 8. SR-2 cross-section #2 (station 225 ft) left bank.

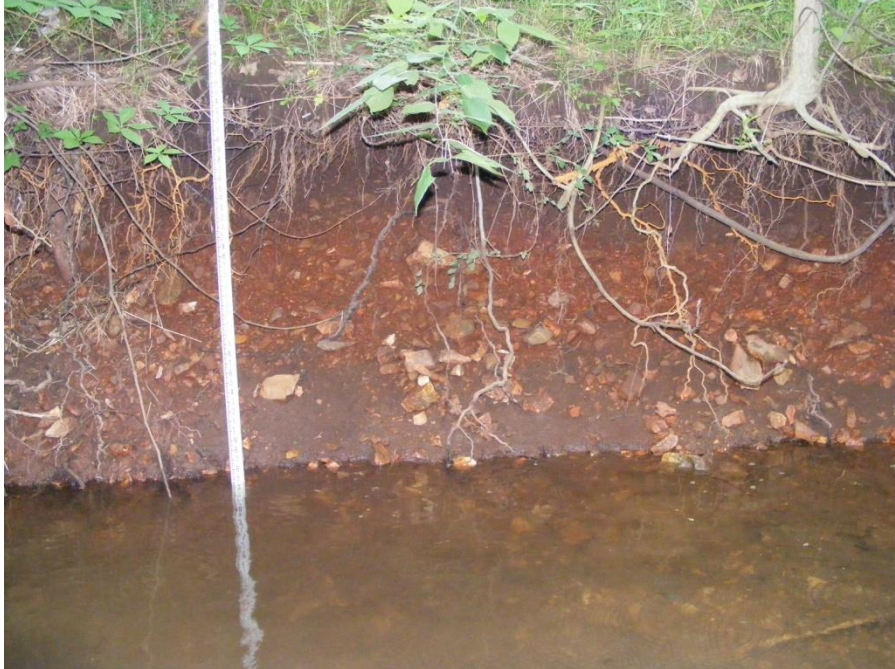
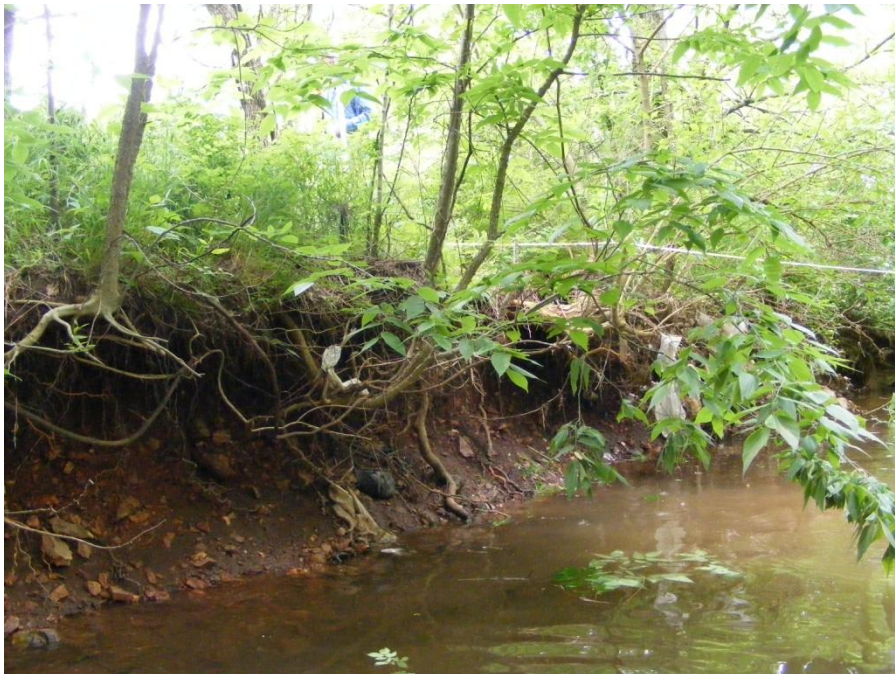
Sub-Reach 4 – (420 – 570 ft) This area is pooled upstream of mega-bar complex (Photos 11 and 12). This reach has bank erosion along the left bank with a floodplain beginning to form along the right bank (Photos 13 and 14). Cross-section #3 located at station 460 feet. Between stations 420 ft and 520 ft the risk to the detention basin embankment is more moderate as the distance from the top of the embankment is 50 ft from the edge of the vertical stream bank.

Photo 13. SR-4 cross-section #3 (station 460 ft) right bank.

Photo 14. SR-4 cross-section #3 (station 460 ft) left bank.

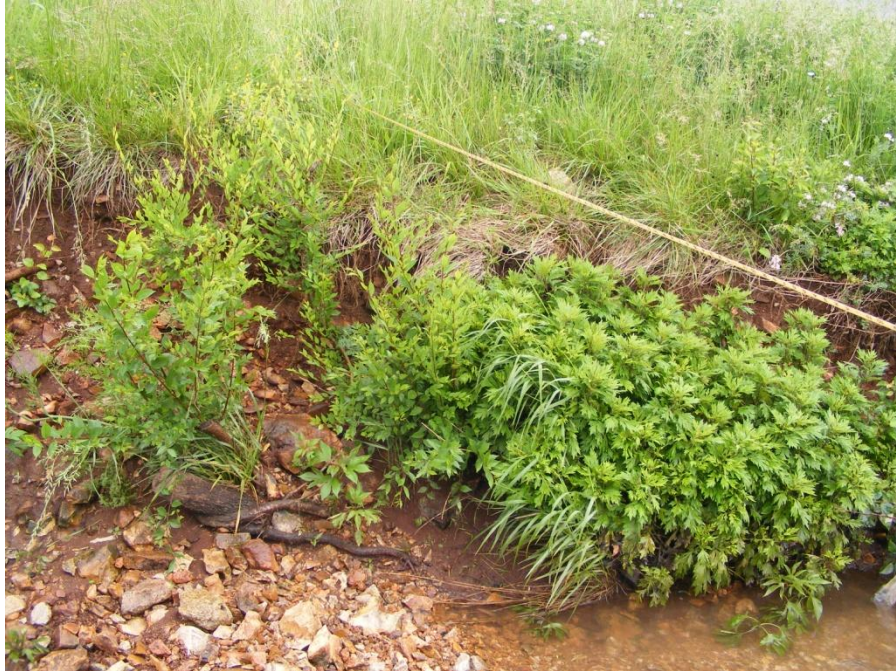
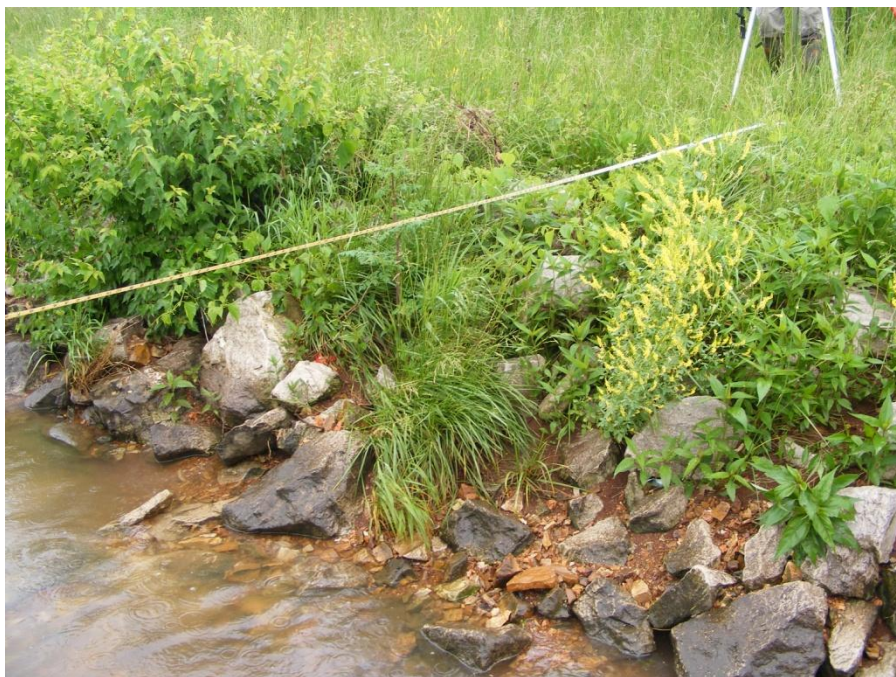
Sub-Reach 8 – (1,246 – 1,390 ft) This reach consists of a gravel and cobble bed with failing grouted rip-rap along the right bank located below the outfall located at 1,390 feet (Photos 29 and 30). Cross-section #5 located at station 1,340 feet (Photos 31 and 32).

Photo 31. SR-8 cross-section #5 (station 1,340 ft) right bank.

Photo 32. SR-8 cross-section #5 (station 1,340 ft) left bank.

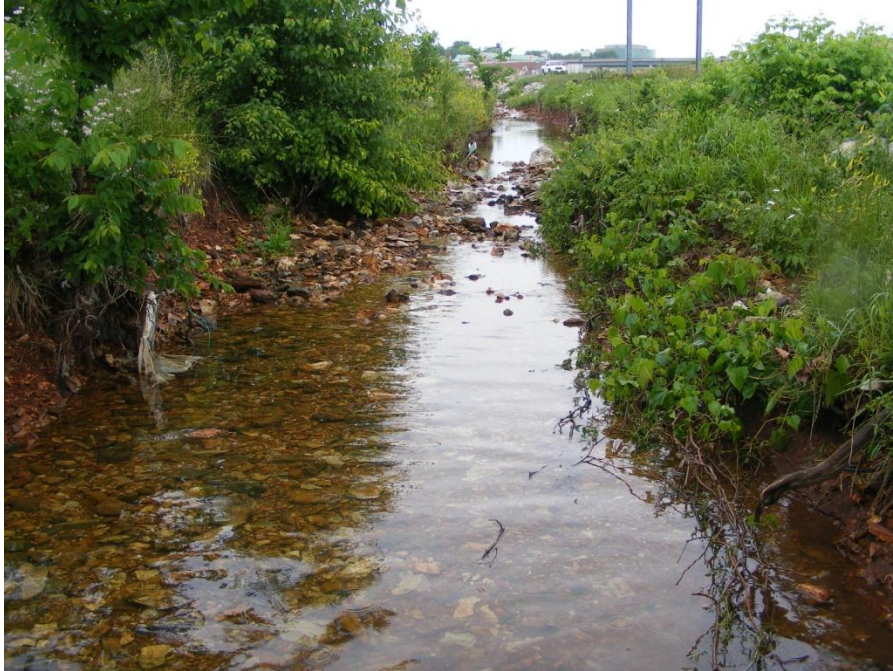
Sub-Reach 9a – (1,390 – 1,600 ft) There is evidence of **relatively severe bank and bed scour through this reach supplying gravel and fine-grain material to downstream areas** (Photos 33 and 34). This reach is located below the forced riffle at station 1,600 feet.

Photo 33. SR-9a looking upstream at station 1,500 ft.

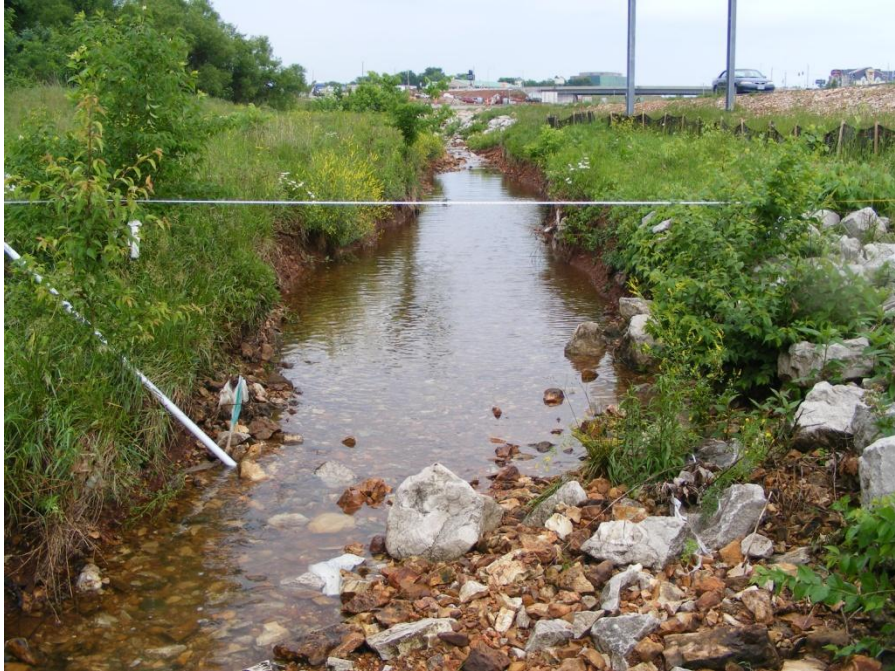
Sub-Reach 9b – (1,600 – 1,760 ft) There is **bank and bed scour within this reach, but not as severe as in 9a** (Photo 35). Could be held up by forced riffle created from large boulders located within the channel (Photo 36). Cross-section #6 located at station 1,620 feet (Photos 37 and 38).

Photo 35. SR-9b cross-section #6 (station 1,620 ft) looking upstream.

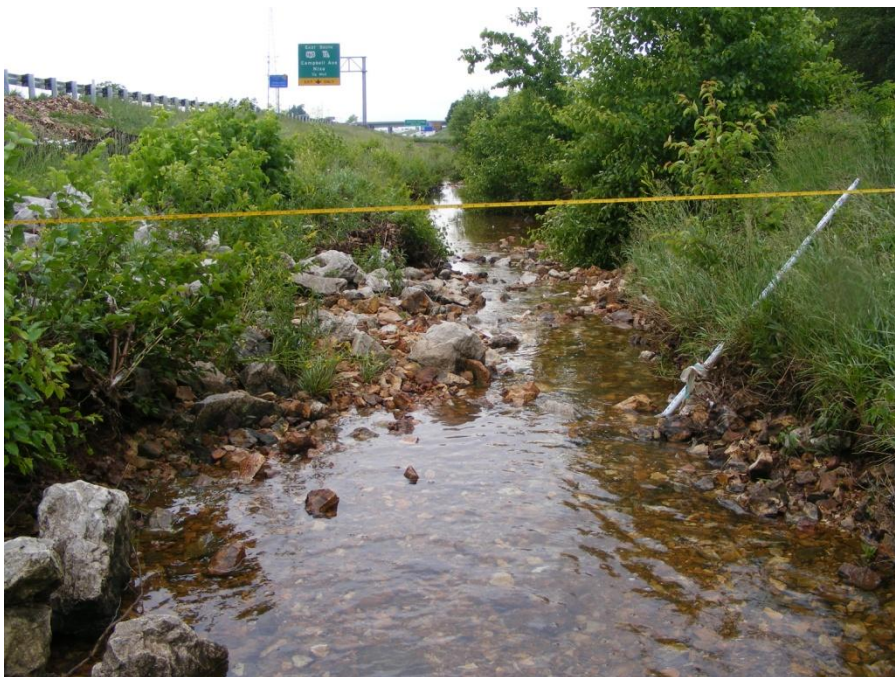
Photo 36. SR-9b cross-section #6 (station 1,620 ft) looking downstream.

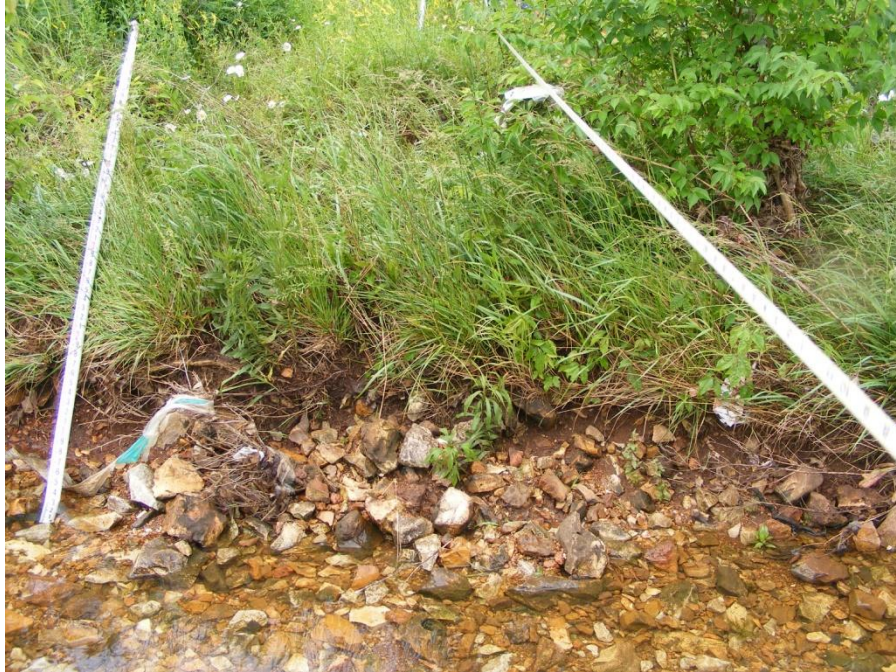
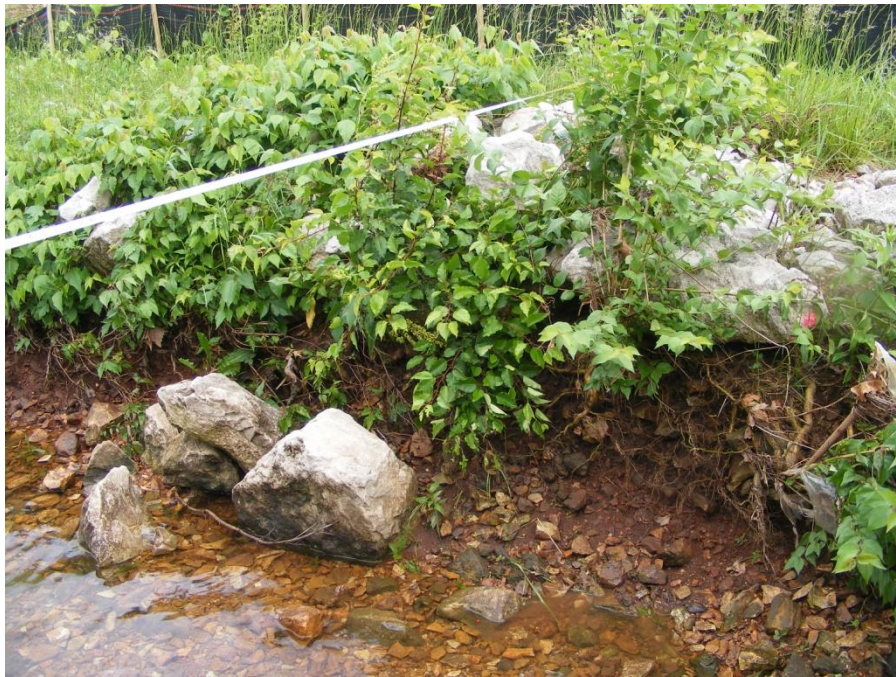
Photo 37. SR9b cross-section #6 (station 1,620 ft) right bank.

Photo 38. SR-9b cross-section #6 (station 1,620 ft) left bank.

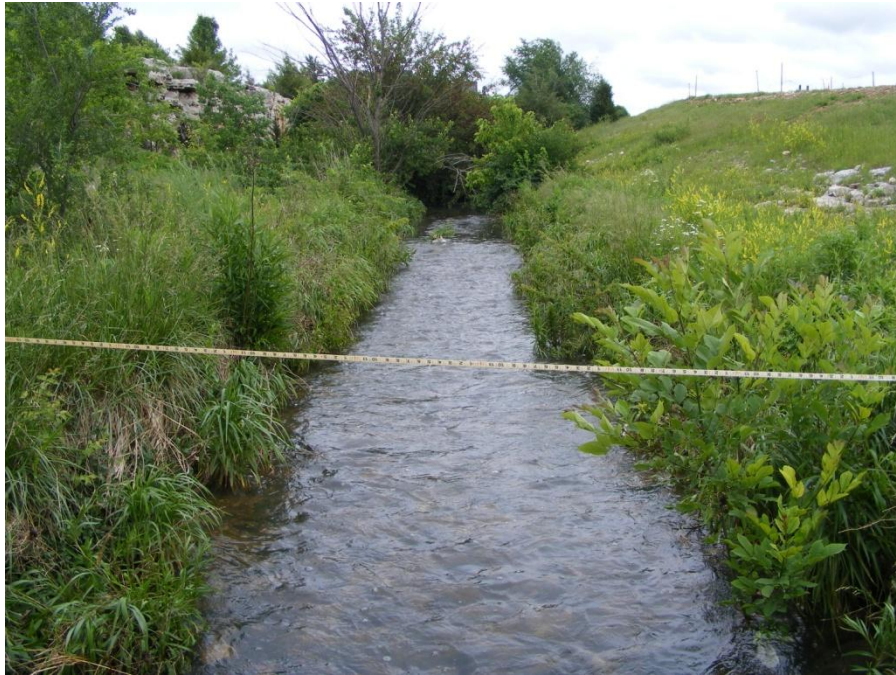
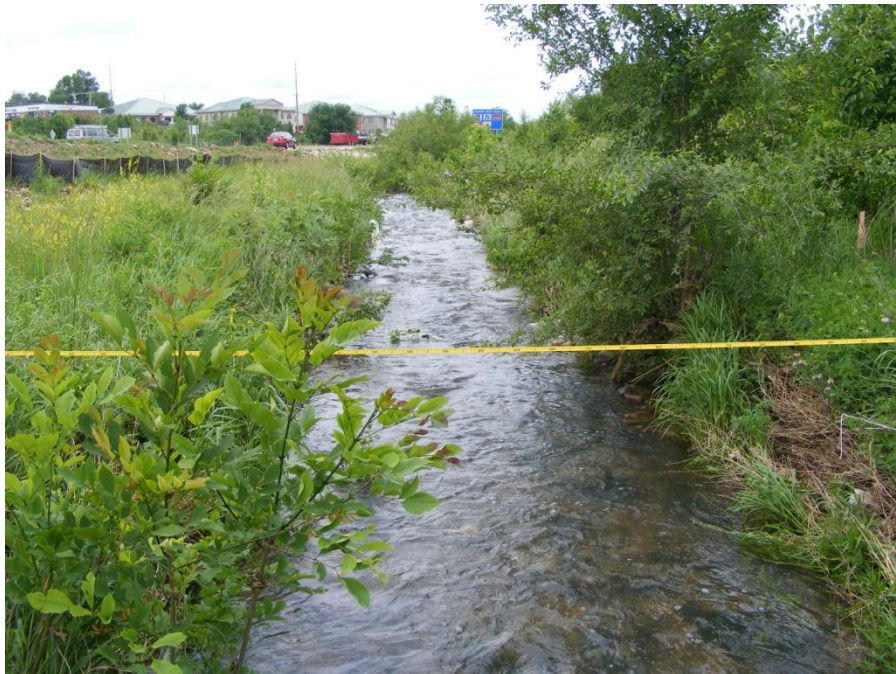
Sub-Reach 12 – (2,050 – 2,550 ft) This reach has stable bed and banks (Photos 43 and 44). Moss covered gravel/cobble bed suggests there is not a lot of bed erosion or excessive bedload transport. Banks are artificial with large rip-rap boulders that are now mostly vegetated (Photos 45 and 46). Cross-section #7 located at station 2,210 feet.

Photo 43. SR-12 cross-section #7 (station 2,210 ft) looking upstream.

Photo 44. SR-12 cross-section #7 (station 2,210 ft) looking downstream.

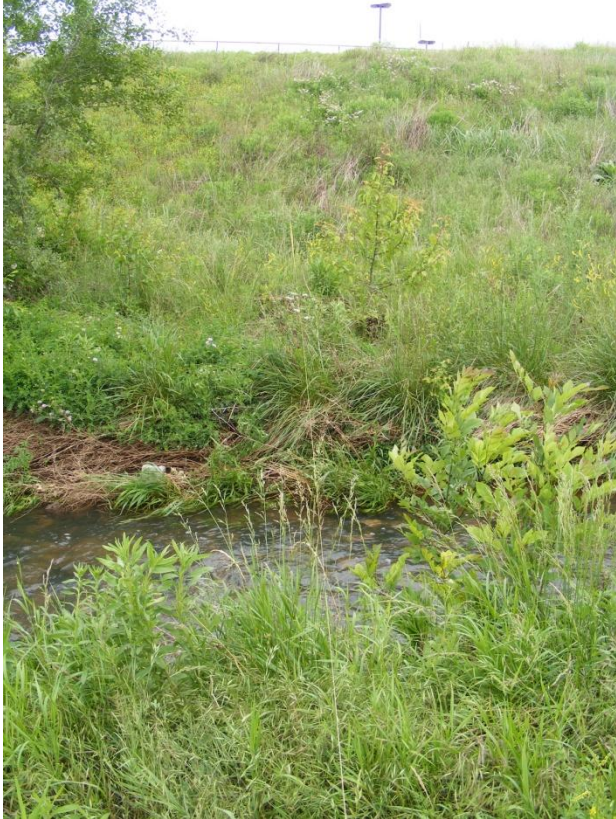
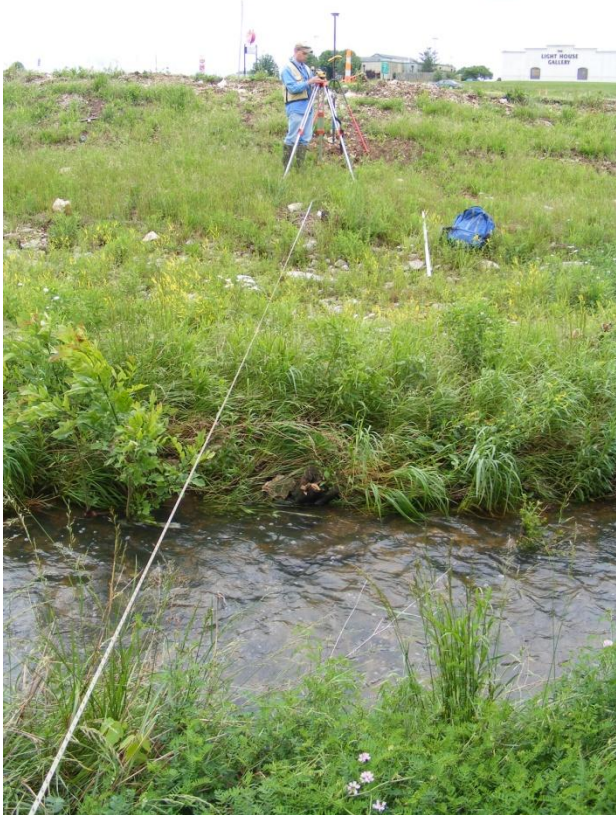
Photo 45. SR-12 cross-section #7 (station 2,210 ft) right bank.

Photo 46. SR-12 cross-section #7 (station 2,210 ft) left bank.

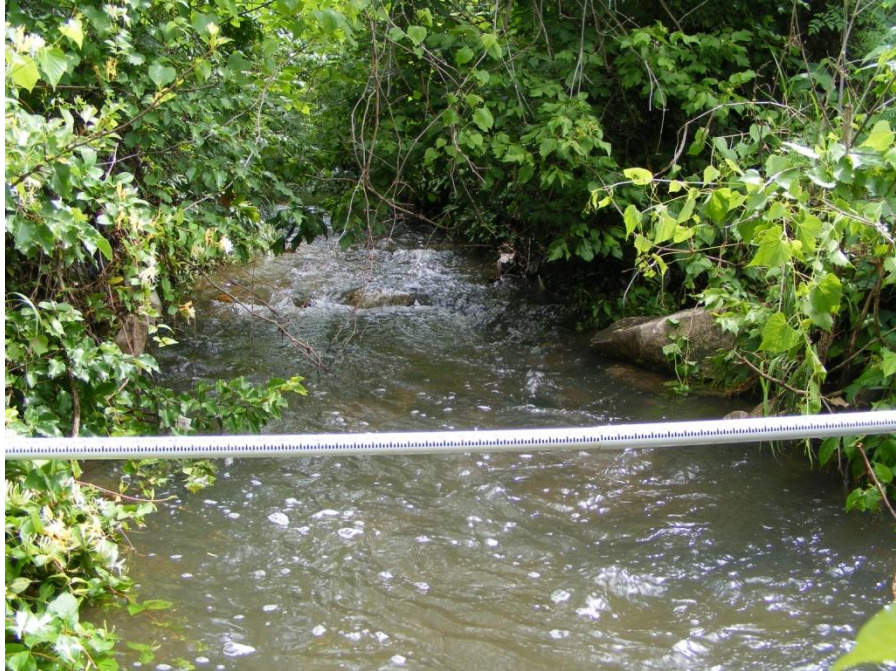
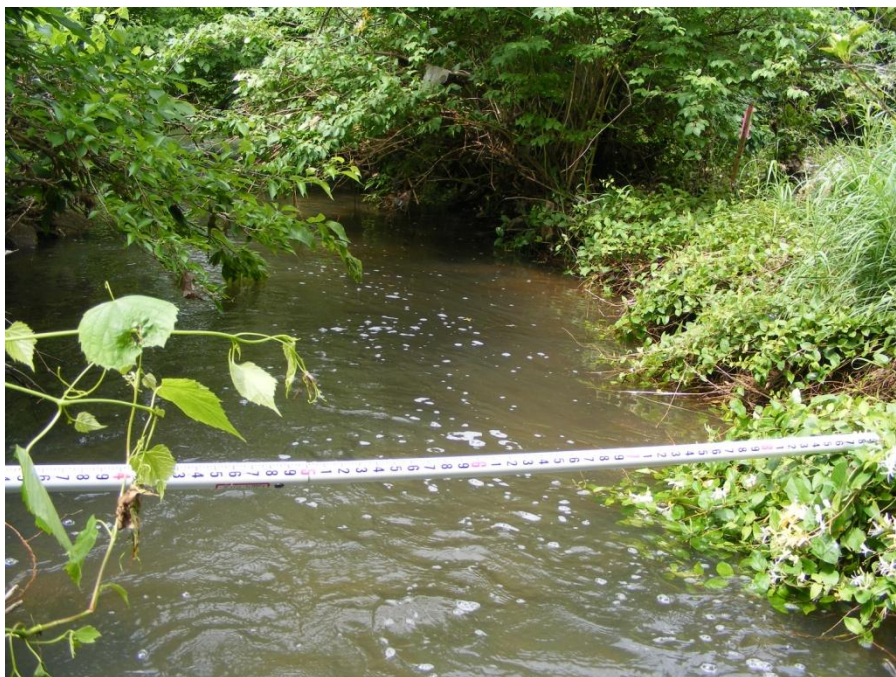
Sub-Reach 13 – (2,550 – 2,800 ft) **Bedrock channel with stable rip-rap bank material** (Photos 47 and 48). There is evidence of floodplain scour at high flows due to narrow “valley” between the bedrock cut wall and the off ramp from National, but bedrock appears to stop further cutting (Photos 49 and 50). Cross-section #8 located at station 2,615 feet.

Photo 47. SR-13 cross-section #8 (station 2,615 ft) looking upstream.

Photo 48. SR-13 cross-section #8 (station 2,615 ft) looking downstream.

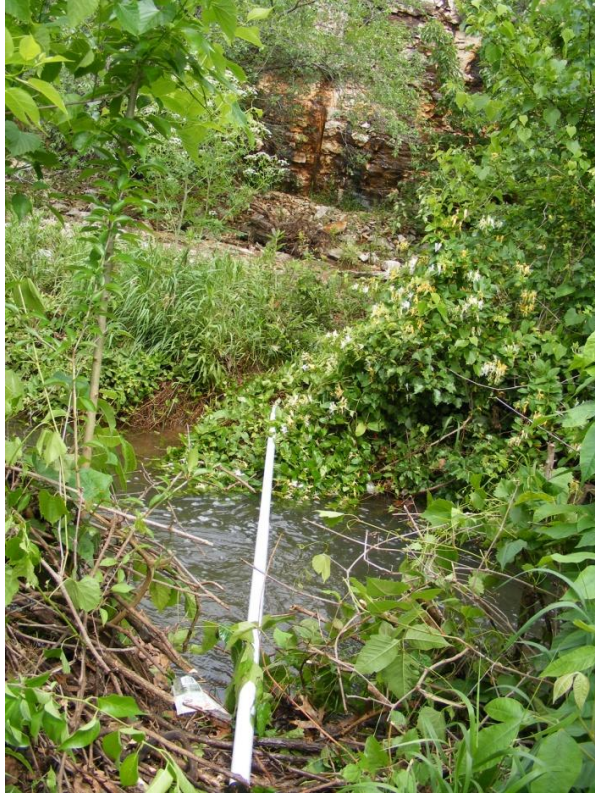
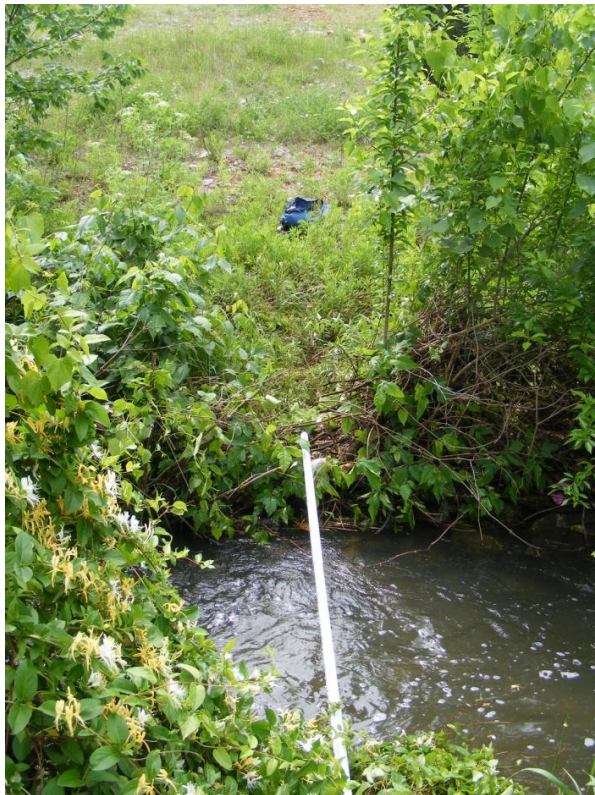
Photo 49. SR-13 cross-section #8 (station 2,615 ft) right bank.

Photo 50. SR-13 cross-section #8 (station 2,615 ft) left bank.

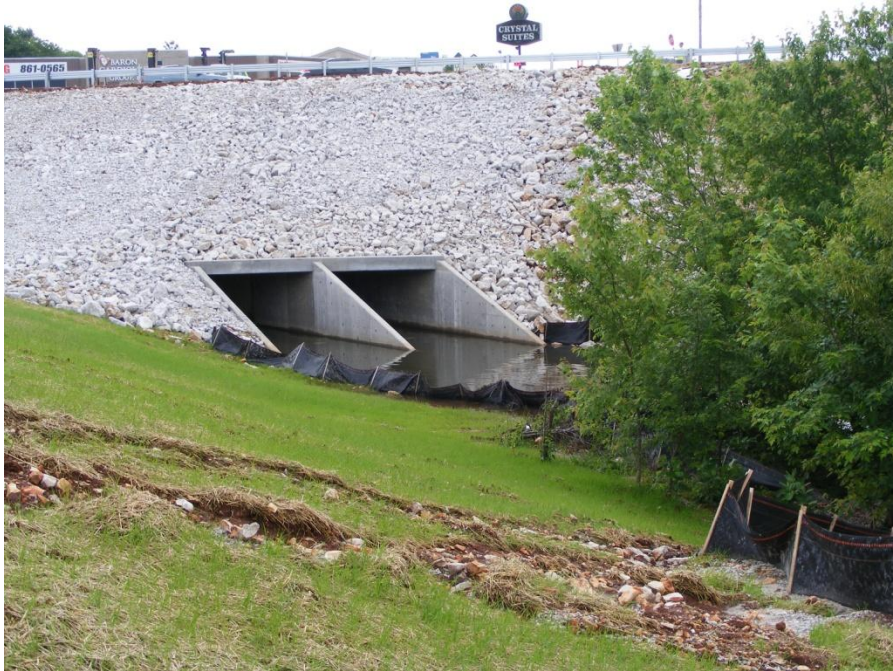
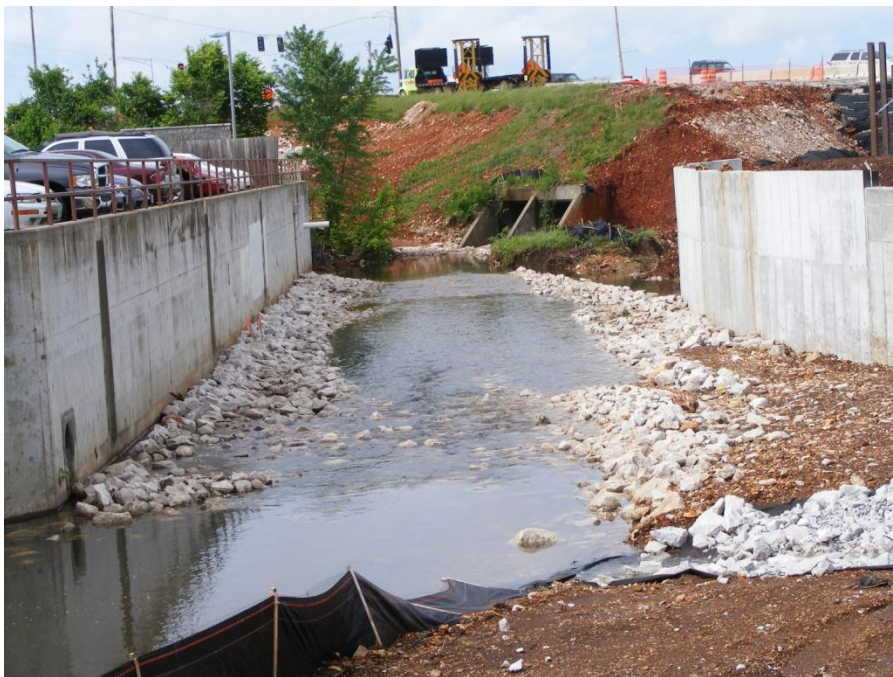
Sub-Reach 14 – (2,800 – 3,750 ft) This is the **construction reach** under National Avenue to Independence Road Culvert (Photos 51 and 52).

Photo 51. SR-14 downstream of National in the construction reach (station 3,050 ft).

Photo 52. SR-14 upstream of National in the construction reach (station 3,700 ft).

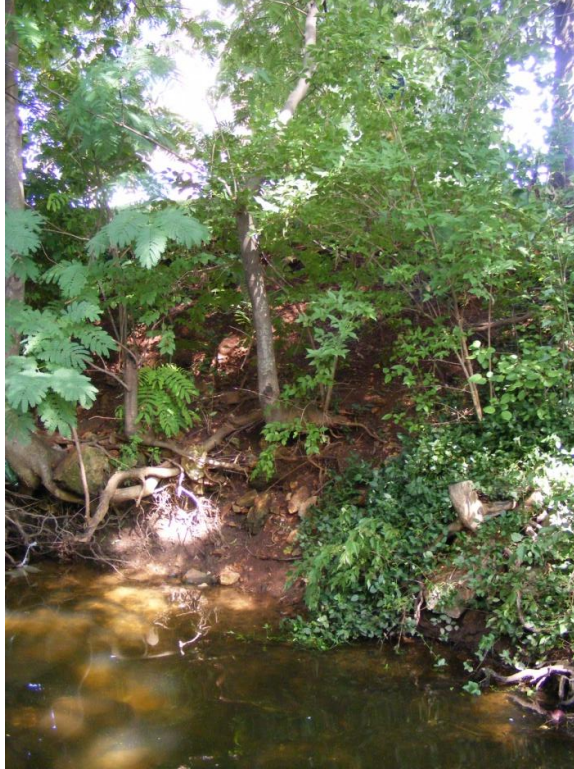
Sub-Reach 15 – (3,750 – 4,000 ft) This reach is located **below the Bradford Lake Dam** and consists of large boulders and construction debris with some bank collapse (Photos 53 and 54). Sediment supply below dam is low and flood peaks are reduced due to impoundment. Channel bank is largely fill on right side and bed elevation appears to have been lowered to meet downstream culvert. Banks are presently slowly eroding towards a lower bank angle but tree roots and boulders keep bank recession rates moderate. Bank erosion rates are also checked by lower shear stress due to controlled peaks below the dam and slope control caused by downstream culvert. However, the right bank between stations 3,750-3,900 ft could destabilize the embankment under Bradford Parkway. The toe of the right bank is 9.5-10 ft lower in elevation and 20-30 ft in horizontal distance from the edge of the curb. Cross-section #9 is located in the reach at station 3,875 ft (Photos 55-58). Additionally, the spillway apron has been undercut about 3 ft exposing the supporting fill material that will continue to deteriorate over time (Photos 59-62).

Photo 53. SR-15 right bank erosion and slump along Bradford Parkway (station 3,825 ft)
