**Geomorphic Assessment of Upper Wards Branch,  
Springfield, Missouri**

**Final report to Olsson Associates for  
the City of Springfield, Missouri**

**OEWRI EDR-10-006**

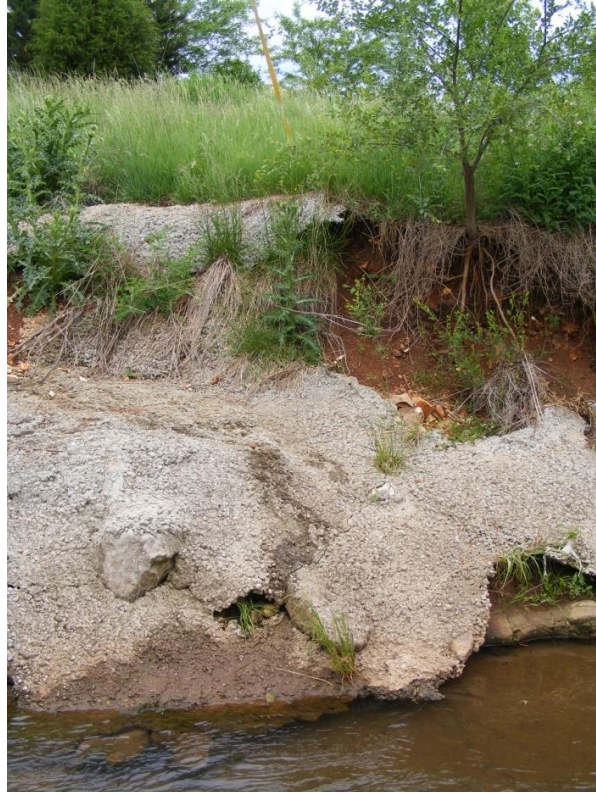
Sub-Reach 1 – (0 – 115 ft) Bedrock reach below concrete channel liner (Photo 1) at station 115 ft indicating gravel is transported during floods. Grouted rip-rap on right bank in bridge embankment (Photo 2 and 3). **Eroding high right bank** upstream of the culvert threatens west wing-wall and embankment. Cross-section #1 at located station 35 feet.

**Photo 3. SR-1 cross-section #1 (station 35 ft) right bank.**

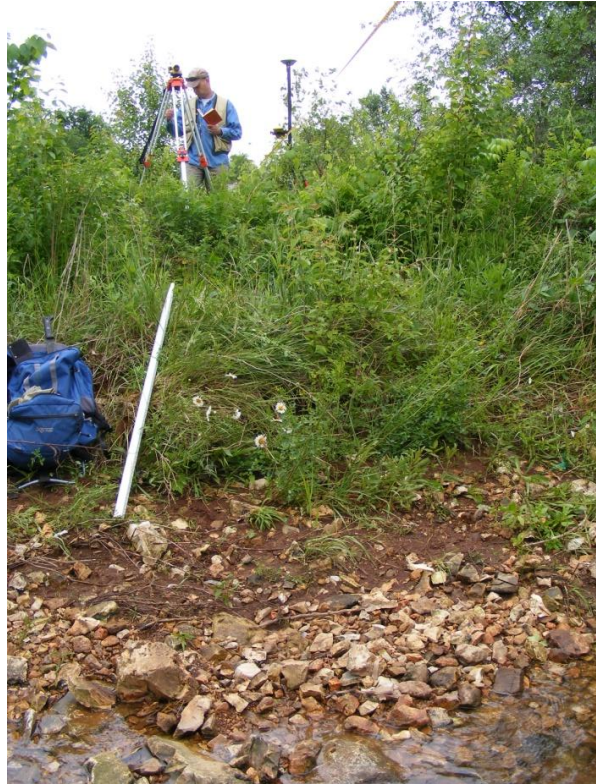
**Photo 4. SR-1 cross-section #1 (station 35 ft) left bank.**

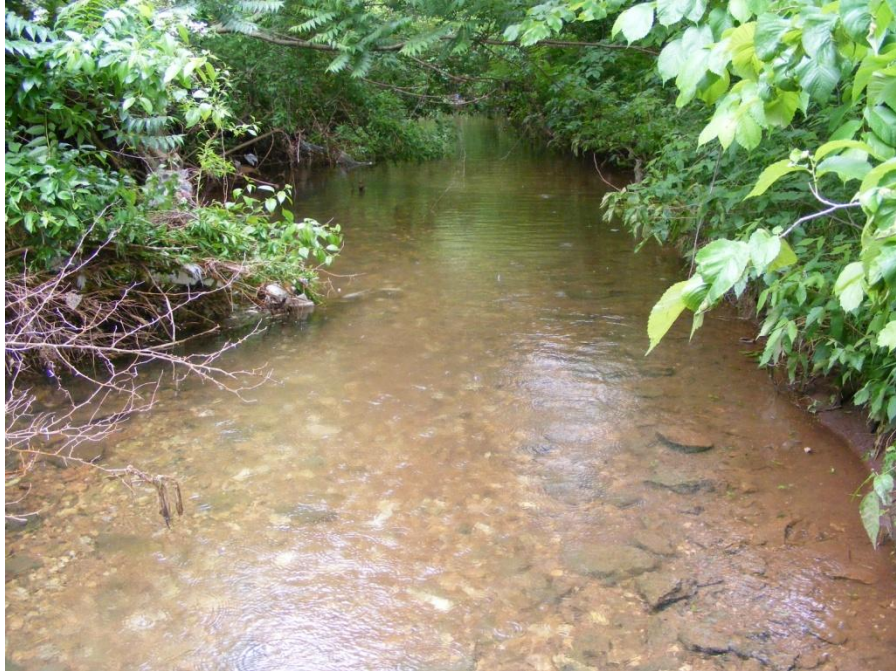
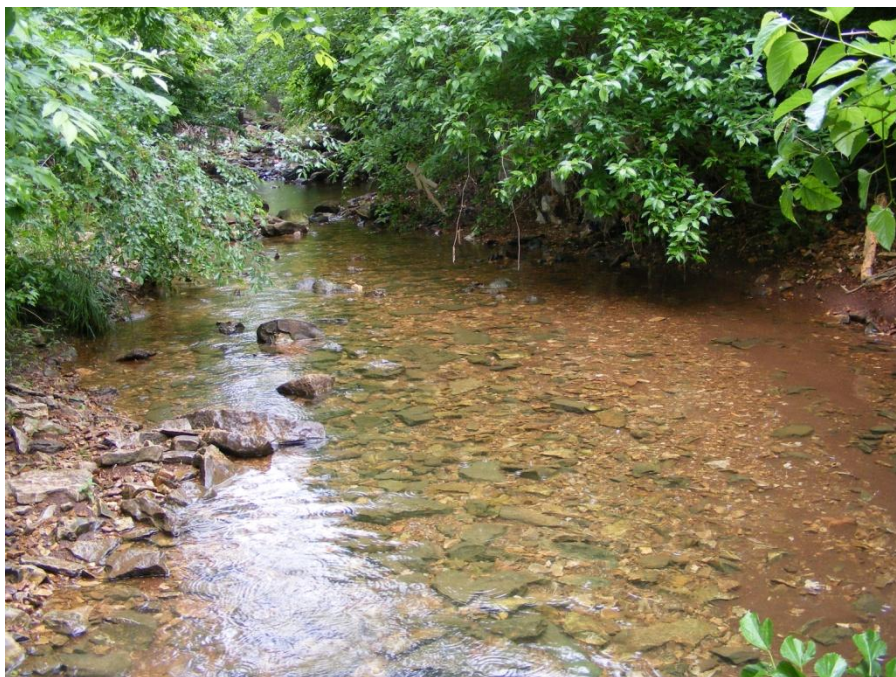
Sub-Reach 4 – (420 – 570 ft) This area is pooled upstream of mega-bar complex (Photos 11 and 12). This reach has bank erosion along the left bank with a floodplain beginning to form along the right bank (Photos 13 and 14). Cross-section #3 located at station 460 feet. Between stations 420 ft and 520 ft the risk to the detention basin embankment is more moderate as the distance from the top of the embankment is 50 ft from the edge of the vertical stream bank.

**Photo 11. SR-4 cross-section #3 (station 460 ft) looking upstream.**

**Photo 12. SR-4 cross-section #3 (station 460 ft) looking downstream.**

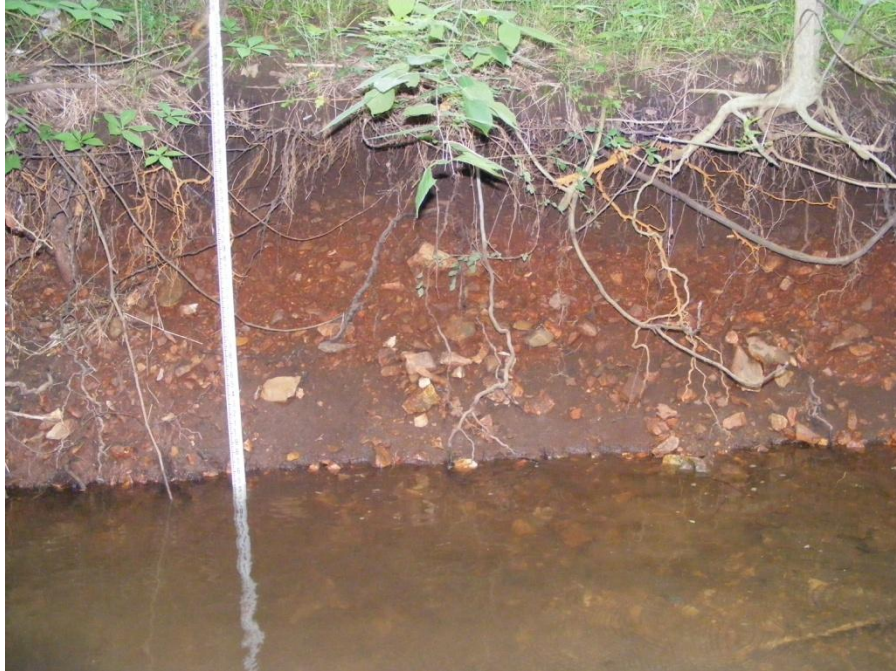
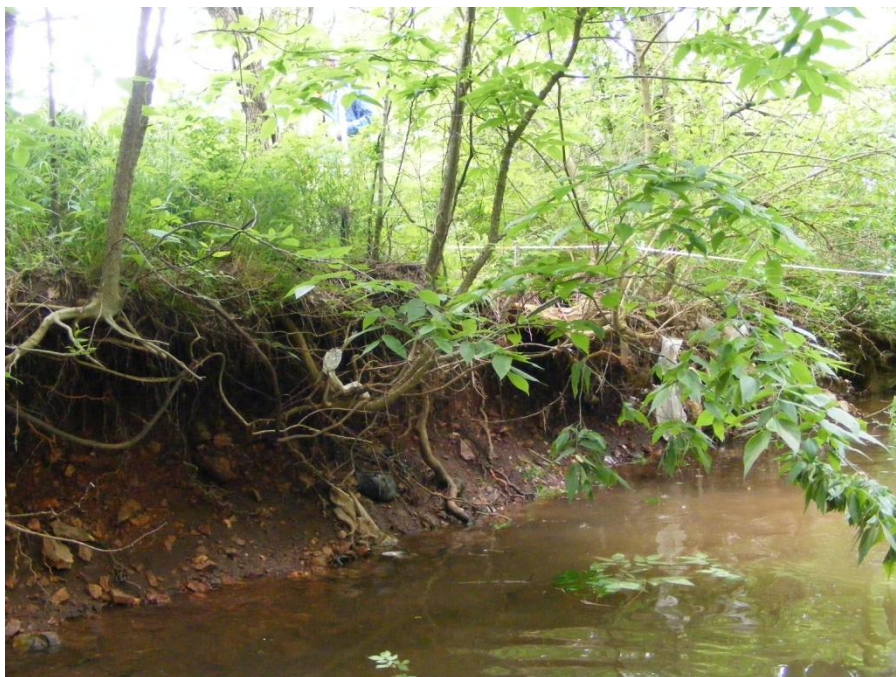
**Photo 13. SR-4 cross-section #3 (station 460 ft) right bank.**

**Photo 14. SR-4 cross-section #3 (station 460 ft) left bank.**

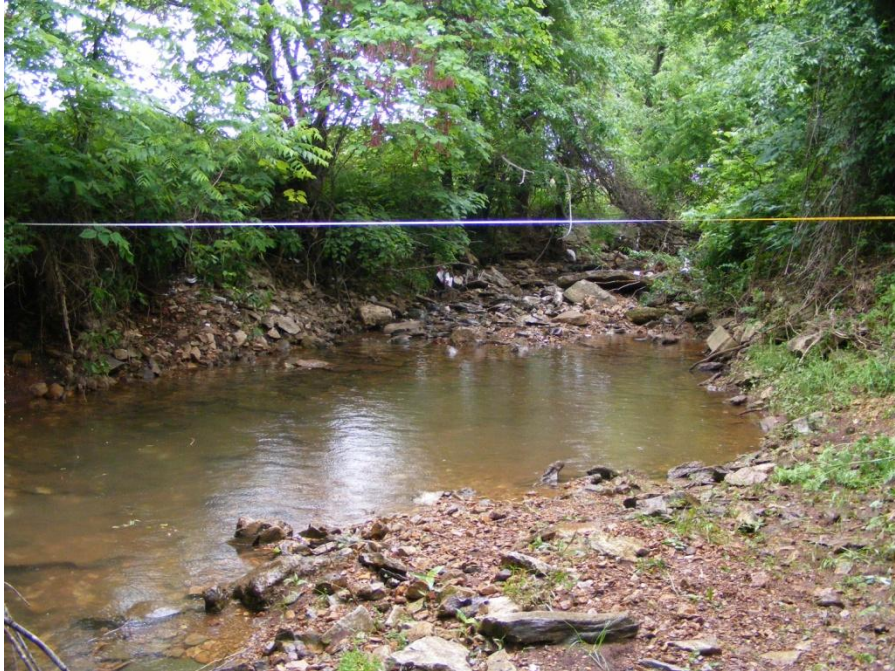
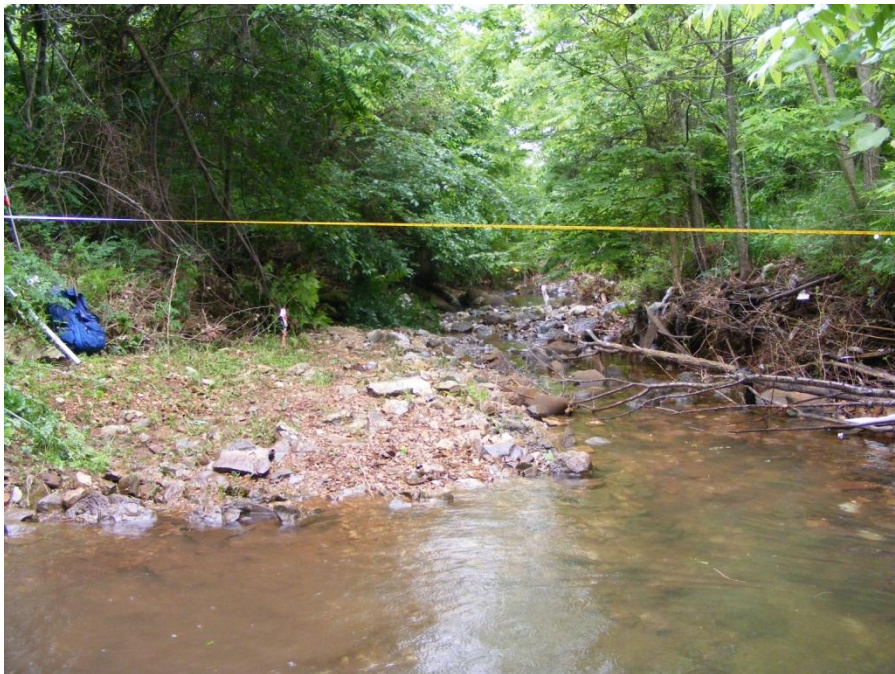
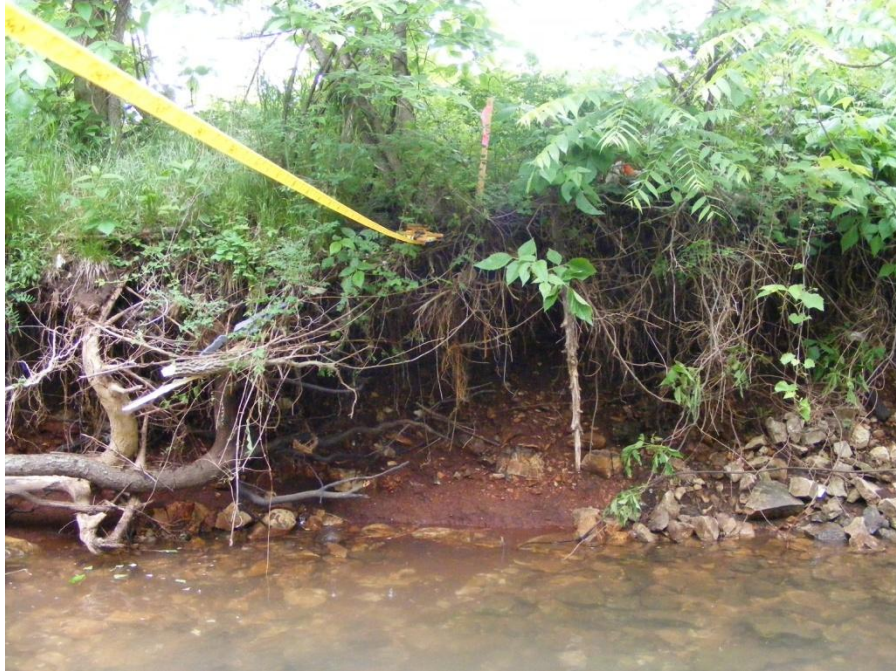
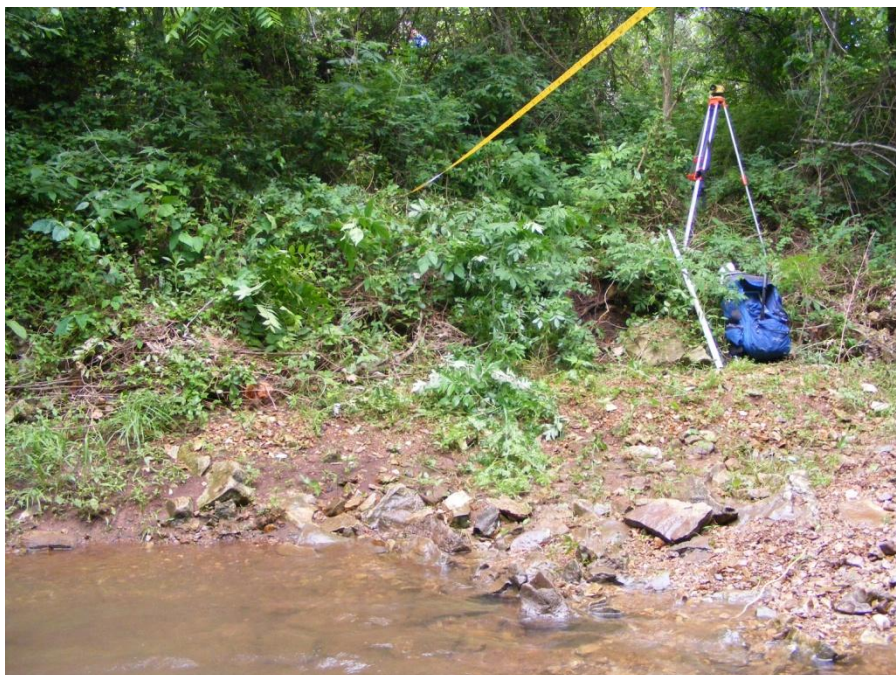
**Photo 15. SR-5 cross-section #4a (station 700 ft) looking upstream.**

**Photo 16. SR-5 cross-section #4a (station 700 ft) looking downstream.**

**Photo 17. SR-5 cross-section #4a (station 700 ft) right bank.**

**Photo 18. SR-5 cross-section #4a (station 700 ft) left bank.**

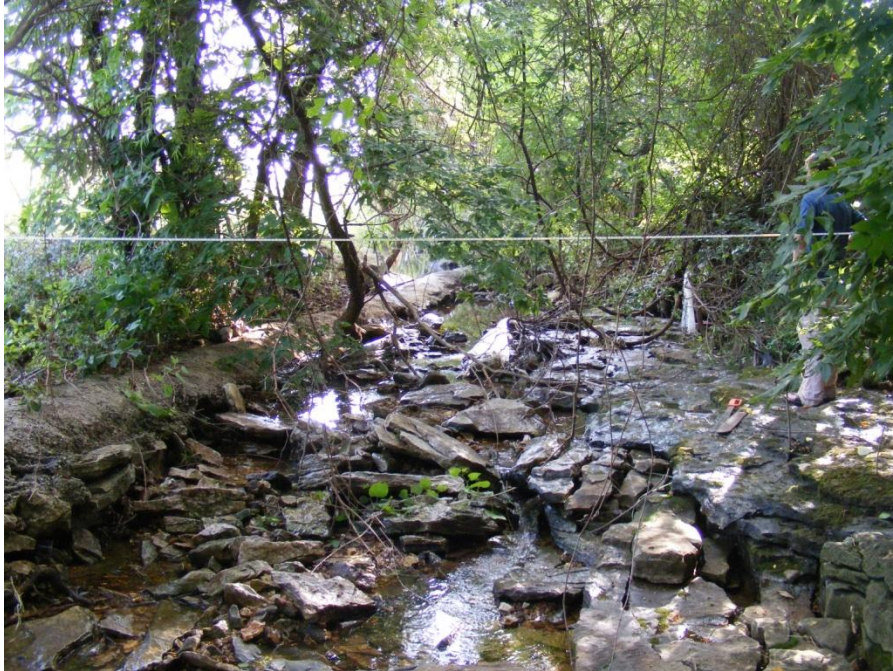
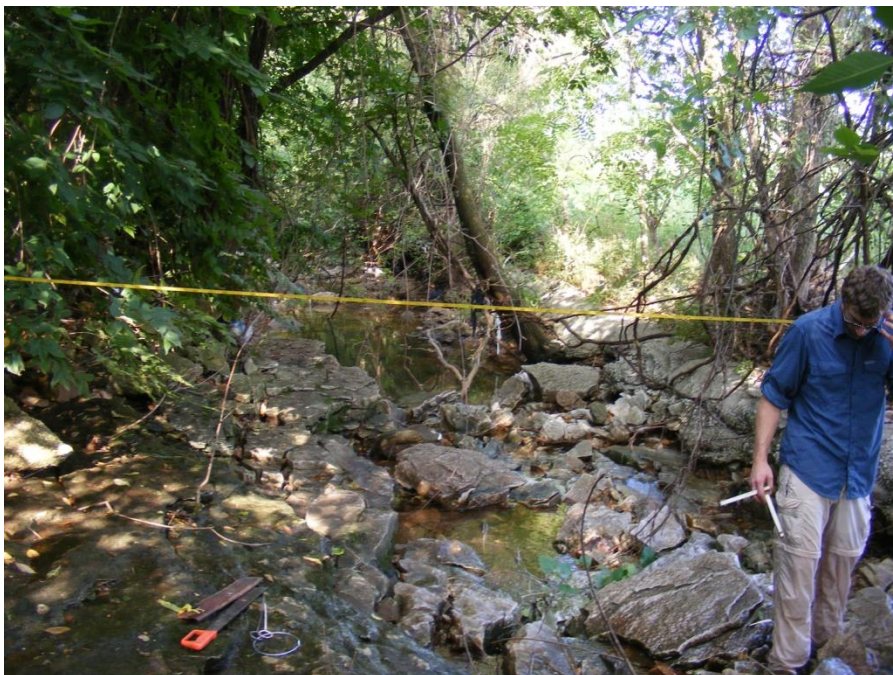
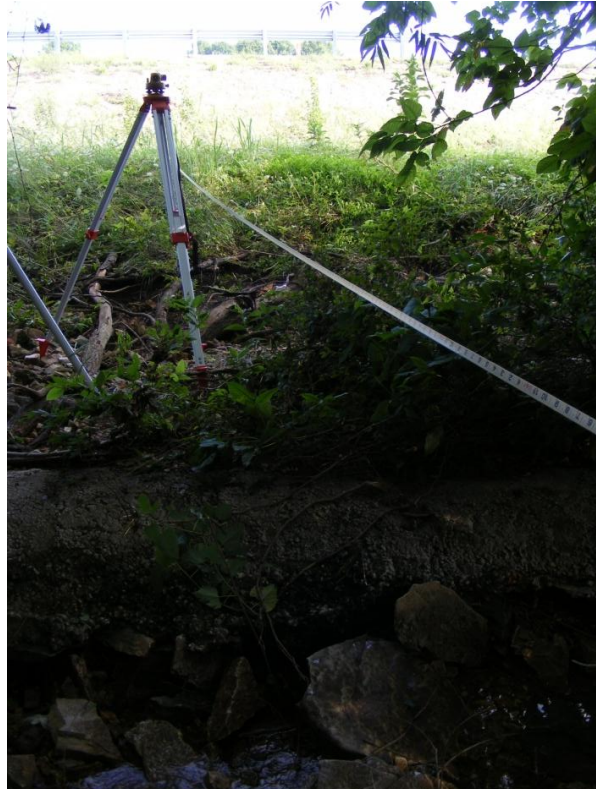
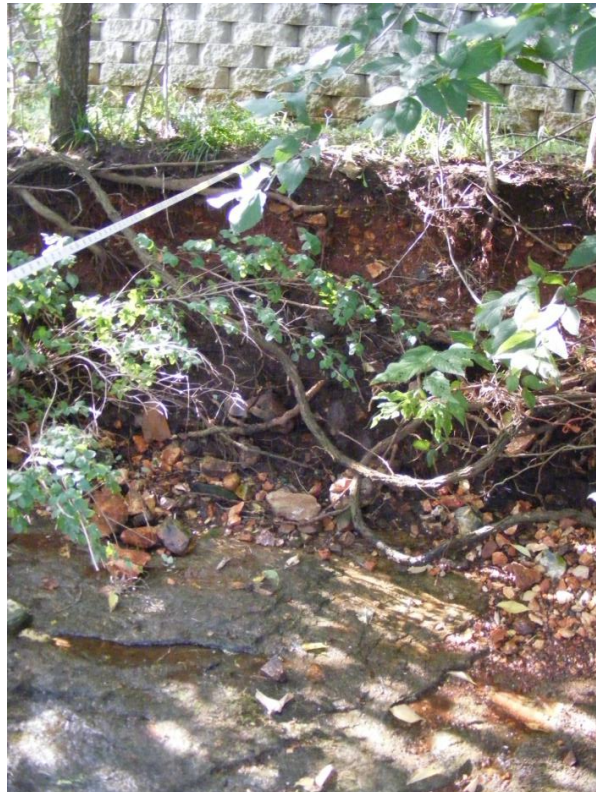
**Photo 23. SR-5 cross-section #4b (station 825 ft) looking upstream.**

**Photo 24. SR-5 cross-section #4b (station 825 ft) looking downstream.**

**Photo 25. SR-5 cross-section #4b (station 825 ft) right bank.**

**Photo 26. SR-5 cross-section #4b (station 825 ft) right bank.**

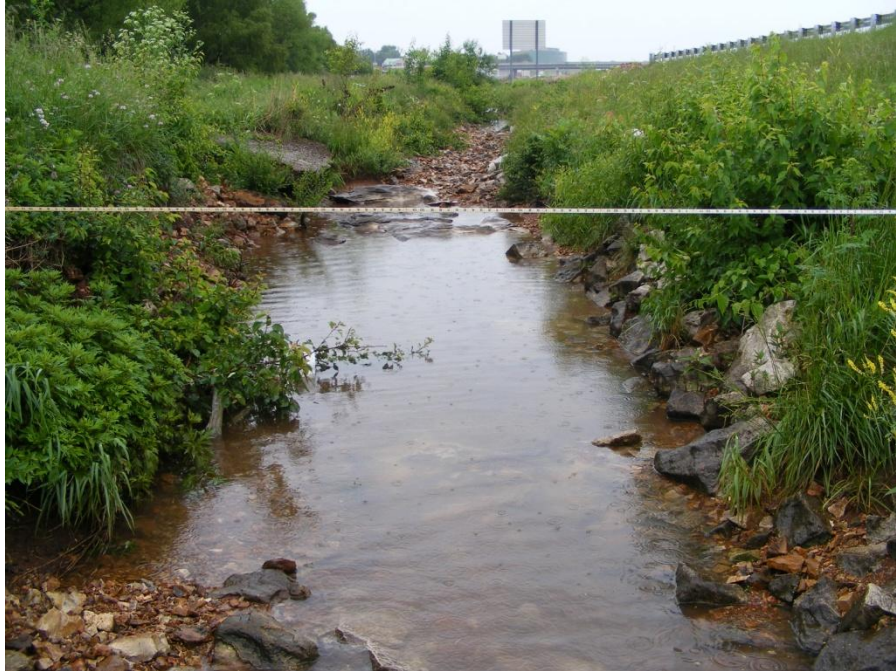
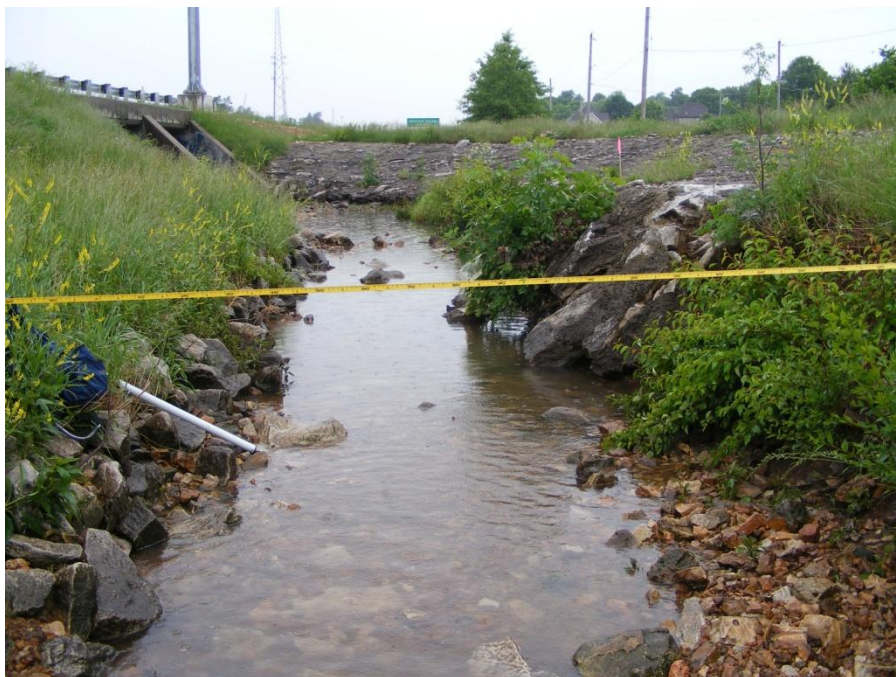
Sub-Reach 8 – (1,246 – 1,390 ft) This reach consists of a gravel and cobble bed with failing grouted rip-rap along the right bank located below the outfall located at 1,390 feet (Photos 29 and 30). Cross-section #5 located at station 1,340 feet (Photos 31 and 32).

**Photo 29. SR-8 cross-section #5 (station 1,340 ft) looking upstream.**

**Photo 30. SR-8 cross-section #5 (station 1,340 ft) looking downstream.**

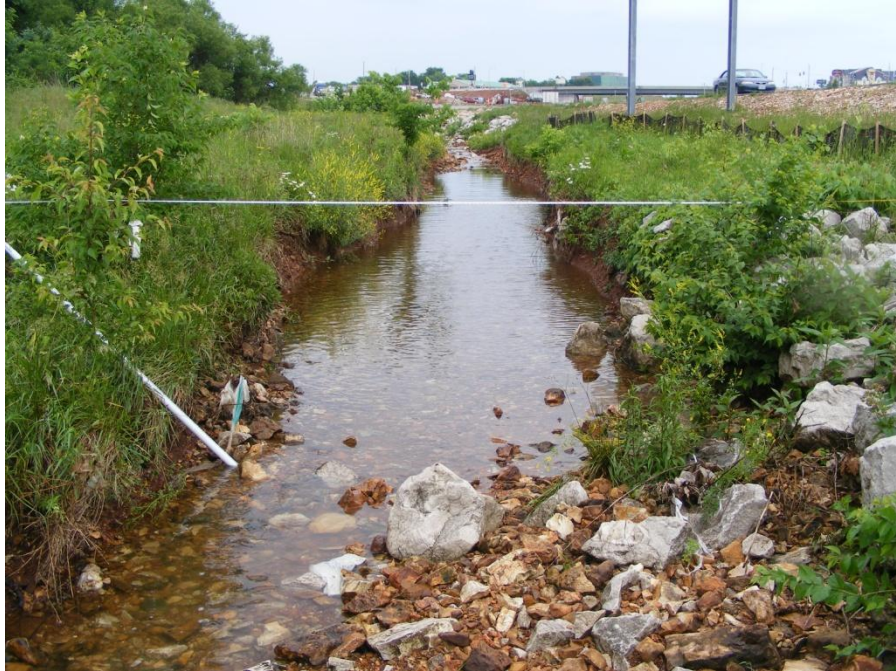
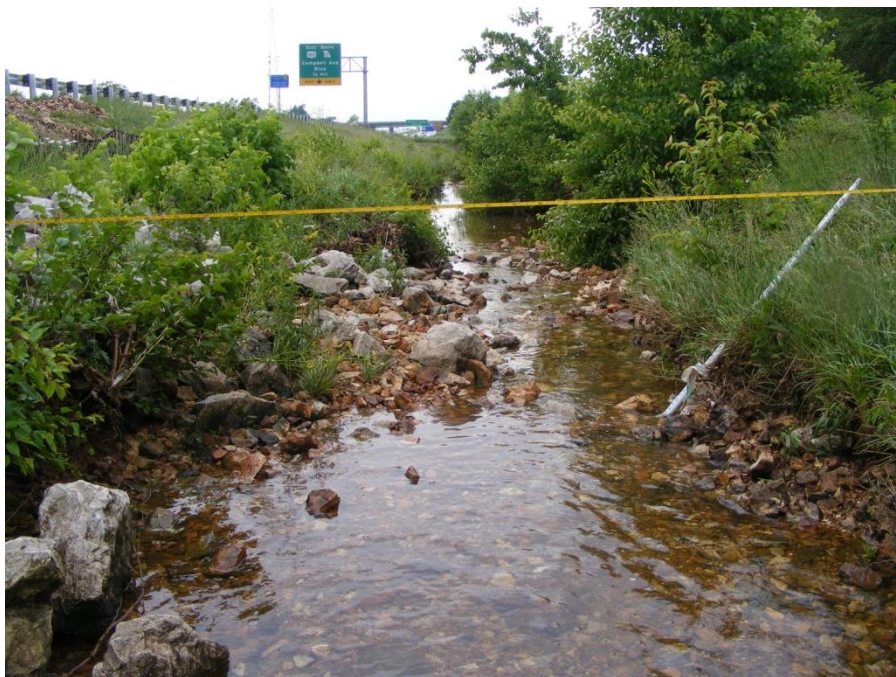
Sub-Reach 9b – (1,600 – 1,760 ft) There is **bank and bed scour within this reach, but not as severe as in 9a** (Photo 35). Could be held up by forced riffle created from large boulders located within the channel (Photo 36). Cross-section #6 located at station 1,620 feet (Photos 37 and 38).

**Photo 35. SR-9b cross-section #6 (station 1,620 ft) looking upstream.**

**Photo 36. SR-9b cross-section #6 (station 1,620 ft) looking downstream.**

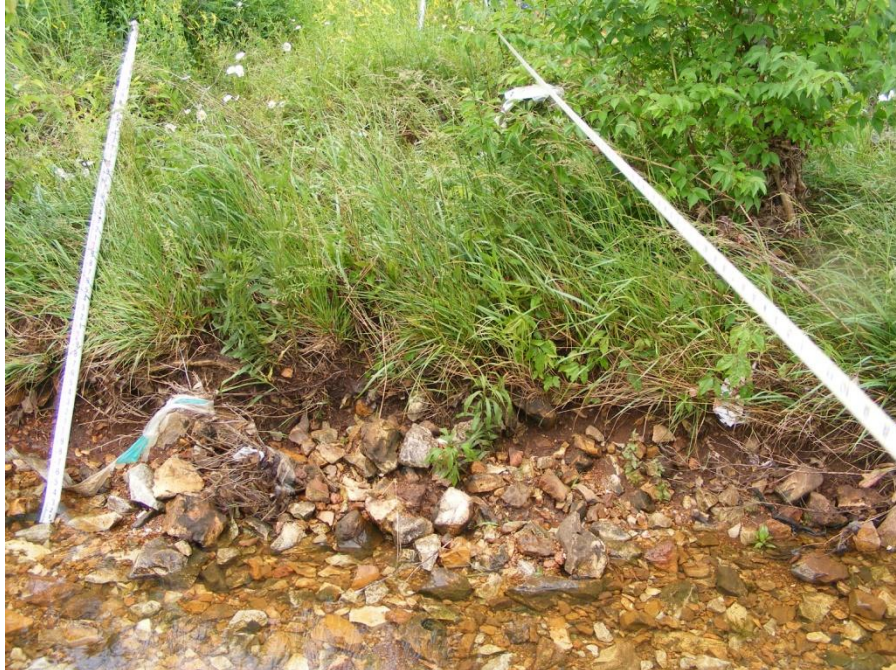
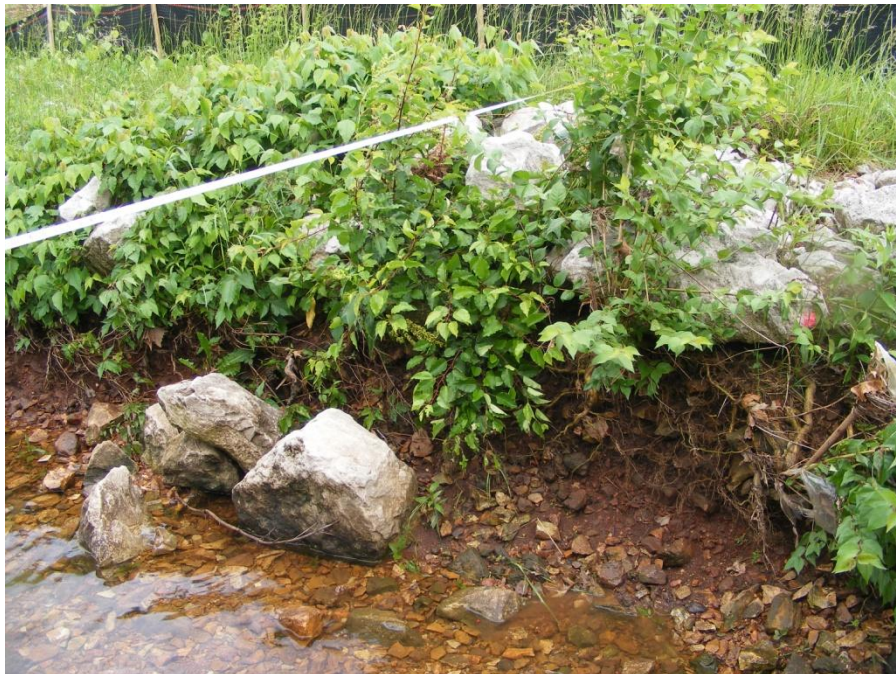
**Photo 37. SR9b cross-section #6 (station 1,620 ft) right bank.**

**Photo 38. SR-9b cross-section #6 (station 1,620 ft) left bank.**

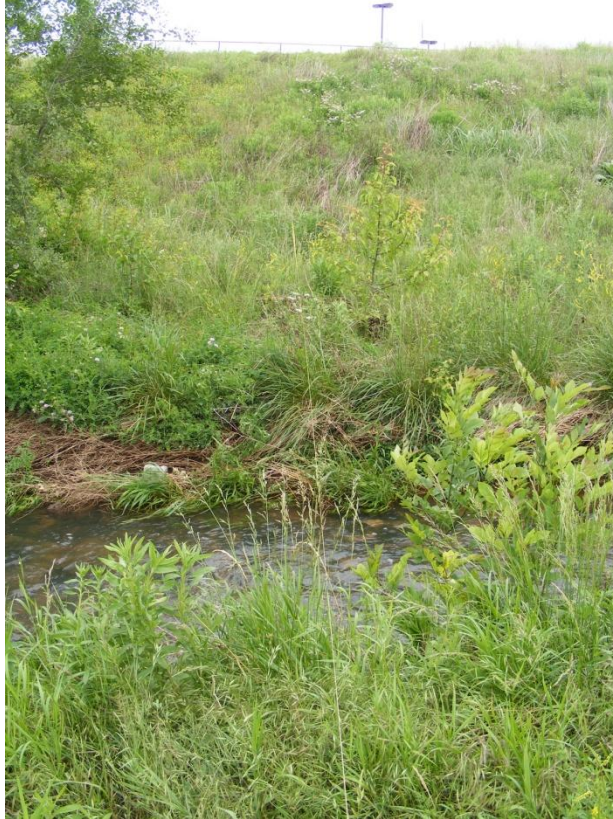
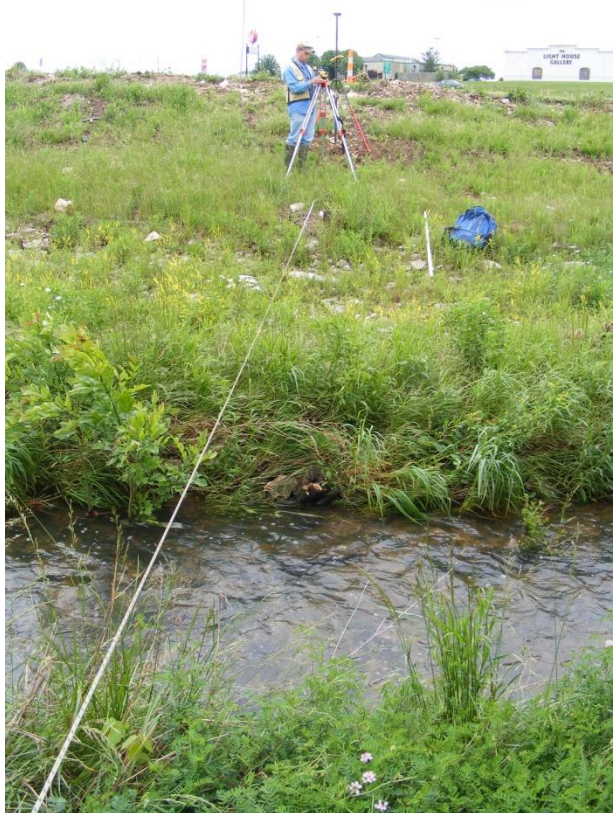
Sub-Reach 12 – (2,050 – 2,550 ft) This reach has stable bed and banks (Photos 43 and 44). Moss covered gravel/cobble bed suggests there is not a lot of bed erosion or excessive bedload transport. Banks are artificial with large rip-rap boulders that are now mostly vegetated (Photos 45 and 46). Cross-section #7 located at station 2,210 feet.

**Photo 45. SR-12 cross-section #7 (station 2,210 ft) right bank.**

**Photo 46. SR-12 cross-section #7 (station 2,210 ft) left bank.**

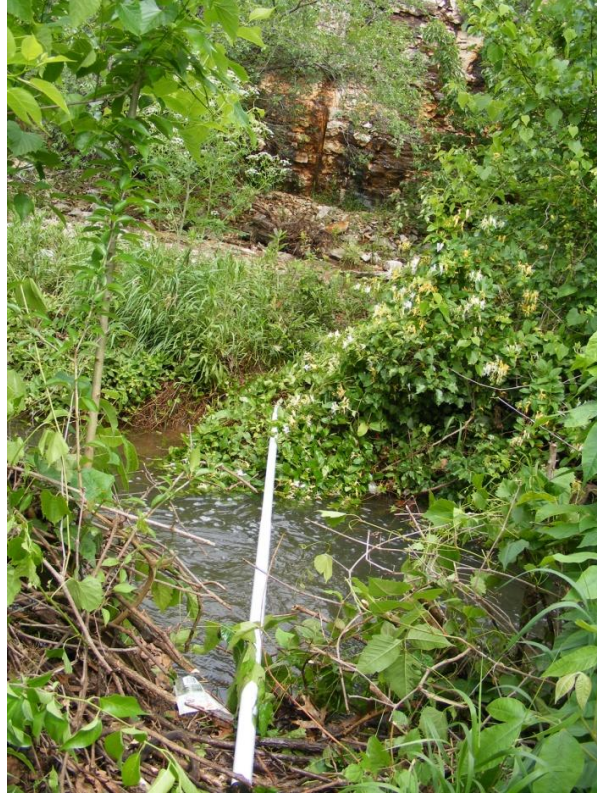
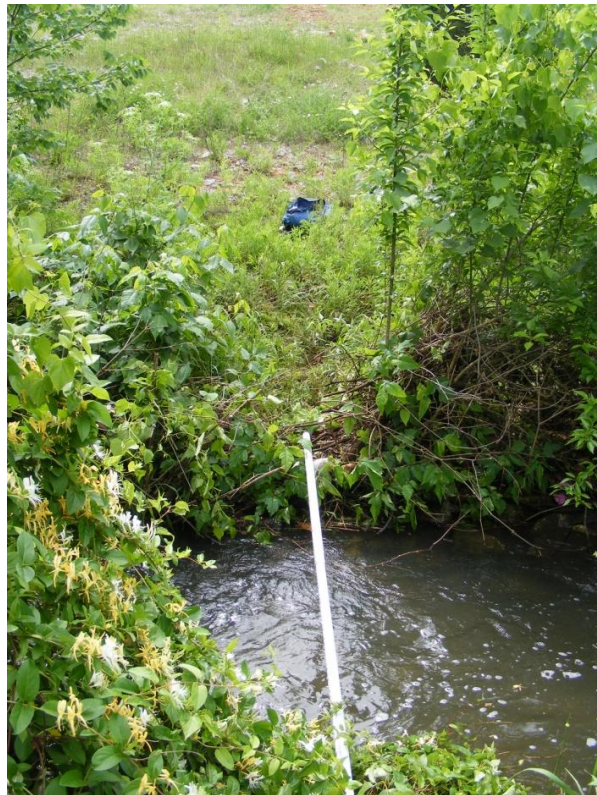
Sub-Reach 13 – (2,550 – 2,800 ft) **Bedrock channel with stable rip-rap bank material** (Photos 47 and 48). There is evidence of floodplain scour at high flows due to narrow “valley” between the bedrock cut wall and the off ramp from National, but bedrock appears to stop further cutting (Photos 49 and 50). Cross-section #8 located at station 2,615 feet.

**Photo 49. SR-13 cross-section #8 (station 2,615 ft) right bank.**

**Photo 50. SR-13 cross-section #8 (station 2,615 ft) left bank.**

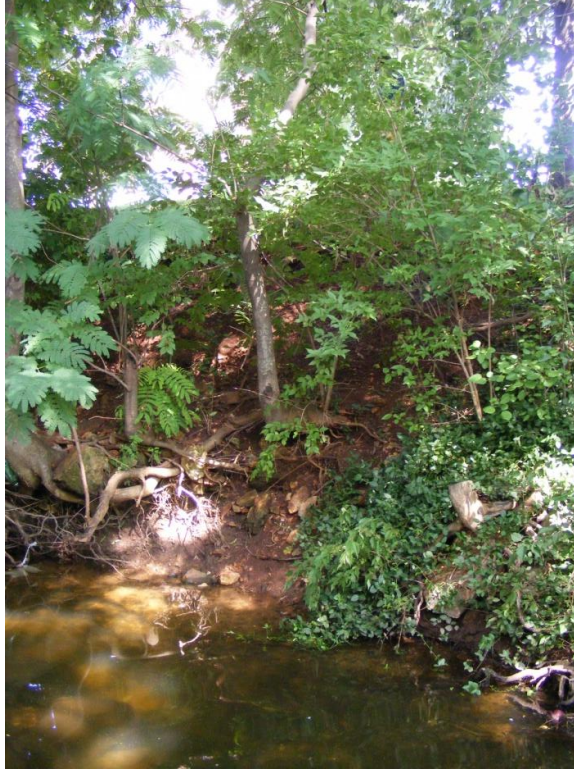
Sub-Reach 15 – (3,750 – 4,000 ft) This reach is located **below the Bradford Lake Dam** and consists of large boulders and construction debris with some bank collapse (Photos 53 and 54). Sediment supply below dam is low and flood peaks are reduced due to impoundment. Channel bank is largely fill on right side and bed elevation appears to have been lowered to meet downstream culvert. Banks are presently slowly eroding towards a lower bank angle but tree roots and boulders keep bank recession rates moderate. Bank erosion rates are also checked by lower shear stress due to controlled peaks below the dam and slope control caused by downstream culvert. However, the right bank between stations 3,750-3,900 ft could destabilize the embankment under Bradford Parkway. The toe of the right bank is 9.5-10 ft lower in elevation and 20-30 ft in horizontal distance from the edge of the curb. Cross-section #9 is located in the reach at station 3,875 ft (Photos 55-58). Additionally, the spillway apron has been undercut about 3 ft exposing the supporting fill material that will continue to deteriorate over time (Photos 59-62).

**Photo 53. SR-15 right bank erosion and slump along Bradford Parkway (station 3,825 ft)**

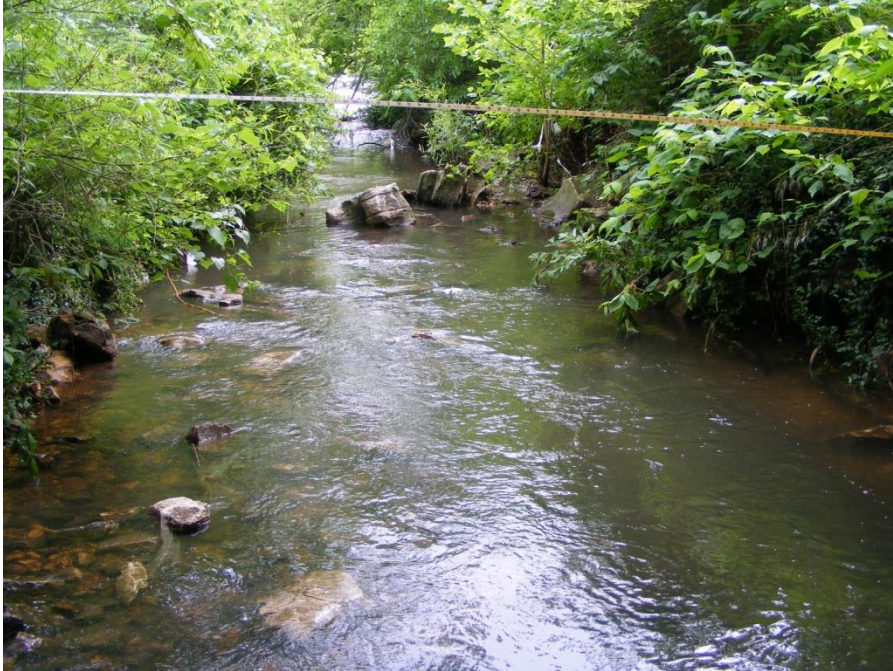
**Photo 55. SR-15 section #9 (station 3,875 ft) looking upstream.**

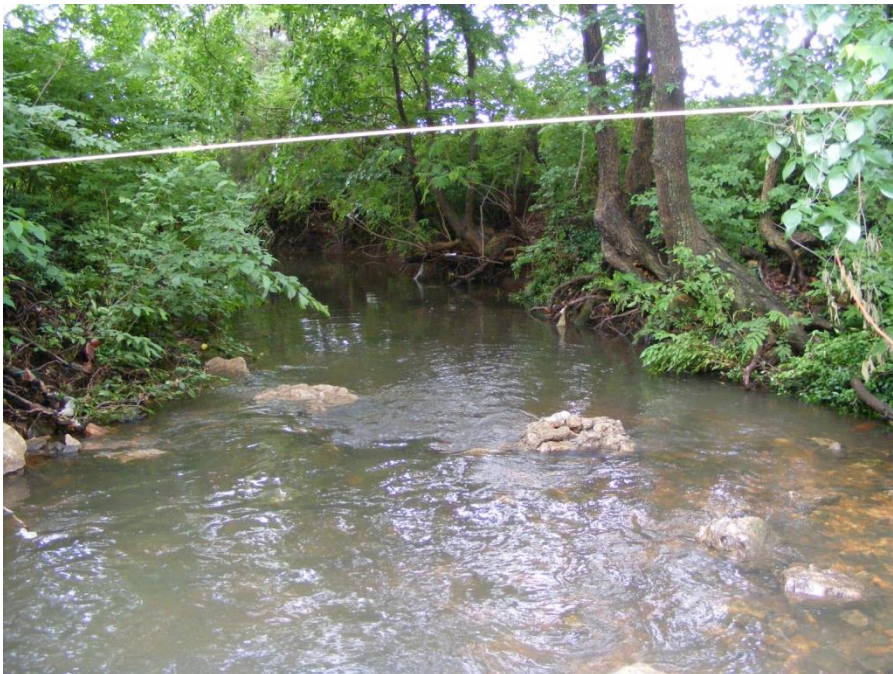
**Photo 56. SR-15 section #9 (station 3,875 ft) looking downstream.**

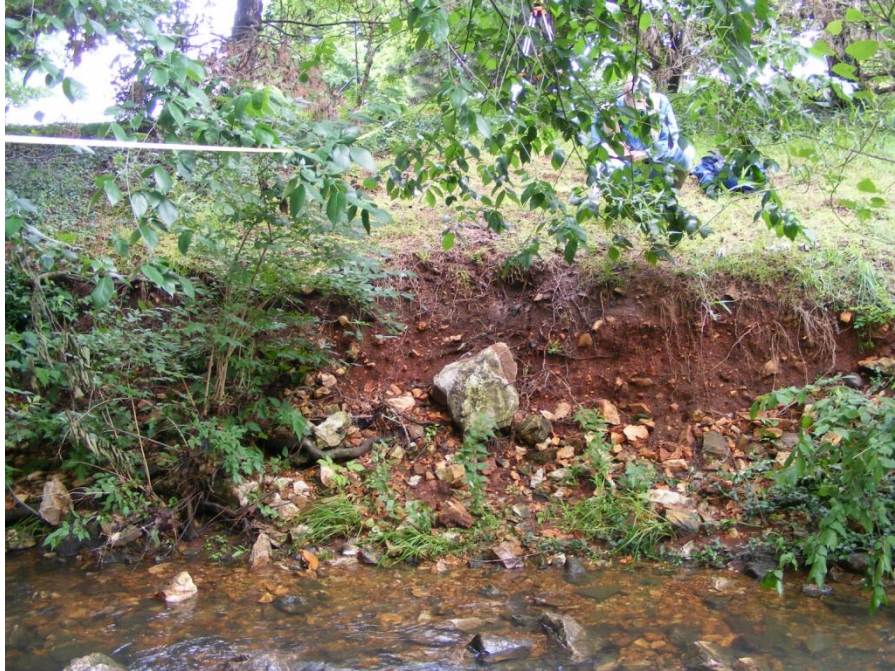
**Photo 57. SR-15 section #9 (station 3,875 ft) right bank.**

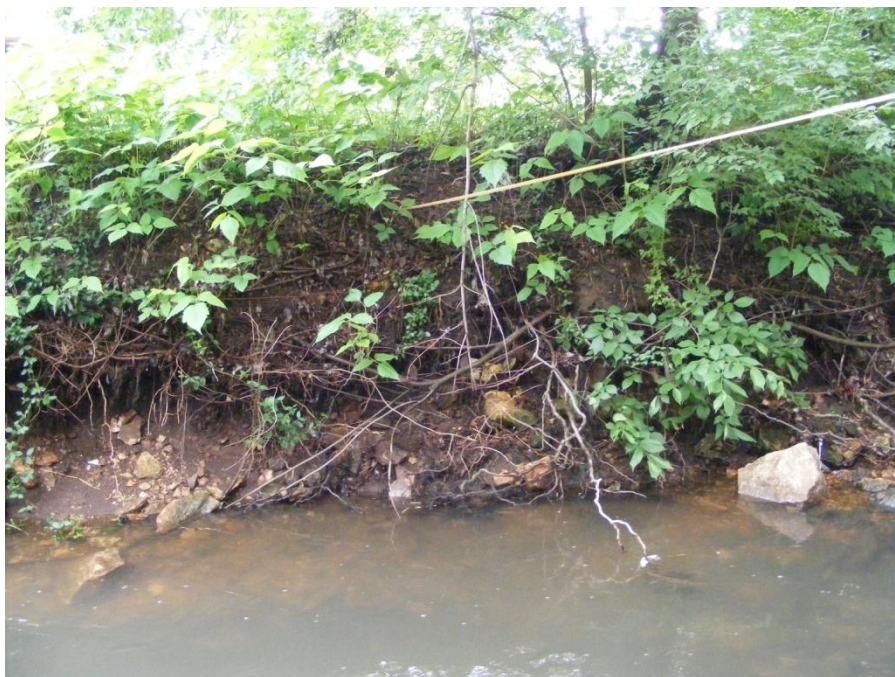
**Photo 58. SR-15 section #9 (station 3,875 ft) left bank.**
