The Ozarks Environmental and Water Resources Institute (OEWRi)

PRE-CONSTRUCTION REPORT FOR THE WARD BRANCH STREAM RESTORATION PROJECT

Completed for: **Greene County, Missouri**

November 14, 2007

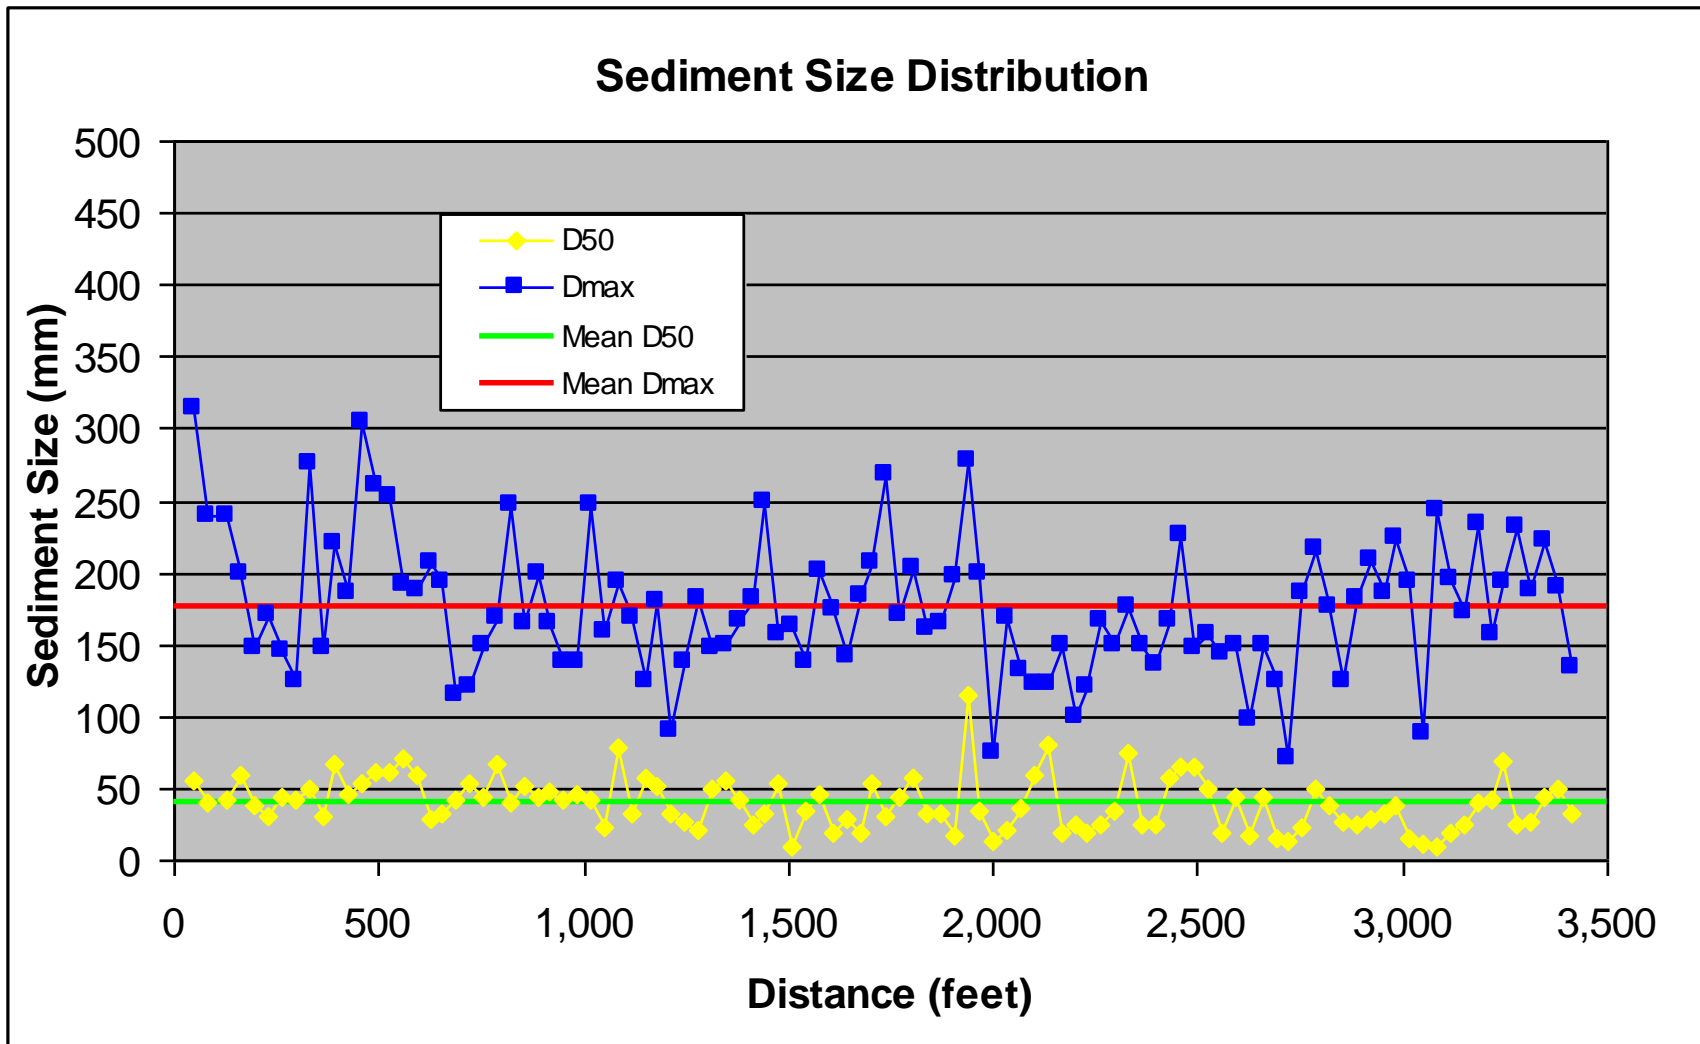
Figure 7. Bed Sediment and Slope

Over 1,000 pieces of sediment at 103 transects were measured along the study reach (Photo 8). Overall, the largest Dmax sediment sizes tend to be found in the upper 2,000 feet of the stream, which is above the first bridge in the subdivision (Figure 7). From station 2,000-3,500 the overall Dmax seems to be lower. This suggests sediment transport potential is higher in the upstream sections. The D50 however is relatively consistent through both the upper and lower section with the exception of the portion of the stream immediately upstream of the first bridge where slopes increase due to the scour hole formed at around station 2,000. The mean D50 was 40 mm (very coarse gravel) and the reach mean Dmax was 176 mm (large cobble). Data collected for bed material evaluation can be found in Appendix G.

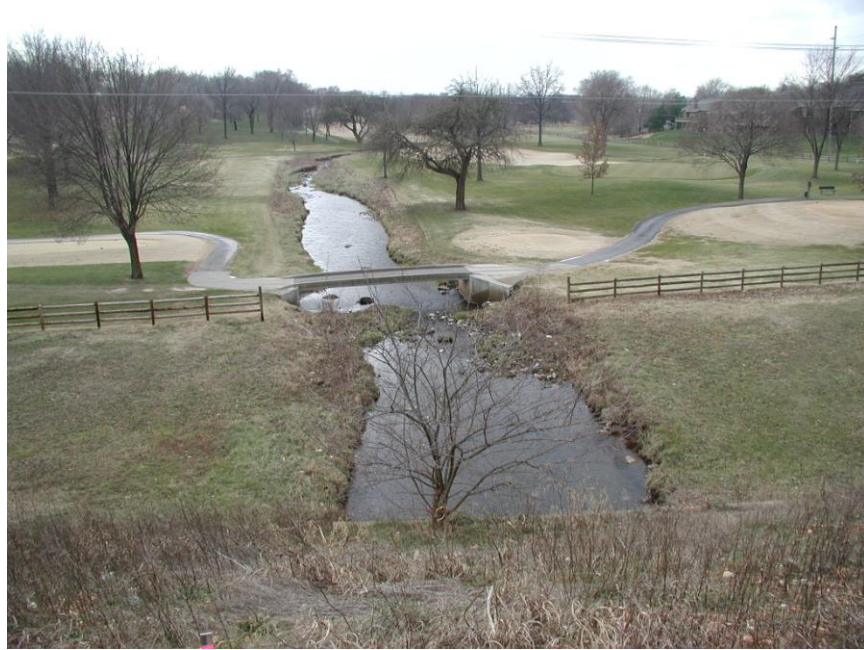
The channel survey begins (0 feet) at the downstream face of the Republic Road culvert at a pool. A riffle crest at approximately 300 feet marks the beginning of a relatively steep reach that extends to 500 feet (Figure 3 and Photos 1 and 2). The slope exceeds 2% through this section and bank heights are relatively low. Bedrock does begin to appear in the channel at 500 feet along the profile suggesting bedrock may be controlling the headcut elevation along this section. Downstream of 500 feet station, bank heights and pool depths begin to rise indicating either a headcut moved through this reach due to bedrock elevation change or the channel was able to cut through fill material or colluvium increasing the bank height due to increased flooding from urban runoff or historical land clearing and row cropping activities. Downstream bedrock appears at a lower elevation along the high right bank between 800 and 1,200 feet along the profile limiting further downcutting. This 400 foot long vertical right bank along the west side of the stream is approximately 6 foot in height (Photo 3).

Photo 1. Looking south at Republic Road

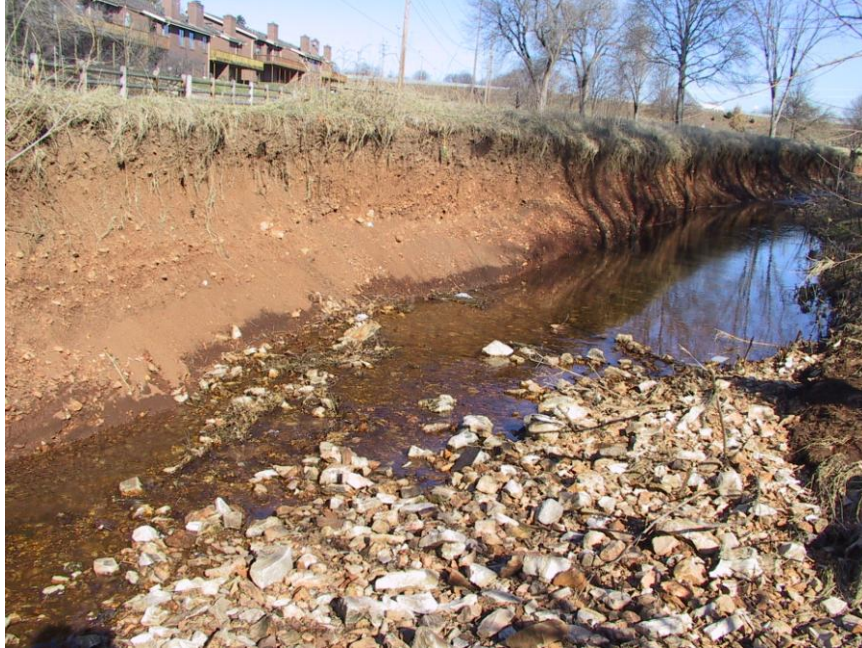
Photo 3. High bank at station 1,000 feet

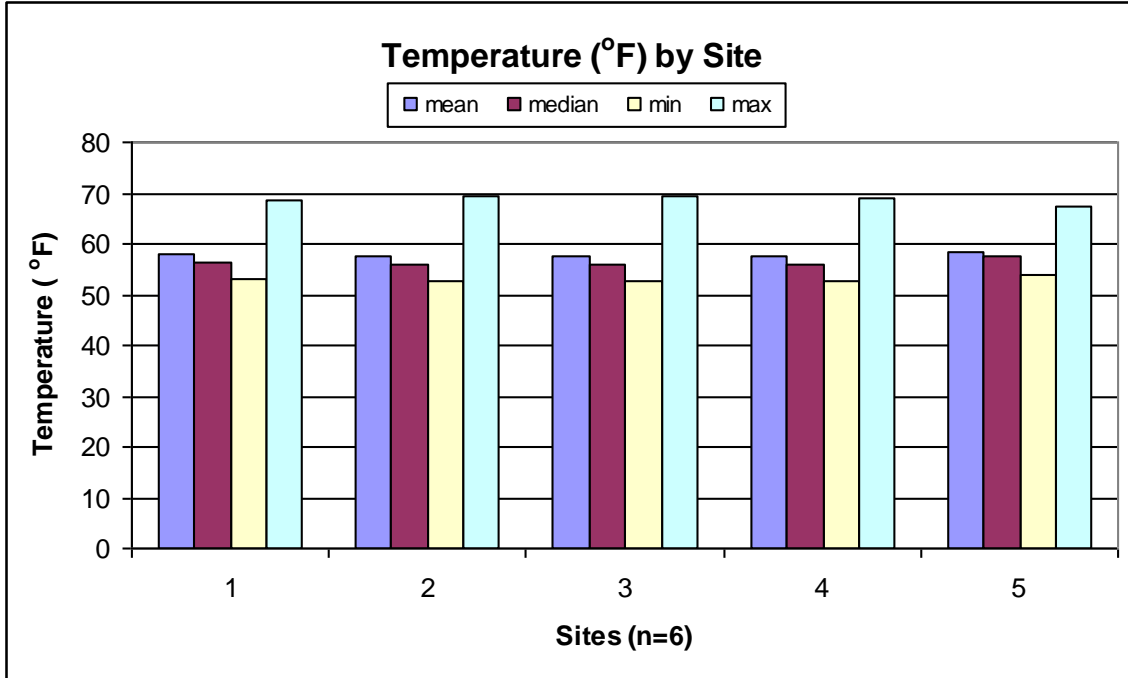
Figure 50. Temperature Data by Site

Mean, median, and minimum temperature values for all 5 sites are between 52-59 °F (Figure 50). Maximum temperature readings were near 70 °F on the September 15, 2005 sampling.
