Quantifying the Effectiveness of Cedar Revetment in Mitigating Bank Erosion in Riceford Creek, Minnesota

A Master's Thesis

Master of Science, Geospatial Sciences

December 2019

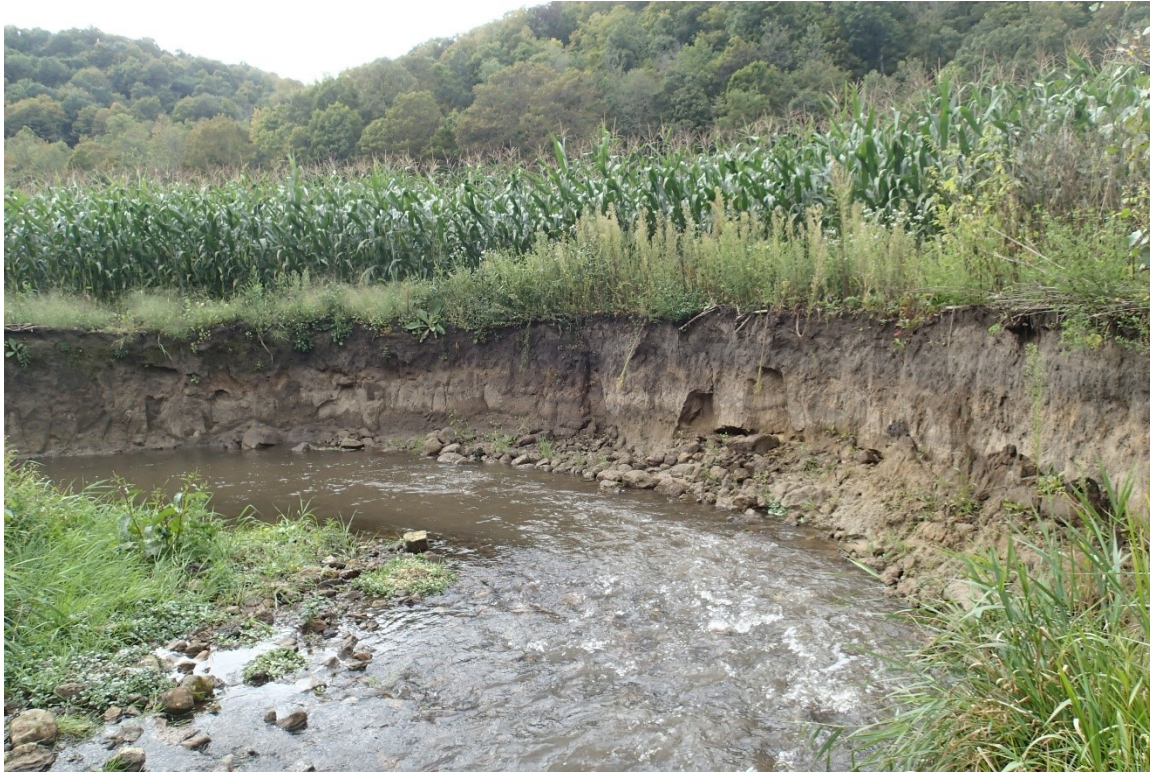
Figure 2. Planting crops directly by stream banks without a buffer exacerbates erosion and was common before buffer laws were adopted. Picture taken in Southeastern Minnesota in September 2013 by Toby Dogwiler and Kat Schroeder.

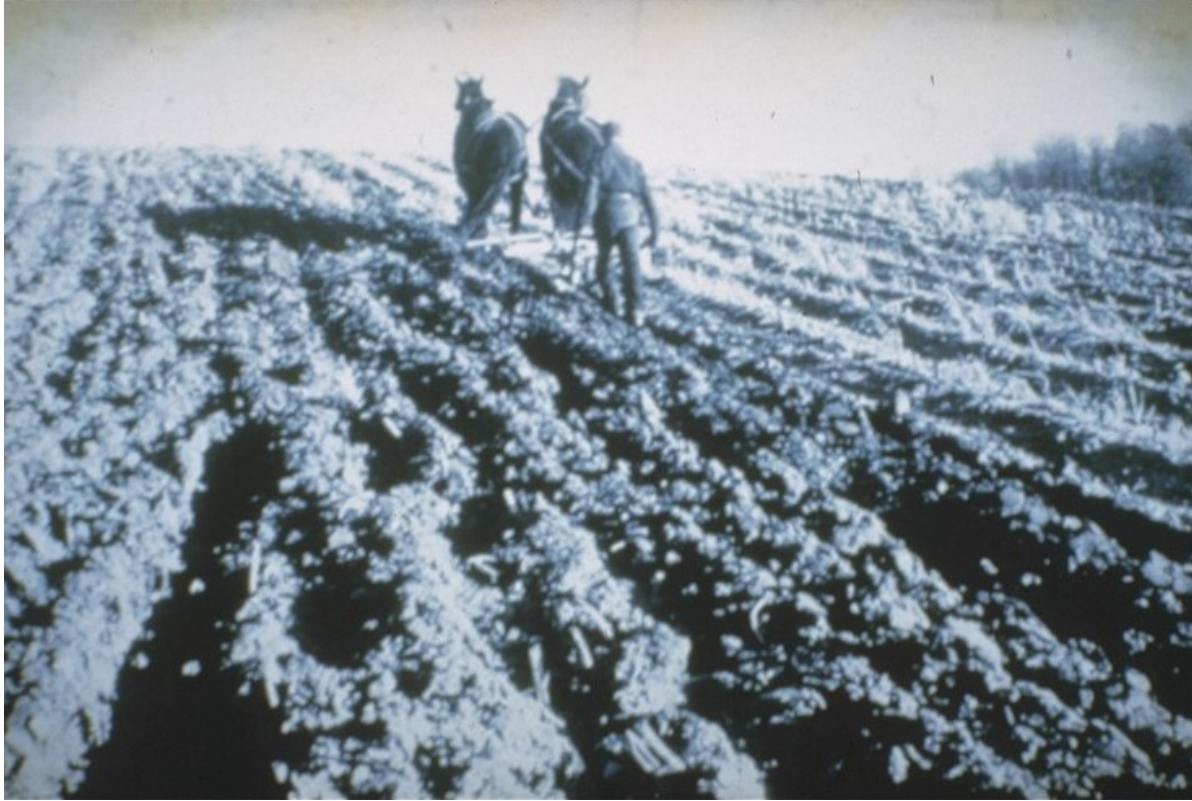
Figure 6. Early farming practices of plowing up and down steep slopes allowed runoff from the frequent and heavy rainfall in the Driftless Area to quickly erode loose soil and easily transport sediment directly to streams. Copy of photo is courtesy of Toby Dogwiler, source unknown.

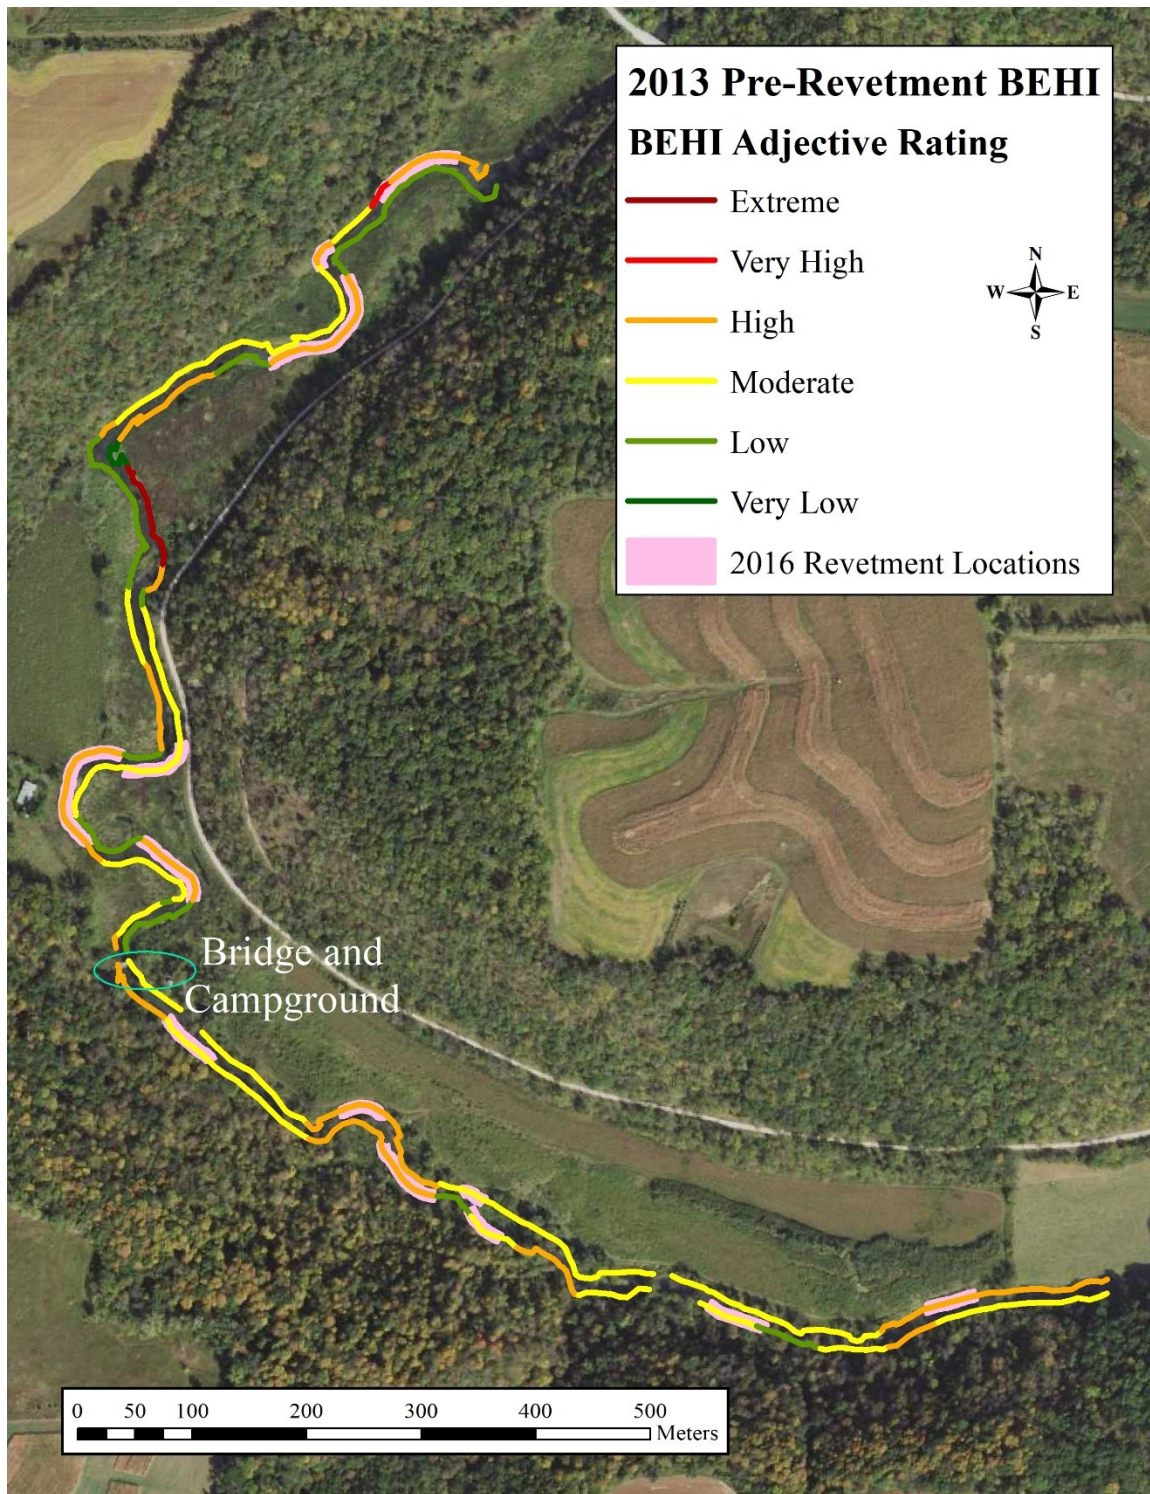
Figure 13. Pre-revetment BEHI classifications of Lea and Sinclair Reaches, Riceford Creek. The pink polygons indicate the stream banks where revetments were installed.

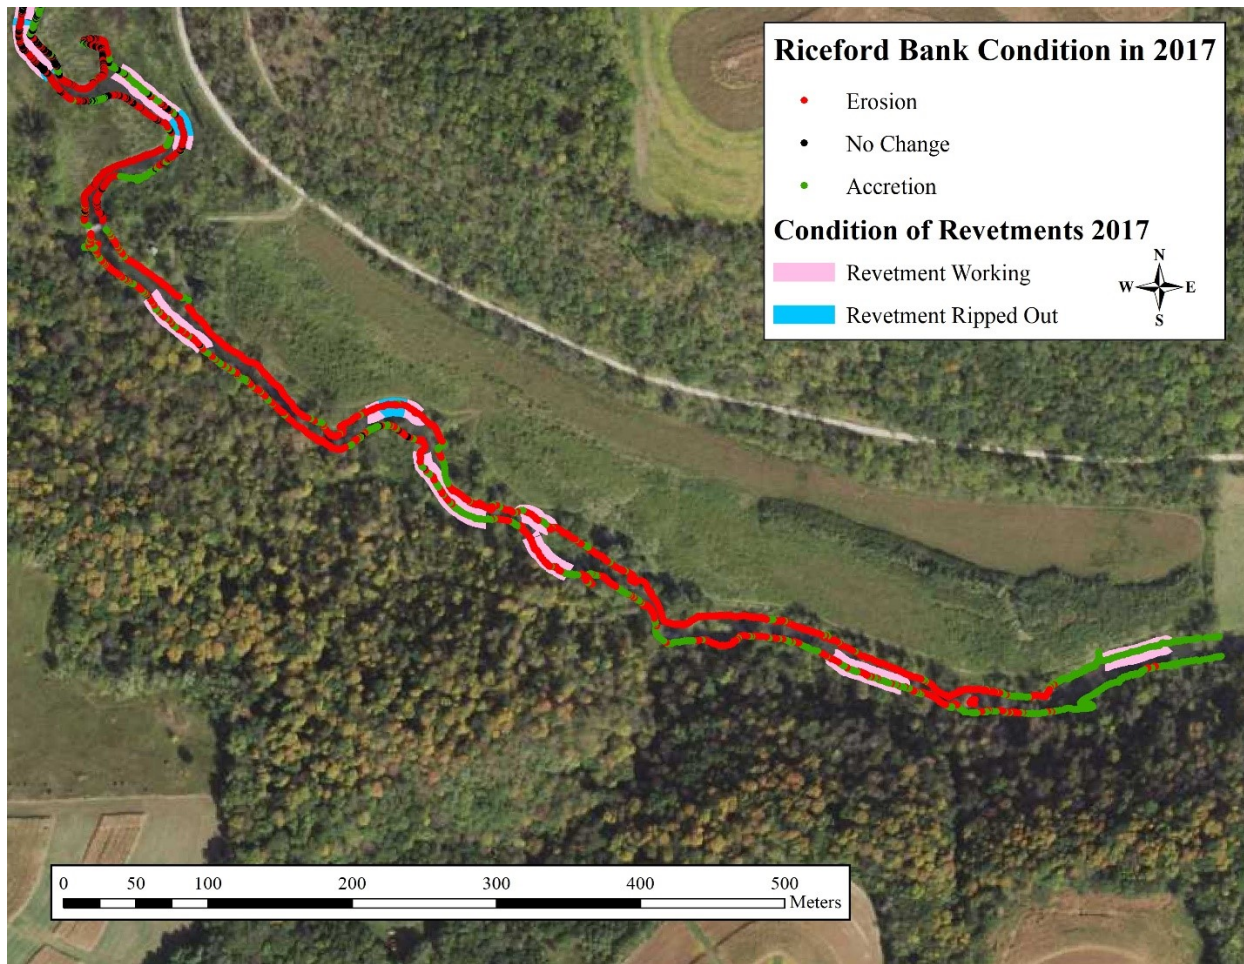
Figure 18. Change in channel position from 2016 to 2017 in the Lea Reach. Red indicates areas where the bank retreated away from the thalweg (i.e., eroded) and green indicates areas where the bank accreted (i.e., deposition in the channel). Black dots are areas of no change.

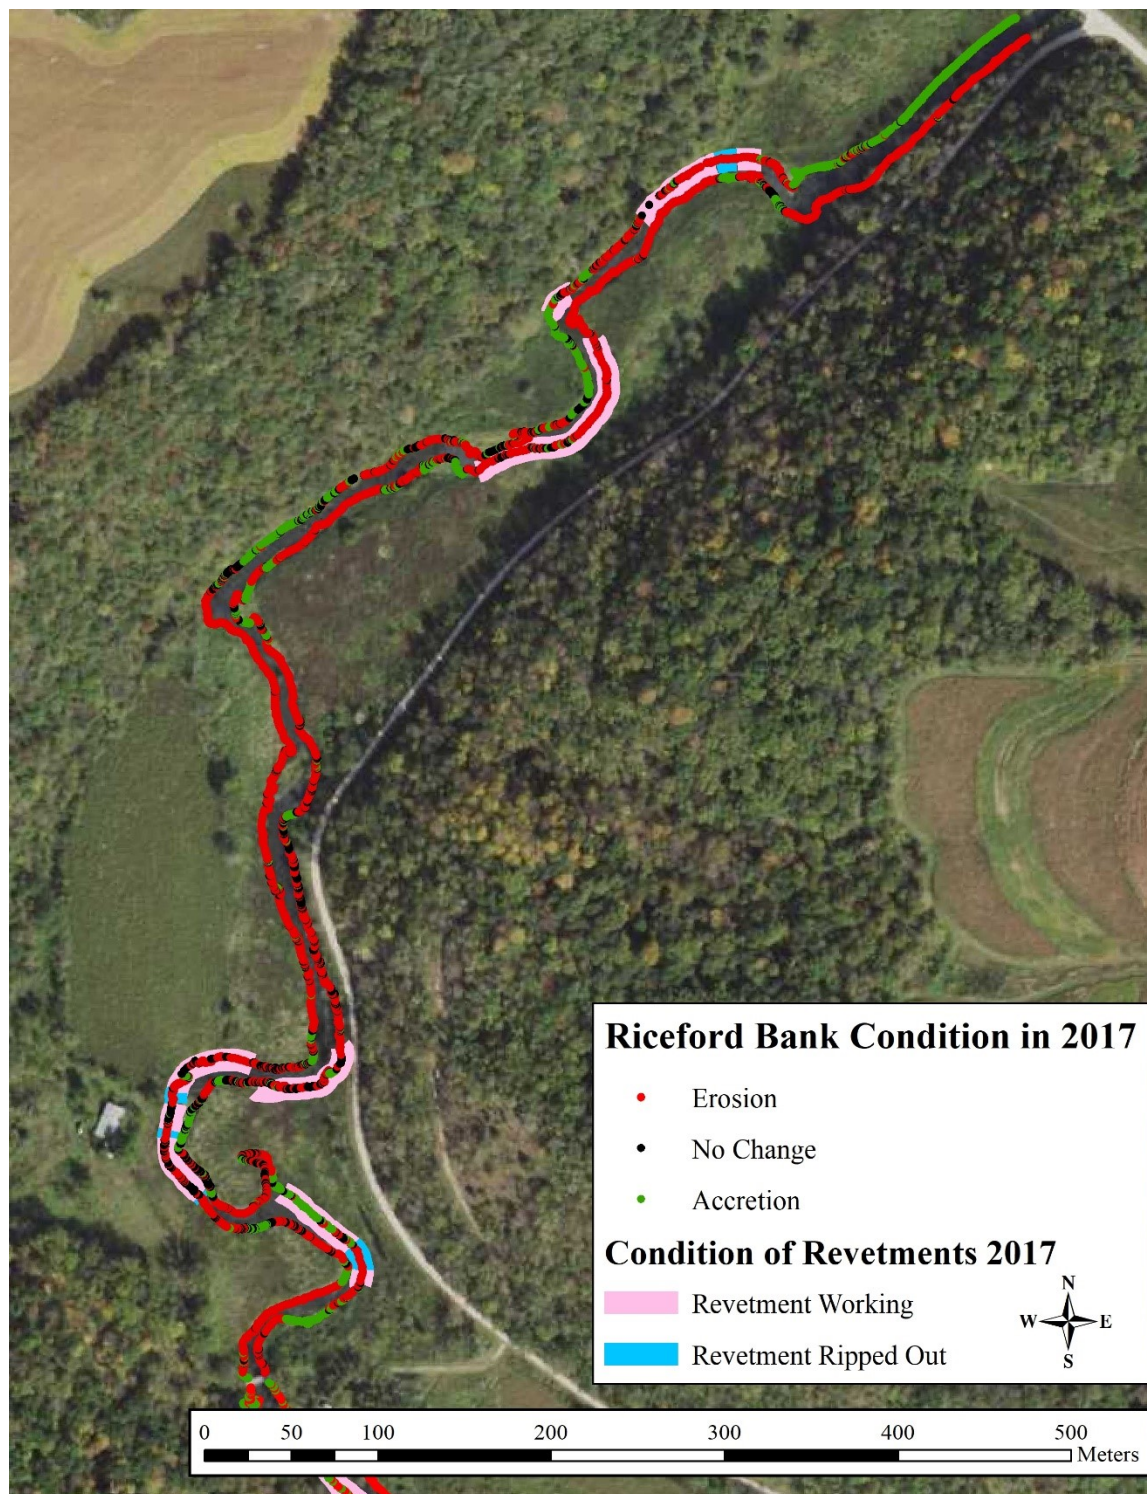
Figure 19. Change in channel position from 2016 to 2017 in the Sinclair Reach. Red indicates areas where the bank retreated away from the thalweg (i.e., eroded) and green indicates areas where the bank accreted (i.e., deposition in the channel). Black dots are areas of no change.

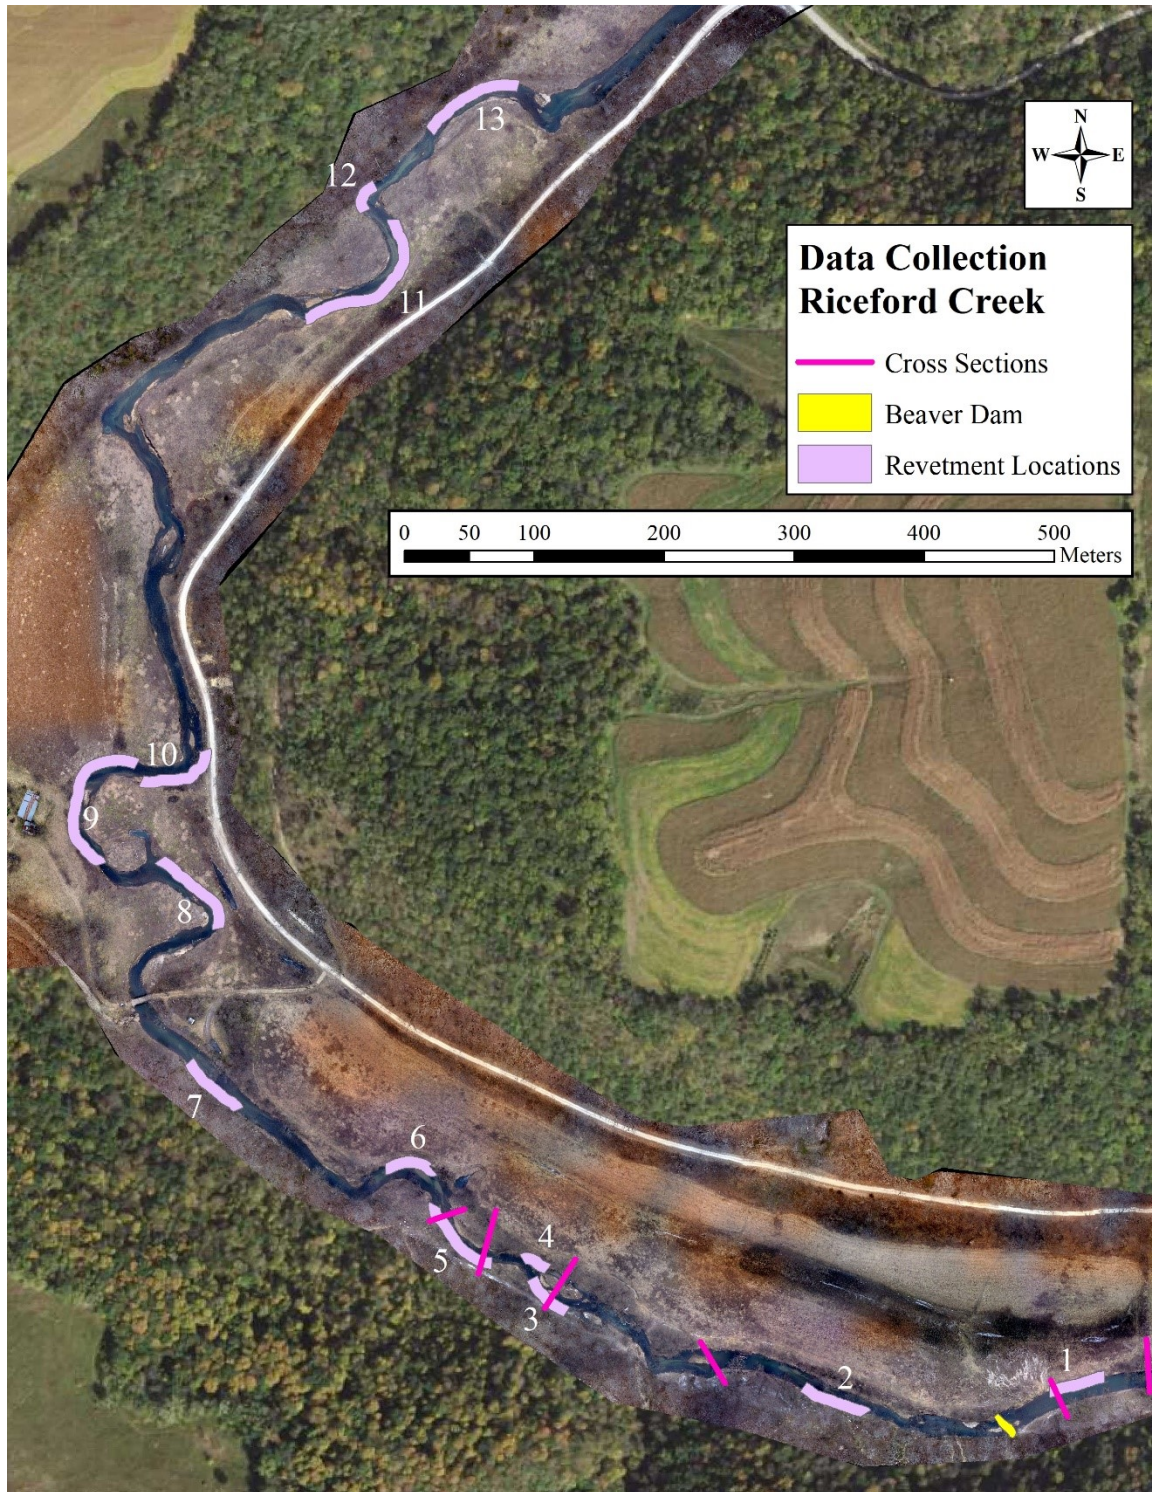
An analysis of how well each revetment performed individually during the flood reveals that while some of the revetments had portions of the revetment washed out (which will be referred to as “damaged”), none of the revetments were completely washed out. Revetment 5 performed best with an average of 0.22 m of accretion (Table 2). The next best performing revetment was Revetment 12 with 0.13 m of accretion. Erosion rates for each revetment in Table 2 were first calculated based on where revetments were originally installed in 2013/2014 (ignoring the fact that some revetments were damaged by being partially washed out). Results show revetments that were damaged generally had more erosion than revetments that stayed intact. The two exceptions are Revetment 3 and Revetment 11.

Table 3 compares how much erosion occurred in areas where revetment stayed intact versus areas where revetment was damaged. Of the 771 m of revetments that were placed, only 61 m (or 7.9% of revetments) were damaged during the 2016 flood. The majority (92.1%) of revetments that were installed successfully stayed intact during a high-flow event and resulted in an average of 0.19 m of erosion. Areas where revetment was damaged had 0.98 m of erosion.

Figure 29. Locations where cedar revetments were placed along the Lea and Sinclair reaches.

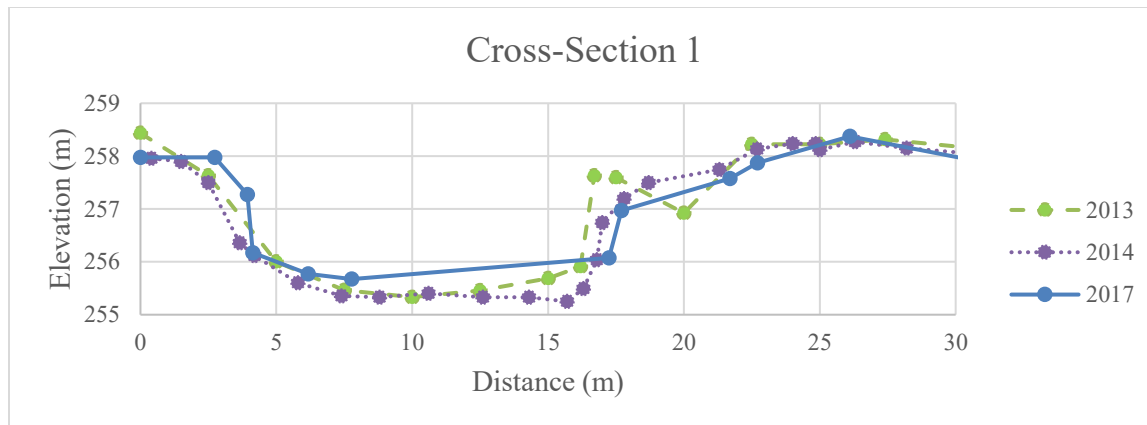
Figure 30. Cross-Section 1 did not receive any revetment treatment. This is located upstream of the beaver dam noted in 2016. The 2017 line is shallower than the previous years, likely partially due to increased sedimentation upstream of the dam.

Cross-Section 1			
Year	2013	2014	2017
Channel Width (m)	11.2	12.6	13.1
DSL Bank Height (m)	1.6	1.8	1.67
DSL Bank Slope	33°	34°	50°
DSR Bank Height (m)	1.7	1.9	0.87
DSR Bank Slope	74°	42°	60°

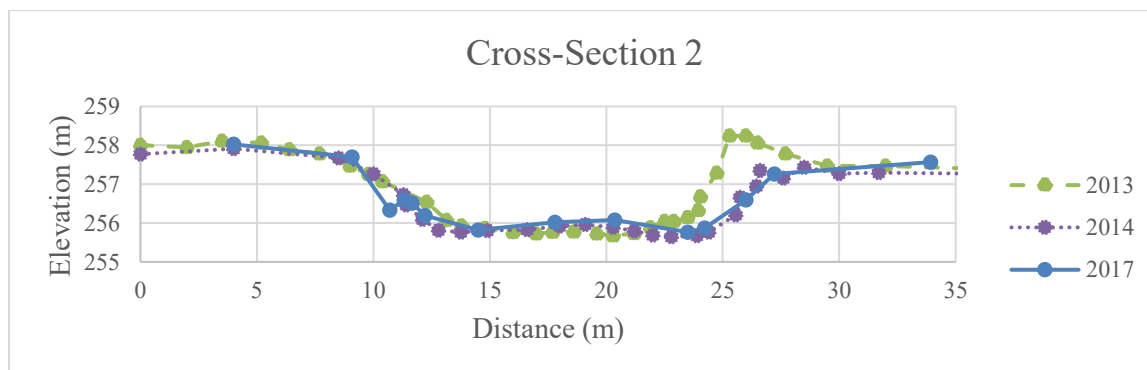
Figure 31. Cross-Section 2 was revetted on the DSR bank. This is located upstream of the beaver dam noted in 2016. The 2017 line is shallower than the previous years, likely partially due to increased sedimentation upstream of the dam.

Cross-Section 2			
Year	2013	2014	2017
Channel Width (m)	12.75	14.95	15.29
DSL Bank Height (m)	1.4	1.9	1.5
DSL Bank Slope	19°	24°	26°
DSR Bank Height (m)	2.1	1.15	1.3
DSR Bank Slope	49°	48°	23°

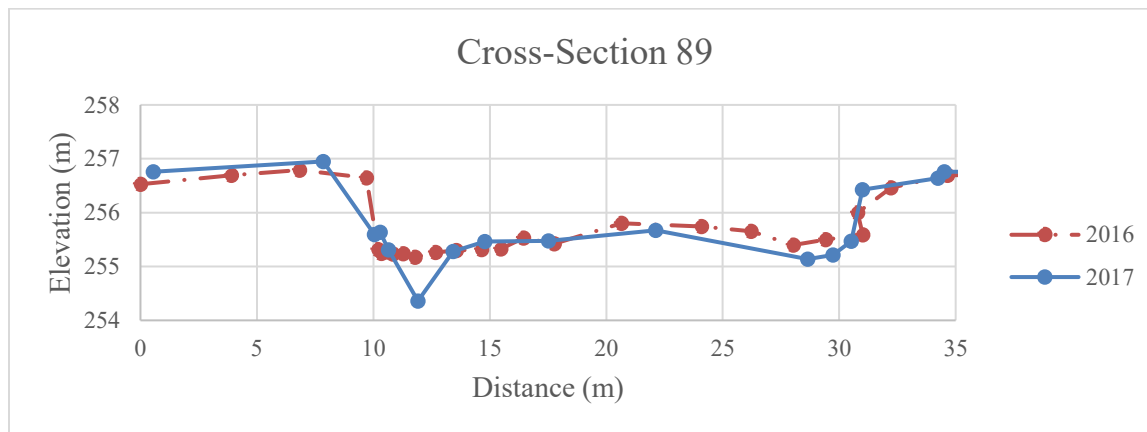
Figure 32. Cross-Section 89 did not get revetted. It was determined to be an analog to Cross-Section 88

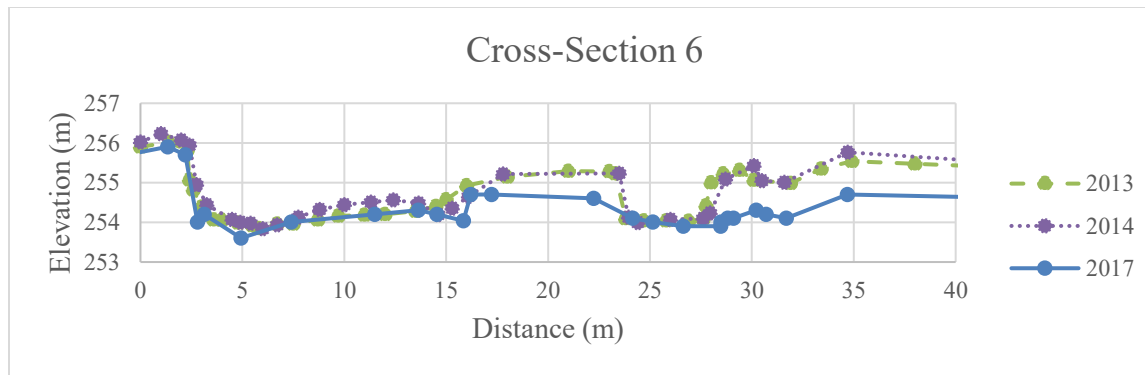
Figure 34. Cross-Section 6 was revetted on the DSL bank.

Cross-Section 6			
Year	2013	2014	2017
Channel Width (m)	24.6	23.45	25.68
Channel DSL to Small Island (m)	-	6.8	8.69
Channel DSL to Main Island (m)	10.5	10.8	13.04
DSL Bank Height (m)	1.44	1.5	1.32
DSL Bank Slope	60°	60°	55°
DSR Bank Height (m)	1.15	1.0	0.4
DSR Bank Slope	49°	42°	13°
Small Island Width (m)	-	3.3	3
Main Island Width (m)	9.3	8.7	7.17
Main Island Height (m)	0.85	0.93	0.37
DSR Channel (m)	3.8	4	4.34

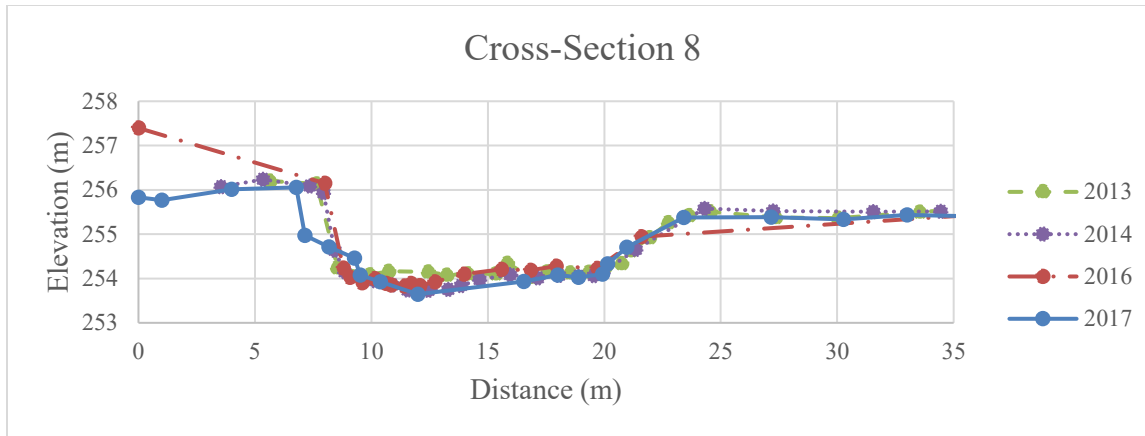
Figure 35. Cross-Section 8 was revetted on the DSL bank. The 2013 data appears much shallower in the channel than all other years. We believe the elevations in the channel are inaccurate, since this is where the 2013 water elevations graph. The data was likely recorded wrong during collection. Even though elevations are off, the channel width and shape are still reasonably accurate.

Cross-Section 8				
Year	2013	2014	2016	2017
Channel Width (m)	11.5	11.1	10.9	10.4
DSL Bank Height (m)	1.9	1.94	2.07	1.98
DSL Bank Slope	65°	52°	69°	36°
DSR Bank Height (m)	1.24	1.44	0.72	1.28
DSR Bank Slope	15°	18°	21°	20°
DSL Upper Bank Height (m)	-	-	-	1.08
DSL Upper Bank Slope	-	-	-	71°
DSL Lower Bank Height (m)	-	-	-	1.06
DSL Lower Bank Slope	-	-	-	18°

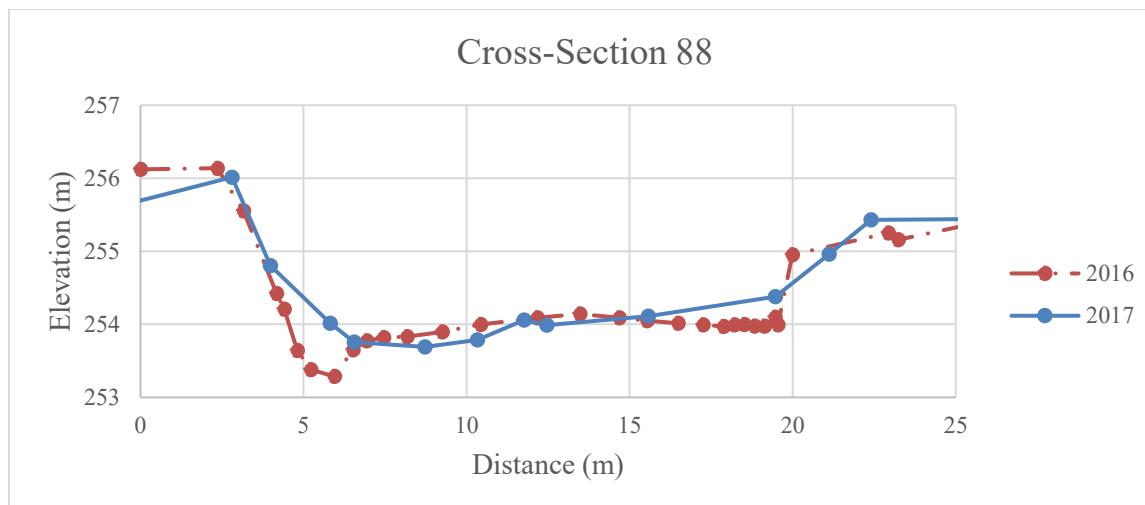
DSR slope became shallower by about 40°. There was a deep scour in the stream bed on the DSL side of the channel in 2016 which is no longer present in the 2017 cross-section. During field work it was noted that the scour had moved about 1 m downstream of the cross-section. This cross-section also had a shallow medial gravel bar in 2016, which was almost completely washed out in 2017 (Fig. 37).

Figure 36. Cross-Section 88 was revetted on the DSL bank. Analog to Cross-Section 89.
