**Ozarks Environmental and Water Resources Institute (OEWRI)
Missouri State University (MSU)**

**PRE-PROJECT WATER QUALITY
MONITORING FOR SOUTH CREEK AT
CAMPBELL AVENUE AND KANSAS
EXPRESSWAY, SPRINGFIELD, MISSOURI
April 1, 2014 – March 31, 2015**

FINAL REPORT

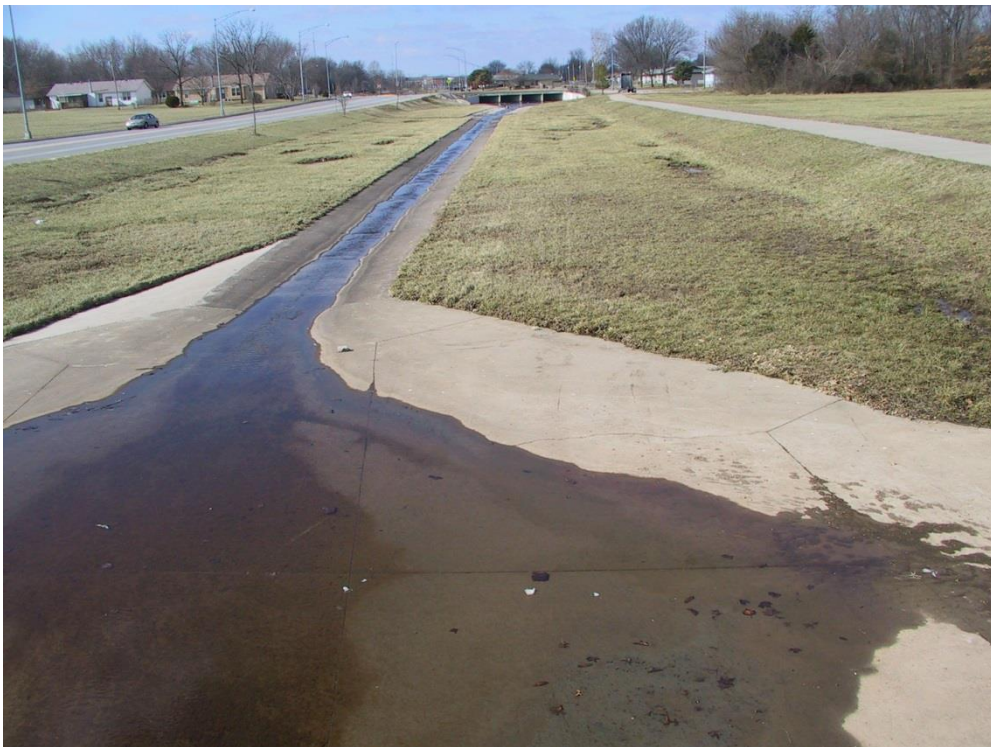
Photo 4. Concrete low flow channel and mowed turf grass riparian corridor downstream of Campbell Avenue.

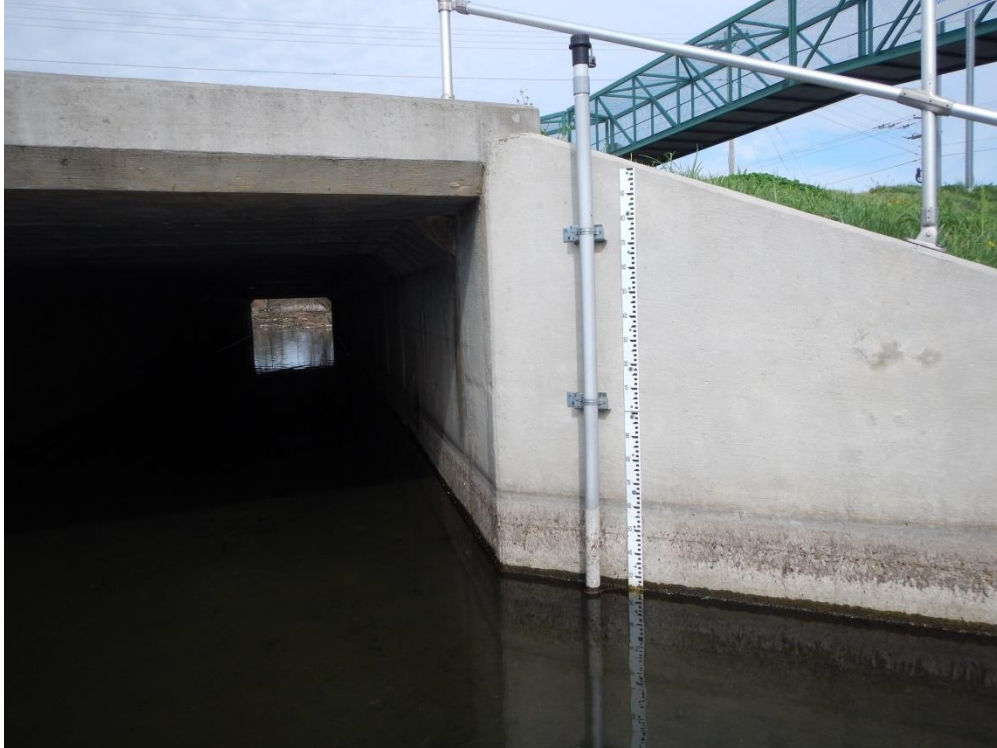
Photo 5. Levelogger and staff gage installed at KAN.

Stage was recorded at both sites every 15-minutes over the monitoring period using Solinst Levellogger and Baralogger levelloggers (OEWR 2012). The levelloggers were installed inside a PVC pipe assembly and secured (Photo 5). As water rises in the pipe the levellogger uses the change in pressure to record changes in the water level. The barologger was used to compensate for barometric pressure changes. Raw data was downloaded from the levelloggers onto a laptop periodically over the monitoring period to create a continuous stage record for each site.

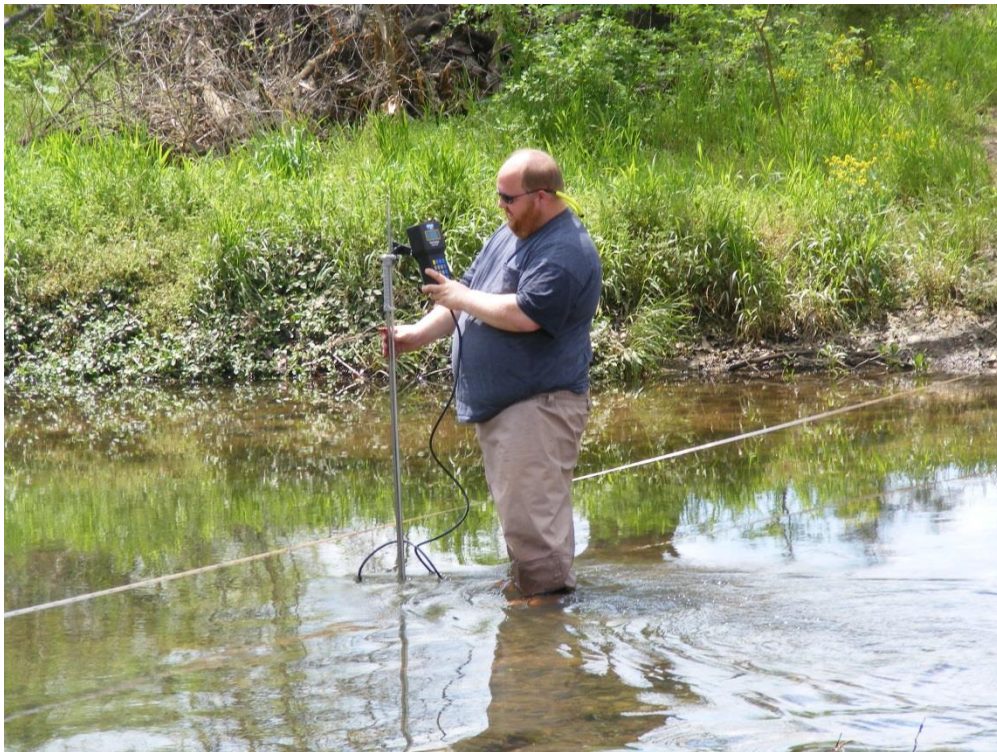
Photo 6. Discharge measurement using the FlowTracker ADP

Stage gages were installed at each site and the channel at both sites were surveyed to calibrate each levellogger. Channel survey data were then used to create discharge rating curves at each site to estimate flows at different stream levels over the monitoring period (Figures 4 and 5, Appendix A). Additional flow measurements were collected using a SonTek FlowTracker Acoustic Doppler velocity meter in the field to verify and calibrate rating curves (OEWR 2007e, Photo 6). The highest calibration flows were provided by the City of Springfield Storm Water Division. Flow frequency curves were created using the levellogger readings in 1% increments over the monitoring period using discharge rating curve equations.
