**Ozarks Environmental and Water Resources Institute (OEWRI)
Missouri State University (MSU)**

**PRE-PROJECT WATER QUALITY
MONITORING FOR SOUTH CREEK AT
CAMPBELL AVENUE AND KANSAS
EXPRESSWAY, SPRINGFIELD, MISSOURI
April 1, 2014 – March 31, 2015**

FINAL REPORT

OEWRI EDR-15-002

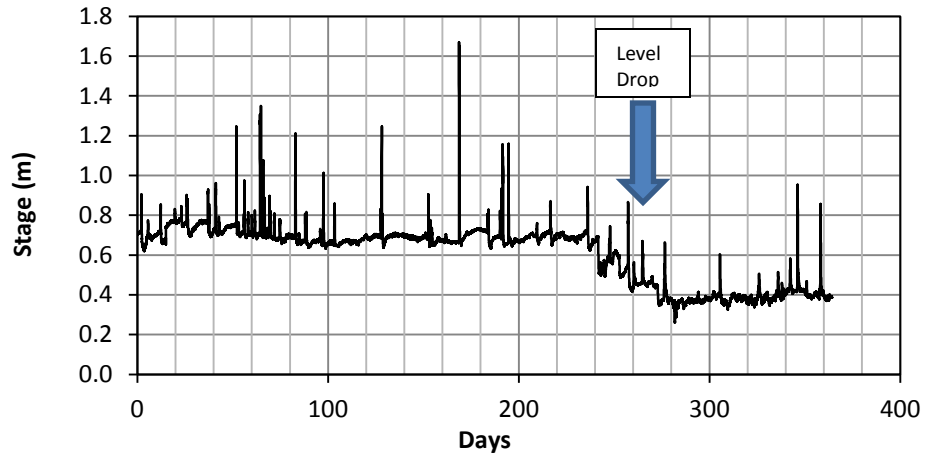
Figure 5. Monitoring period stage readings for KAN.

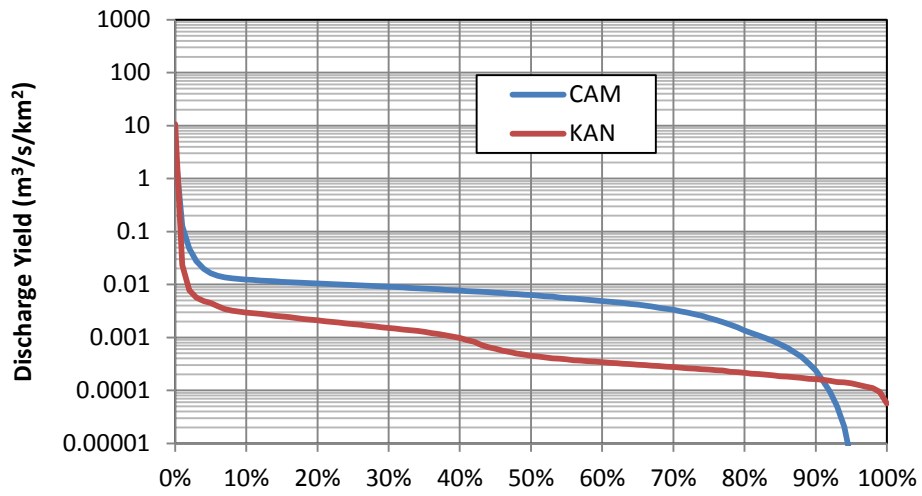
Figure 6. Flow frequency curve for CAM and KAN.

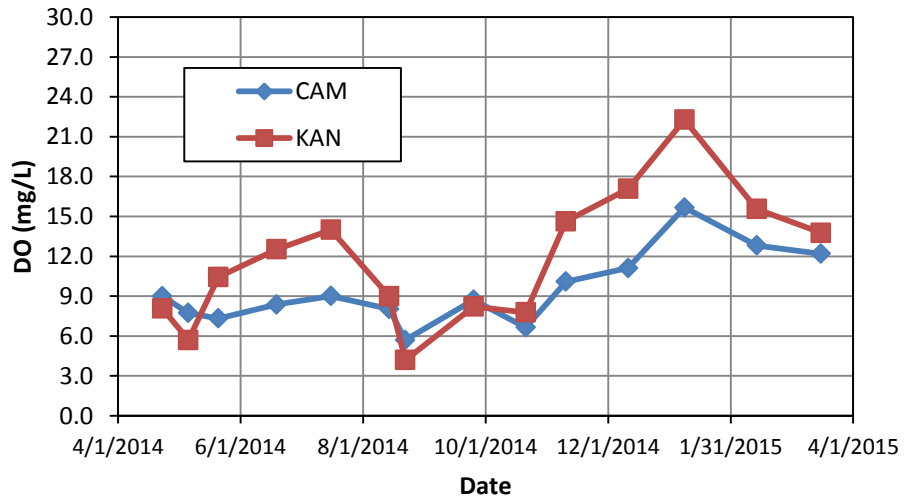
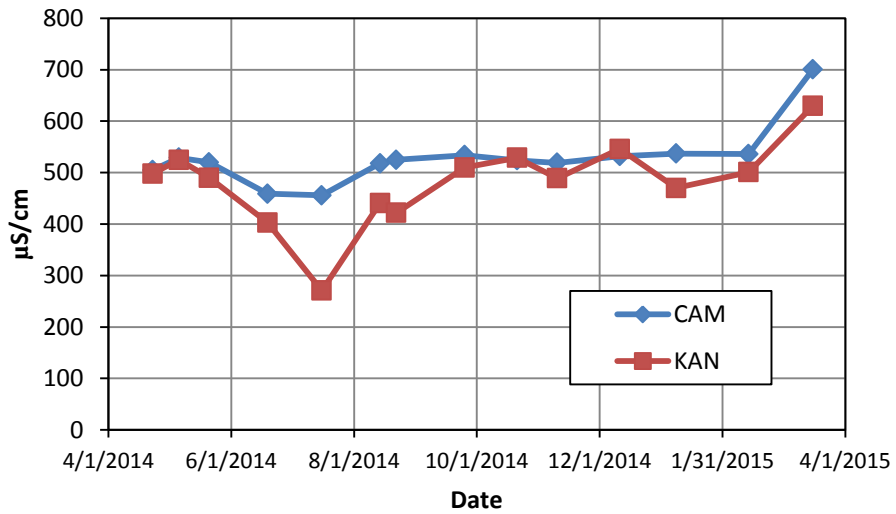
Figure 7. Water chemistry parameter comparison between CAM and KAN at base flow.

Analysis of paired base flow values of T, DO and SC over the monitoring period shows the largest variations in water chemistry parameters occur in the summer and winter. The channel conditions at each site appear to make the most impact on T over the monitoring period. The T at KAN varied from 0-30°C over the monitoring period, while it only varied from 5-20°C at CAM (Figure 7). The channel above Campbell is natural, more narrow and shaded by trees in contrast to the channel below Campbell which is a flat concrete channel without shade. This is especially true in the summer where the biggest variation occurs when T at KAN can be 5-10°C higher than at CAM. Similarly, DO is 5-6 mg/L higher at KAN compared to CAM suggesting the increase in DO is due to photosynthesis occurring in the water standing under the bridge from the pond downstream and is mixing with the water flowing down from CAM. Base flow SC is similar at both sites throughout much of the monitoring period.

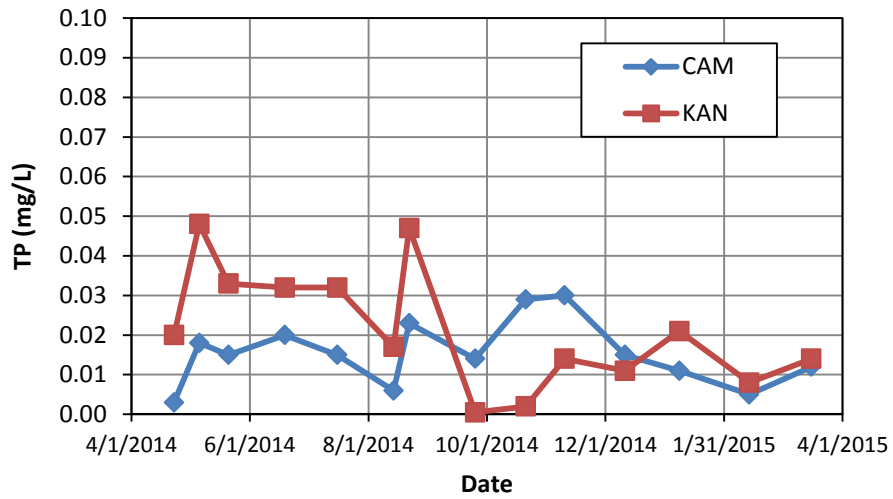
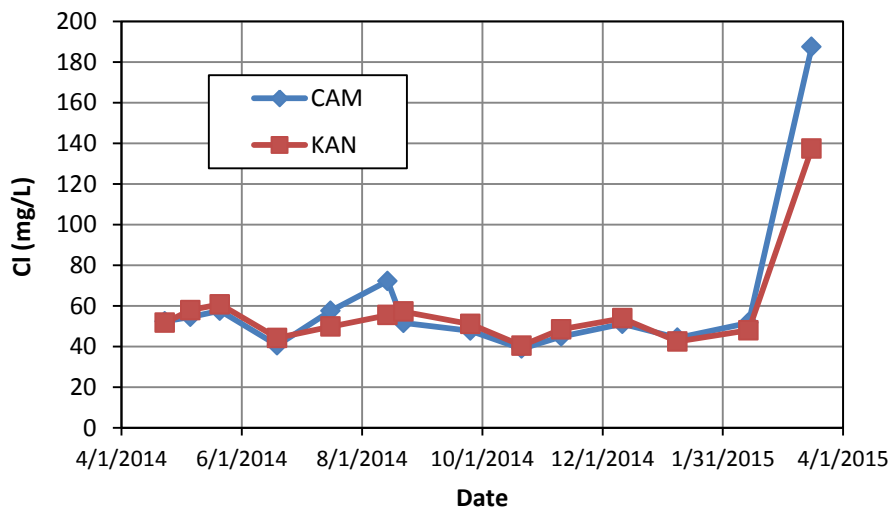
Figure 8. Nutrient and chloride comparison between CAM and KAN at base flow.

Paired sample time-series analysis of base flow nutrients shows seasonal shifts between sites while Cl concentrations remain relatively consistent over the monitoring period. Concentrations of TP are higher at KAN for most of the year, except for in the winter when they are actually lower than at CAM (Figure 8). However, TP concentrations at both sites remain well below the TMDL eutrophic threshold of 0.075 mg/L at base flow throughout the year. Concentrations of TN are higher at CAM during the warmer months of the monitoring period and are similar to KAN during the colder months. Over the entire monitoring period concentrations of TN at CAM were above the TMDL eutrophic threshold of 1.5 mg/L and above that limit from October-March at KAN. Concentrations of Cl remain consistently similar at both sites throughout the year.

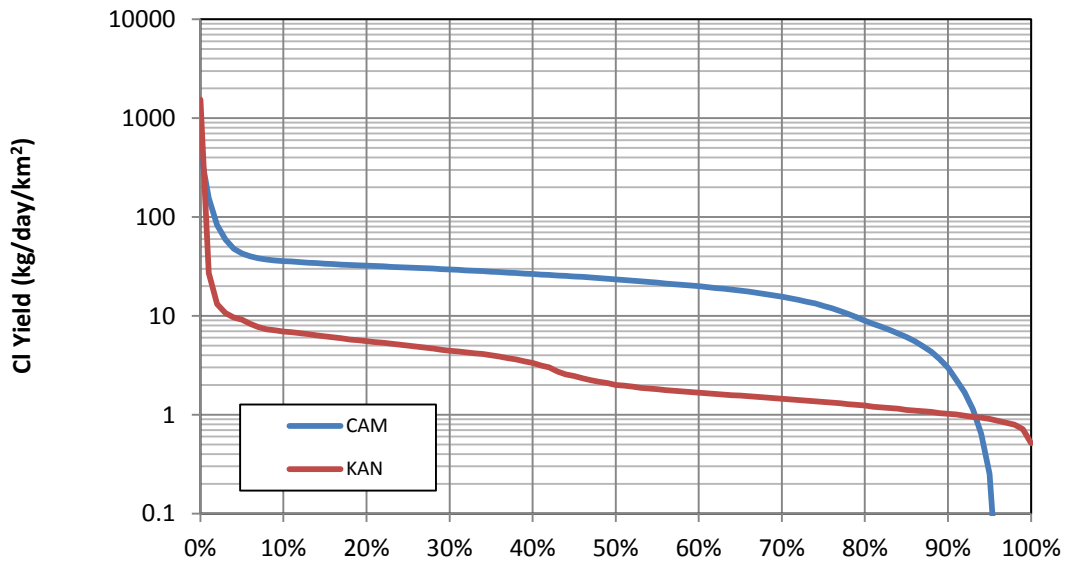
Figure 12. CI yield duration curve for CAM and KAN.

The annual Cl load at CAM is 54.0 Mg/yr with an average flow weighted concentration of 13.9 mg/L Cl (Table 6). The annual Cl load at KAN is 66.8 Mg/yr with an average flow weighted concentration of 4.52 mg/L. The annual Cl yield for CAM is 11.3 Mg/km²/yr and at KAN is 7.77 Mg/km²/yr. The yield duration curve shows Cl is higher at CAM most of the year (Figure 12).

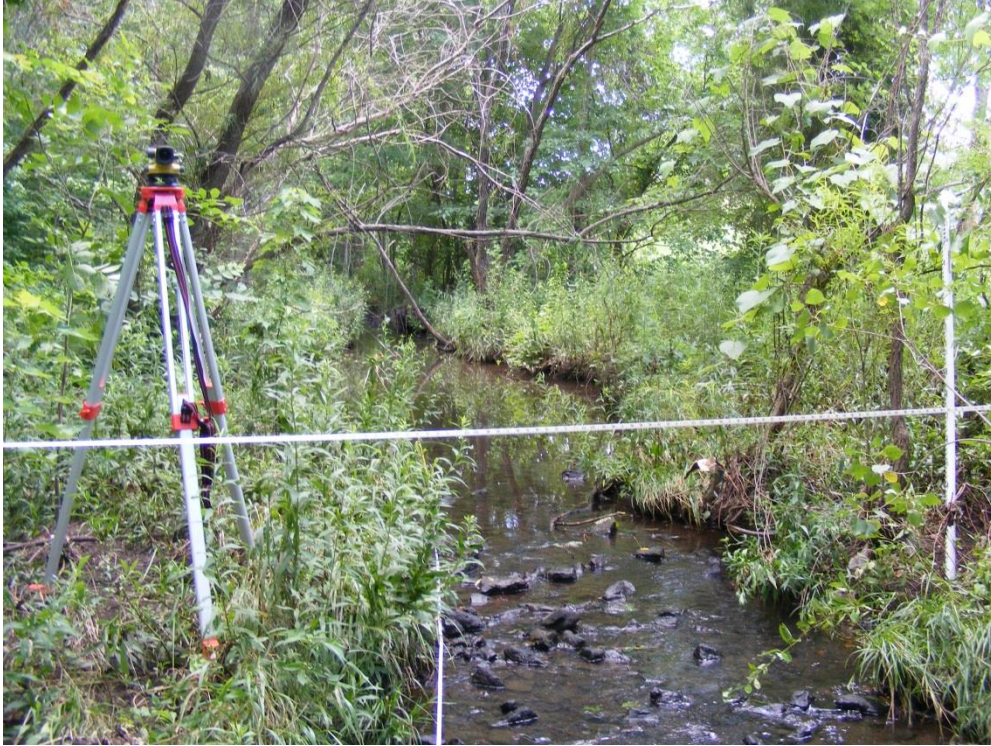
Photo 3. Natural stream bed and vegetated riparian corridor upstream of Campbell Avenue.

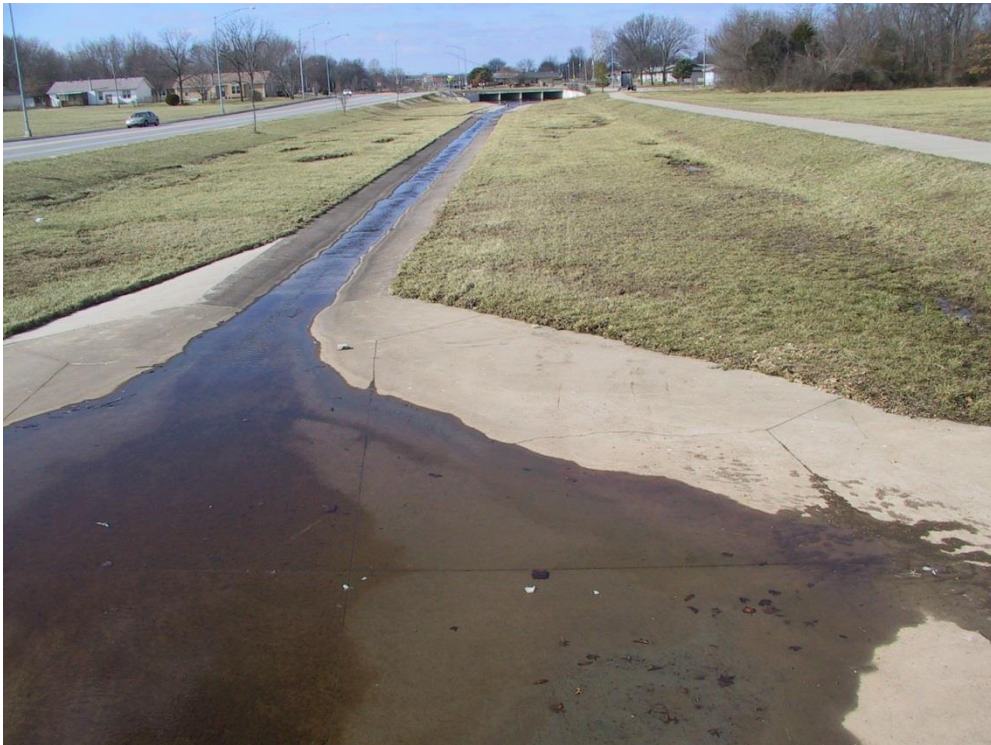
Photo 4. Concrete low flow channel and mowed turf grass riparian corridor downstream of Campbell Avenue.

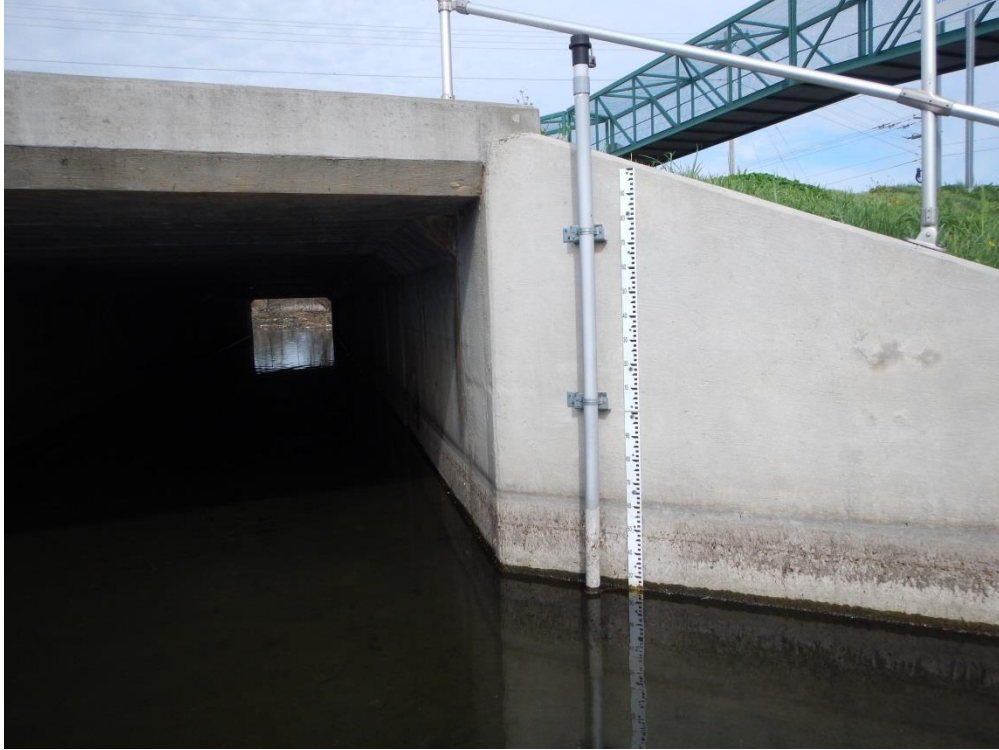
Photo 5. Levellogger and staff gage installed at KAN.

Stage was recorded at both sites every 15-minutes over the monitoring period using Solinst Levellogger and Barologger levelloggers (OEWR 2012). The levelloggers were installed inside a PVC pipe assembly and secured (Photo 5). As water rises in the pipe the levellogger uses the change in pressure to record changes in the water level. The barologger was used to compensate for barometric pressure changes. Raw data was downloaded from the levelloggers onto a laptop periodically over the monitoring period to create a continuous stage record for each site.

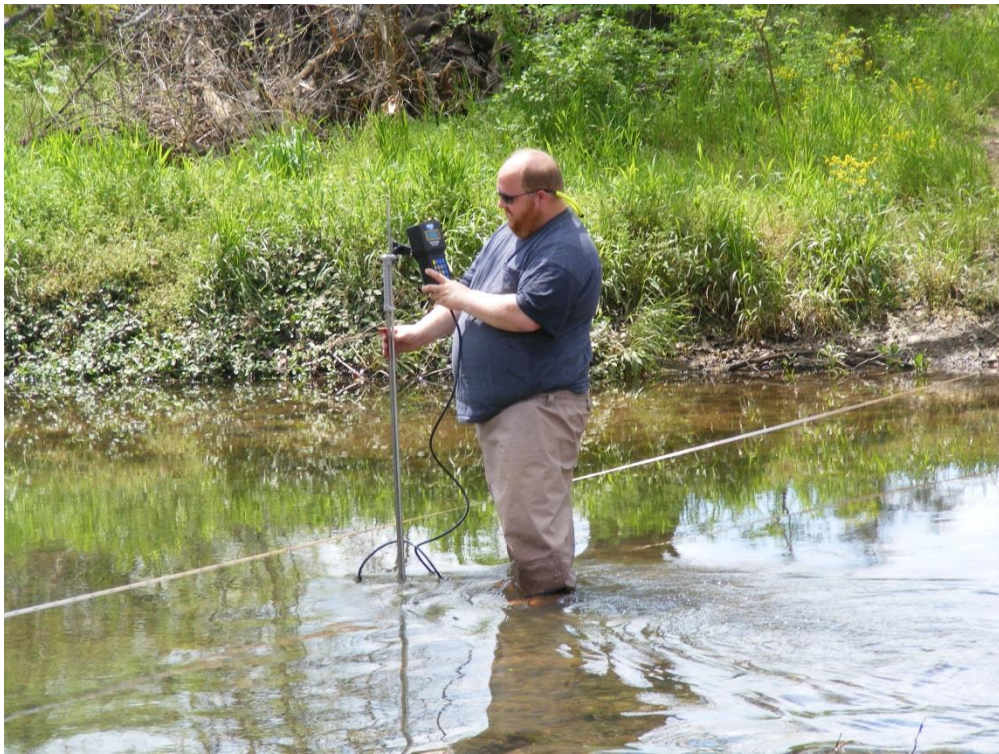
Photo 6. Discharge measurement using the FlowTracker ADP

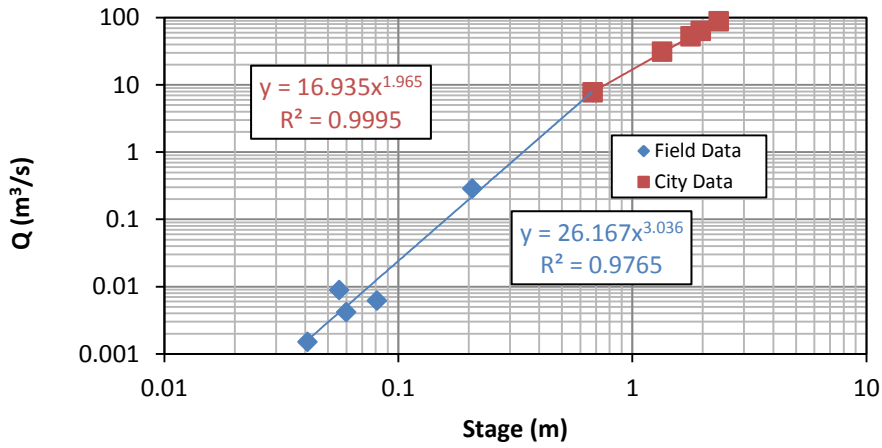
Figure 13. Discharge rating curve for CAM.

Stage gages were installed at each site and the channel at both sites were surveyed to calibrate each levellogger. Channel survey data were then used to create discharge rating curves at each site to estimate flows at different stream levels over the monitoring period (Figures 4 and 5, Appendix A). Additional flow measurements were collected using a SonTek FlowTracker Acoustic Doppler velocity meter in the field to verify and calibrate rating curves (OEWR 2007e, Photo 6). The highest calibration flows were provided by the City of Springfield Storm Water Division. Flow frequency curves were created using the levellogger readings in 1% increments over the monitoring period using discharge rating curve equations.

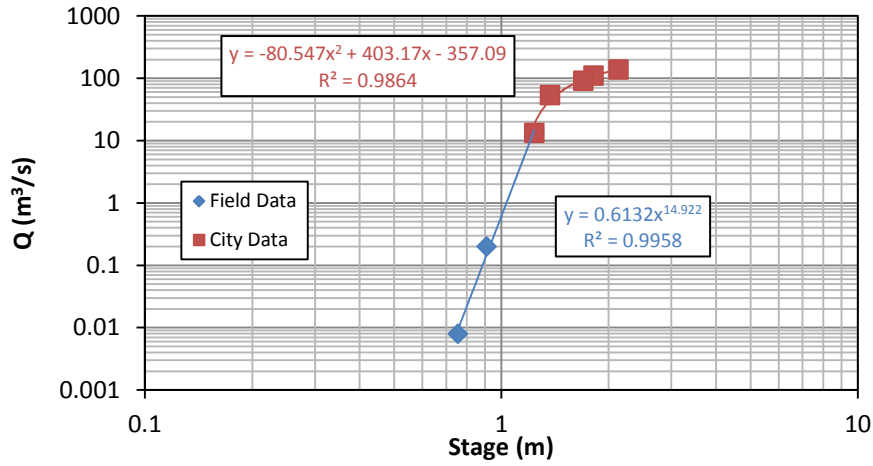
Figure 14. Discharge rating curve for KAN for the first 240 days.

A shift in the stage-discharge rating curve occurred in the middle of the monitoring period at KAN making it necessary to adjust the rating curve over that period. In November of 2014, the pond downstream of KAN started holding back less water, lowering the base flow level over 30 cm in 40-days (Figure 5). After that 40-day period, the base flow stage was fairly consistent. An additional discharge measurement was collected to shift the lower portion of the rating curve to better reflect the new condition. The 40-day period during the active lowering of stage, discharge was estimated using a straight line between the two stable base flow periods representing the average flows over that period. Consequently, the discharge estimates over those 40 days are not as accurate and represent the average flow conditions over that time.

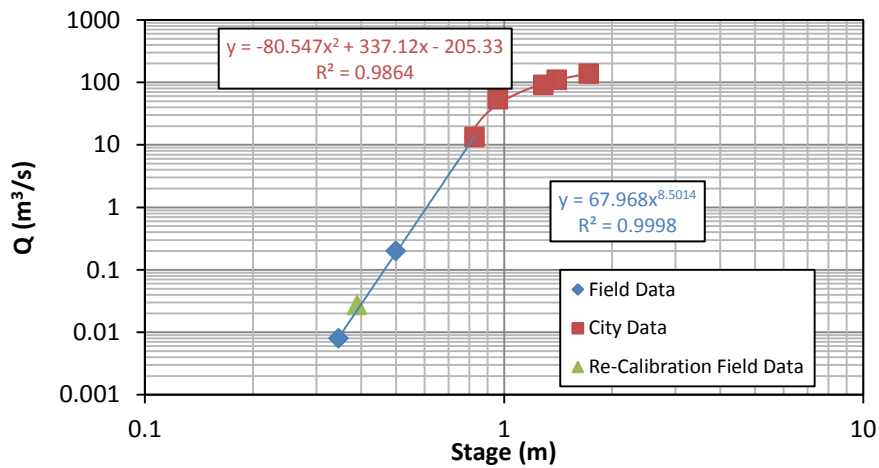
Figure 15. Discharge rating curve for KAN from 280-365 days.

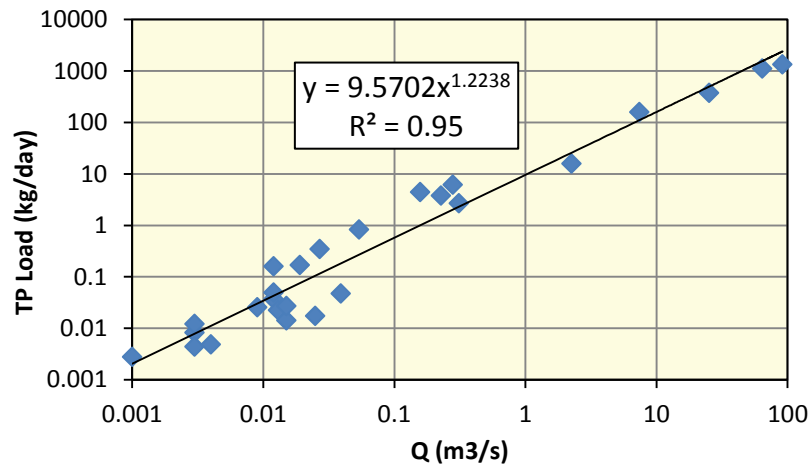
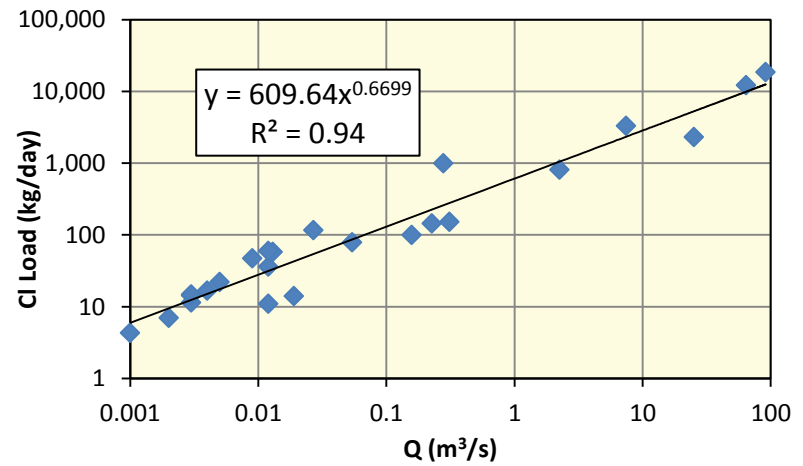
Figure 17. TP, TN, TSS and Cl load rating curves for KAN.
